The Bii Wenii Kwa/Owen Creek watershed, located west of Houston B.C., supports numerous culturally and ecologically important fishes and their habitat. For millennia, the Wet'suwet'en have occupied and relied on the Morice watershed for food and resources, and the confluence of Owen Creek and Morice River is a culturally important fishing area (Wet'suwet'en 2013a). The spiritual relationship between the Wet'suwet'en and the Bii Wenii Kwa provides an intimate connection to their ancestors, and its fish values help ensure community health and overall cultural well being (Wet'suwet'en 2013b). In addition to the area's current and historical significance to the Wet'suwet'en, the watershed is the focus of a variety of industrial, agricultural, and recreational activities.

# 1 WATERSHED OVERVIEW

## 5 BII WENII KWA/OWEN CREEK WATERSHED STATUS — SUMMARY

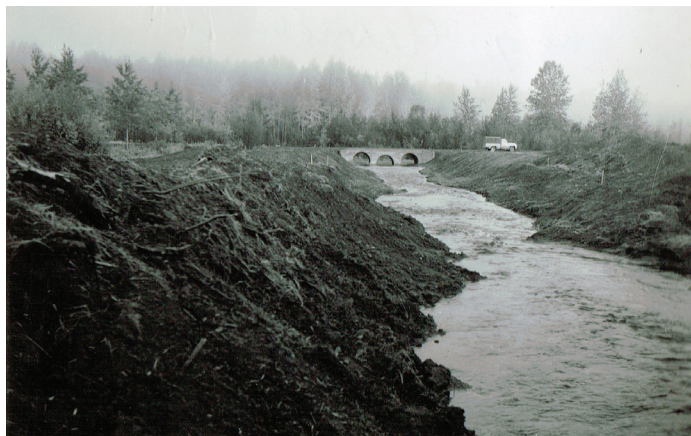
**Figure 2.** Owen Creek channel diversion and new crossing structure at its confluence with the Morice River, circa 1956. (Photo courtesy of the Office of the Wet'suwet'en.)

**(iii) Channel restoration** – The channelization and placement of a hard crossing structure on Owen Creek at the confluence with the Morice River in the mid 1950s (Gottesfeld et al. 2002) saw the loss of important high-value main channel fish habitat. The FSR and bridge have also been problematic from a maintenance perspective as the Morice River migrates toward it. Reintroducing Owen Creek in its entirety back into its original channel is seen as a priority and would result in the recovery of several kilometers of (additional) main channel fish habitat. This work should be integrated with the relocation of the FSR to a stable location that would put the new road location and Owen Creek crossing above the apex of the Owen Creek alluvial fan (several hundred meters south of its current location).

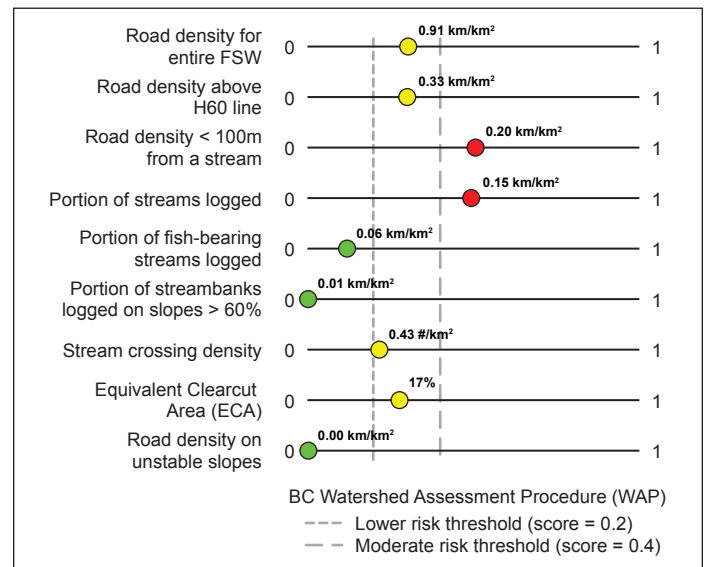
Figure 4 summarizes results from Tier I geospatial data analysis for key watershed pressure indicators. Each indicator is scored against fish-oriented risk benchmarks (Porter et al. 2013). Using 2014 data, 6 out of 9 indicators for the watershed show moderate to high levels of pressure. Specifically, both "roads close to streams" and "streams logged" scored as high. The high "roads close to streams" indicator is important in relation to the Tier II findings (e.g., Morice-Owen and Morice West FSRs) as is "streams logged" for many small streams in the watershed. Table 1 shows a synthesis of Tier II field data representing key components of watershed condition. A green checkmark here indicates a condition within an acceptable range of variability (RAV), whereas a red outcome (X) indicates that a high benchmark has been reached or exceeded, and thus the component condition is considered "impaired" (Pickard et al. 2014). Given that each component (i.e., riparian, fish passage, and sediment) and

**Figure 4.** 2014 Tier I remotely sensed (GIS) indicators of potential risk (Porter et al. 2015). These results closely align with the Wet'suwet'en (2013b) analysis.

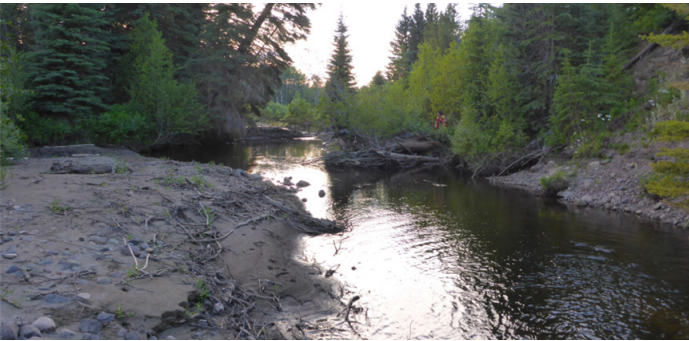
Figure 6. Site #166 — beaver dams, like this one on the right bank located along the lower Owen Creek mainstem, store and release large quantities of accumulated fine sediments when they breach.

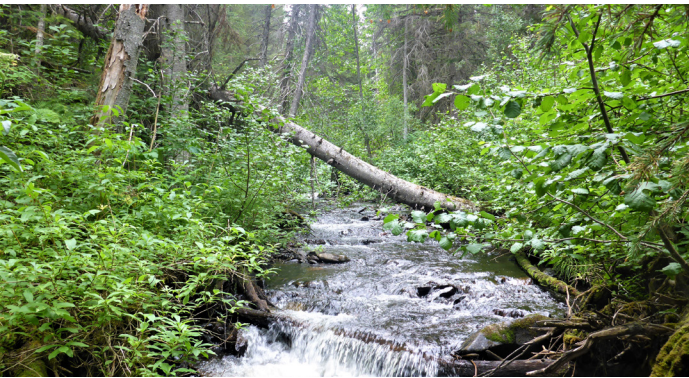
Figure 7. Site #168 — an example of a properly functioning stream reach. Riparian area retention and conservation of functioning streams should be a priority while impacted areas recover.

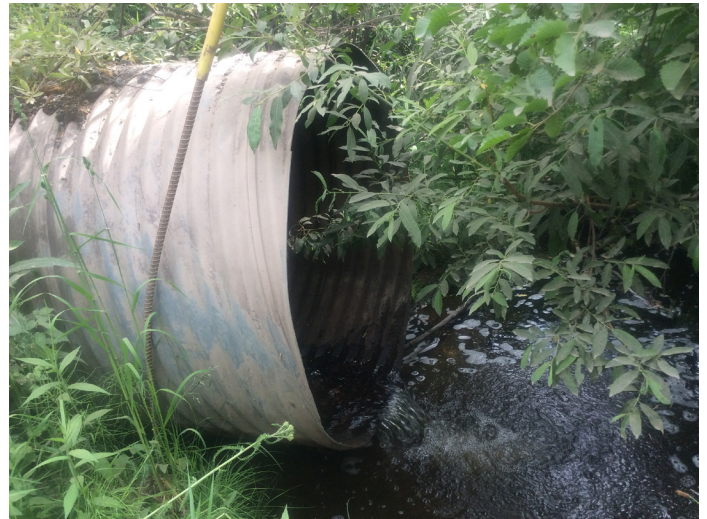
**Figure 10.** Located on the southern end of the Morice-Owen FSR (MCR #59), this 1.2 m culvert was deemed to be a significant barrier due to the following factors: channel constriction, length, absence of natural stream bed, and outlet drop, all of which restrict or prevent fish access to several kms of high value upstream habitat (Irvine 2021).

**MANAGEMENT OPPORTUNITIES** — Remediate priority fish passage locations commencing with the Riddeck Creek culvert on the Morice-Owen FSR mainline (Site #59).

**(ii) Fish passage** – Several stream crossing structures have been identified that significantly limit access to high value fish habitat. Replacing these structures should be a high priority activity, commencing with the Riddeck Creek crossing on the Morice-Owen FSR culvert (MCR #59). This structure blocks fish access to a large sub-basin and extensive high-value fish habitat (Irvine 2021a) at the south end of Owen Lake. Fish passage recommendations in Irvine (2021b) should also be prioritized for restoration.

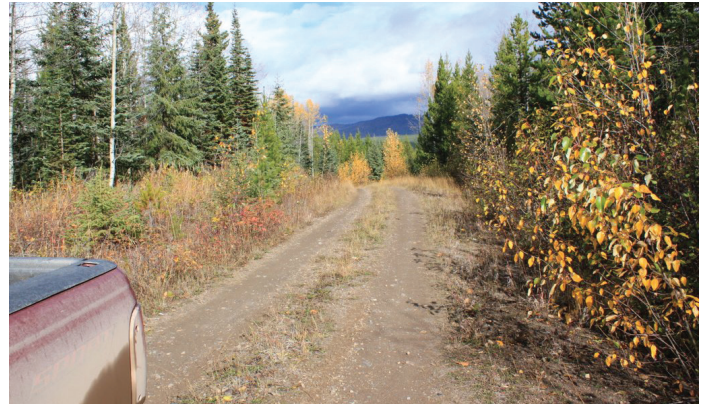
Most spur and branch roads generated and delivered low volumes of sediment at crossings or inter-drainage sites (Figure 12). Although there are records of mass wasting events in the Owen Creek watershed (Schwab 2011), within the sampled road network only one such site was observed (Carson 2014). Thirty-three percent of all sites sampled ( $n=19$ ) delivered moderate to high volumes of fine sediment to streams (Table 4); most of these sites were located on mainline forest service roads (FSRs). Throughout the watershed, FSRs are in close proximity to high value fish habitat. FSR road locations and road surface materials make it difficult to manage road surface sediment generation and delivery to fish habitat (Figure 13). Sample sites ( $n=12$ ) along FSRs adjacent to Owen Creek delivered sediment loads averaging  $2.4\text{m}^3$  per site (Carson 2014). An estimate of the mean fine sediment delivery concentrations from roads during coho or steelhead egg incubation periods in Owen Creek (downstream of Owen Lake), indicate potential for chronic impacts (above natural background levels) during egg to fry life stages for both species (Tripp 2019b).

**Figure 12.** Site #18 is characteristic of a network of lightly used branch roads throughout the watershed. Their impact on water quality, quantity, and timings of flow are often minimized as vegetation reclaims and armors the road surface and increases soil infiltration along the road right-of-way. Lightly used roads like Site 18 and deactivated roads most often generate "very low" volumes of fine sediment.

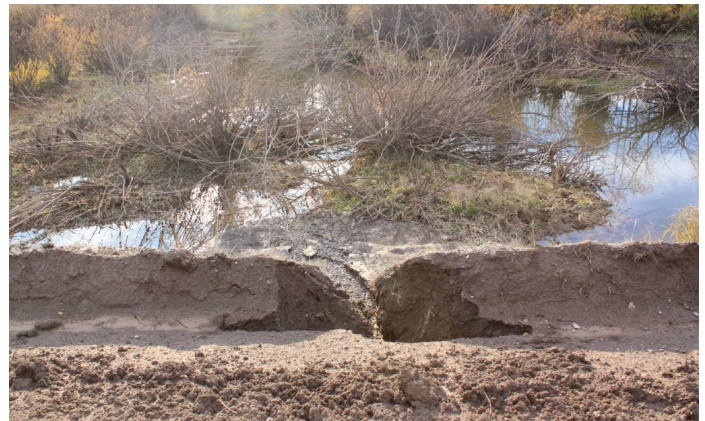
**Figure 13.** Site #47 – where the Morice-Owen FSR runs immediately adjacent to the Owen Creek historic channel. Frequent berm ruptures as depicted here were observed along FSRs, often delivering high volumes of fine sediment to important fish habitat.

**MANAGEMENT OPPORTUNITIES** — Implement sediment management practices (e.g., grader-berm management), especially along FSRs. Harden FSR road surfaces as required to prevent fine sediment generation and delivery to stream channels.

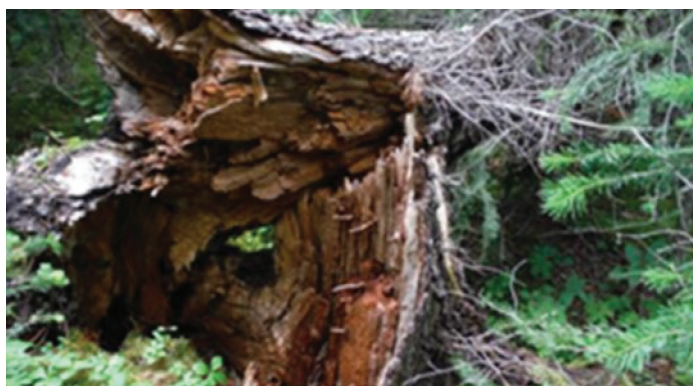
**Figure A2.1.** Beetle-killed (pine and spruce) trees are prevalent throughout the Owen Creek watershed (Site #168). The image depicts a root rot fungal infection (*tomentosus*) that may interact with beetles in a primary-secondary relationship causing widespread tree mortality.
