**Project “Experimental Evaluation of Concrete Decks with Guard Rail Systems”
for
Ministry of Forests, Lands and Natural Resource Operations**

Project Report by
C. Villiard & C. Dickof & M. Angers & J. Schneider & S.F. Stierner

UBC

Final Report Vancouver May 2011

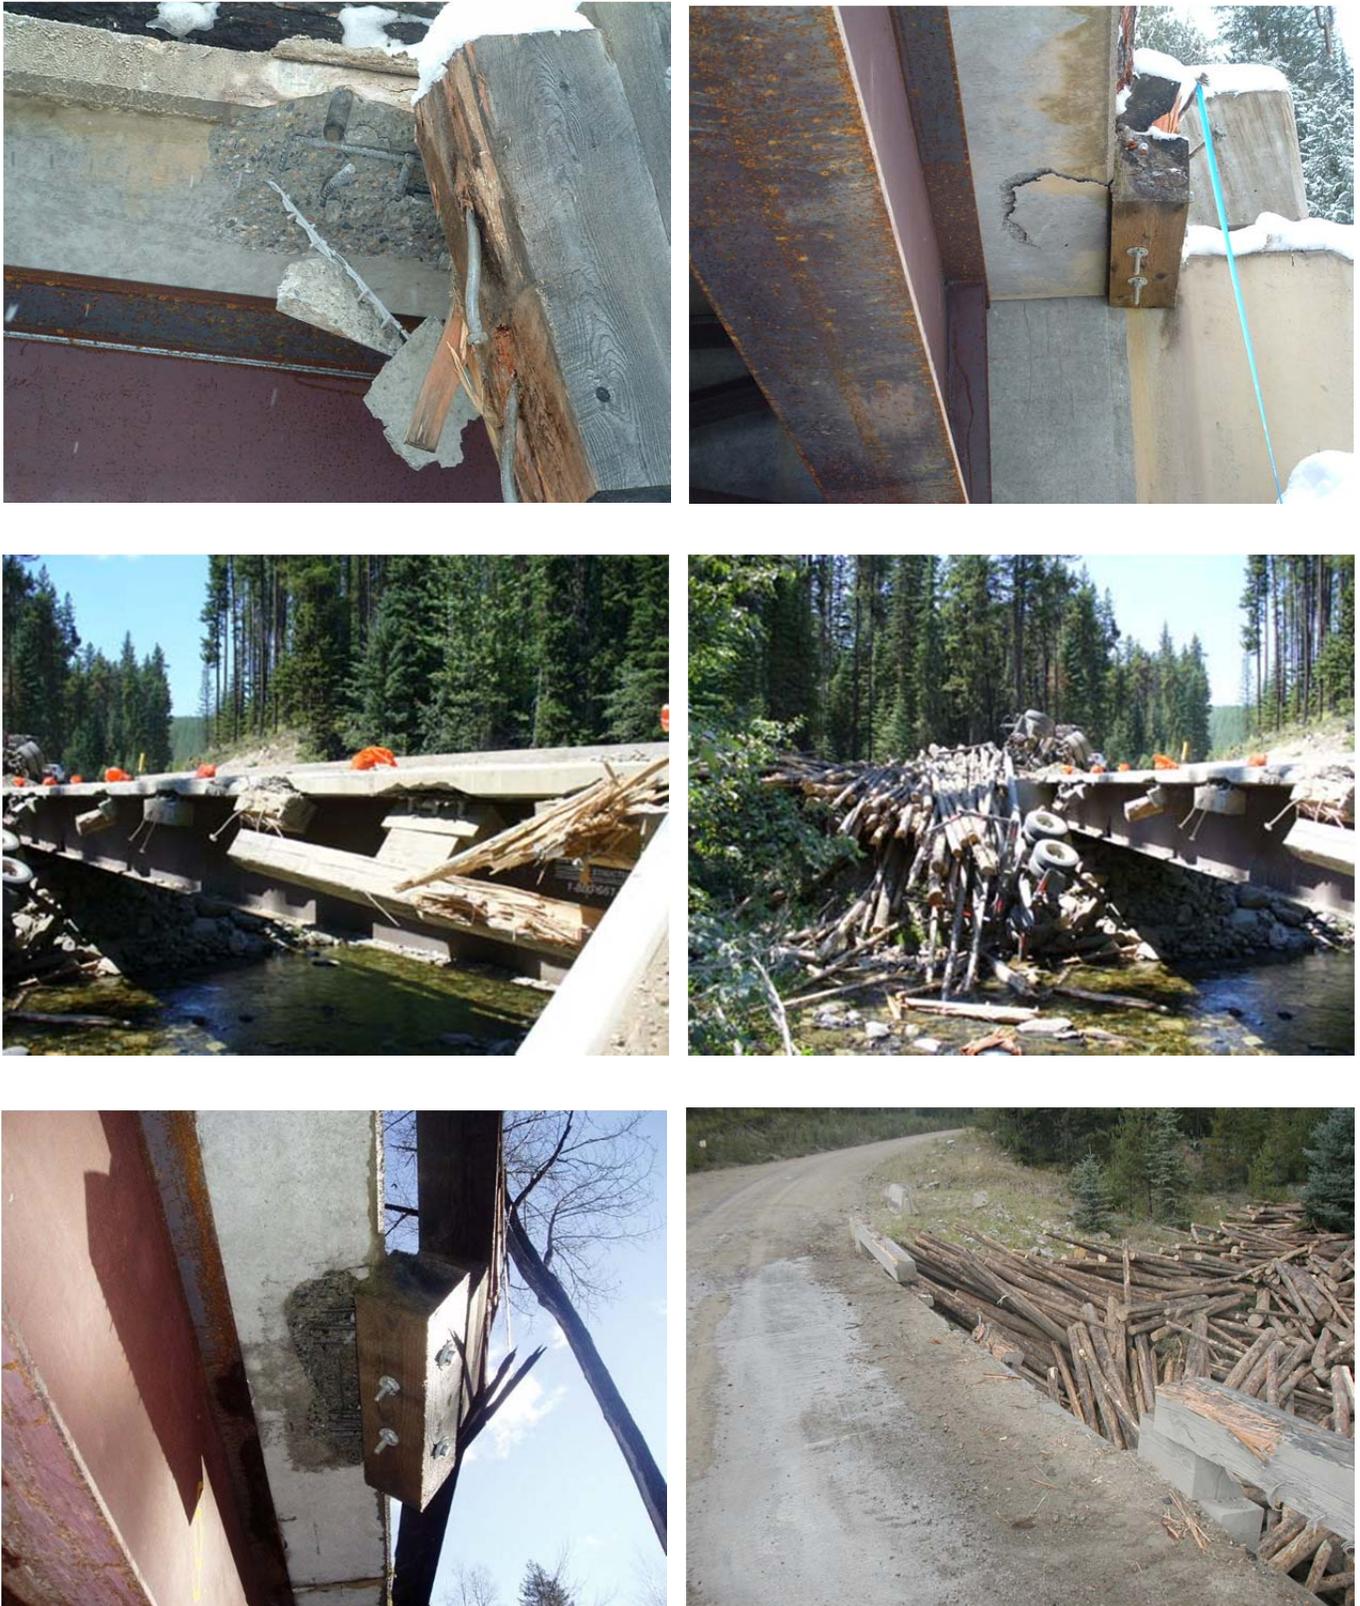
Figure 1: Photos from Actual Field Failures of Various Barrier Types, Group 1

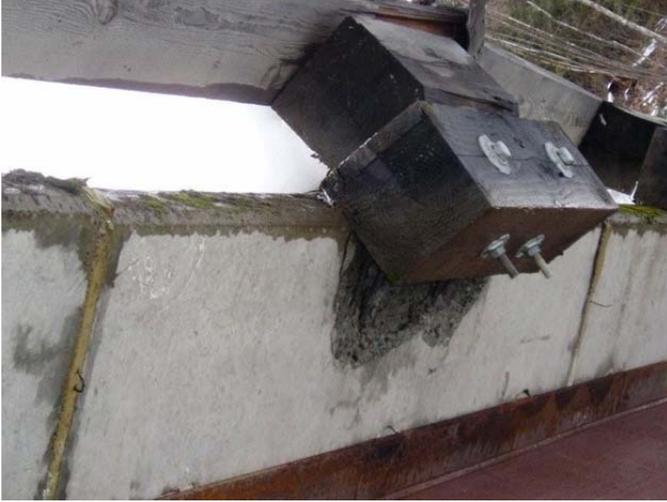
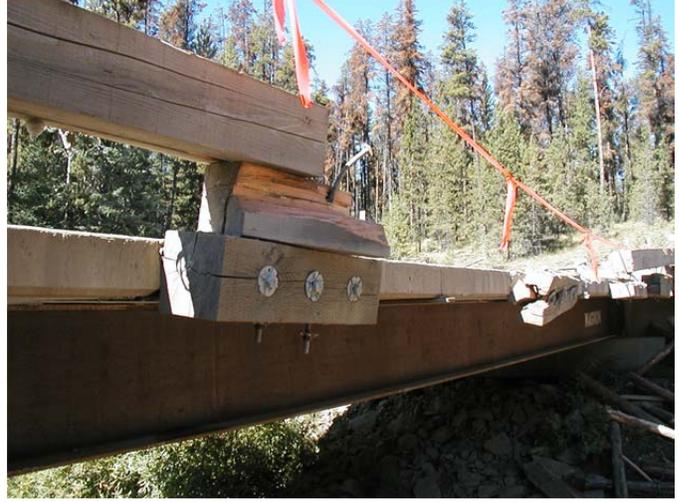
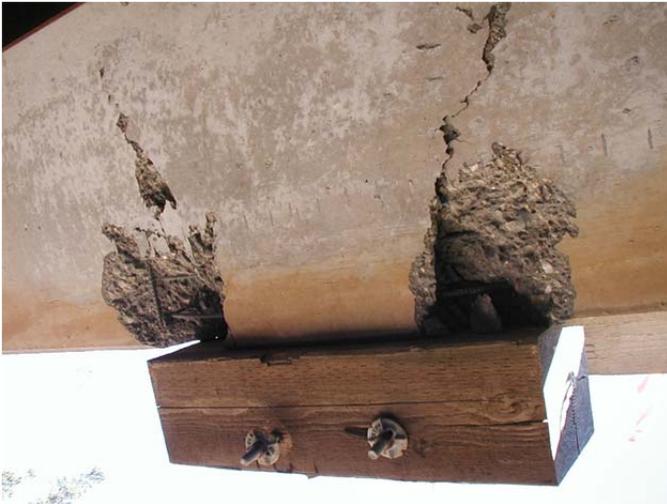
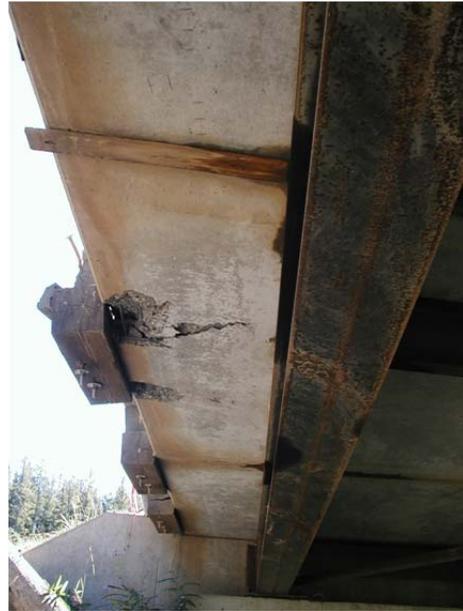
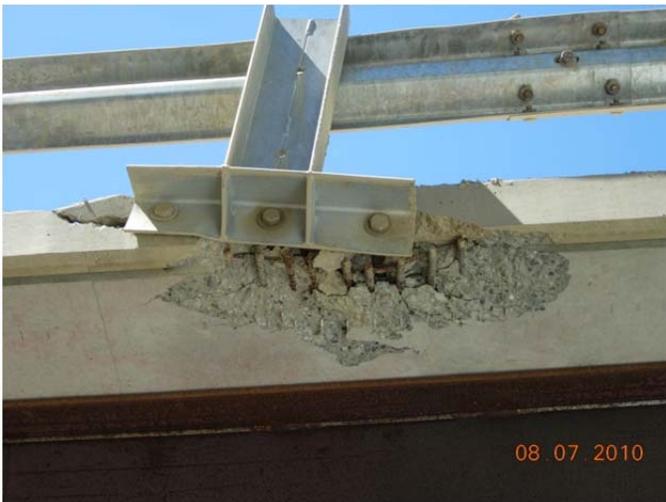
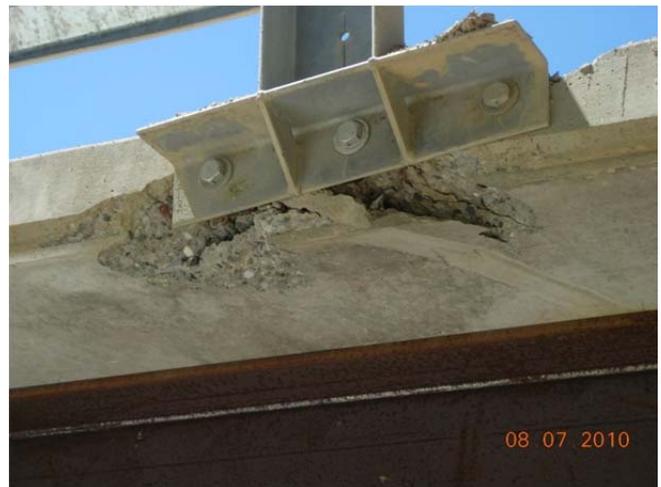
Figure 2: Photos from Actual Field Failures of Various Barrier Types, Group 2

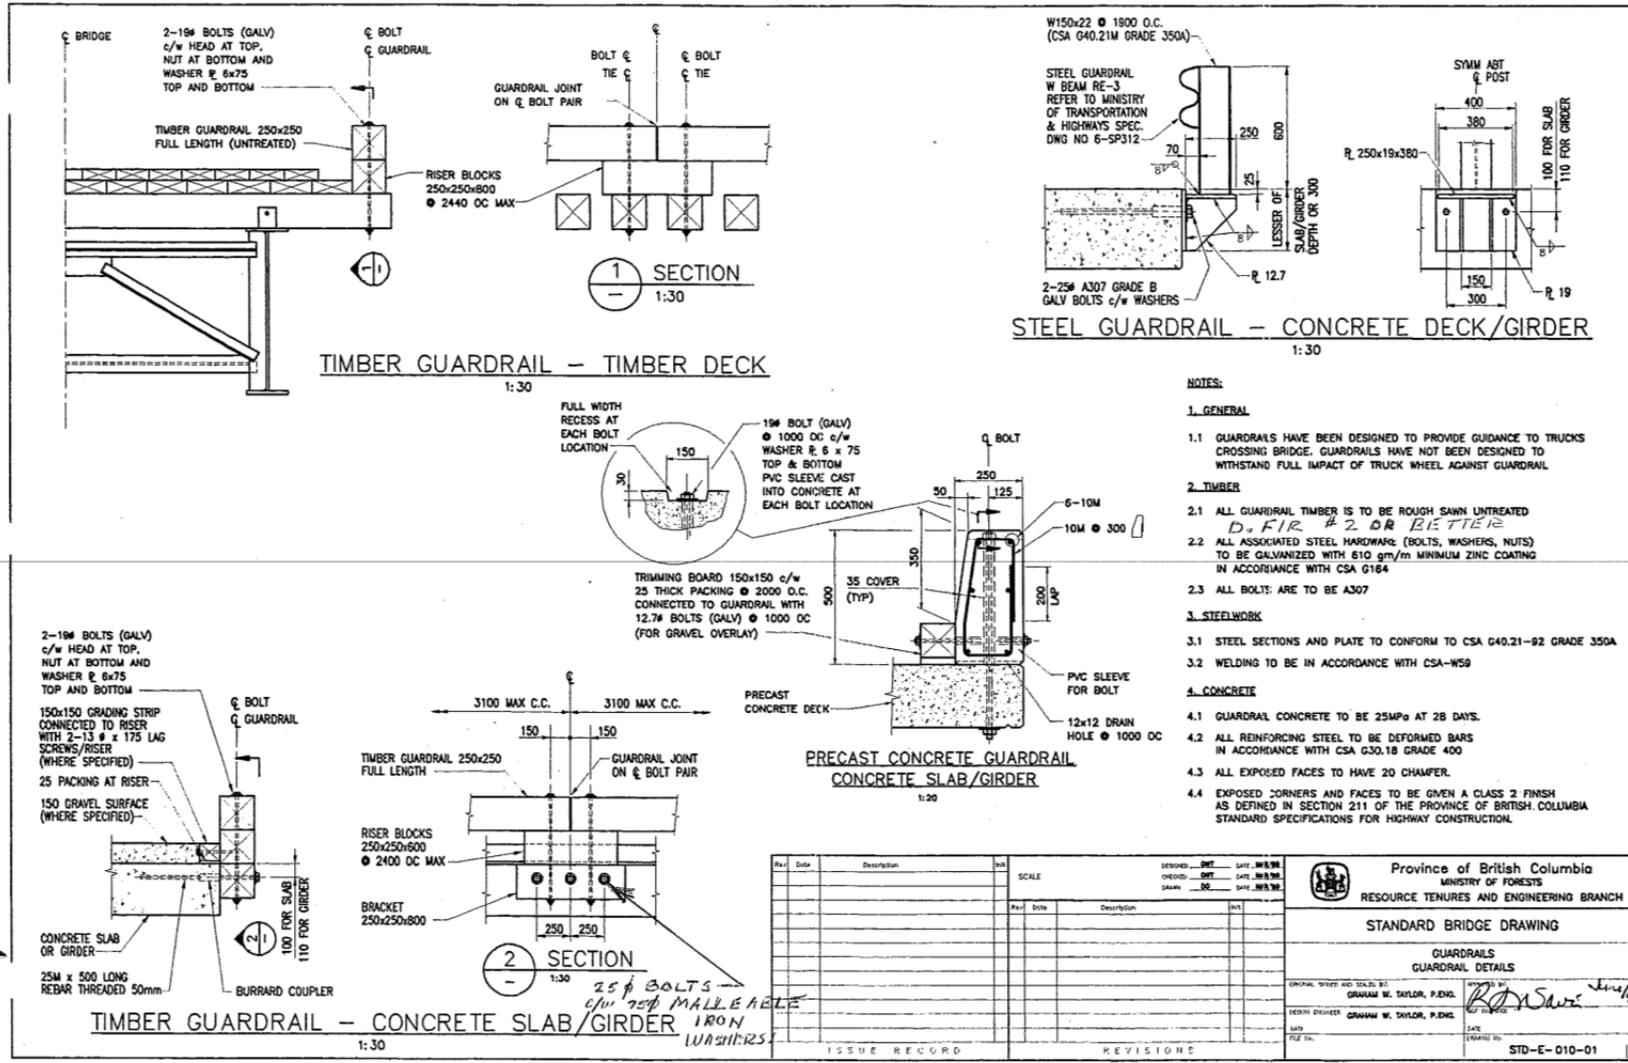
Figure 3: Standard bridge drawing

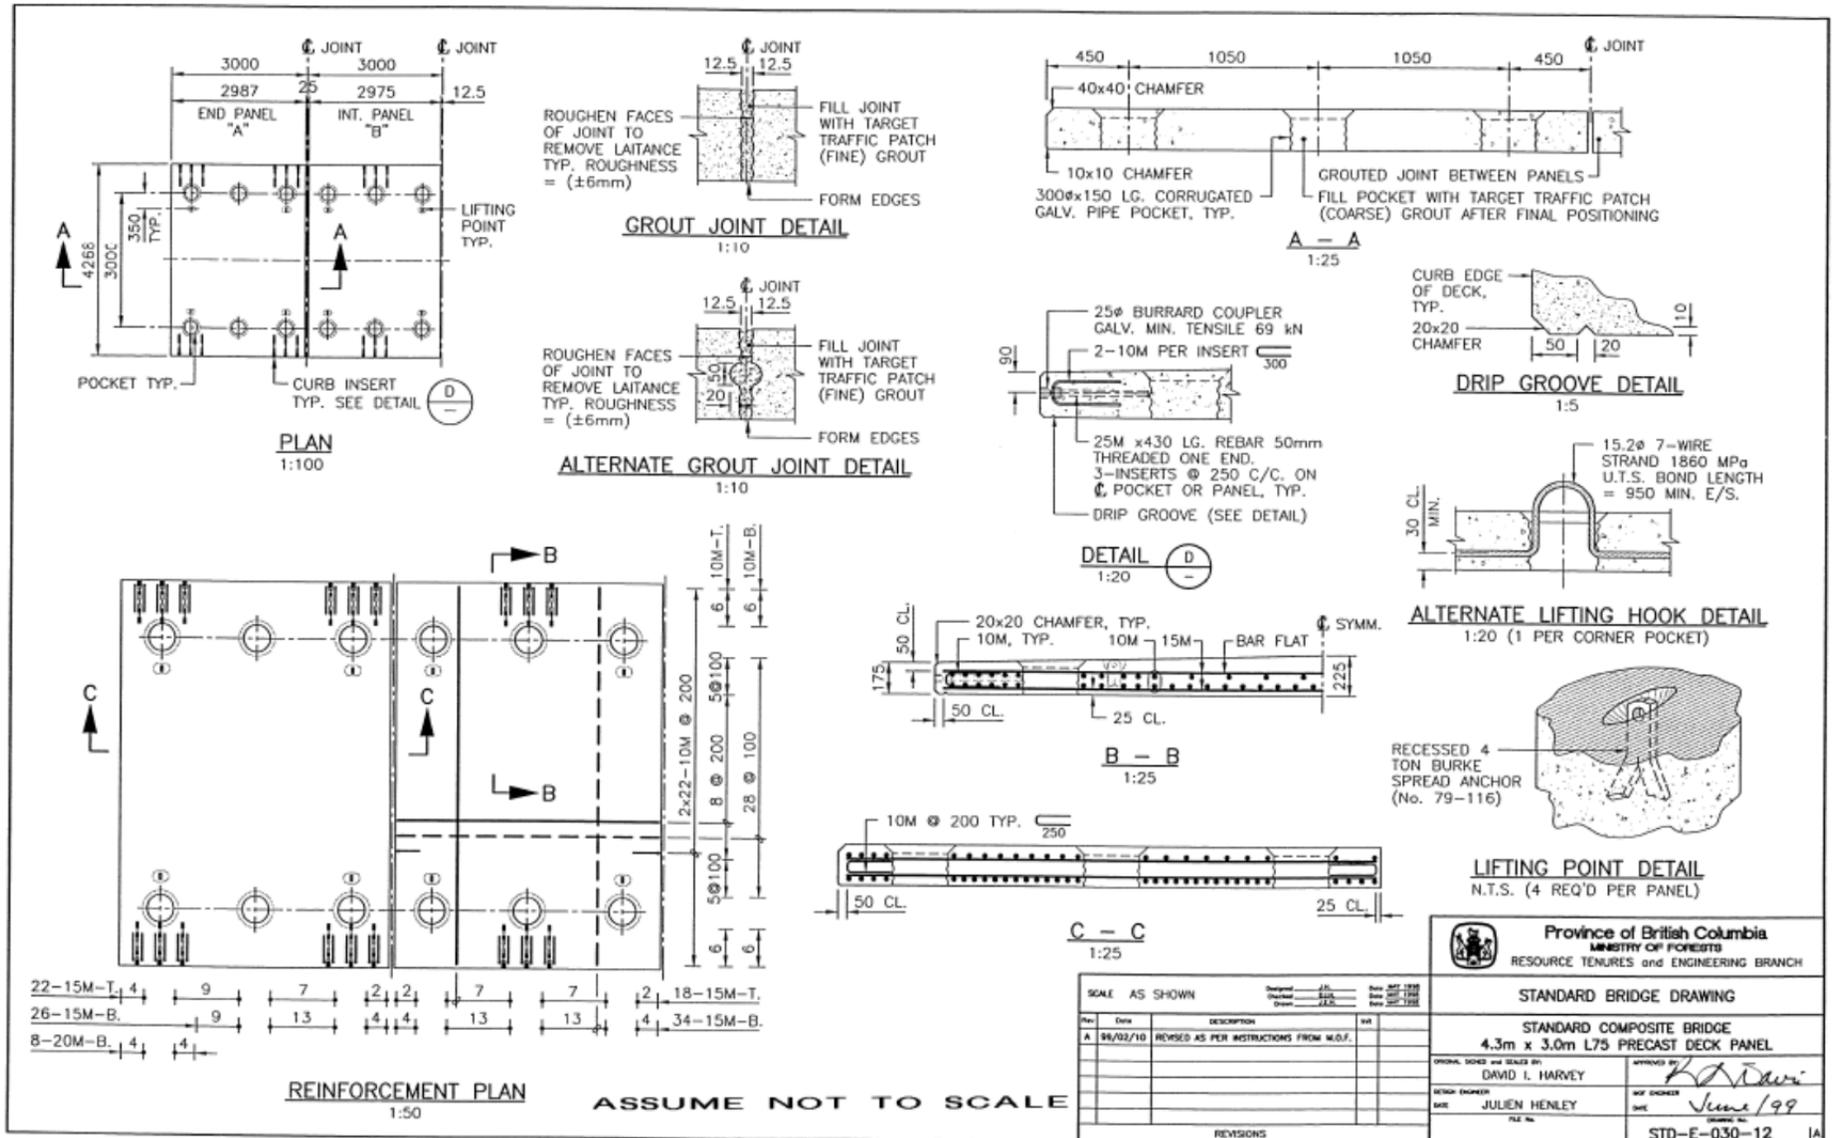
Figure 4: Original drawing of standard composite deck

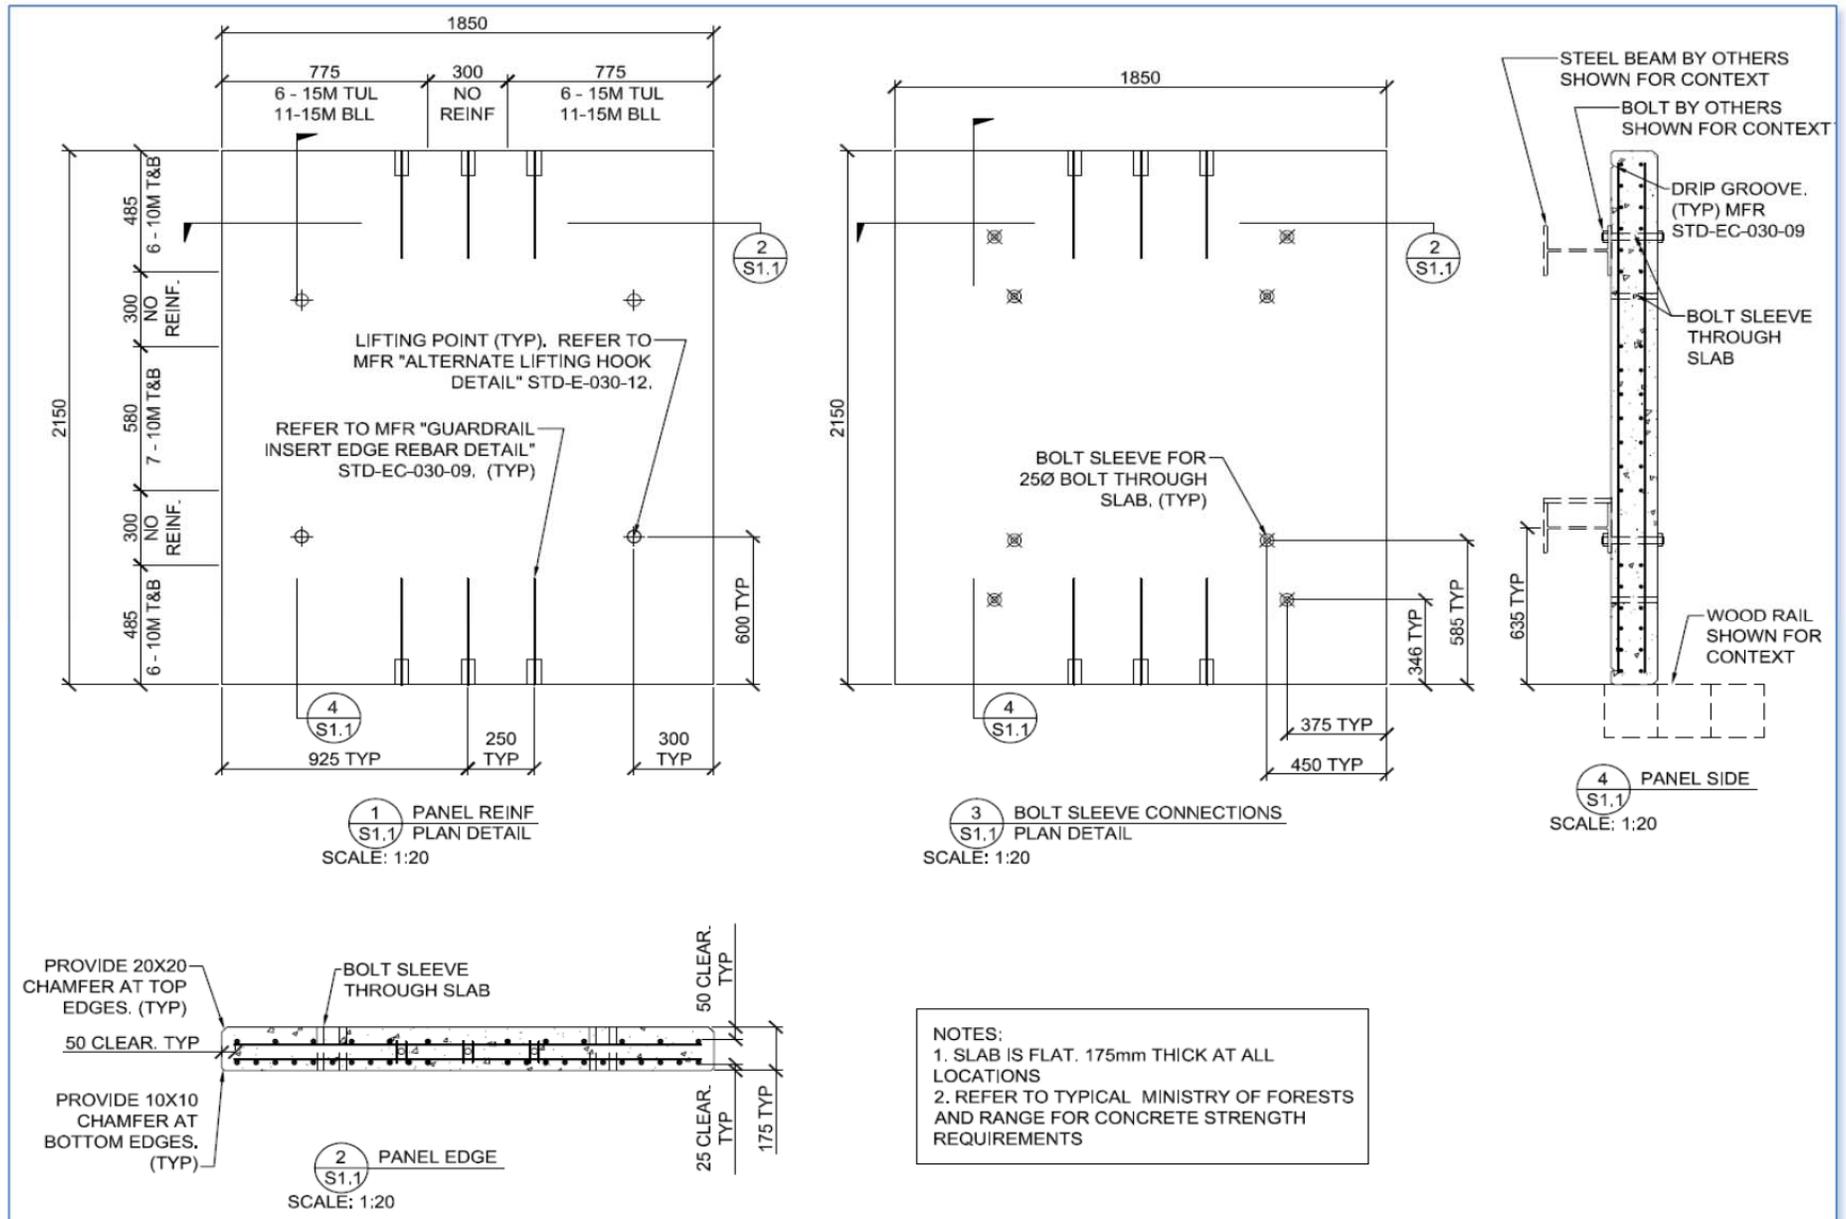
Figure 5: Standard test panel, two edges useful for testing

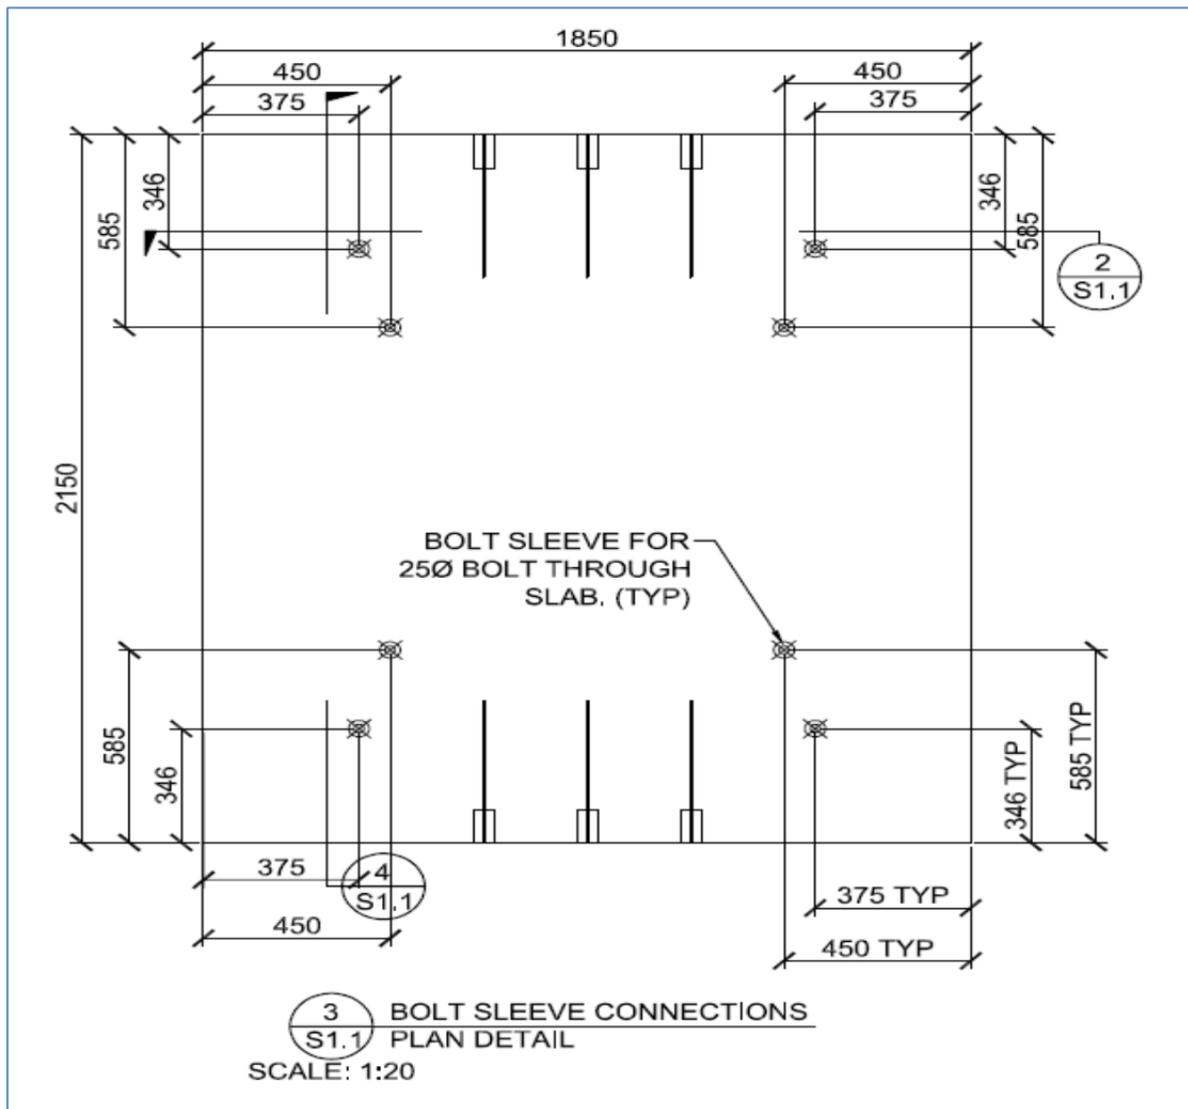
Figure 6: Bolt sleeve locations on concrete test panel

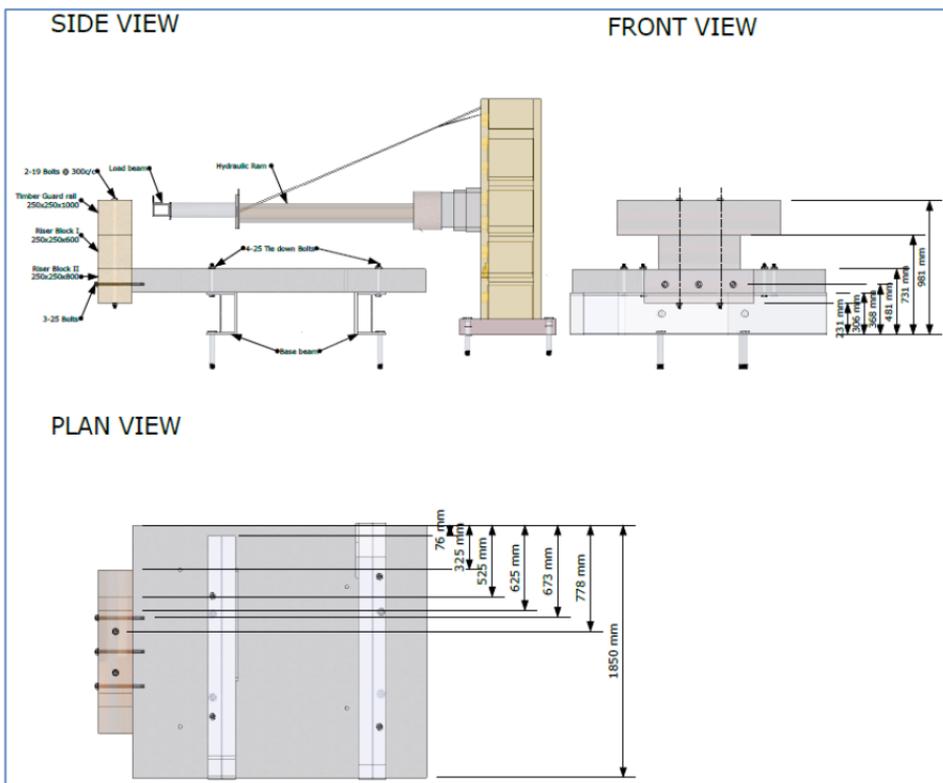
Figure 8: Set-up for testing with standard timber barrier

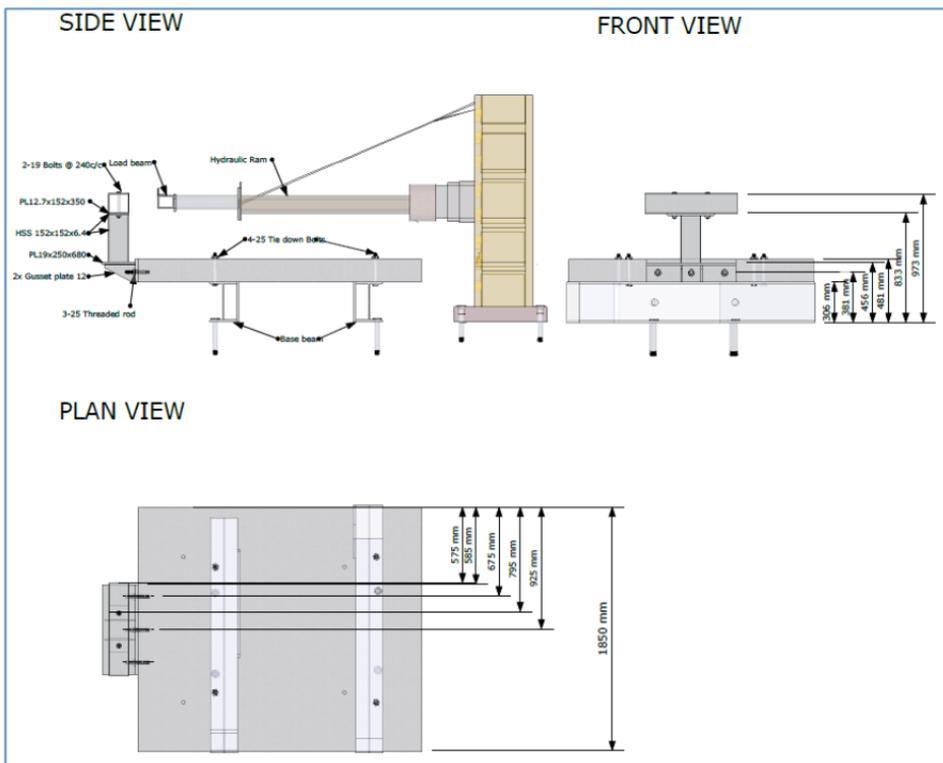
Figure 10: Set-up for testing with steel posts SS

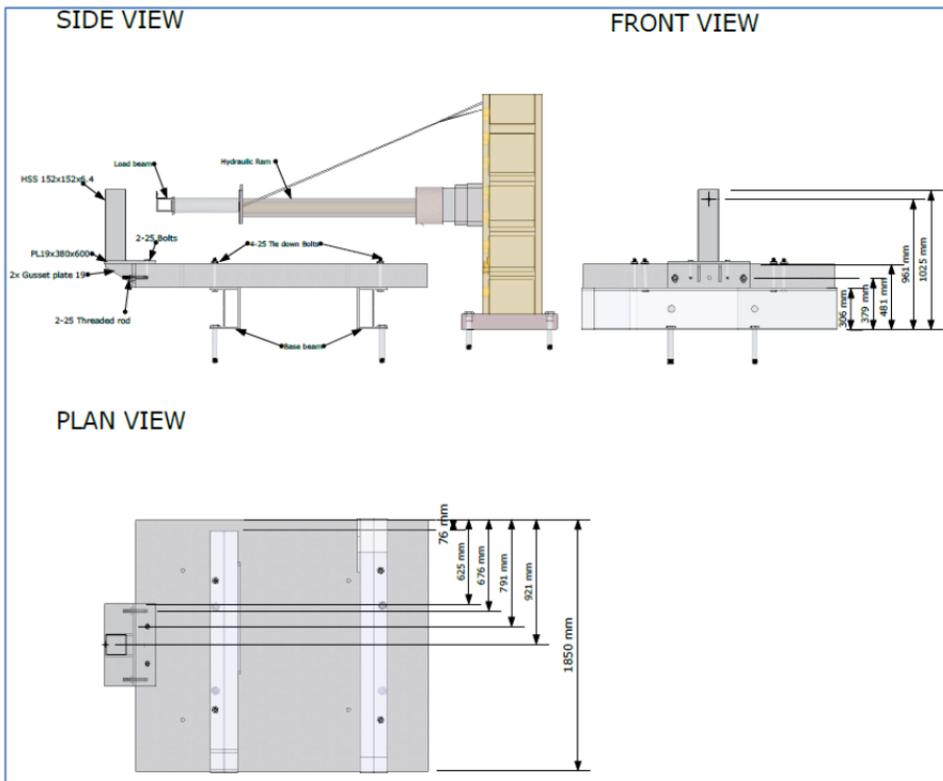
Figure 12: Set-up for testing with (modified) steel posts SM

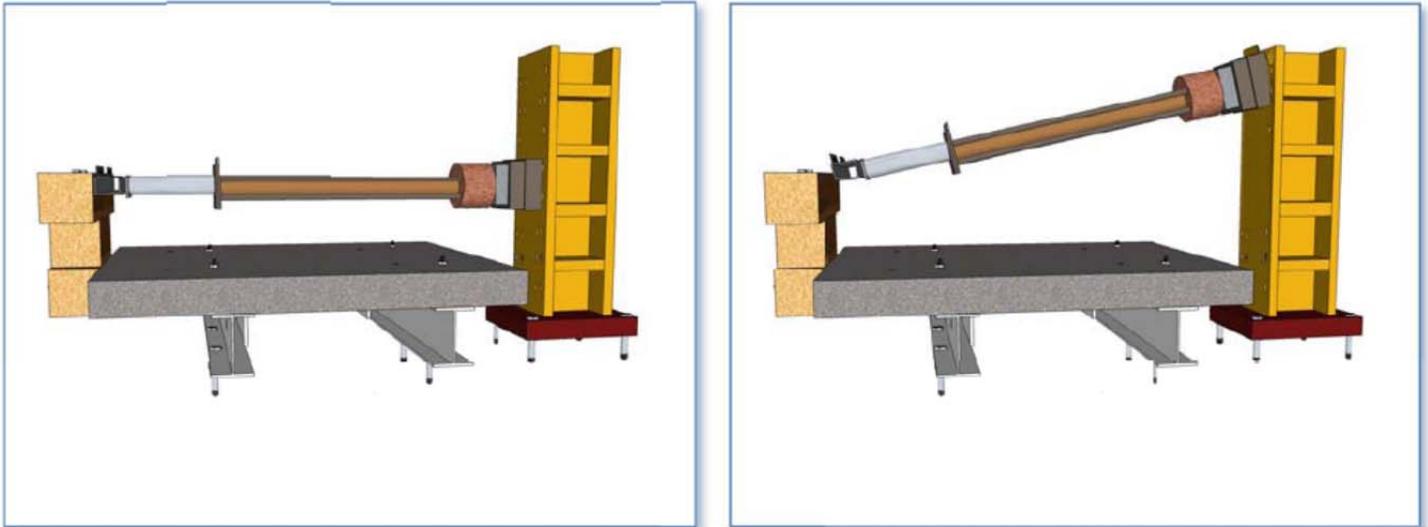
Figure 13: Alteration of Test Set-up (in order to achieve vertical load component) –horizontal and vertical loads are applied progressively and at constant ratio.

It should be noted that the ratio of transverse load to vertical load for on guard rail post is 6:1.08 for AASHTO and 5:1 for CHBDC.

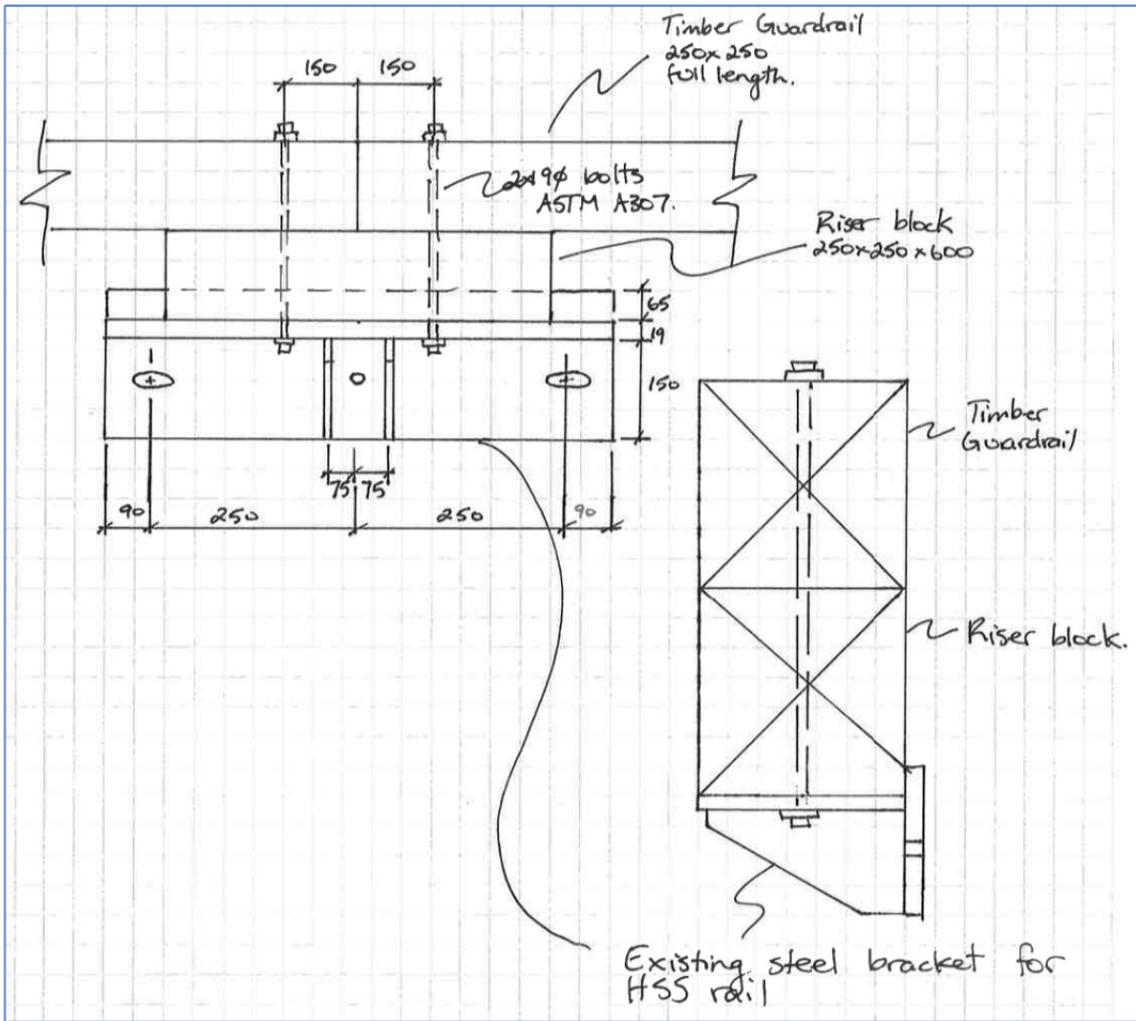
Figure 17: Modification I. as suggested by G. Fraser, (mail attachment Fri, Mar 4, 2011 at 10:38 AM, Associated Engineering)

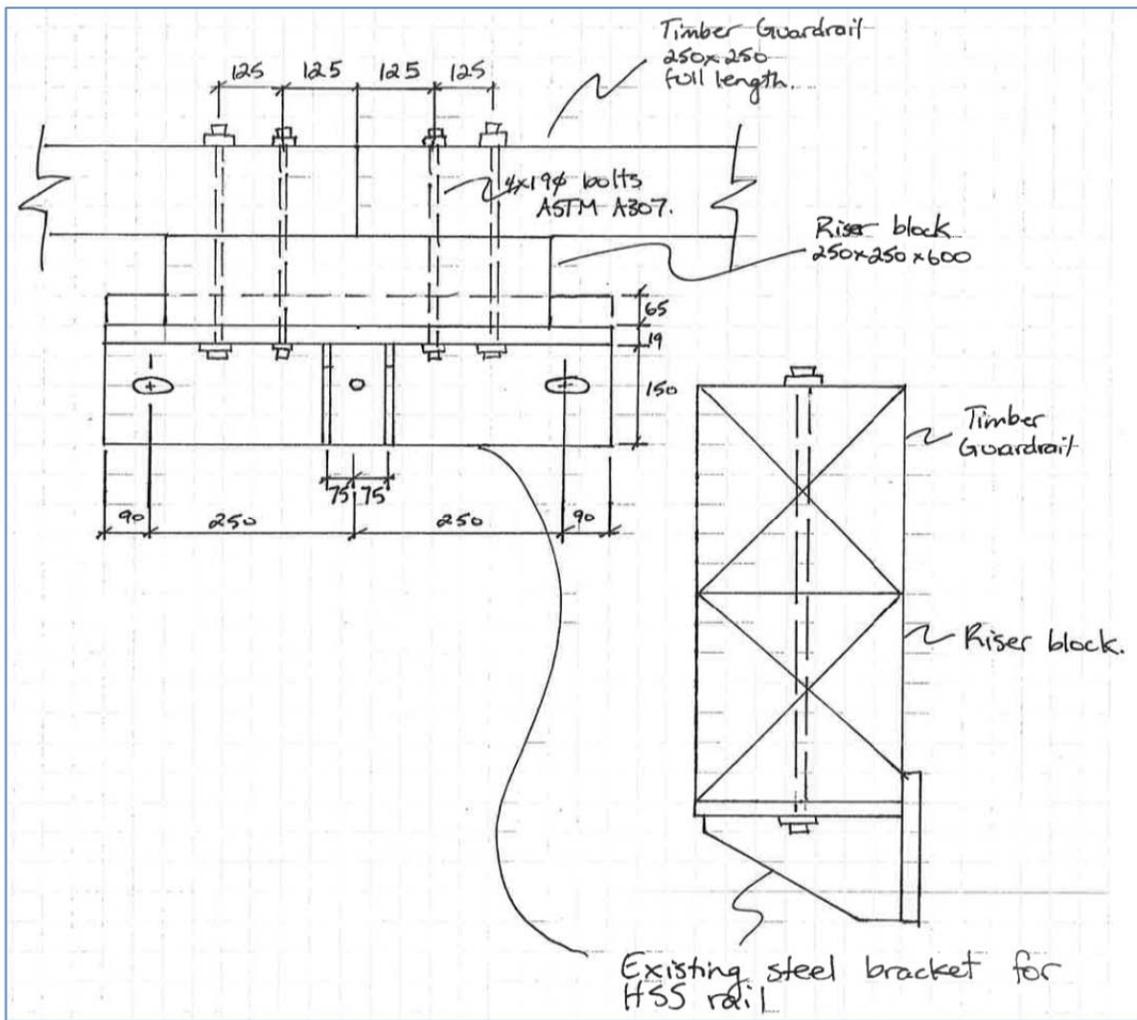
Figure 18: Modification II. as suggested by G. Fraser, (mail attachment Fri, Mar 4, 2011 at 10:38 AM, Associated Engineering)

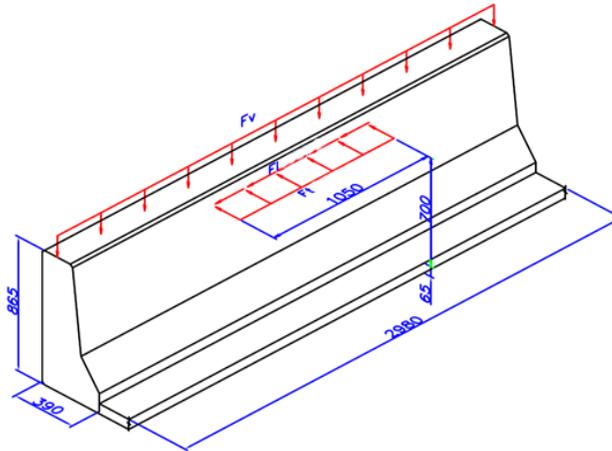
Figure 20: Example Traffic Barrier Loads and Locations as per CHBDC for (PL-2), Clause 3.8.8.1., in Isometric View

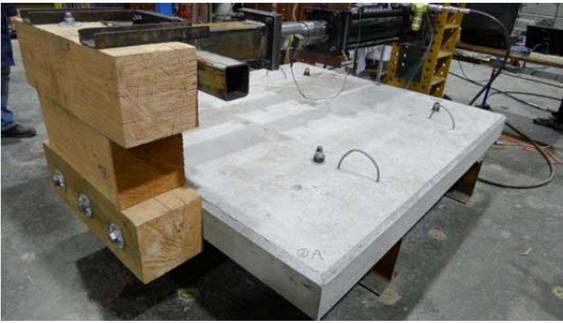
<ul style="list-style-type: none"> • Capacities correlate nicely for tests • Failure mode similar to previous tests (two blocks) on steel base • Ultimate capacities similar to previous tests (two blocks) on steel base

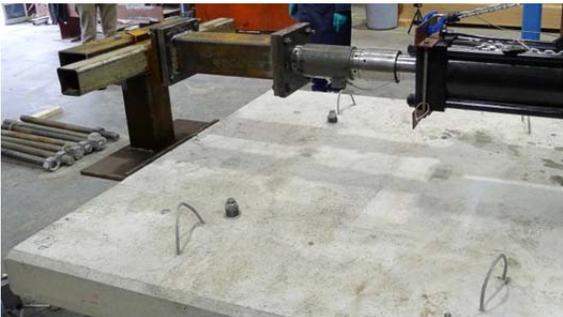
<ul style="list-style-type: none"> • Capacities correlate nicely for both A307 and A325 bolts respectively • Failure mode similar to previous tests (two blocks) on steel base • Ultimate capacities similar to previous tests (two blocks) on steel base

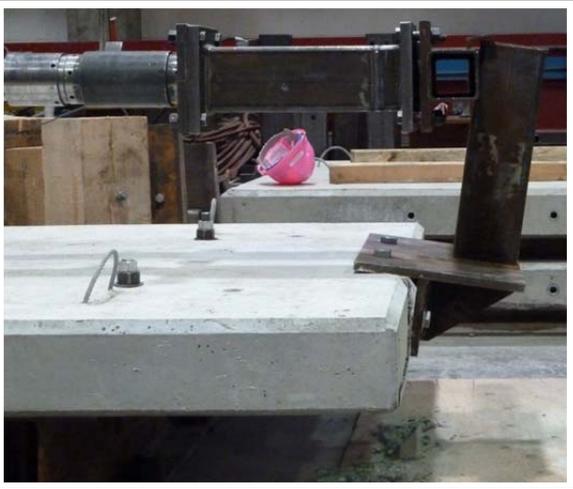
<ul style="list-style-type: none"> • Hilti drill did not work due to heavy steel reinforcement, therefore core drilling of holes in deck is underway • These tests will cause the deck to fail
3.1	#4	11	09/03/2011	50.1	<ul style="list-style-type: none"> • A307 bolts • horizontal loading
3.2	#4	12	10/03/2011	68.7	<ul style="list-style-type: none"> • A307 bolts • horizontal loading
3.3	#5	13	11/03/2011	67.2	<ul style="list-style-type: none"> • A307 bolts • horizontal loading
3.4	#5	14	11/03/2011	58.3	<ul style="list-style-type: none"> • A307 bolts • horizontal loading

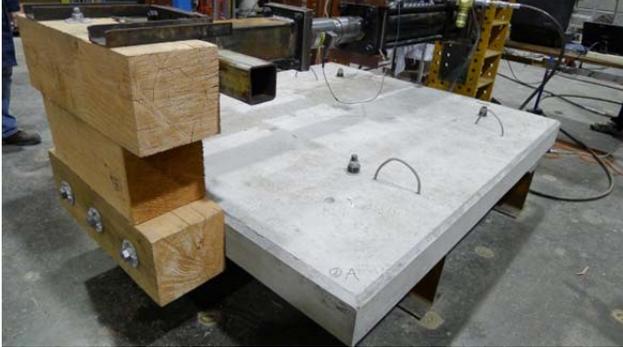
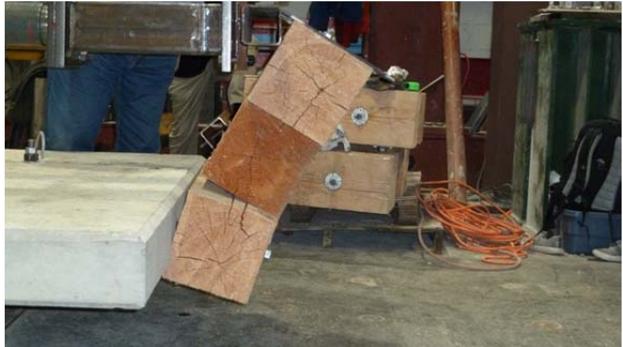
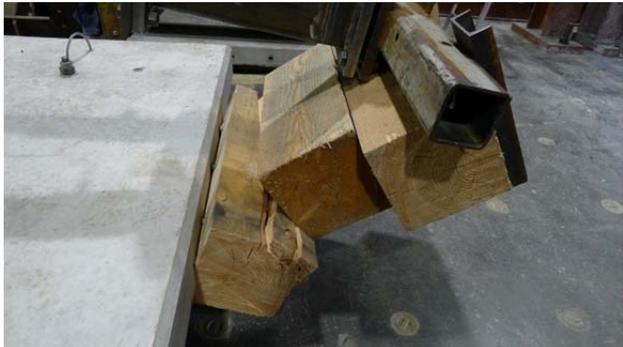
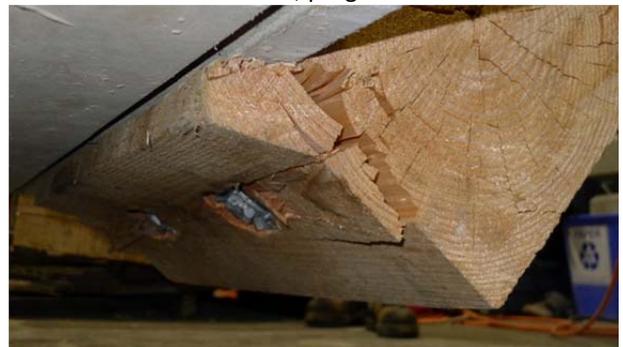
Capacities (averages) in [kN]	Failure Description	Photo
<p>Timber Curb Block Tests 1.1 – 1.4</p>	<p>23.25</p>	<p>failure in timber, vertical crushing of blocks at the bolt washers, bottom block of timber splits vertically along the three bolt holes</p>

<p>during testing</p>

<p>at failure, begin</p>

<p>at failure, progressed</p>

<p>at failure, detail</p>

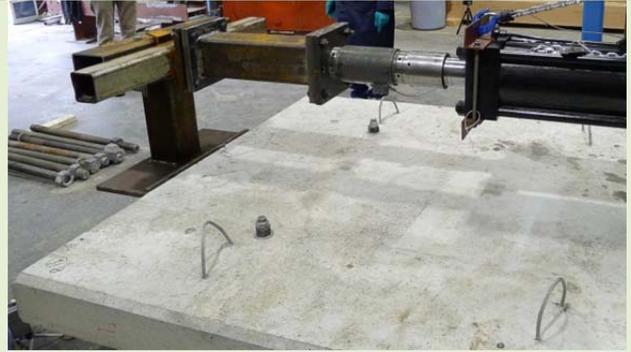
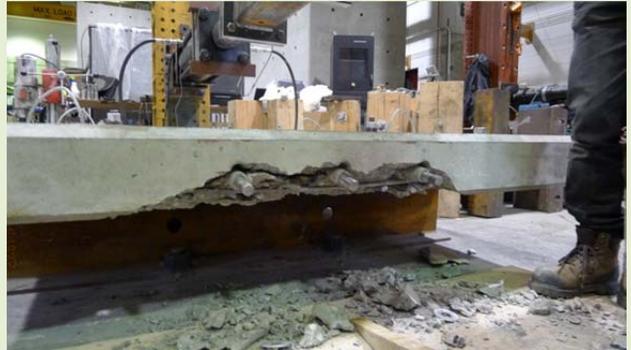
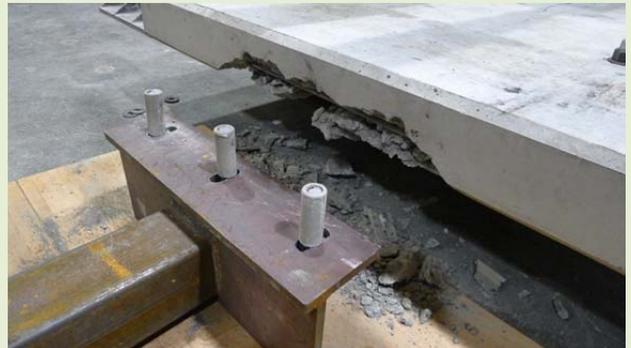
A307: bolts rupture in tension and spalling of concrete in vicinity of bolt inserts (failure shown in second photo to the right)
A325: spalling of concrete (failure shown in third photo to the right)

during testing

at failure, A307 bolts

at failure, A325 bolts

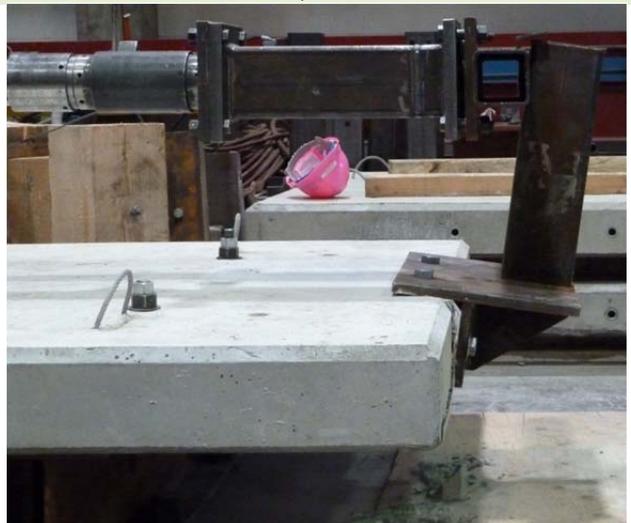
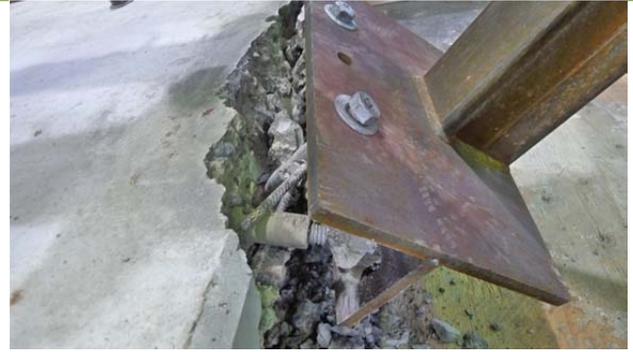
deck fails in block shear

during testing

at failure

- Vertical bolts through deck cause the deck to fail by block shear failure
- Holes for vertical bolts need to be placed at casting of deck, drilling or coring of holes is difficult due to the existing rebar
- Horizontal bolts did not contribute much to capacity of post system
- Test panel fabrication did not include the additional U-bars that should have gone around the inserts for the vertical bolts through the deck.
- These U-bars would likely have provided some additional capacity up to the maximum shear/tensile capacity of the vertical bolts as tested in 2010 (up to 90 [kN] – prorated).

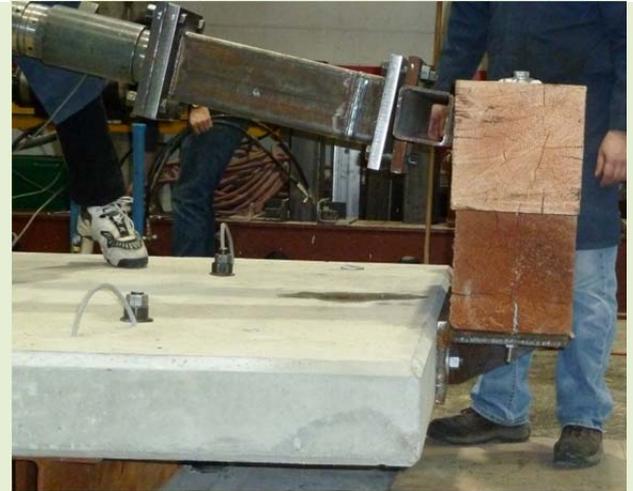
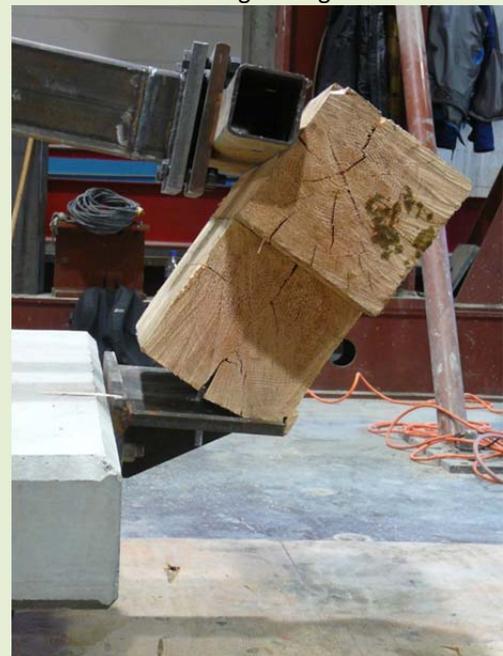
36.1 failure in timber, vertical crushing of blocks at the bolt washers, bottom block of timber splits vertically along the three bolt holes

during testing

at failure

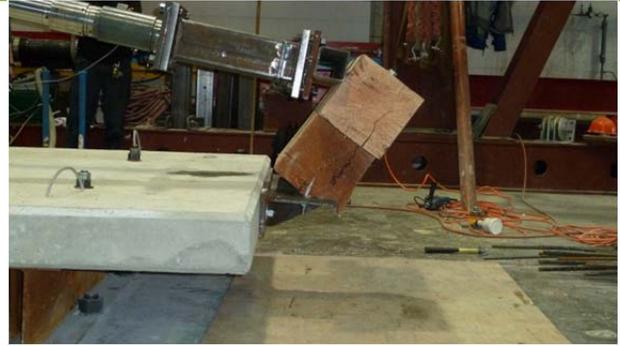
failure in timber, vertical crushing of blocks at the bolt washers, bottom block of timber splits vertically along the three bolt holes

at failure

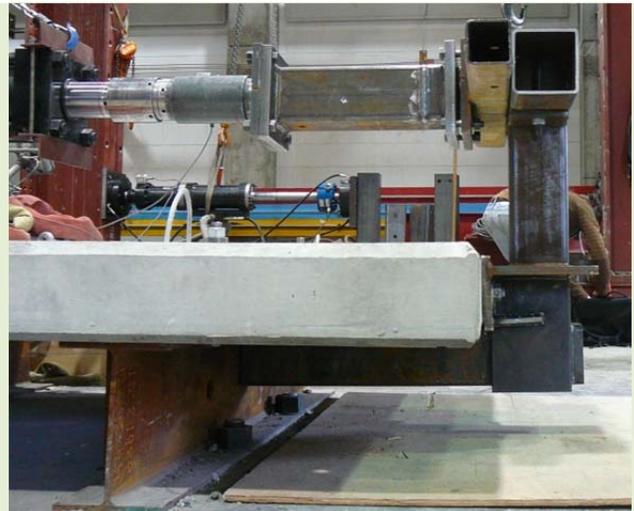
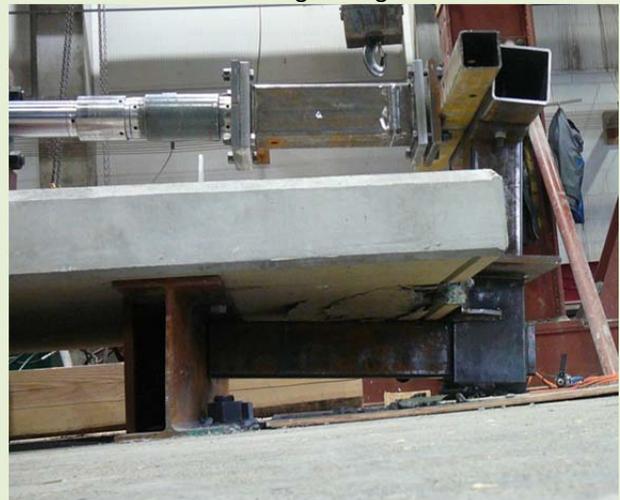
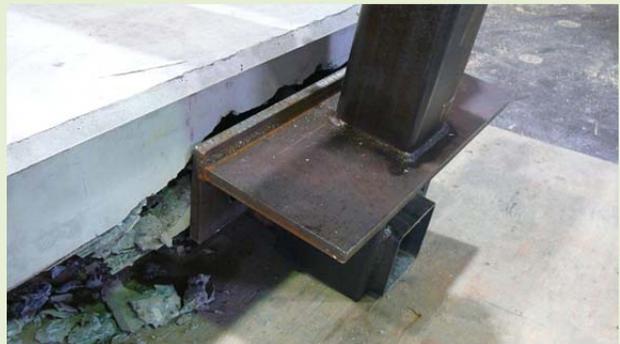
a) welds in knee-bracket fail in corner of elbow where stresses are concentrated (not shown),
b) after reinforcing of knee with gusset plates and larger welds: spalling of large area of deck (shown)

during testing

at failure

- In the tests the knee bracket with the lower leg reaching to the main plate girder of the deck has shown superior behaviour and capacities. This way one could design this type to fail without any damage to the concrete deck, however, still achieving very high resistances.
