**Project “Experimental Evaluation of Concrete Decks with Guard Rail Systems”
for
Ministry of Forests, Lands and Natural Resource Operations**

Project Report by
C. Villiard & C. Dickof & M. Angers & J. Schneider & S.F. Stierner

UBC

Final Report Vancouver May 2011

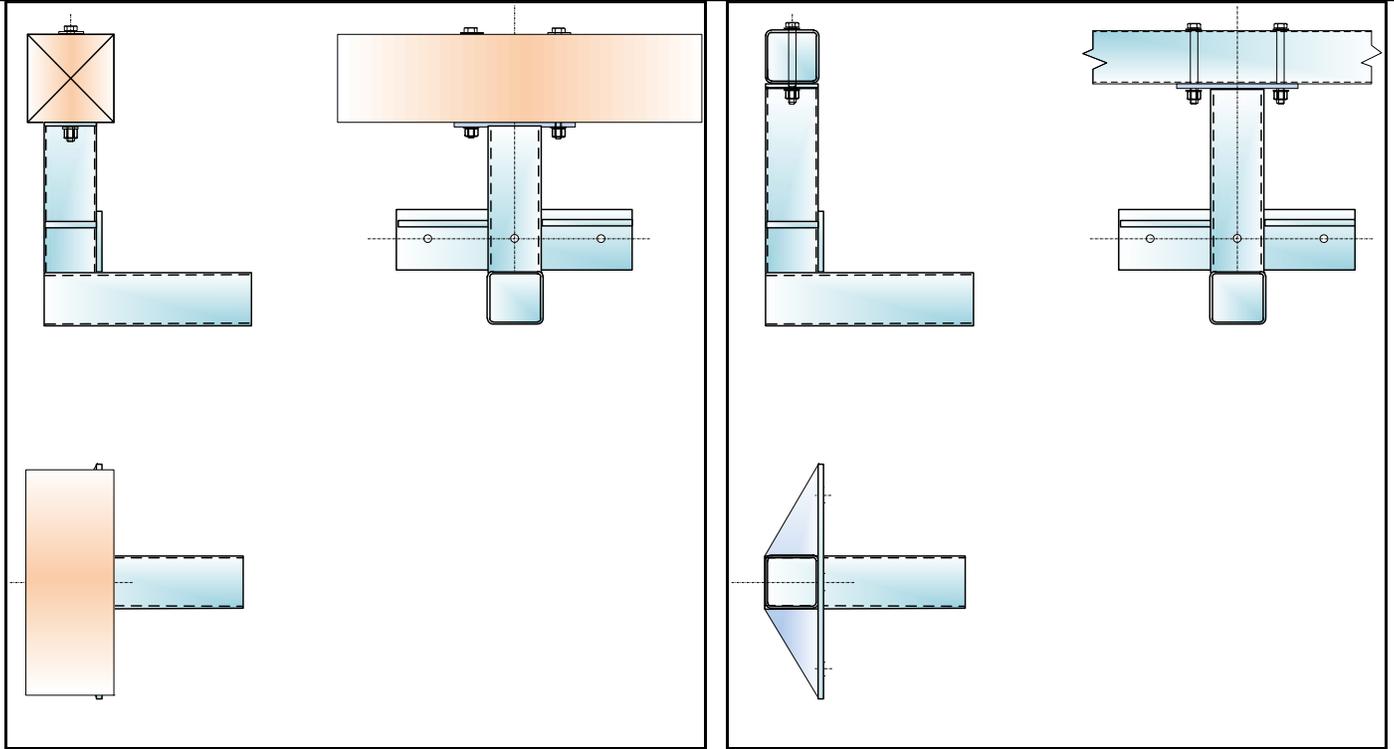
Figure 24: Modified Steel Post System #2- SS with improved Knee Bracket as proposed for Prototype with Timber (left) and Steel Rail (right)

- In the tests the knee bracket with the lower leg reaching to the main plate girder of the deck has shown superior behaviour and capacities. This way one could design this type to fail without any damage to the concrete deck, however, still achieving very high resistances.

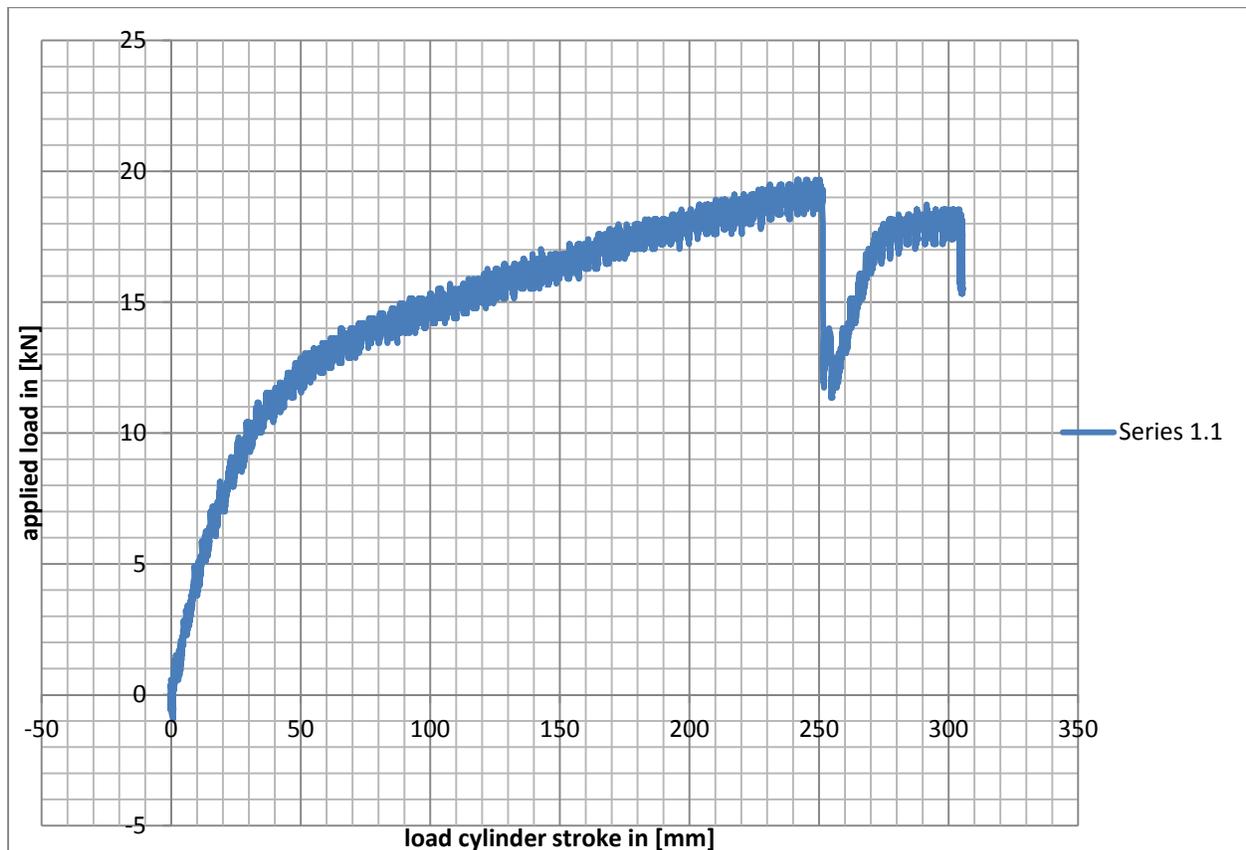
Figure 26: Load Deflection Diagramme of Test 1.1

1.1	#2	3	17/02/2011	19.7	<ul style="list-style-type: none"> • Failure in timber • Relatively long sustained maximum load due to large crushing deformation in timber

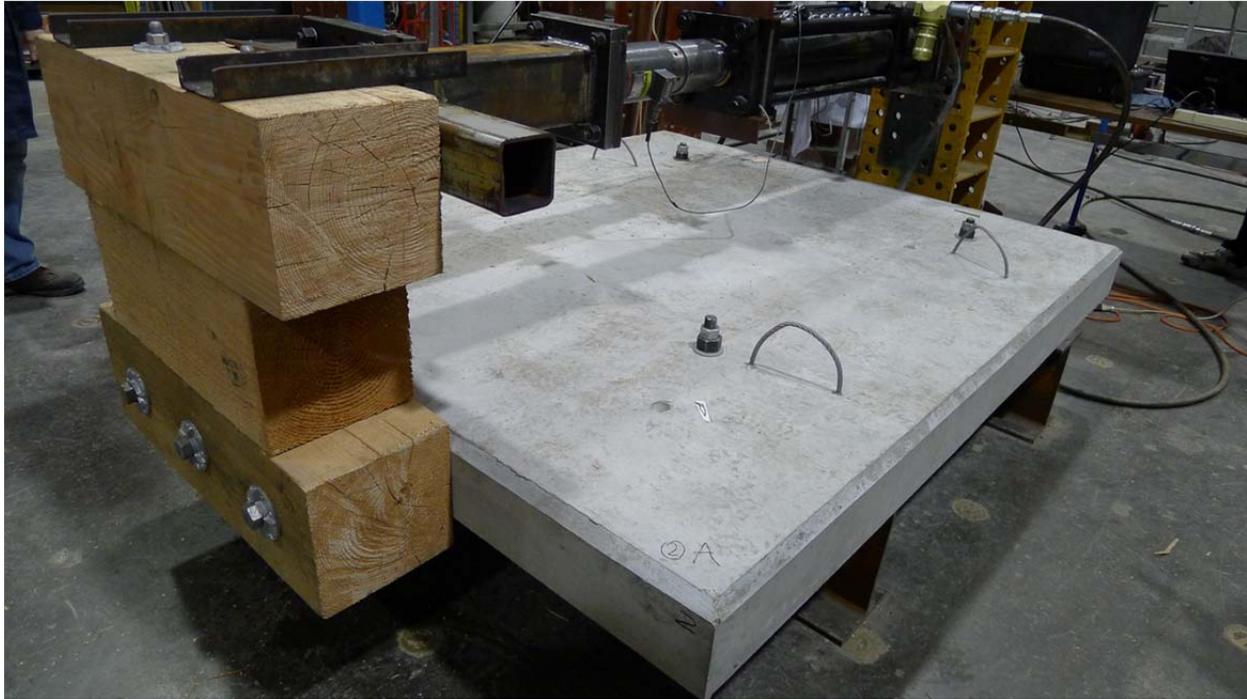
Figure 28: Timber curb block, Test #1.2

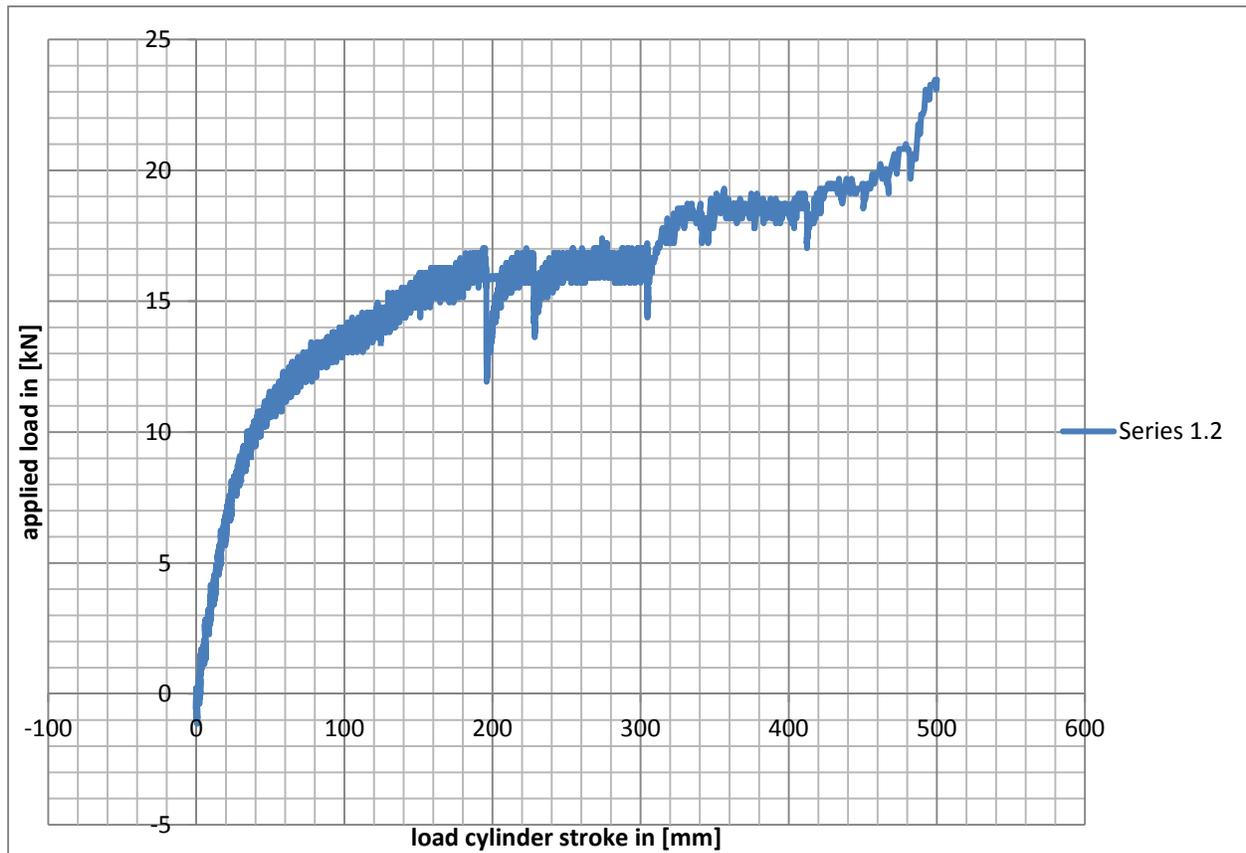
Figure 29: Load Deflection Diagramme of Test 1.2, horizontal load direction

1.2	#2	4	17/02/2011	23.5	<ul style="list-style-type: none"> • Failure in timber • Relatively long sustained maximum load due to large crushing deformation in timber • First plateau at 17 kN, then rise to 23.5 kN

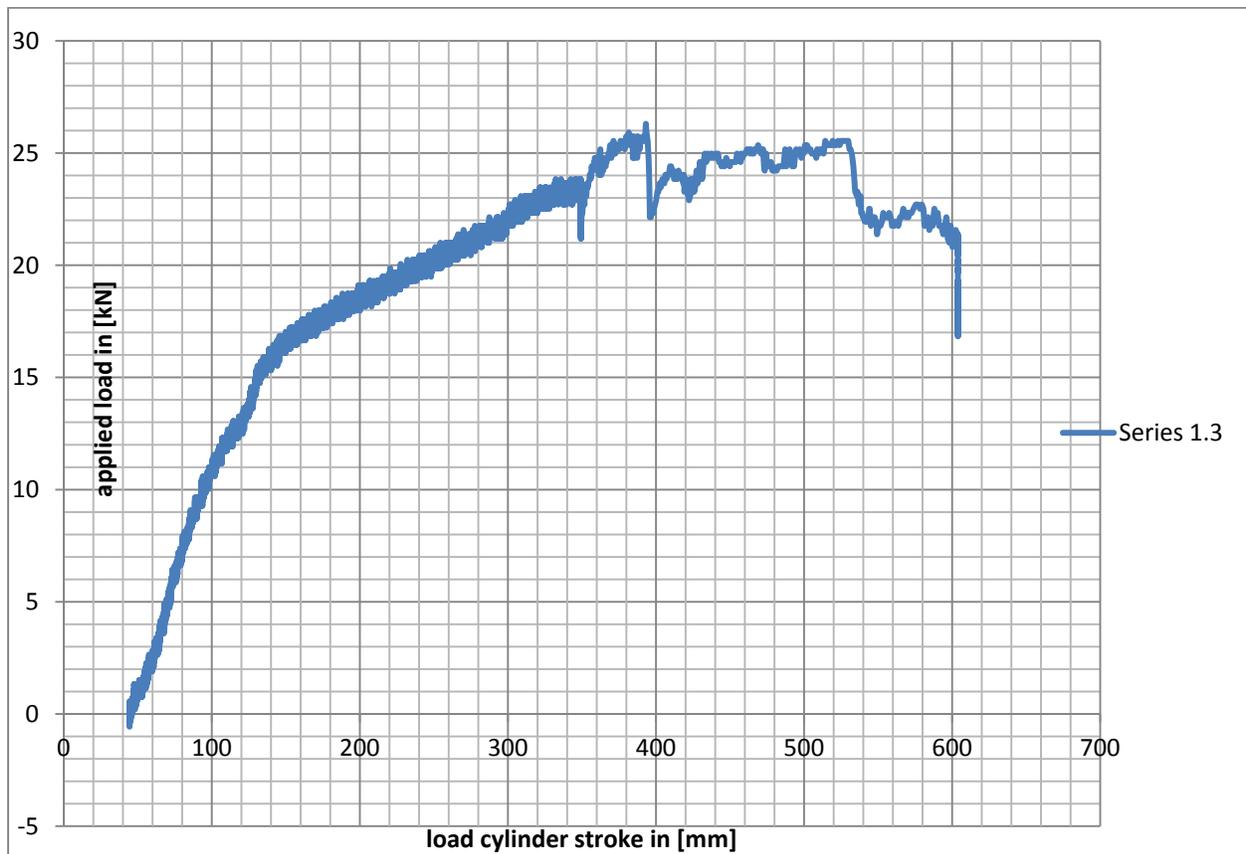
Figure 32: Load Deflection Diagramme of Test 1.3

1.3	#3	7	01/03/2011	26.3	<ul style="list-style-type: none"> • Vertical/horizontal loading ratio = 1.08/6 • Horizontal and vertical load component • Significant failure in timber at 23 kN, then increase due to change in geometry to 26 kN (block bends over and is increasingly loaded in tension) • Relatively long sustained maximum load due to large crushing deformation in timber

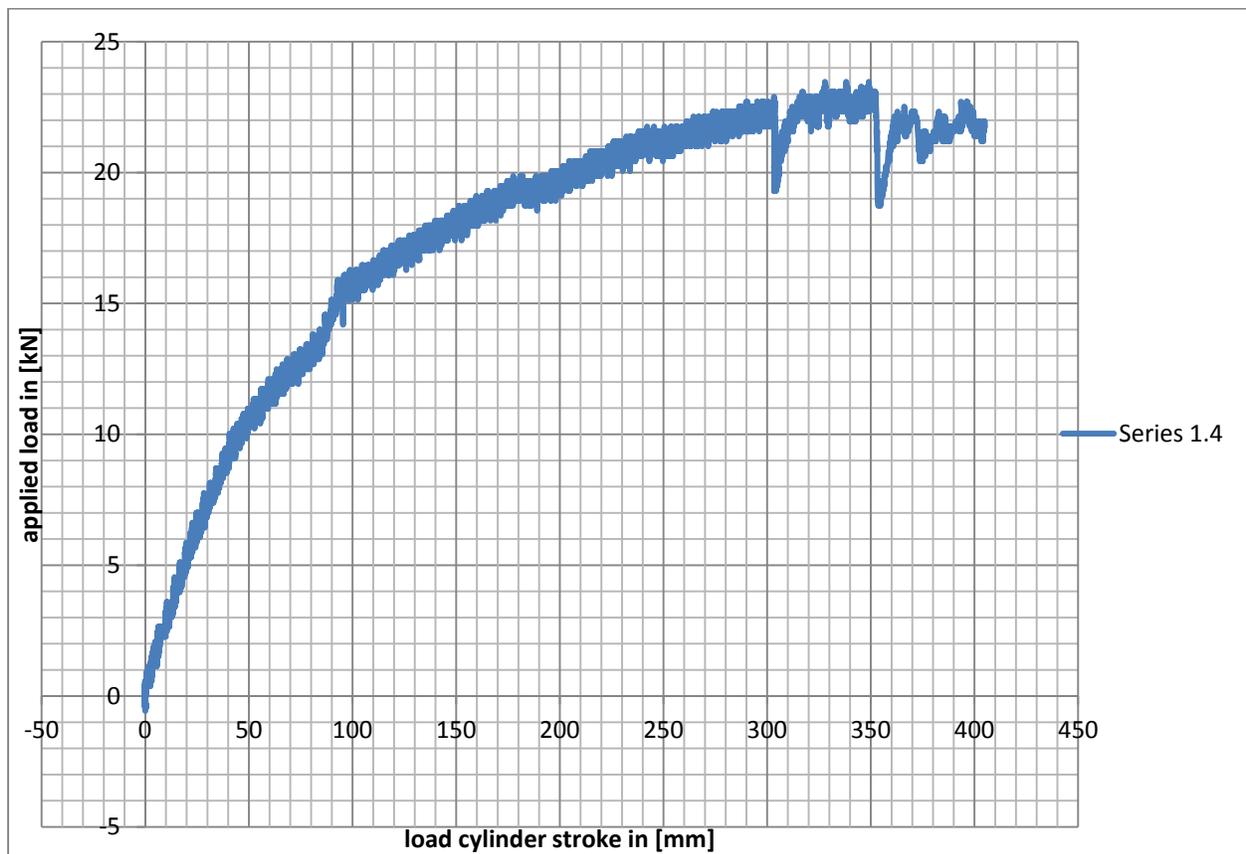
Figure 34: Load Deflection Diagramme of Test 1.4

1.4	#3	8	02/03/2011	23.5	<ul style="list-style-type: none"> • Vertical/horizontal loading ratio = 1.08/6 • horizontal and vertical load • Failure in timber • Bottom block of timber splits vertically along the three bolt holes

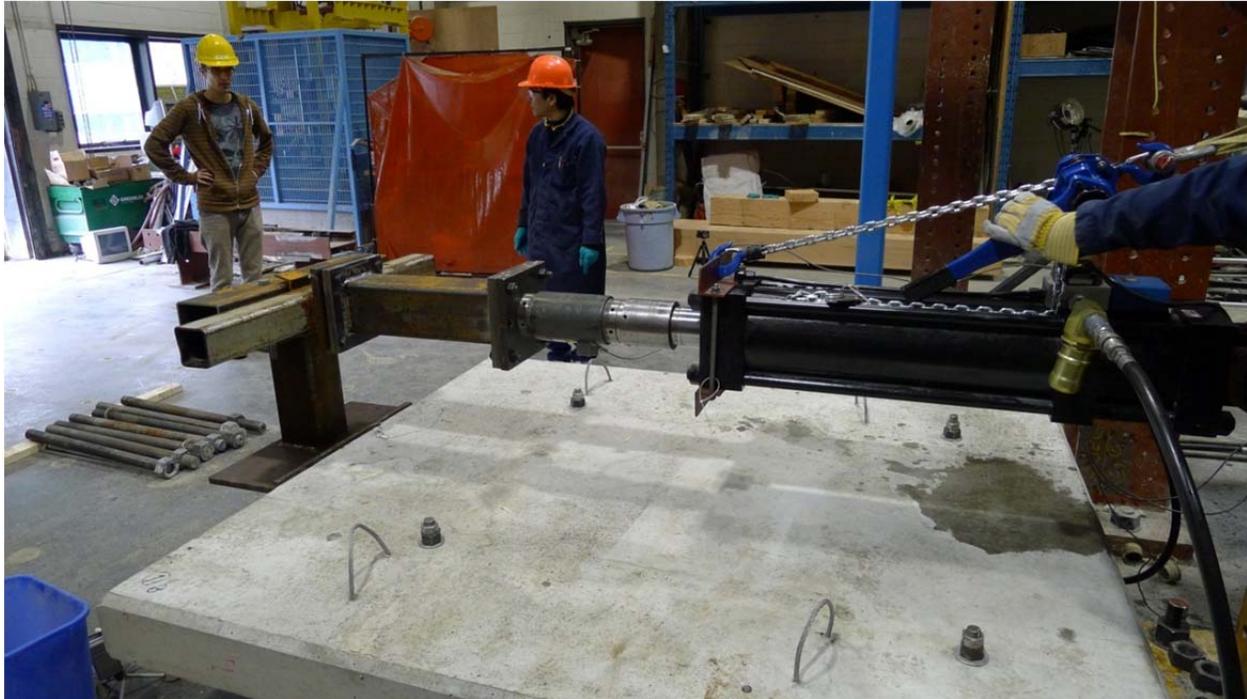
Figure 35: Steel post, Test #2.1, horizontal load direction, 3 x A307 horizontal bolts

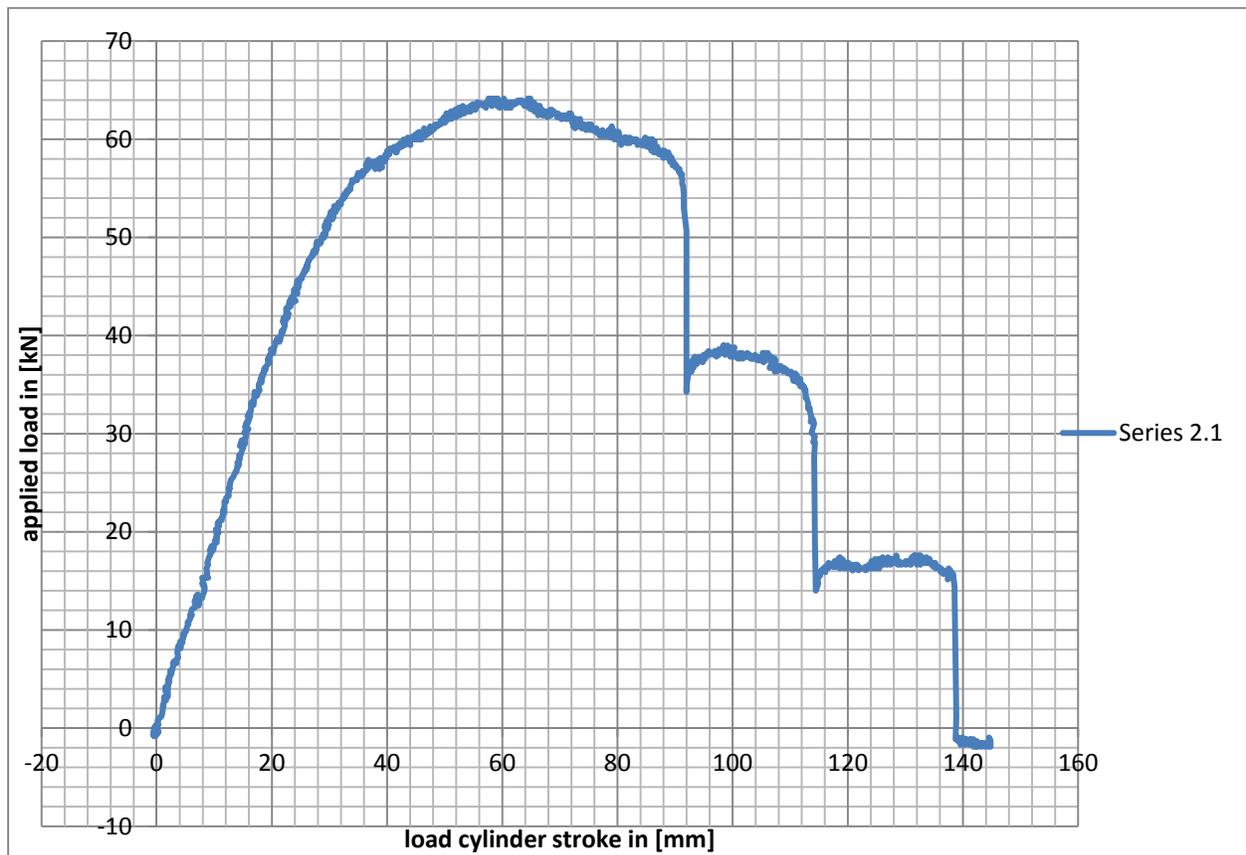
Figure 36: Load Deflection Diagramme of Test 2.1– One bolt failed at a same time / first at 64 kN / second at 38 kN / last at 18 kN

2.1	#1	1	08/02/2011	64.2	<ul style="list-style-type: none"> • Use of A307 bolts in horizontal inserts • Bolts rupture in tension • Failure mode different from field observation

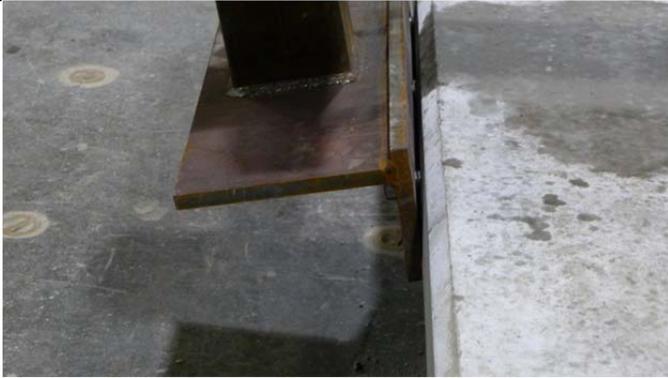
Figure 37: Note: Bolt elongation just before failure

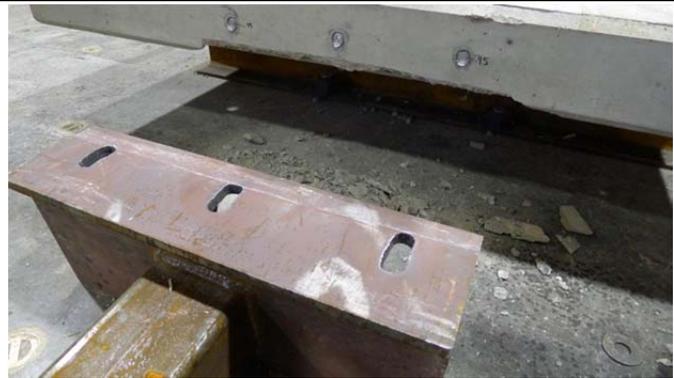
Figure 38: All three bolts stripped in tension, lower concrete face spalled

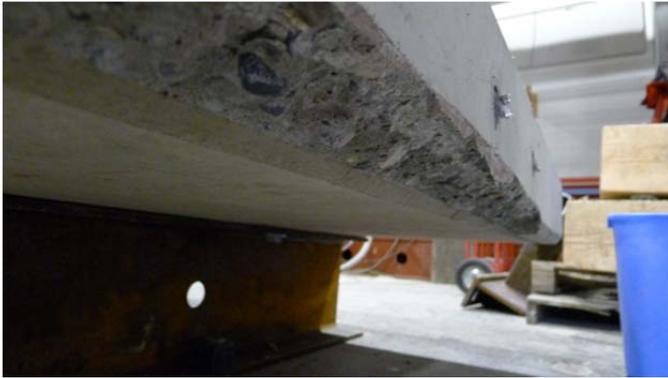
Figure 39: Concrete deck edge, spalled material limited by drip groove, Note: highlighted crack at midthickness of deck panel

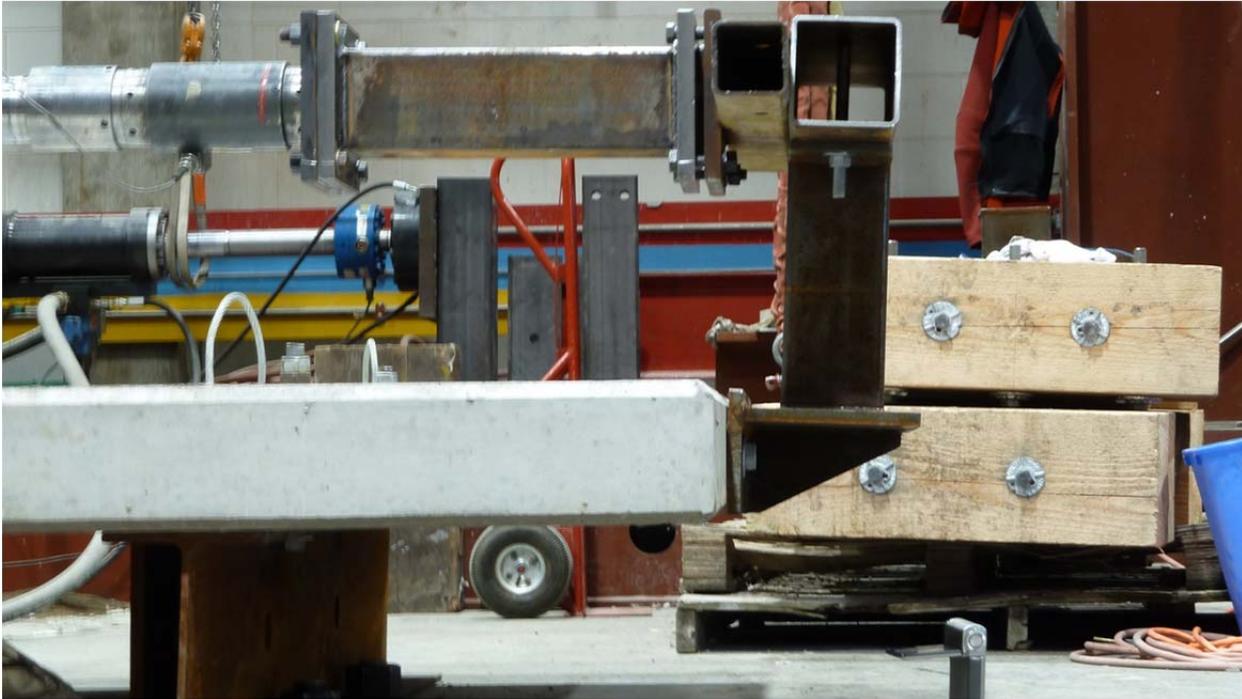
Figure 40: Steel post, Test #2.2, 3 x A307 horizontal bolts

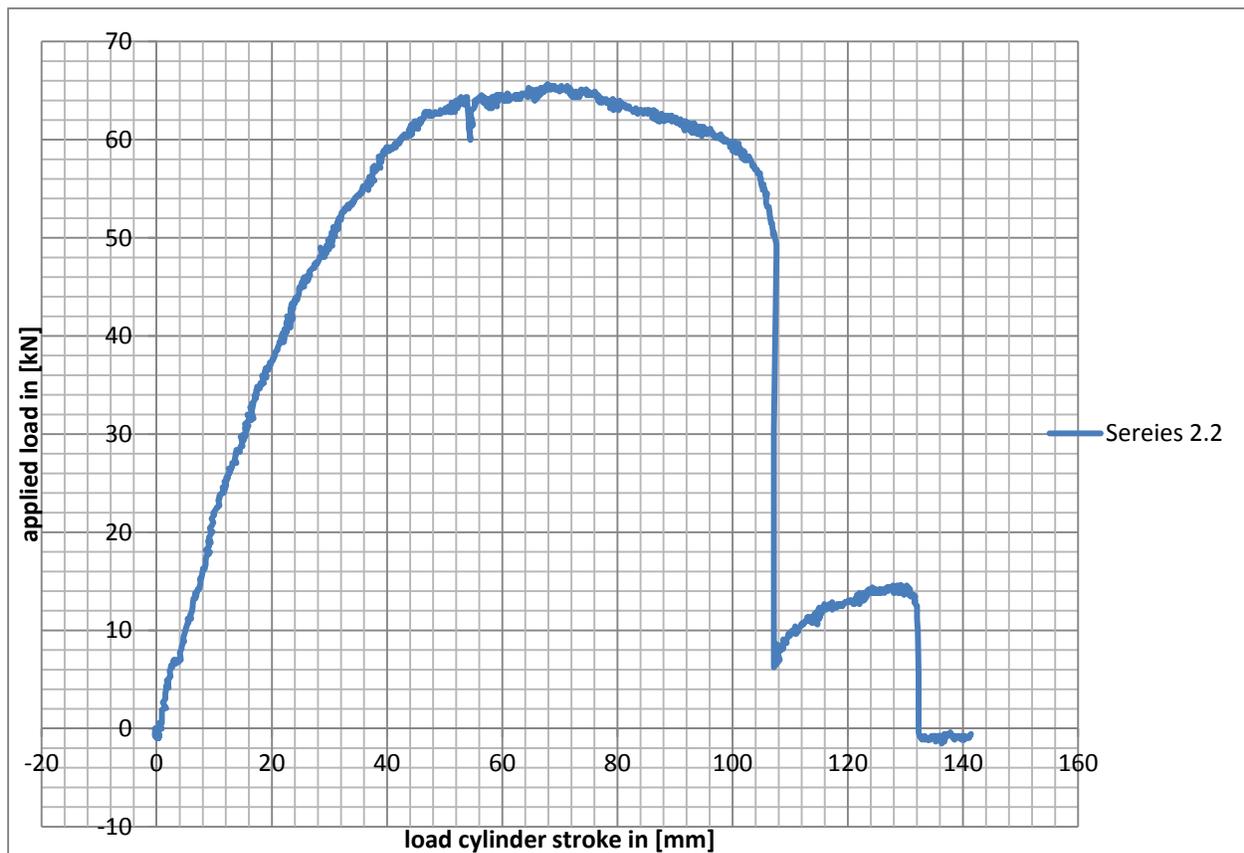
Figure 41: Load Deflection Diagramme of Test 2.2, horizontal load direction, two bolts failed at the same time at max. load

2.2	#1	2	08/02/2011	65.7	<ul style="list-style-type: none"> • Use of A307 bolts in horizontal inserts • Bolts rupture in tension • Failure mode different from field observation

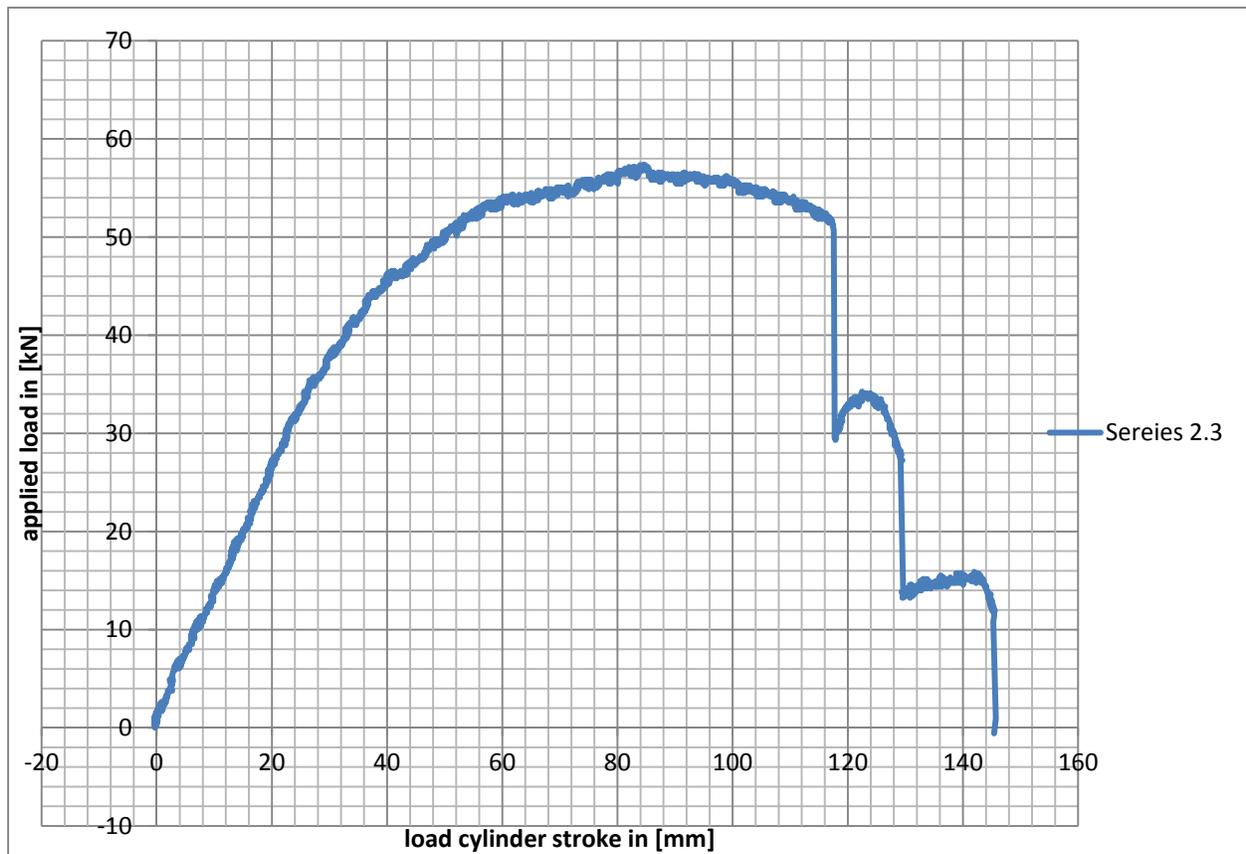
Figure 43: Load Deflection Diagramme of Test 2.3

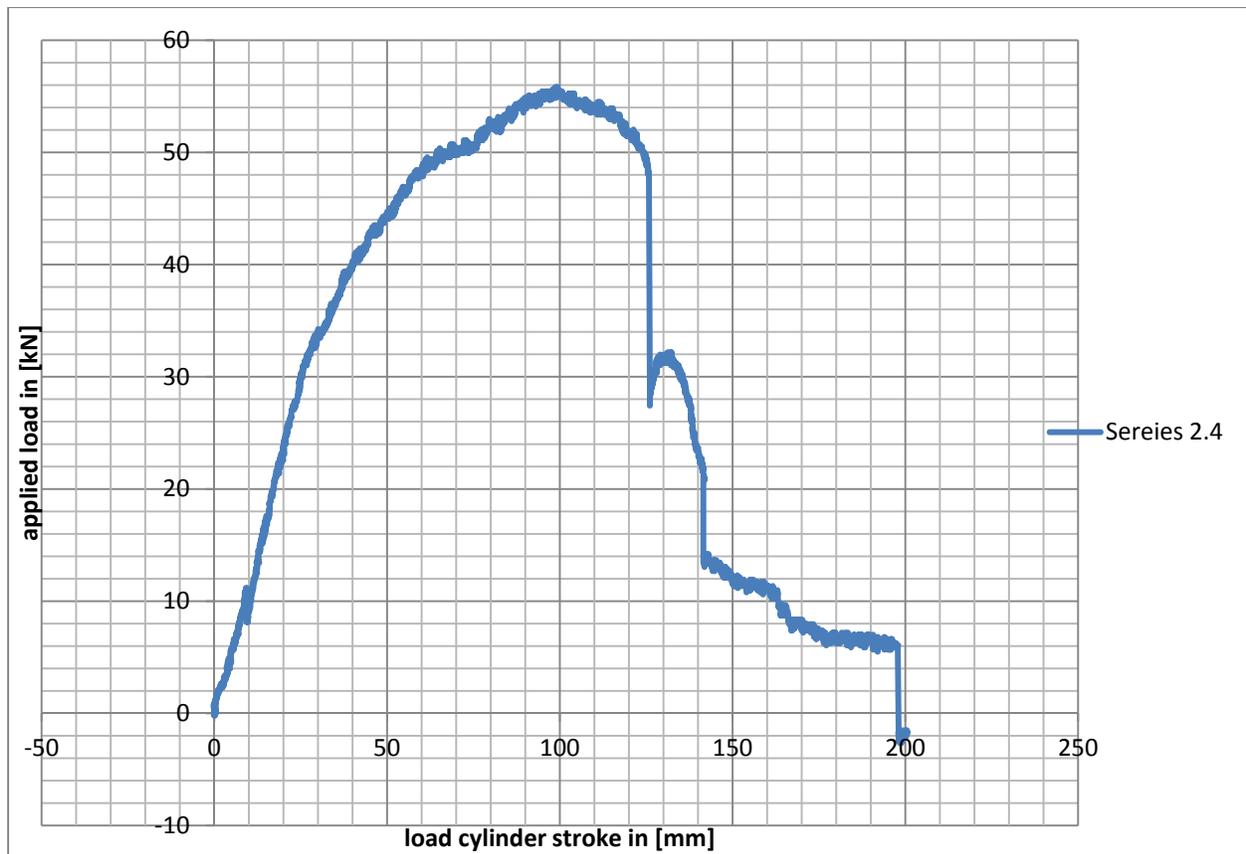
Figure 45: Load Deflection Diagramme of Test 2.4

2.4	#3 recycled	10	03/03/2011	55.8	<ul style="list-style-type: none"> • use of A307 • Vertical/horizontal loading ratio = 1.08/6 • horizontal component variable by hydraulic ram

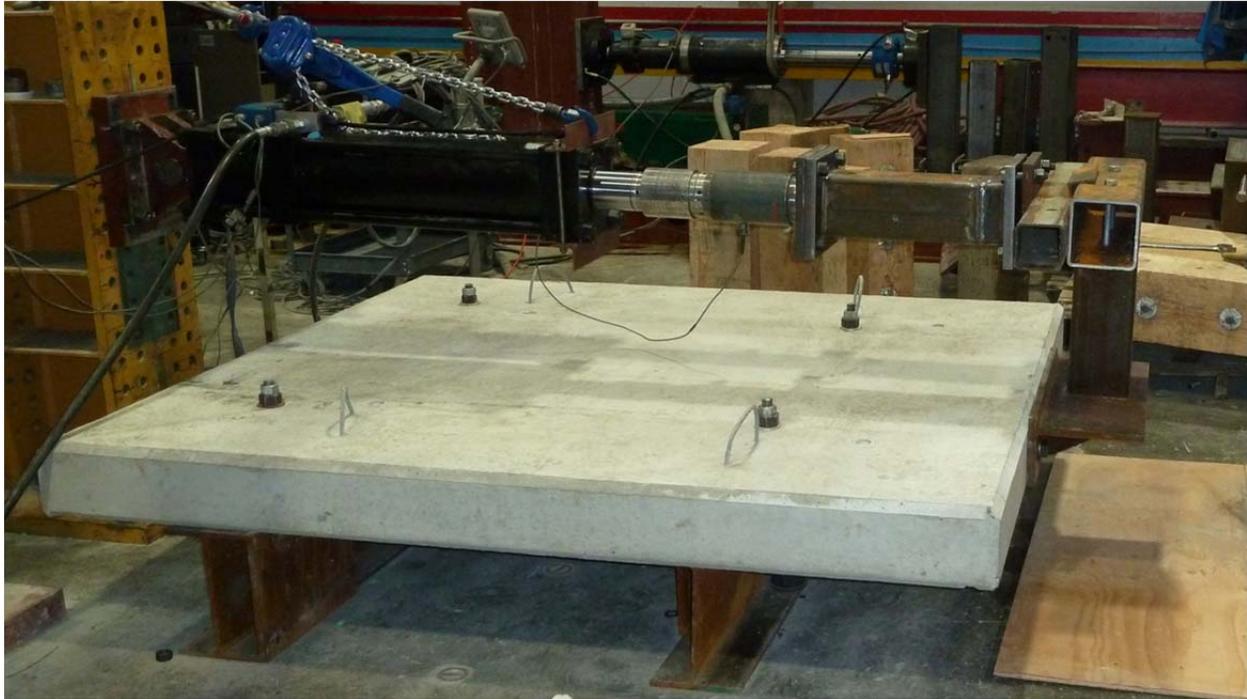
Figure 46: Steel post, Test #2.11, 3 x A325 horizontal bolts

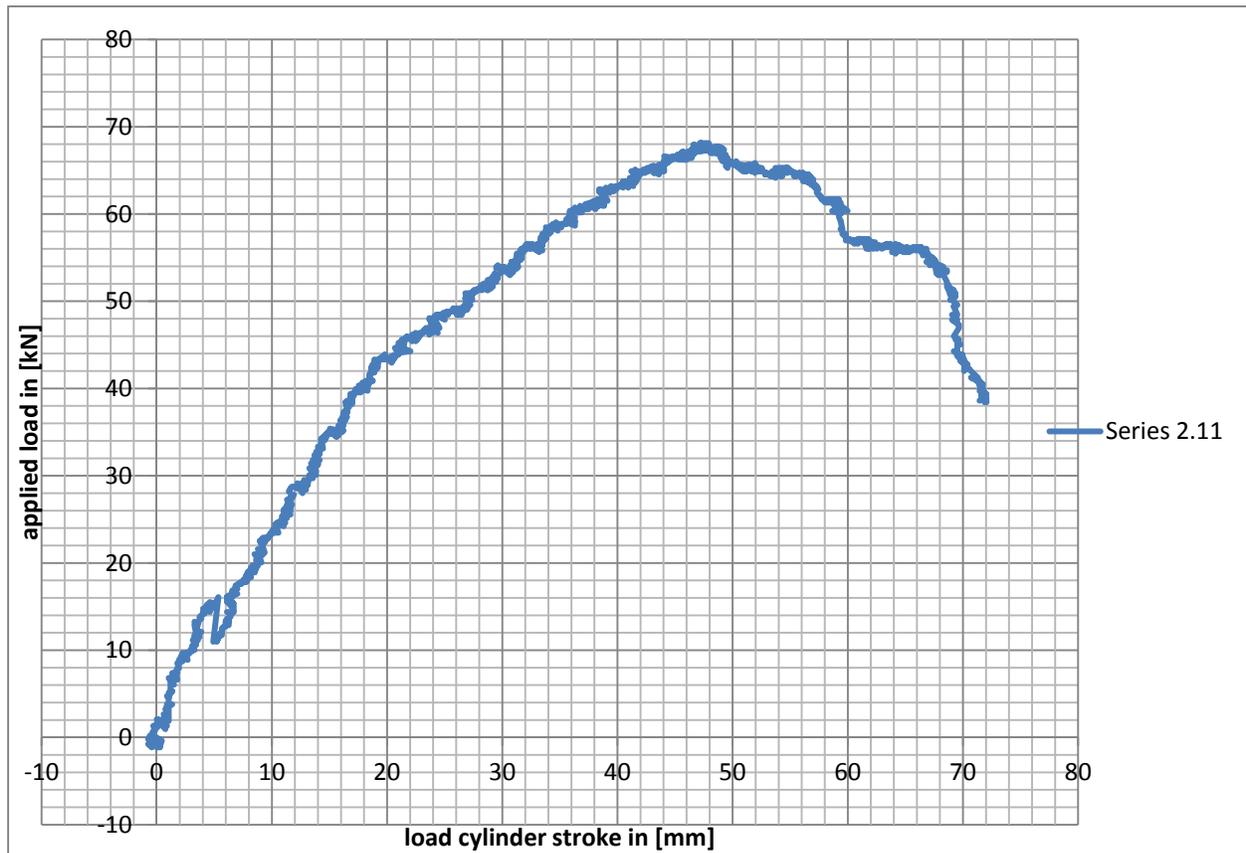
Figure 47: Load Deflection Diagramme of Test 2.11, horizontal load direction

2.11	#2 recycled	5	18/02/2011	68.1	<ul style="list-style-type: none"> • Reuse of concrete panel from test 2.1 – which was practically unscathed, A325 bolts • Failure mode with spalling of concrete in vicinity of bolt inserts • Stress concentration at sleeve-to-rebar interface

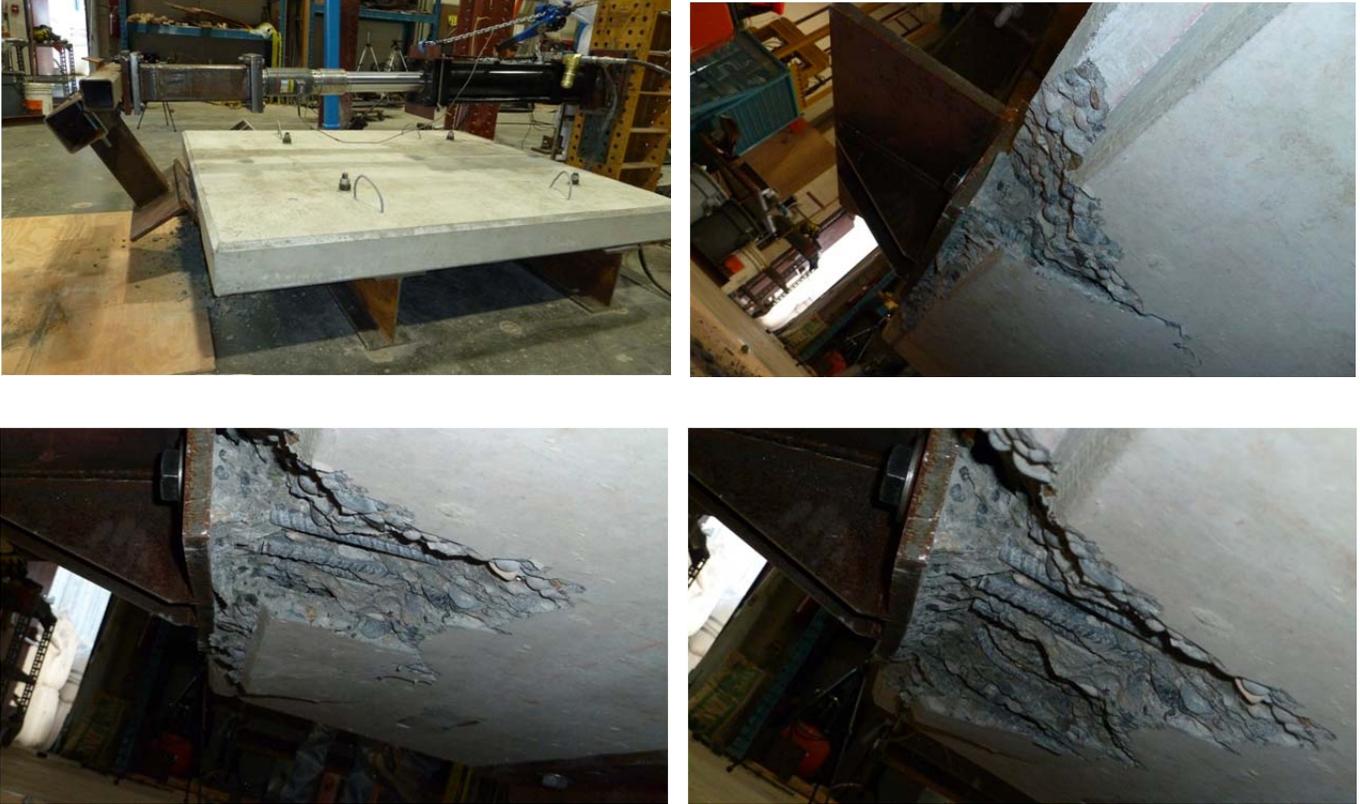
Figure 48: Typical Images during Test for Series #2.11

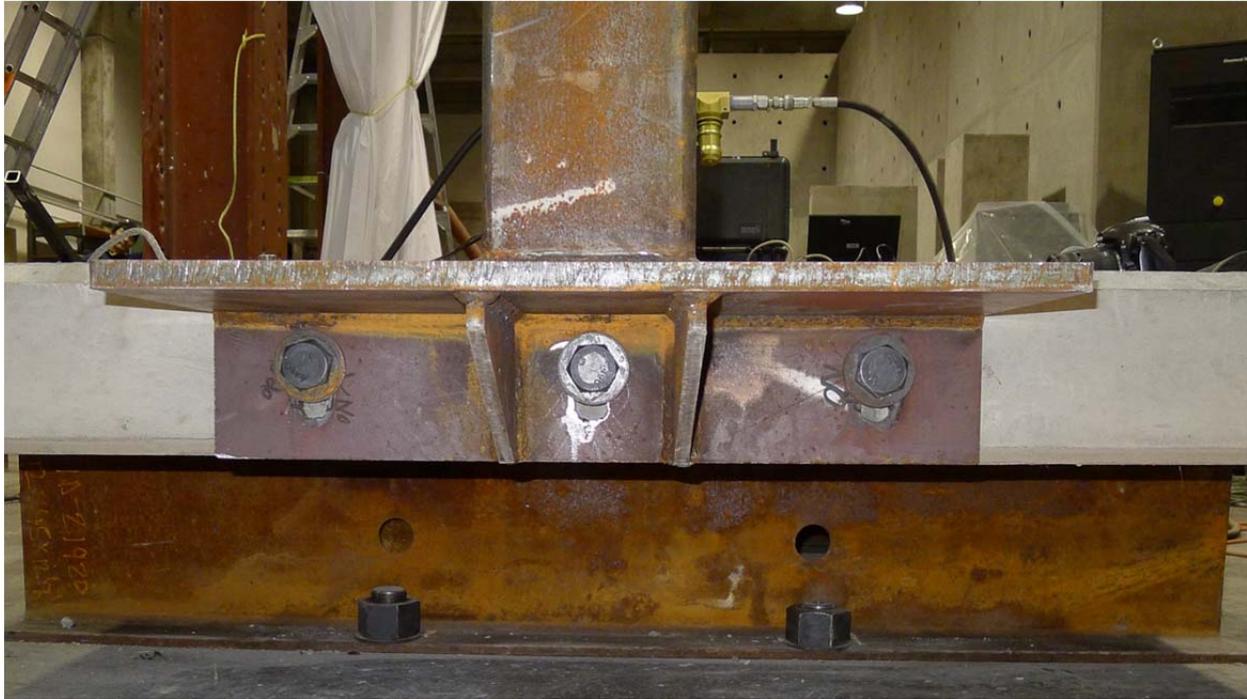
Figure 49: Steel post, Test #2.21, 3 x A325 horizontal bolts

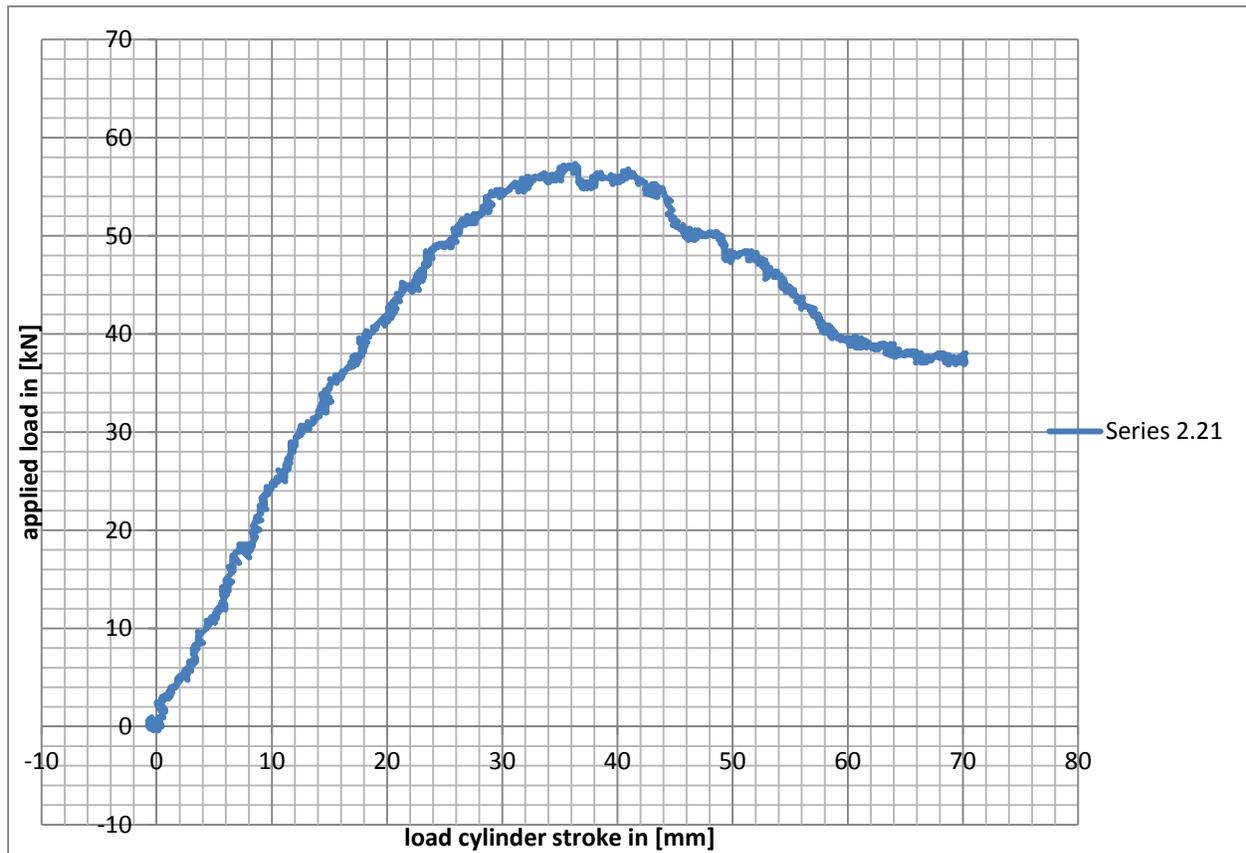
Figure 50: Load Deflection Diagramme of Test 2.21

2.21	#2 recycled	6	18/02/2011	57.3	<ul style="list-style-type: none"> • Reuse of concrete panel from test 2.1 – which was practically unscathed, A325 bolts • Failure mode with spalling of concrete in vicinity of bolt inserts • Stress concentration at sleeve-to-rebar interface, causes larger variability in ultimate capacity

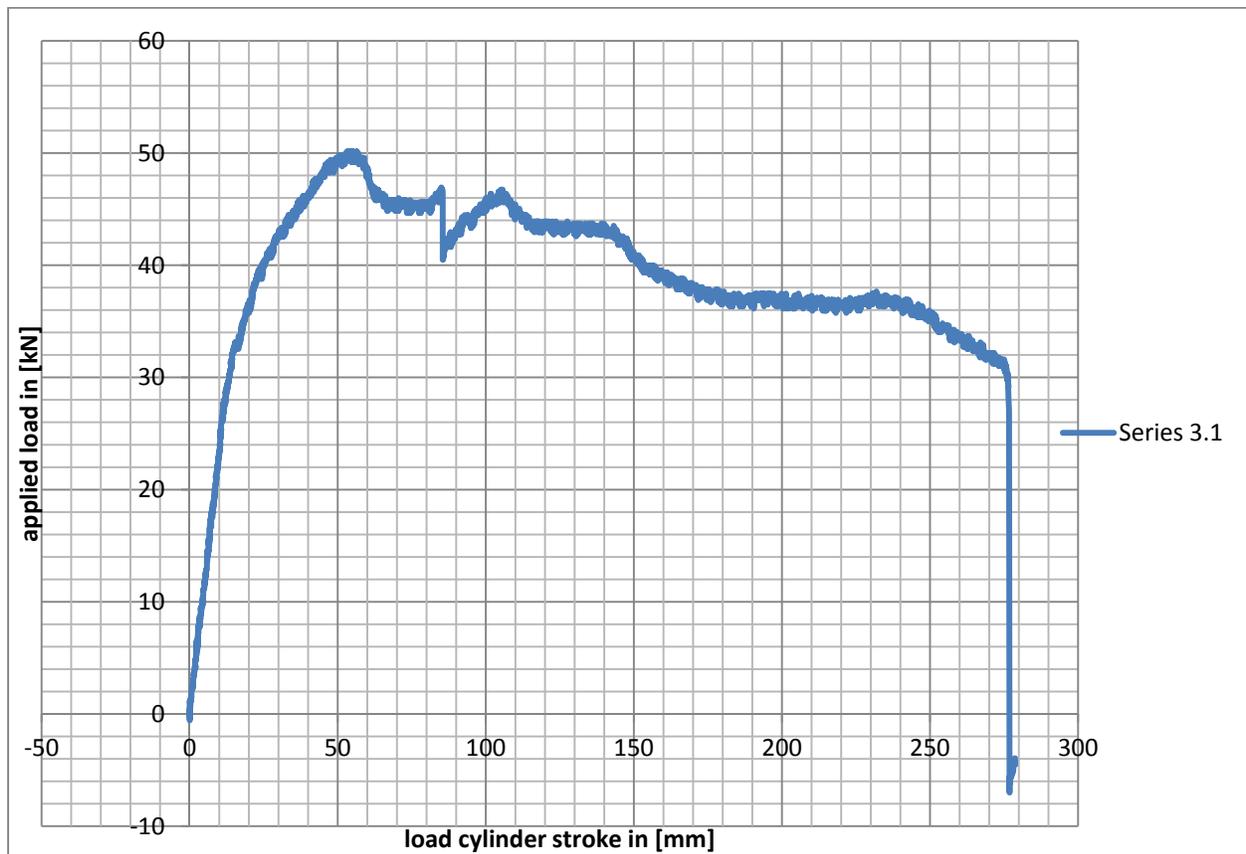
Figure 53: Load Deflection Diagramme of Test 3.1

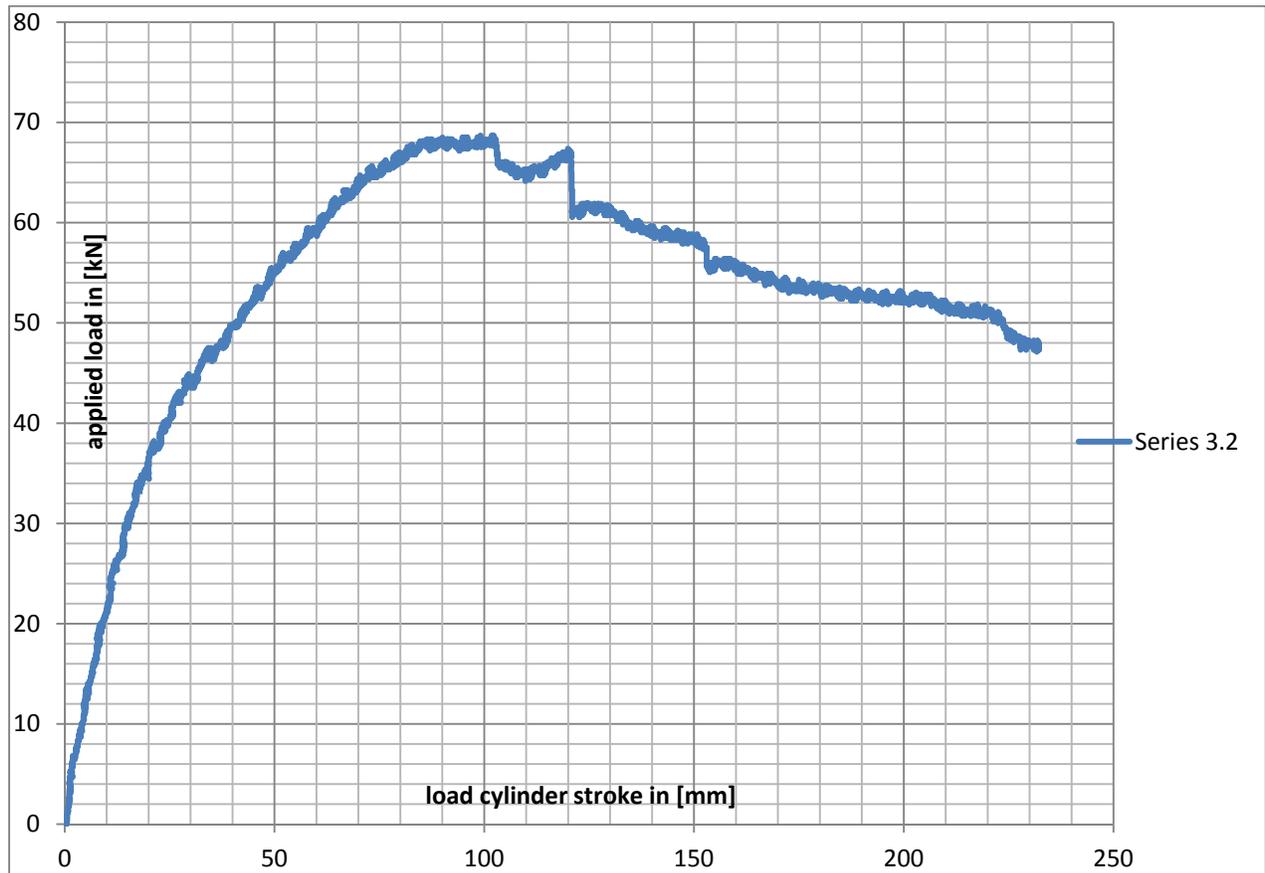
Figure 55: Load Deflection Diagramme of Test 3.2

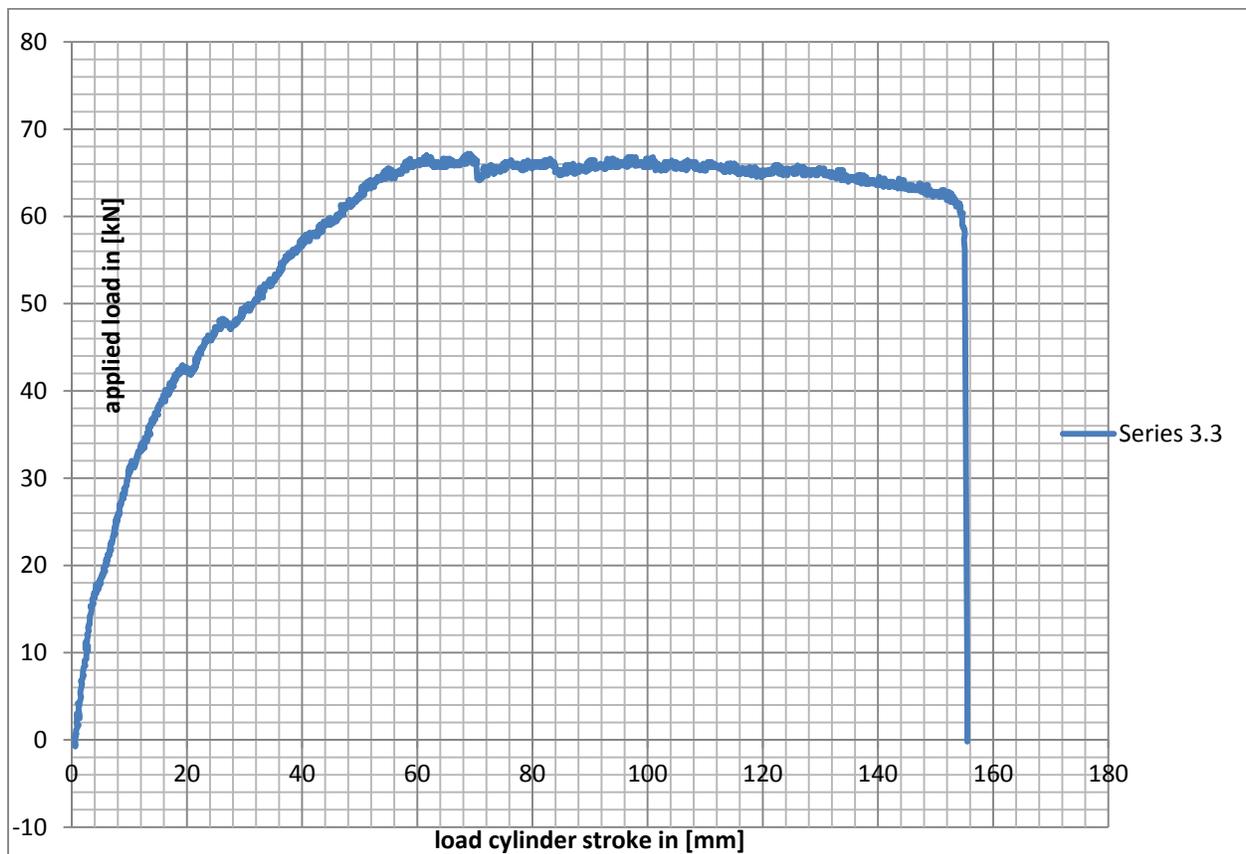
Figure 57: Load Deflection Diagramme of Test 3.3
