**Project “Experimental Evaluation of Concrete Decks with Guard Rail Systems”
for
Ministry of Forests, Lands and Natural Resource Operations**

Project Report by
C. Villiard & C. Dickof & M. Angers & J. Schneider & S.F. Stierner

UBC

Final Report Vancouver May 2011

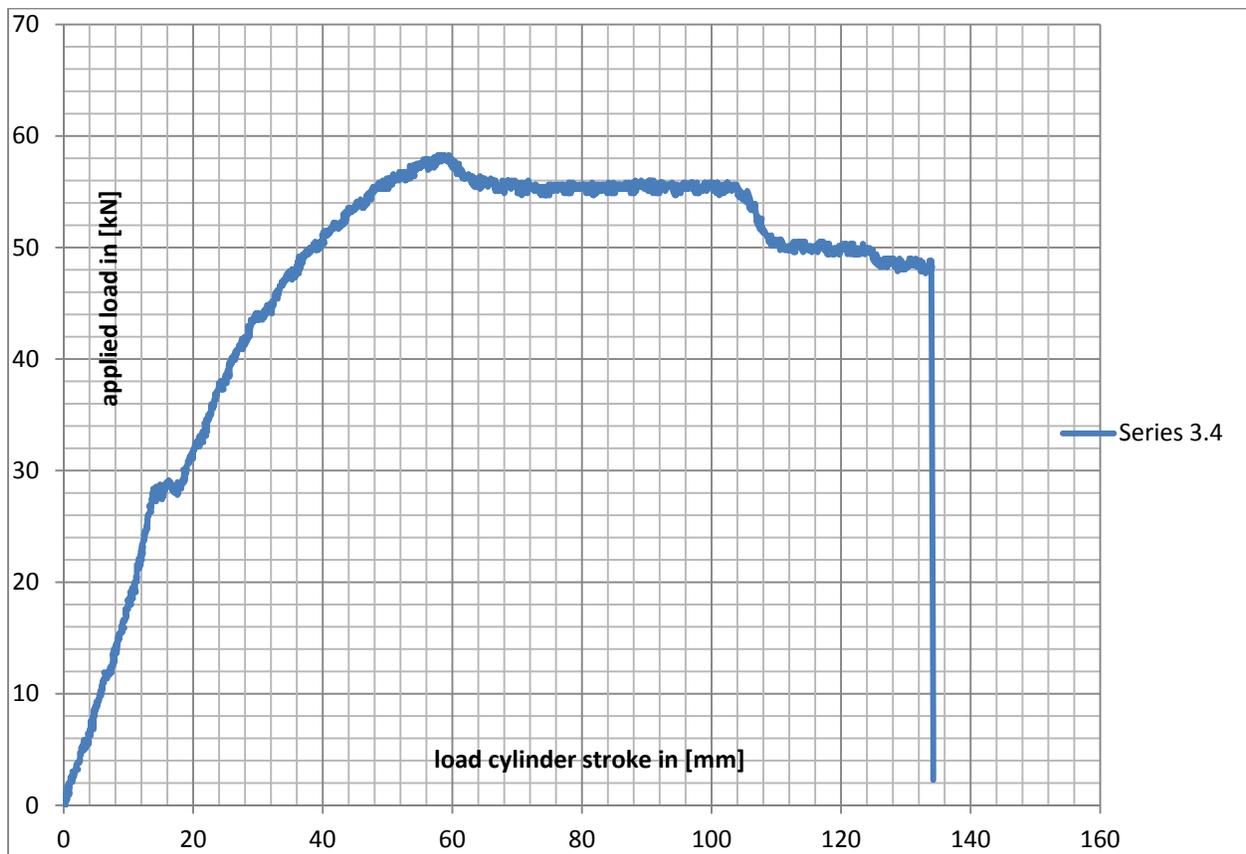
Figure 59: Load Deflection Diagramme of Test 3.4

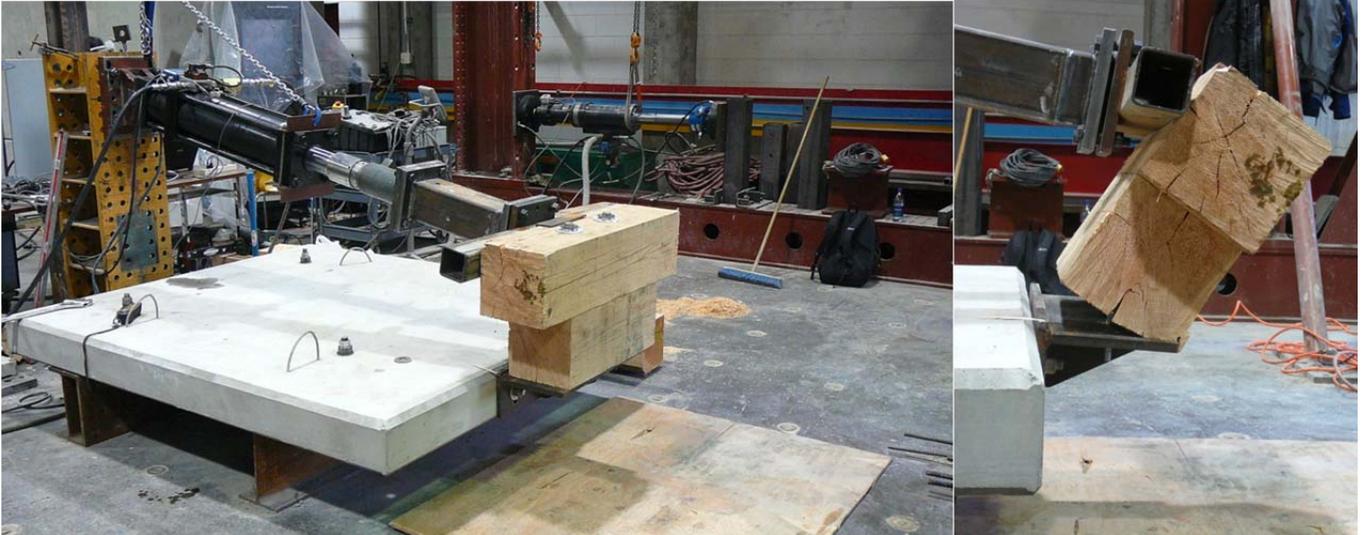
Figure 60: Steel post, Test #4.1, steel base, timber riser, vert. and hor. components applied, 3 A307 horizontal bolts

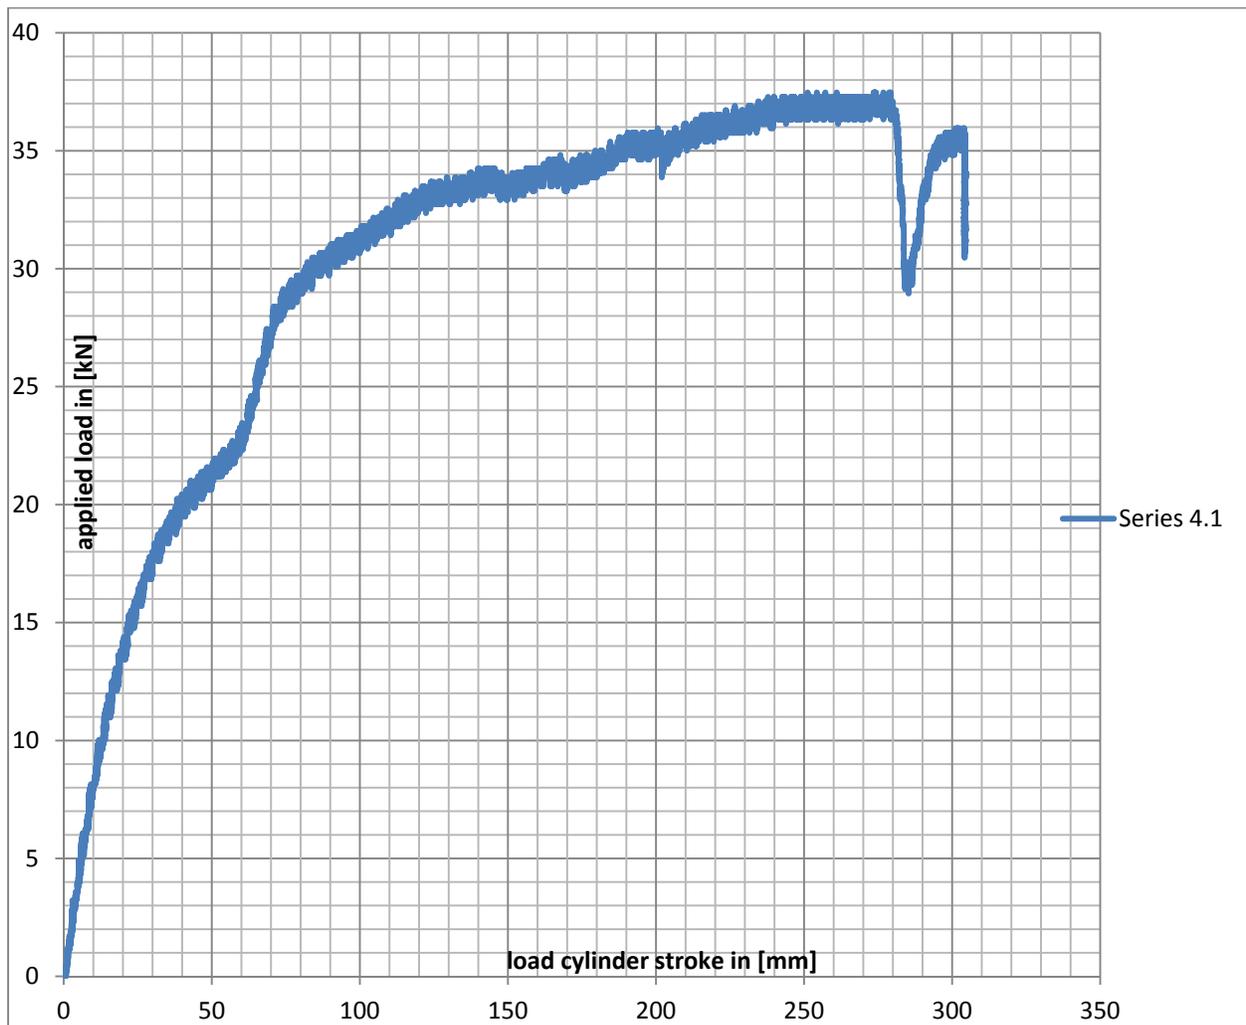
Figure 61: Load Deflection Diagramme of Test 4.1

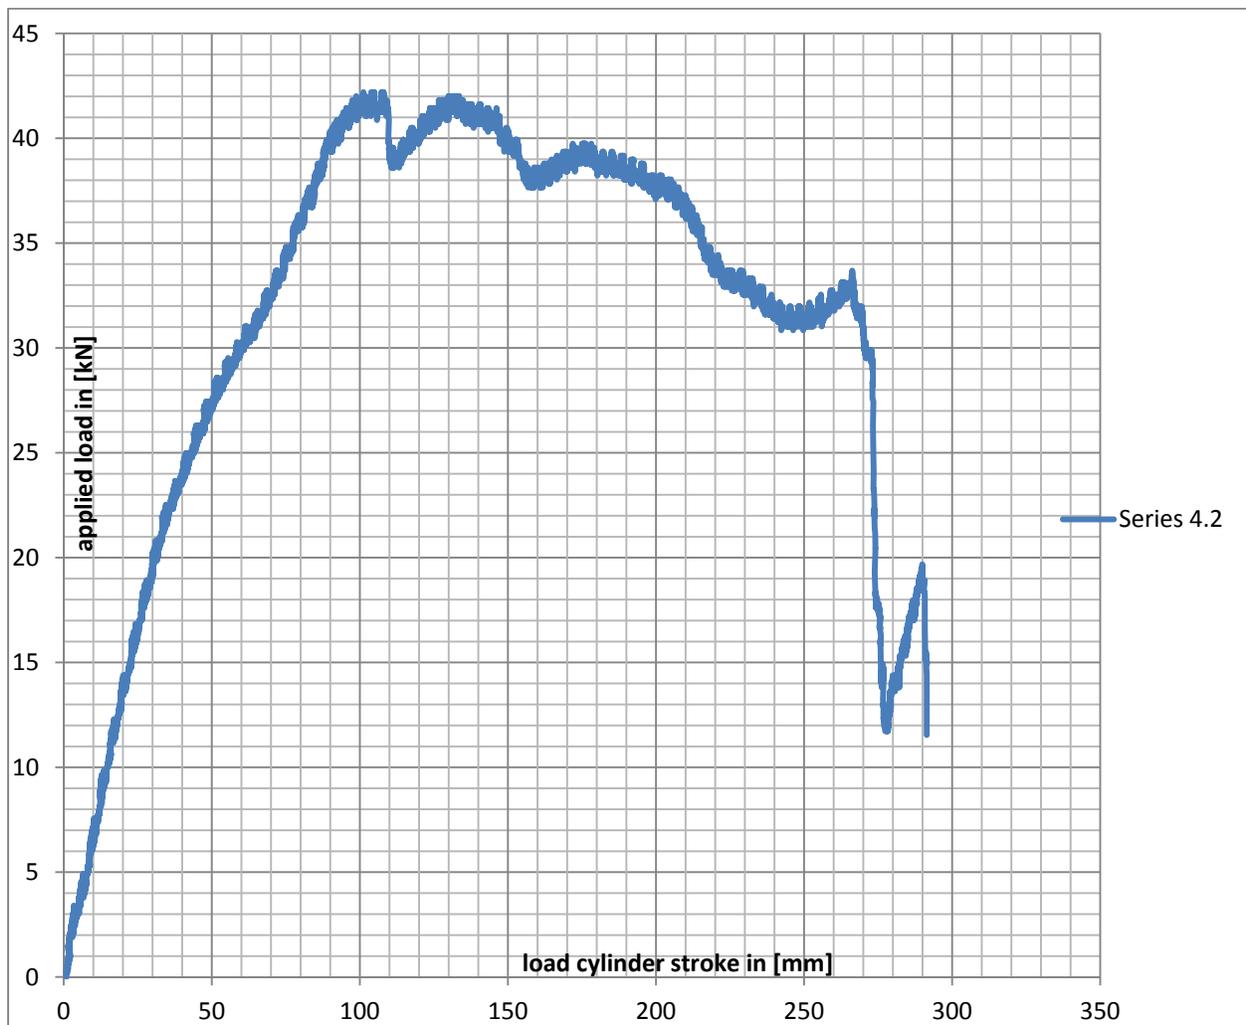
Figure 63: Load Deflection Diagramme of Test 4.2

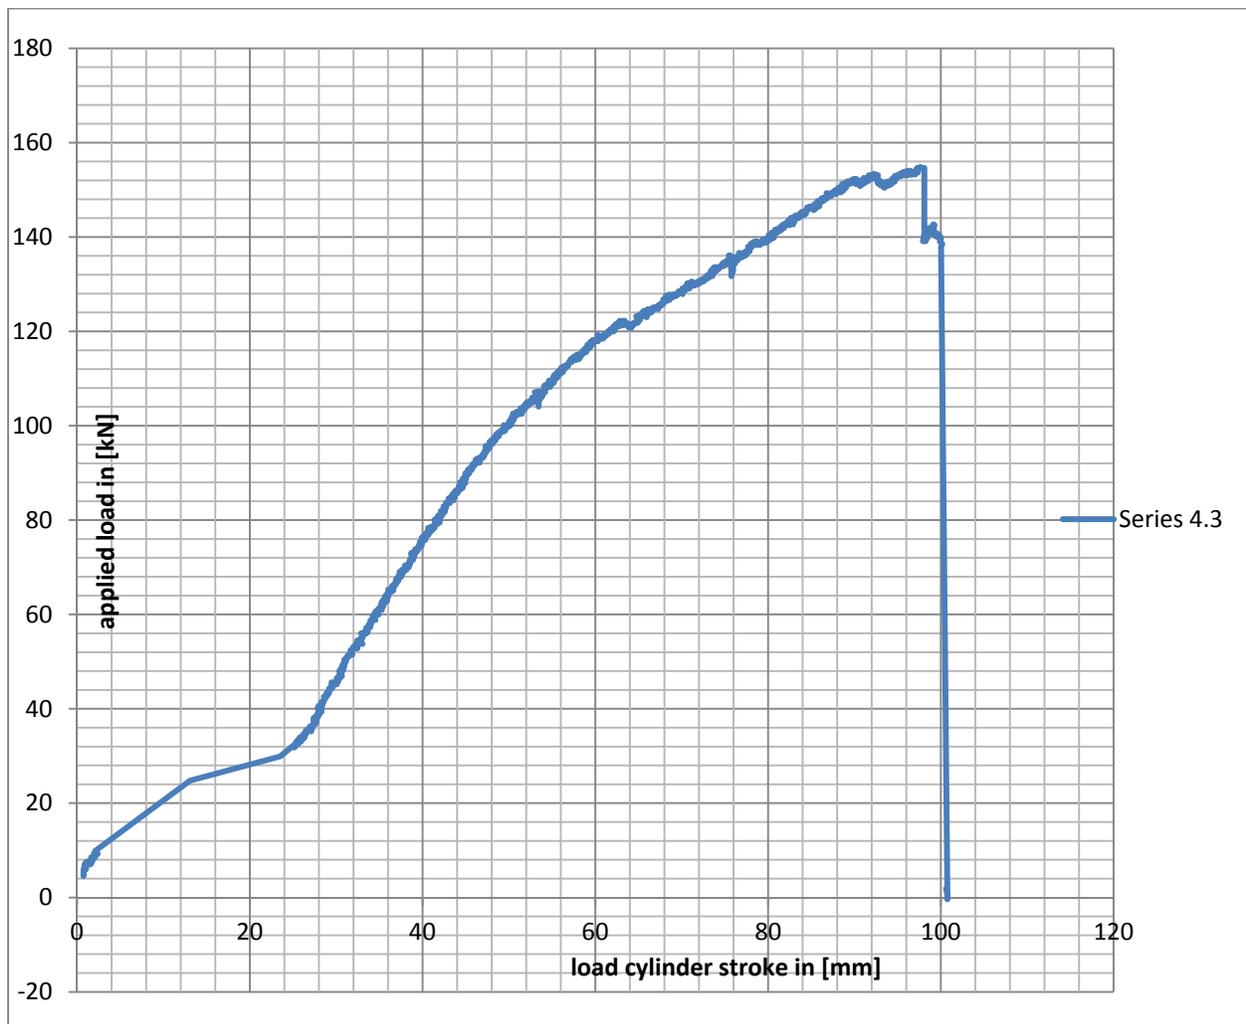
Figure 65: Load Deflection Diagramme of Test 4.3

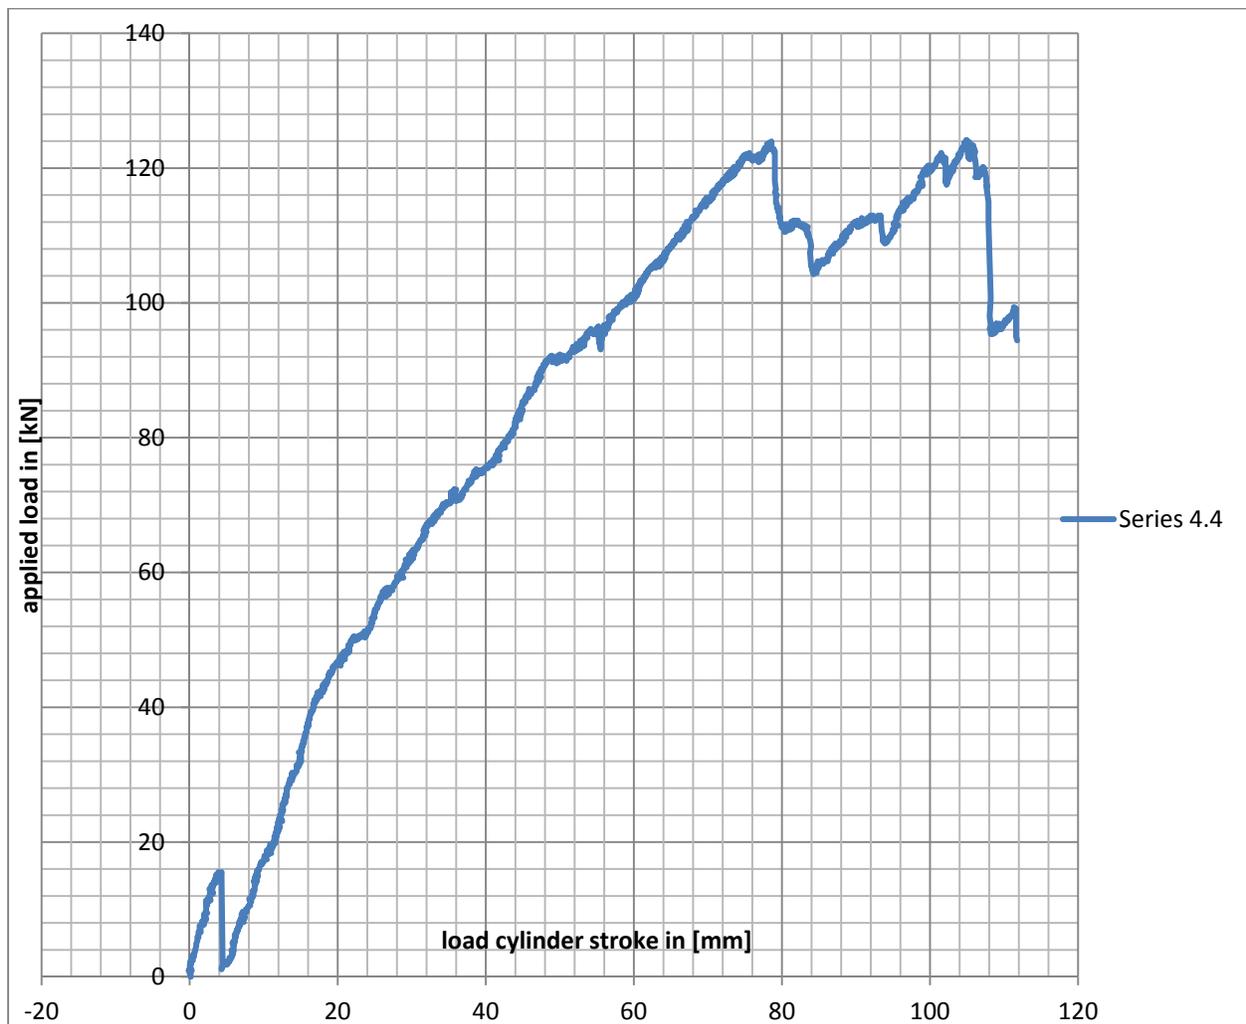
Figure 67: Load Deflection Diagramme of Test 4.4

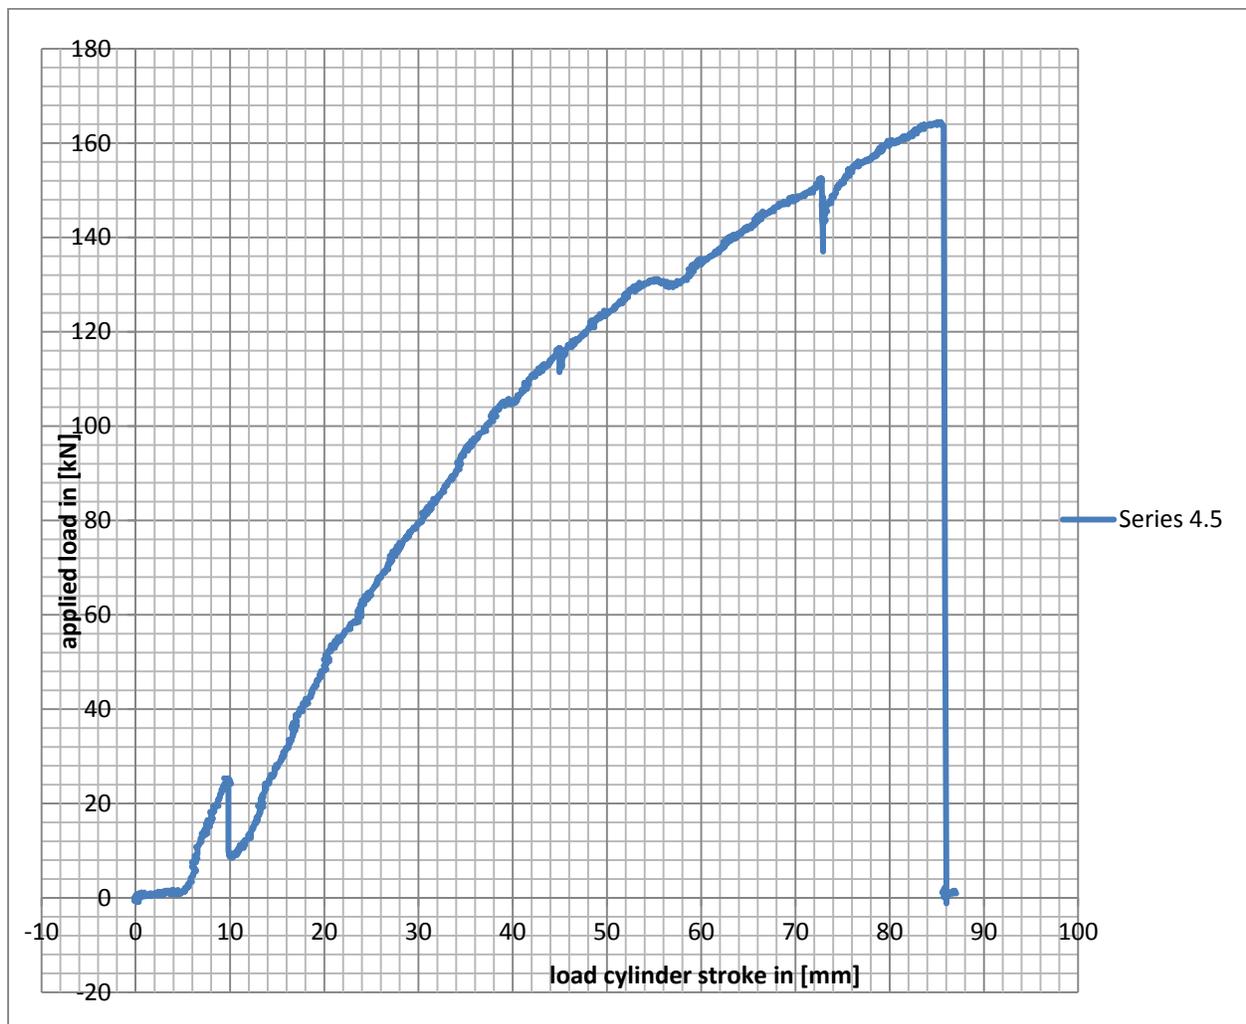
Figure 69: Load Deflection Diagramme of Test 4.5
