Reasons for Decision

Conditional Approval of 2019 Final Closure Plan for Cobble Hill Holdings Landfill

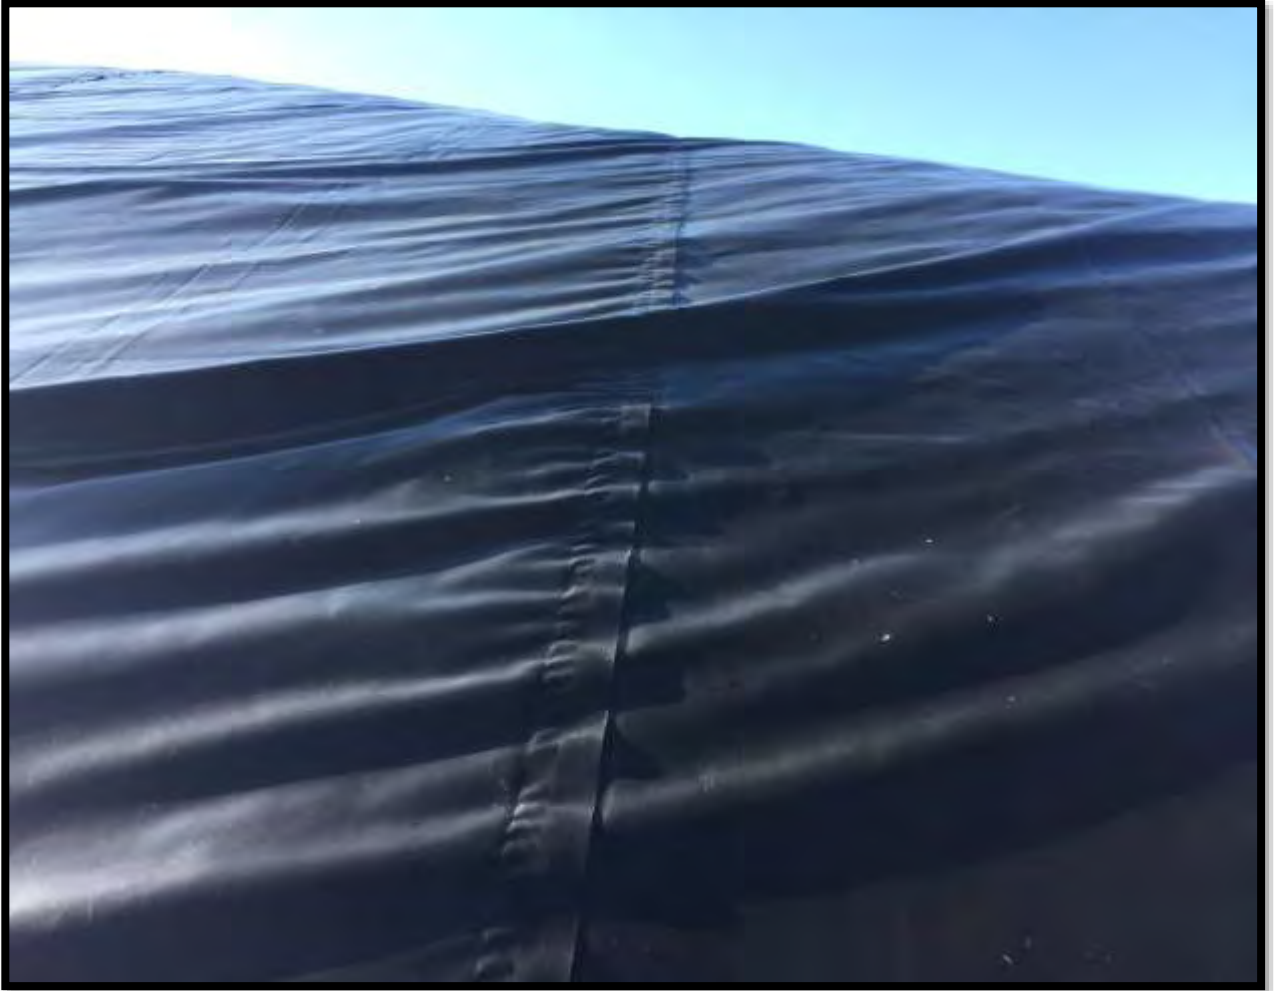
Photo 1 – PEA North Face Liner Folds

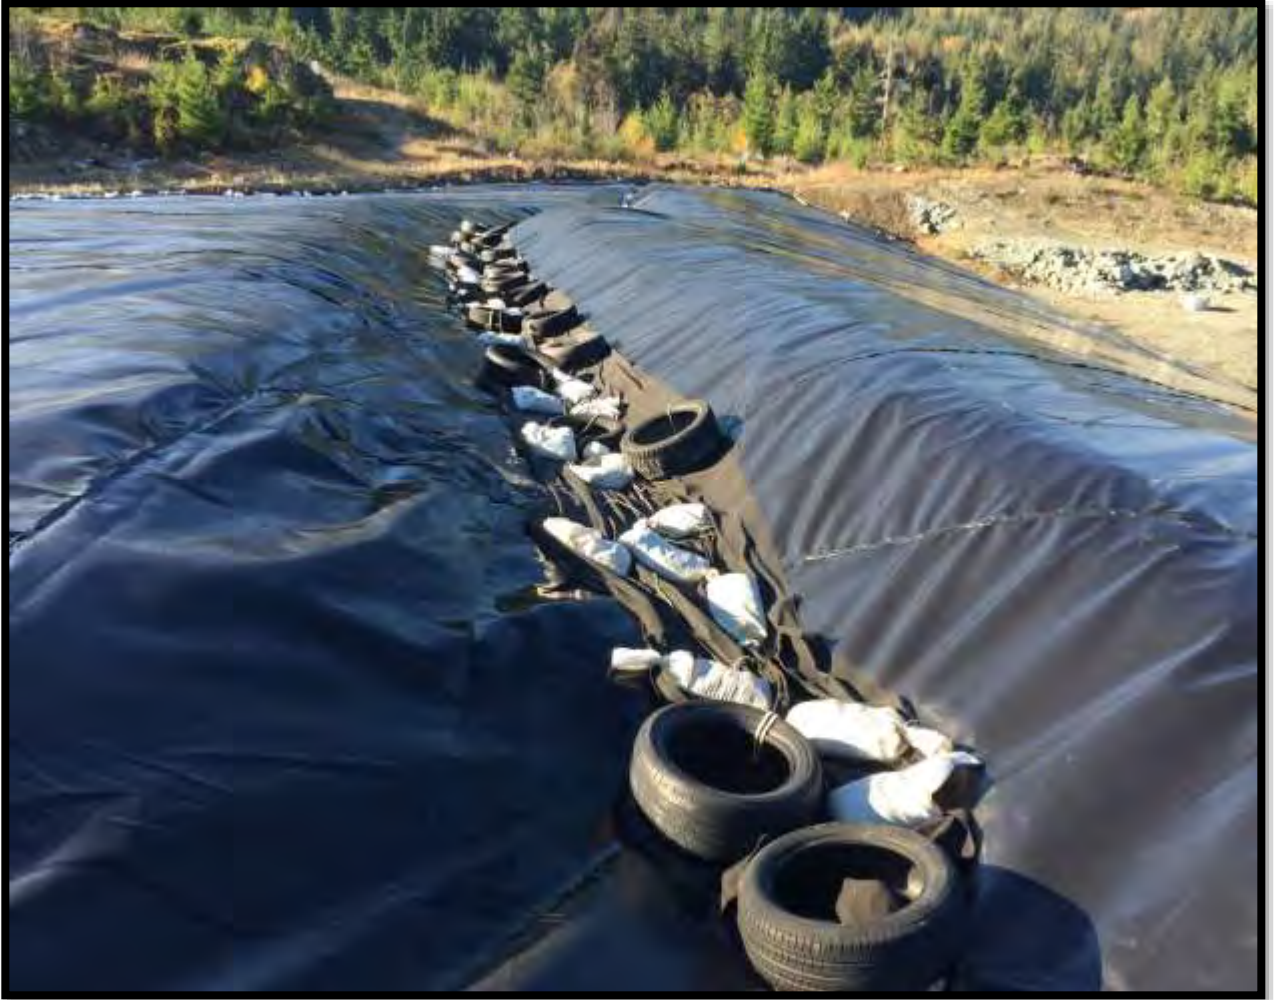
Photo 2 – PEA East-West Surface Ditch System

Ditches were observed as lined with tires and sand bags placed upon geotextile fabric followed by the PEA liner underneath. Tires, sandbags, and fabric were removed to show no signs of tearing, stretching, or warping (Photos 2 and 3).

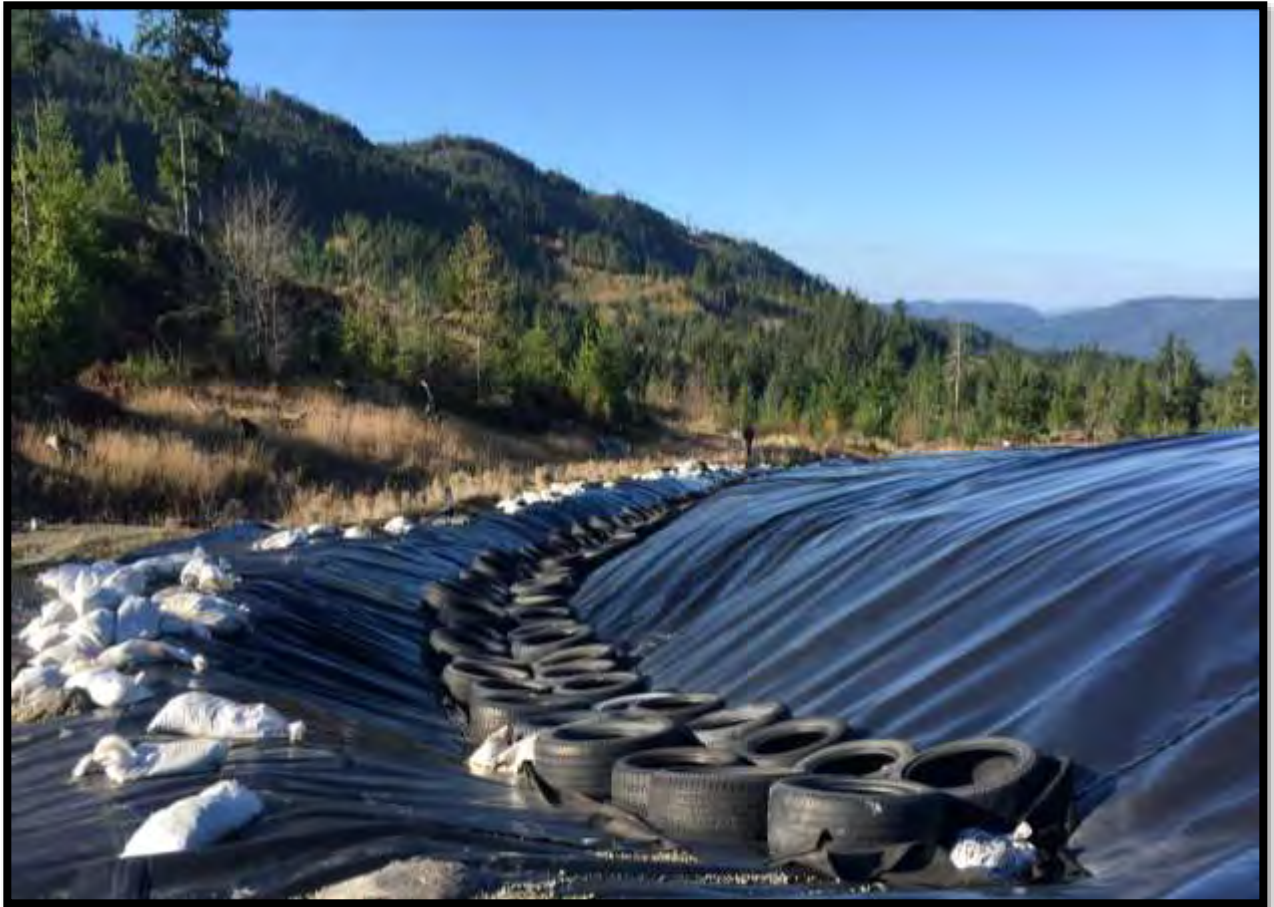
Photo 3 – PEA North-South Surface Ditch System

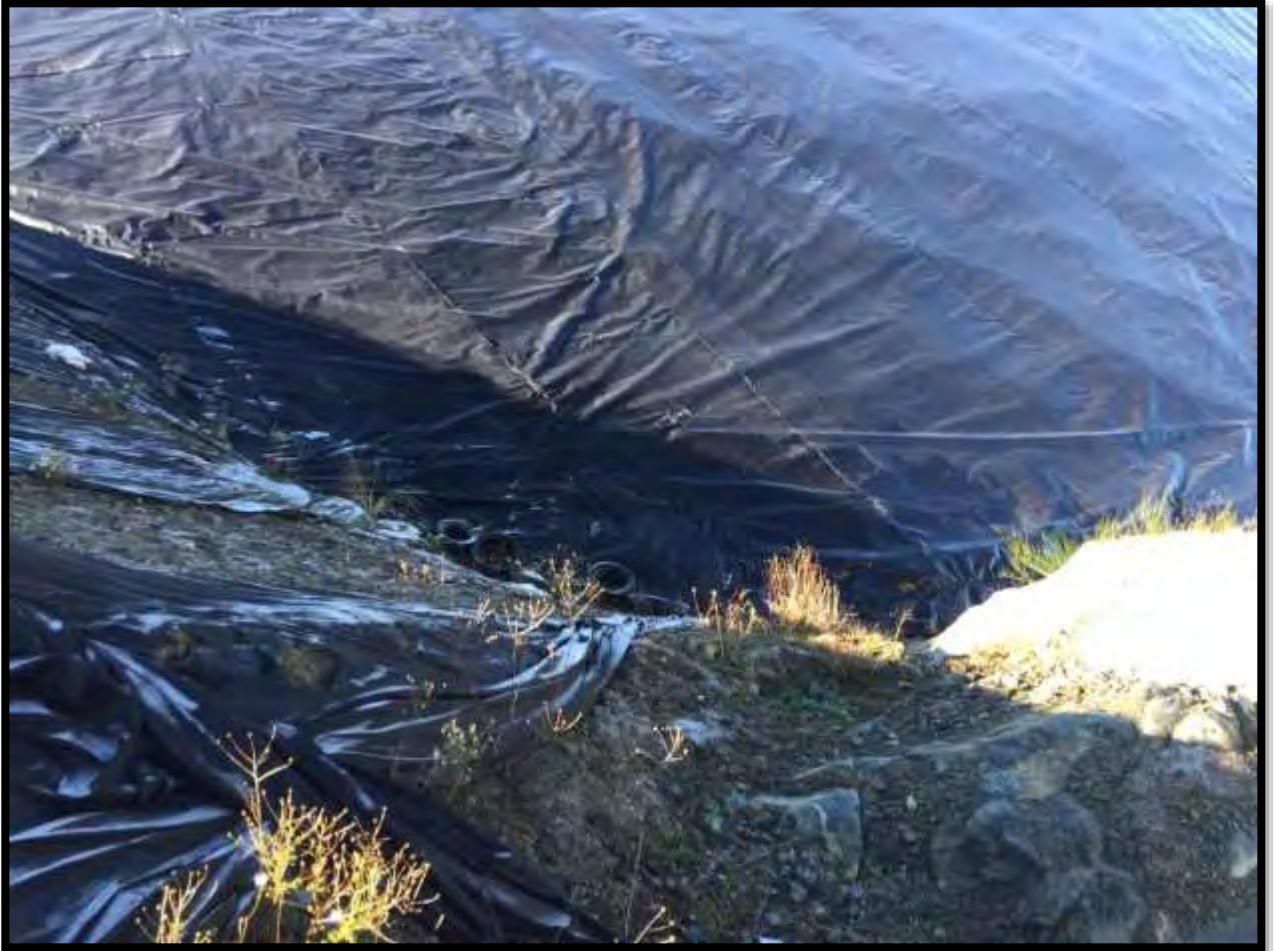
Photo 4 – PEA East Face- Evidence of Wildlife is devoid on the liner system

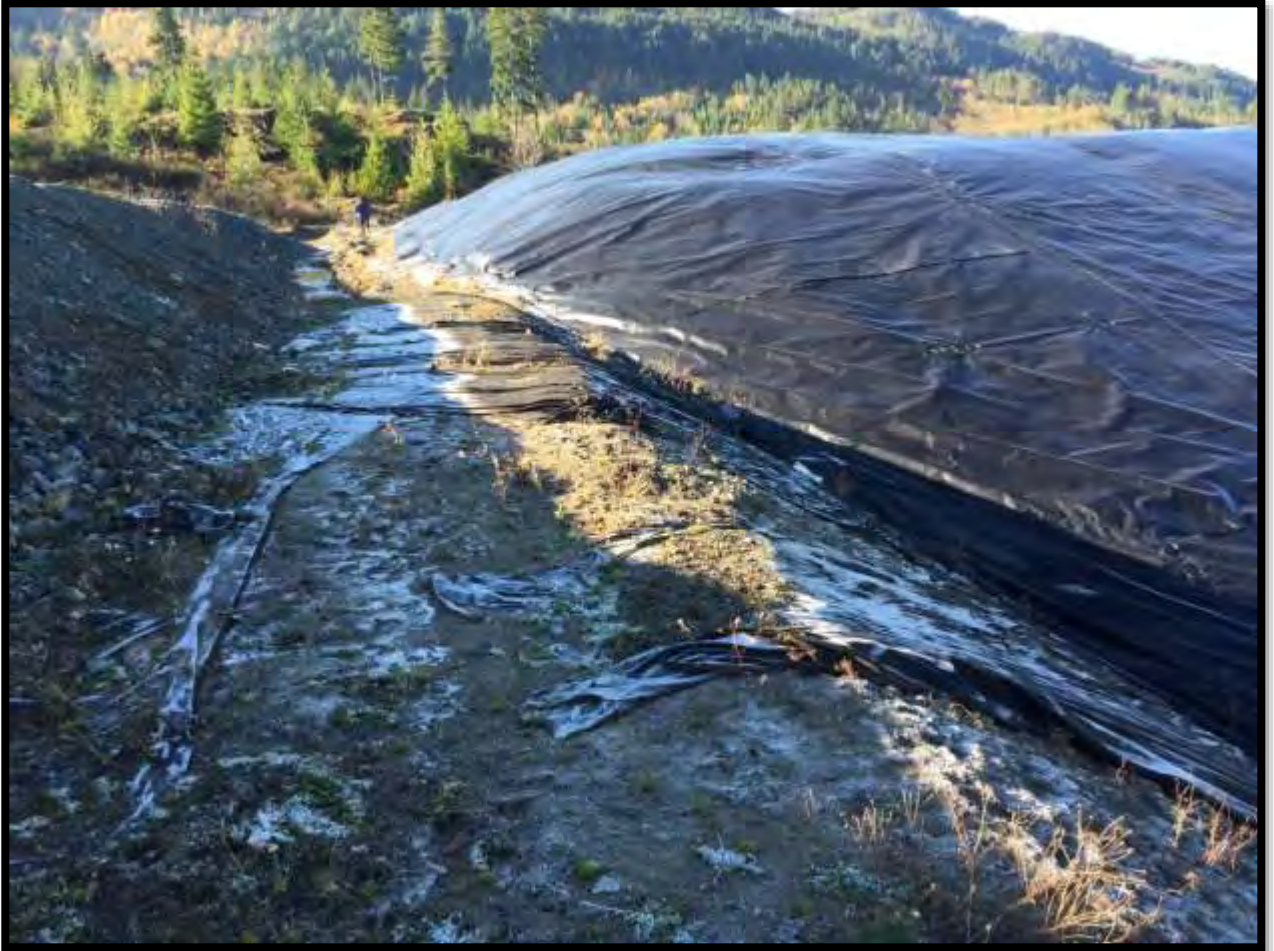
Photo 6 – PEA South-East Surface- Evidence of Wildlife is devoid on the liner system

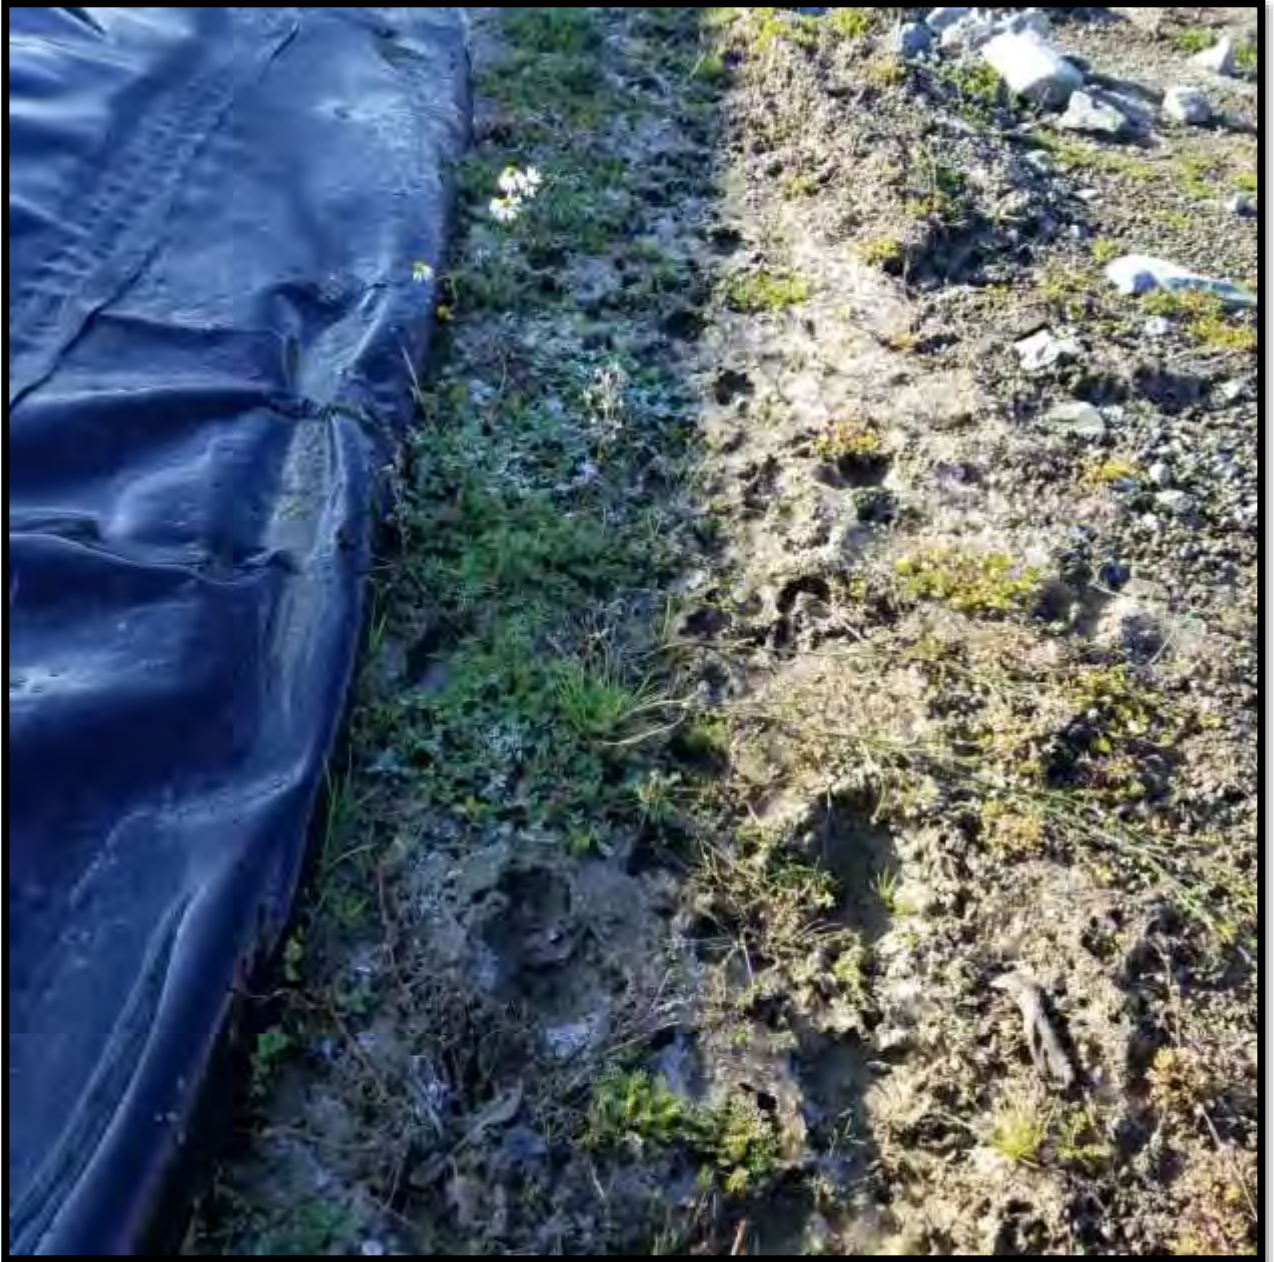
Photo 7 – Wildlife track marks outside of the PEA-Base of north toe

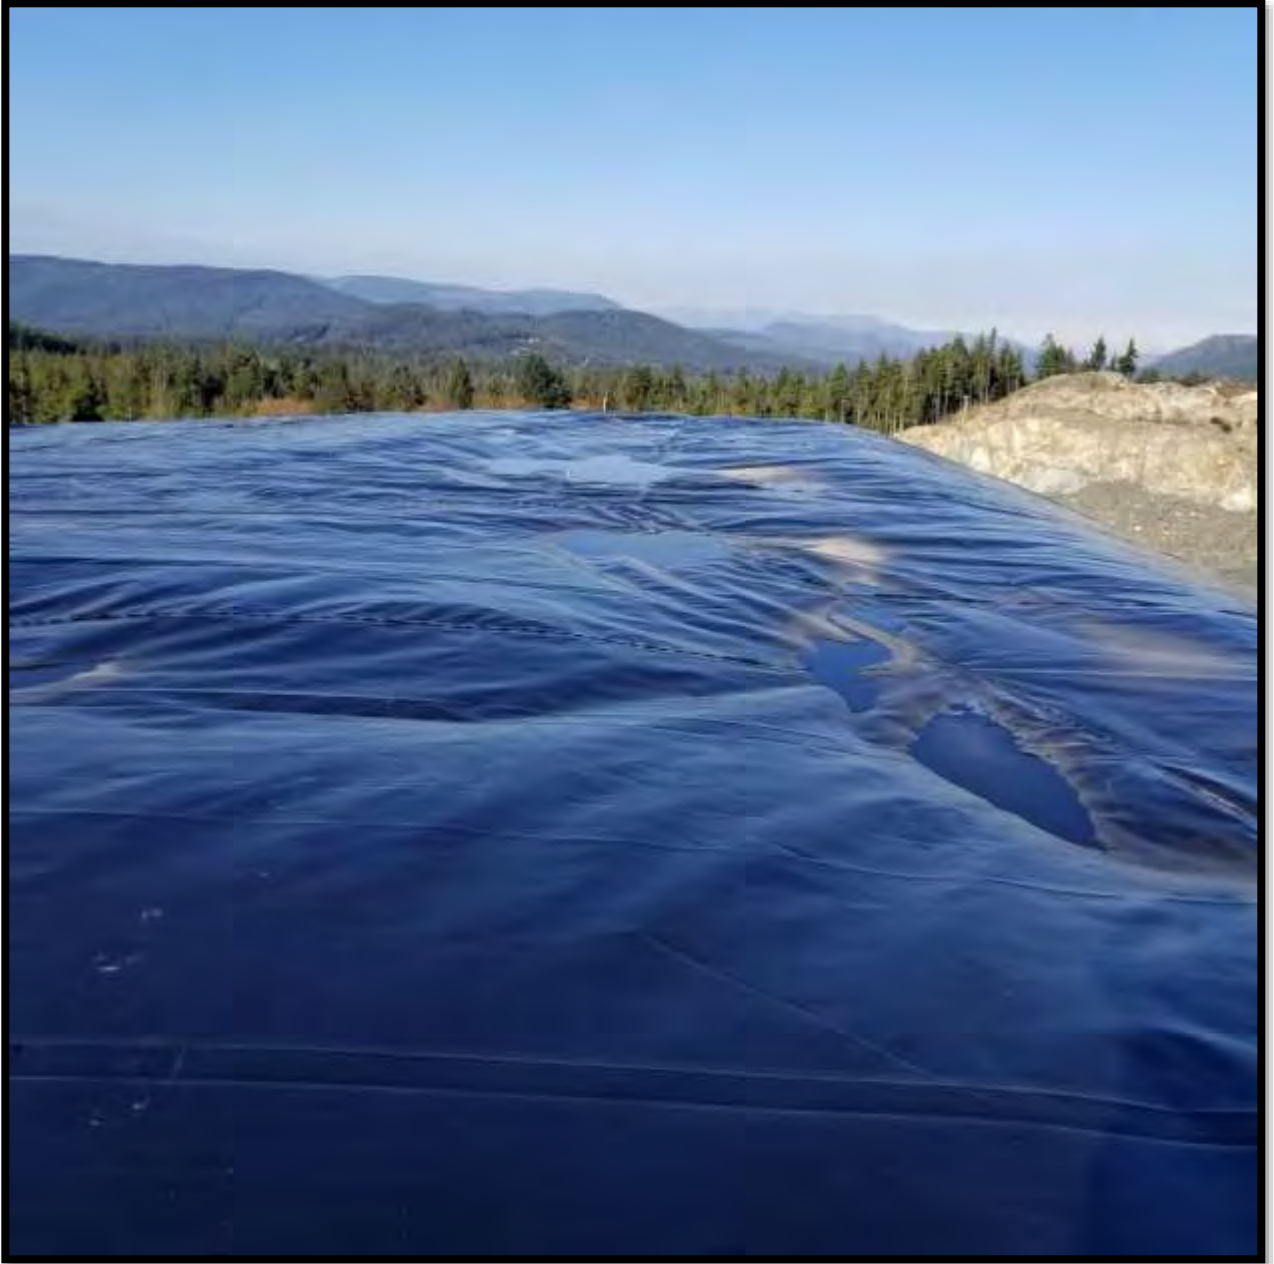
Photo 8 – Minimal ponding of surface waters is observed

The surface contours and ditch systems of the PEA appear to promote adequate drainage of surface waters from the PEA with minimal surface pooling observed (Photo 8). Signs of abrasion are devoid on the liner itself including PEA surface ditch works. Erosion caused by PEA surface water to ditch works designed to transfer water from the south east corner to the southwest corner and onto the surrounding property is not evident (Photo 9), however, there are small signs of minimal erosion to the quarry most noticeably at the toe of the NW corner (Photo 10).

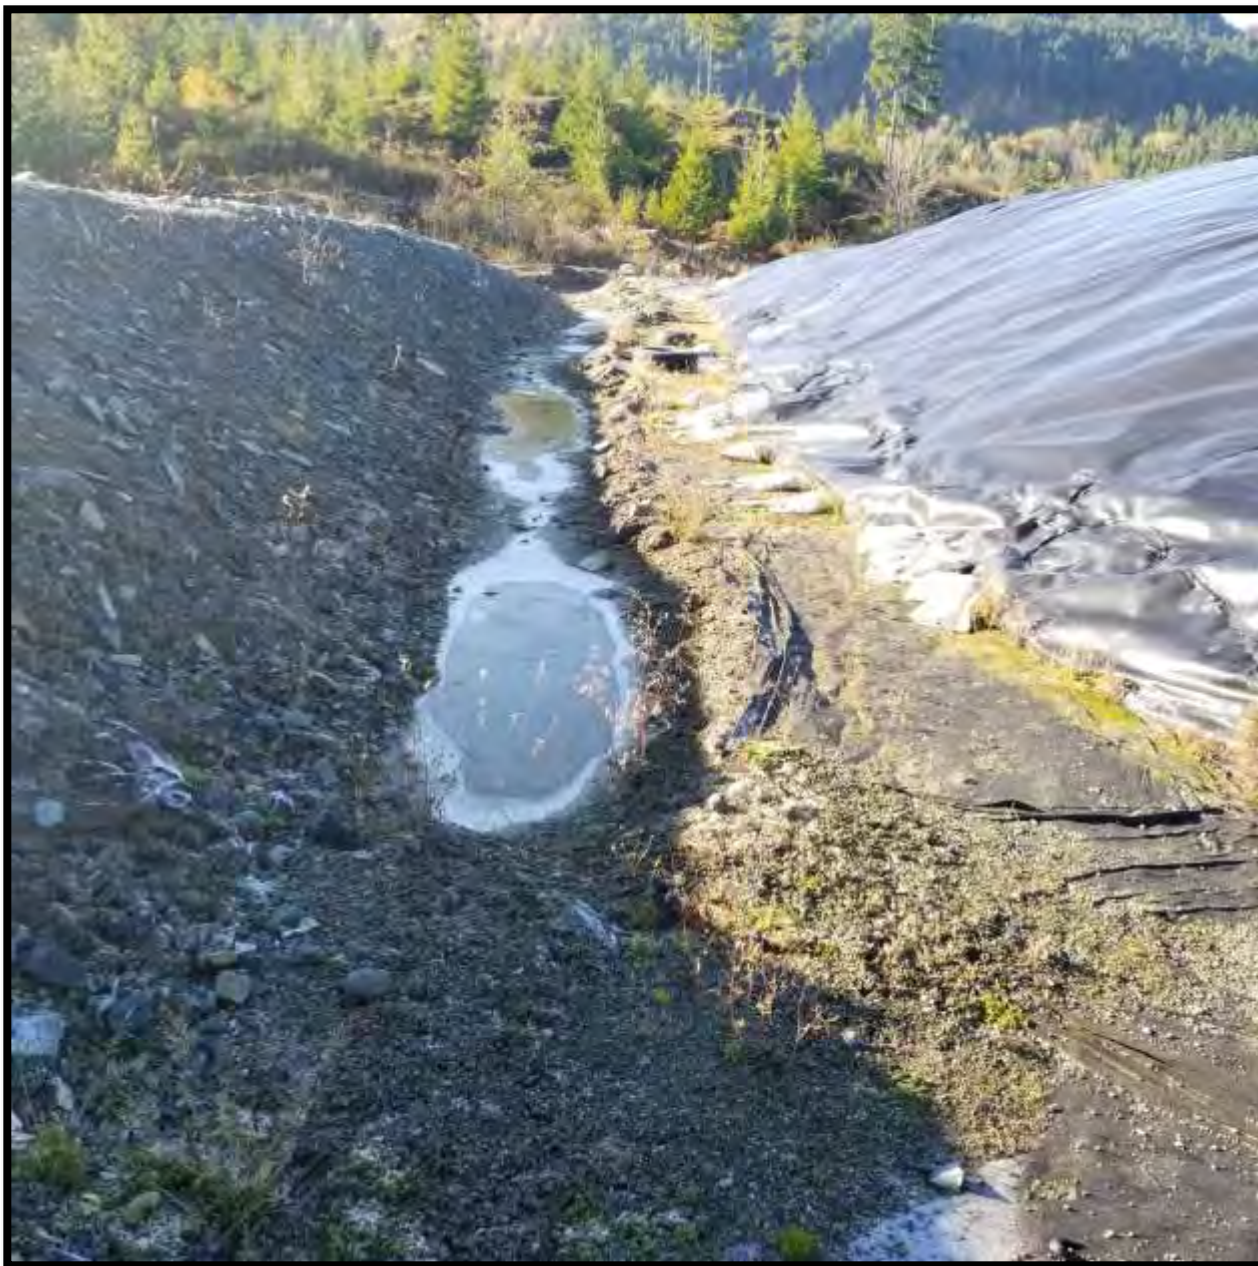
Photo 9 – South ditch erosion is not present

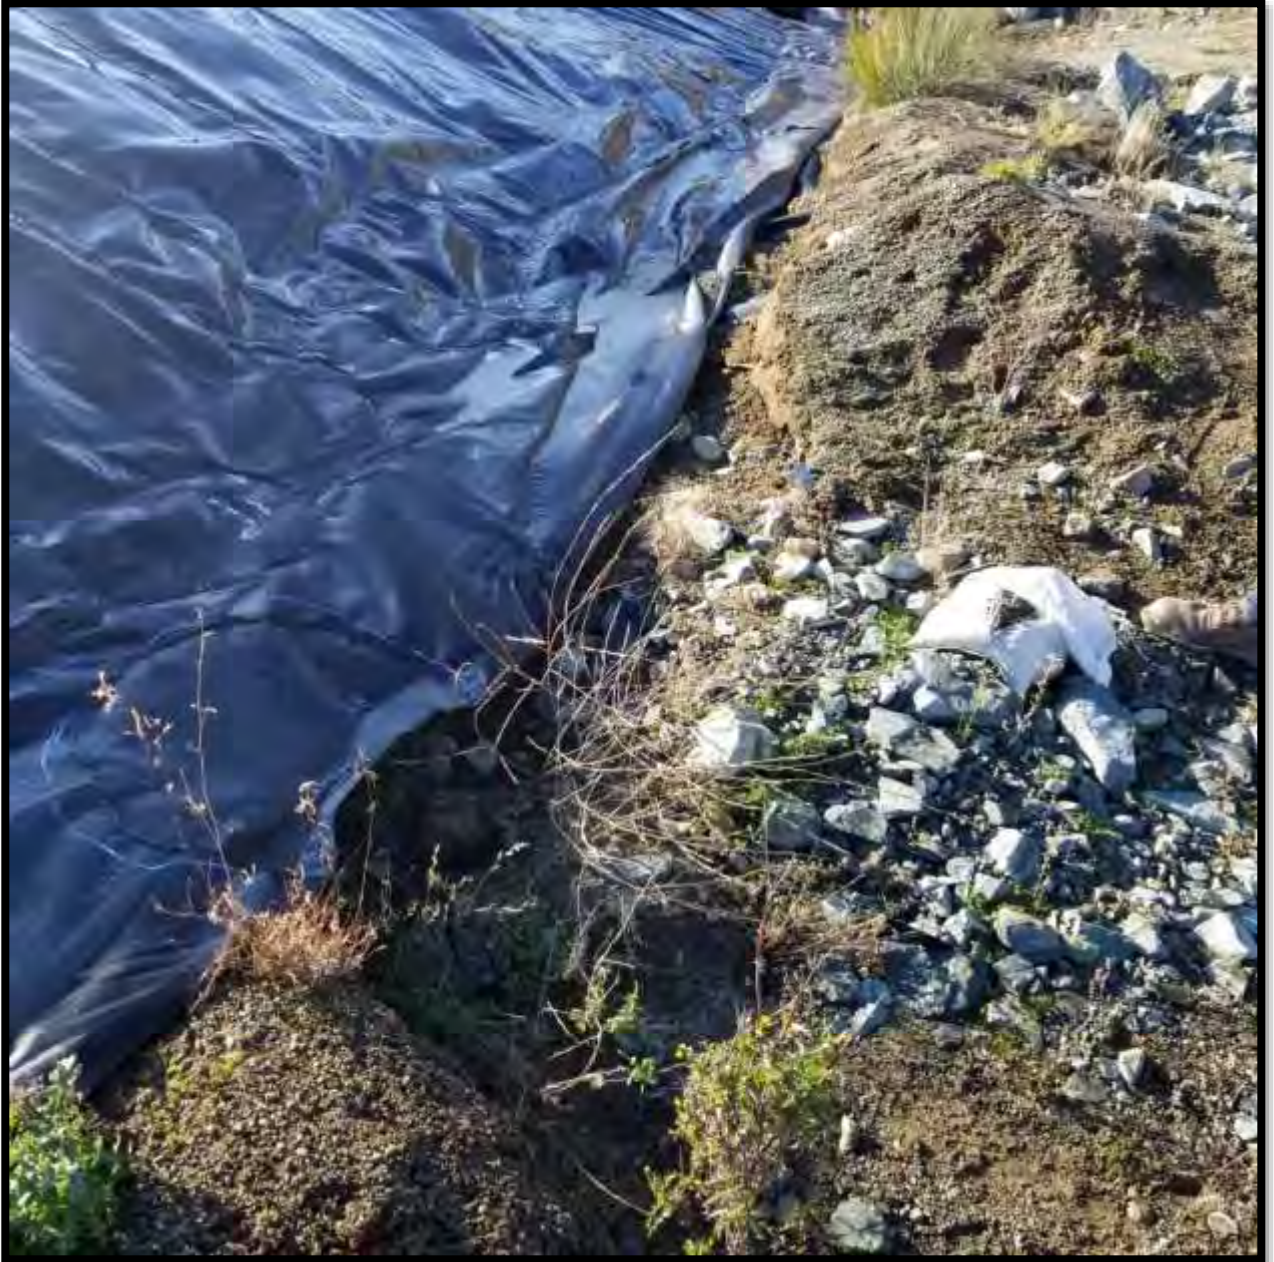
Photo 10 – Slight erosion of the quarry is noted at the NW toe-the liner is fully sealed at this location

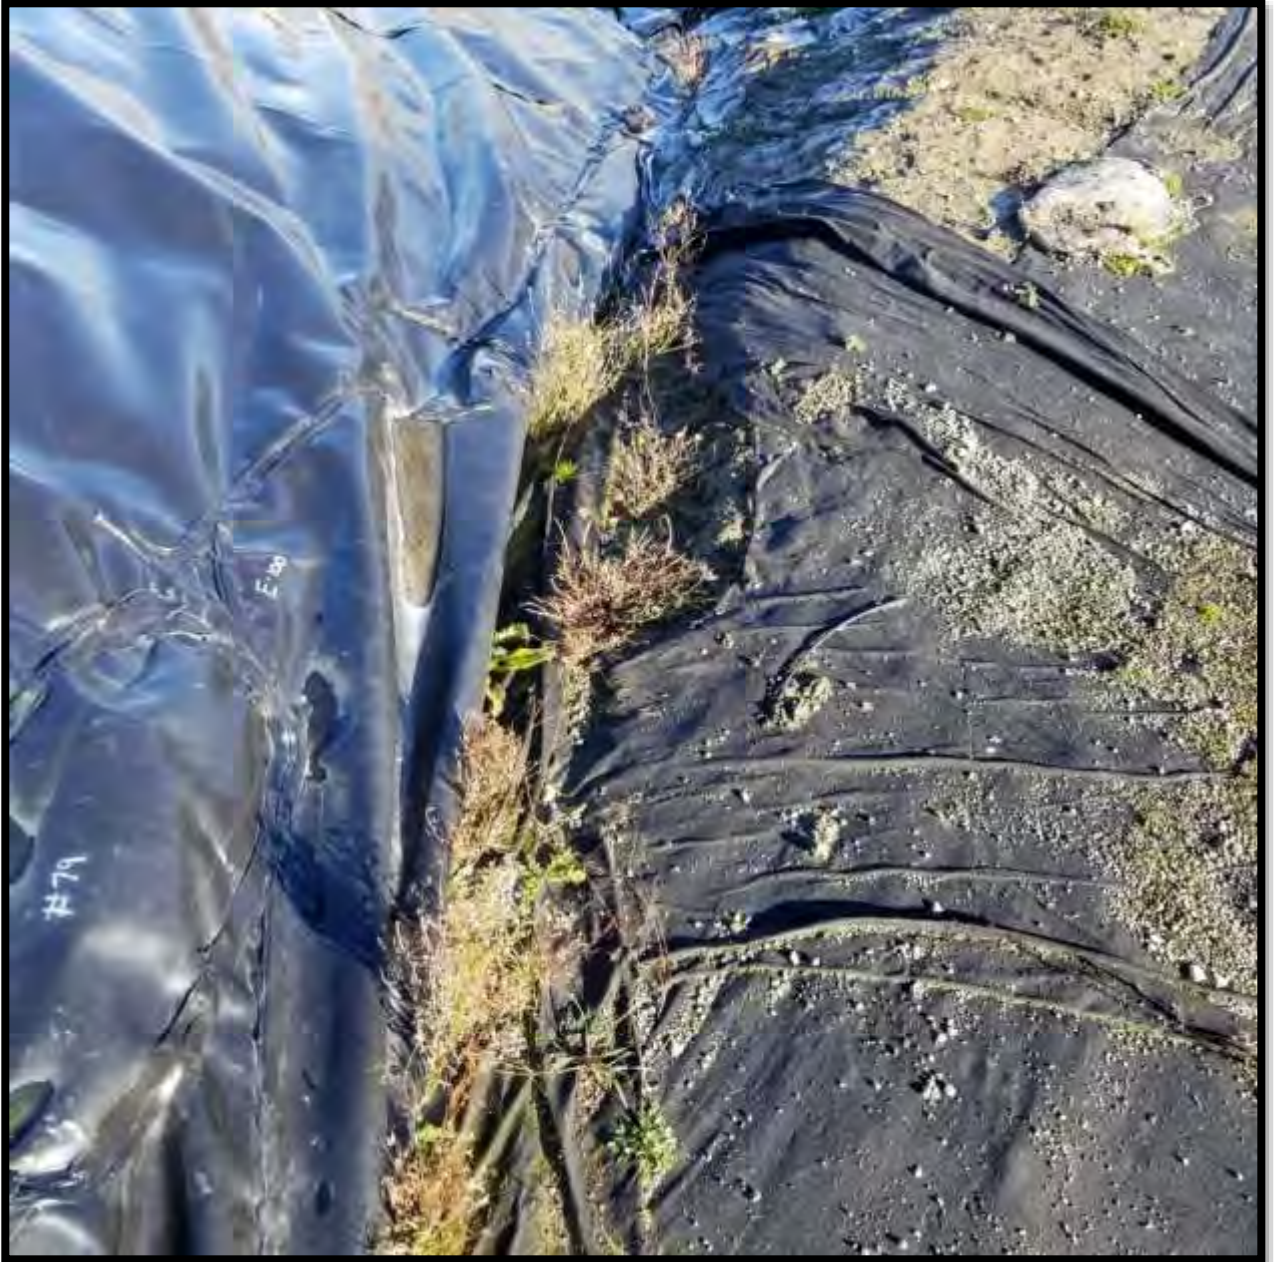
Photo 11 – Grasses, weeds, small shrubs are present along the PEA perimeter-SE crest

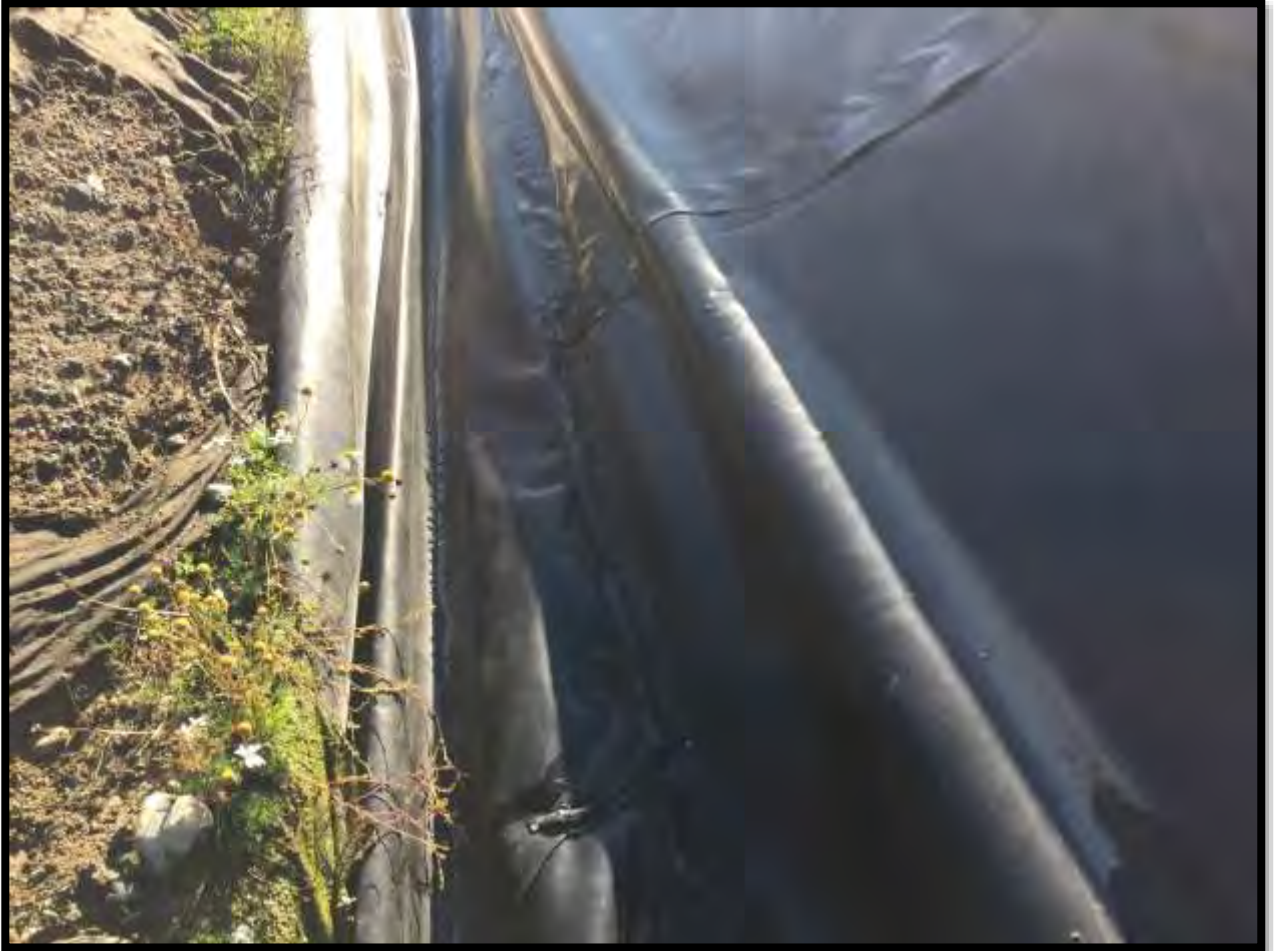
Photo 12 – Grasses, weeds, small shrubs are present along the PEA perimeter

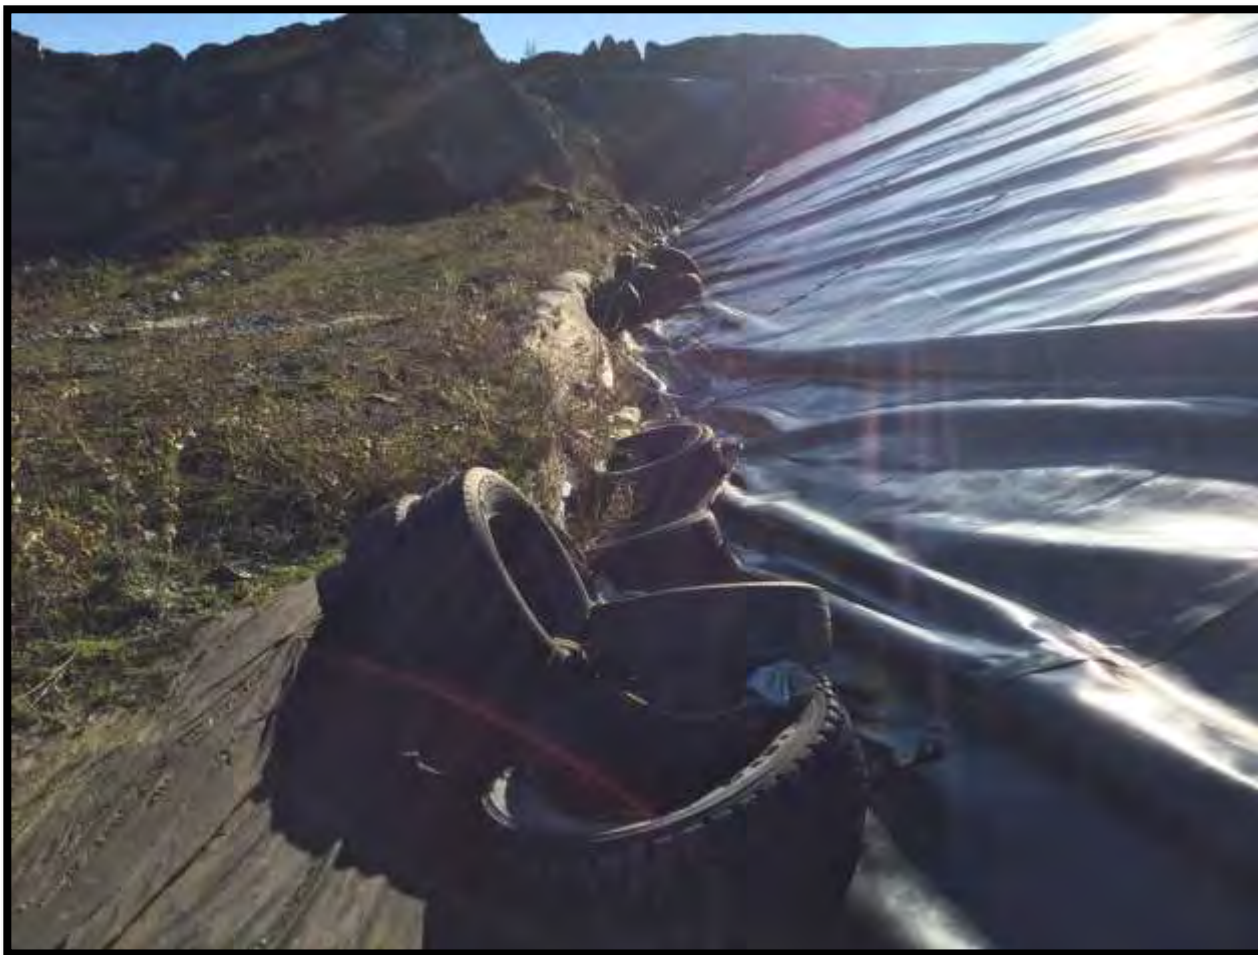
Photo 13 – Grasses, weeds, small shrubs are present along the PEA perimeter

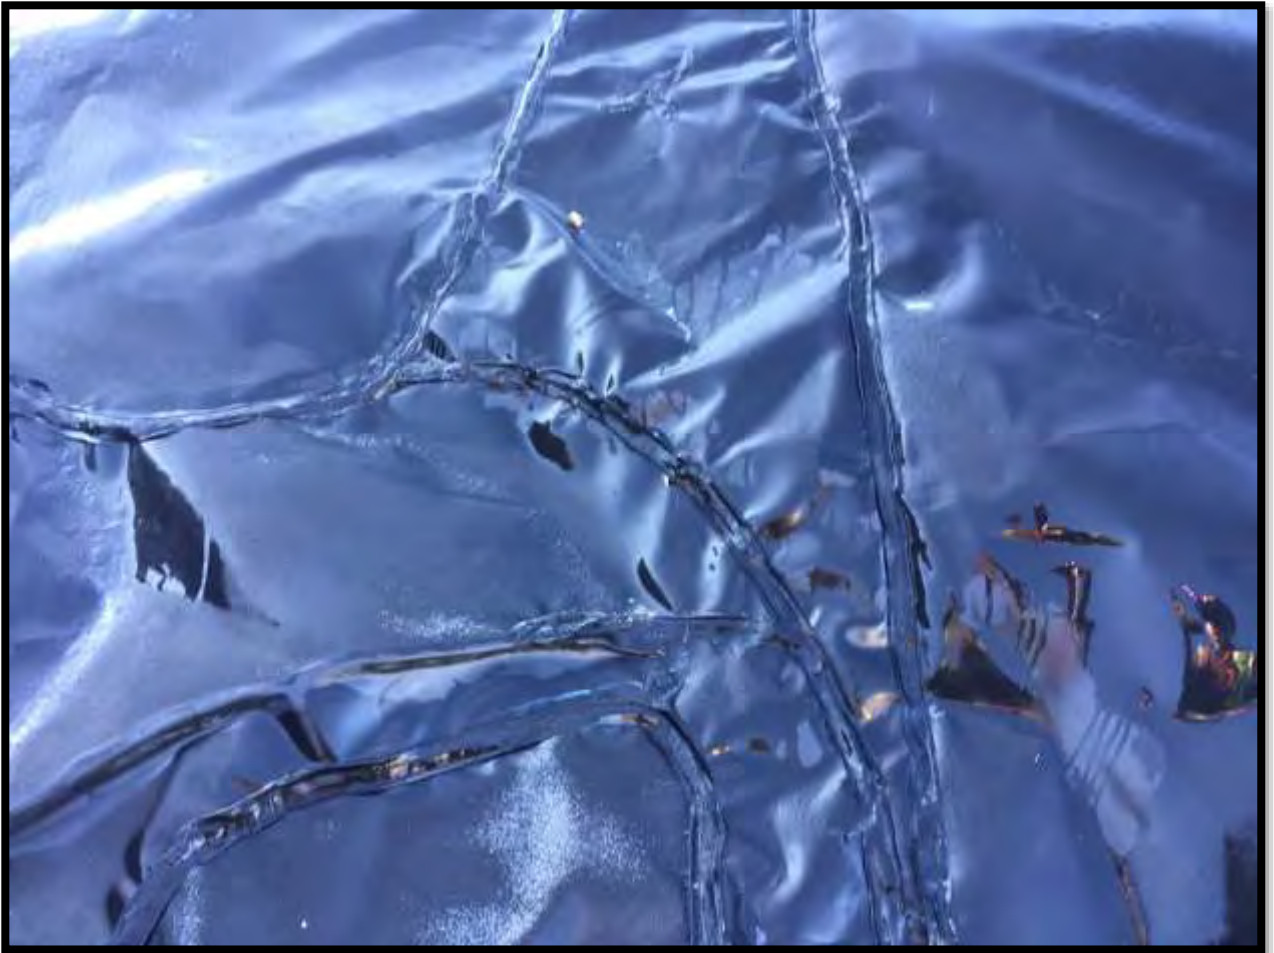
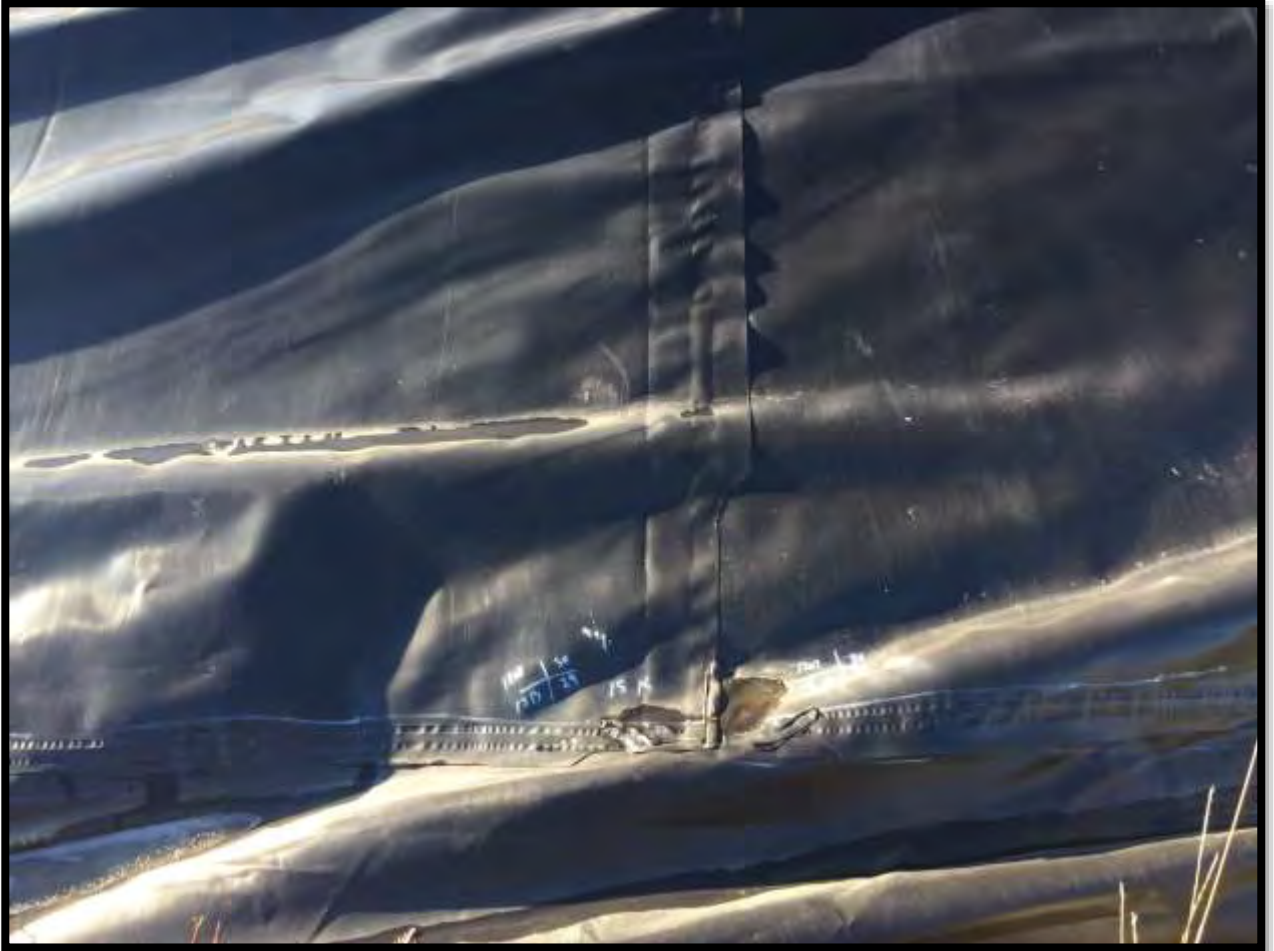
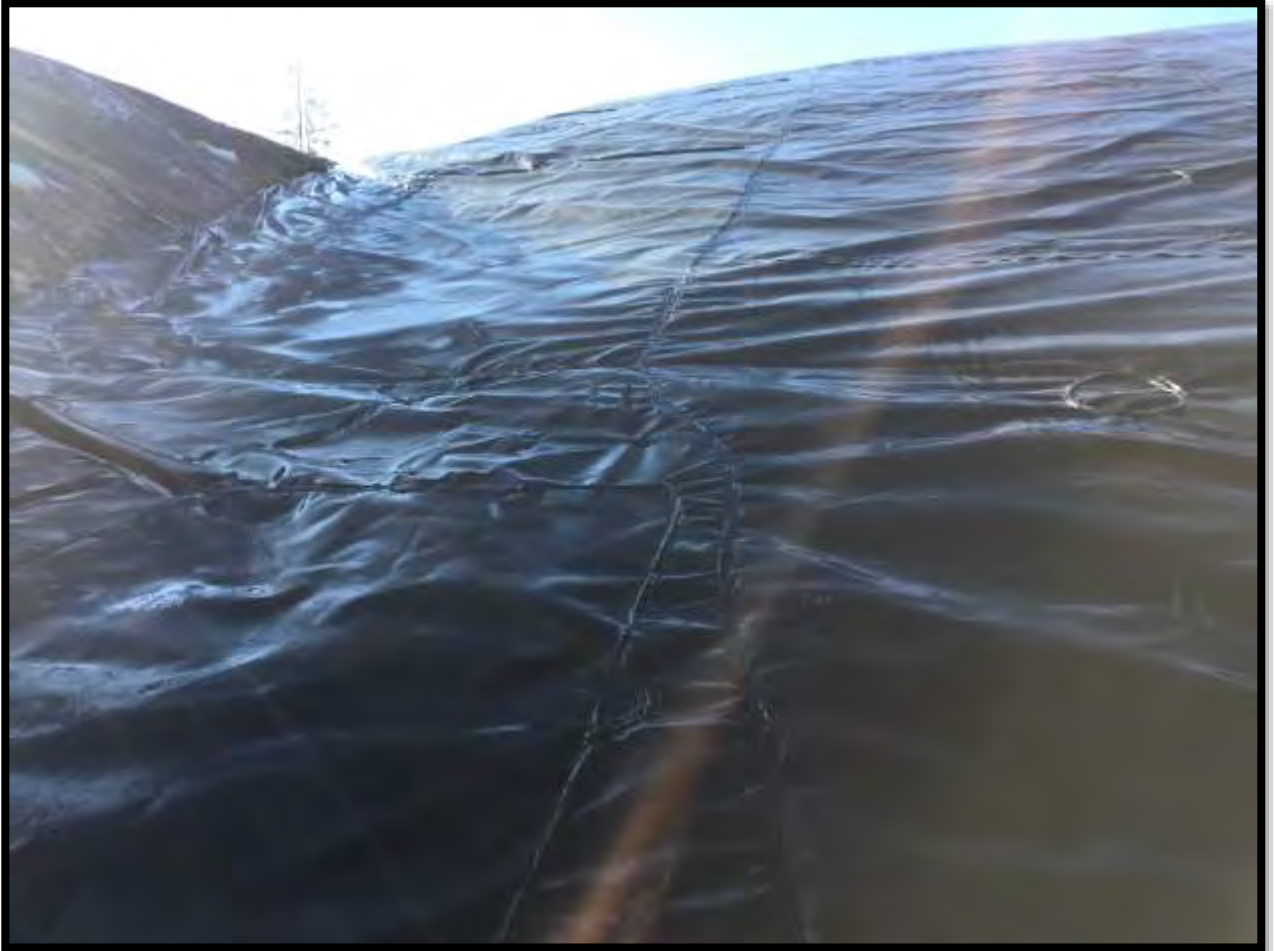
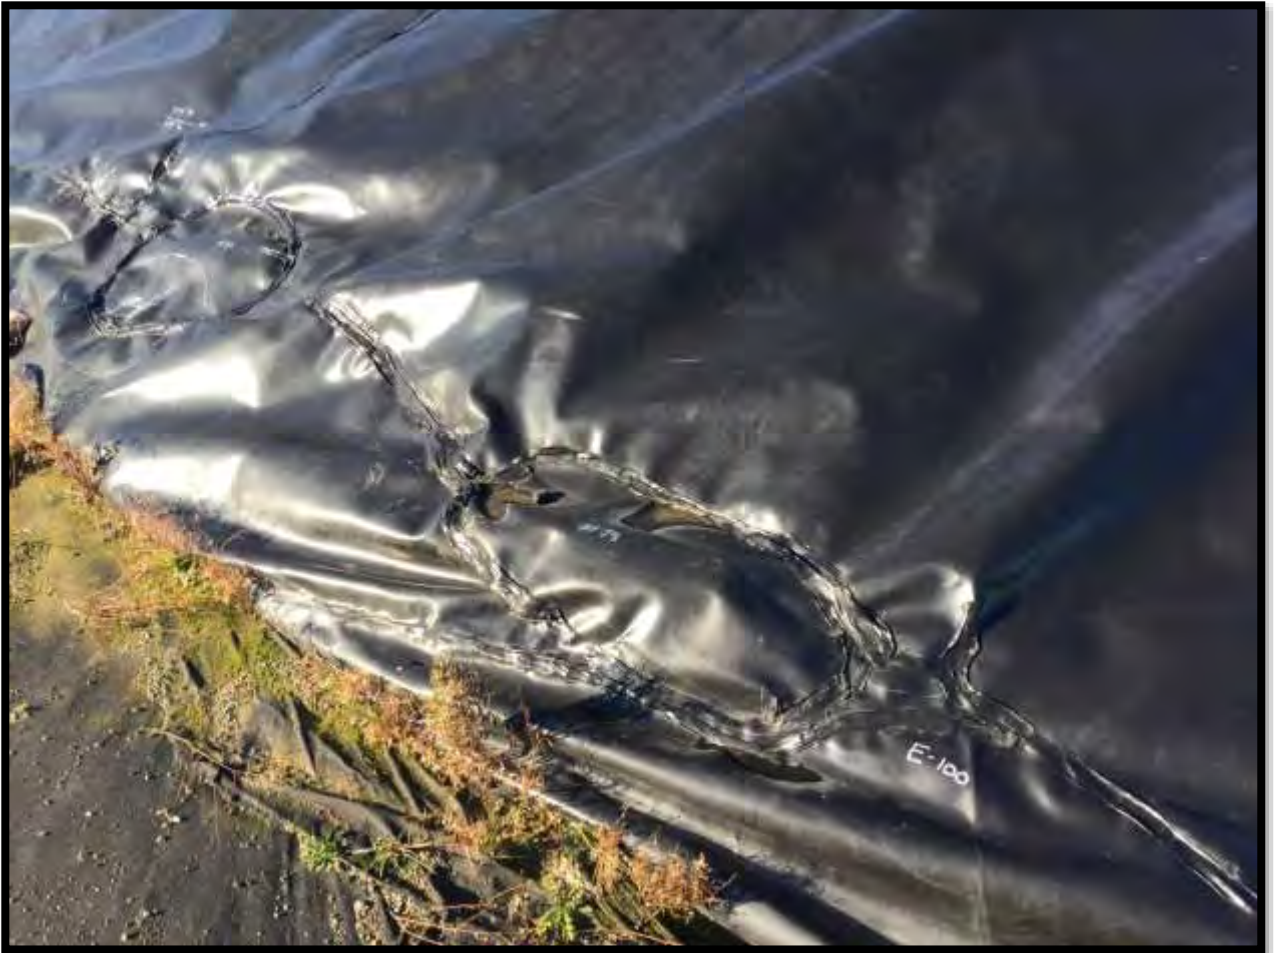
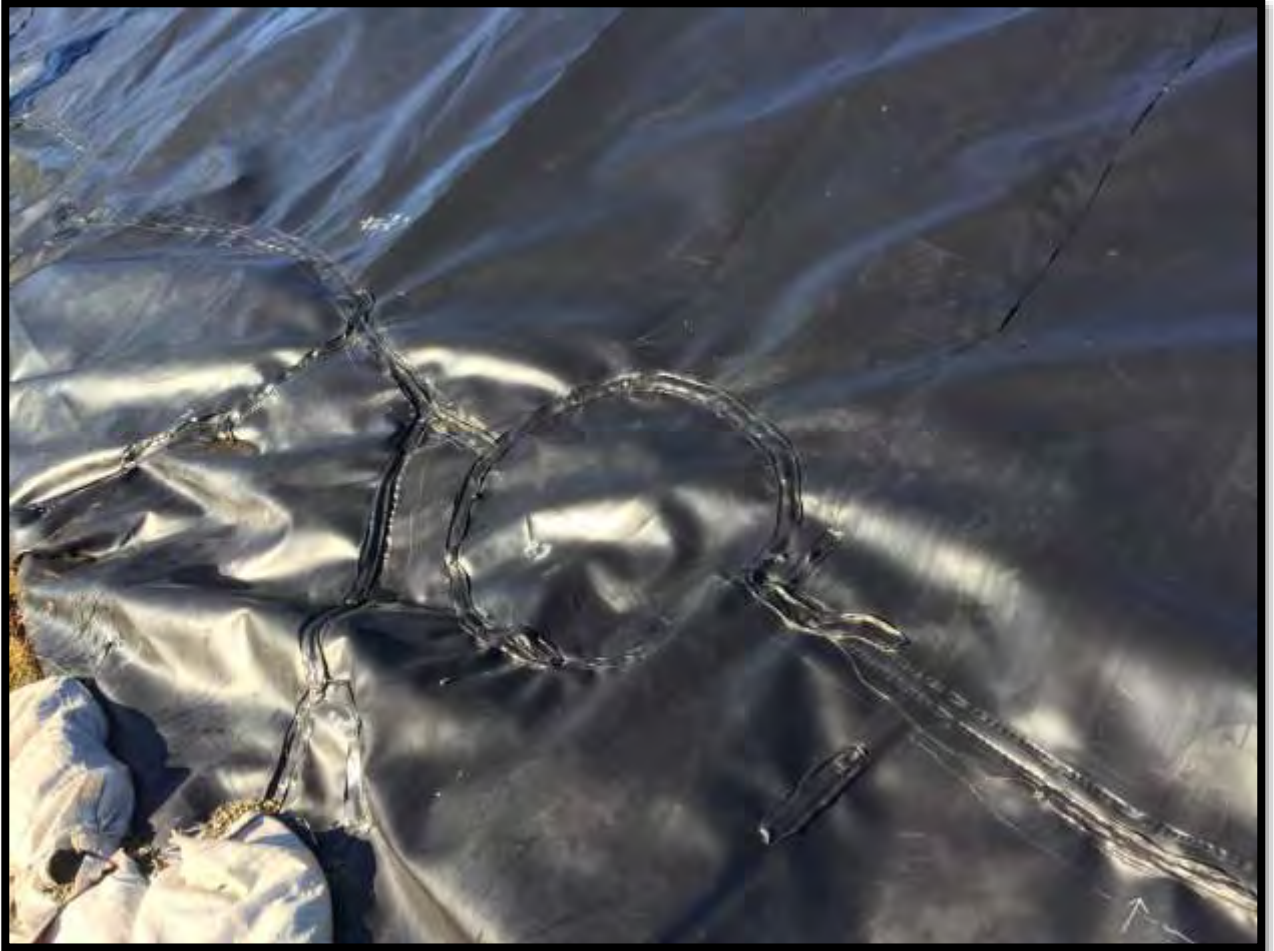
Photo 14 – Liner seams show no signs of deterioration

Seams were inspected throughout the PEA including those welded during the minor construction works during the fall of 2017. Original seams welded by the liner manufacturer were also inspected including others that could be visually detected. Seams show no sign of degradation (Photo 14, 15, 16, 17, 18). Extrusion welds were observed to hold strong with no observable deterioration. Additionally, water was devoid within the liner system itself i.e. there was no pooling within the liner system at all toes along the perimeter.
