Reasons for Decision

Conditional Approval of 2019 Final Closure Plan for Cobble Hill Holdings Landfill

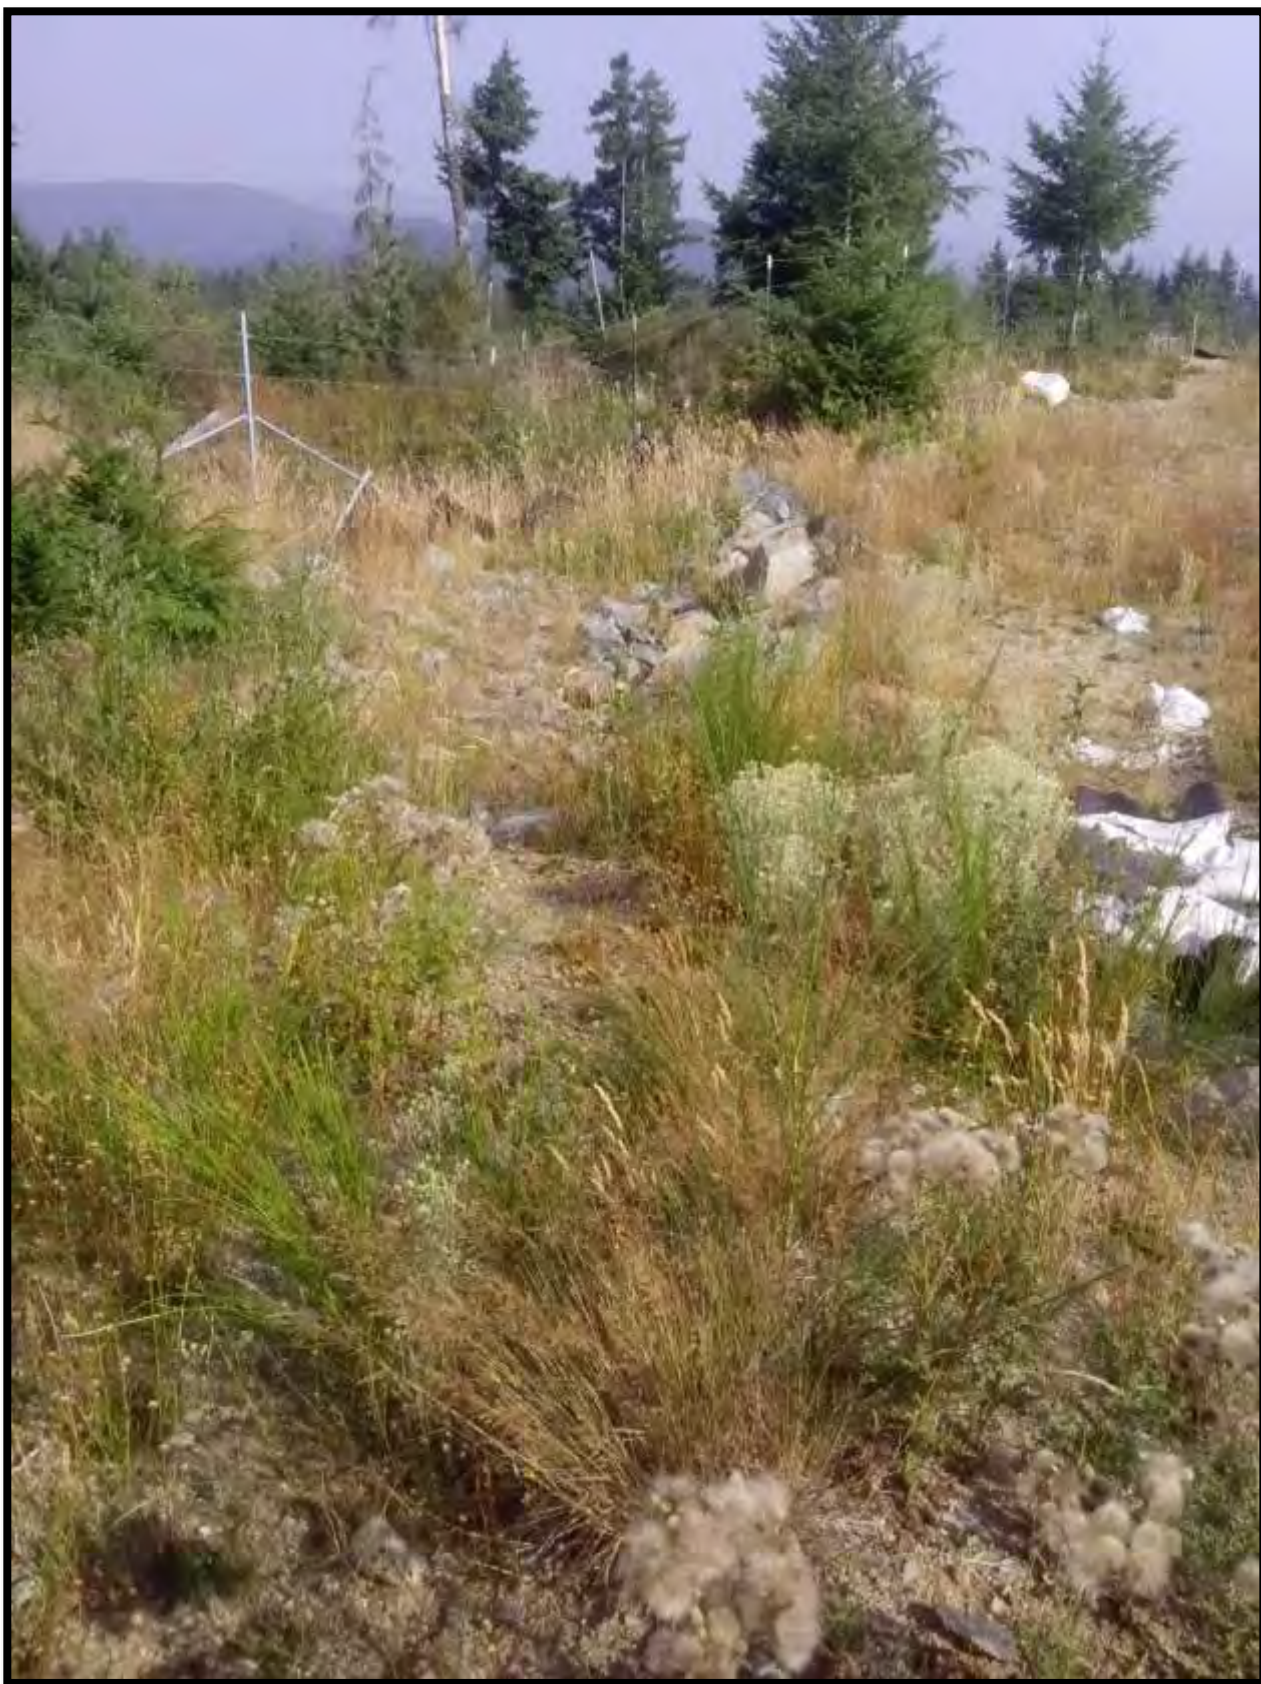
Photo 19 – Monitoring site SHA-SW-2

Monitoring sites are maintained well. Surface water stations SHA-SW-2 and SHA-SW-1 are shown **in Photo's 19 and 20 respectively** and show natural foliage. The leachate/leak detection enclosure and piping system is shown in Photo 21. IEL did not observe any soil discoloration or vegetative stress surrounding the closure. Monitoring wells are encased in metal housing and show no signs of deterioration.

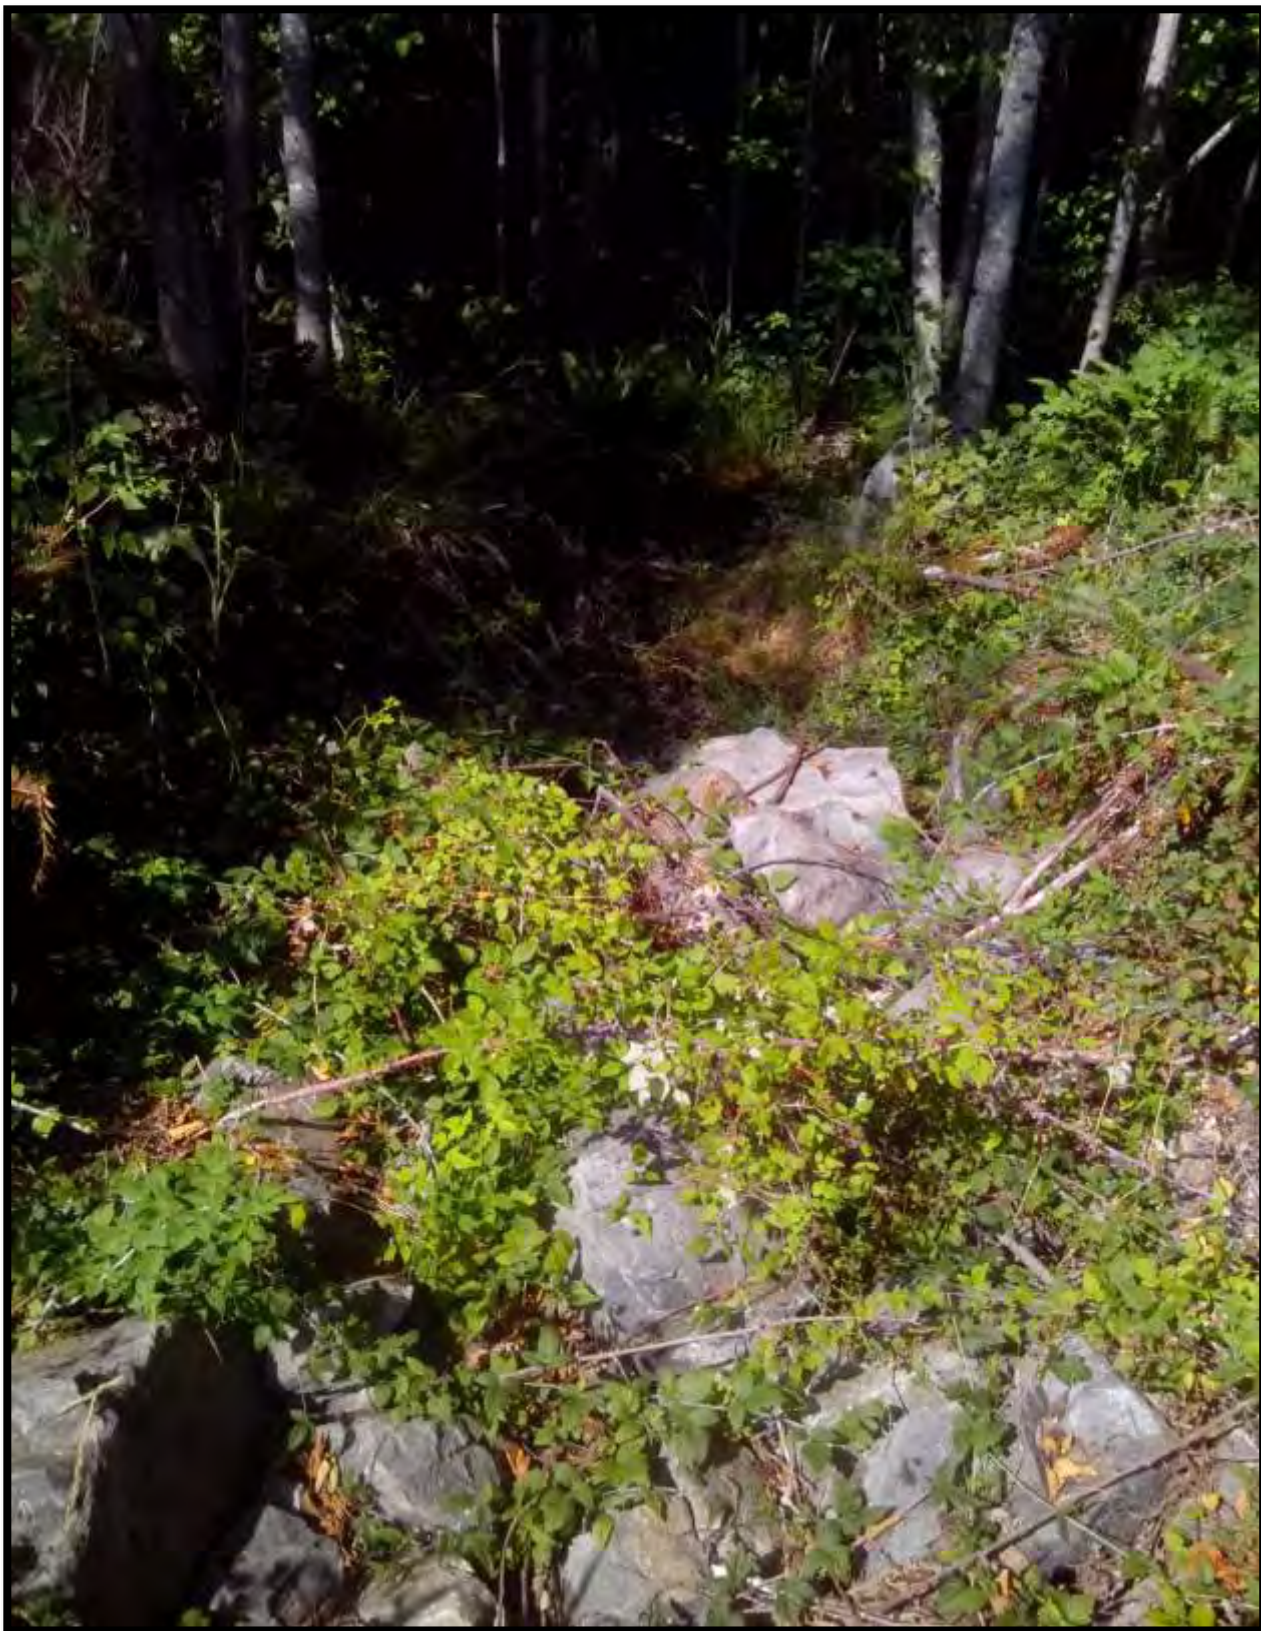
Photo 20 – Monitoring site SHA-SW-1

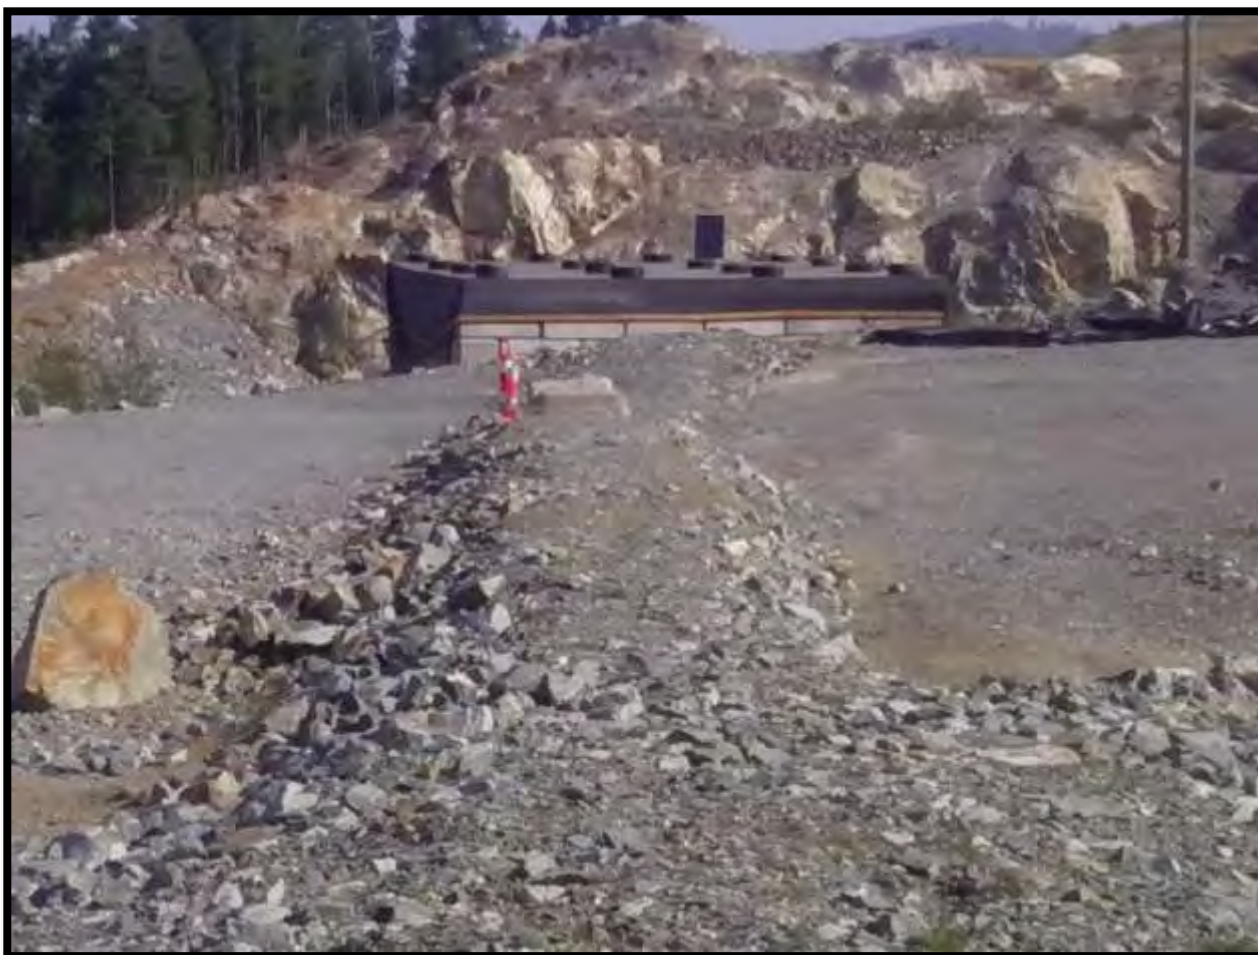
Photo 21 – Monitoring site Leachate and Leak Detention piping and enclosure

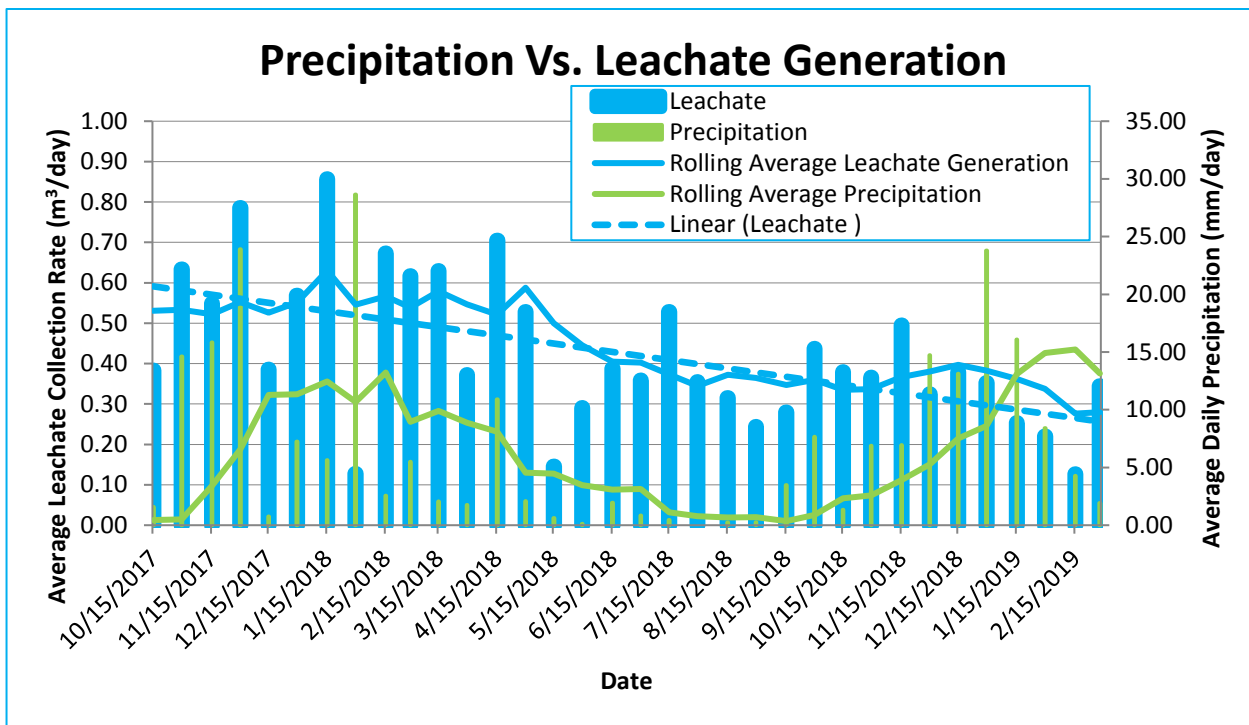
Figure 3.1 – Precipitation vs. Leachate Generation

GHD compared the precipitation from the Lake Cowichan Station to the leachate collection rates measured at the leachate storage facility. Figure 1 shows the comparison of the average daily leachate collection rates (a rolling average over 6 measurements/3 months) and average daily precipitation from October 2017 through February 2019.

As shown in Figure 3.1 and in the Closure Plan, the leachate generation rate is trending downwards. In general, spikes in the precipitation do not appear to have a strong correlation with increases in leachate generation. There is a period between February 2018 and September 2018 where both the precipitation and leachate generation rates are decreasing. However, the leachate generation rate is expected to decrease following closure and precipitation decreases for the summer months. From October 2018 through December 2017, the precipitation increases without a significant increase in leachate generation. Note, also, that the leachate generation rate falls from November 2018 through February 2019, which is the wettest season. This timeframe is also beyond the chart shown in Figure 7-3 in the Closure Report and would support the continuation of the downward trend line presented on that figure. From the data available, there does not appear to be a strong correlation between precipitation and leachate generation. GHD does note that this assessment is based on approximately 16 months of data. The fluctuations in leachate generation illustrated in the graph may be due to the heterogeneity of the waste soil matrix rather than influences from water ingress. A larger data set would facilitate additional trend comparisons between precipitation and leachate generation over multiple seasons. Also note that precipitation that infiltrates into the waste soil mass would need to flow through what is reported to be silty soil, so regardless, any effect of a leak on leachate generation would be muted and likely take months to reach the leachate collection system.

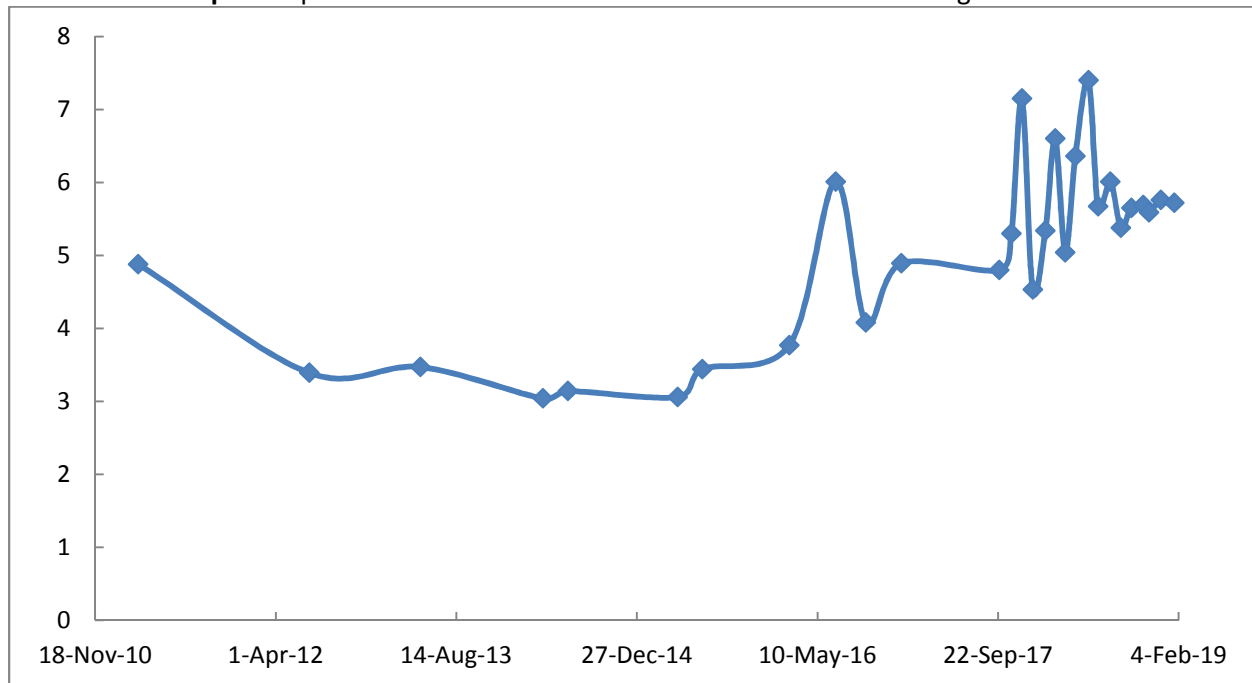
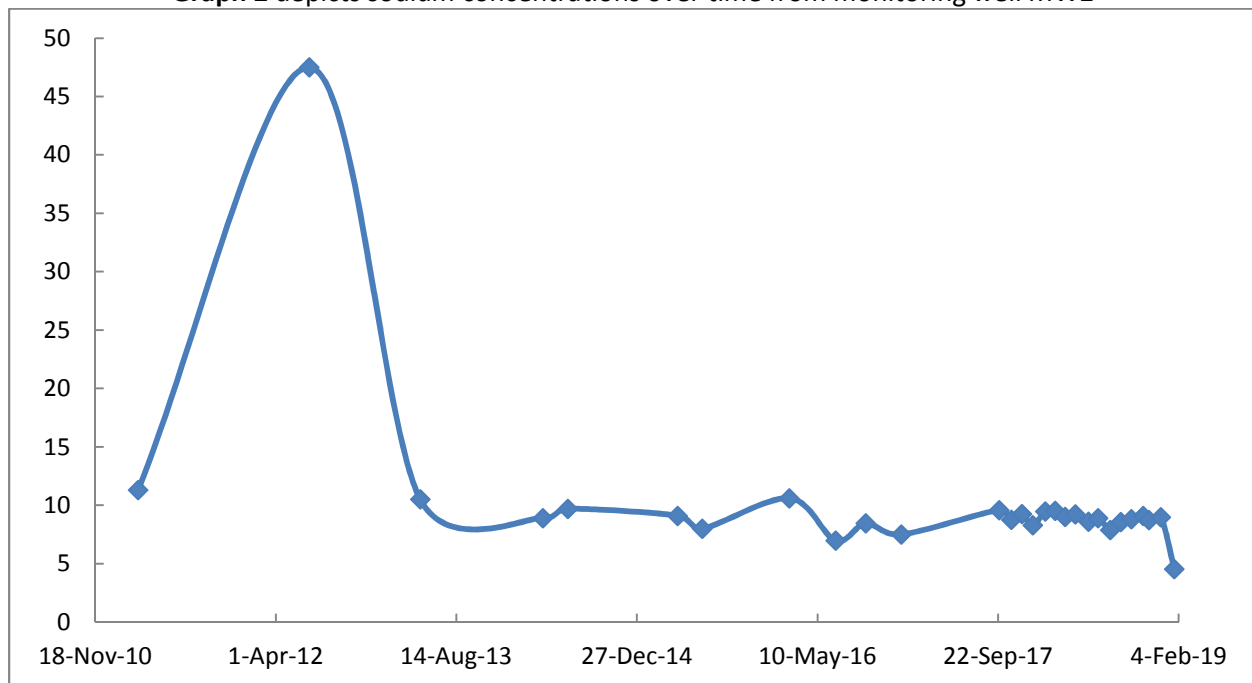
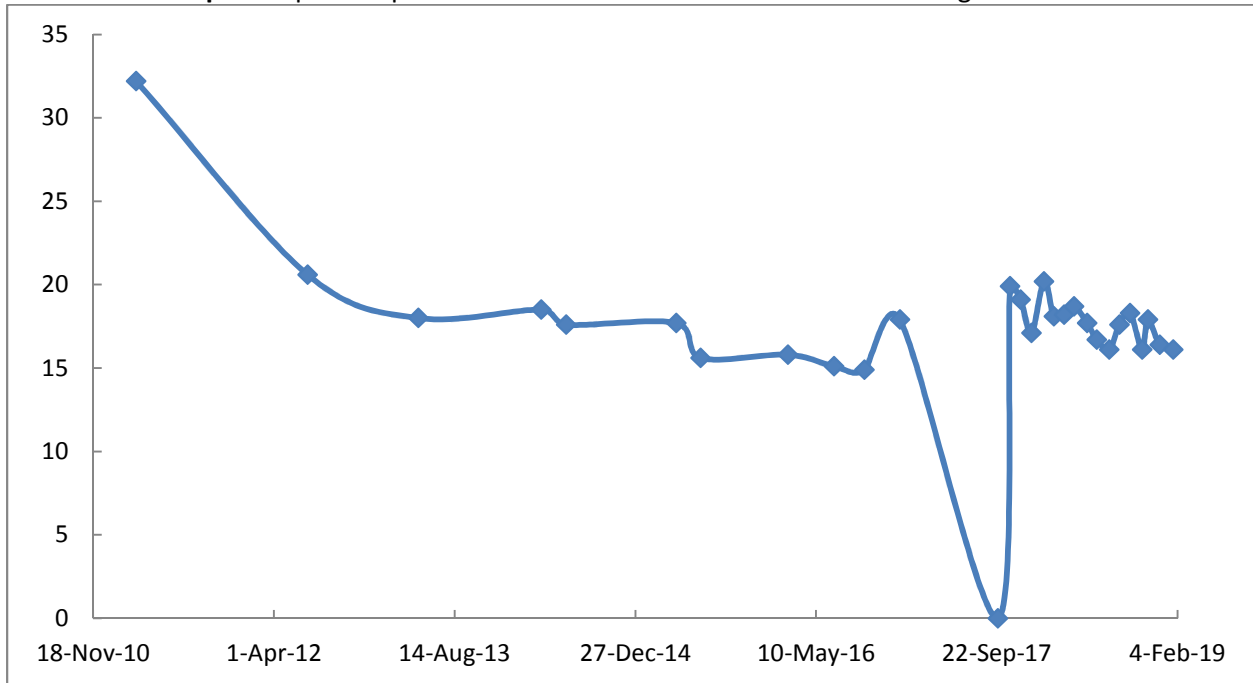
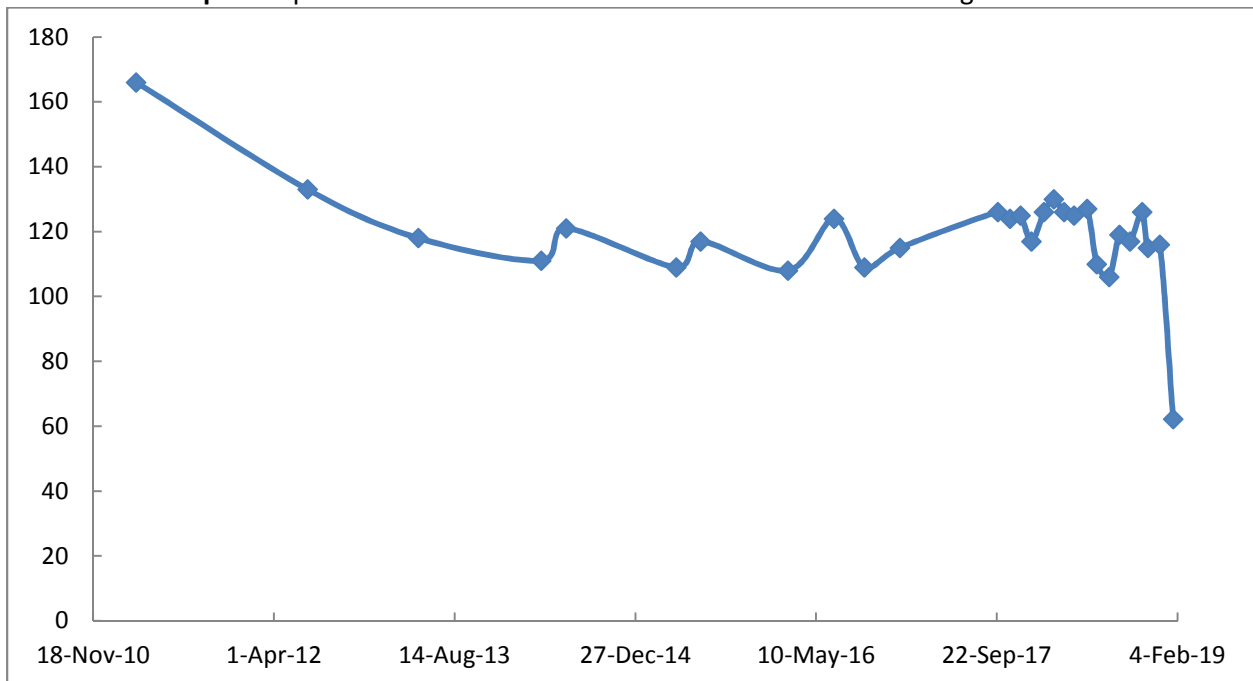
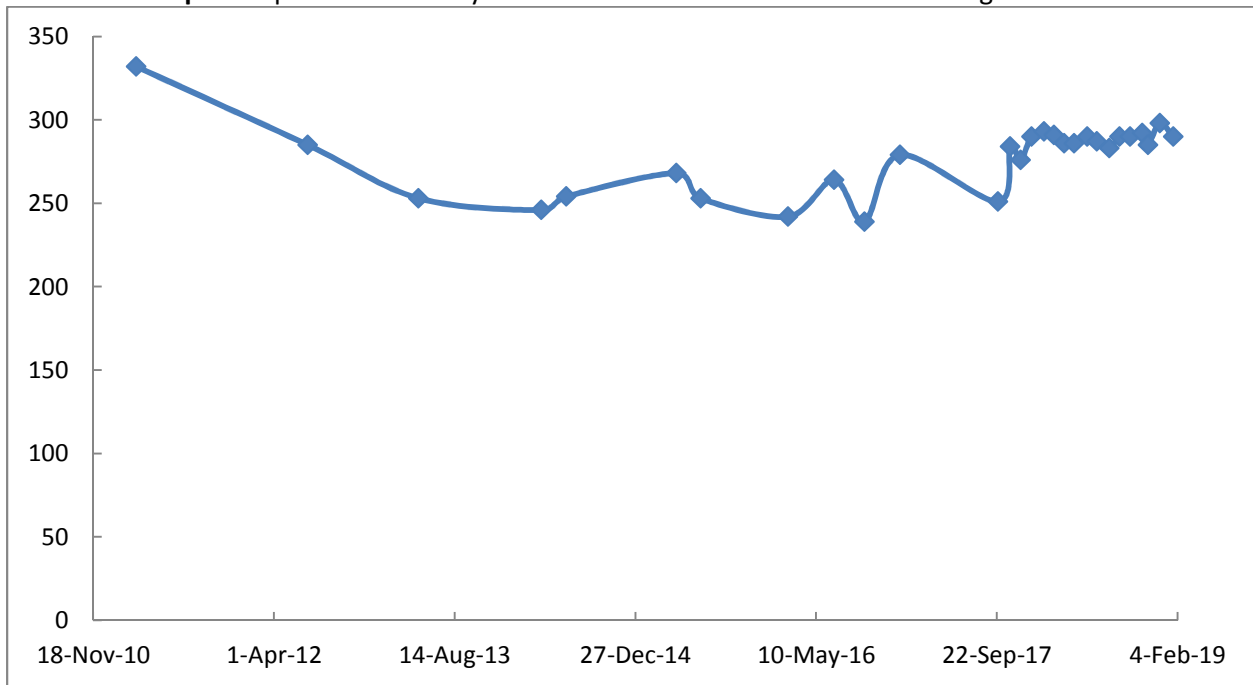
Graph 1 depicts chloride concentrations over time from monitoring well MW2

Graph 2 depicts sodium concentrations over time from monitoring well MW2

Graph 3 depicts sulphate concentrations over time from monitoring well MW2

Graph 4 depicts hardness concentrations over time from monitoring well MW2

Graph 5 depicts conductivity concentrations over time from monitoring well MW2

All water quality indicators graphed above are generally stable. The chloride graph may show a minimal upward trend, but additional monitoring is required to confirm this interpretation.

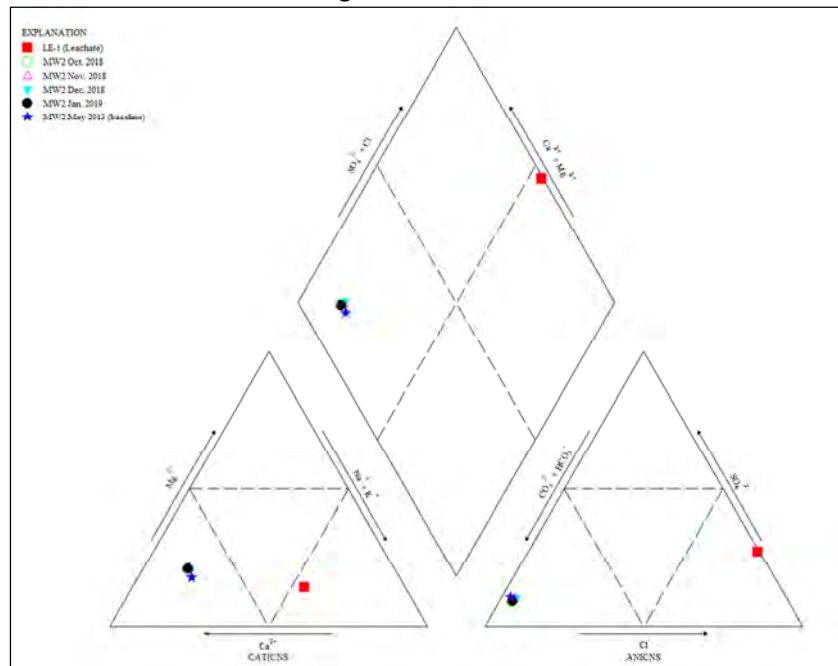
The trilinear diagram presented below indicates that the geochemical character of the recent water quality collected from MW2 is stable and unaffected by leachate. As such, there is no evidence that water quality in monitoring well MW2 is impacted by the landfill.

Plot 2 shows the difference between the geochemical character of water from MW2 and leachate

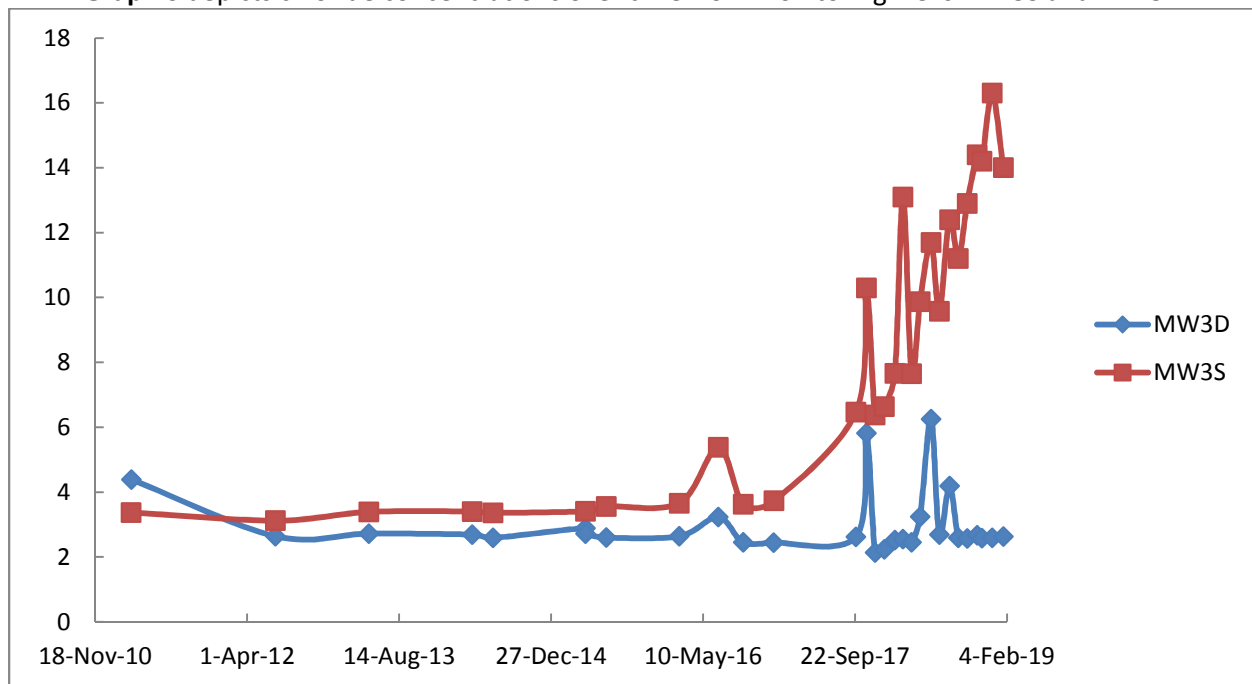
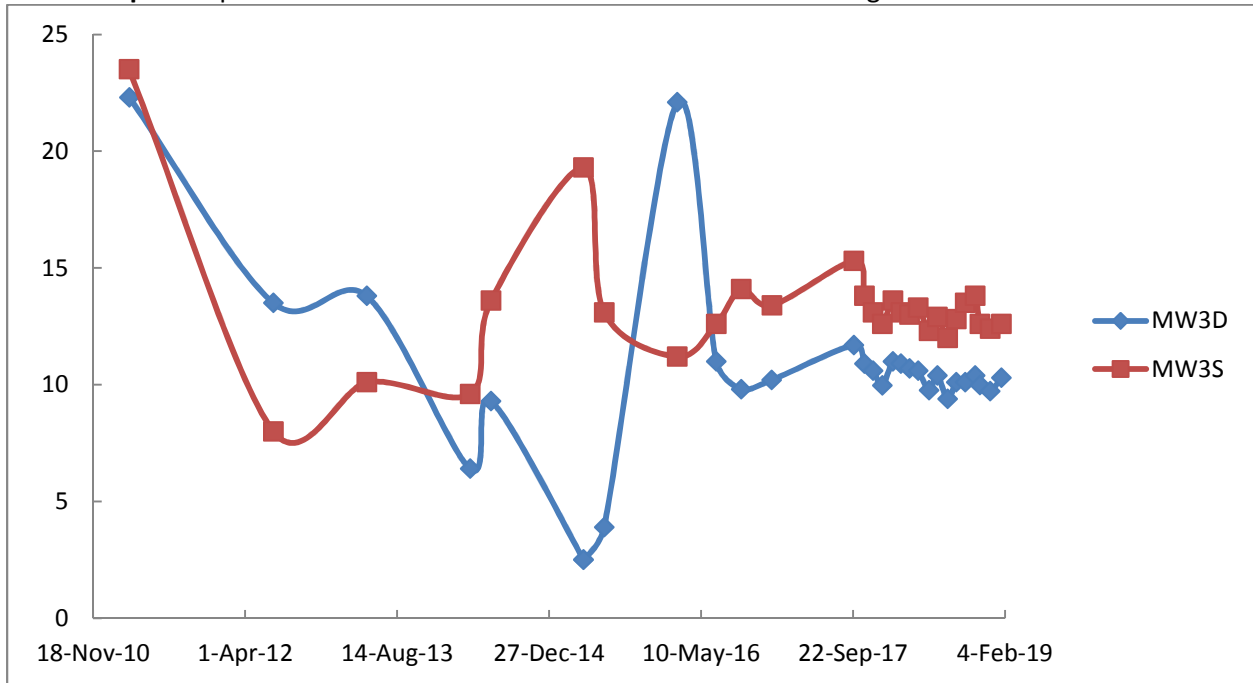
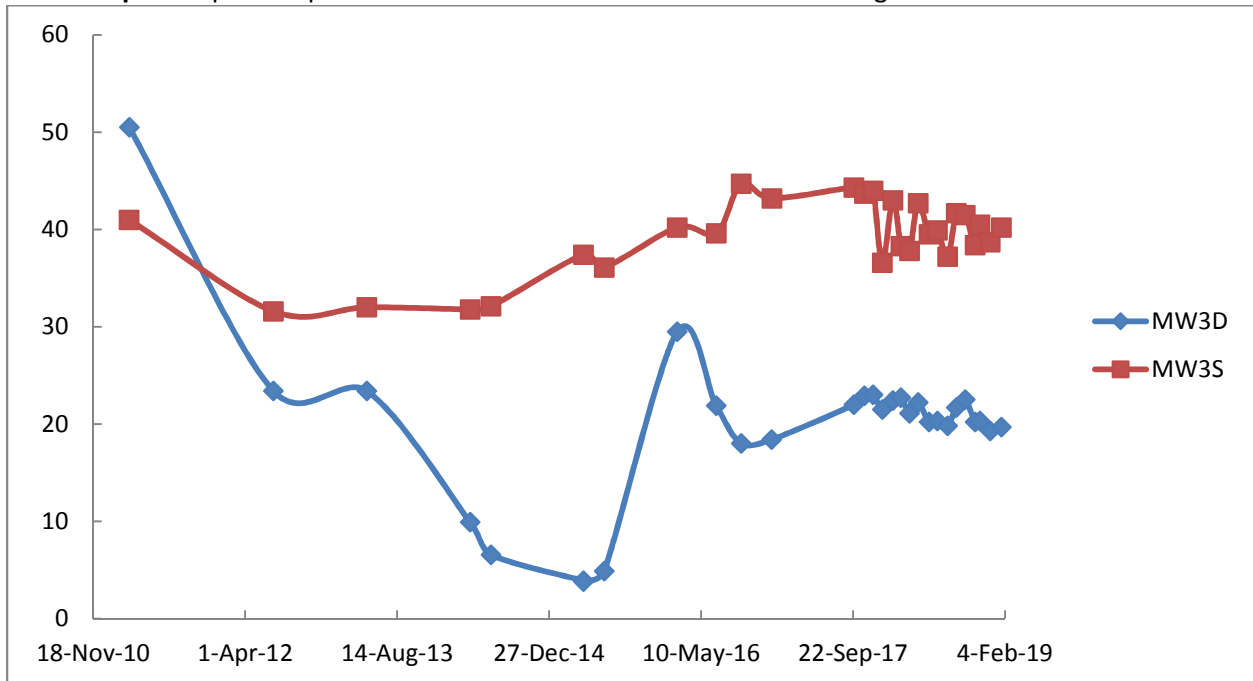
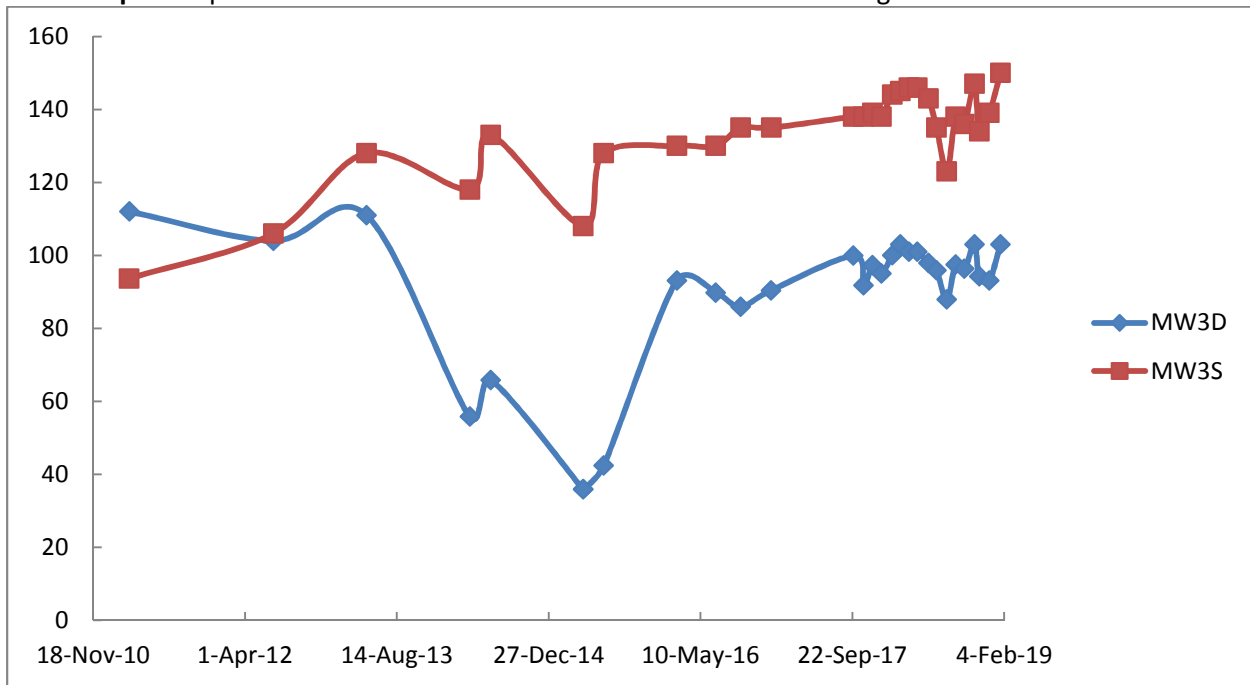
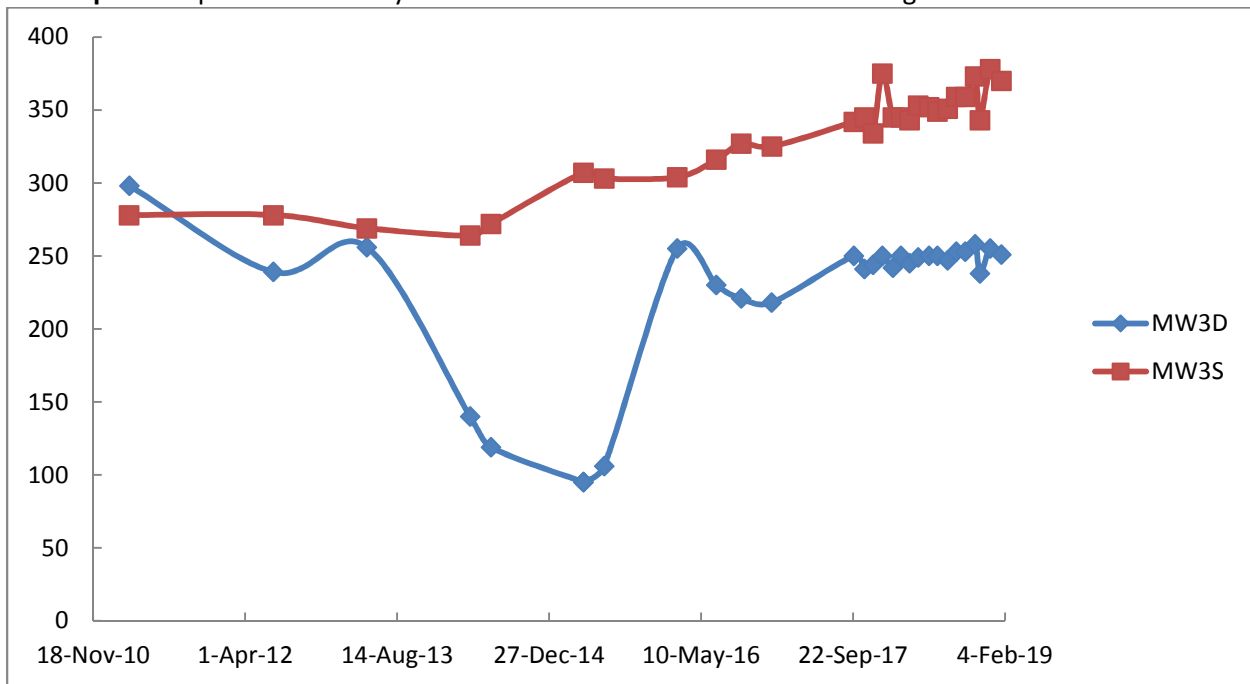
Graph 6 depicts chloride concentrations over time from monitoring wells MW3S and MW3D

Graph 7 depicts sodium concentrations over time from monitoring wells MW3S and MW3D

Graph 8 depicts sulphate concentrations over time from monitoring wells MW3S and MW3D

Graph 9 depicts hardness concentrations over time from monitoring wells MW3S and MW3D

Graph 10 depicts conductivity concentrations over time from monitoring wells MW3S and MW3D

An increasing trend in chloride concentrations is evident in the shallow monitoring well MW3S (Graph 6). Similar but less pronounced trends are observed at MW3S in the electric conductivity and hardness graphs (Graphs 9 and 10). These small increases pose no risk to the environment at this time, since the water quality guideline for chloride is 250 mg/L. The reason for the upward trends is unknown, but the

landfill may be a likely source. However, the trends may not be attributed to the landfill alone or at all. A detailed discussion regarding the small changes in water quality at MW3S is described later in this review. All other indicators at MW3S and all indicators at MW3D are generally stable.

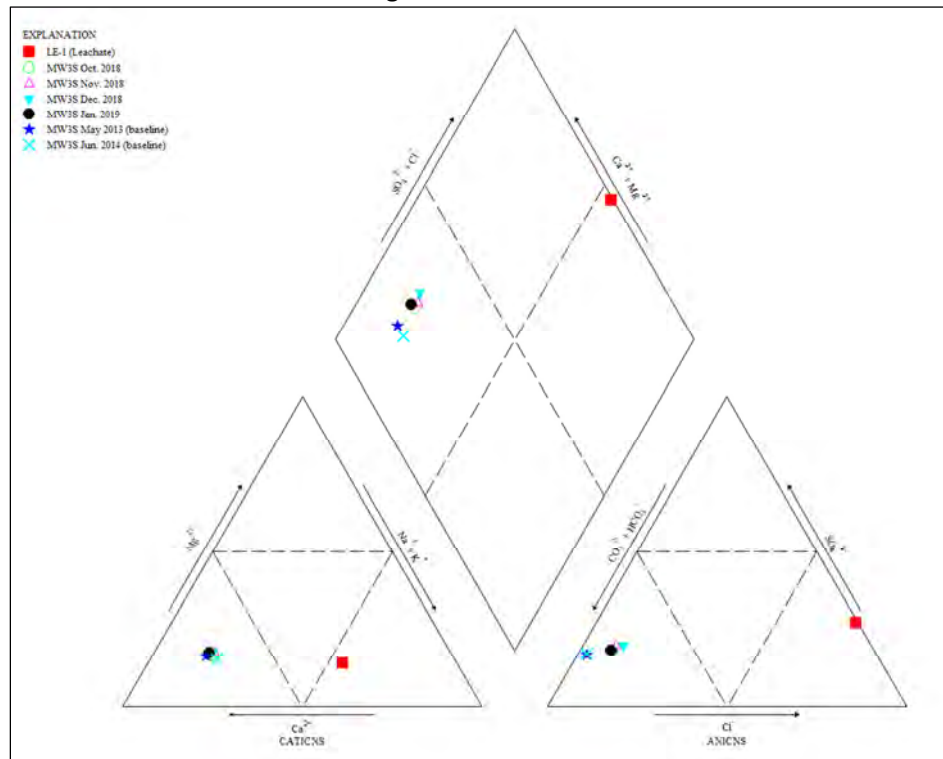
Plot 3 shows the difference between the geochemical character of water from MW3S and leachate

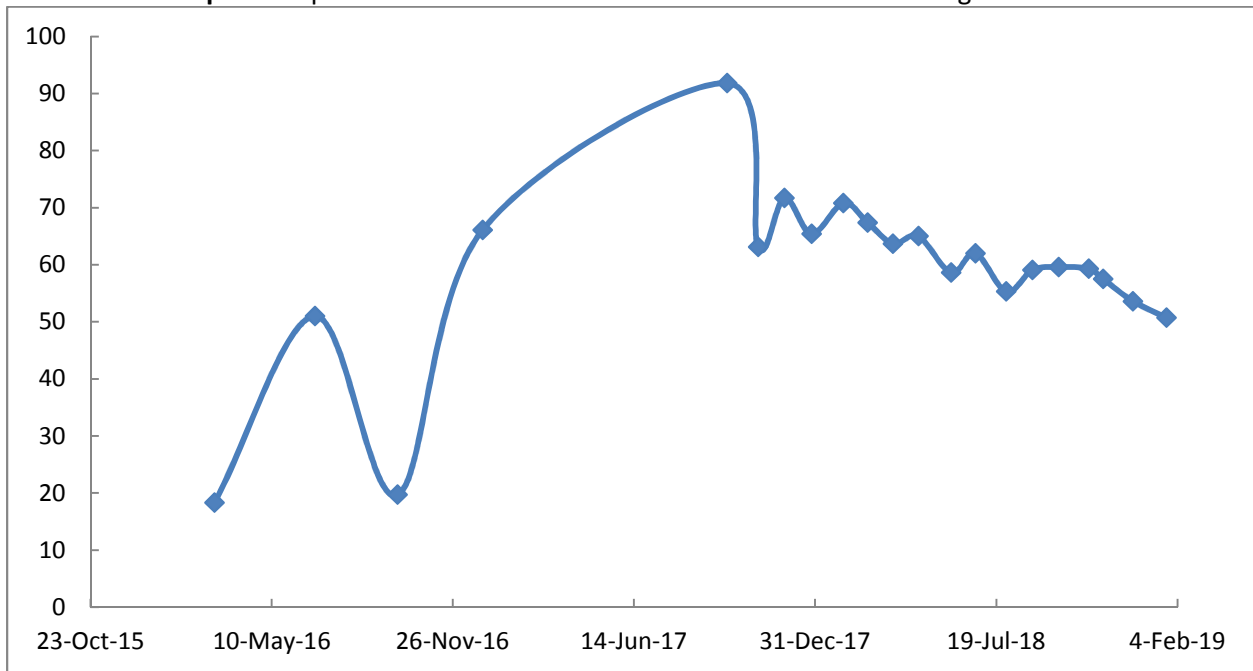
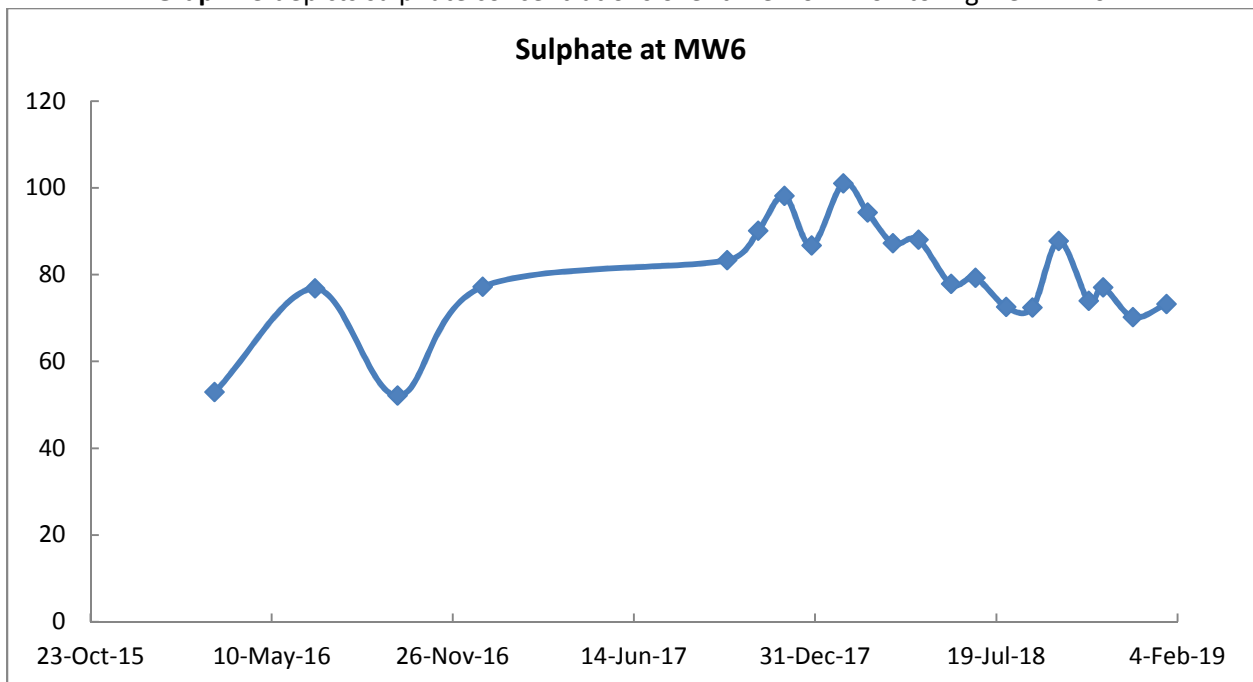
The water quality indicators at MW6 remain generally stable, as is shown in the following time-series graphs.

Graph 11 depicts chloride concentrations over time from monitoring well MW6

Graph 12 depicts sodium concentrations over time from monitoring well MW6

Graph 13 depicts sulphate concentrations over time from monitoring well MW6

Graph 14 depicts conductivity concentrations over time from monitoring well MW6

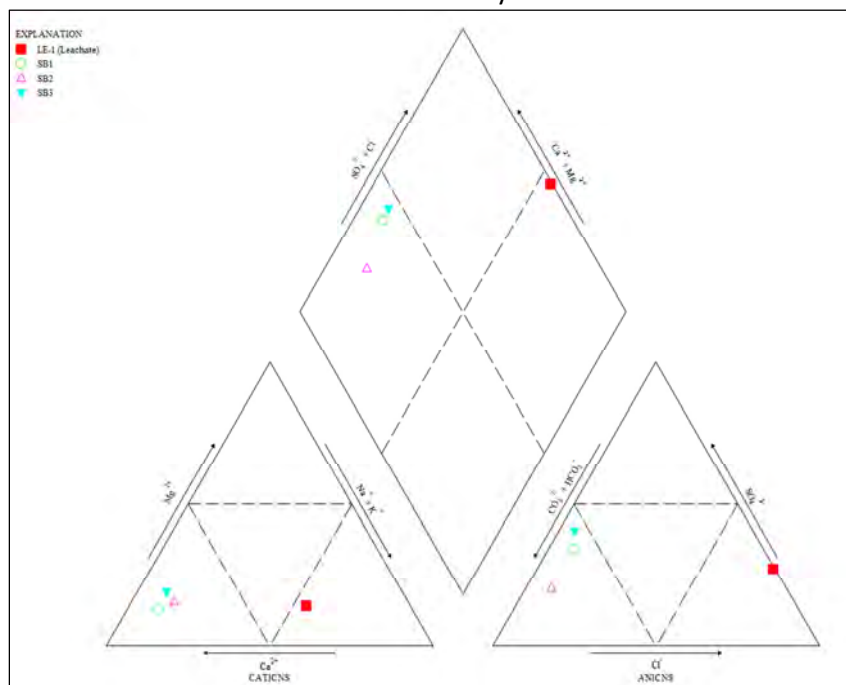
Plot 8 shows the difference between the geochemical character of leachate and water from SB1, SB2 and SB3 in January 2019.

The geochemical interpretations of the interflow water described above are consistent with the water quality conclusions from the time-series graphs. In summary, the interflow is influenced by precipitation, which leads to elevated concentrations of the indicators during the fall flush, followed by reduction of the indicators during the winter season and, finally, increasing concentrations of the indicators during the summer season due to absence of flow and water stagnation. These seasonal fluctuations can obscure early detection of potential leakage, which is the key limitation of the interflow wells.

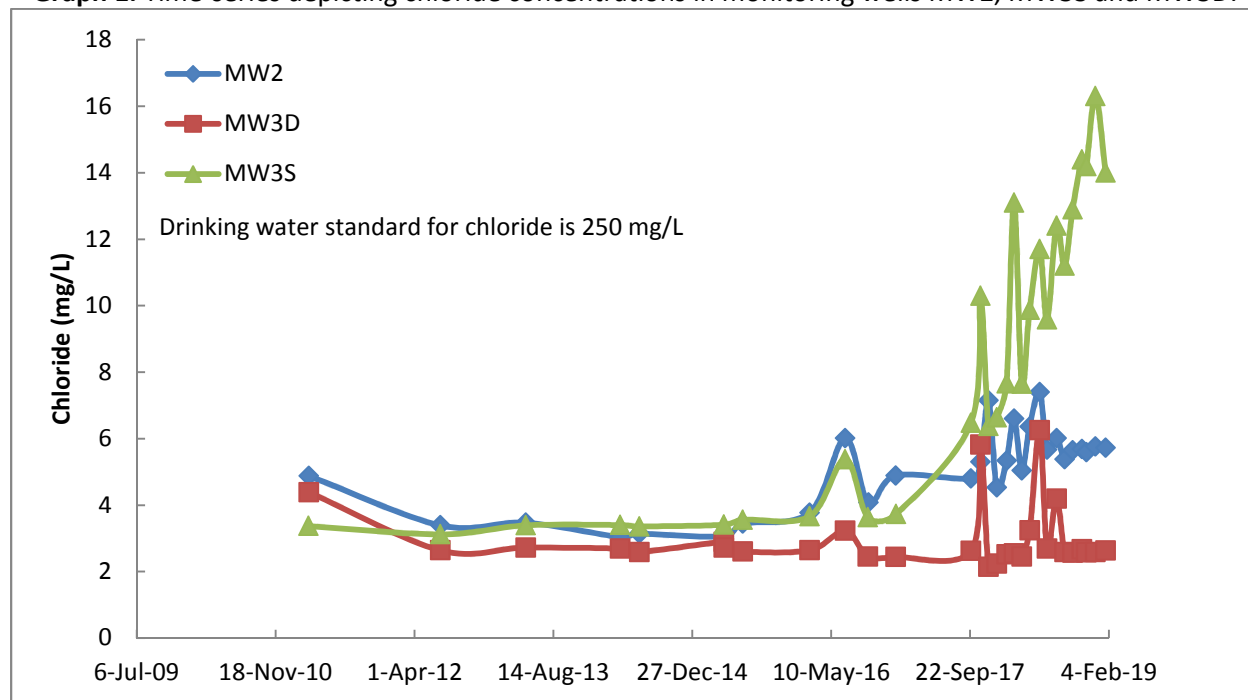
Graph 1. Time-series depicting chloride concentrations in monitoring wells MW2, MW3S and MW3D.

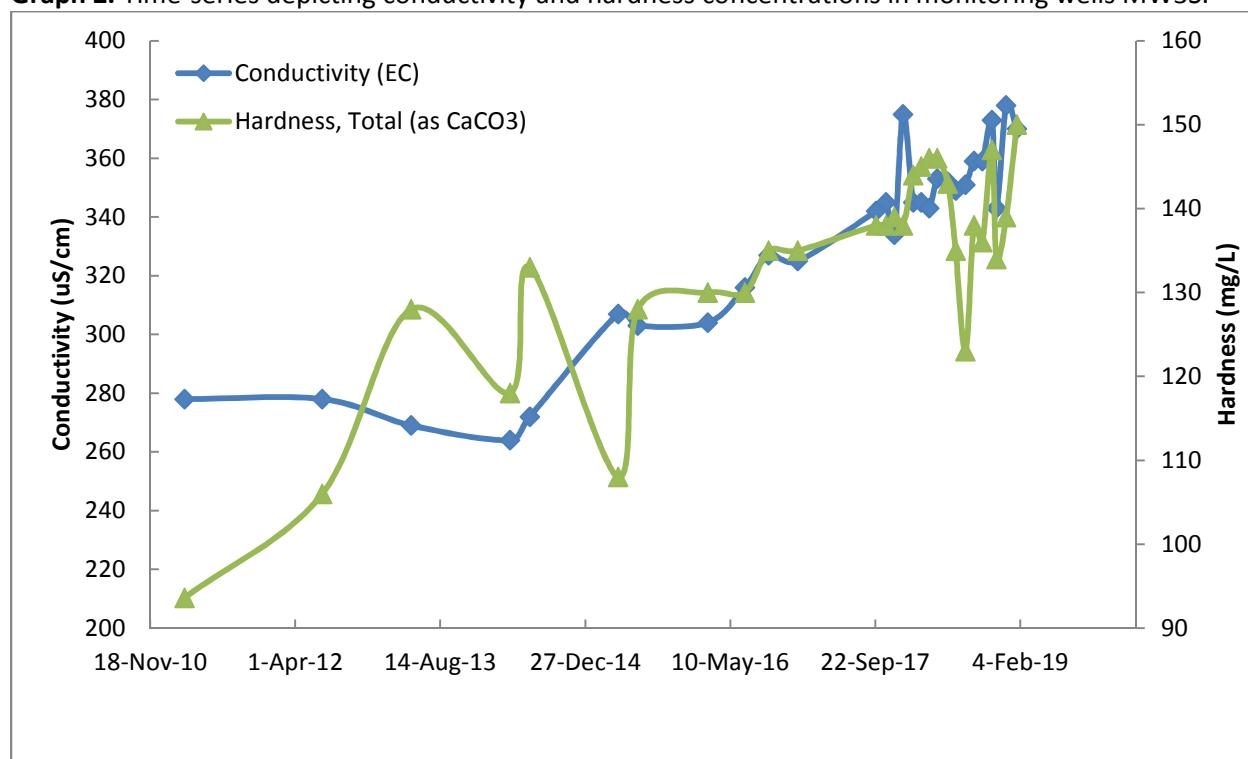
Graph 2. Time-series depicting conductivity and hardness concentrations in monitoring wells MW3S.

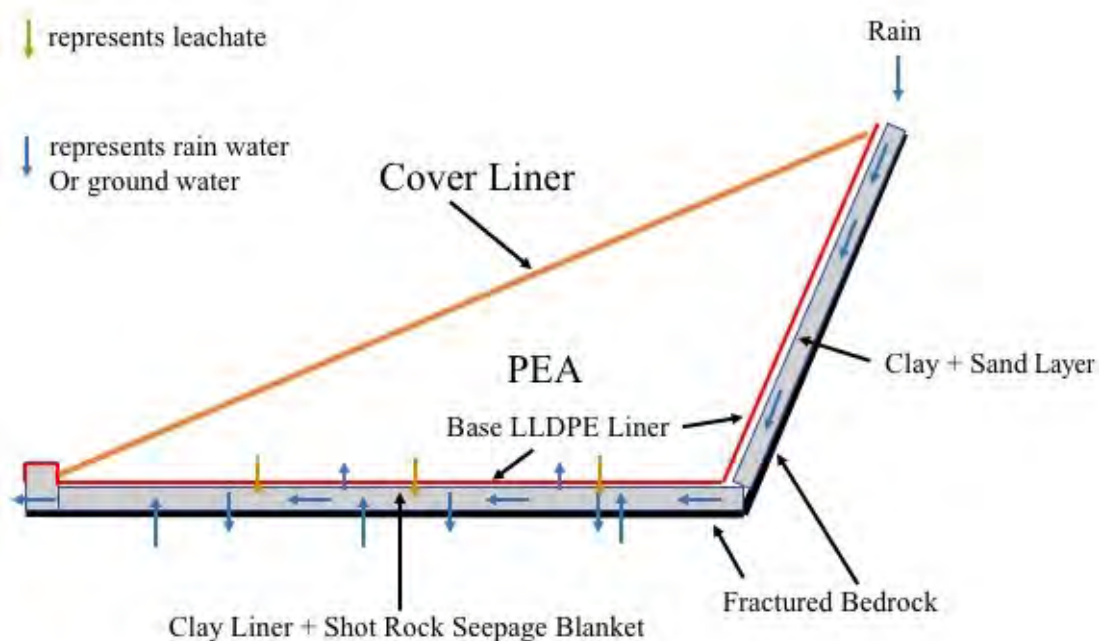
Figure 1 illustrates how rain water and ground water can penetrate the base of the PEA.

Figure 1. Diagram shows how leachate can pass through failed seams and ruptures in the base LLDPE liner to enter the ground water and if the area of the seepage blanket is saturated with water, then water can penetrate the PEA itself. The diagram also shows how rainfall at the edge of the PEA where it abuts the south-easterly and south-westerly walls can enter the space between the LLDPE base liner and the fractured bedrock.
