Reasons for Decision

Conditional Approval of 2019 Final Closure Plan for Cobble Hill Holdings Landfill

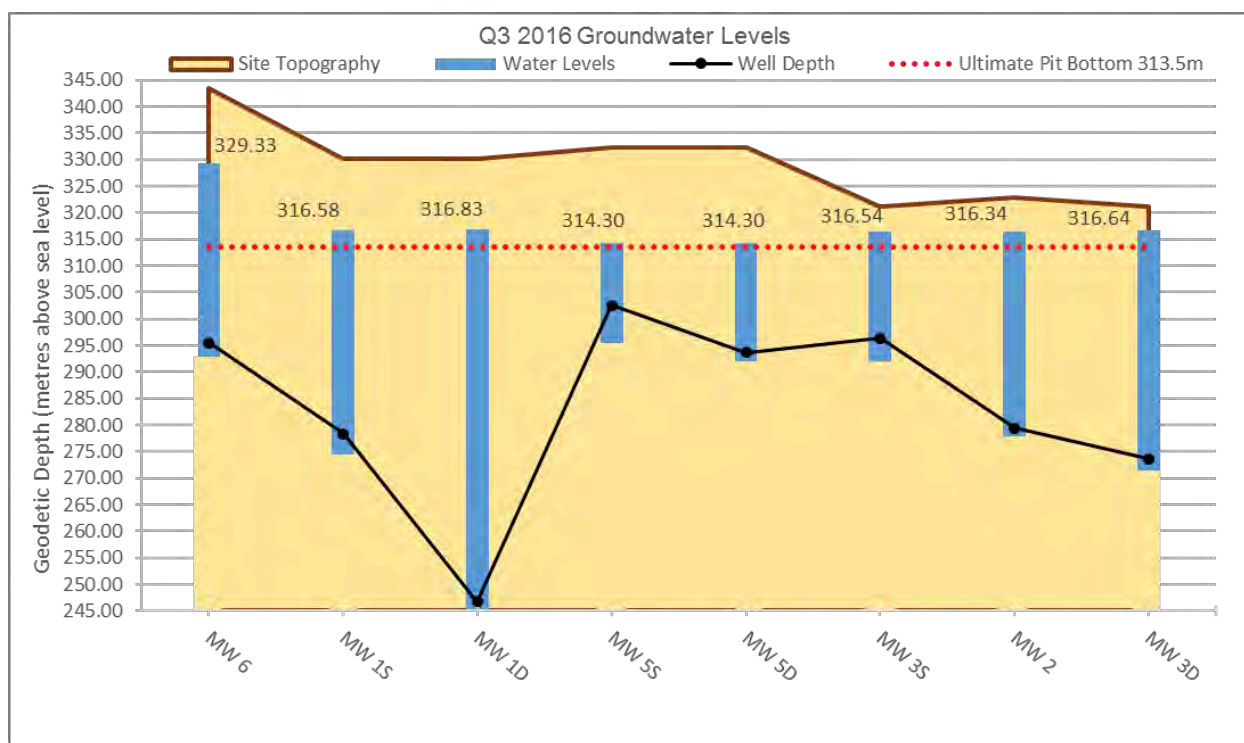
Further, SHA's Figure 6.2 represents a very selective use of data. It uses data from the rainy months when rain water influences the levels of the wells. One notes at the bottom of the graph shown in the Updated Final Closure Plans's Figure 6.2 that in the summer and early fall period of 2018, the wells are at essentially the same metres above sea levels. This is also seen in the Groundwater levels figure in the Quarter 3 Report of 2016 (Page 7 of the Report (p. 13 of pdf) and shown as Figure 2 in this Critique. Here there is essentially no difference between MW#1S and MW#3D and wells in between. Using winter well level data to argue the direction water will travel we consider to be deceptive.

Figure 2. Water levels in the monitoring wells shown taken from the Quarter 3, 2016 Report by the Named Parties.

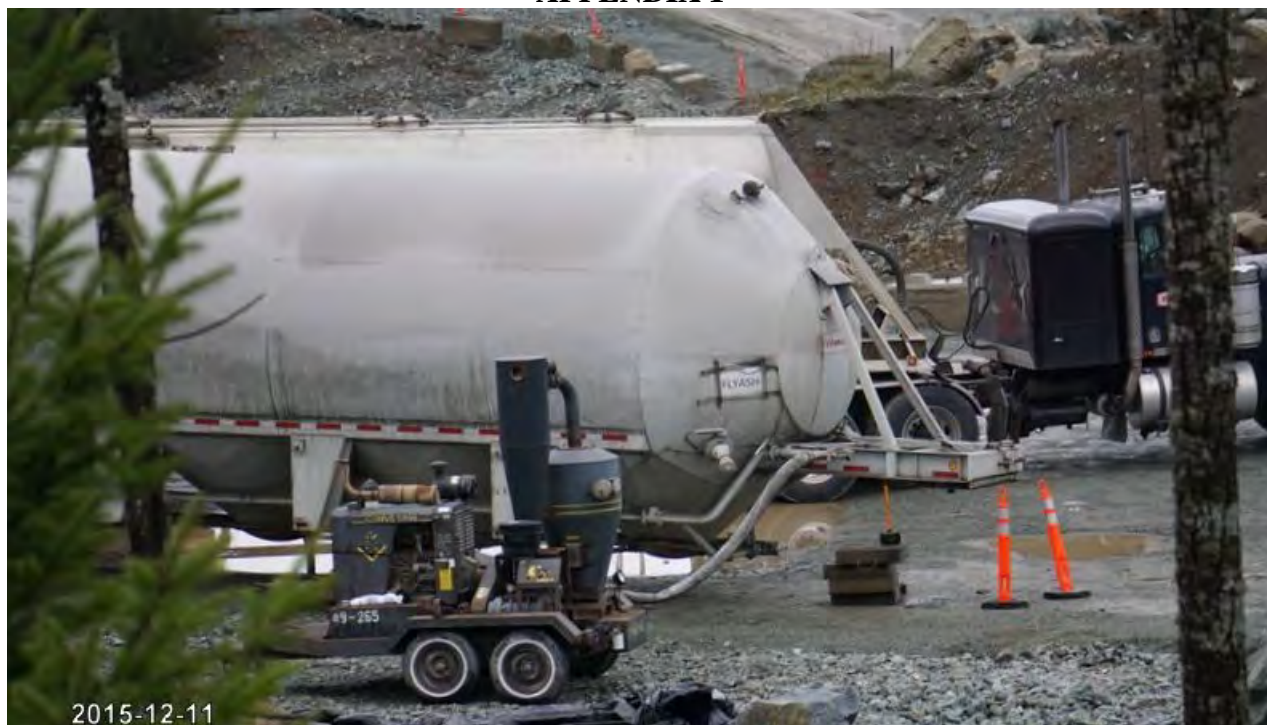
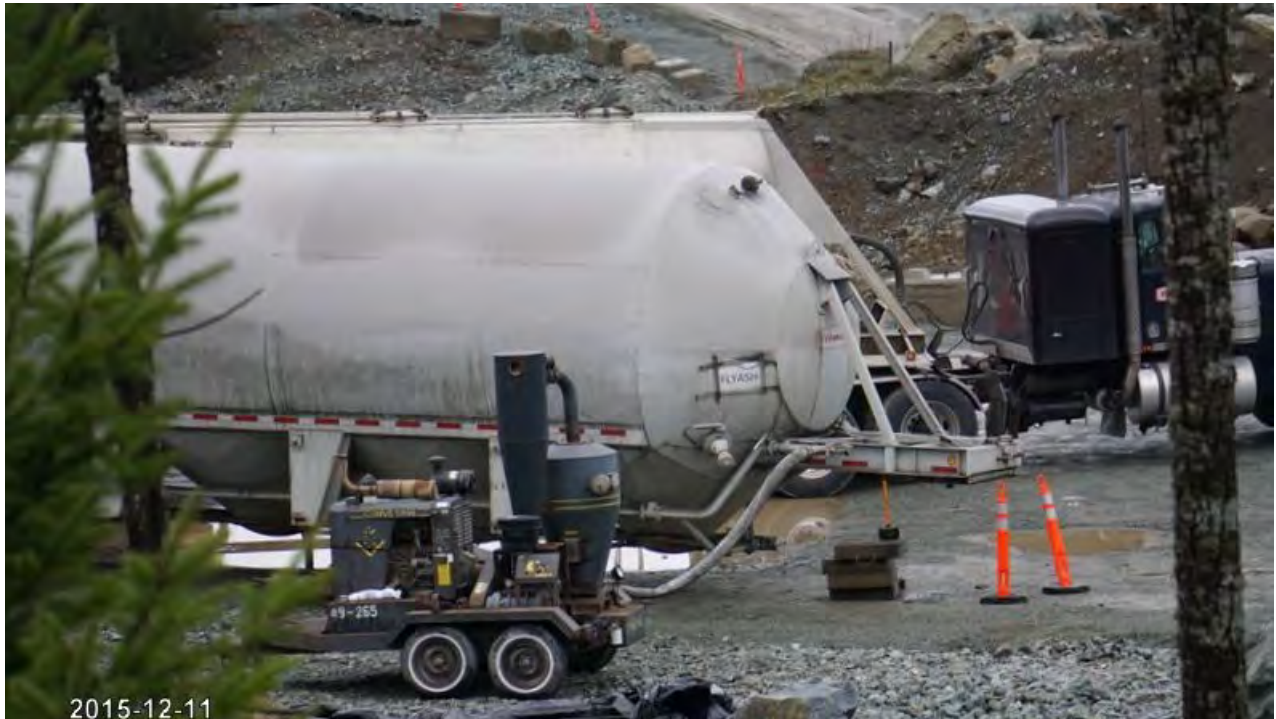
Figure A-1. Tanker on site clearly labelled FLYASH.

From the 2015 Annual Report, p. 8, line 6: “No ash was accepted during the 2015 reporting period.” Yet we have documented the presence of a tanker clearly labelled FLYASH unloading a dusty material onto the PEA during December 2015, a time when the Pacific Coast Terminals soil was transported to Lot #23.

Figure 1. Tanker on site clearly labelled FLYASH.

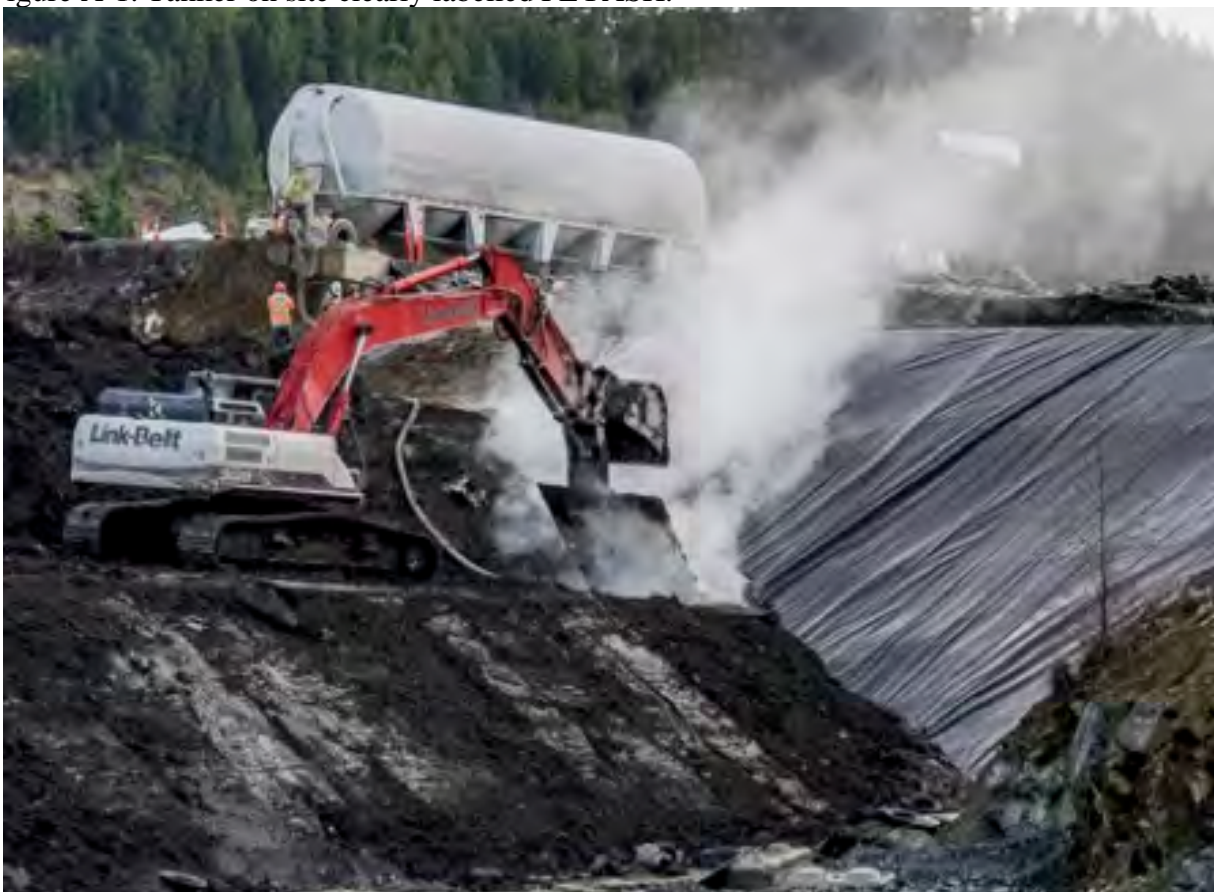
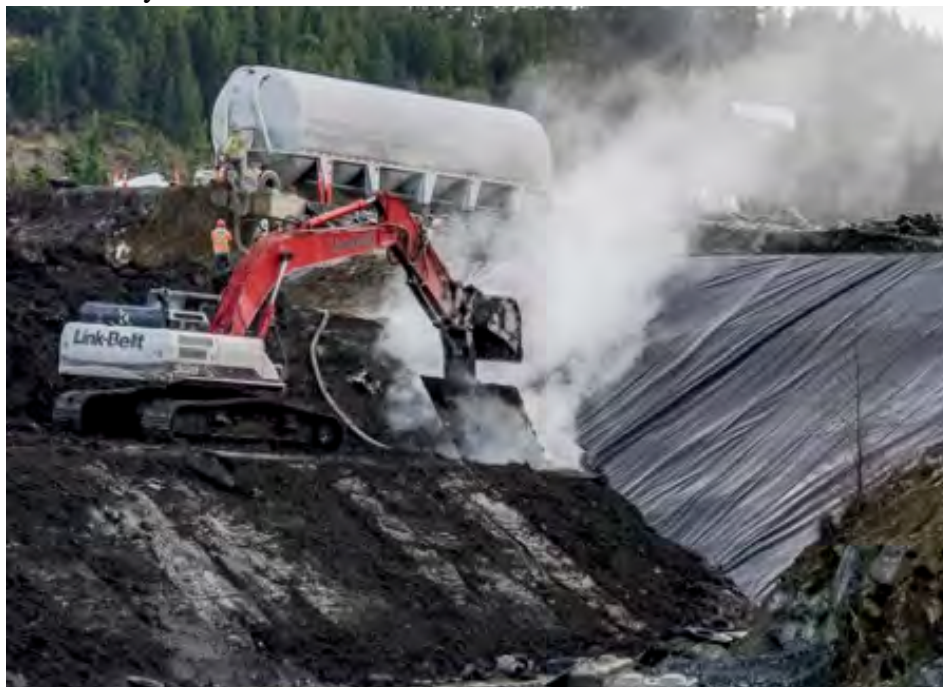
Figure A-2. Material from the tanker labelled FLYASH being dumped onto the PEA.

Figure 2. Material from the tanker labelled FLYASH being dumped onto the PEA.

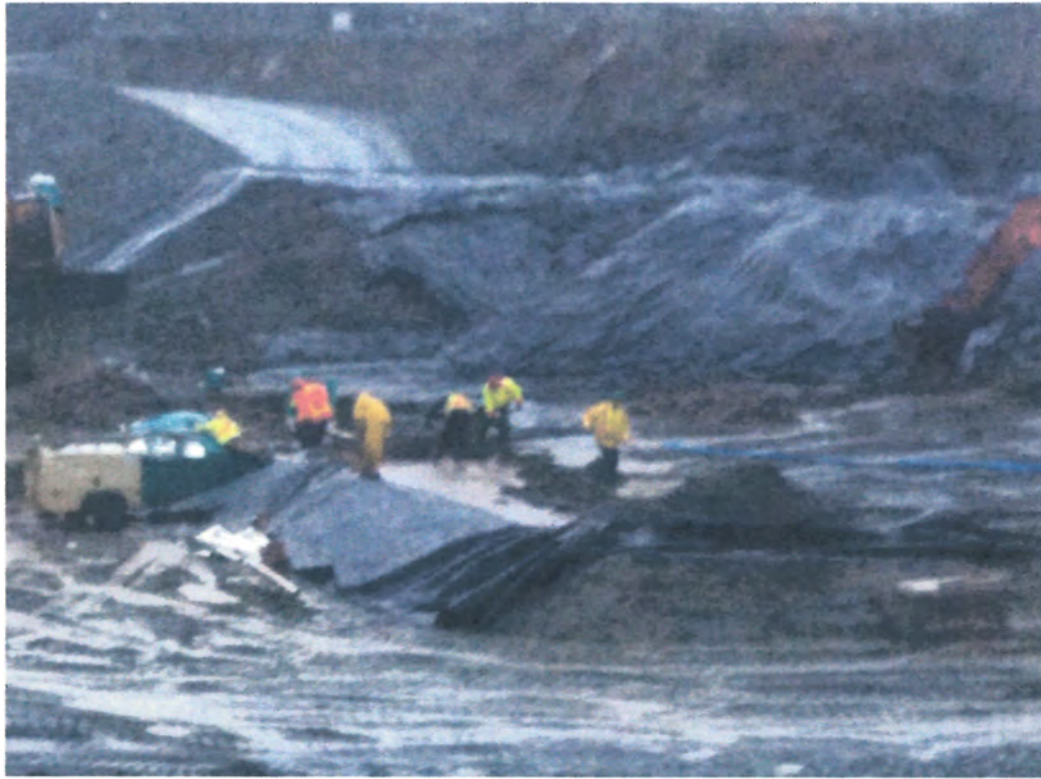
Figure 1: Photo taken November 17, 2015 during the installation of the base liner of PEA 1B.

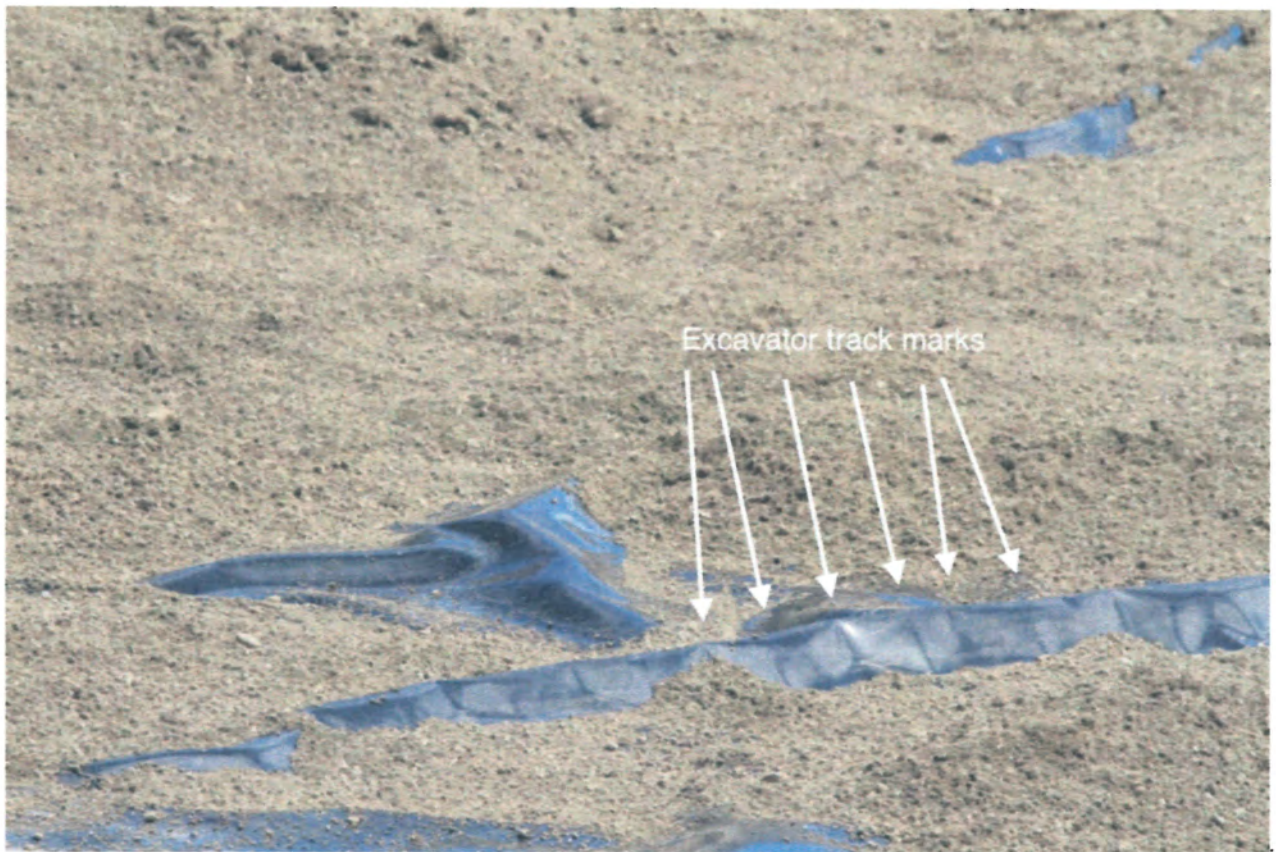
Figure 3: Excavator track marks on base liner of PEA 1C.

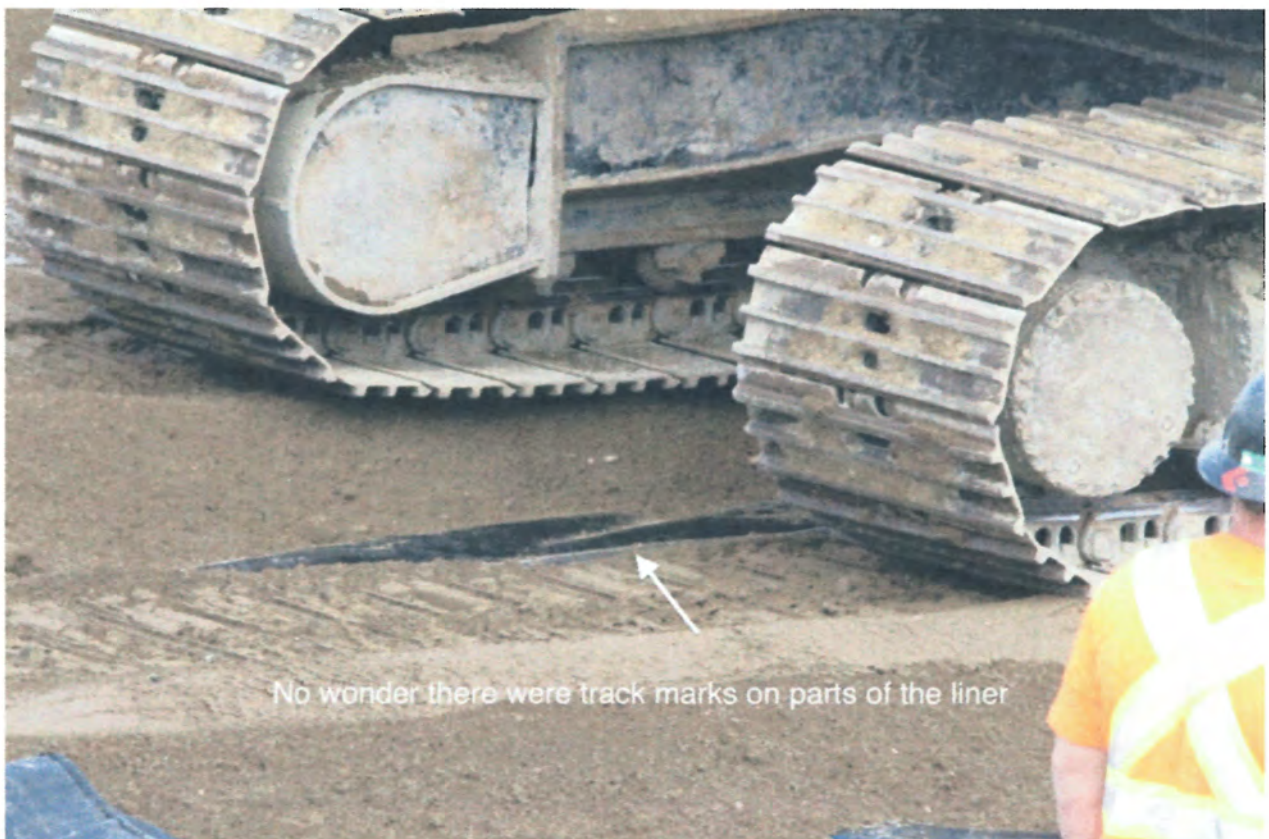
Figure 4: Note how close this excavator track is to the base liner of PEA 1C.

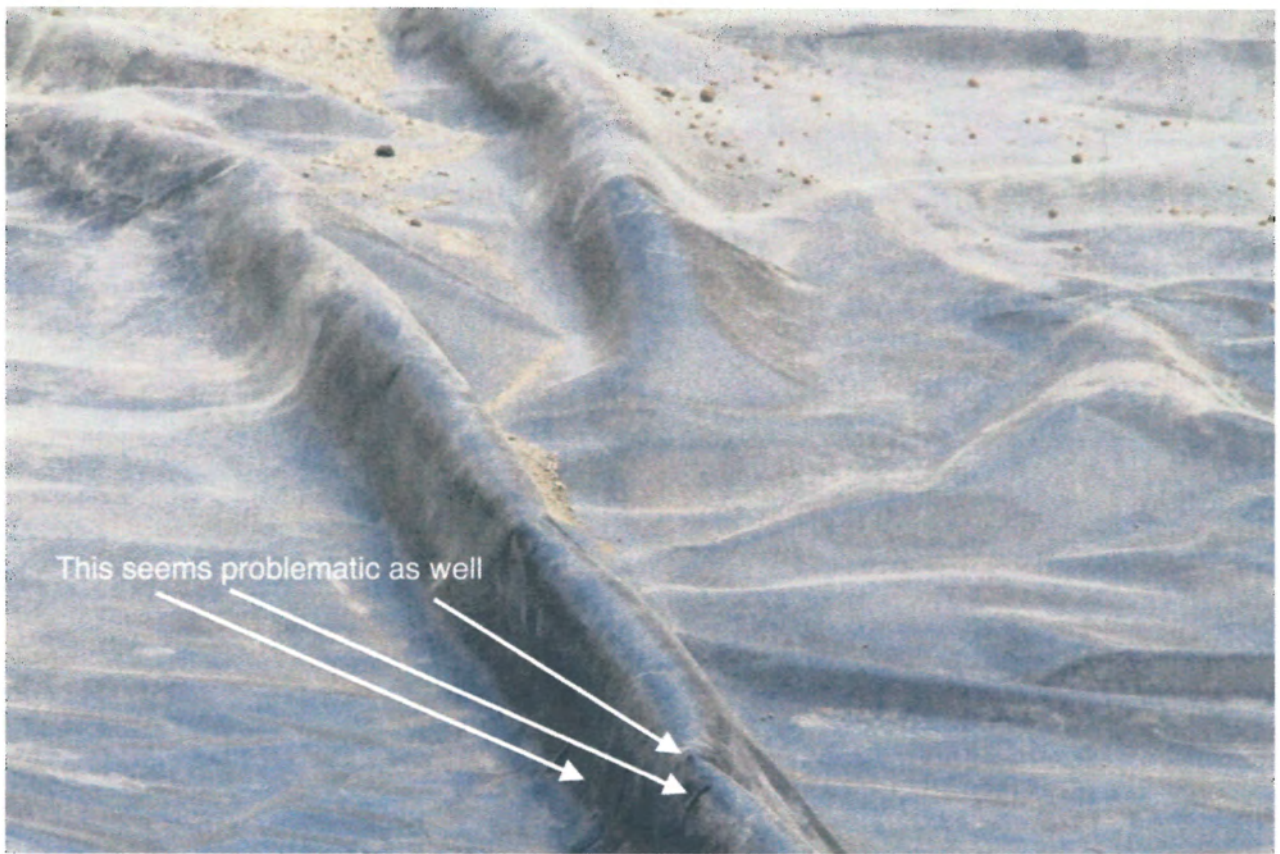
Figure 5: Cracks in base liner fold of PEA 1C.

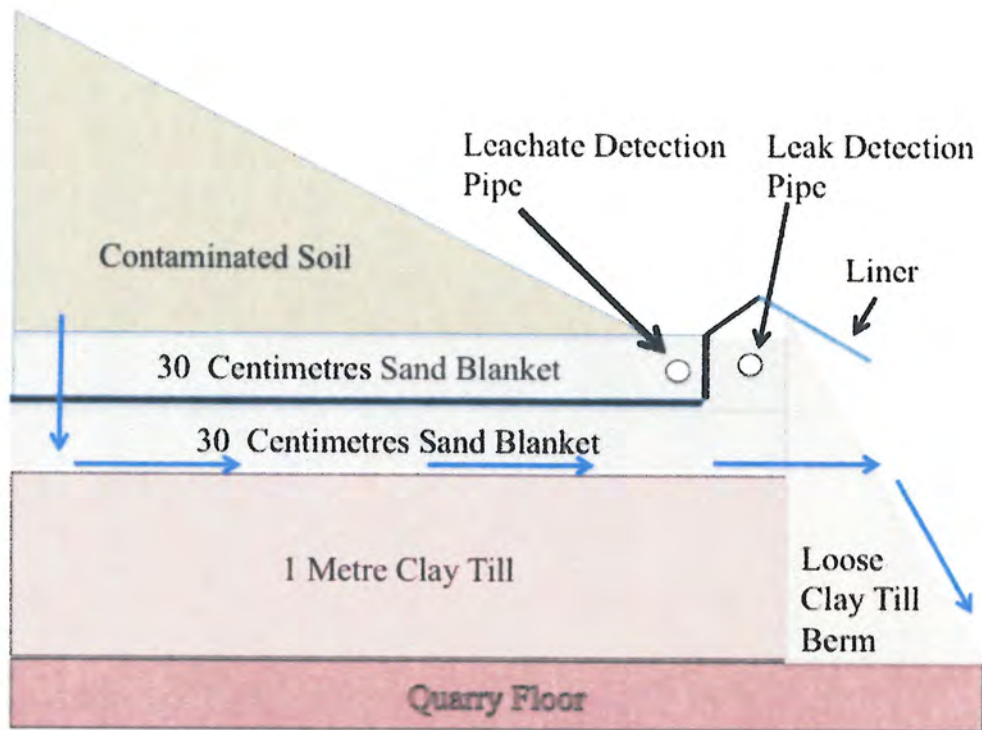
Figure 6: The so-called “leak detection system” designed by SIRM. The leaks would have to go **uphill** through sand and coarse crushed rock to enter the leak detection pipe. The simplest route for leaks is to flow through the sand blanket below the liner and through the loose clay till berm and from there the leak makes its way ultimately to the Ephemeral Stream. This is the source of the wet patches seen in Figure 4.

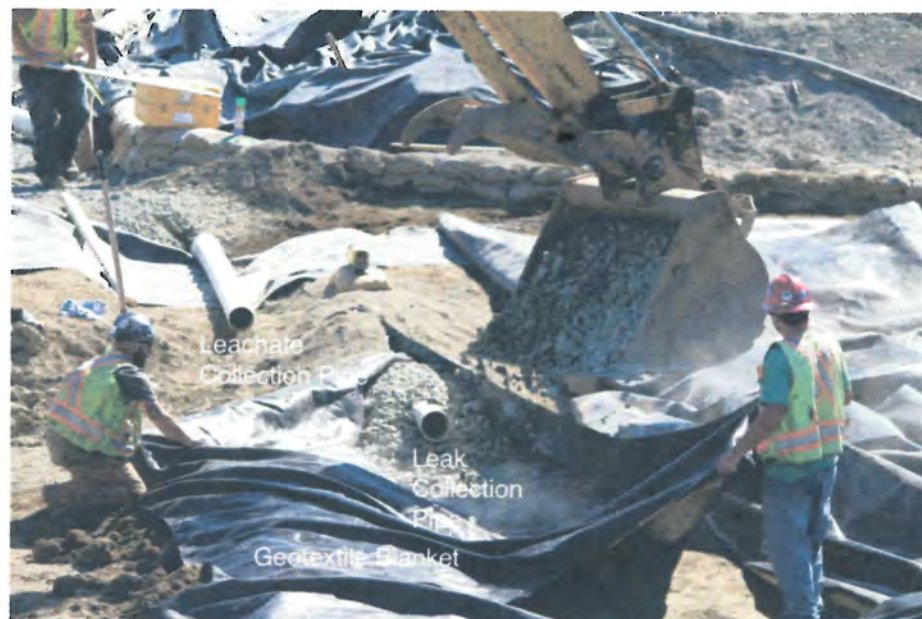
Figure 7: Early stage of installation of the leak collection and leachate collection pipes in PEA 1C. The worker on the right is standing on the PEA 1C floor. It can be seen that the leak collection pipe is well above the floor of PEA 1C.

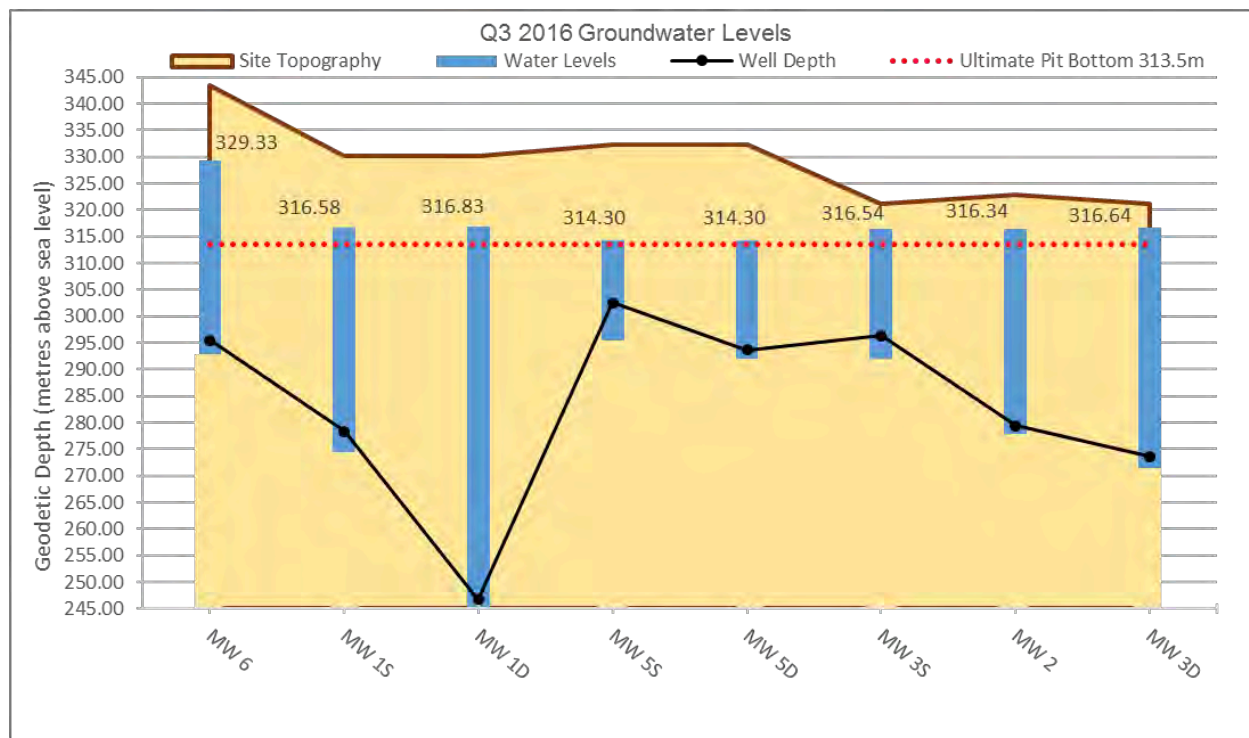
The Ministry previously informed the SRG that its hydrogeologist stated that the high ionic content of Monitoring Well #6 is due to the fact that this is a much deeper well than all the other monitoring wells. This clearly is incorrect as can be seen in Figure 3.

Figure 3. Water levels in the monitoring wells shown taken from the Quarter 3, 2016 Report by the Named Parties.

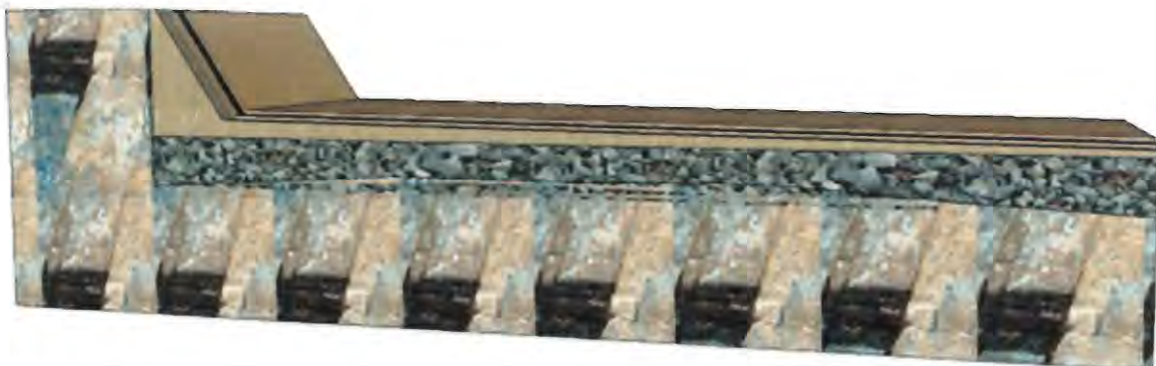
As Built Landfill Model

This model shows the 6 parts of the landfill on which the contaminated waste rests.

This model is to scale. The height on the wall on the left is about 10 m (meters) and the length of the base is about 65 m.

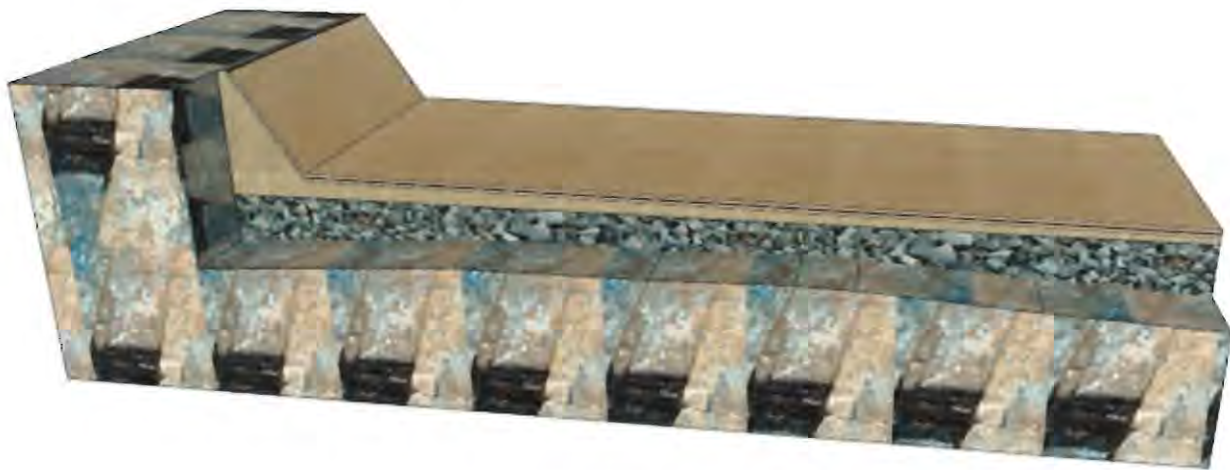
Bedrock Layer surface unknown

This level of the landfill base - the bedrock - therefore fails completely to meet **16Spec**.

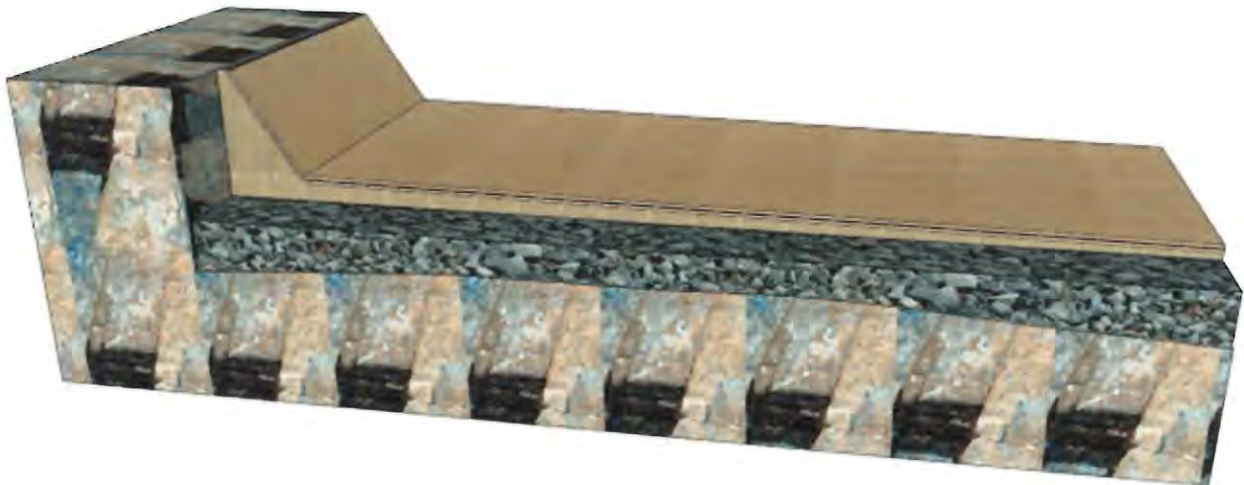
As Built Seepage Layer

Some of the blast rock was left in place so that the area was a suitable surface for mining equipment.

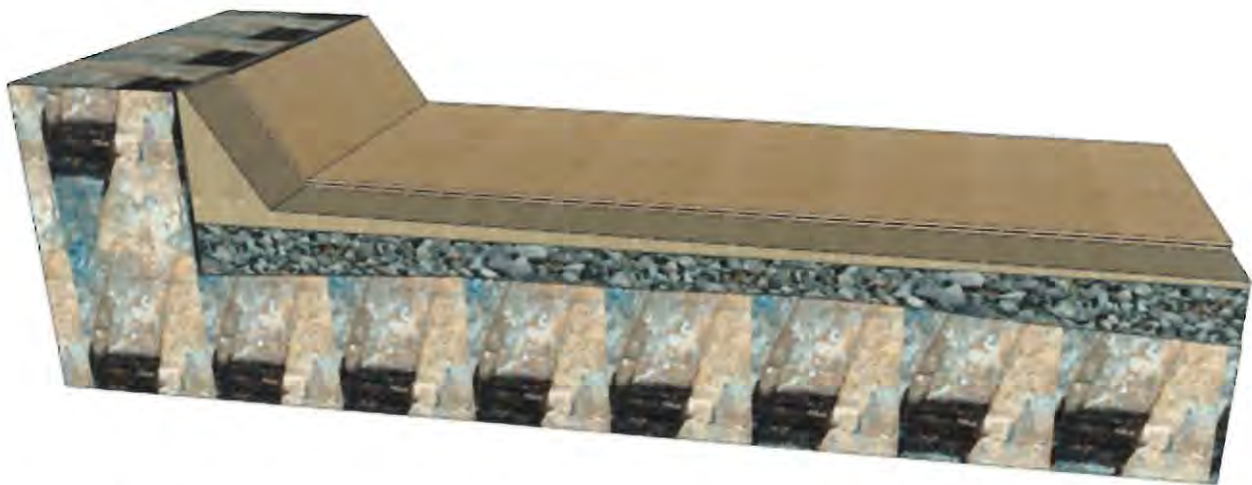
As Built Clay liner

The clay liner is the main protection from leachate leaving the landfill and entering the seepage layer.

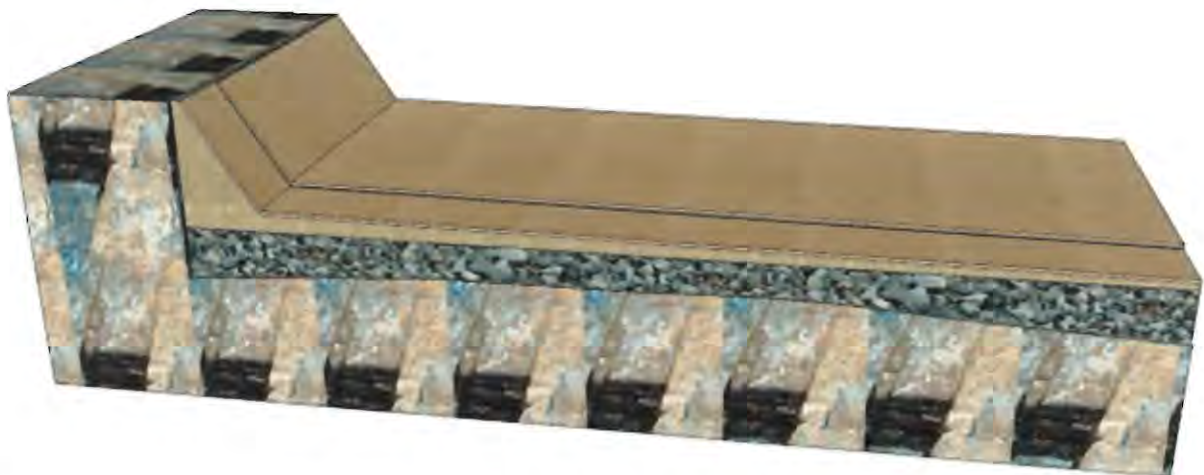
As Built Sand Leak Detection Layer

The **As Built** landfill has a layer of sand on top of the clay.

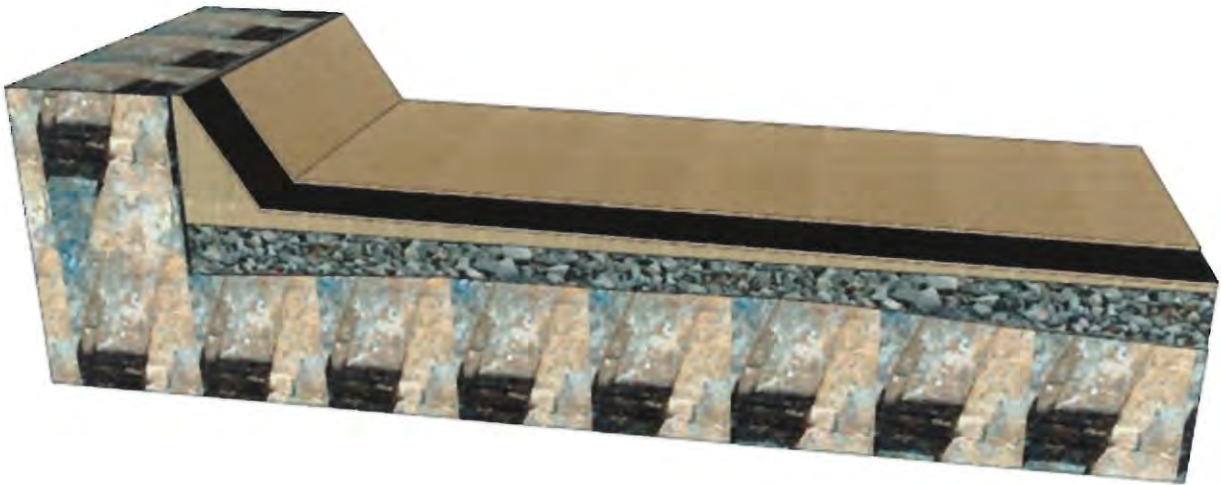
As Built - Plastic Liner

The plastic liner both prevents movement of water into the lower layers and prevent movement of the layers themselves.

The existing landfill has a single 40 mil LLDPE liner that was installed during the rainy season.

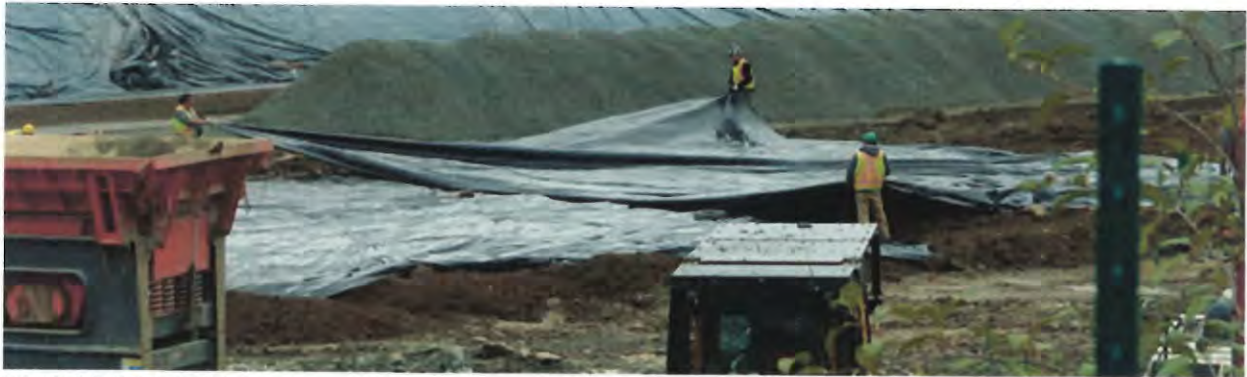
2015:10:29 14:50:51

The next day 29 mm of rain fell at the Shawnigan Lake Environment Canada weather station. Typically, rainfall at the landfill is 133% of the rainfall at lake level. The liner was installed and welded in the rain.

Perhaps the **As Builts** did not include the fact that the base liner was laid down and welded during the rainy season. However, in several meetings with them, the SRG has repeatedly made this point. To no avail.

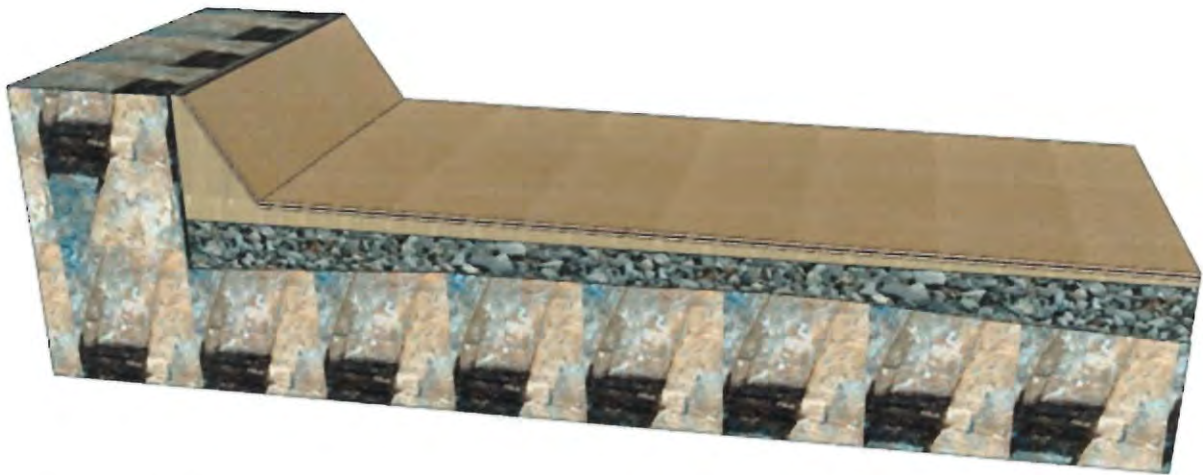
Sand - Leachate Collection

The **As Built** drawings for the site show the sand layer for leachate collection as an even 30 cm (about 1 foot) layer on top of the base liner.

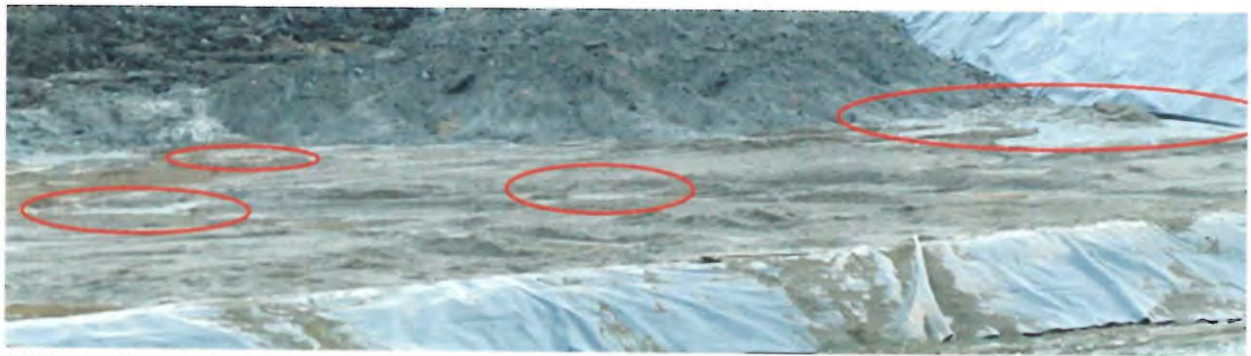
2015-11-13 11-47-36 -sand missing and disturbed

The reality is quite different. The above picture was taken after they started moving waste onto cell 1B. It is clear in the picture that the sand layer is missing in many places.

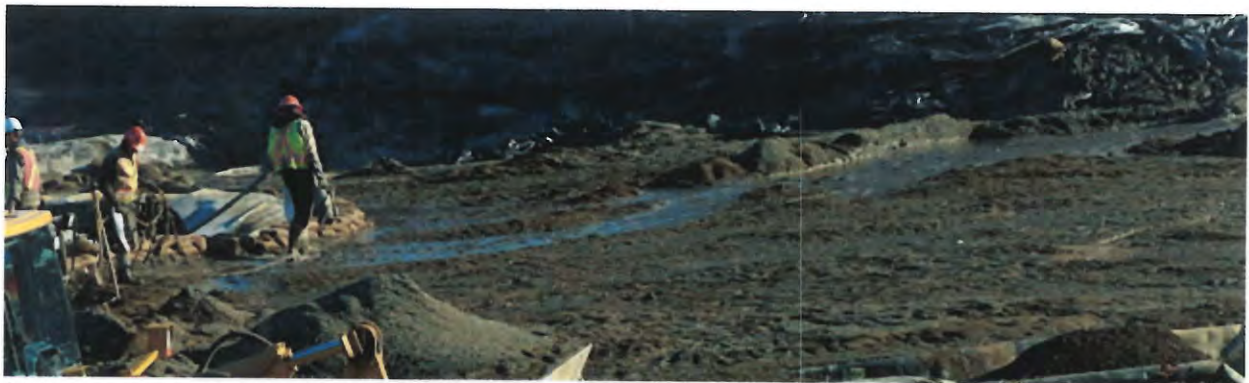
2015-11-19 11-47-29 sand washed off liner

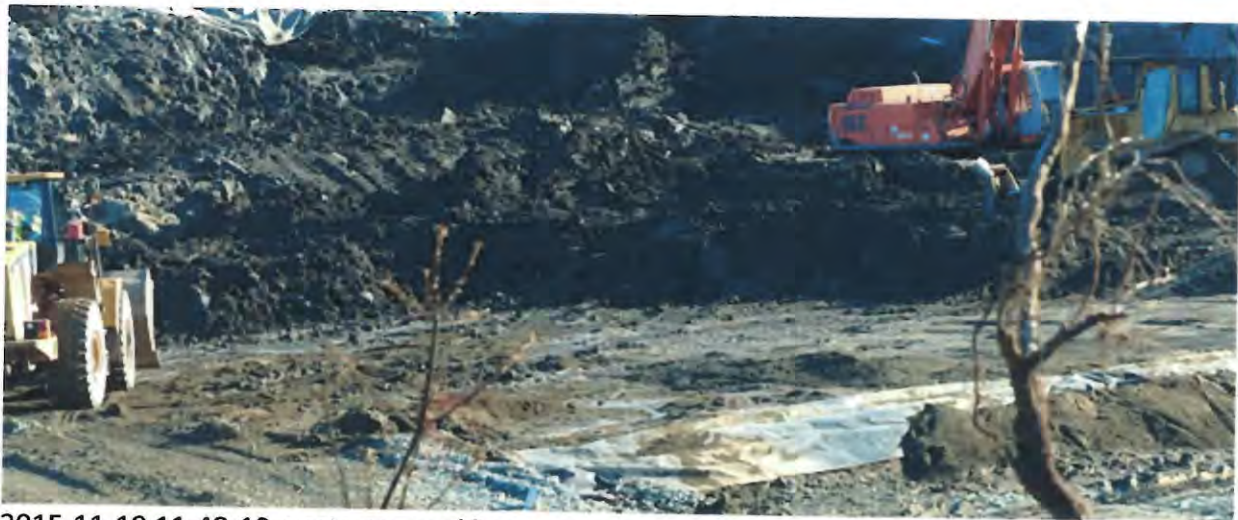
Lest you think they repaired the sand layer before placing the waste on top:

2015-11-19 11-48-10 waste on sand layer
