Ministry of Energy, Mines and Natural Gas

Hazard Alert Overhead Power Line Contact

Incident Summaries

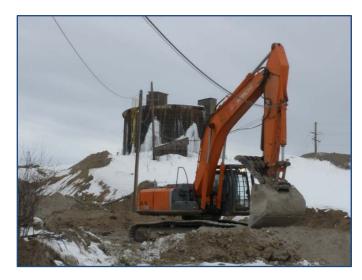
At approximately 0740 hours, a worker was fatally injured when the mast of the Joy MS2 Air Track he was moving came into contact with a 14.4 kilovolt overhead power line. A second worker walking alongside the Air Track to control an air hose was uninjured.

The two workers arrived on site at 7:00 a.m. to drill six holes that required them to change the Air Track's drill steel from 12-foot to 14-foot steel. The workers carried the 14-foot drill steel (without bit) from another drill parked on the far side of the overhead power line. They raised the drill mast to install the 14-foot drill steel but did not lower it, since a new bit also had to be installed. The workers proceeded to walk the Air Track to the location of the new bit. After moving approximately 135 feet, the upright drill mast came into contact with the overhead line, resulting in the fatality.

- ✓ Before starting work, perform a hazard assessment of the area. This should include overhead hazards such as power lines.
- ✓ Ensure that policies and procedures are developed for working around overhead power lines. Operators need to be trained on how to respond should a piece of equipment come into contact with an overhead line.

- ✓ Before moving equipment to a new location, become familiar with the route and ensure safe clearance distances between the equipment and all power lines along the way.

- ✓ Use signage to warn of overhead power line hazards at road crossings.
- ✓ When moving equipment under power lines, ensure proper limits are maintained as per section 4.3.6 (Overhead Supply Lines) of CSA M421-11, Use of Electricity in Mines.

- ✓ When working near overhead power lines, adhere to the requirements related to section 4.19.8 (Distance from High Voltage Conductors) of the Health, Safety and Reclamation Code for Mines in British Columbia.

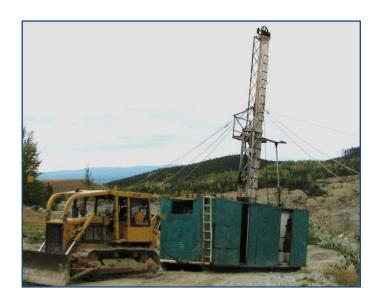
At approximately 1400 hours, an employee discovered a broken neutral line conductor that had fallen to the ground from an overhead power line. Subsequently, while spreading crush on the road, a truck box came into contact with the neutral line conductor. Neither the grader operator nor the truck drivers noticed the line come into contact with the truck box.

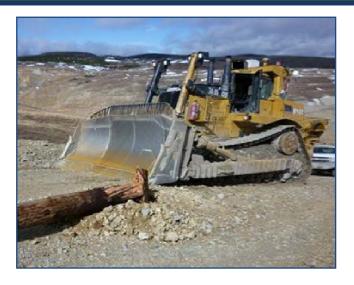
At approximately 0945 hours, a mine operations employee travelling along a power line access noticed smoke coming from the engine compartment of his dozer.

While shifting in his seat to get a better look, he accidentally bumped the left track control of the moving vehicle and caused the dozer to immediately veer left and sheer the power pole. The operator called for assistance and remained in the cab until it was safe to exit the dozer.
