WATERSHED REVIEW GORDON CREEK WATERSHED Draft March 23, 2012

Ministry Contract No: CS12NRH-011

BIOPHYSICAL AND LAND-USE CHARACTERISTICS OF THE WATERSHED

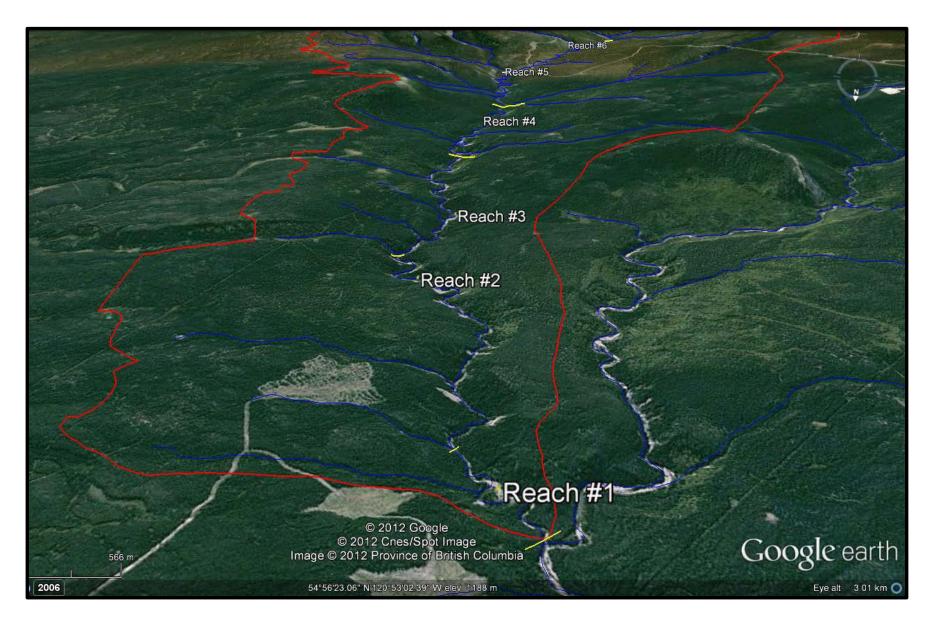
Figure 4. Identification of reaches along the mainstem of Gordon Creek watershed

The mainstem of Gordon Creek is a moderate gradient confined channel that flows through entrenched canyons with limited floodplain (Figure 4). There are a few occurrences of natural failures of these steep valley walls that flow directly into Gordon Creek, which makes the channel somewhat unstable (Figures 5 and 6). There is also an abundance of flat-over-steep terrain along many of the canyon reaches (Figures 5 to 7). The surficial geology of this watershed is dominated by a mixture of fine and moderately coarse morainal tills in the lower part of the watershed and coarse colluvium rubble in the upper parts (Figure 2). Much of the lower mainstem reaches have been classified as a slightly unstable Rosgen F4 type channel (Table 7, Figures 4 to 6), with the upper reaches being classified as B3 channels. The mainstem has been well protected from riparian harvesting throughout the watershed (Table 7) and thus has a very low riparian hazard rating.

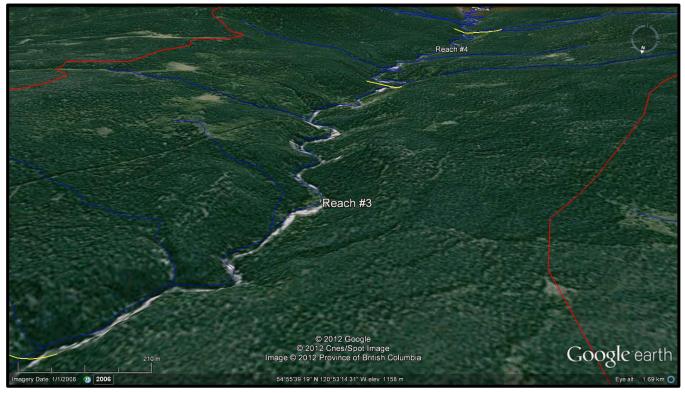
Figure 6. Google Earth image looking upstream along Reaches #3 and 4 of Gordon Creek.
