# FREP

REPORT #43

## THE INFLUENCE OF RIPARIAN FOREST AGE AND COMPLEXITY IN THE RECOVERY OF POST-HARVEST "AT- RISK" STREAMS AND RIPARIAN AREAS

Lisa Nordin and Leah Malkinson

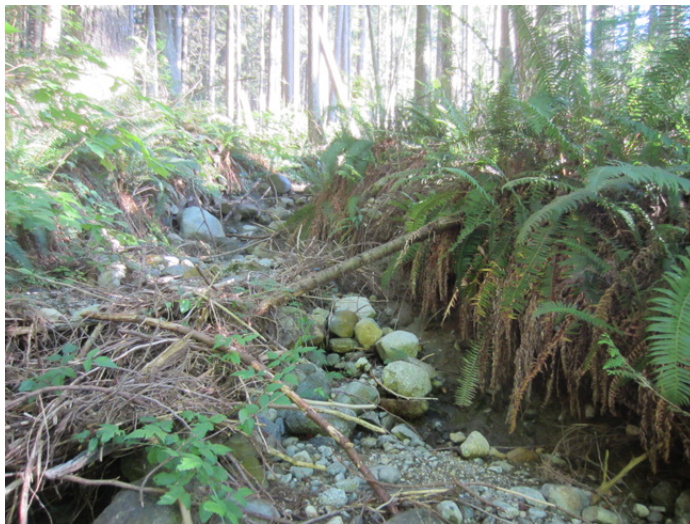
The reassessment sampling design required equal proportions of non-alluvial and alluvial stream reaches as well as sites that had been assessed previously as *functioning at-risk* or *functioning at high-risk* so that any differences related to these variables could be identified. However, the results were not found to be significantly different between stream morphologies, their initial assessed condition categories, or the combination of both (ANOVA;  $p > 0.05$ ). This could partly be because in some cases, a stream that had been initially identified as non-alluvial (doesn't contain enough power to actively erode, transport, sort, and deposit bed and bank materials) but contains erodible soils, will function much like an alluvial system if peak flows increase post-harvest, and this could subsequently affect channel bed and bank integrity (Hogan and Luzi 2010). Recent bank erosion and deposition of materials was evident at several of the sites that had been classed as non-alluvial, confirming this rationale (Fig. 2).

**Figure 2.** Erosion of bed and bank material in a non-alluvial stream.

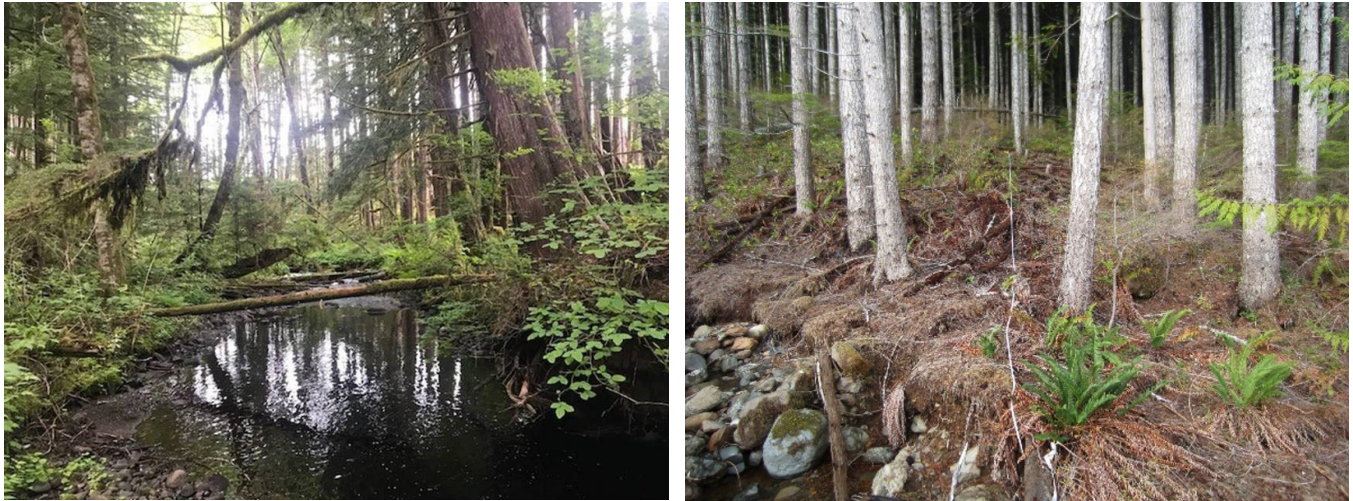
The quicker recovery of streams within the older stands lends credence to the greater resiliency of complex forest structure. Keeton et al. (2017) found that riparian vegetation composition and structure were directly related to channel geomorphic processes including degradation, aggradation, widening, and change in planform and concluded that streams within riparian forests of greater structural complexity are more likely to exhibit channels in better geomorphic condition. Anecdotal results from annual random FREP assessments on the B.C. coast indicate streams within maturing riparian forests (100+ yrs) that show signs of self-thinning and diversity of layers are more effective at resisting erosive forces than those in younger second-growth stands (Fig. 4).

**Figure 4.** North Island resource district riparian area age 112 years (left), and ~ 50 years (right).

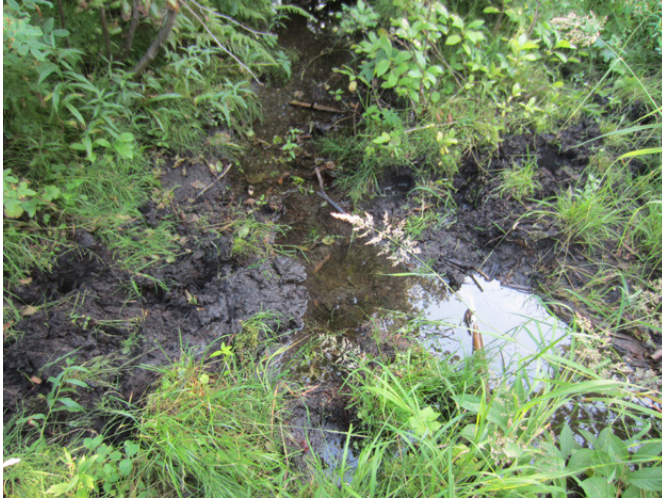
Livestock was the primary cause of animal disturbance and linked to at least one impaired indicator at 7 of the sites, followed by ungulates (2 sites) and beavers (2 sites). Though these factors are not a direct result of logging, animal disturbance to riparian areas (Fig. 6) can increase when surrounding habitat is reduced or access to a stream is made easier through the removal of timber or the construction of roads.

**Figure 6.** Cattle damage to stream bed and banks.

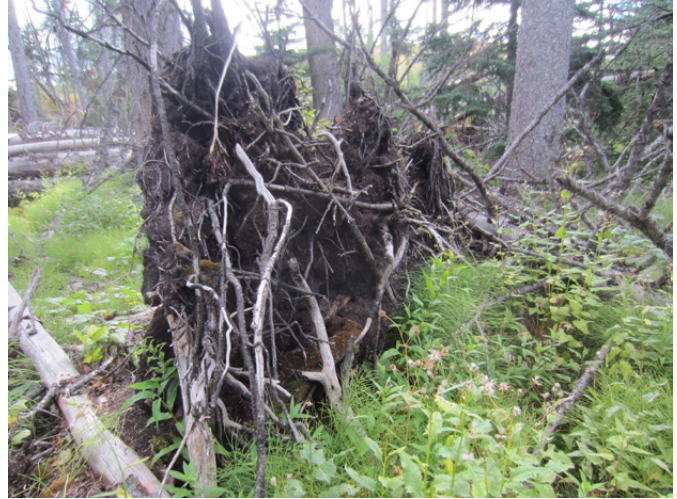
Excessive windthrow is defined in the assessment as windthrow that exceeds a benchmark percentage over and above what occurs naturally at a site, with the percentage depending on whether or not there is a reserve zone within the riparian management area. Excessive windthrow was recorded in both coastal (3) and interior (3) regions, and it was readily apparent that it was the result of increased exposure to wind after harvest. In addition to triggering the main windthrow indicator in the assessment, the up-turned root wads (Fig 7) and high levels of woody debris

associated with downed timber near the stream edge influenced other indicator results by contributing excessive fine sediments, channel bank disturbance, and within-channel debris jams. While the value of retaining riparian timber for fish and riparian habitat cannot be overstated, it is also imperative that windthrow is managed to be within the range of natural variation to avoid undue affects to other ecological processes.

**Figure 7.** Upturned root wad in riparian area.

In all stream reaches where a no-harvest reserve zone (RRZ) is required, a windfirm buffer is important in the adjacent riparian management zone (RMZ) to protect the reserve from windthrow. Options to reduce risk of windthrow in a reserve zone include widening and realigning the boundary of the RMZ to a natural windfirm edge or an angle that will be stable to prevailing winds, removing unsound trees, and/or employing edge stabilization treatments such as feathering and topping or pruning (B.C. Ministry of Forests and B.C. Ministry of Environment, 1995).

In cases where there is no required RRZ, any treed retention in the RMZ should be windfirm and robust enough to protect trees nearest the stream from windthrow using the techniques described above. Avoid leaving wind-prone trees in riparian areas with narrow retention strips. Studies have shown that a fully intact 10 m riparian zone can be effective at buffering the stream from harvest-related effects, regulating water temperatures, supplying the channel with LWD, and facilitating the consistent delivery of nutrients and organic matter to downstream reaches (Gomi et al. 2006; Nordin et al. 2009; Clinton 2011; Rex et al. 2011; Nordin et al. 2017). Therefore, where narrow buffers are prescribed, it is important to ensure these are protected from windthrow. It should also be noted that what might be assumed to be an adequate retention width in older forests, may not be the case in second growth stands. Mitchell (2000) explains that when similar-aged trees compete for nutrients and space, the resulting stand is comprised of slender trees with high crowns, which increases the risk of windthrow.
