CANADA – BRITISH COLUMBIA WATER QUALITY MONITORING AGREEMENT

WATER QUALITY ASSESSMENT OF Fraser River AT HANSARD (1984 – 2004)

B.C. Ministry of Environment

March 2007

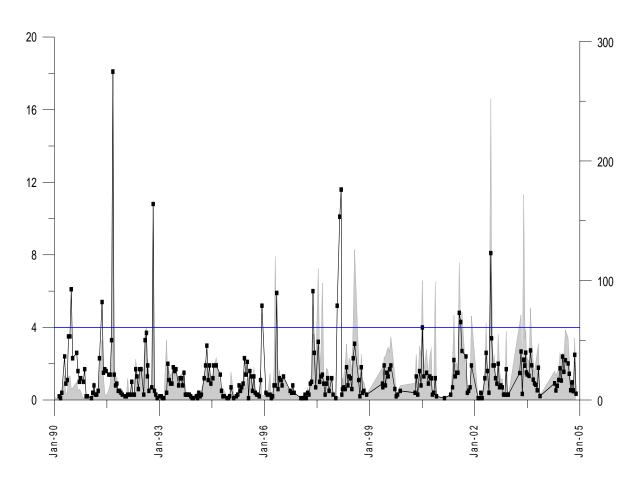
Fraser River at Hansard Cobalt Total (ug/L) Figure 17

Cobalt (Figure 17): values often exceed the guideline for drinking water supplies when turbidity is high. The cobalt would be removed from the water with partial or complete treatment since it is related to particulate matter. There do not appear to be any trends in the data through time.

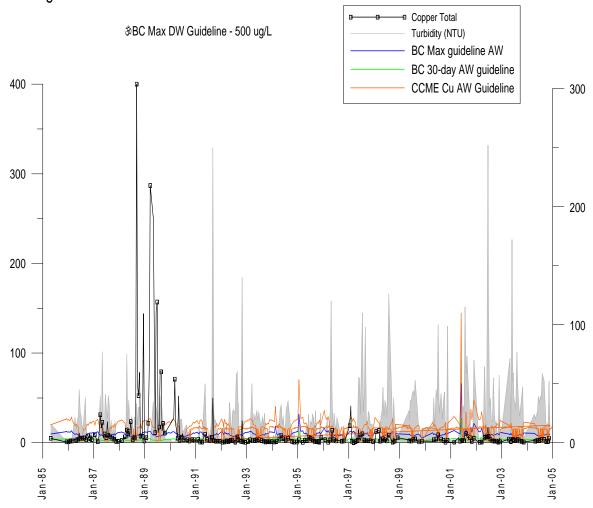
Fraser at Hansard Copper Total (ug/L) Figure 22

Copper (Figures 22 and 23): values regularly exceed the BC guidelines for 30-d mean concentrations but only on occasion exceed the guideline for maximum concentrations.

As well, values varied in relation to turbidity values, meaning that the higher copper values are likely in particulate form and not biologically available.

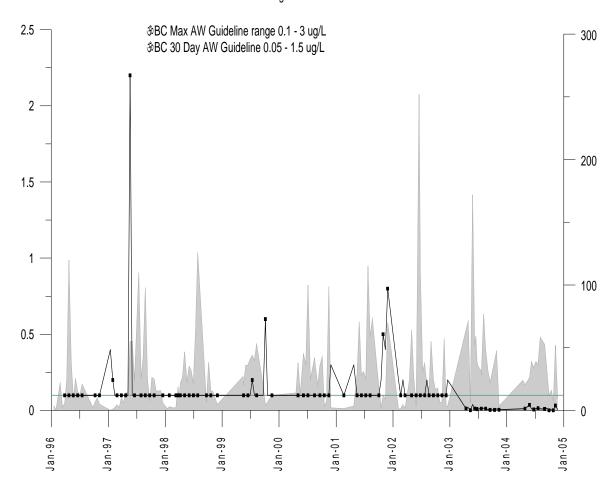
Fraser River at Hansard Silver Total (ug/L) Figure 56

Silver (Figure 56): values prior to 2003 on occasion exceeded the guideline that is at the former detection level. Since 2003 when detection levels were lowered, no values have exceeded the guideline. Values that were higher seemed to be correlated to higher turbidity values.
