# BIG BAR LANDSLIDE UPDATE

SEPTEMBER 24, 2019

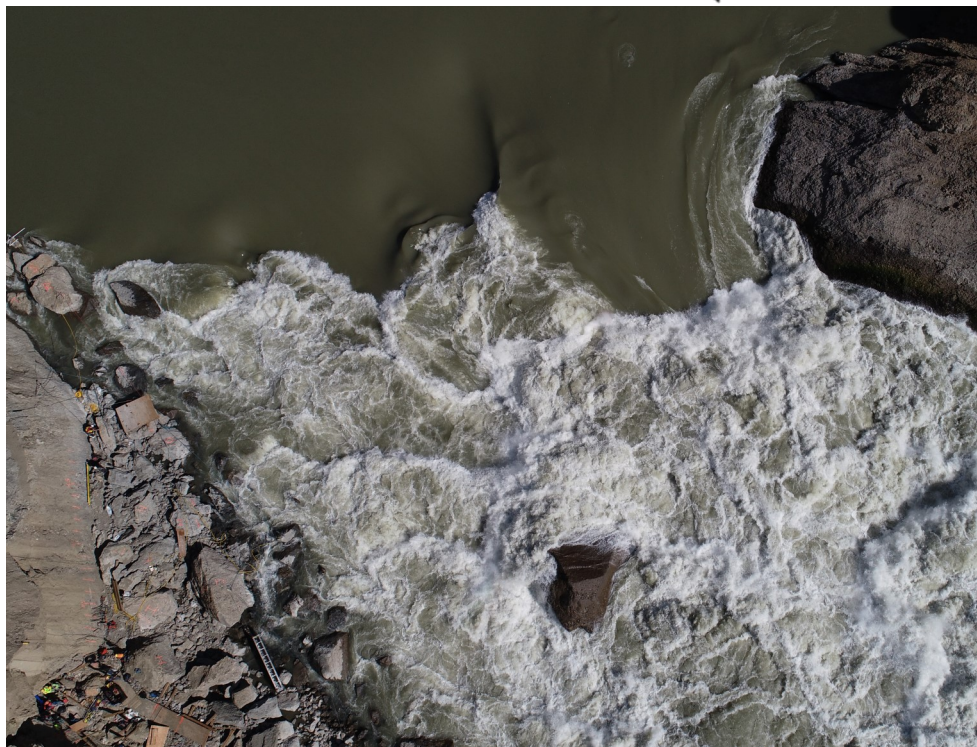
- An overhead shot, shown above, of the landslide on Sept. 19, 2019 shows the large boulder mid-river that rope technicians are currently working to access.
- Large excavators are being brought in and organized by the Advanced Planning Unit and Environmental Unit and will be mobilizing to site this week. These large machines will be winched down the bank in the same fashion as the spider excavator. These machines will be vital to long term operations at the base of the slide going forward.

- The spider excavator has successfully made its way to the base of the slide and is working to break up large rock.
- Due to high winds gusting to 50km/h scalers were not able to work all of yesterday and were pulled off mid afternoon.
- The current priority for scalers and rope technicians is installing anchors by drilling into the rocks on the east and west side of the river to allow a highline cable to be installed from the top of the west slope to the base of the east to improve crew and equipment access to water level. Additional anchors will also allow cross river highlines to be installed to allow crews to access, drill, and blast various mid river boulders as water levels drop.

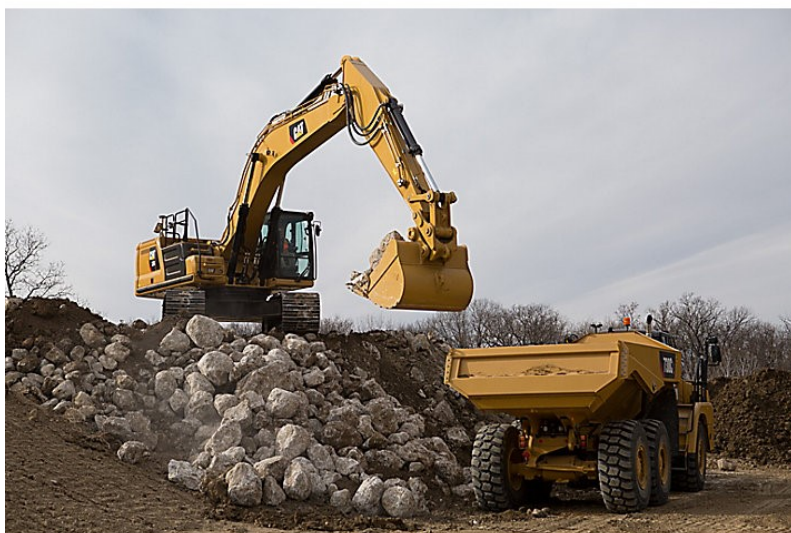
A Cat 336 excavator, as seen above, has an operating weight of 81,900 lbs and is capable of moving large amounts of debris. Image: cat.com
