Ministry of Environment Inspection Record

Environmental
Protection
Division

Inspection Number: 29087		Inspection Status: FINAL	
EP System: <u>AMS</u>		Inspection Date: 2016-09-26	
EP System Number: 108371		EP System Status: <u>Active</u>	
Region: <u>Okanagan</u>		Office: <u>Penticton</u>	
Trigger: <u>Planned</u>		Incidents of Non-Compliance Observed: <u>No</u>	
Non-Compliance Decision Matrix Level: <u>Level 0</u>		Non-Compliance Decision Matrix Category: <u>Category 0</u>	
Inspector Name(s): Devan Oldfield		CPIX: <u>0 to 1 = Low</u>	
Audit:		Total Non-Compliance(s): 0	
Regulated Party: Darlene R Huxley			
Regulated Party Contact(s): Ken Huxley			
Legal Address: 2148 Pyott Road Armstrong, BC V0E 1B4			
Phone No: (250)546-6296		Fax No:	
Contact Email: <u>kenhuxley@telus.net</u>			
Location Description or Site Address: 2148 Pyott Road Armstrong, BC V0E 1B4			
Latitude: 50.536705 N		Longitude: 119.217207 W	
Receiving Environment(s): <u>Groundwater & Land</u>

Authorization: 108371	Ken and Darlene Huxley
CVIS IR #: 29087	July 13, 2016

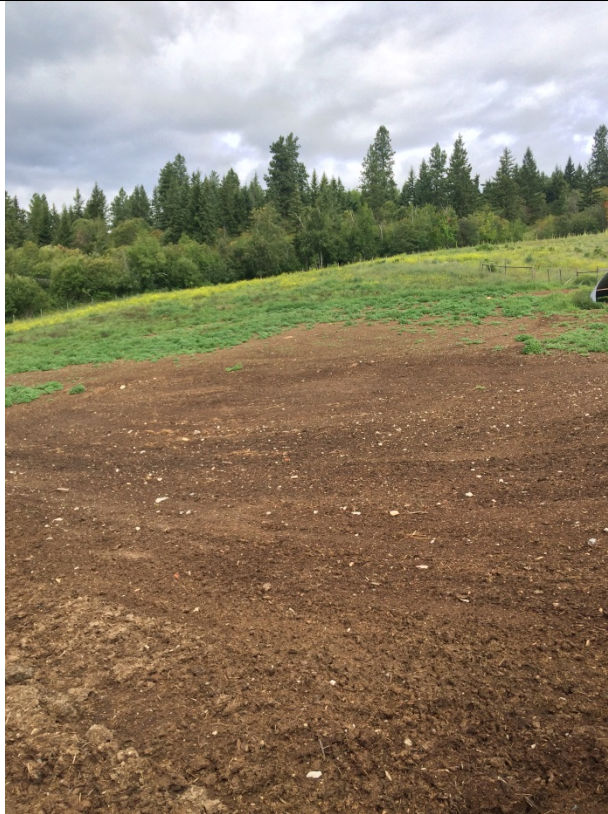
Photo 1

Location of historic manure field storage and future permanent manure storage.

Photo facing northwest from west end of barn.

During the site visit on July 13, 2016, no field manure storage was observed. Historically, all winter manure was stored in the field to the immediate west of the barn (photo 1). Ken Huxley informed me that a permanent storage facility will be constructed in this area and it would be used going forward in place of field storage.

During the site visit on July 13, 2016, no field manure storage was observed. Historically, all winter manure was stored in the field to the immediate west of the barn (photo 1). Ken Huxley informed me that a permanent storage facility will be constructed in this area and it would be used going forward.

During the site visit on July 13, 2016, no manure storage was observed. During the summer season, the cattle are grazing the fields and no manure stockpile is generated (i.e. it is spread as it is generated). Historically, all winter manure was stored in the field to the immediate west of the barn (photo 1). Ken Huxley informed me that a permanent storage facility will be constructed in this area and it would be used going forward.

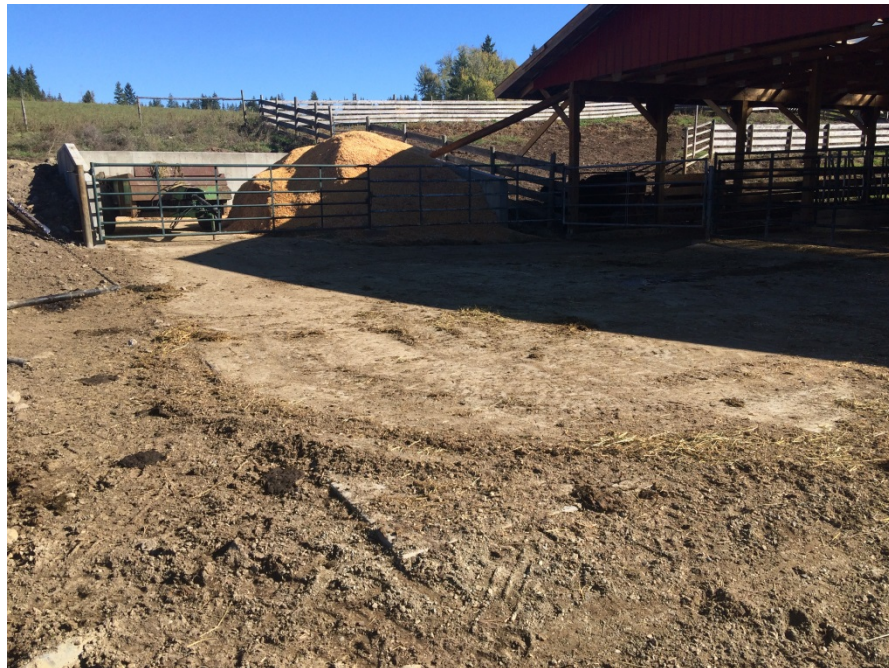
Photo 2

Permanent manure storage facility with concrete pad in front. Storage facility used for the winter months.

Photo facing north from southwestern corner of the concrete pad.

An inspection conducted on September 26, 2016 verified the construction of the permanent manure storage facility as well as verifying its volume was adequate to hold all the winter manure as well as precipitation.

An inspection conducted on September 26, 2016 verified the completion of the permanent manure storage facility as well as its ability to store the required volumes defined in the Manure and Nutrient Management Plan.

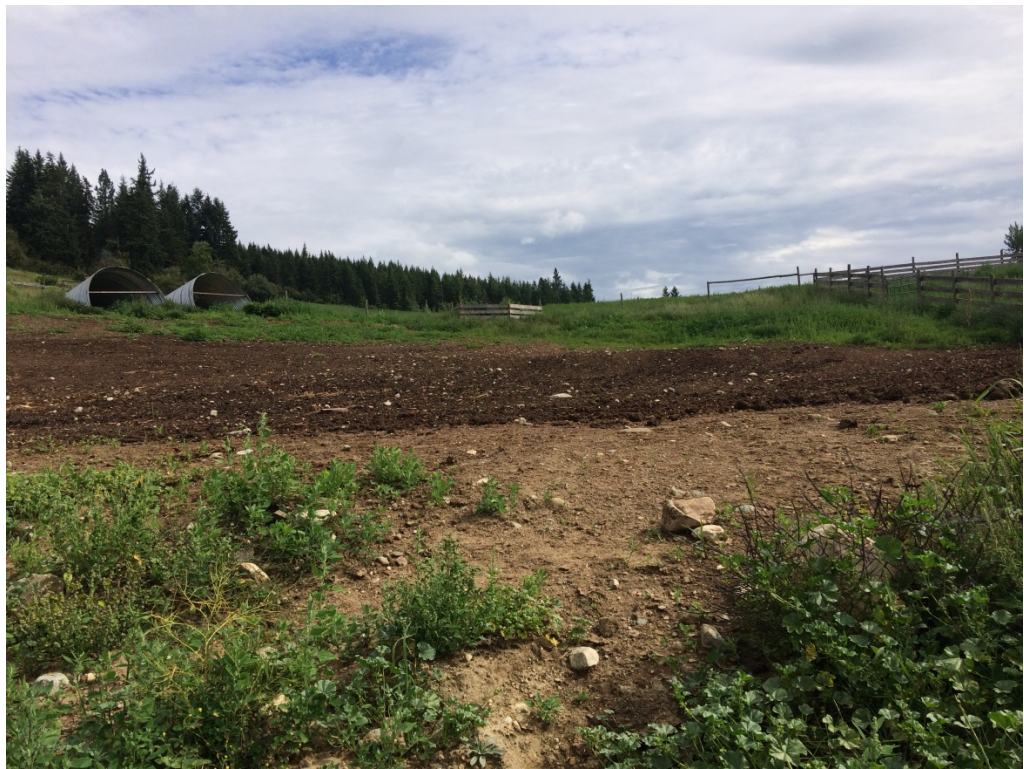
Photo 3

Location of future permanent manure storage.

Underground drainage culvert is situated along a top to bottom (photo) orientation along the middle of the photo.

Photo taken facing north northwest at west end of barn.

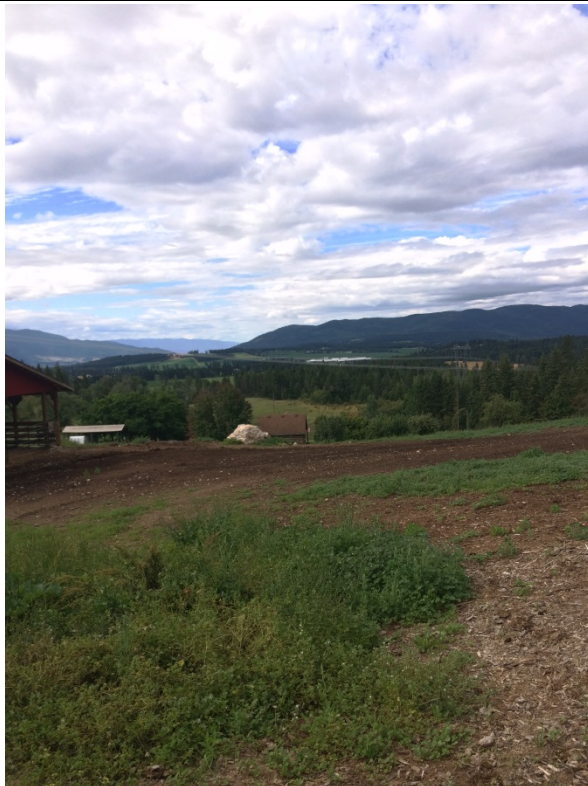
Photo 4

Underground drainage culvert travels bottom to top along centre line of photo. Boulder (photo centre) marks the approximate location of the culvert discharge.

Photo taken facing south southeast near west end of barn where culvert opening is found.

The Manure and Nutrient Management report identified an occasional (1 in 5 year) runoff channel through the winter feed field. Mr. Huxley had recently (2014) constructed a drainage management structure to divert this runoff away from his field manure storage area. Another measure used to control runoff is the construction of a permanent storage facility to hold the winter manure, secured against contact with runoff.
