## Sullivan Reclamation Site Accident Timeline

## *May 15 to 20, 2006*

### Independent Air and Water Quality Sampling and Measurements

The investigation into the four tragic fatalities at the decommissioned Sullivan Mine on May 15 and 17, 2006 showed that the incident was caused by oxygen-depleted air displacing ambient air inside a shed. Oxygen-depleted air produces no warning symptoms, such as dizziness. The oxygen concentration inside the shed was approximately 2%. At oxygen concentrations below 6%, two breaths can cause a person to lose consciousness, with death following within minutes (EIGA, 2003).

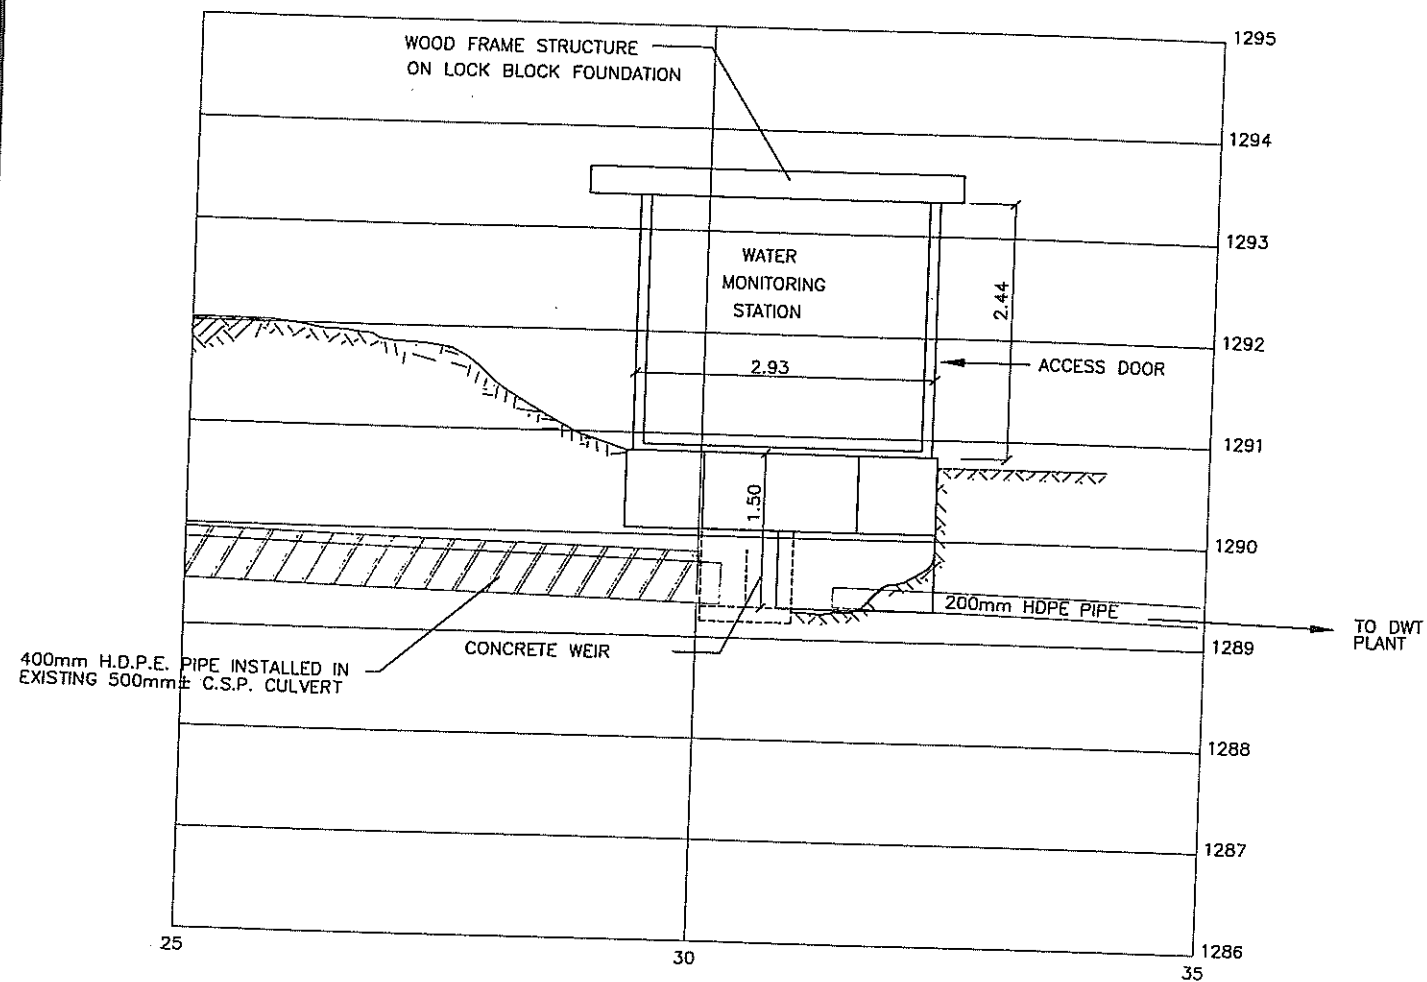
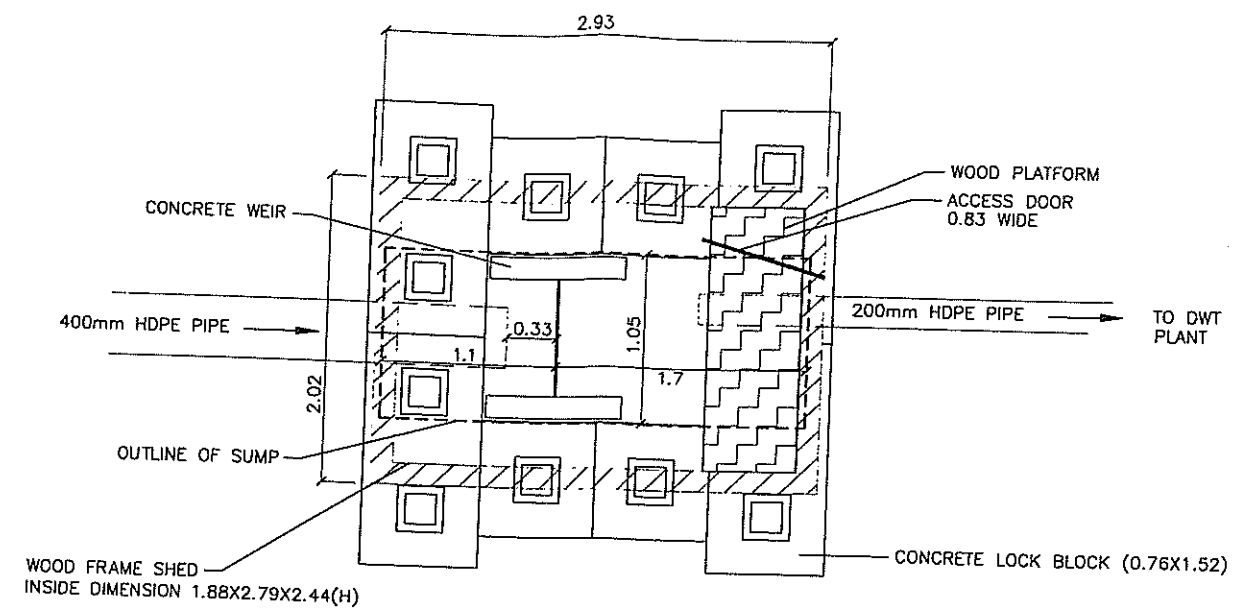
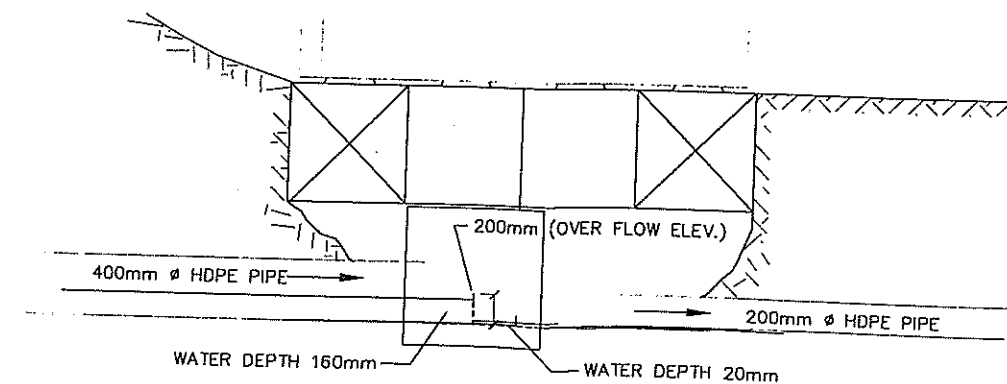
K100A3196

WEST FACE  
SEE DRAWING K100A3193R1

OVERHEAD VIEW

WEIR DETAIL

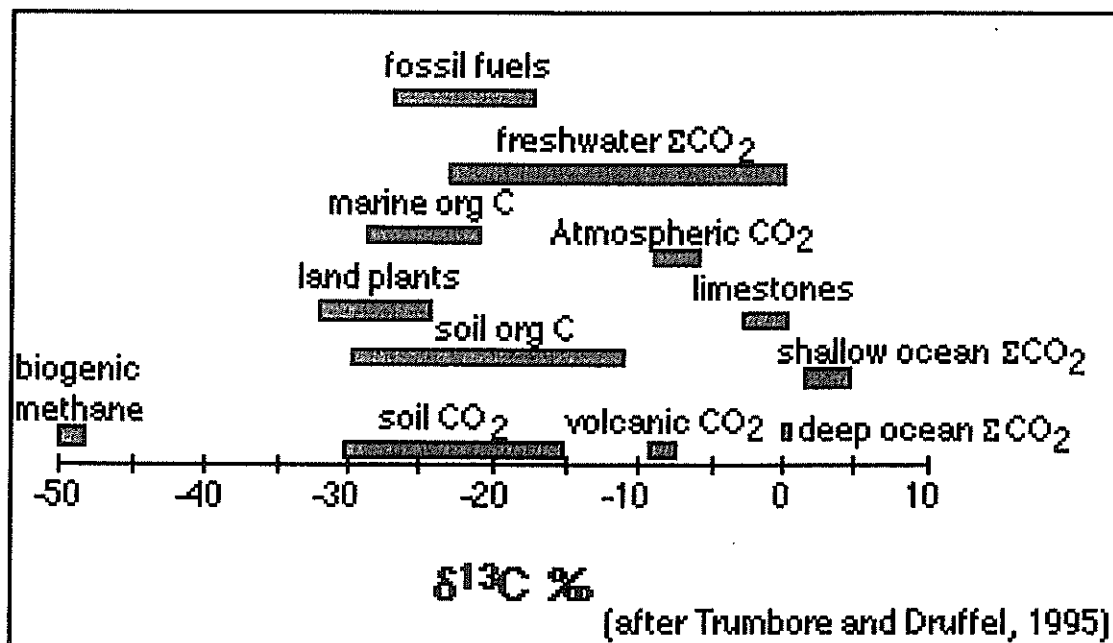
Figure 1.  $^{13}\text{C}/^{12}\text{C}$  ratios are expressed relative to a standard as  $\delta^{13}\text{C}$  values,

Trumbore & Druffel, (1995) have given the isotopic range of different sources of carbon as shown in Figure 1.

Note that limestones show the least shift (with  $\delta^{13}\text{C}$  ranging from 0 to -4) while organic carbon, on the contrary, is distinguished by a comparatively large shift (from -15 to -30, in most cases). This bimodal distribution of carbon isotopic ratios provides a valuable tool to distinguish between organic and inorganic sources of carbon. (Kump, 1991, Kwon & Schnoor, 1994, Trumbore & Truffel, 1995).

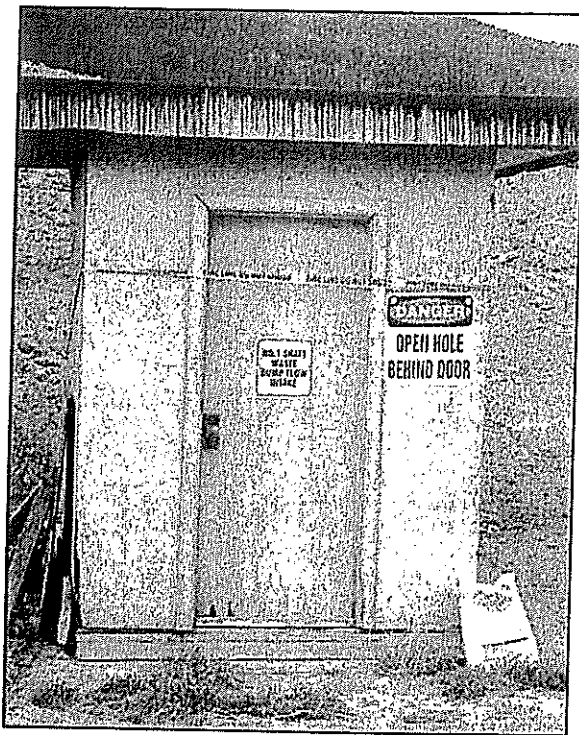
**Plate 1-1** The shed at the decommissioned Sullivan Mine where the asphyxiation deaths of four people occurred on May 14 and 16, 2006.

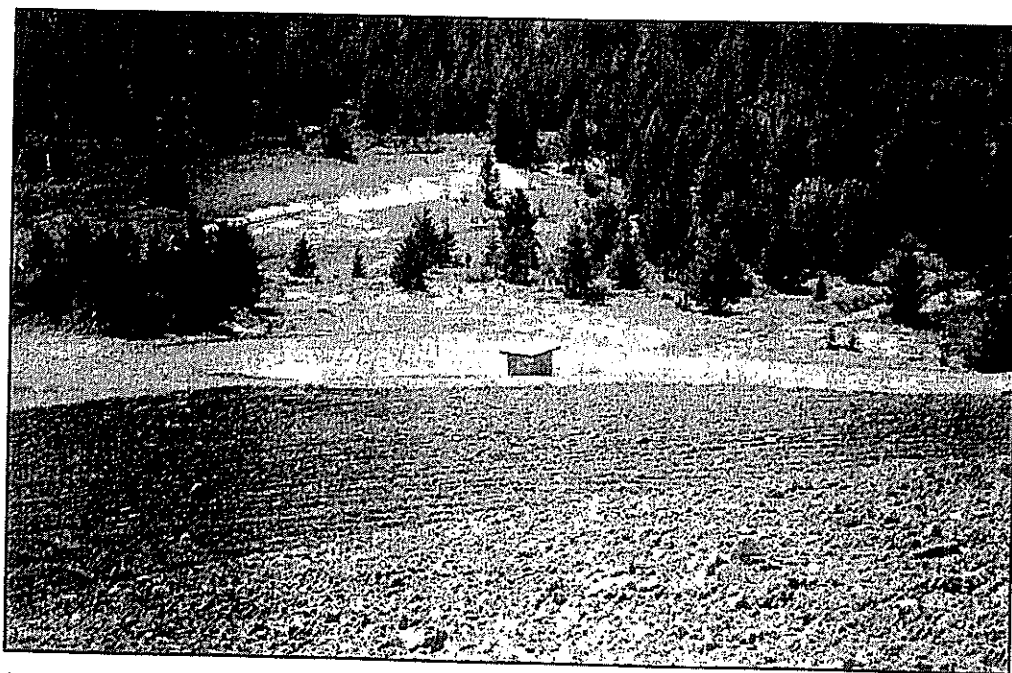
**Plate 1-2** The shed where the fatalities occurred, situated at the toe of the reclaimed waste rock pile.

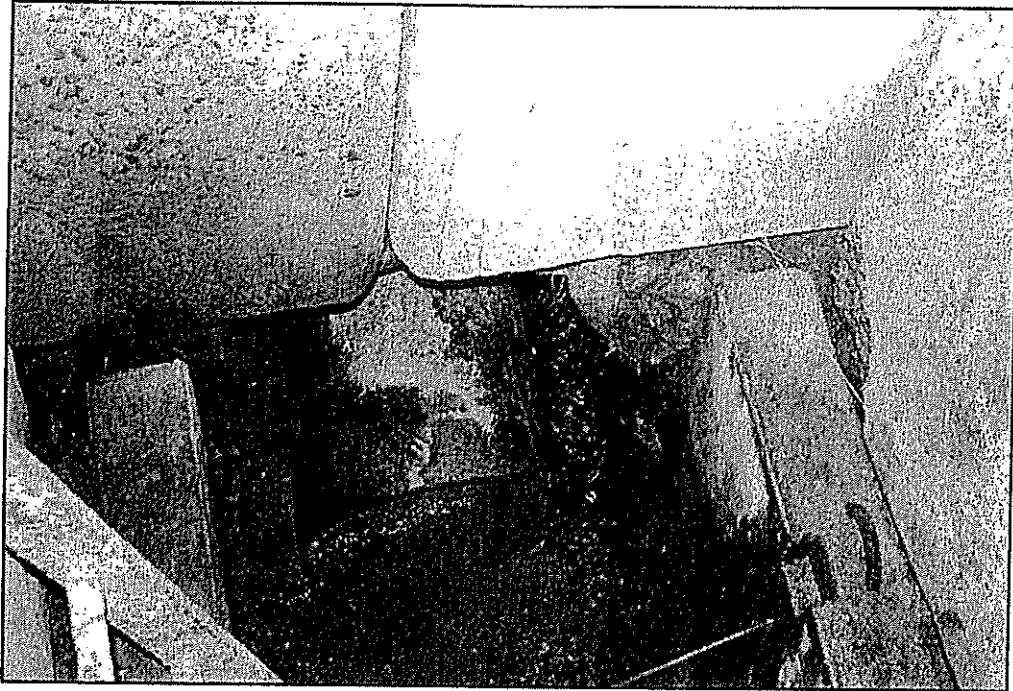
**Plate 1-3** A PVC pipe at the bottom of the sump inside the shed. The pipe, which was the conduit for exhausting the oxygen-depleted air, is installed in a culvert (not pictured) that drains waste rock seepage to the sump.

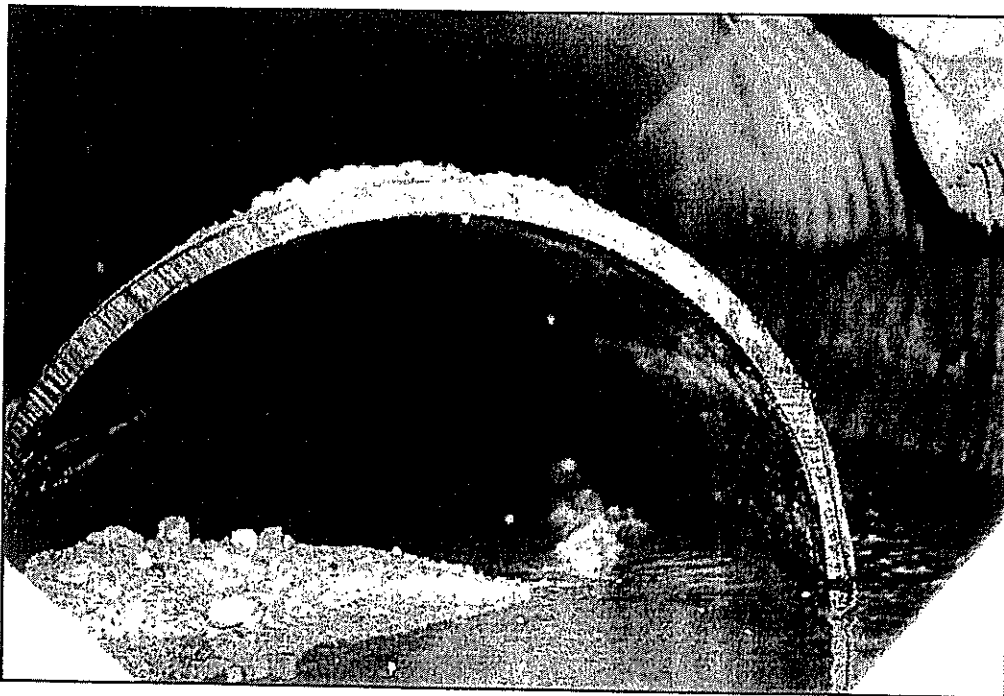
**Plate 1-4** End view of the partially sanded PVC pipe at the bottom of the sump; the culvert leading into the bottom of the waste rock pile surrounds the pipe.

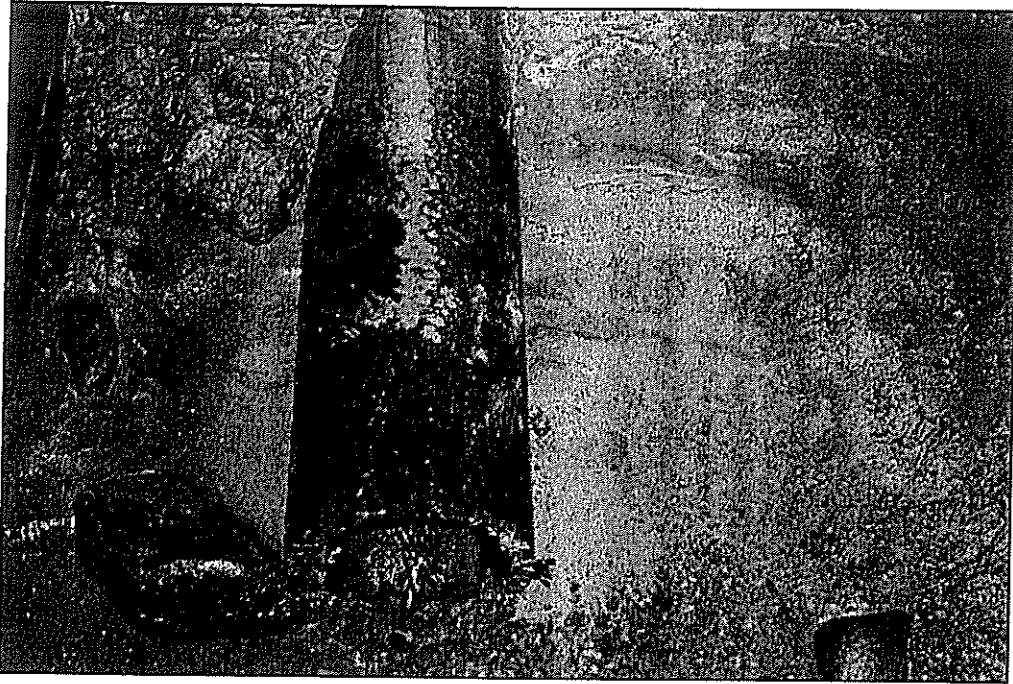
**Plate 1-5** The outflow pipe at the bottom of the sump.

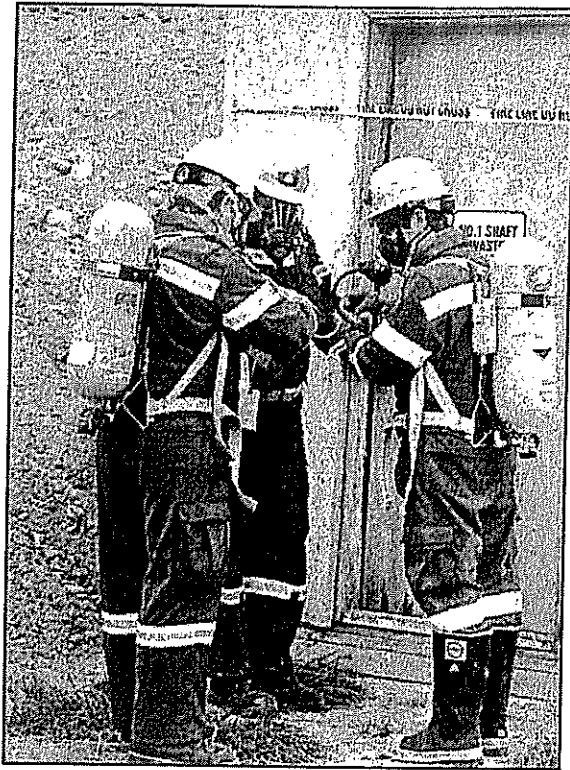
Plate 2-1 Teck Cominco HazMat team members collecting air quality samples from the shed at the Sullivan Mine (8:00 AM, May 20, 2006)

1. **Near the ceiling of the shed:** The door to the shed was opened just enough to allow the HazMat team members to fit the stainless steel sample tube over the top of the door to collect an air sample near the ceiling of the shed (Plate 2-1).
2. **Inside the pipe draining into the sump:** HazMat team members climbed into the sump wearing SCBA and collected the air sample.
3. **At grade inside the sump.**
4. **At the floor level inside the shed.**
5. **At the Sullivan Mine 3900 level portal sump shed.**

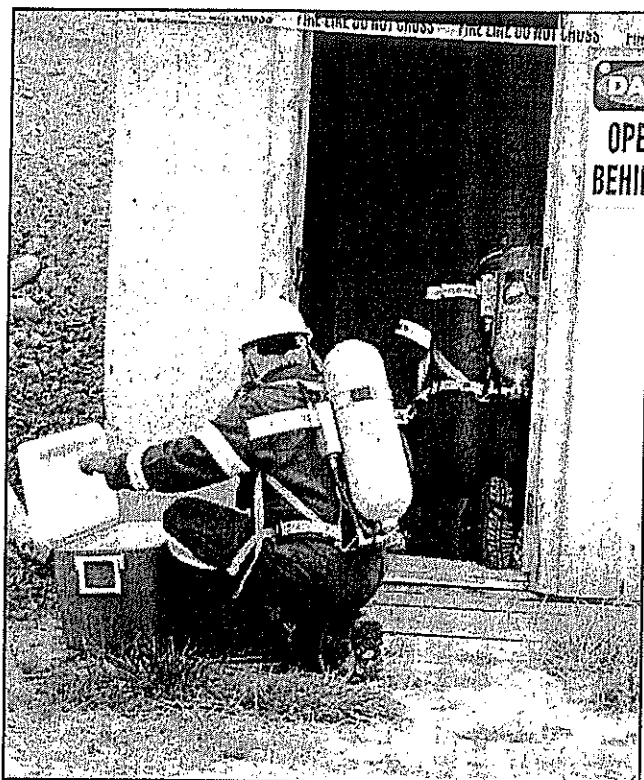
**Plate 2-2 Teck Cominco HazMat team members collecting water samples from the shed at the Sullivan Mine on May 20, 2006**

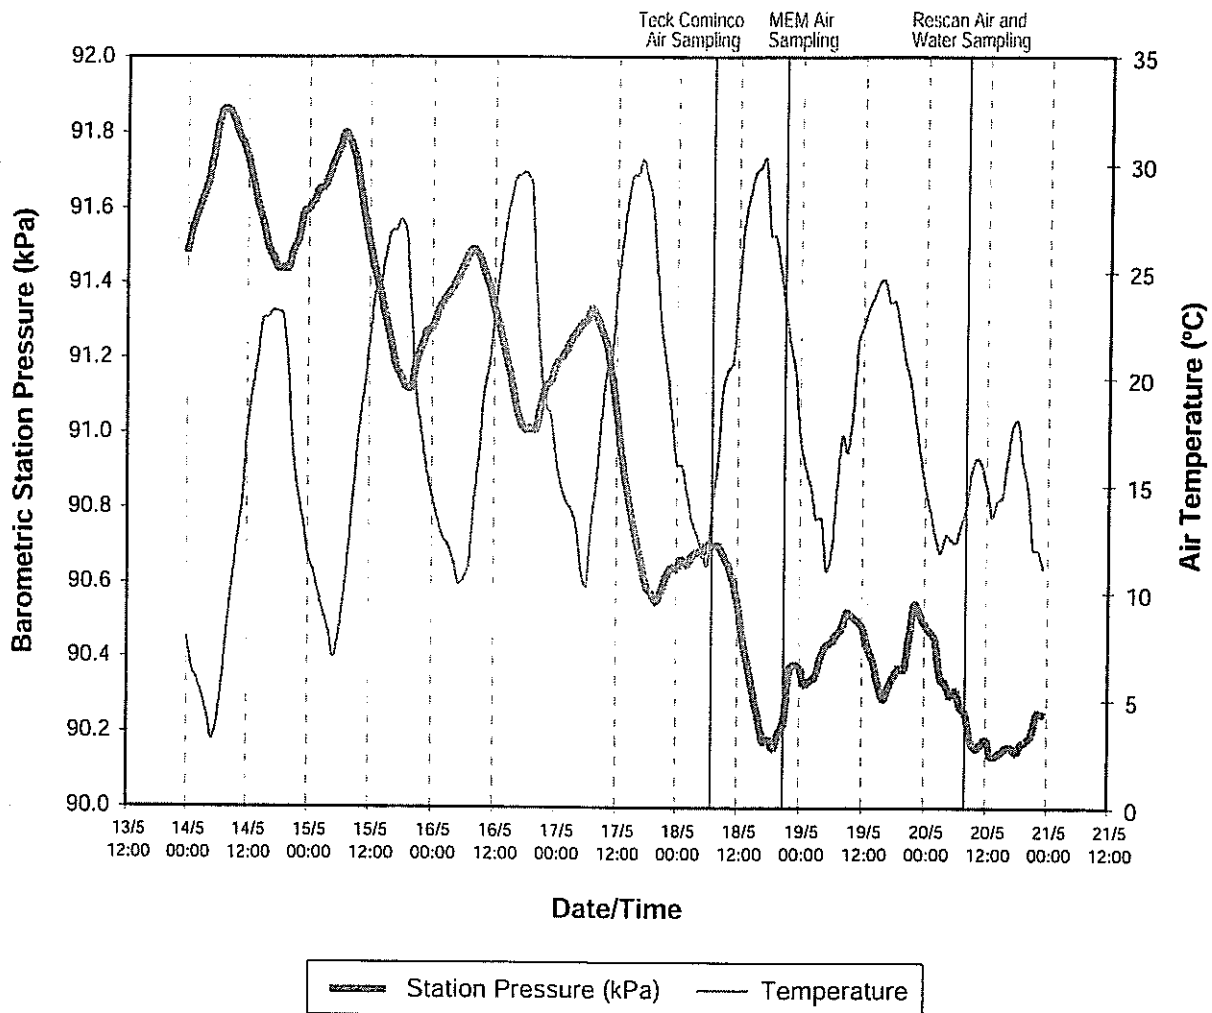
FIGURE 4-1

From May 14 to May 19, there were distinct diurnal fluctuations in temperature and barometric pressure, with an overall trend of decreasing barometric pressure and increasing temperature. Starting at approximately 8:00 AM, the air temperature would start to increase, causing the barometric pressure to drop. This trend would last until sunset – between 7:00 PM and 8:00 PM – when the trend would slowly reverse (decreasing air temperature and increasing pressure). This hypothesis is supported by the airflow measurements taken in the pipe from the rock pile. The flows in the pipe in the evening were approximately double the flows in the morning. The ambient temperature during the daytime hours was generally well above the temperature of the air flowing from the waste rock pile (9°C).

Hourly Temperature and Barometric Pressure  
at Cranbrook Airport, May 14 to 21, 2006

Records of barometric pressure and air temperature are not available for Kimberly for May 2006. However, barometric pressure measured and recorded hourly at Cranbrook Airport, located approximately 30 km southeast of Kimberly was available. Figure 4-1 shows hourly barometric pressure and air temperature at Cranbrook Airport between May 14 and 21, 2006.

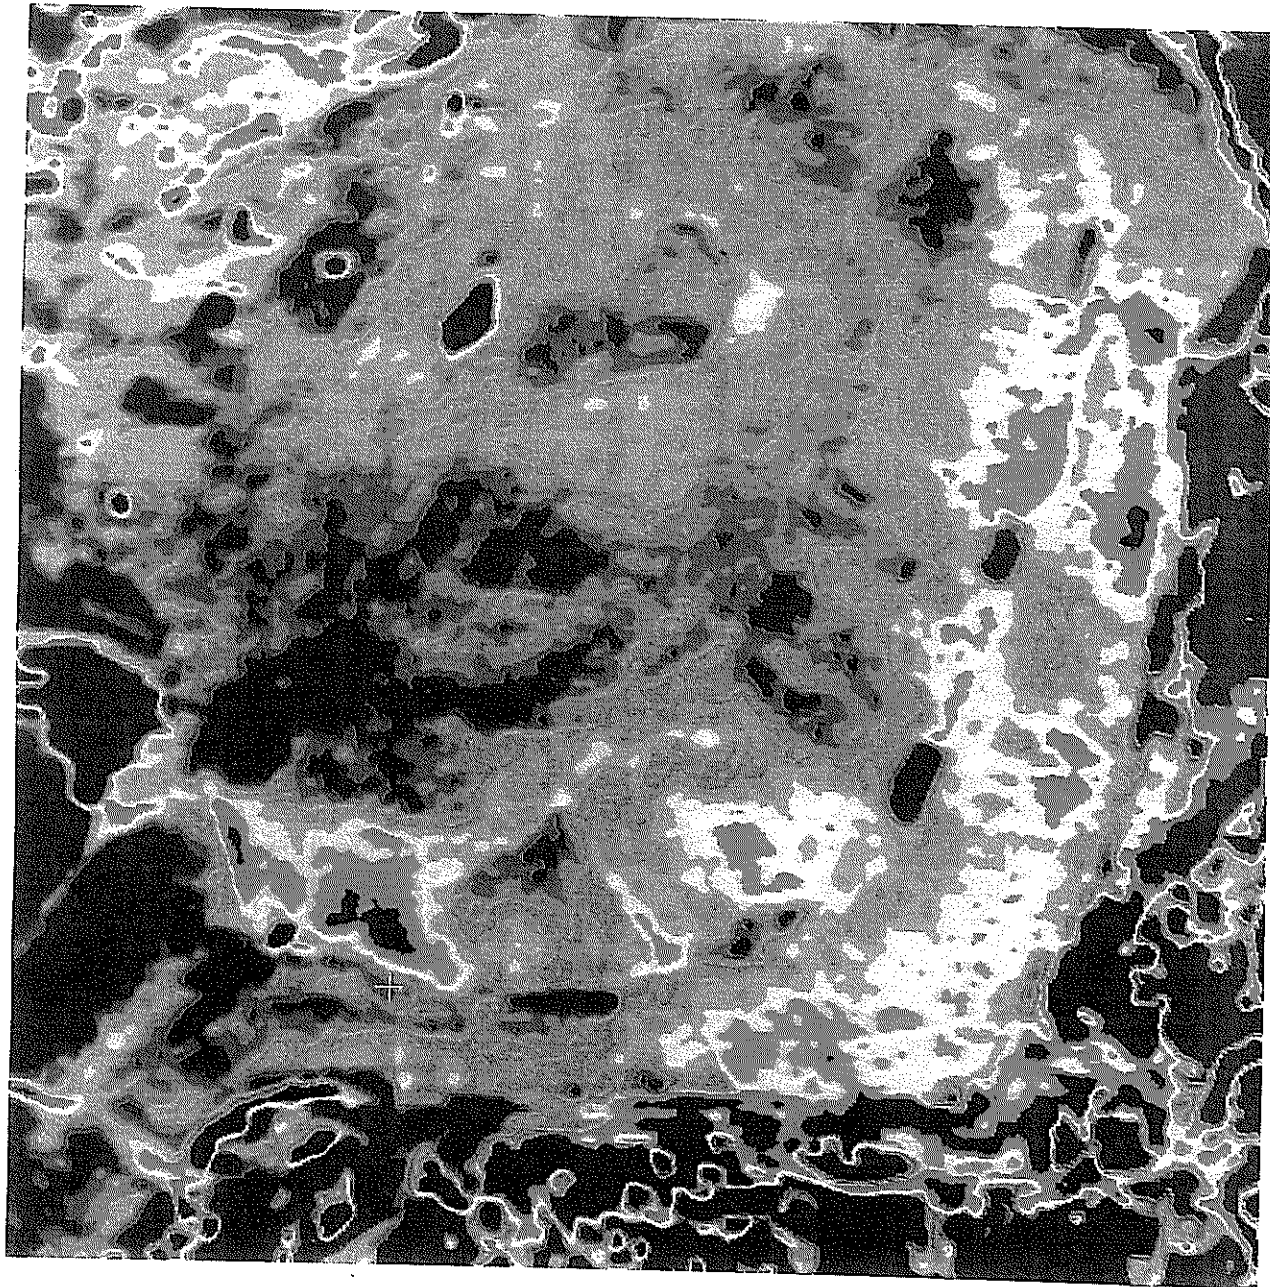
**Sullivan No. 1 Waste Dump  
Long-wave Thermal IR  
Image, May 30th, 2006.**

Figure 2. Calibrated surface temperatures from Long Wave Thermal Infra-red flight data acquired just after sunset. Black areas within red areas slightly exceed  $6^{\circ}\text{C}$  while black within blue represents slightly less than  $5^{\circ}\text{C}$ . Temperature range across the entire scene is about  $2^{\circ}\text{C}$ . Generally, warmest areas are on the lower flanks of the dump, perhaps reflecting moisture content in the till or elevation differences.

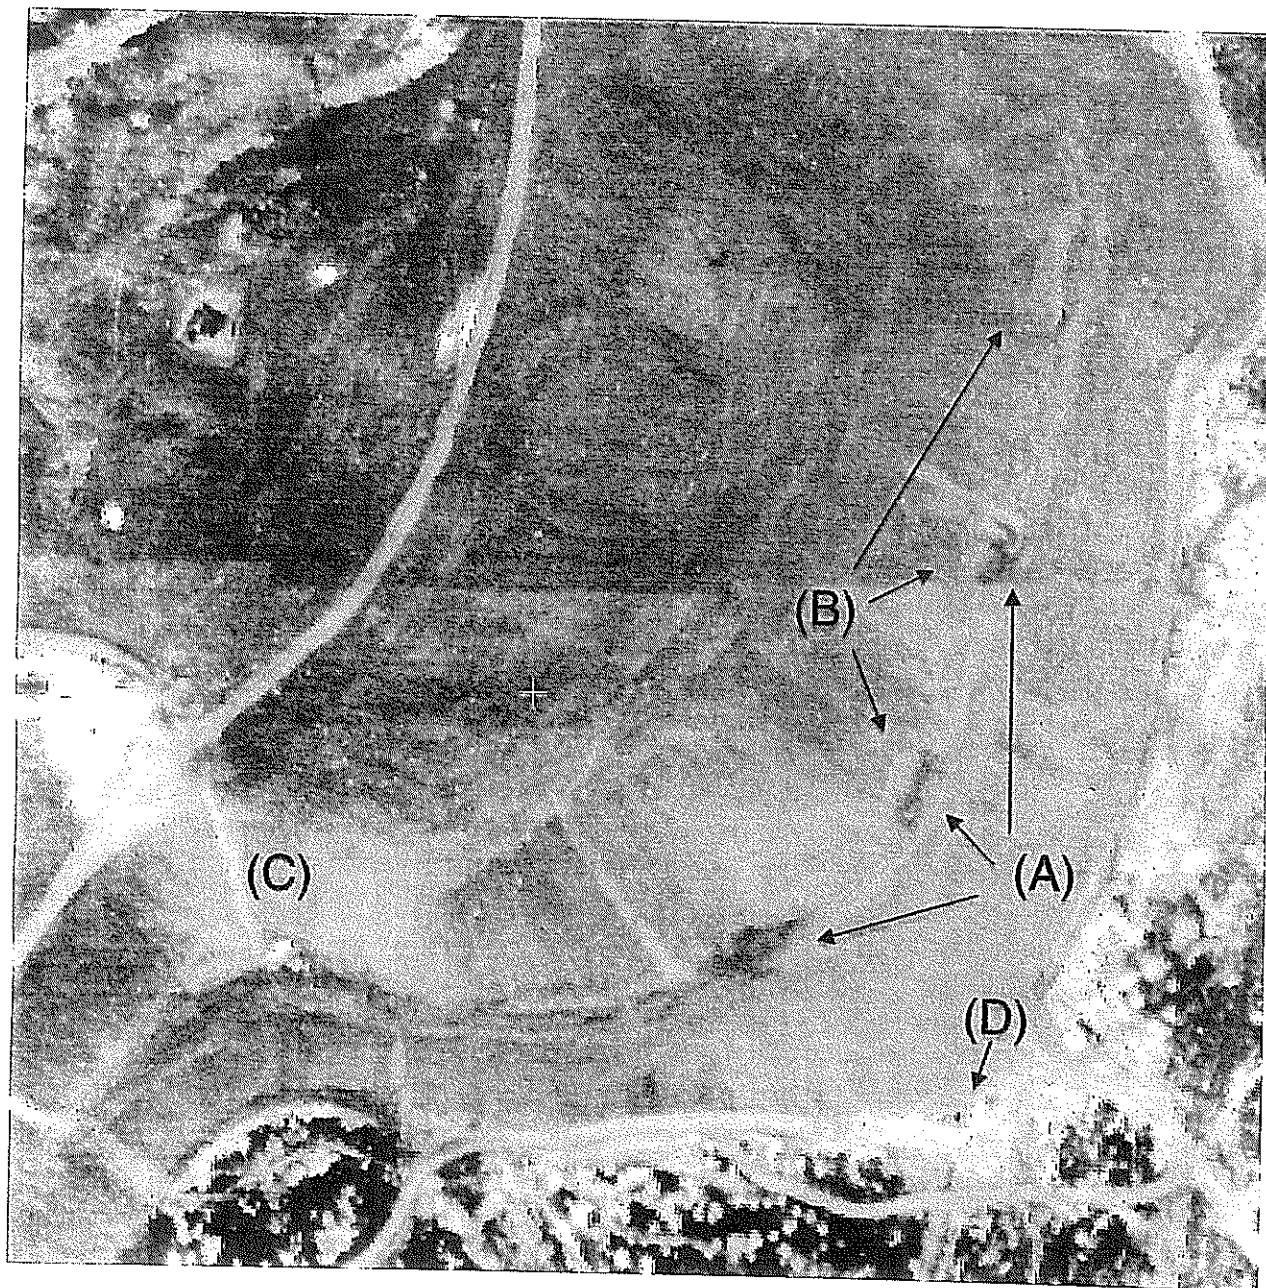
**Sullivan No. 1 Waste Dump  
Evening Mid-wave Thermal  
IR Image, May 30<sup>th</sup>, 2006.**

Figure 3. The till covering the dump appears homogeneous. Dark cool areas (A) at the base of the steep slope are probably due to moisture. Immediately above these patches (B), the till is very slightly warmer than surrounding material. These lighter, warm areas show clearly in the scene taken the next morning. The steep slope (C) just to the east of the main portal is the warmest area on the dump during the day time. The shed where the accidents occurred is the small dark square on the southeast flank of the dump (D). Also apparent on the image are the lighter drainages, or erosional channels that cut down the steep slope. The jagged horizontal line across the middle of the image is the "seam" where 2 flight lines have been joined together.

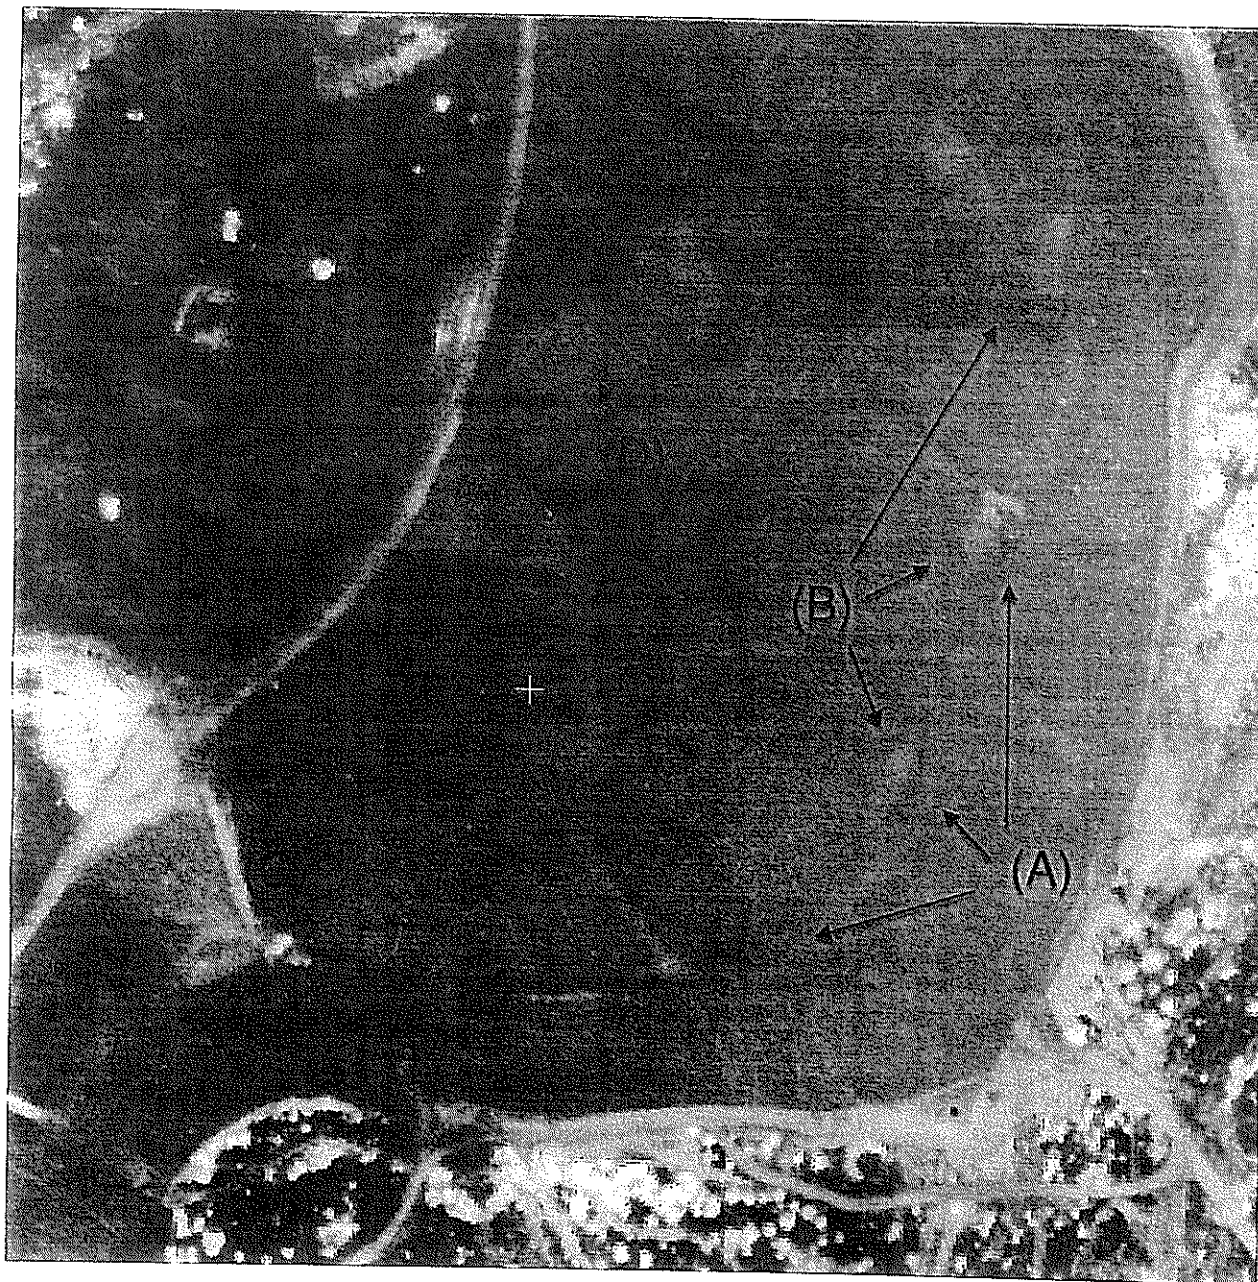
**Sullivan No. 1 Waste Dump  
Morning Mid-wave Thermal  
IR Image, May 31st, 2006.**

Figure 4. This mid-wave thermal image was acquired just before sunrise, about 6 hours after the evening image. The images are quite different, and the difference between them (Figure 5) can be used to determine the thermal inertia characteristics of different materials on the ground. In the morning image, the light, relatively warmer areas (B) at the base of the slope are now more pronounced than the darker areas (A) that showed up well on the evening shot. The slope at (C) has remained lighter than the surrounding till and two new warm spots (D) are now evident. These new anomalies are on the highest part of the dump where it is flat and probably represent moisture in the till where it collects runoff from the road. This image shows all of the major areas that should be field checked.

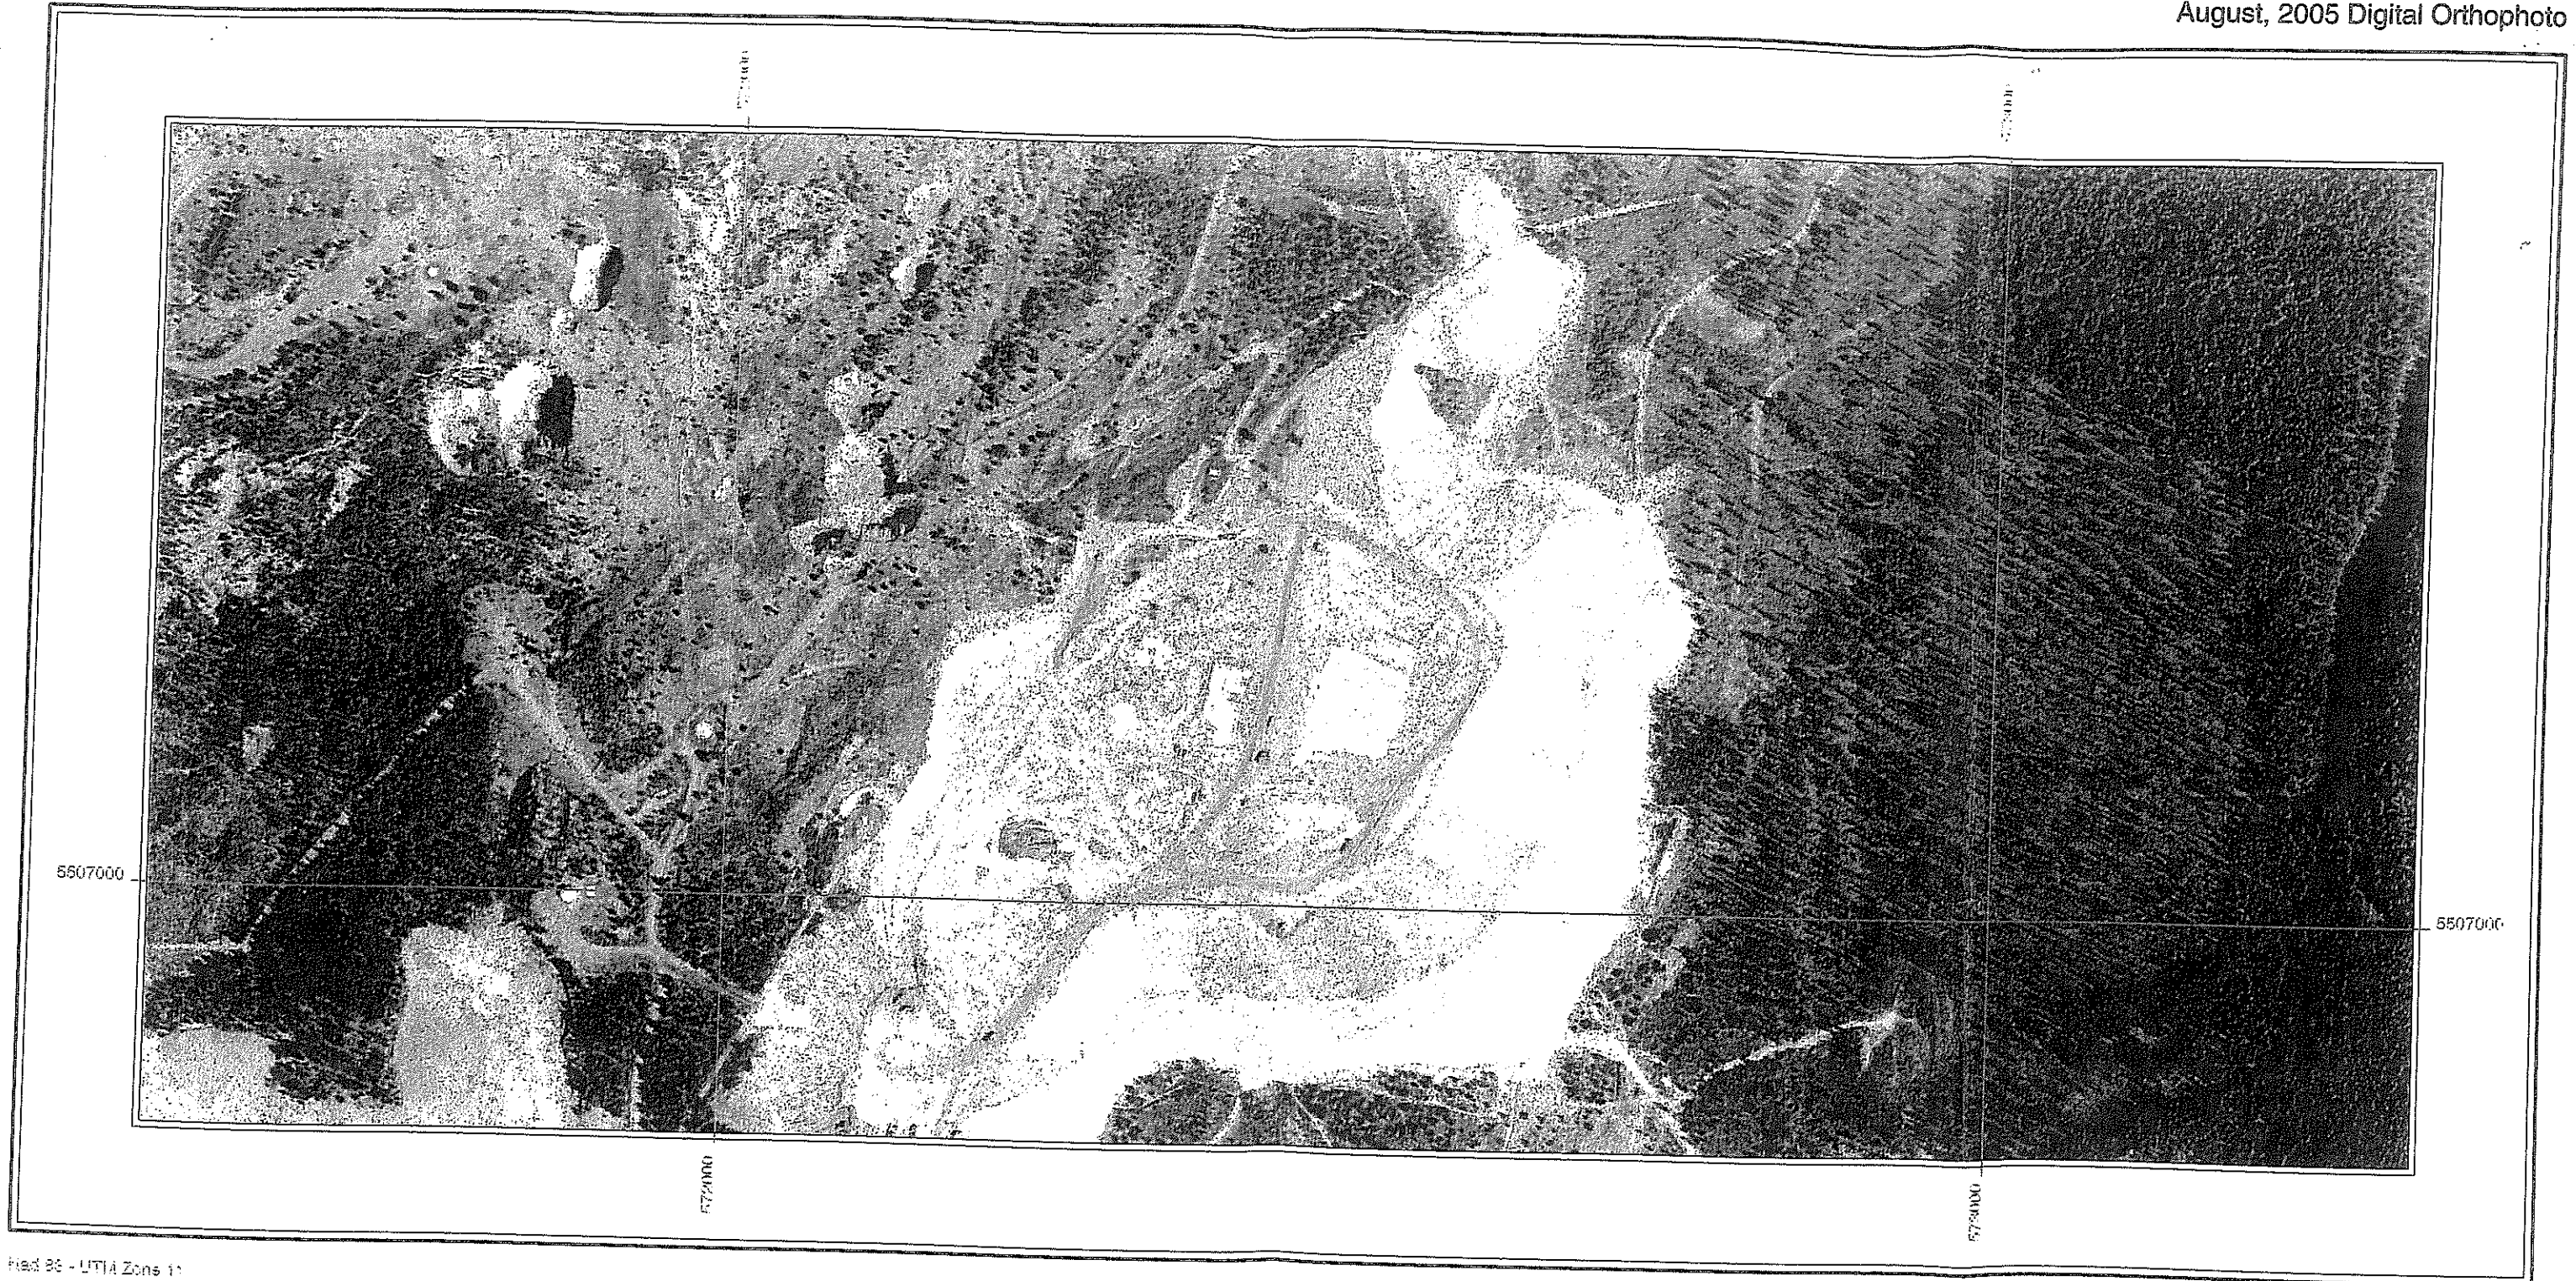
# Sullivan Mine No. 1 Waste Dump

August, 2005 Digital Orthophoto

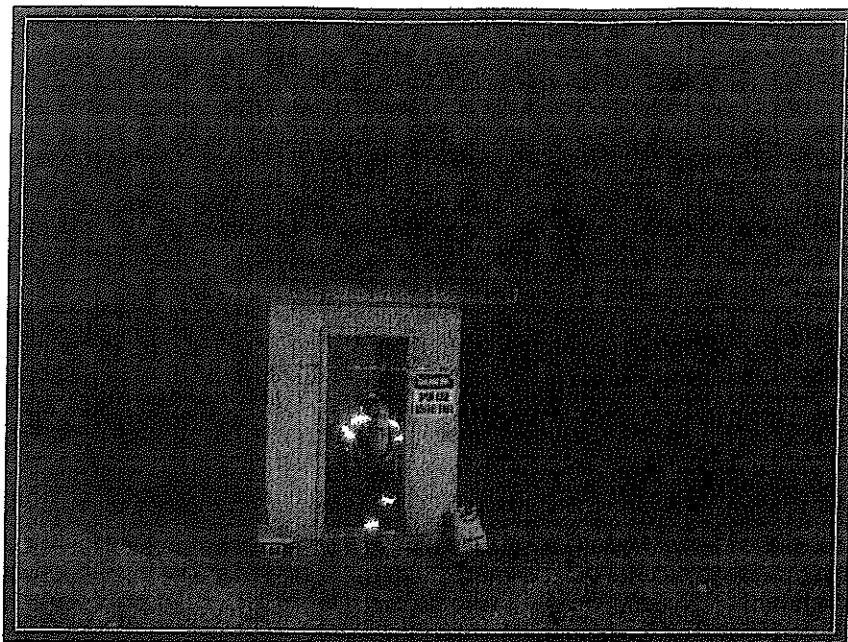
Figure 1 Team member enters the water monitoring shed.

A photograph showing a member of the HAZMAT team entering the sampling shed is shown in Figure 1 below:

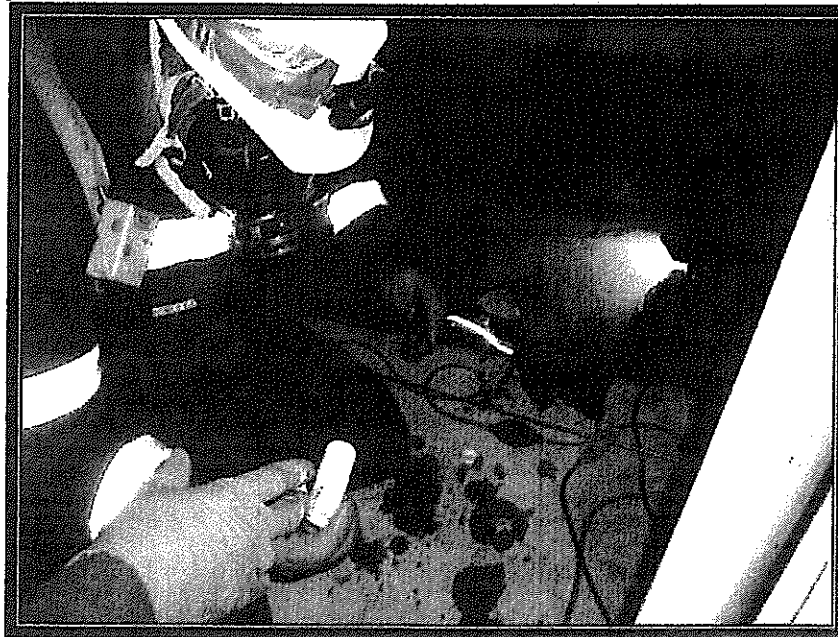
Water samples were also collected from the inlet pipe at the bottom of the shed sump as shown in Figure 2.
