# Cobble Hill Holdings Ltd.

**RE: Spill Prevention Order MO1701**

The enclosed binder presents information compiled from various sources specific to PART A: Final Closure bullet number 3 in the amended Spill Prevention Order: MO1701 issued March 15, 2017 for the 460 Stebbings Road Lot 23 Cobble Hill Holding's Ltd. (CHH) site (the "Facility").

## Cell 1 Phase A

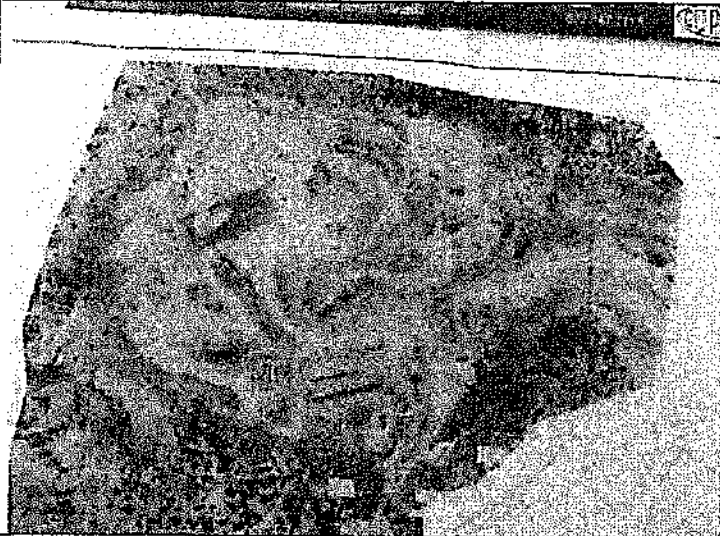
The Encapsulation Cell 1 westward expansion is the triangle indicated by the blue arrow. North is to the right.

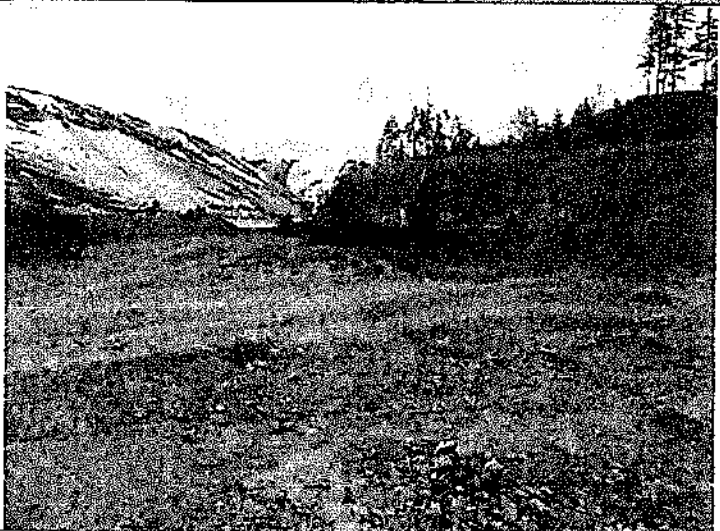
The expansion area, looking south

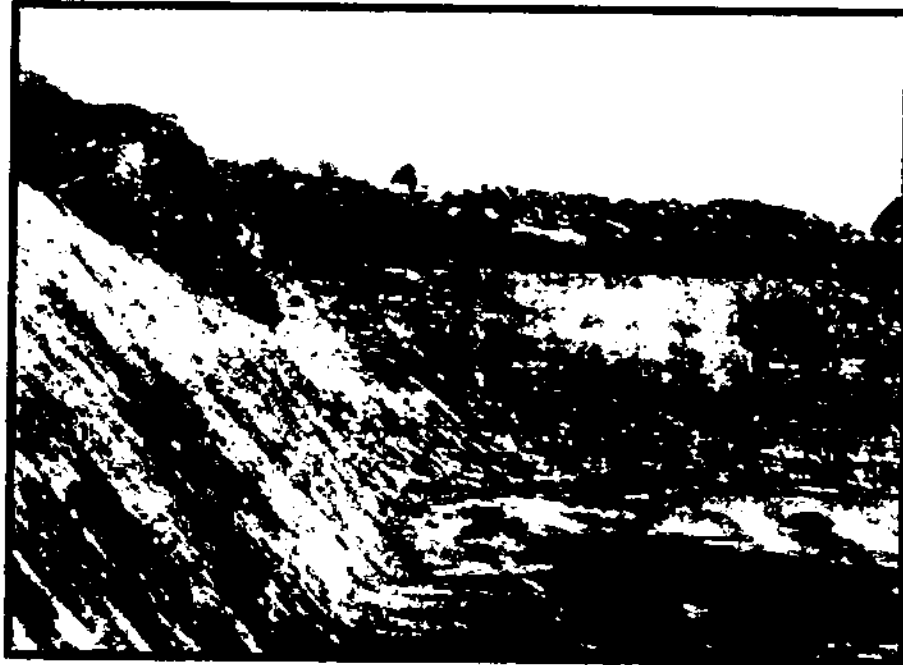
Photo 1 – Looking south at clay berms

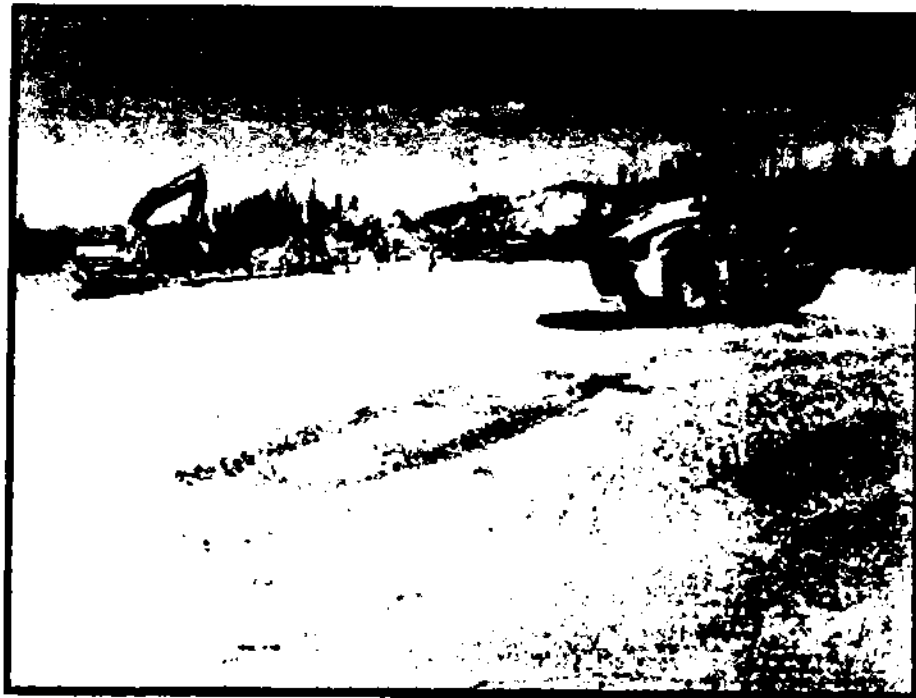
Photo 3 – Base sand surface being prepared for liner deployment

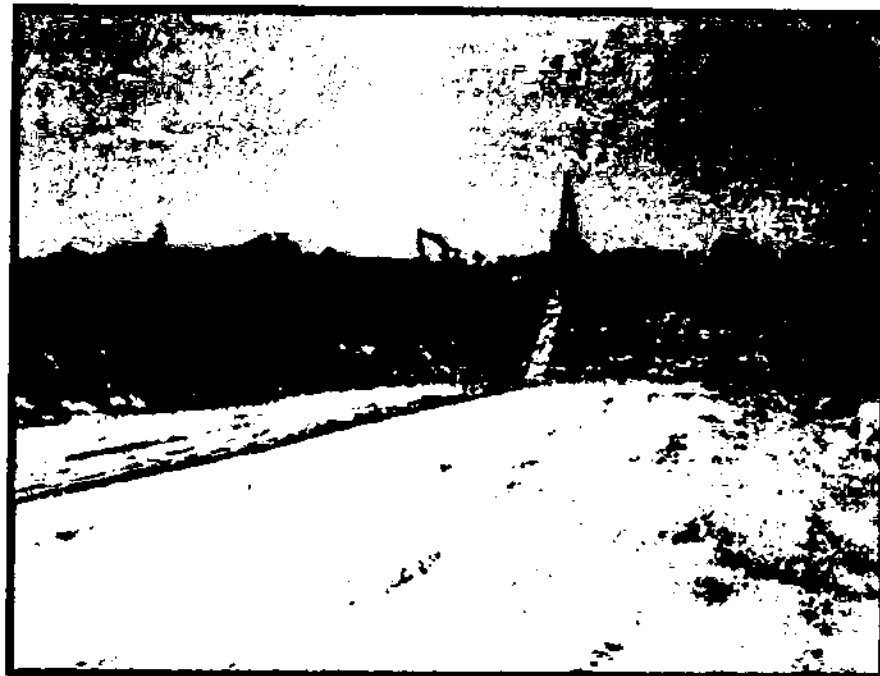
Photo 4 – Liner deployment

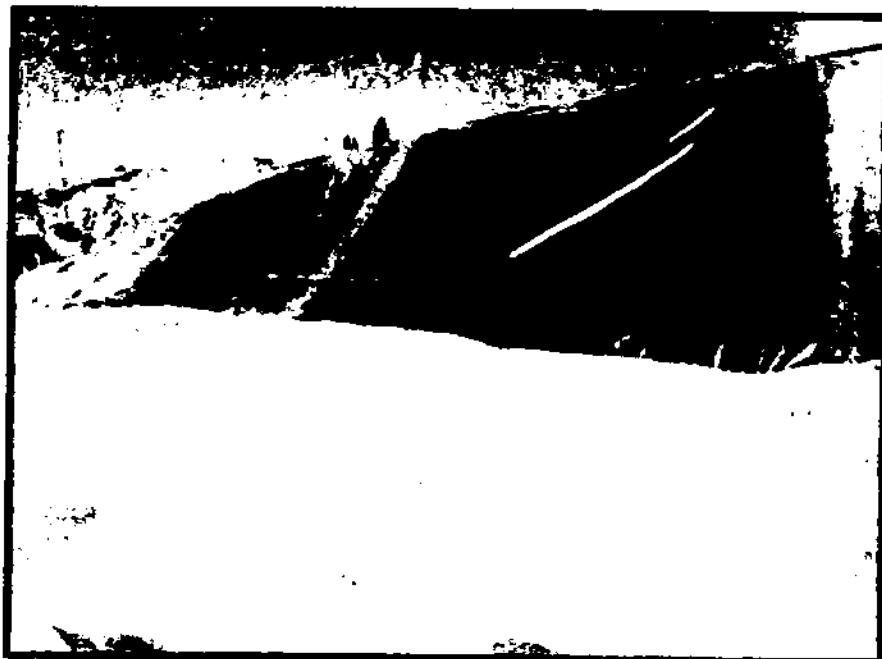
Photo 6 – Looking East at completed Cell 1 berm

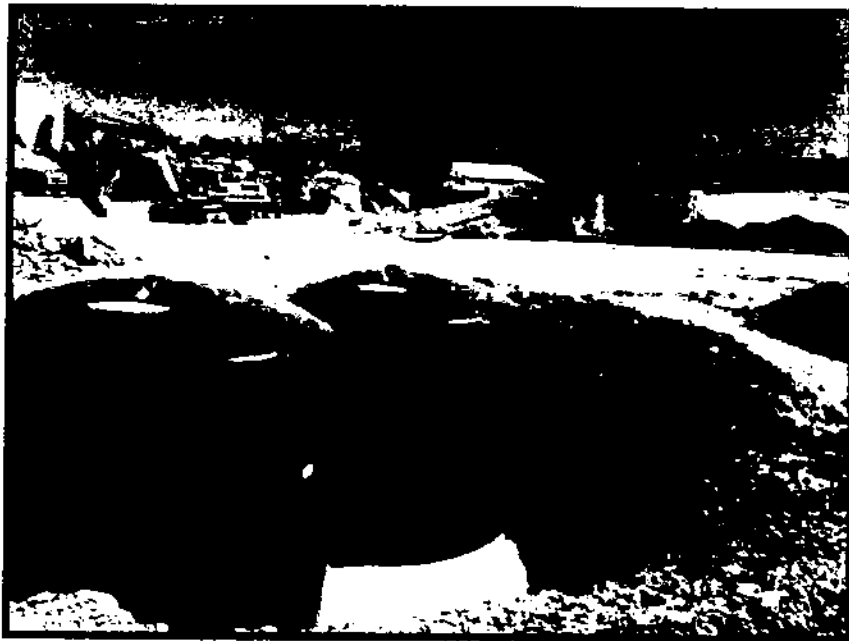
Photo 7 – Leak Detection and Leachate Collection Tanks

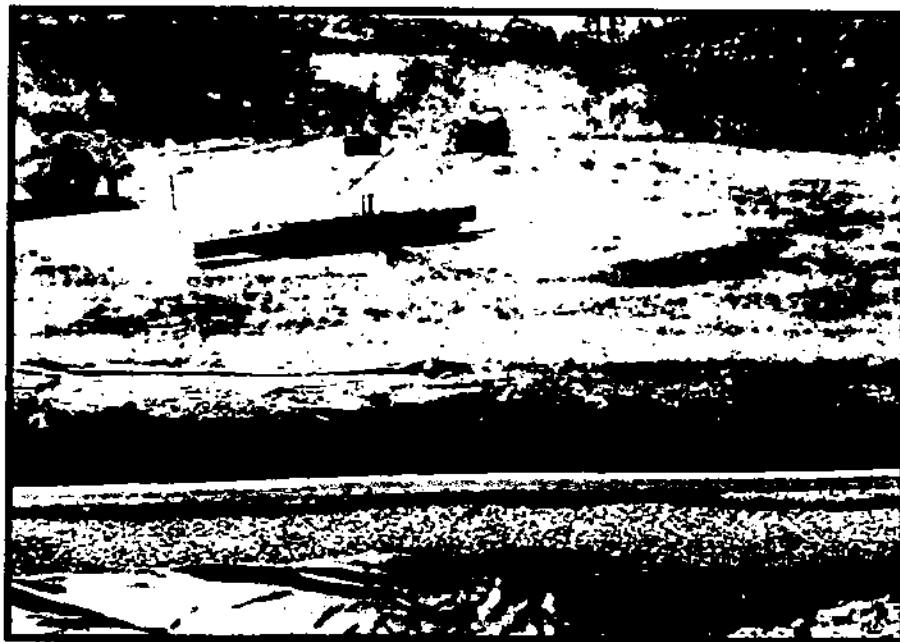
Photo 8 – Leak Detection and Leachate Collection Piping Systems

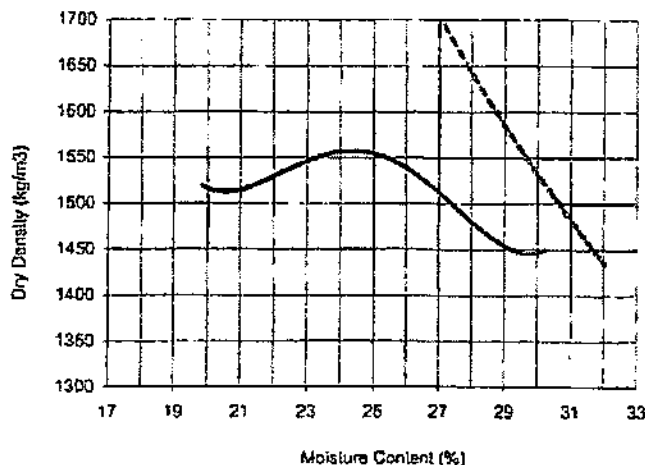
Moisture-Density Relationship

Sample Information					
Material Classification: Cell Liner					
Material Description: Fine Sandy Silt					
Date sampled	April 9, 2014	Sampled by	Client	Estimated SG	2.700
Date received	April 9, 2014	Supplier	N/A	Insitu moisture	NA
Sample Source	Client site			Sample Number	1

Test Information						
Trial Number	1	2	3	4	5	Test Standard
Wet Density (kg/m <sup>3</sup> )	1820	1886	1940	1919	1887	Standard
Dry Density (kg/m <sup>3</sup> )	1519	1539	1556	1511	1449	Test Procedure
Moisture Content (%)	19.8	22.6	24.7	27.0	30.2	ASTM D-698 Method C
						Date tested
						April 11, 2014
						Tested by
						GG

Test Result Summary	
Over-size correction method:	ASTM 4718
Retained 19.0mm sieve:	0%
Over-size specific gravity:	2.700
Maximum Dry Density Values	
Uncorrected Value	1567 kg/m <sup>3</sup>
Corrected Value	1667 kg/m <sup>3</sup>
Optimum Moisture Content	
Uncorrected Value	24.5 %
Corrected Value	24.5 %

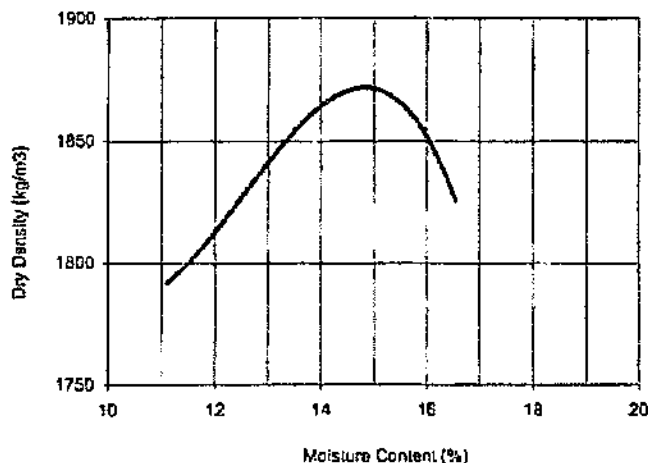
Moisture-Density Relationship

Sample Information					
Material Classification: Cell Liner					
Material Description: Return haul clay with gravel					
Date sampled	April 9, 2014	Sampled by	Client	Estimated SG	2.650
Date received	April 9, 2014	Supplier	N/A	Insitu moisture	NA
Sample Source	Client site			Sample Number	2

Test Information							
Trial Number	1	2	3	4	5	Test Standard	Standard
Wet Density (kg/m <sup>3</sup> )	1991	2048	2155	2128		Test Procedure	ASTM D-698 Method C
Dry Density (kg/m <sup>3</sup> )	1792	1823	1868	1826		Date tested	April 14, 2014
Moisture Content (%)	11.1	12.4	15.4	16.6		Tested by	GG

Test Result Summary	
Oversize correction method:	ASTM 4718
Retained 19.0mm sieve:	9%
Oversize specific gravity:	2.700
Maximum Dry Density Values	
Uncorrected Value	1872 kg/m <sup>3</sup>
Corrected Value	1923 kg/m <sup>3</sup>
Optimum Moisture Content	
Uncorrected Value	14.8 %
Corrected Value	13.6 %

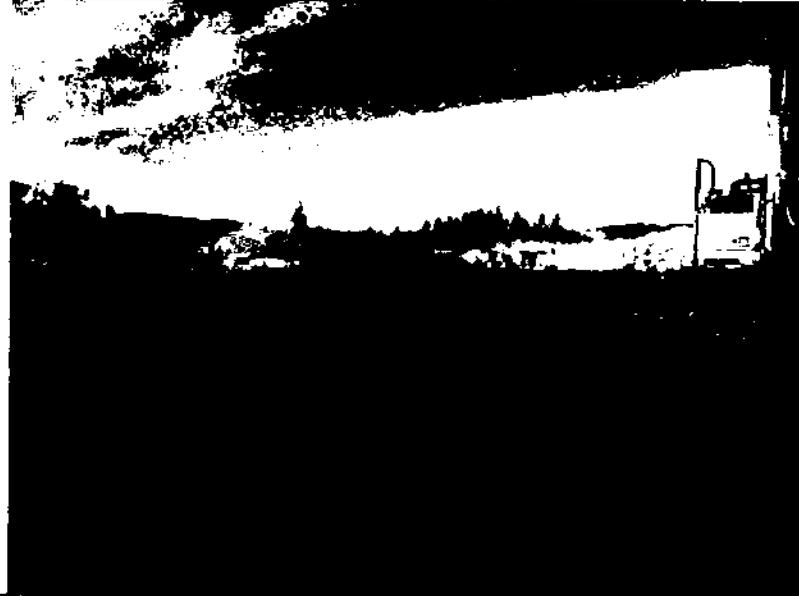
Test pitting of the clay liner on Oct 27. The clay was found to be well consolidated but not thick enough. Looking north.

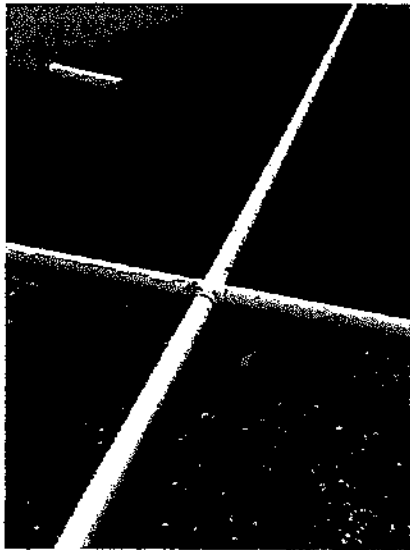
The PVC pipes were covered with a minimum of 0.3m of clear crush, and a geotextile fabric was placed over the clear crush to provide a surface for the synthetic liner and protect it from potential puncture. The photo below shows the leak detection piping with laterals connected to the main central trunk.
