## WATER QUALITY MONITORING AGREEMENT

### WATER QUALITY ASSESSMENT OF Columbia River AT WANETA (1979 – 2005)

B.C. Ministry of Environment  
and  
Environment Canada

March 2008

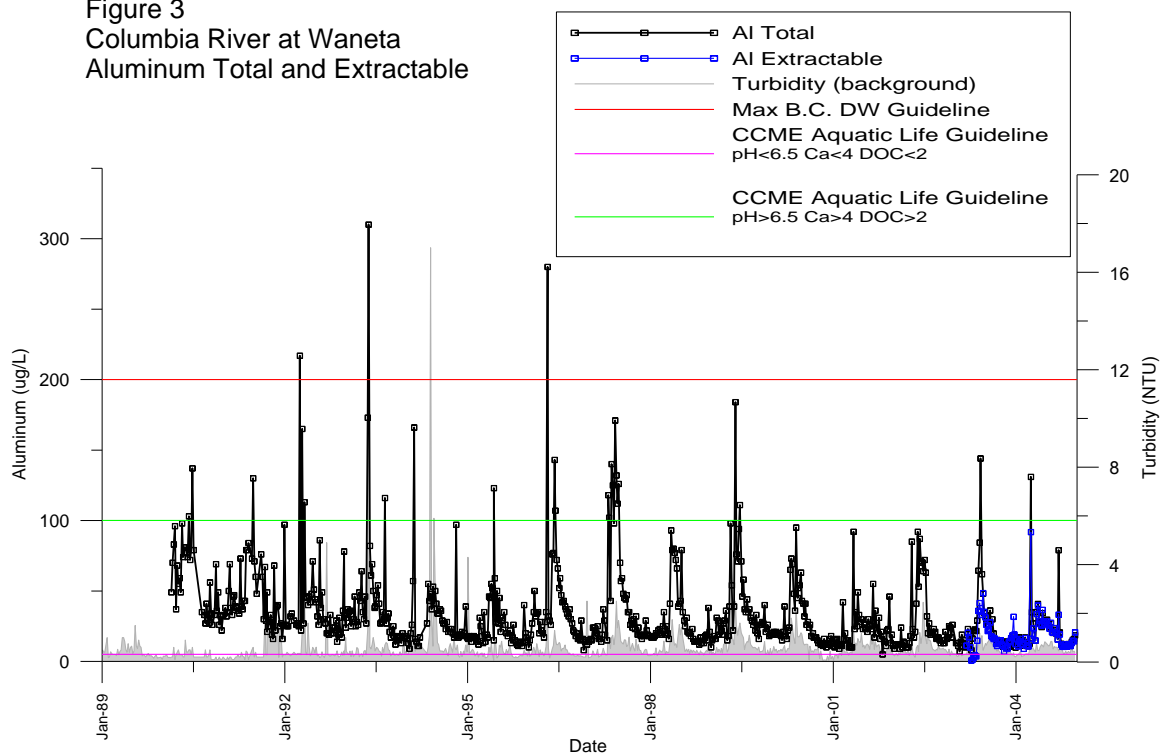
Figure 3  
Columbia River at Waneta  
Aluminum Total and Extractable

**Aluminum** (Figures 3 and 4) concentrations are related to turbidity, with highest total and extractable concentrations being measured during periods of higher turbidity. (Turbidity is generally quite low in the river.) Total and extractable concentrations occasionally exceed the guidelines to protect aquatic life; however, the guidelines are expressed as dissolved aluminum. For this reason there is likely no concern in the river with respect to aluminum. An apparent downward trend in aluminum was noted over time, which had identified in a previous (Pommen, 2002). This trend may in part be due to the trapping effect of upstream dams and reservoirs.

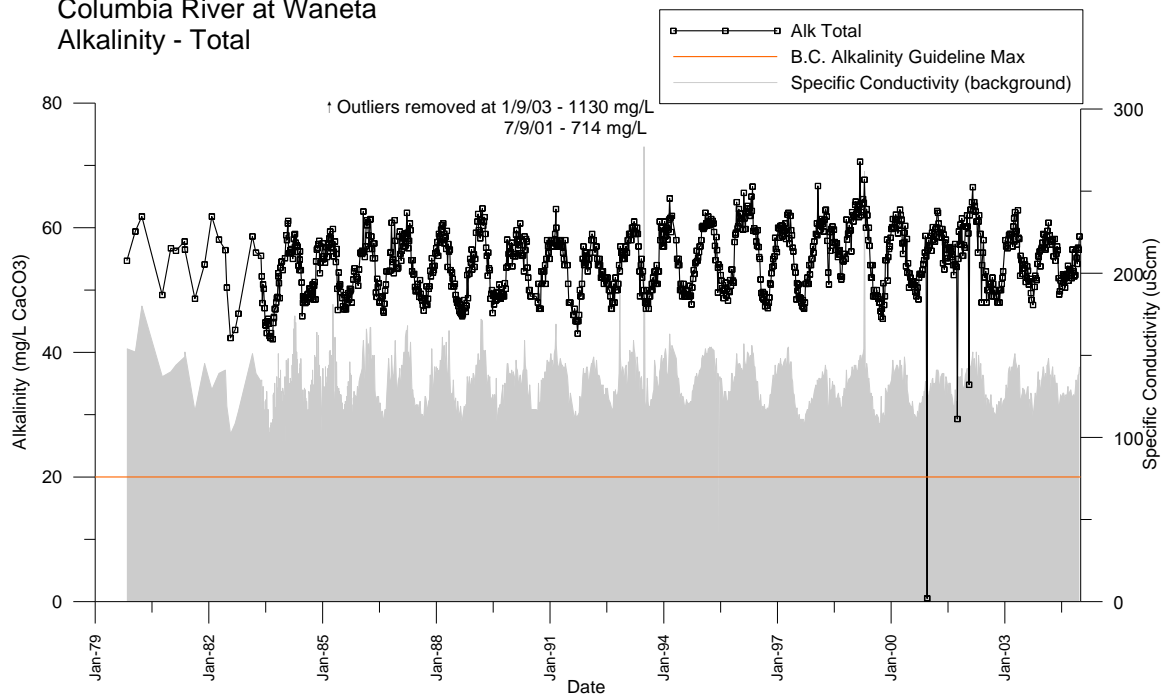
Figure 5  
Columbia River at Waneta  
Alkalinity - Total

**Alkalinity** (Figure 5) concentrations generally fluctuated with specific conductivity as would be expected. Alkalinity was usually greater than 40 mg/L, indicating that the river is well buffered for acidic inputs.

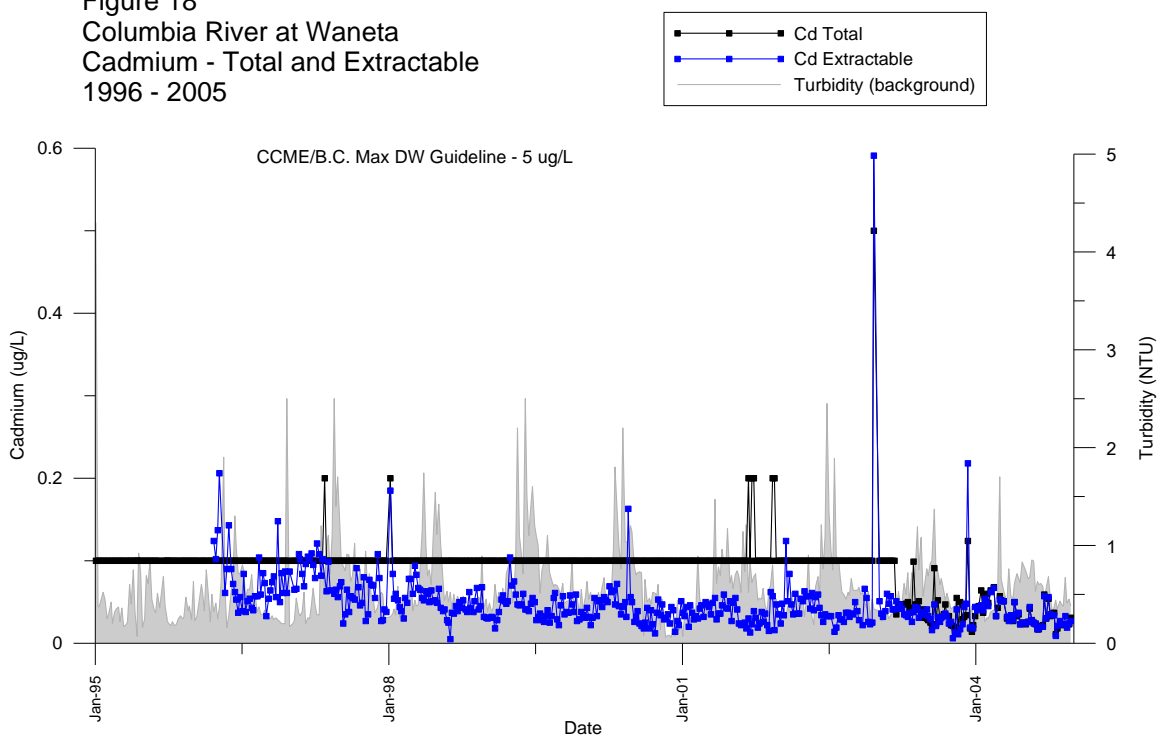
Figure 17  
Columbia River at Waneta  
Cadmium - Total and Extractable  
1979 - 2005

**Cadmium** (Figures 17 and 18) concentrations exhibit a declining trend that had been noted in a previous report and attributed to abatement measures at the upstream smelter and fertilizer plant in Trail (Pommen, 2002).

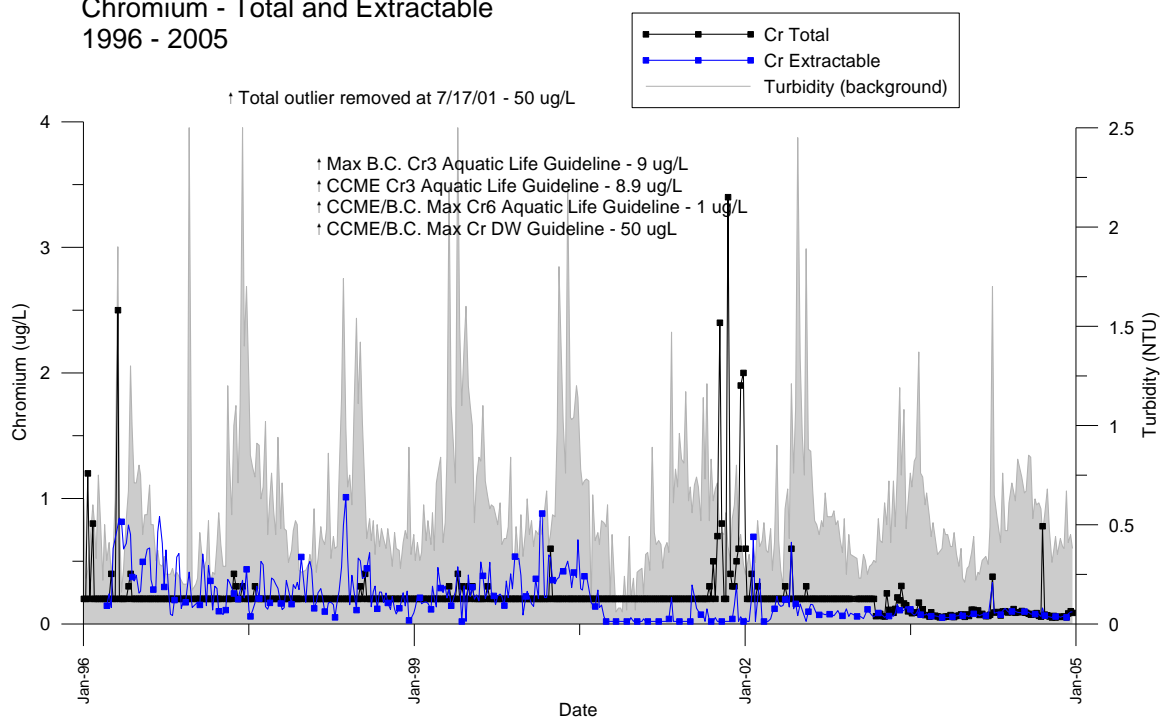
Figure 24  
Columbia River at Waneta  
Chromium - Total and Extractable  
1996 - 2005

**Chromium** (Figures 24 and 25) concentrations appeared to fluctuate with turbidity levels. When it was measured as total chromium, it occasionally exceeded the guideline for hexavalent chromium in 2001; however, when improved detection limits were available all total and extractable concentrations met the guideline. Chromium is therefore not likely a concern in the river.

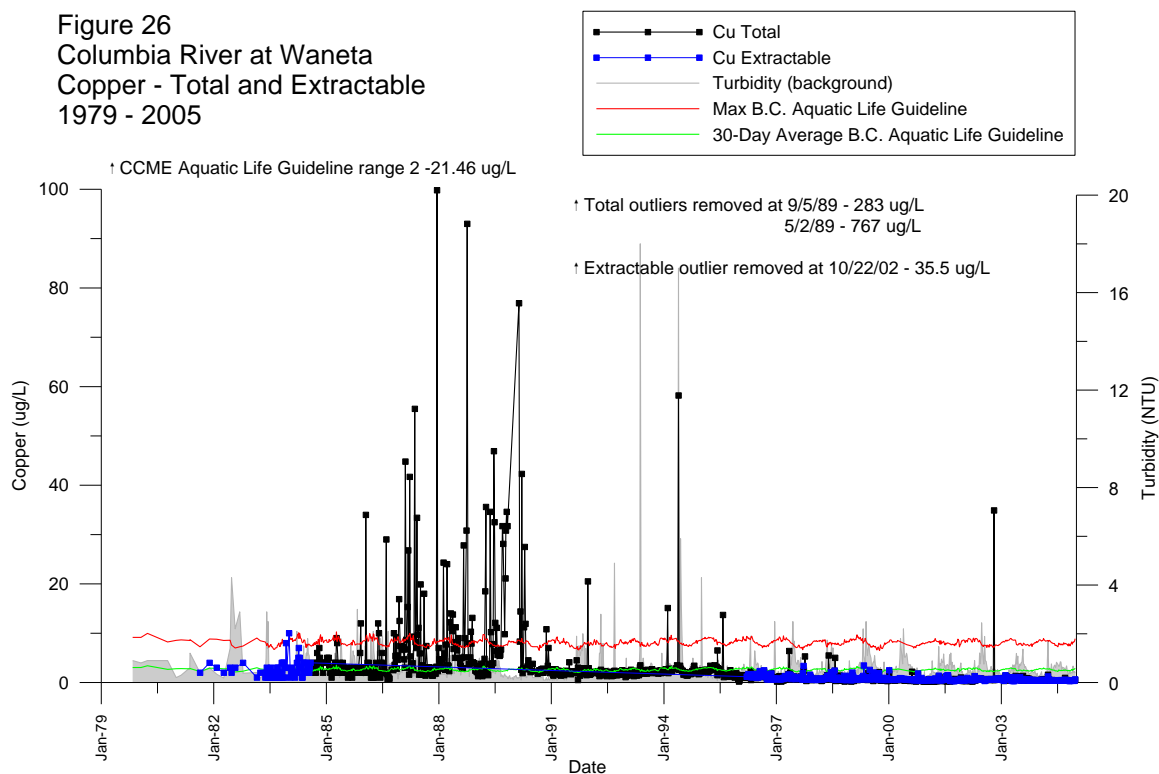
Figure 26  
Columbia River at Waneta  
Copper - Total and Extractable  
1979 - 2005

**Copper** (Figure 26) concentrations generally fluctuated with turbidity. Some values exceeded the B.C. guideline for maximum concentrations; however, the frequency of values that exceed the guideline has been reduced in recent years when the analytical detection limit was lowered. This is an expected outcome from reducing detection limits.

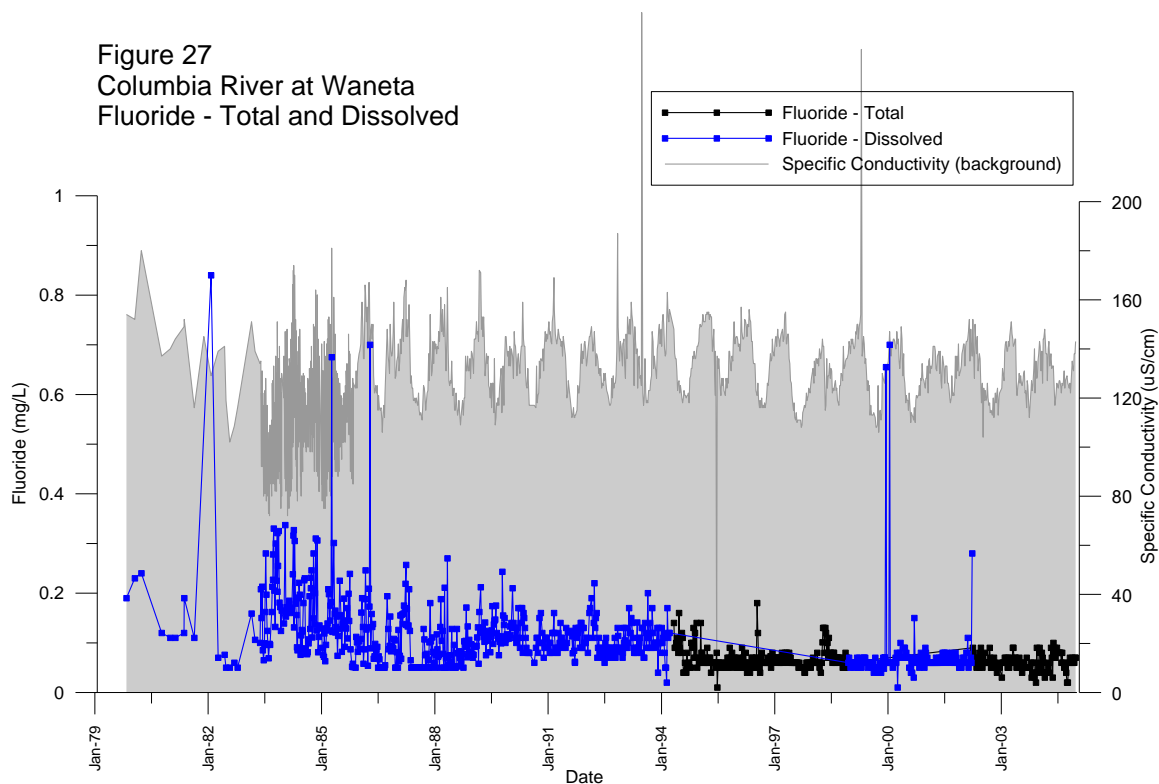
Figure 27  
Columbia River at Waneta  
Fluoride - Total and Dissolved

**Fluoride** (Figure 27) concentrations exhibit a declining trend that had been noted in a previous report and attributed to abatement measures at the upstream smelter and fertilizer plant (Pommen, 2002).

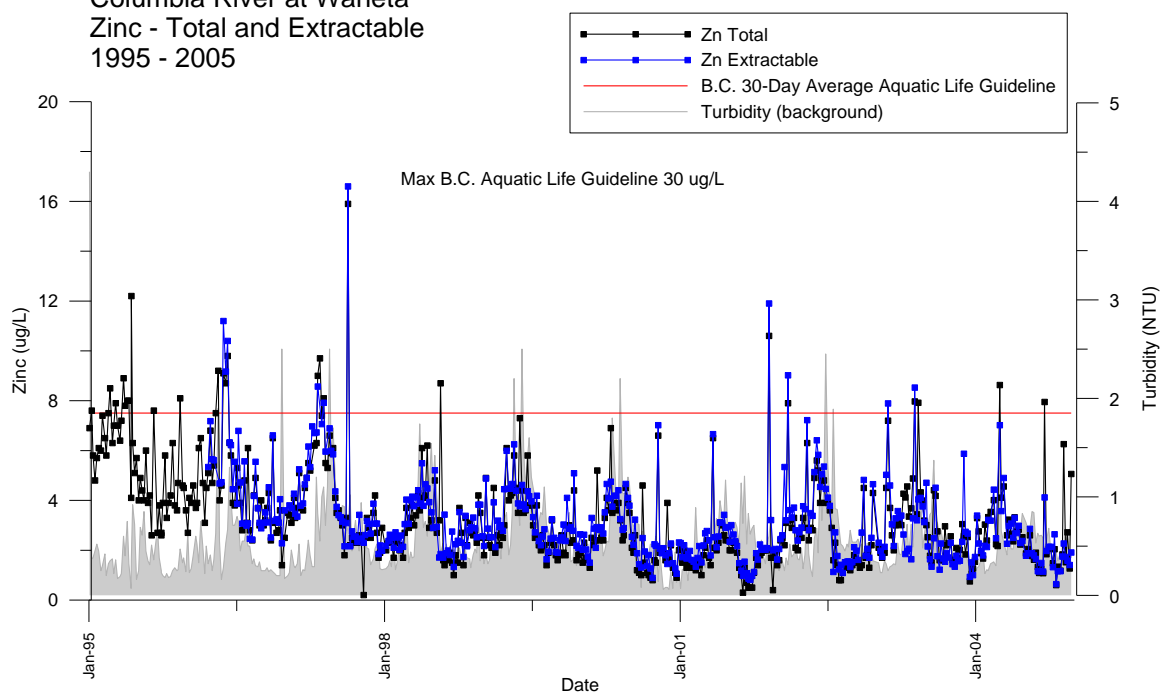
Figure 69  
Columbia River at Waneta  
Zinc - Total and Extractable  
1979 - 2003

**Zinc** (Figures 69 and 70) values fluctuated with turbidity. Individual values often exceeded the B.C. guideline for mean concentrations that are to be averaged during a 30-day period. Values appear to have declined from those values measured in 1995 and those in 2005. This declining trend had been noted in a previous report and attributed to abatement measures at the upstream smelter and fertilizer plant in Trail (Pommen, 2002).
