# **Technical Summary**

March 2009

Pit Name: Crescent Spur

Provincial Pit #: 1811

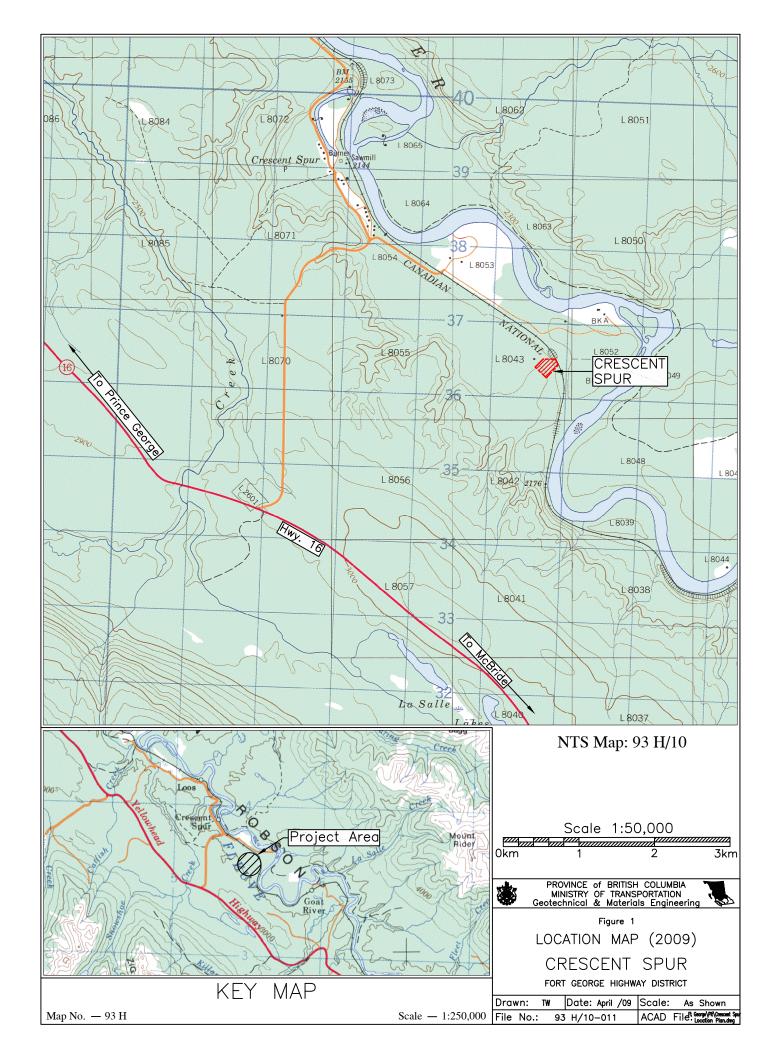
**Location:** The pit is located at the end of Prospect Road, approximately 5km down Crescent Spur Road (off Hwy 16), approximately 50km Northwest of McBride (Figure 1).

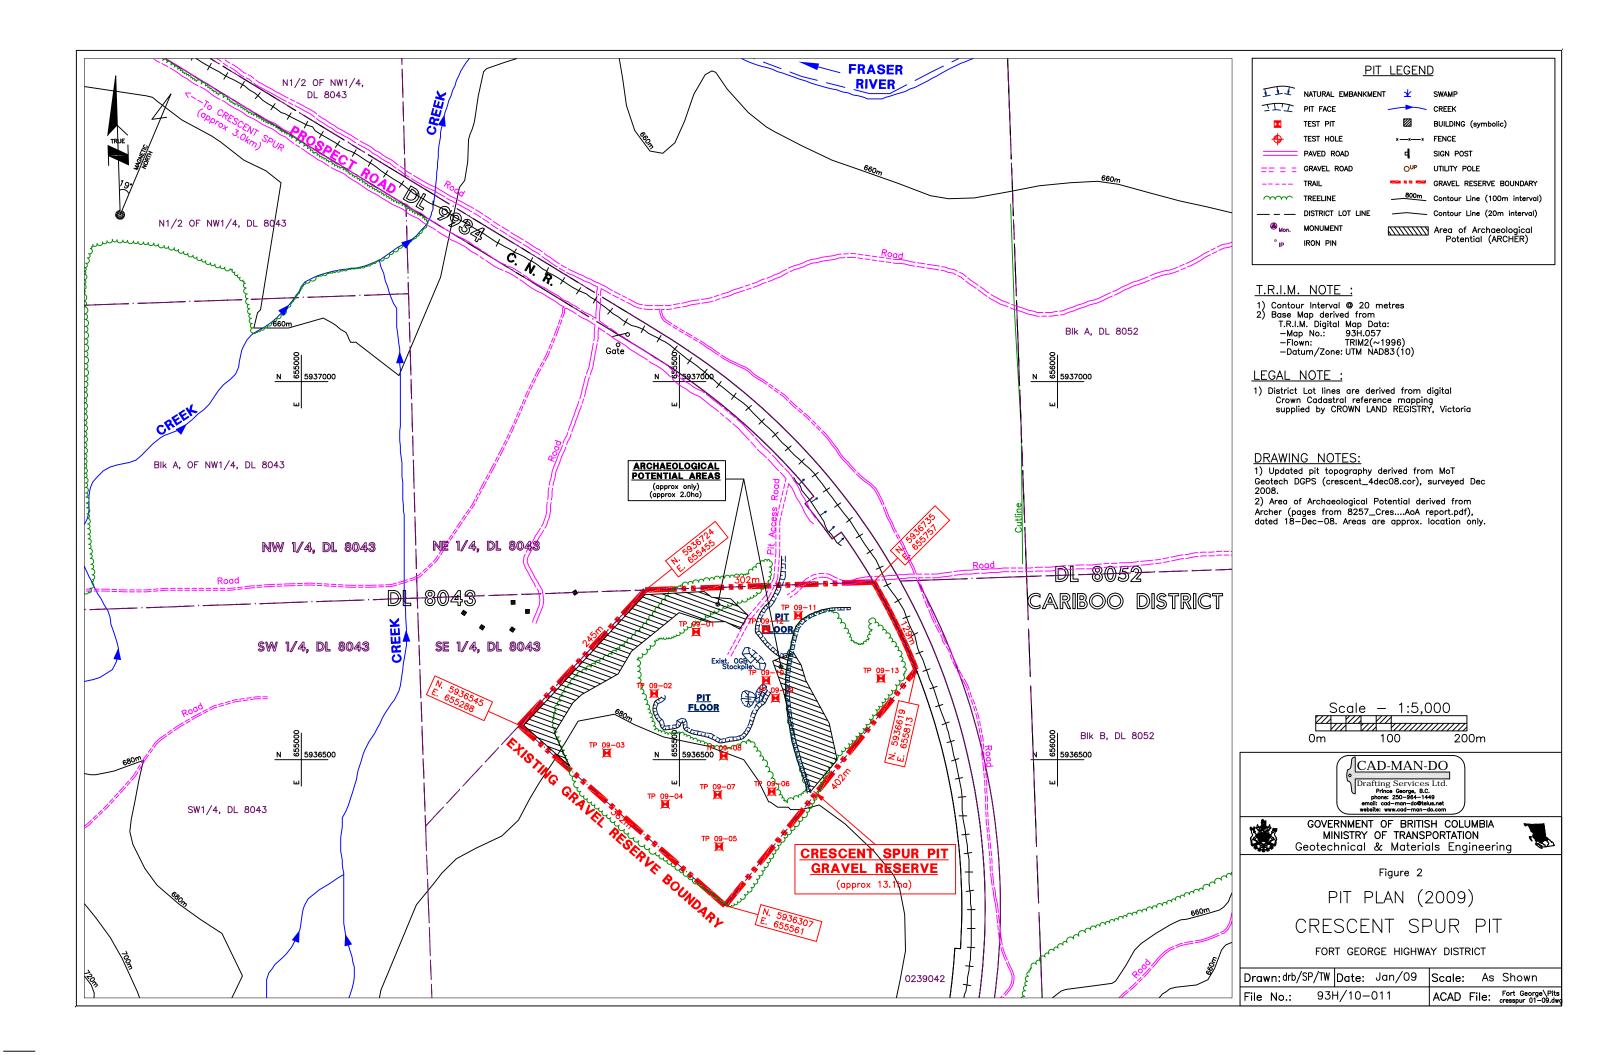
**2009 Investigation:** The 2009 investigation consisted of 13 test pits with depths ranging from 3.1 to 5.1m. Based on the results of this investigation, Area A has been delineated as an area containing usable granular materials (Figure 3).

- Development of the pit should continue from the existing pit face towards the south, as shown on the development plan. Area A can be accessed through the existing access road.

- There are two areas marked out in both Figure 2 and Figure 3 that are areas of high archaeological potential according to an Archaeological Overview Assessment (AOA). These areas are not to be entered unless an Archaeological Impact Assessment (AIA) is carried out and finds no archaeological artefacts.

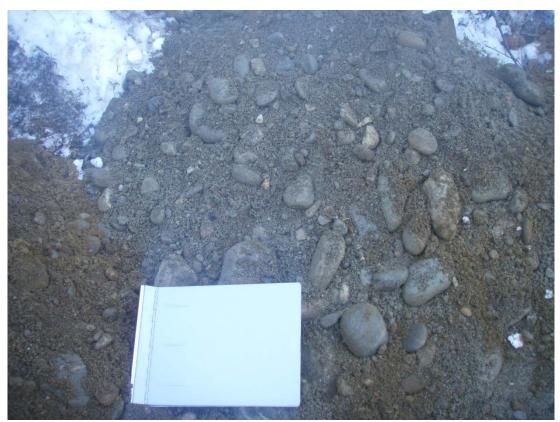
TP09-13

There is a potential for granular materials in the east/northeast portion of the reserve. Test Pit 09-13 excavated in this area encountered approximately 3.6m thick gravel layer and bottomed out in gravel. It is recommended that further exploration be carried out in this area to assess the potential.
