Ministry of Transportation and Infrastructure

Bridge Inspection and Assessment - E&N Railway, Vancouver Island, BC, Canada

**Phase 2 - Evaluation Report
Bridge from Mile 1.30 to Mile 65.1 and two
Bridges on Wellcox Spur (28 Bridges) and
Executive Summary**

February 2012

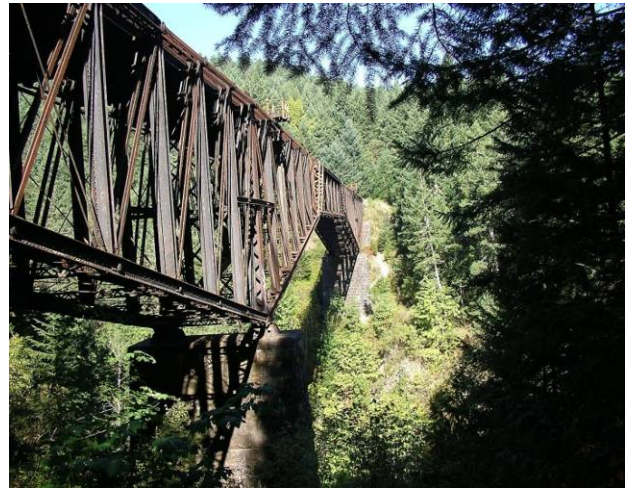
Bridge Mile 14.00 Niagara

Bridge 14.00 Niagara is a 525' cantilever pin-connected deck truss on a tangent alignment. The bridge was originally constructed on the CPR mainline to cross the the Fraser River at Cisco, BC. The bridge was disassembled, moved and re-constructed at Mile 14.0 in 1912.

The costs for Essential Repairs (Immediate) for all three loading types in the Present to 2021 time period total \$158,500. The repairs comprise:

- Replace abutment bearing links with a detail that does not allow movement under loading.
- Replace top 4" pin in the NE corner of north abutment.
- Replace cracked turnbuckle in span 3, panel 3 east exterior truss.
- Replace or tighten loose diagonals of east truss (U25-L24 & U26-L25).

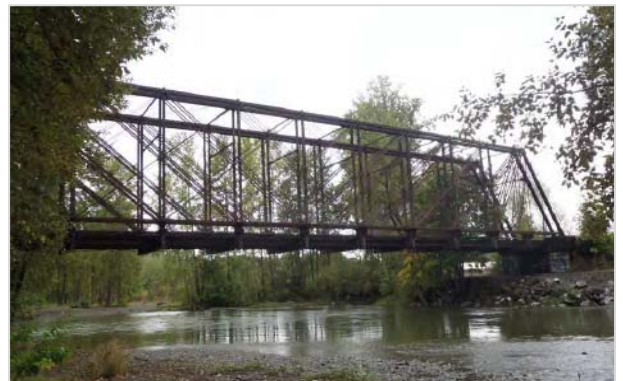
Bridge Mile 39.3 – Cowichan River

Bridge 39.3 is a single span open deck bridge over the Cowichan River. The superstructure consists of a 219 ft. wrought iron double through truss (two trusses on each side of the rail line), with steel floor beams and stringers. The bridge in its present configuration was erected 1909, with trusses fabricated in 1876, previously used at another location. The bridge is supported by stone masonry block abutments with concrete footings built in 1892.

The costs for Essential Repairs (Immediate) for all three loading types in the Present to 2021 time period total \$165,000. The repairs consist of:

- Replace all bridge counters (because of cracked eye nuts).
- Replace or repair bridge South expansion bearings.

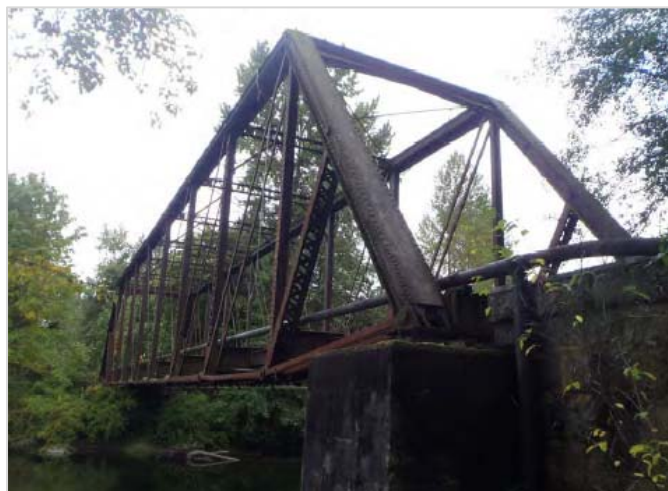
Bridge Mile 47.9 - Chemainus

Bridge 47.9 is a single span open deck bridge over the Chemainus River. The superstructure consists of a 155'-6" ft. steel through truss, with steel floor beams and stringers. The truss was previously used on a different location. The bridge is on a tangent alignment. The bridge was reinforced in the 1940's; bridge stringers were reinforced by queen posts (4 rows of adjustable eye bars). The bridge is supported by stone masonry block abutment with concrete wing walls and ballast wall. There is a reinforced concrete jacket constructed at South abutment. The north abutment is bearing on natural rock; the south abutment is supported by timber piles.

The cost for Strengthening for 263kip loading (and 286kip loading) is estimated at \$2,400,000 for a complete replacement in the Present to 2021 time period. Considering the overall poor condition of the bridge and the fact that the strengthening of the truss required for the freight trains would be expensive and complex, it is recommended that the bridge be replaced if it is to facilitate 263kip and 268kip freight trains. The bridge replacement is not required if the bridge will be used only for the specified passenger trains.

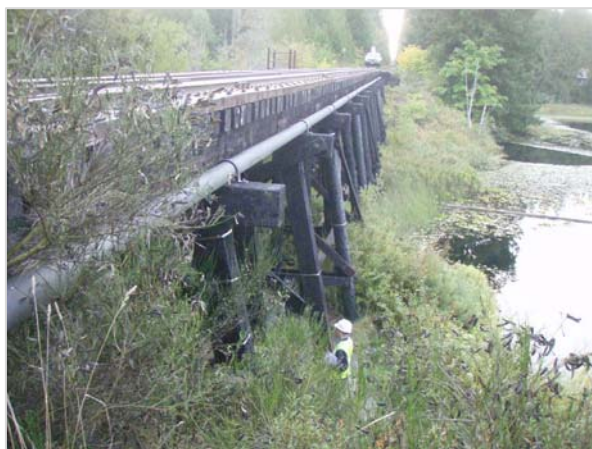
Bridge Mile 79.9 Green Lake

Bridge 79.9 is a 14-span open deck bridge over Green Lake. The superstructure consists of a 15 ft treated timber trestle, with stringer spans supported on timber bents. The bridge is on a tangent alignment. The bridge in present configuration was built in the year 1974. This bridge caught fire in 2005 (or 2006), causing damage to the timber. The components that suffered the worst damage were subsequently replaced.

The costs for Projected Repairs for Passenger Loading (and 263kip loading and 286kip loading) is estimated at \$1,250,000 for a complete replacement in the 2021 to 2031 time period because the fire damage will shorten the expected life span of the timber elements.

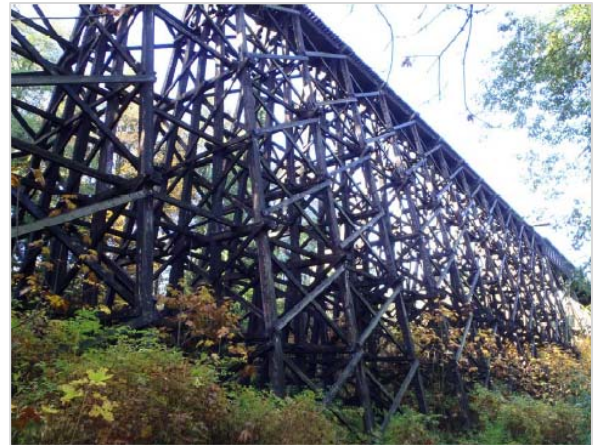
Bridge Mile 98.6 – French Creek

Bridge 98.6 is a 63 ft span open deck bridge over French Creek. The superstructure consists of 56 – 15 ft timber stringer spans supported on timber trestle bents, 2 – 45 ft DPG spans, 1 – 75 ft DPG span and 4 – 15 ft timber stringer transition spans. The steel DPG spans and towers were constructed in the year 1913. The timber trestle approaches were built in 1977.

The timber trestle side spans are 35 years old. Bridge replacement may be required around the year 2030; however with maintenance repairs, the trestle may last until 2041. Estimated replacement for the 898 ft long timber trestle is in the order of \$6,000,000; this replacement cost is distributed equally in three \$2,000,000 increments in the 2021 to 2031 and each of the next two subsequent 10 year periods as timber trestles are normally repaired with major rehabilitations to extend their lifespan. The third \$2,000,000 increment falls in the 2041 to 2051 time frame, which is outside the time frame covered by this study.

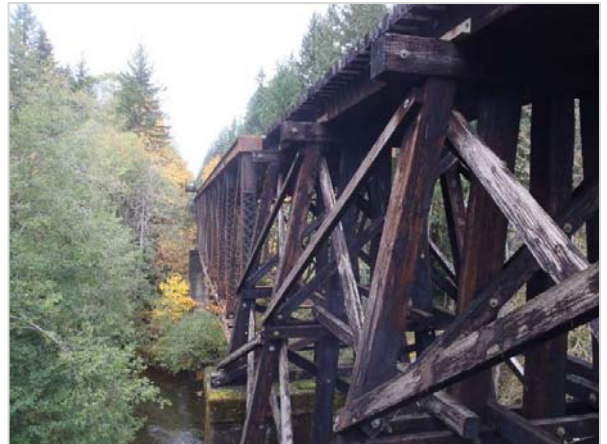
Bridge Mile 125.5 – Tsable River

Bridge 125.50 is a twenty-five span open deck bridge over Tsable River. The superstructure consists of twenty-three 15 ft timber stringer spans, a 154'-6" steel deck truss span and a 100'-8" steel deck plate girder span. The steel spans carry timber structural ties and the timber spans carry timber bearing ties. The bridge is on a tangent alignment and is supported by closed concrete abutments, intermediate timber frame bents and two concrete piers. The bridge was originally built in 1914. In 1977 the timber trestle on the south approach was replaced in kind and the timber trestle on the north approach was replaced with an existing deck plate girder span.

The steel deck truss span was erected at 125.5 in 1914; fabrication was an unknown time prior to 1914. The truss is likely over 100 years old. Multiple members in the truss are either overstressed or nearly overstressed for freight trains, based on the calculation results presented above. Field inspection and NDT revealed cracks in various members and an overall poor condition of the truss members. Based on these items, we recommend that this bridge be replaced if it is to facilitate 263kip and 286kip freight trains. An estimated replacement cost for the steel truss span is \$2,850,000, provided the existing concrete piers are adequate to support freight traffic (a pier investigation is recommended). The bridge replacement is not expected if the bridge will be used only for the specified passenger trains, provided the repairs and maintenance discussed in this report are completed.

The timber trestle approach span is already 35 years old. It is likely that replacement will be required in the next 10-20 years. An estimated replacement cost for the 343' timber trestle is \$2,900,000, including substructure elements; this replacement cost is distributed equally in three \$970,000 increments in the 2021 to 2031 and each of the next two subsequent 10 year periods as timber trestles are normally repaired with major rehabilitations to extend their lifespan. The third \$970,000 increment falls in the 2041 to 2051 time frame, which is outside the time frame covered by this study.

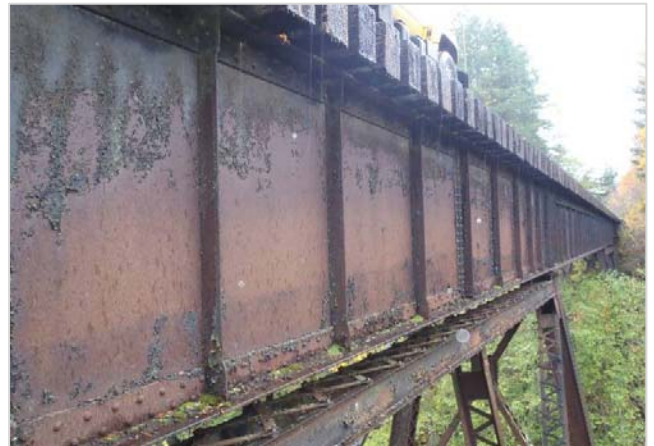
Bridge Mile 135.1 Trent River

Bridge 135.10 is a five-span open deck bridge over Trent River. The superstructure consists of two 73'-1" steel deck plate girder spans, two 43 ft steel deck plate girder spans and a 48 ft steel deck plate girder span. All spans carry timber structural ties. The bridge is on a tangent alignment and is supported by spill-through concrete abutments and steel bent towers. The bridge was originally built in 1913. The steel deck plate girders in the end spans were replaced in 1928.

The costs for Essential Repairs (Immediate) for all three loading types in the Present to 2021 time period total \$110,000. The repairs consist of:

- Repair undermined footing of SE leg at Tower 1.
- Investigate Scour.

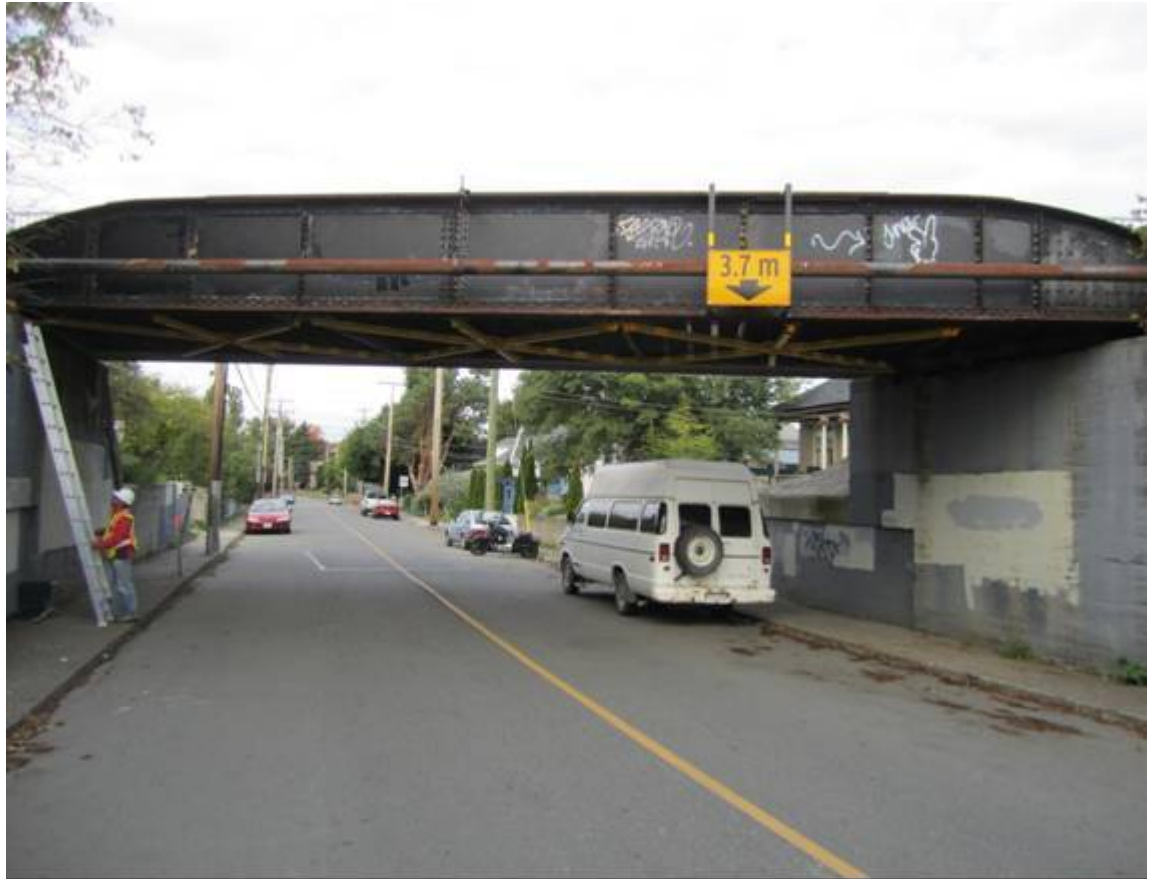
7 Mile 1.30 – Hereward Road

Bridge 1.30 is a single span open deck bridge over Hereward Road. The superstructure consists of a 47 ft steel half deck plate girder with timber structural ties. The bridge is on a skew with a tangent alignment.

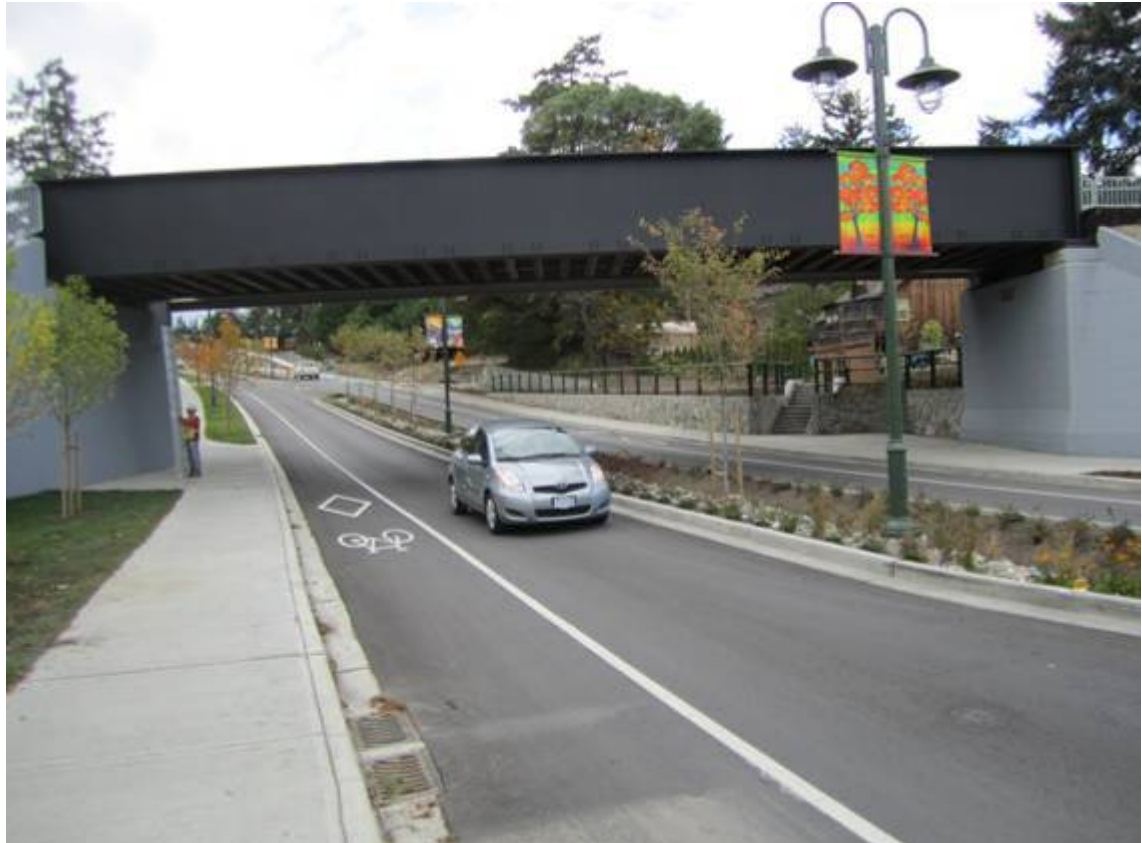
8 Mile 4.00 – Highway 1A

Bridge 4.00 is a single span ballasted deck bridge over Highway 1A. The superstructure consists of 74 ft (22.5 m) steel thru plate girders with steel floor beams and a steel floor plate supporting the ballast deck. The bridge is on a tangent alignment.

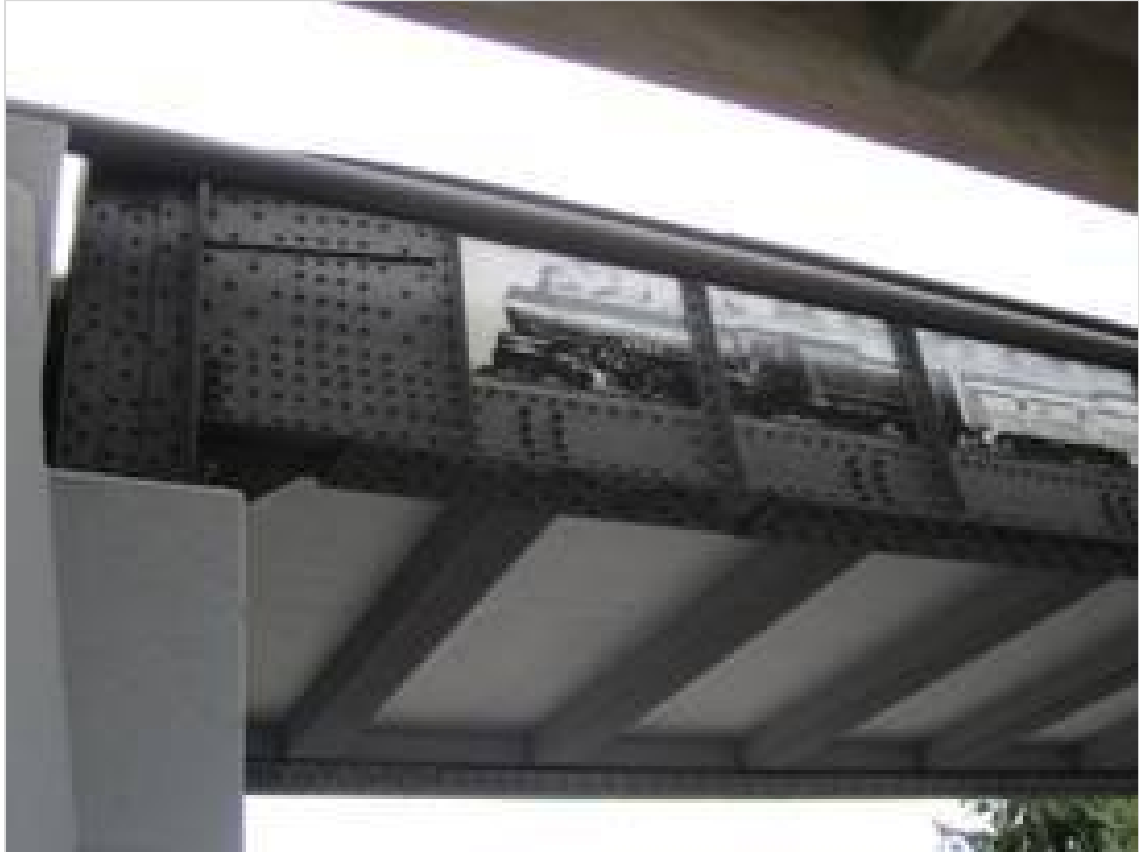
9 Mile 4.50 – Helmcken Road

Bridge 4.50 is a single span concrete ballasted deck bridge over Helmcken Road. The superstructure consists of a 42'-10" steel thru plate girder with steel floor beams encased in concrete. The bridge is on a tangent alignment.

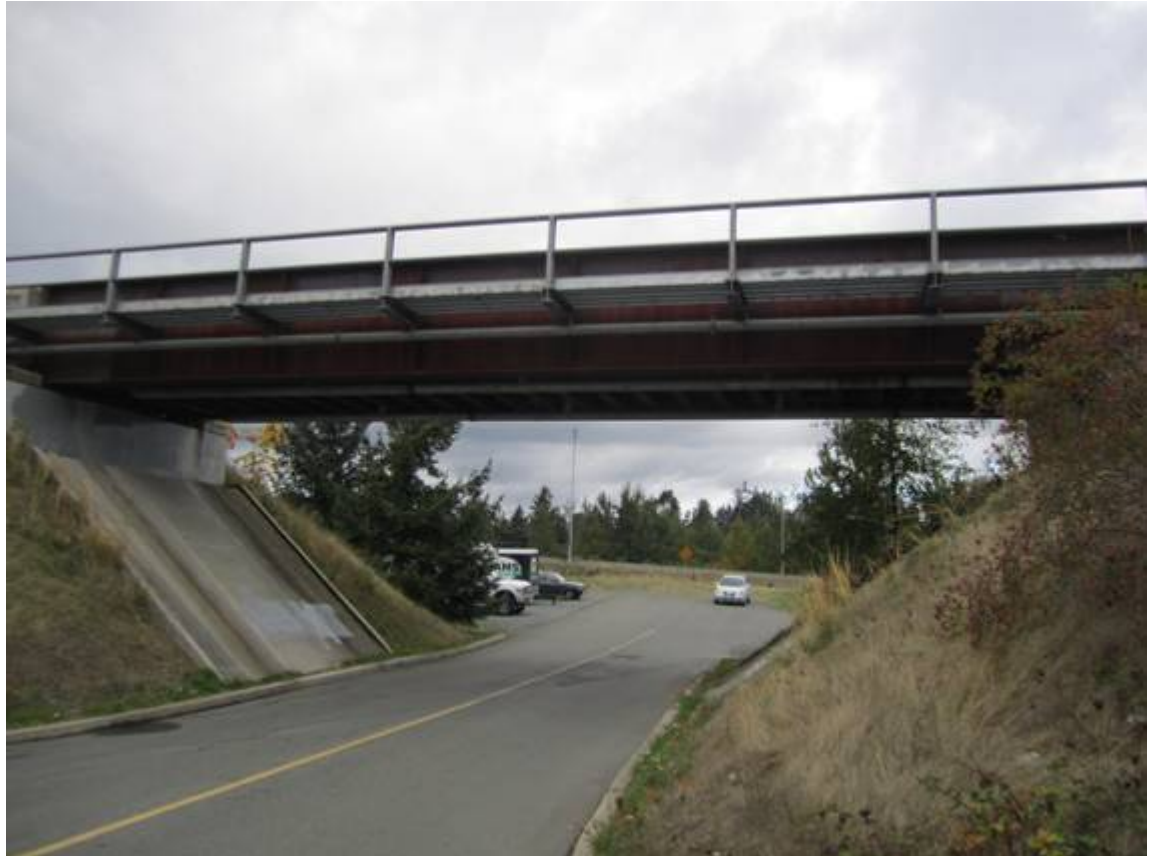
10 Mile 5.20 – Adams Place

Bridge 5.20 is a single span ballasted deck bridge over Adams Place. The superstructure consists of a 65 ft steel thru plate girder with steel floor beams and a steel floor plate supporting the ballast. The bridge is on a tangent alignment.

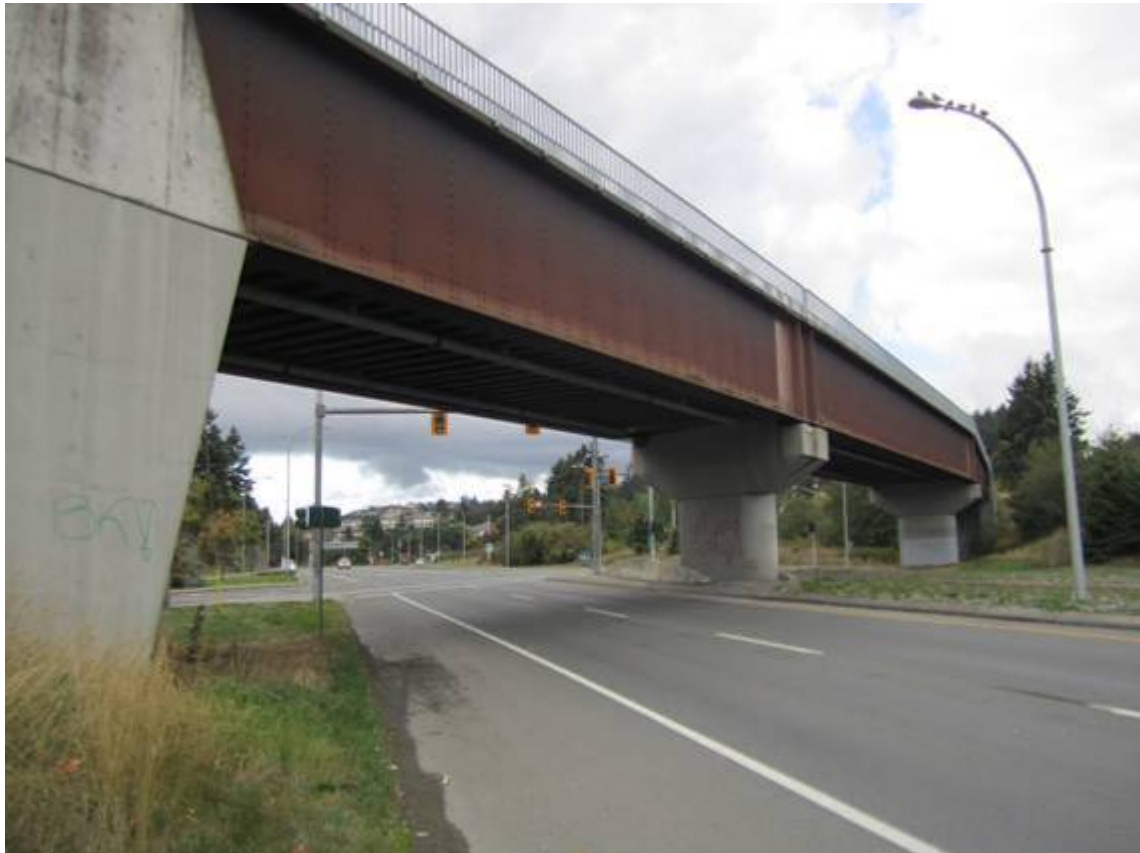
11 Mile 5.34 – Island Highway

Bridge 5.34 is a three span ballasted deck bridge over Island Highway. The superstructure consists of 83', 126' and 116' steel thru plate girders with steel floor beams and a steel floor plate supporting the ballast. The bridge is on a curved alignment.

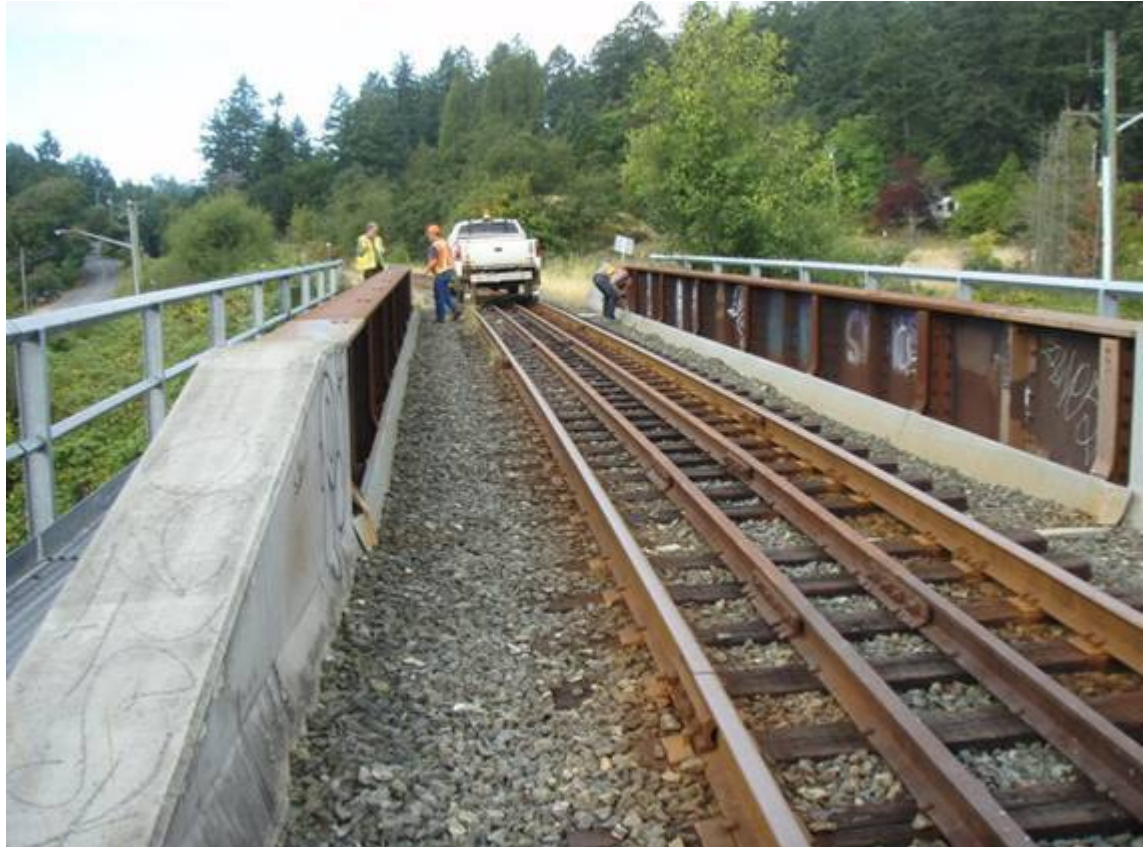
12 Mile 5.45 – Brydon Road

Bridge 5.45 is a single span ballasted deck bridge over Brydon Road. The superstructure consists of a 63'-5" steel thru plate girder with steel floor beams and a steel floor plate supporting the ballast. The bridge is on a tangent alignment.

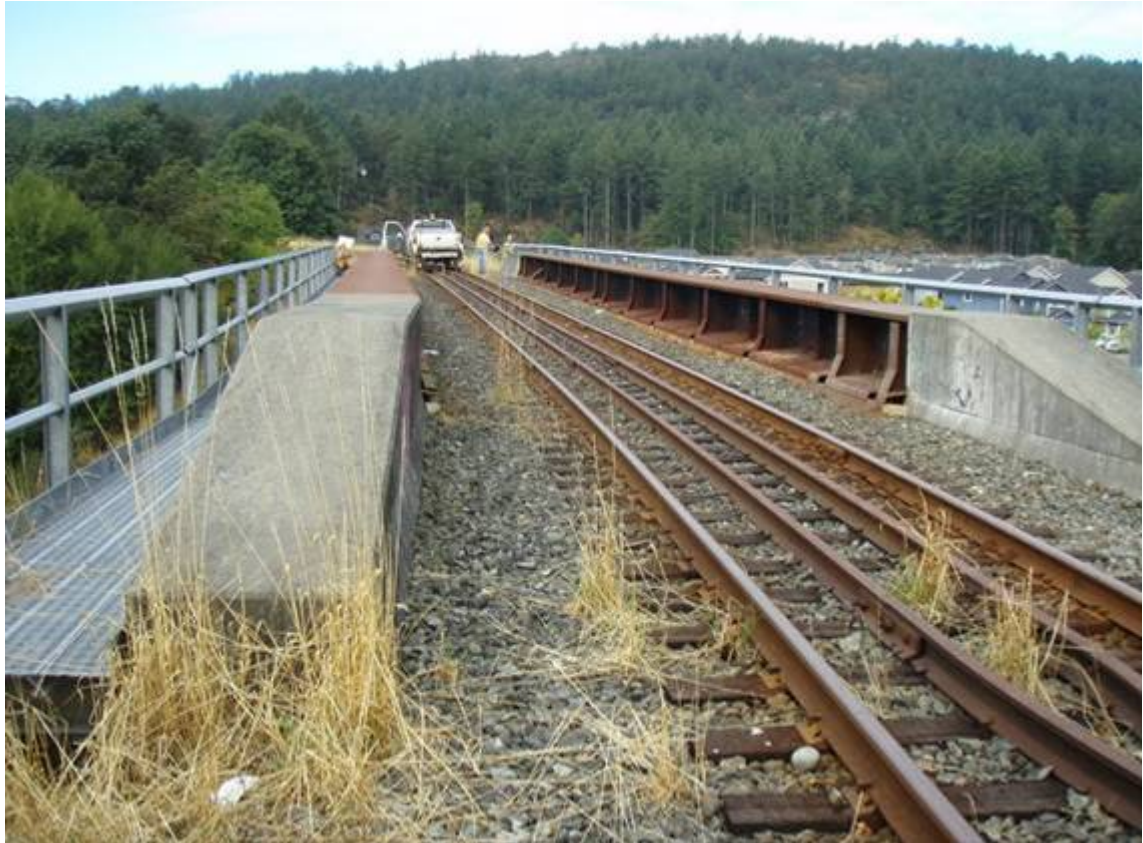
13 Mile 5.80 – Six Mile Road

Bridge 5.80 is a single span ballasted deck bridge over Six Mile Road. The superstructure consists of a 104' steel thru plate girder with steel floor beams and a steel floor plate supporting the ballast. The bridge is on a slight curve.

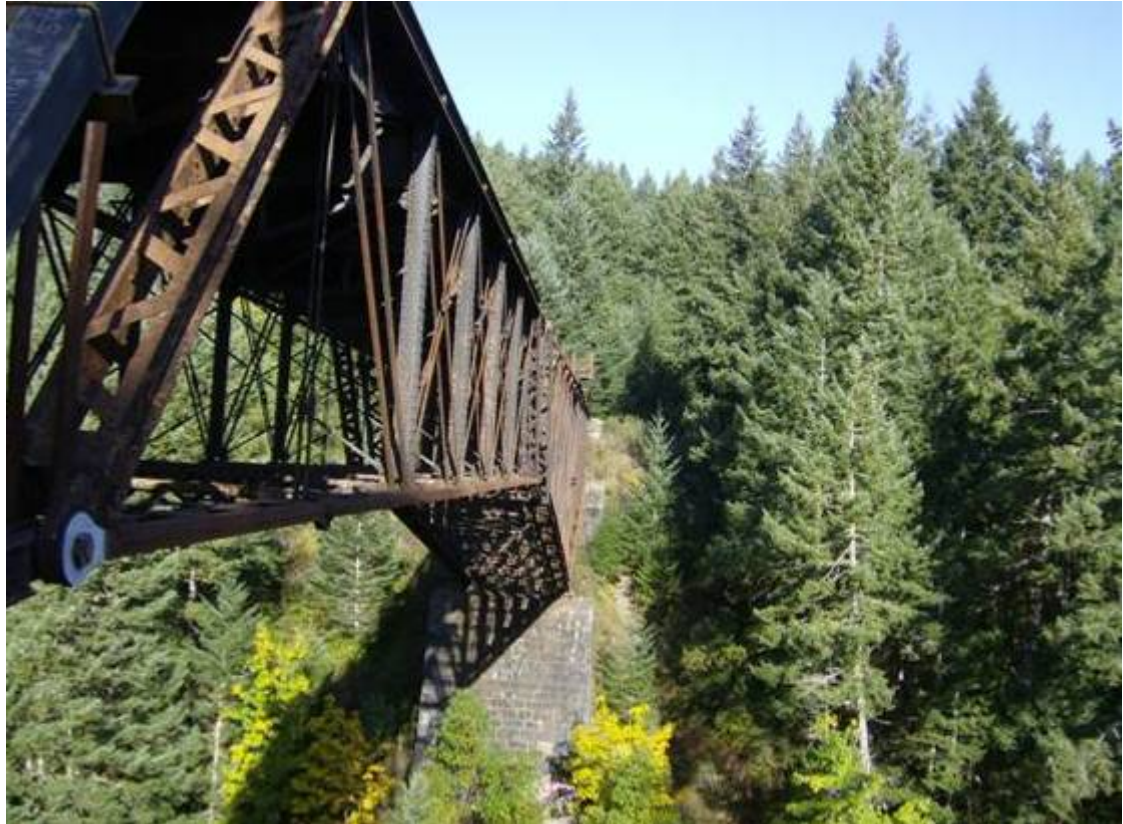
14 Mile 14.00 – Niagara Canyon

Bridge 14.00 is a 525' cantilever pin-connected deck truss on a tangent alignment. The bridge was originally constructed on the CPR mainline to cross the Fraser River at Cisco, B.C. The bridge was disassembled, moved and re-constructed at Mile 14.0 in 1912.

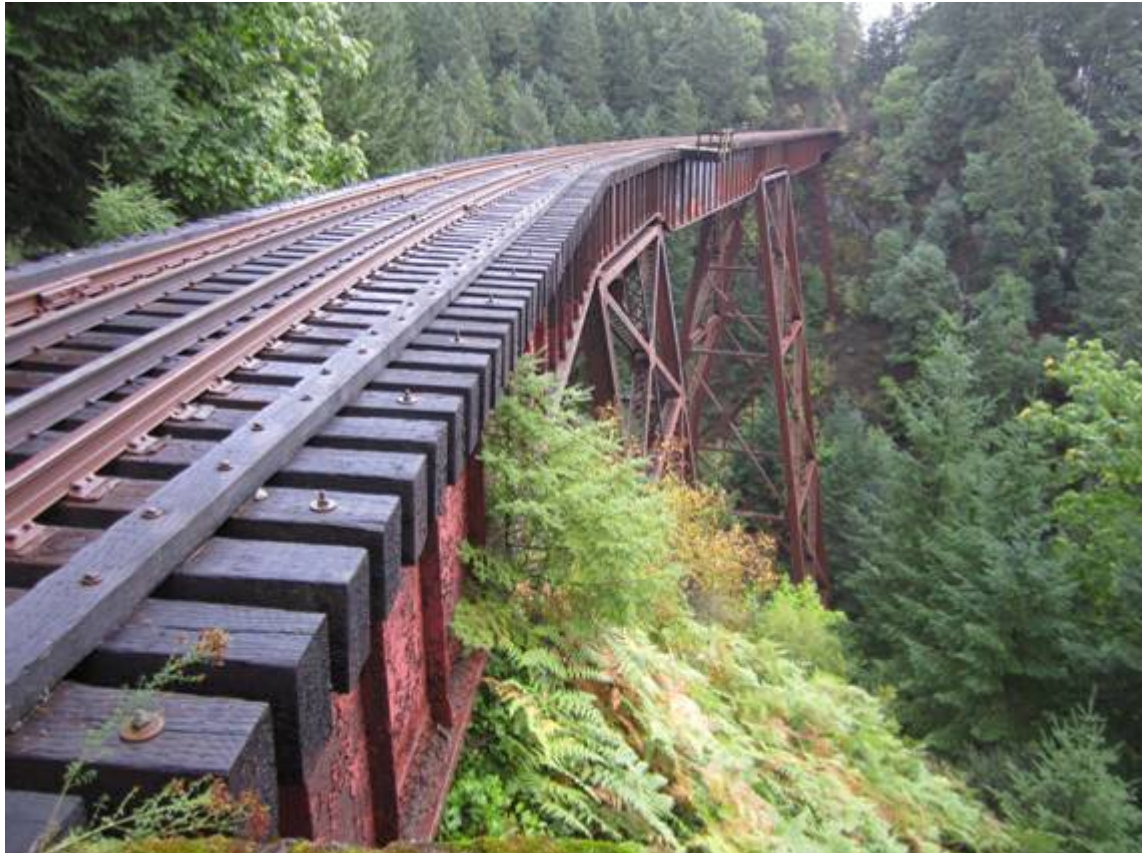
15 Mile 14.90 – Arbutus Canyon

Bridge 14.90 is a six span open deck bridge over Arbutus Canyon. The superstructure consists of steel deck plate girders supporting timber structural ties. The bridge is on a tangent-spiral-curve alignment.

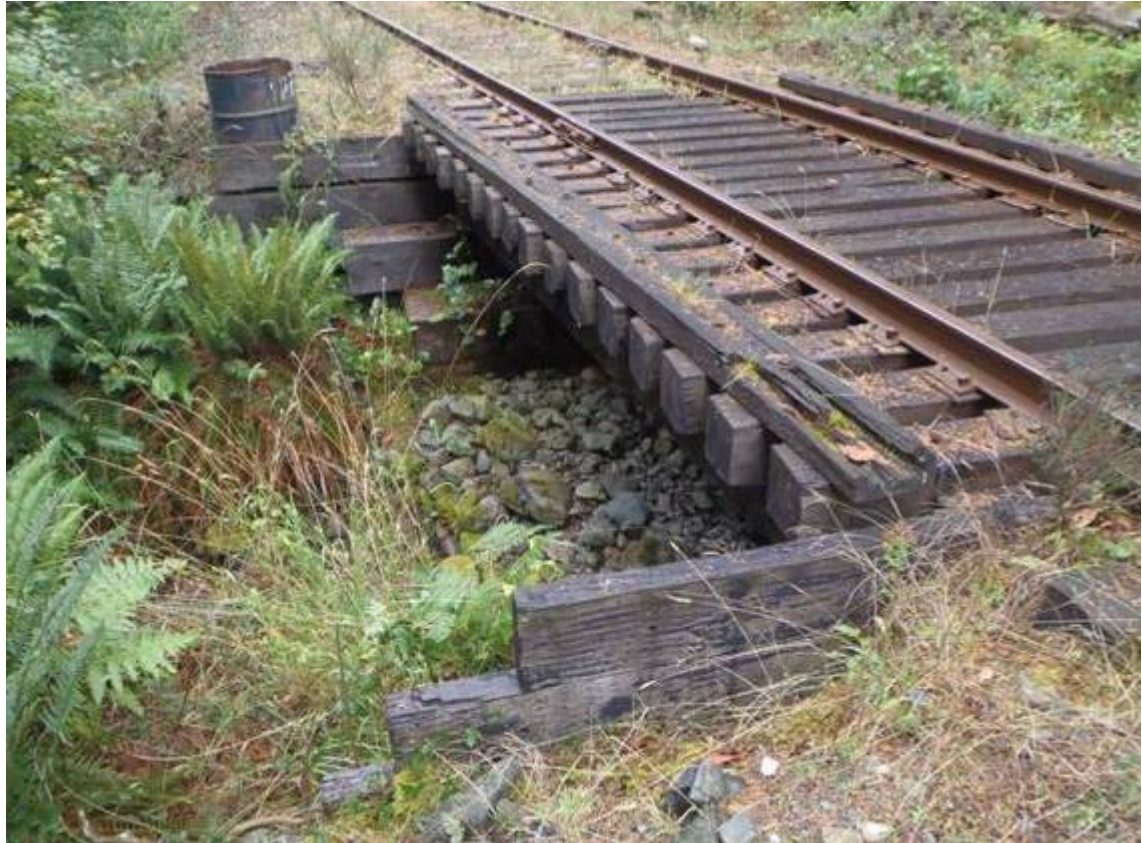
16 Mile 18.20 – Unnamed Waterway

Bridge 18.20 is a single span open deck bridge over an unnamed waterway. The superstructure consists of timber stringers sitting on timber sills. The bridge is on a tangent alignment.

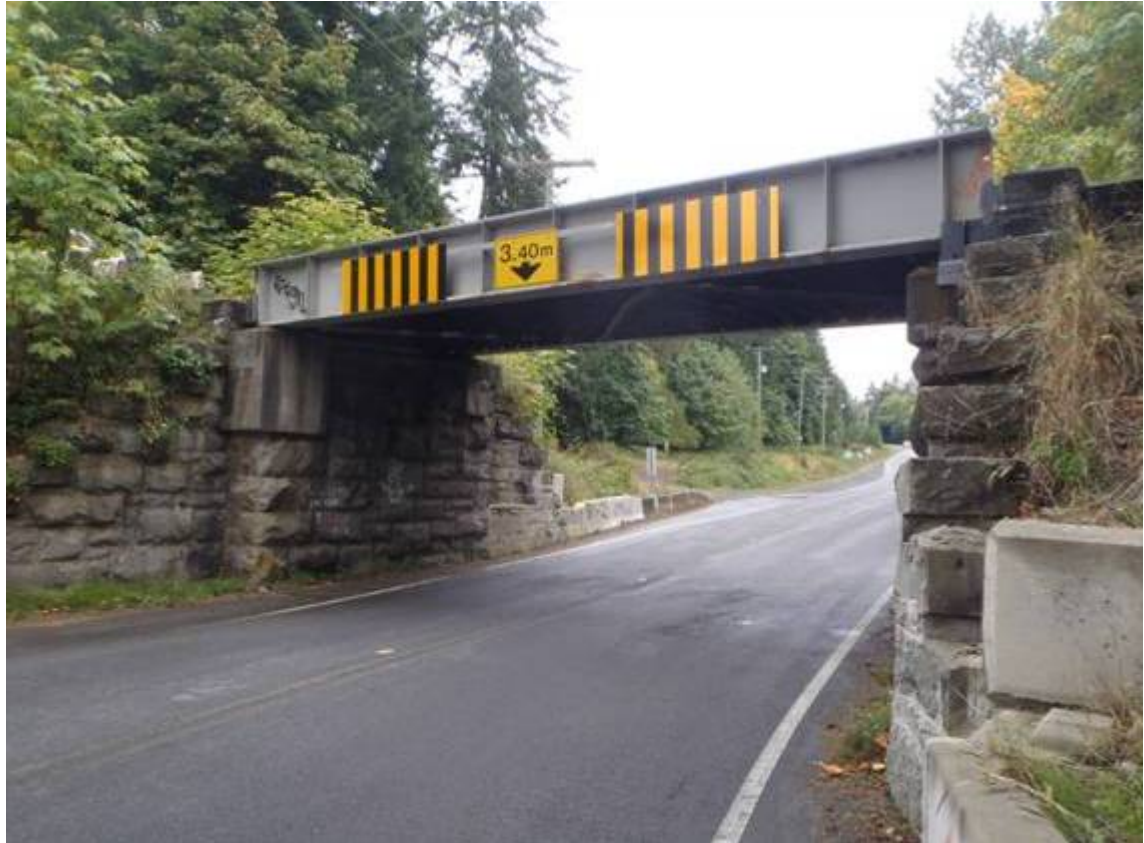
17 Mile 26.80 – Shawnigan Lake Road

Bridge 26.80 is a single span open deck bridge over Shawnigan Lake Road. The superstructure consists of 30'-6" steel rolled beams with timber structural ties sitting on the bottom flange of the beams. The bridge has a tangent alignment.

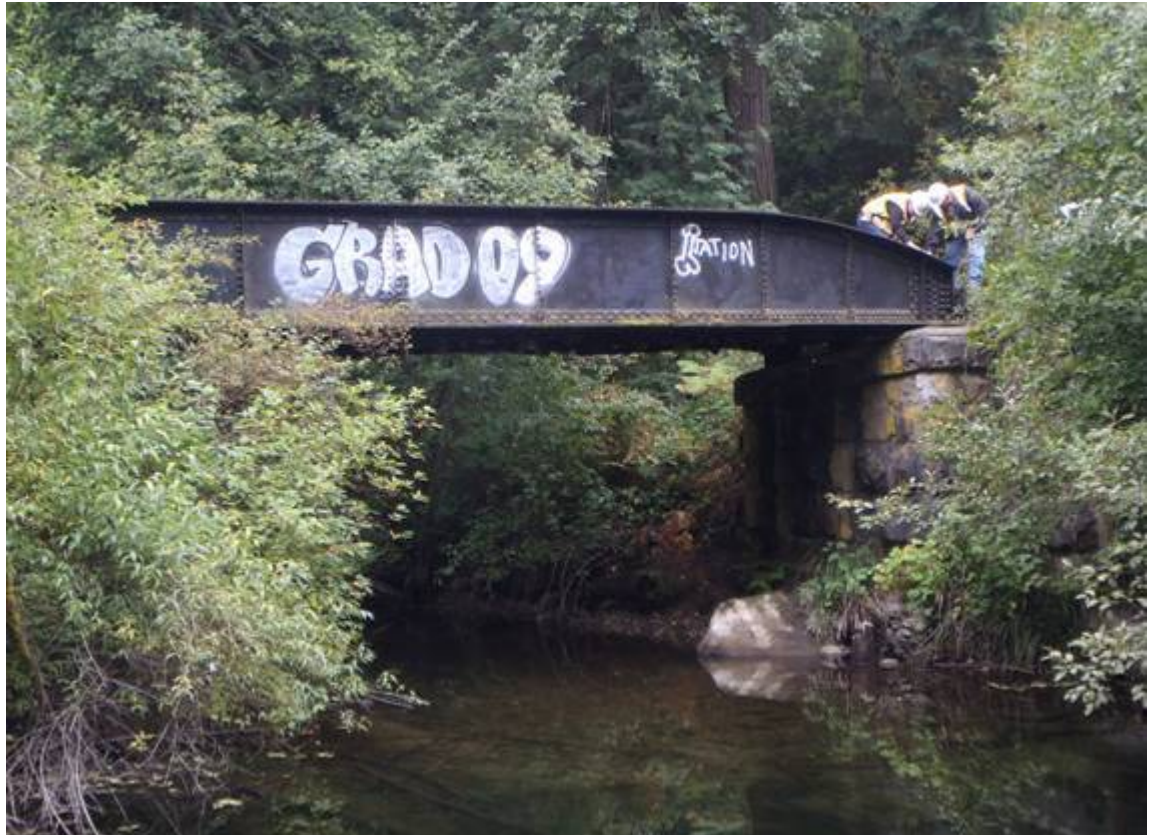
18 Mile 28.20 – Shawnigan Lake Tributary

Bridge 28.20 is a single span open deck bridge over a tributary of Shawnigan Lake. The superstructure consists of a 42 ft steel half deck plate girder with timber structural ties. The bridge is on a tangent alignment.

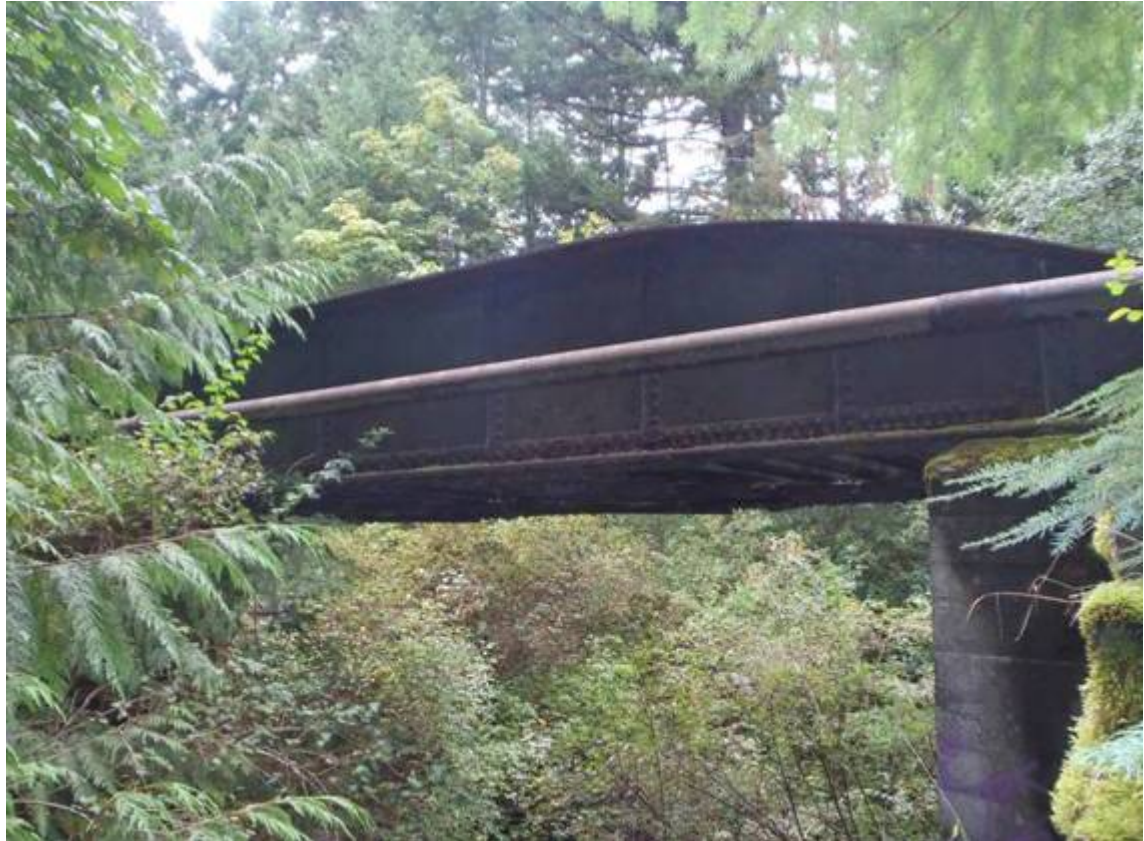
19 Mile 28.40 – Shawnigan Lake Tributary

Bridge 28.40 is a single span open deck bridge over a tributary of Shawnigan Lake. The superstructure consists of a 42 ft steel half deck plate girder with timber structural ties. The bridge is on a tangent alignment.

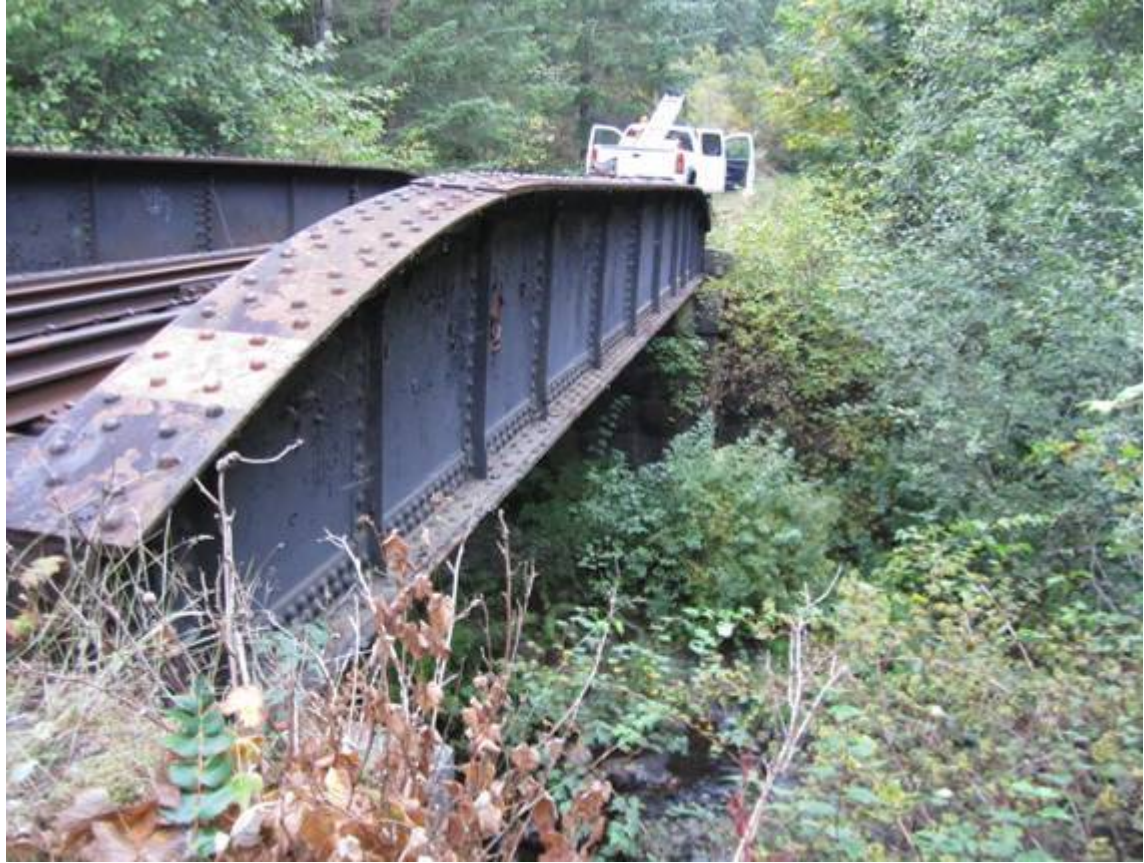
20 Mile 28.60 – Shawnigan Lake Tributary

Bridge 28.60 is a single span open deck bridge over a tributary of Shawnigan Lake. The superstructure consists of a 42 ft steel half deck plate girder with timber structural ties. The bridge is on a curved alignment.

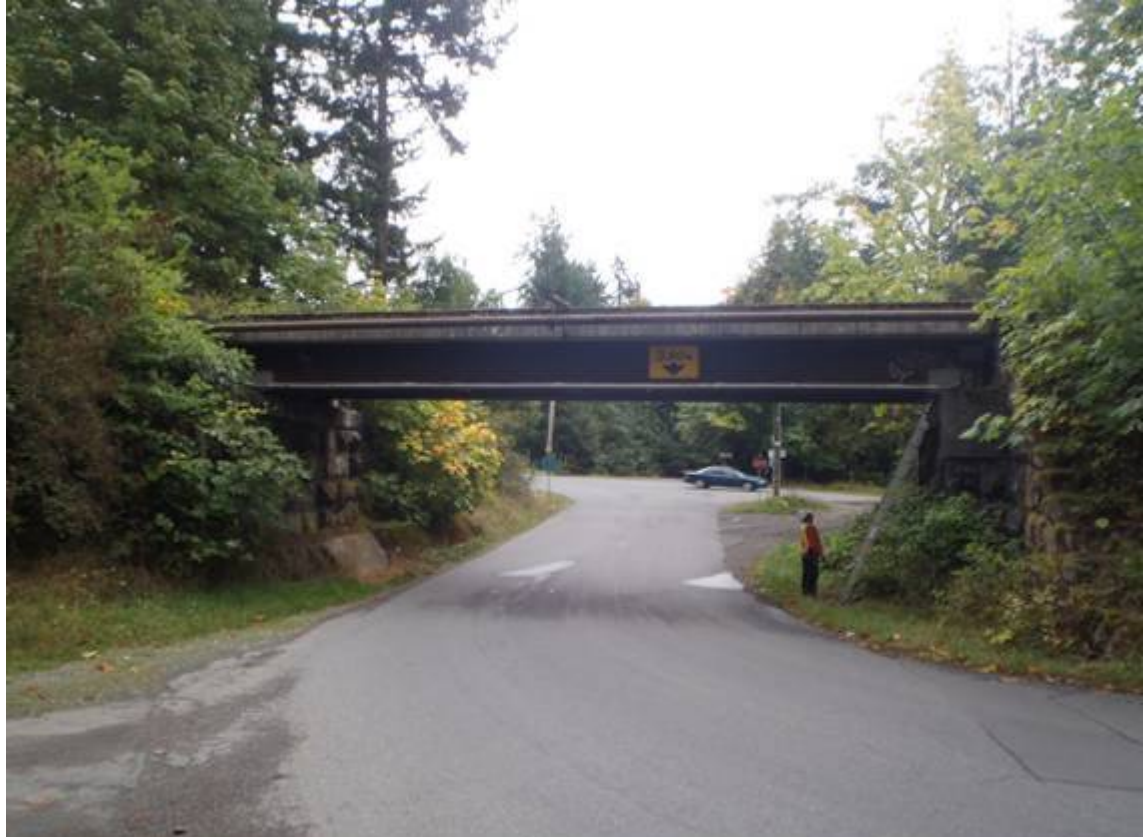
21 Mile 29.80 – Northgate Road

Bridge 29.80 is a single span ballasted deck bridge over Northgate Road. The superstructure consists of 45'-4" steel wide flange beams. The bridge is on a curved alignment.

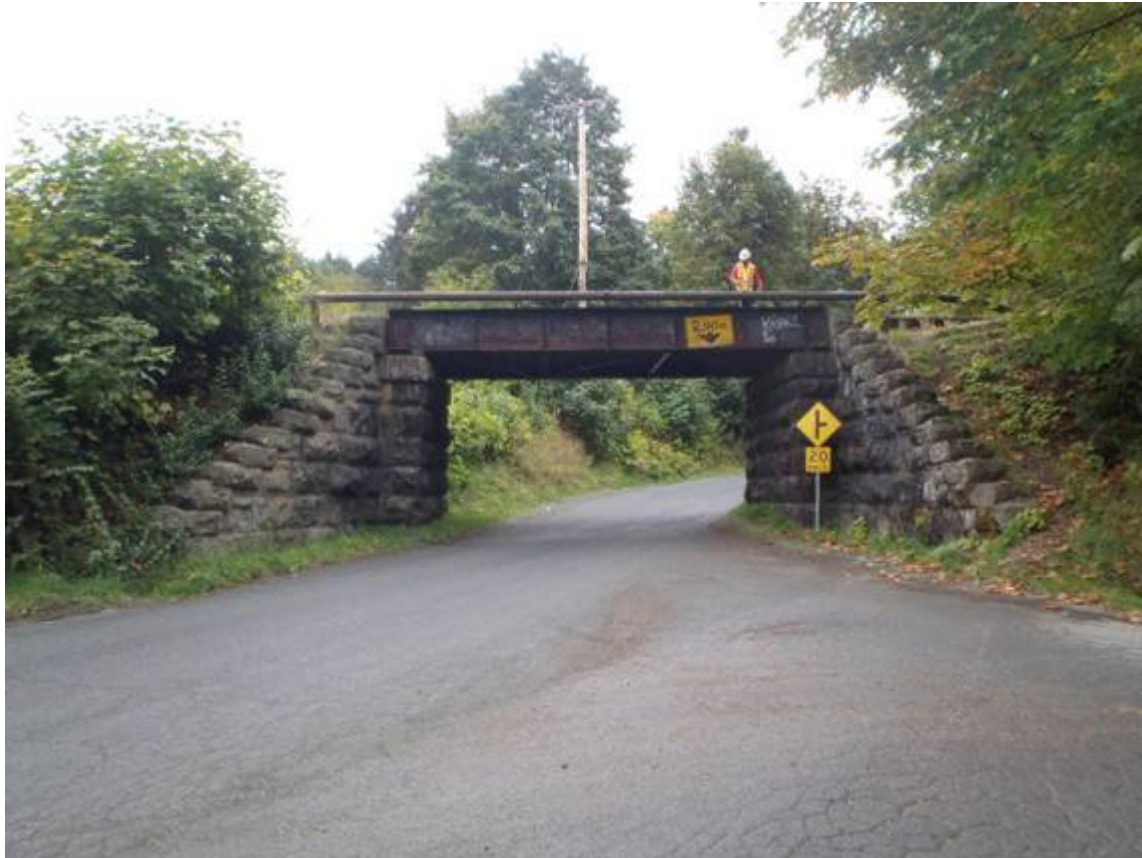
22 Mile 35.60 – Koksilah Road

Bridge 35.60 is a single span open deck bridge over Koksilah Road. The superstructure consists of a 27 ft steel half deck plate girder with timber structural ties. The bridge is on a tangent alignment.

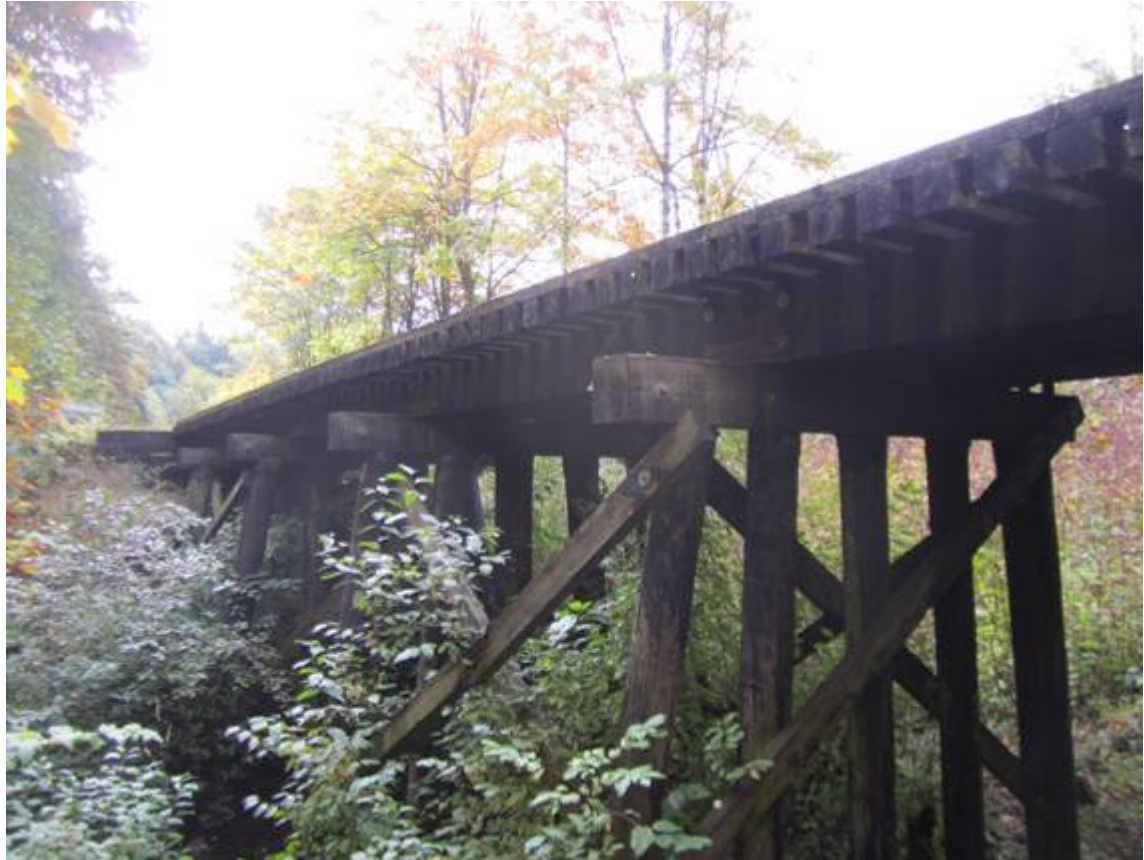
23 Mile 37.60 – Koksilah Overflow

Bridge 37.60 is a five span open deck bridge over Koksilah Overflow. The superstructure consists of timber stringers sitting on timber pile bents. The bridge is on a curved alignment.

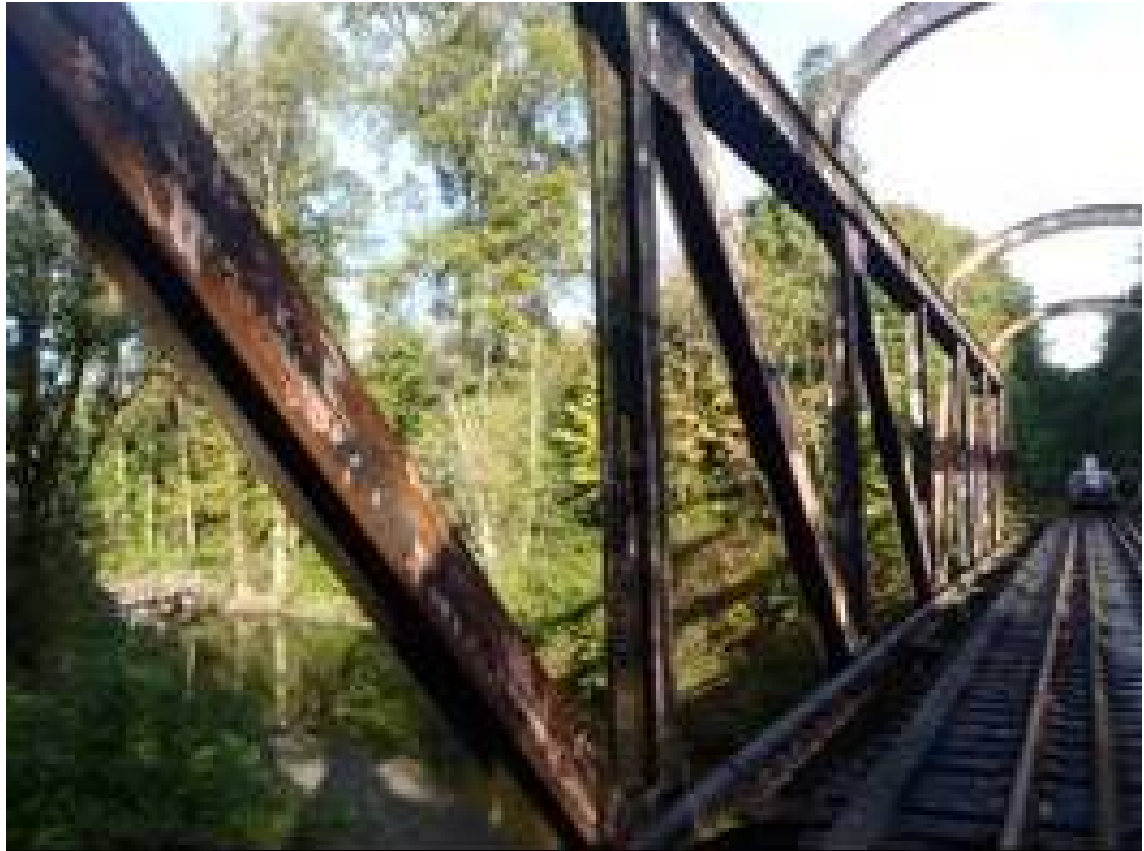
24 Mile 37.80 – Koksilah River

Bridge 37.80 is a single span open deck thru truss over Koksilah River. The floor system is composed of steel floor beams and stringers. The bridge is on a tangent alignment.
