Ministry of Transportation and Infrastructure

Bridge Inspection and Assessment - E&N Railway, Vancouver Island, BC, Canada

**Phase 2 - Evaluation Report
Bridge from Mile 1.30 to Mile 65.1 and two
Bridges on Wellcox Spur (28 Bridges) and
Executive Summary**

February 2012

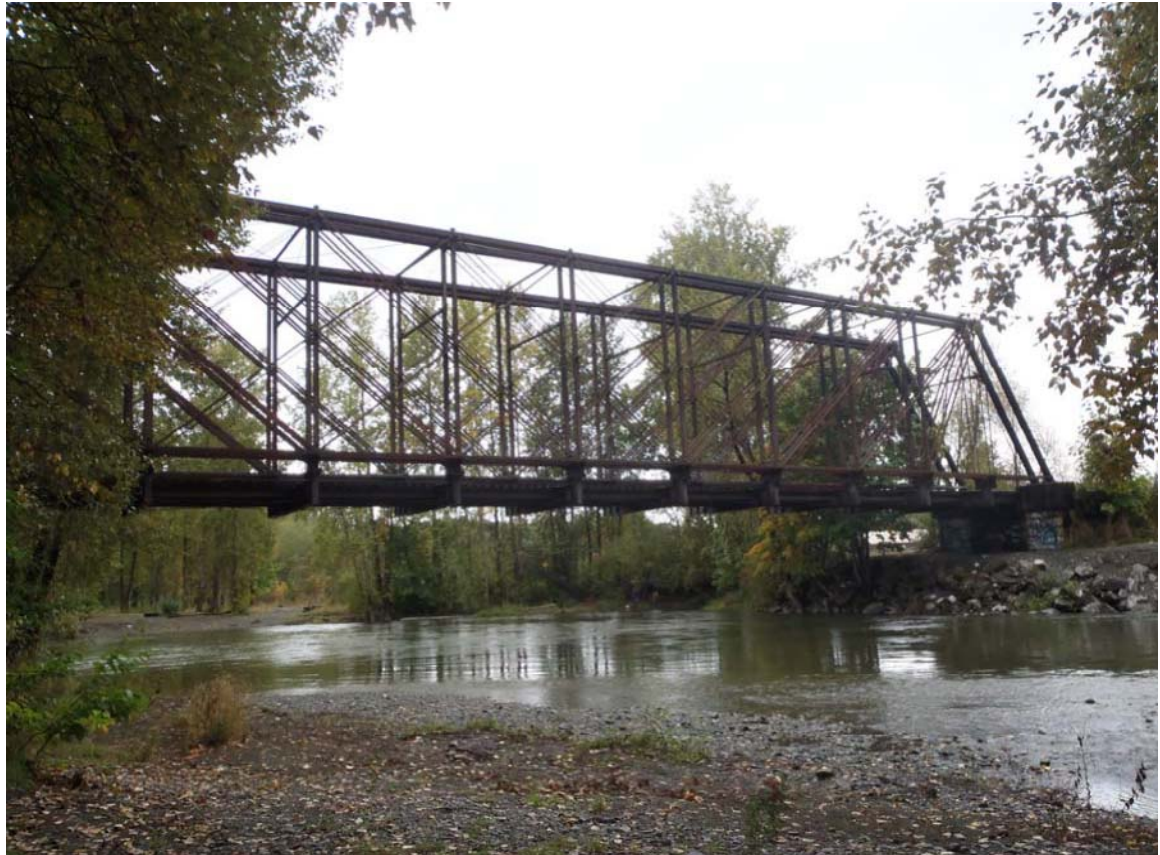
25 Mile 39.3 Cowichan River

Bridge 39.3 is a single span open deck bridge over the Cowichan River. The superstructure consists of a 219 ft. wrought iron double through truss (two trusses on each side of the rail line), with steel floor beams and stringers. The bridge is on a straight alignment.

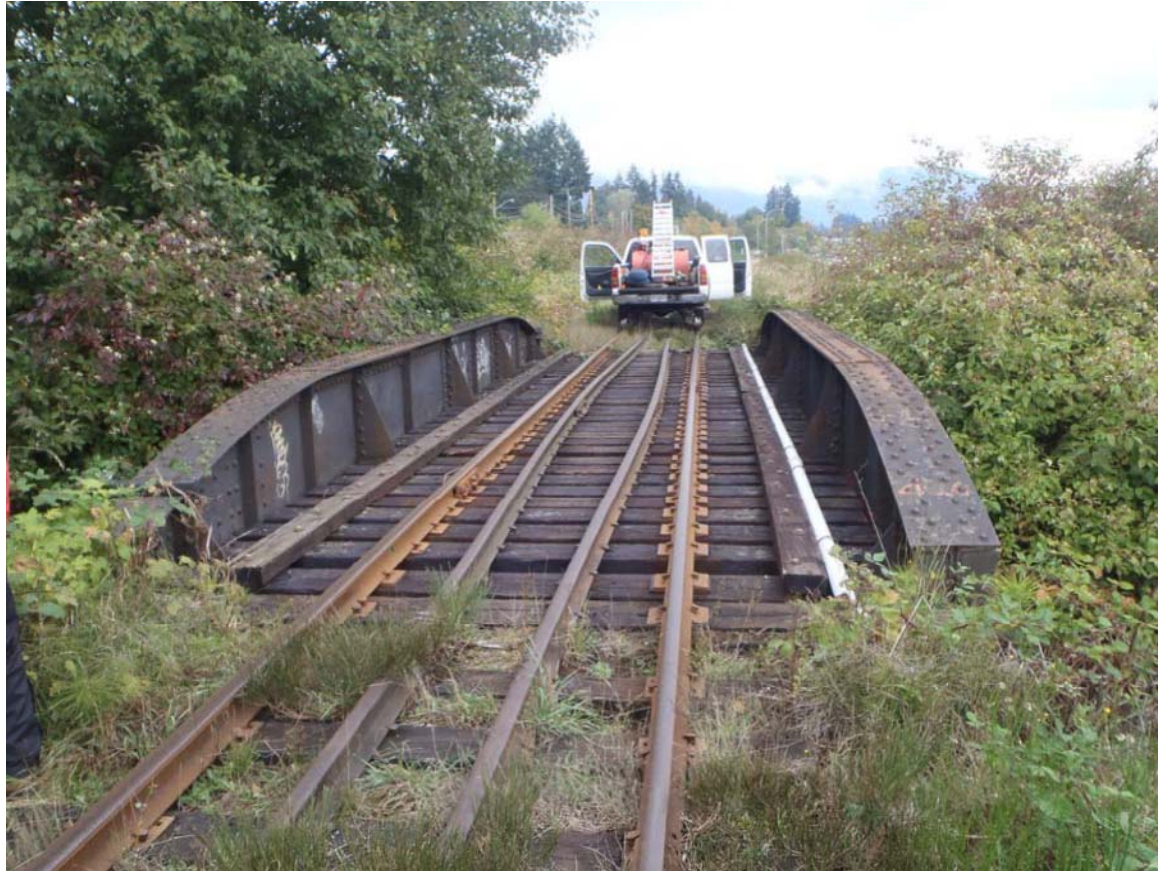
26 Mile 40.6 – Unnamed Watercourse

Bridge 40.6 is a single span, open deck bridge. The superstructure consists of a 38 ft. half depth steel plate girder. The bridge is on a straight alignment.

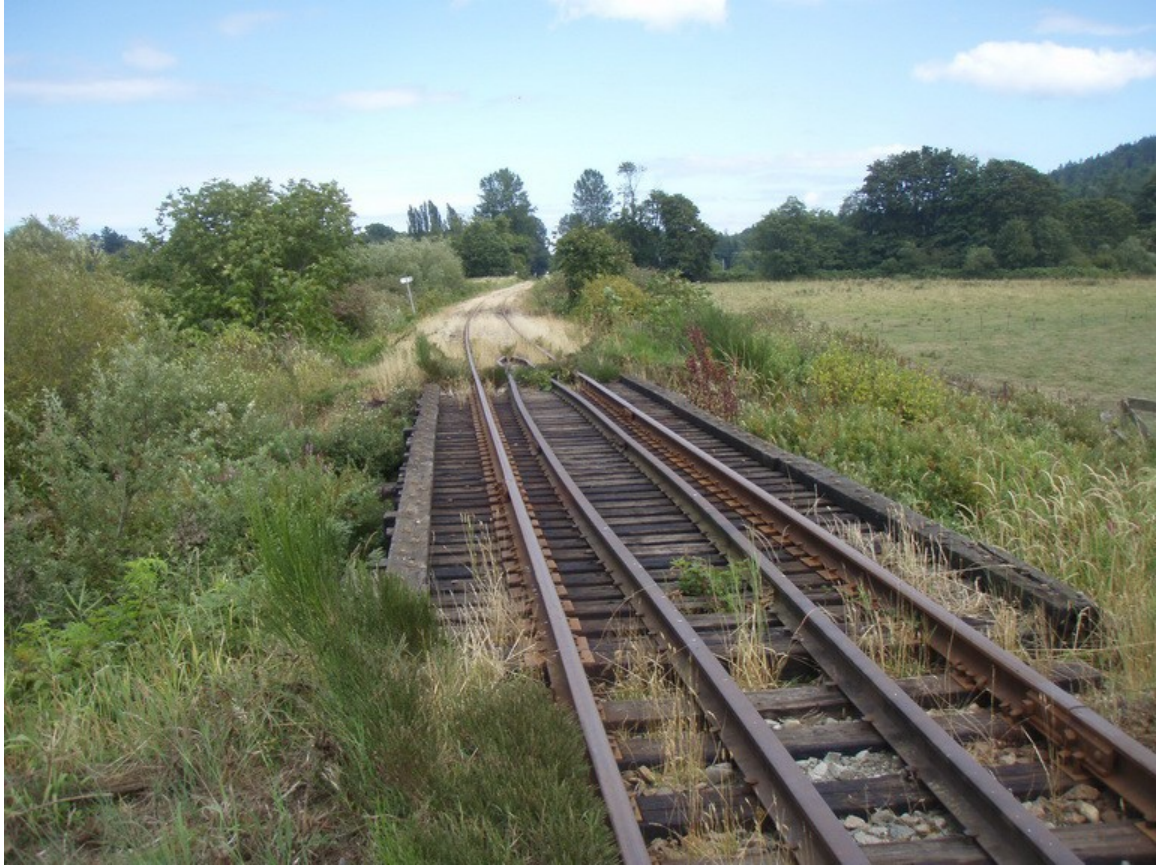
27 Mile 46.6 – Overflow

Mile 46.6 Bridge is a three-span pile trestle with span configuration: 14'-5" – 15' – 14'-5". The trestle was constructed in 1973. The bridge is constructed in accordance with CP standard plans for E60 loading.

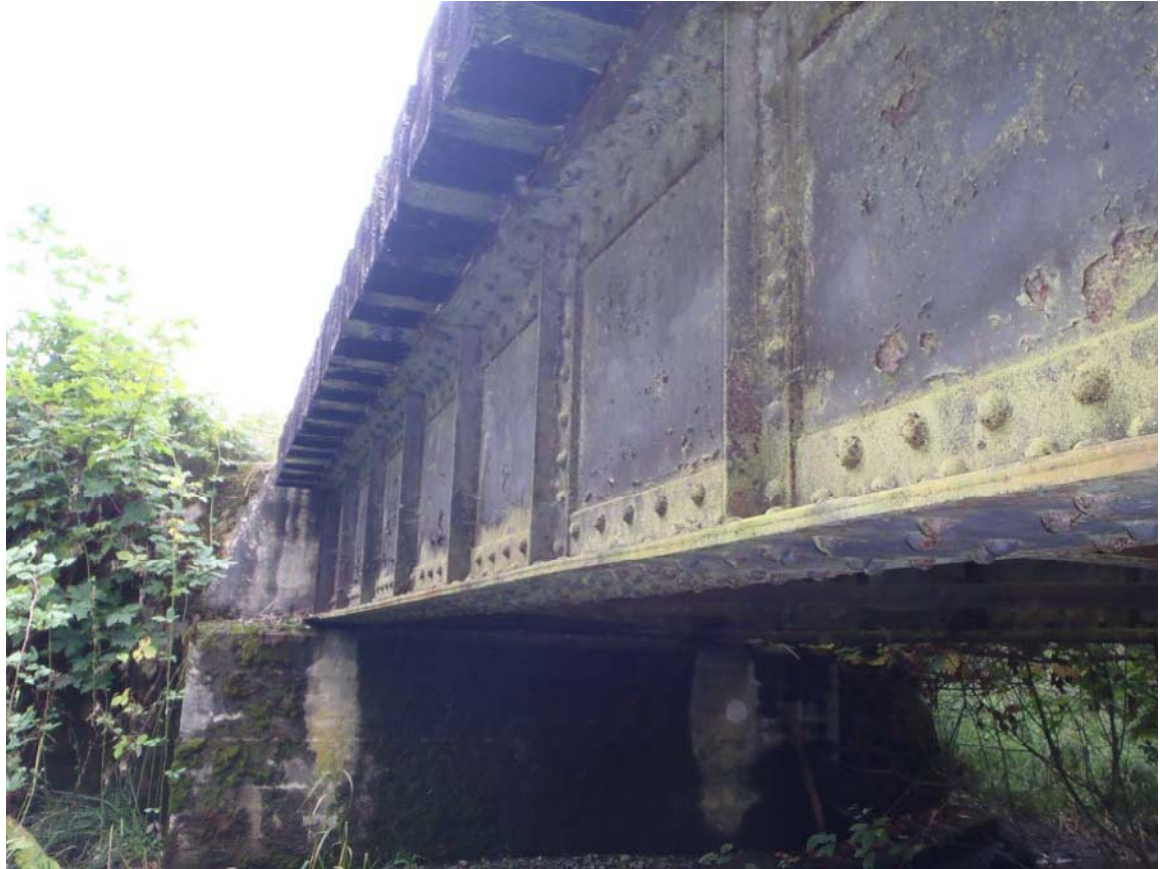
28 Mile 46.8 – Whitehouse Creek

Bridge 46.8 is a single span open deck bridge over Whitehouse Creek. The superstructure consists of a 30 ft. steel DPG span with wood structural tie deck. The bridge is on a straight alignment.

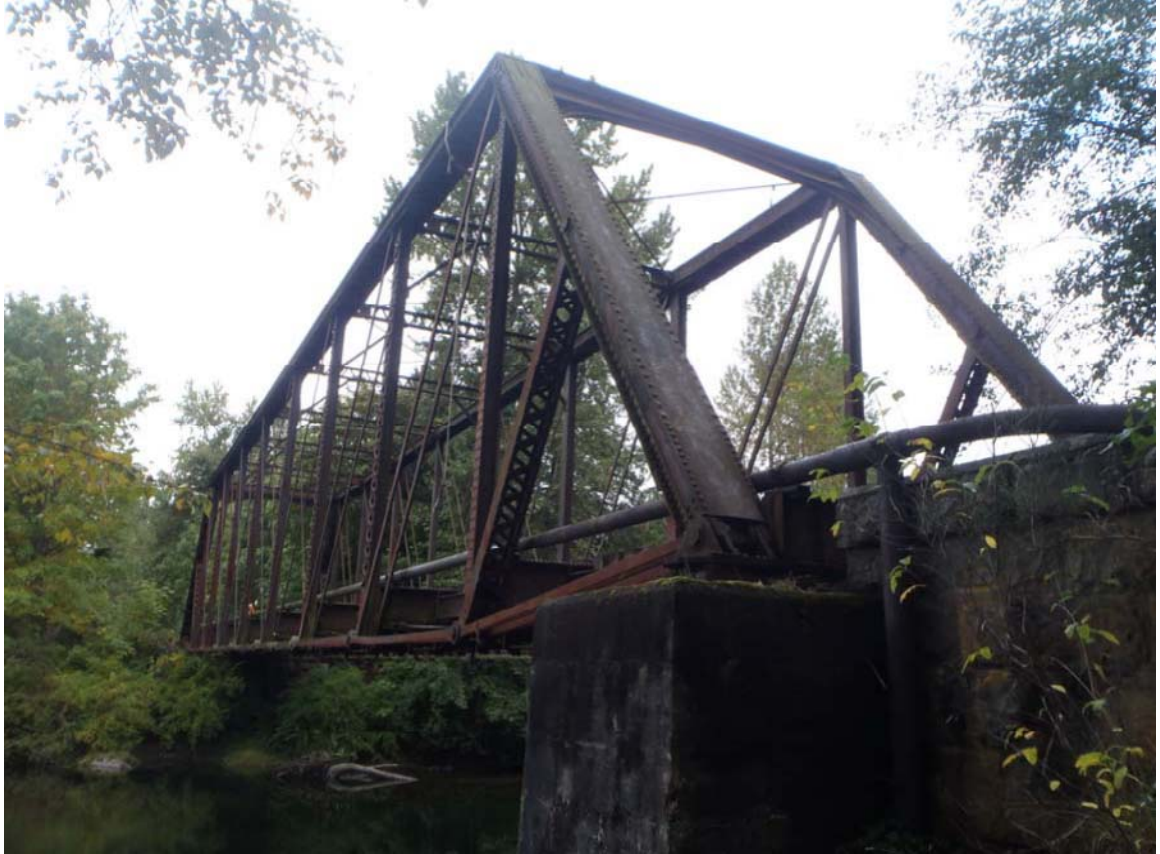
29 Mile 47.9 – Chemainus River

Bridge 47.9 is a single span open deck bridge over the Chemainus River. The superstructure consists of a 155'-6" ft. steel through truss, with steel floor beams and stringers. The truss was previously used on a different location. The bridge is on a straight alignment. The bridge was reinforced in 1940's; bridge stringers were reinforced by queen posts (4 rows of adjustable eye bars).

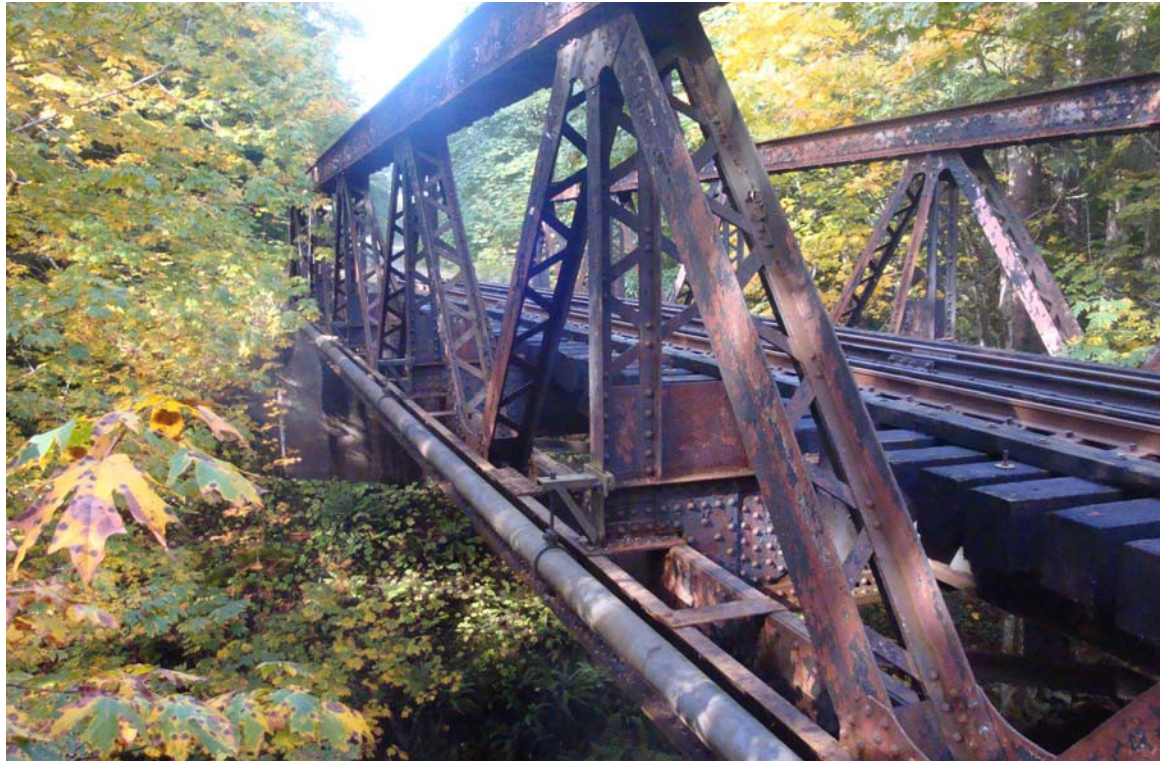
30 Mile 60.7 – Harrison Creek

Bridge 60.7 is a single span open deck bridge over the Harrison Creek. The superstructure consists of a 106 ft. steel (material unconfirmed) through pony truss, with steel floor beams and stringers. The bridge is on a slight horizontal curve (4 degree curve R). The rail offset from the bridge centerline is 8" at abutments and 4" in the opposite direction at the mid span. As the eccentricity is relatively low and the impact of centrifugal force is minute considering the low train speed (maximum allowable speed of 10 mph for GP-9 locomotives and 286 kip cars), the impact of horizontal curvature on the load evaluation results is negligible.

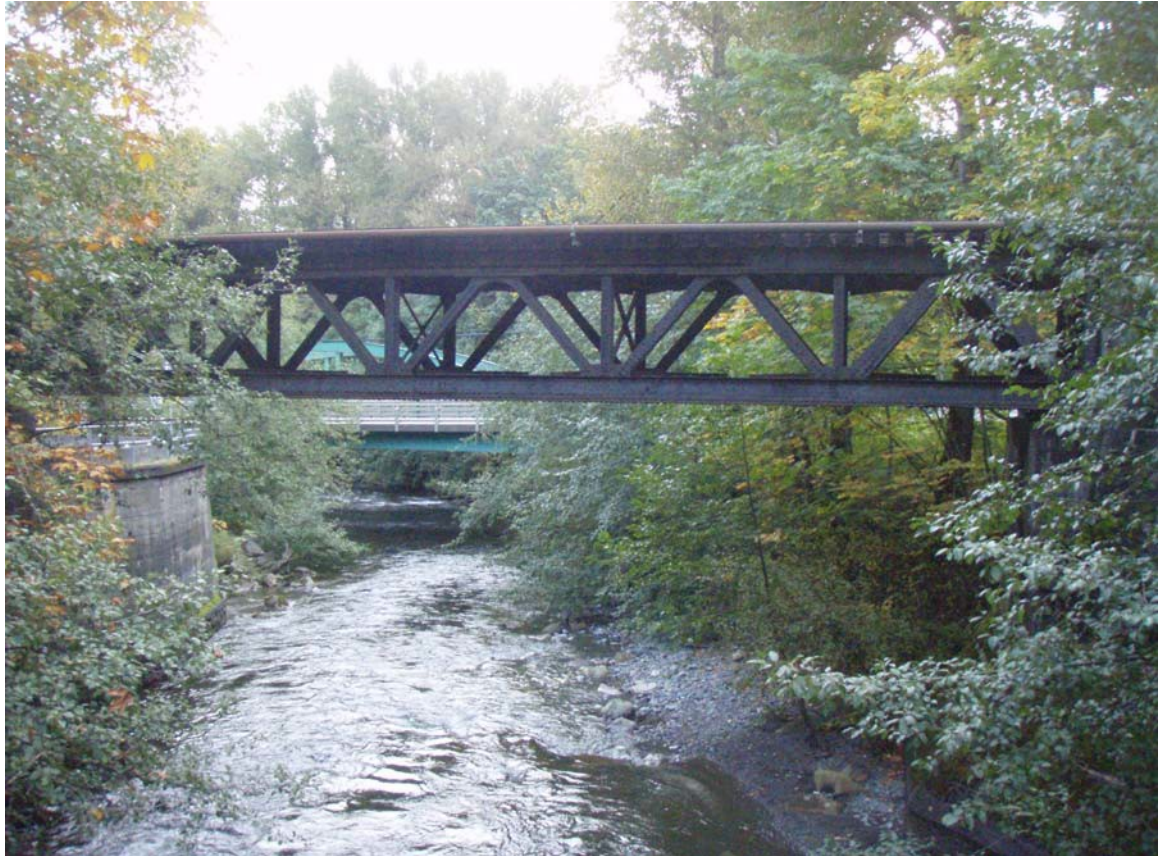
31 Mile 64.4 – Lochner Road and Haslam Creek

Bridge 64.4 is a two-span open deck bridge over the Haslam Creek River. The superstructure consists of one southern span of 76'-4" deck truss, with steel floor beams and stringers and a northern span of 25 ft 5-inches with steel I-Beam Stringers. The bridge is on a straight alignment.

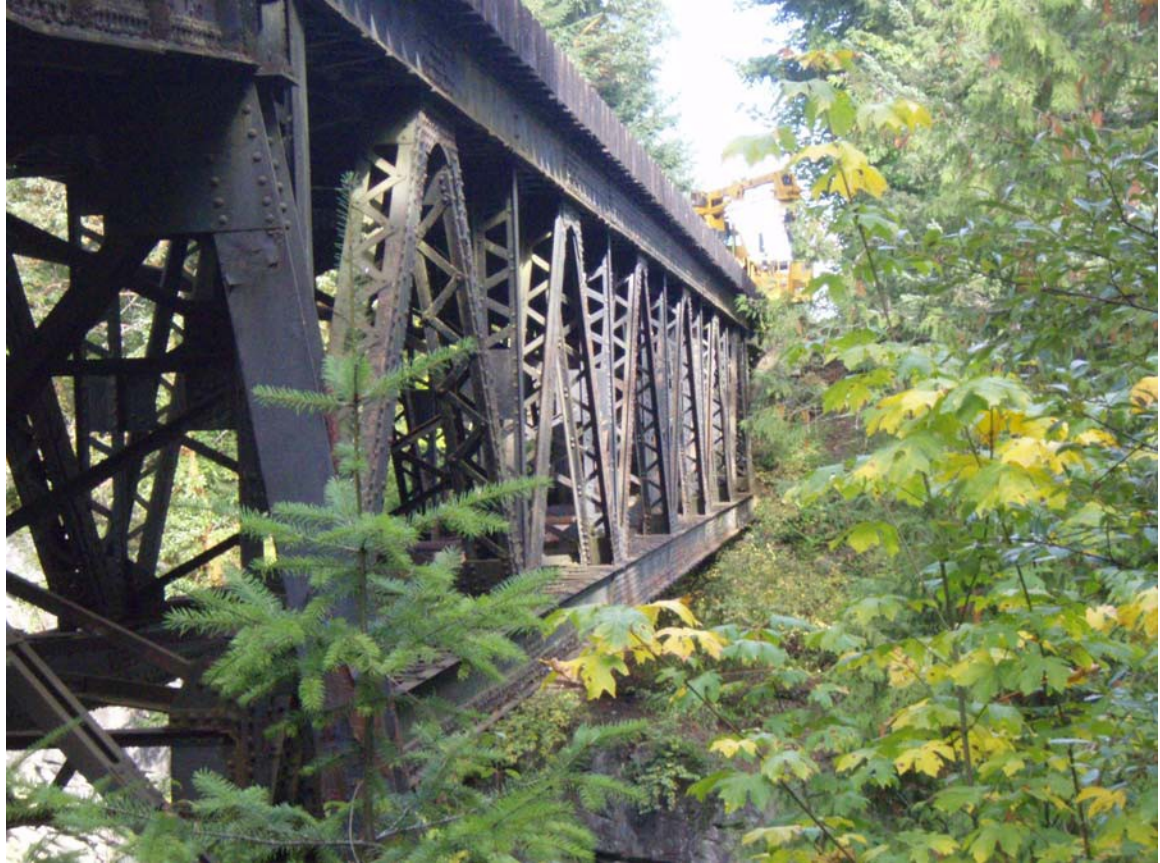
32 Mile 65.1 – Nanaimo River

Bridge 65.1 consists of three steel spans. End spans are DPG's with spans of 40' and 28'-11". Main span is a steel deck truss with a span of 128'. The bridge is on a tangent alignment. The structure is supported on masonry block piers and abutments. The piers and one of the abutments are bearing on the natural rock (sandstone bluff) while the other abutment is supported by timber piles. The piers are situated above a deep canyon; stability of sandstone bluff supporting the piers is a concern although there is no evidence of movement of the supporting rock.

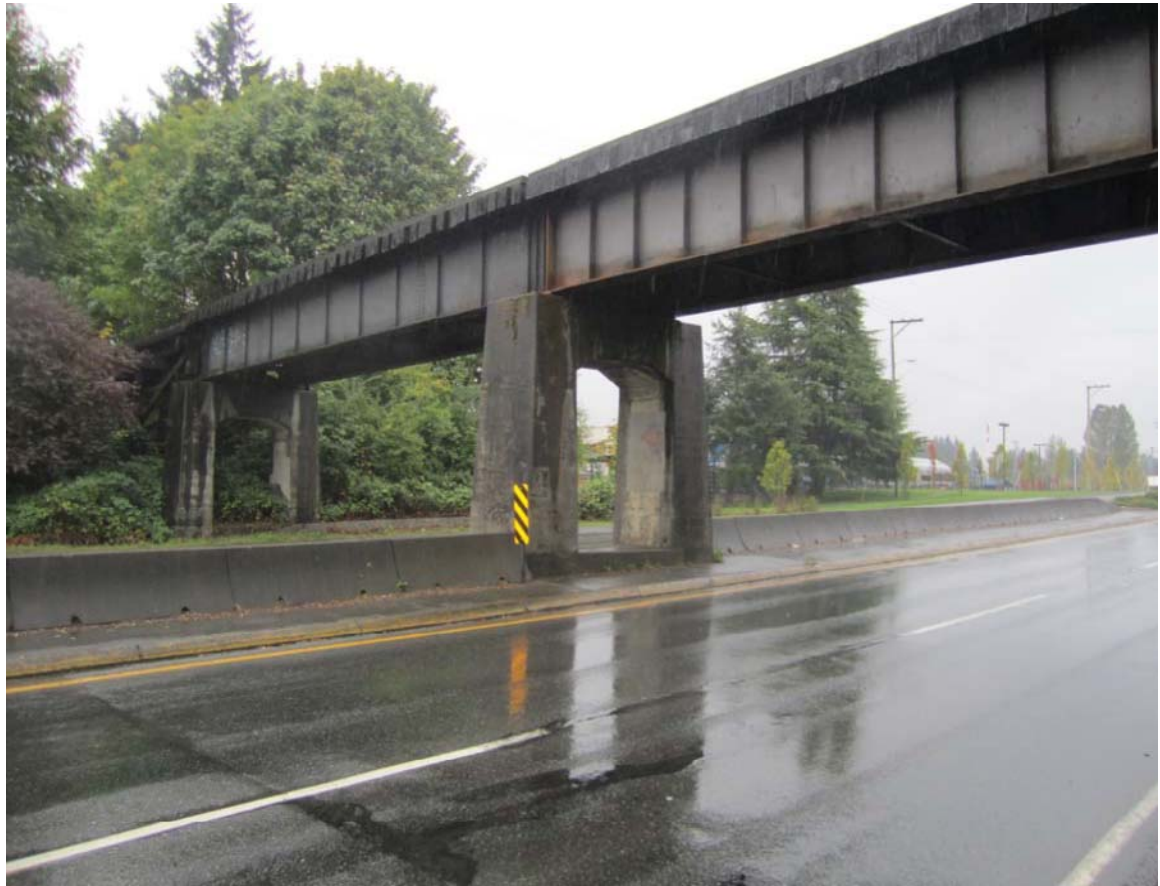
33 Mile 0.69 – Wellcox Spur – Old Island Highway

Bridge 0.69 consists of two 53'-4" steel deck plate girders spanning over the highway, with 2-15' timber trestles on both sides of the bridge. One girder is riveted, constructed in 1953, while the other girder is welded plate girder, constructed in 1975, as well as timber stringers in the approach spans. Timber trestles, with two-four ply timber stringers, are conforming to CP standard design for E60 loading, supported centrally by a timber trestle. The bridge is on a straight alignment.
