Ministry of Transport and Infrastructure Holt Creek Trestle Bridge Replacement – Aquatics Effects Assessment

Project No. 107554-01

July 7, 2023

Ausenco Sustainability Inc.
18th Floor, 4515 Central Boulevard
Burnaby, BC, Canada V5H 0C6
T +1.604.669.0424
F +1.604.669.0430
W ausenco.com

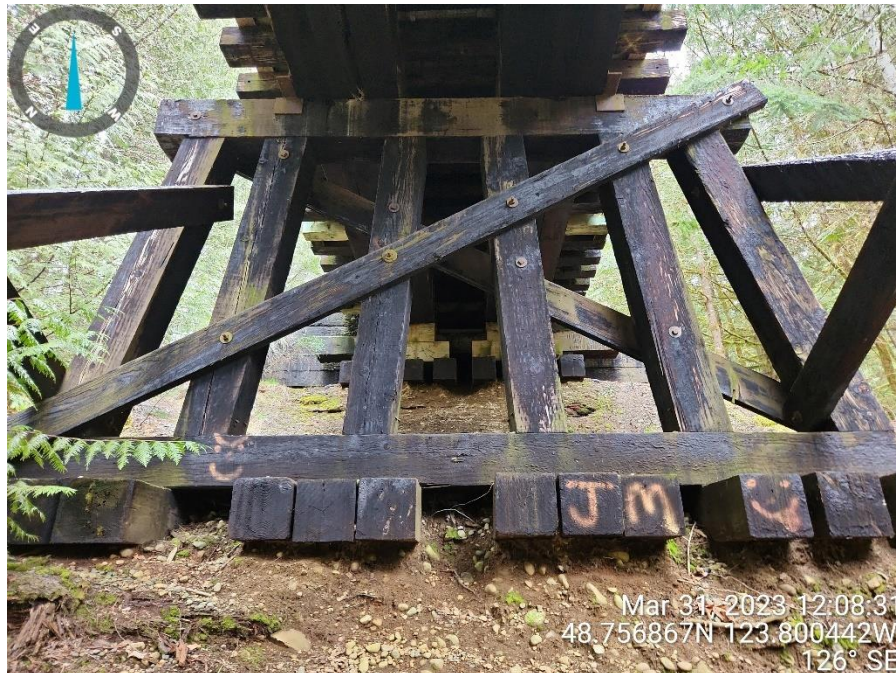
Photo 2 Existing creosote timbers and concrete footings located within the riparian habitat, Facing southeast.

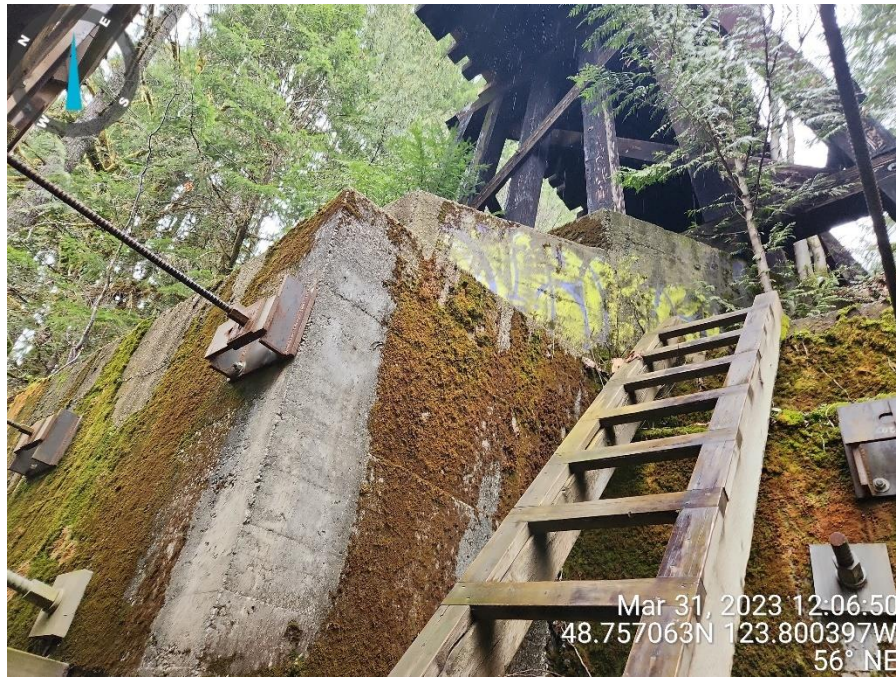
Photo 3 Existing eastern abutment supporting creosote timbers, Facing northeast.

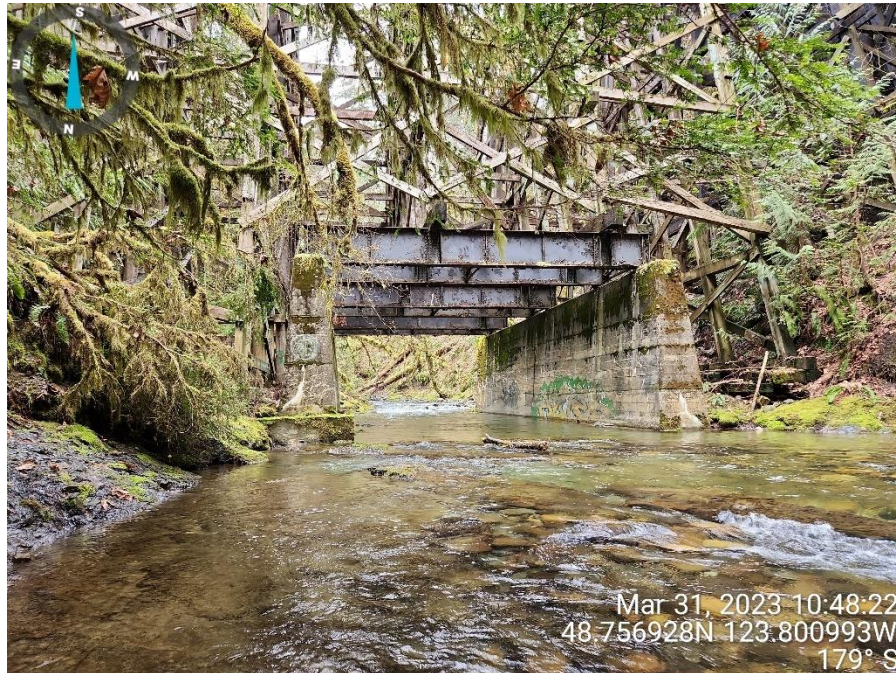
Photo 4 Existing instream footings (to remain) supporting steel beams and wooden trestle. Facing southwest.

The existing concrete footings (to remain in place) are located in the wetted area of Holt Creek, at a natural narrowing of the channel (**Appendix B – Photos 4. 5 and 6**). Visual assessments carried out by Hemmera/Ausenco biologists in 2021 and 2023 indicate that the footings do not create a barrier to fish passage nor do they constrict the channel such that increased velocities would hinder fish passage. No large or small woody debris was observed within the trestle footprint, but log jams are known to occur (Hemmera 2021).

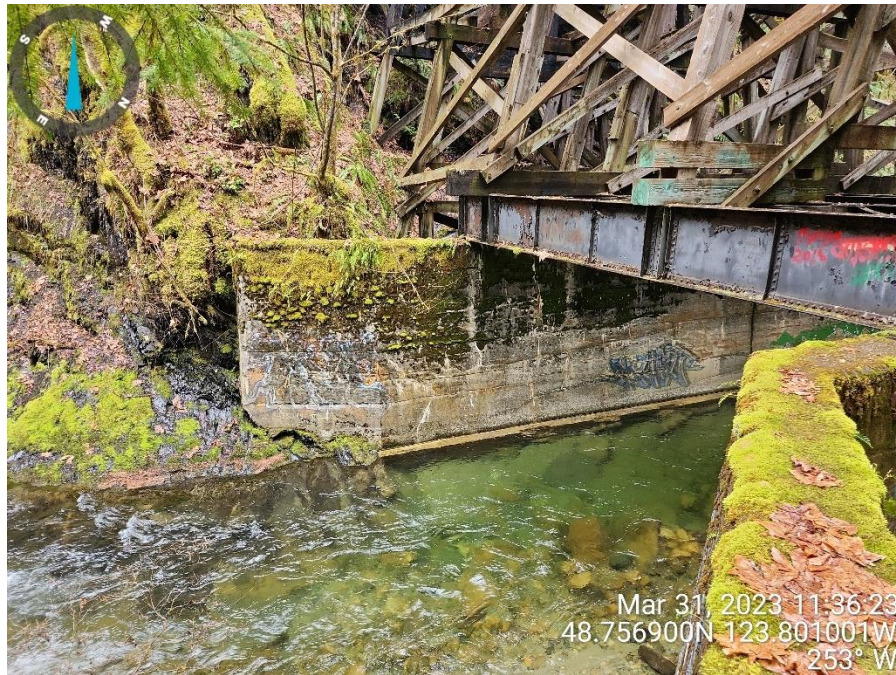
Photo 5 View of existing instream footings (to remain) Upstream facing west.

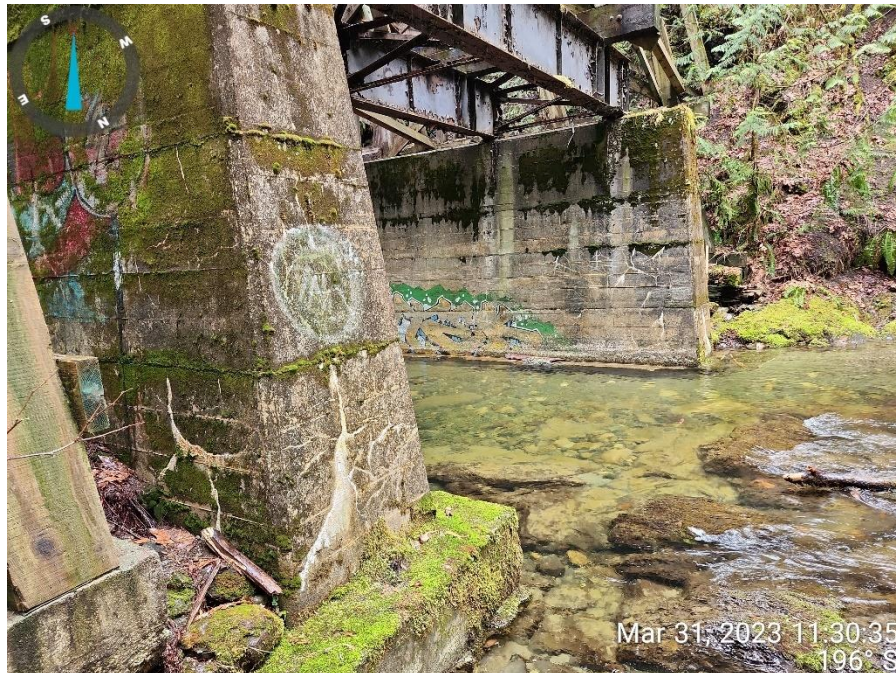
Photo 6 View of existing instream footings (to remain) Downstream Facing south.

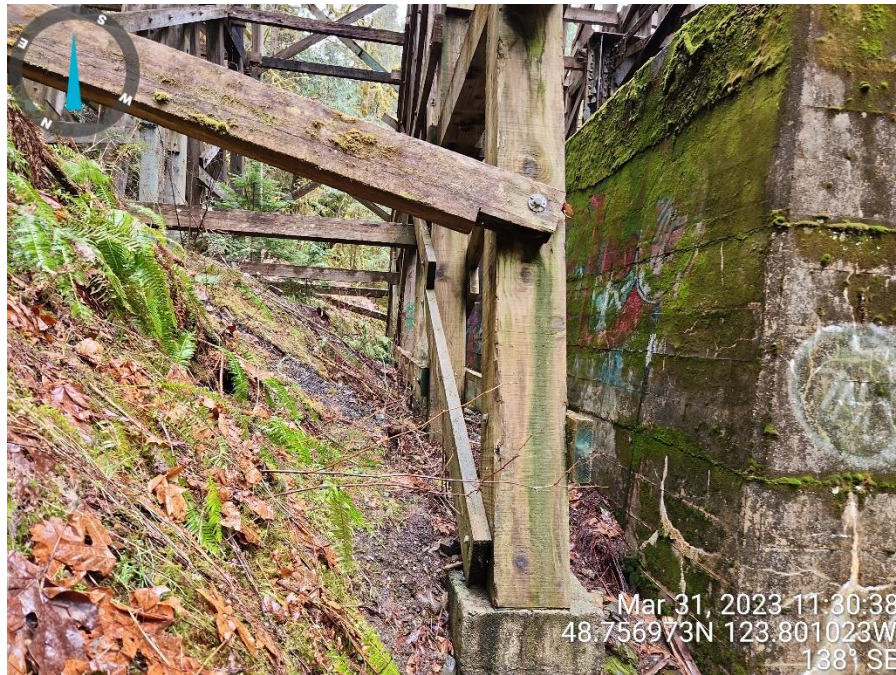
Photo 7 Bridge components (small concrete footings and timber supports) are to be removed. Facing southeast.

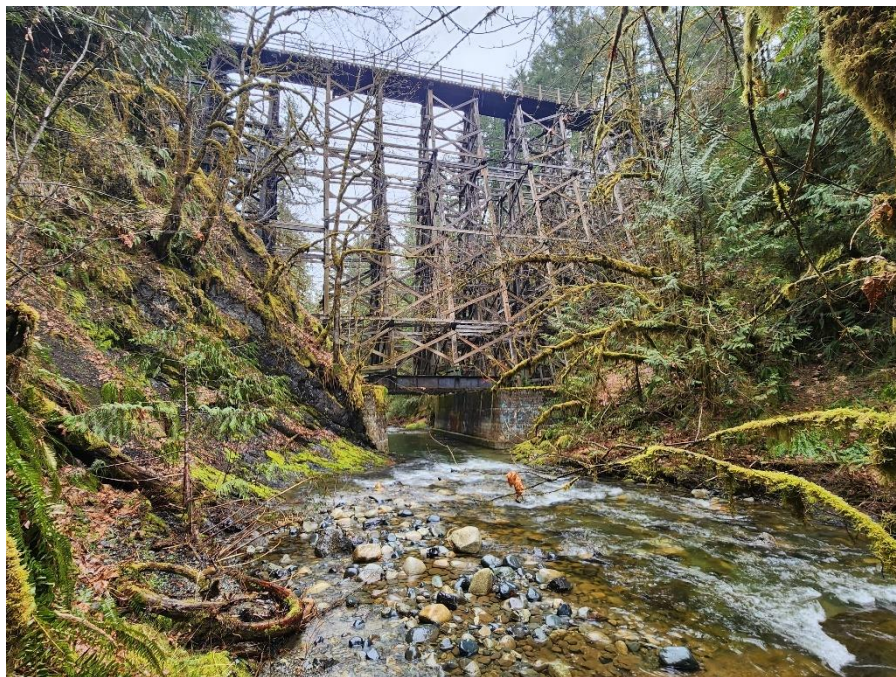
Photo 8 Existing wooden trestle to be removed. Facing south.

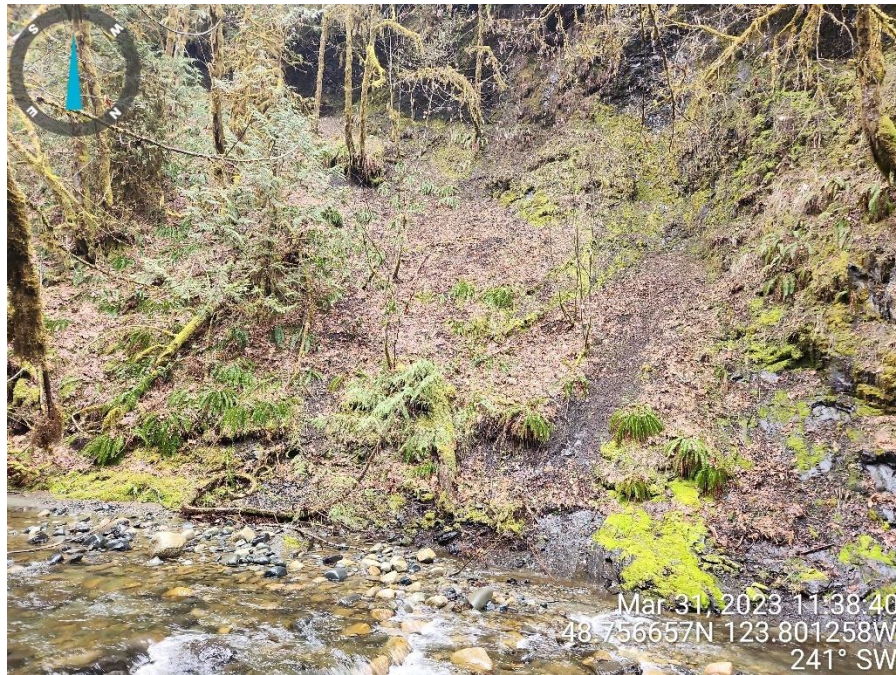
Photo 11 Erosion of the west bank observed upstream from the bridge. Facing southwest.

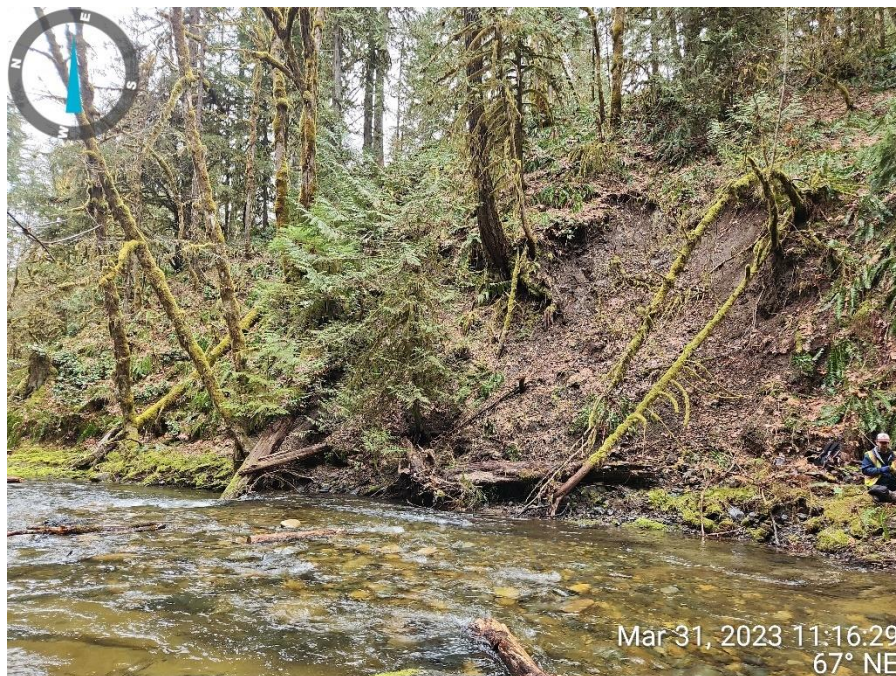
Photo 12 Erosion of the east bank located downstream from the bridge. Facing northeast.

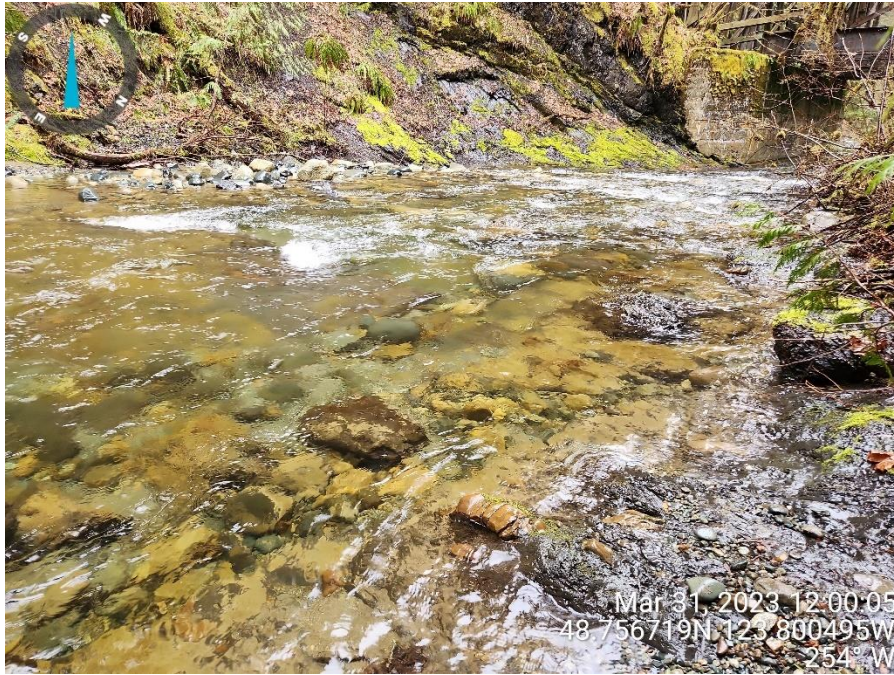
Photo 13 View of instream habitat. Facing west.

Instream substrate within the study area is characterized by exposed bedrock, boulders, and large cobbles that provide abundant interstitial spaces and micro habitat for rearing juvenile salmonids. Small intermittent areas of gravels (<5%) were also noted.

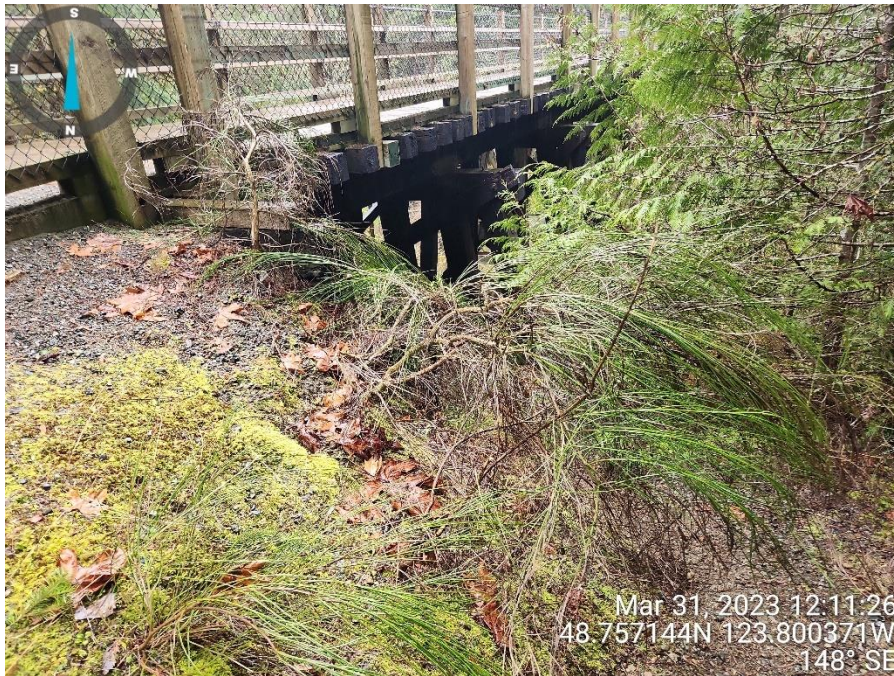
Photo 14 Invasive plant (scotch broom) observed at the west access. Facing southeast.

In the absence of post-construction restoration, vegetation removal and disturbance of soil may increase the potential for invasive or non-native vegetation growth (e.g., scotch broom), which could result in long-term changes to habitat structure and diversity. In addition, vegetation clearing may result in the removal of wildlife habitat features (e.g., wildlife trees, or snags), which are not readily replaced and typically take time to develop in a maturing forest.
