Pavement Rehabilitation Assessment East Porpoise Bay Road/Sechelt Inlet Road

PRESENTED TO
British Columbia Ministry of Transportation and Infrastructure

SEPTEMBER 16, 2022
ISSUED FOR USE
FILE: 704-TRN.PAVE03225-08

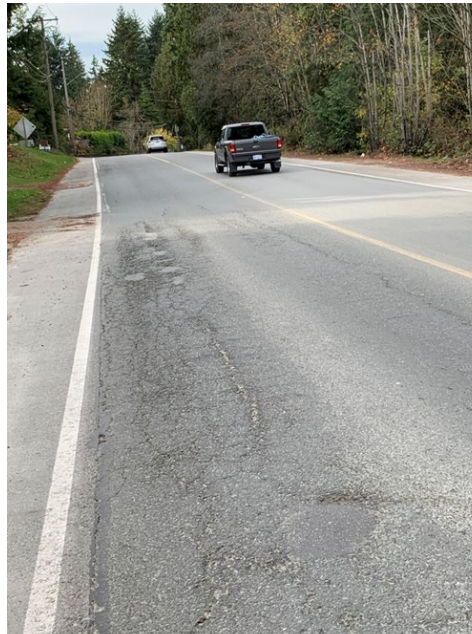
Photo 1: General Condition of the Roadway showing Fatigue Cracks

The pavement surface was generally observed to be in poor condition with excessive fatigue cracking in the wheelpaths at several locations. The pavement surface was also observed to be ravelled. The ride quality was determined to be very poor during the site reconnaissance.

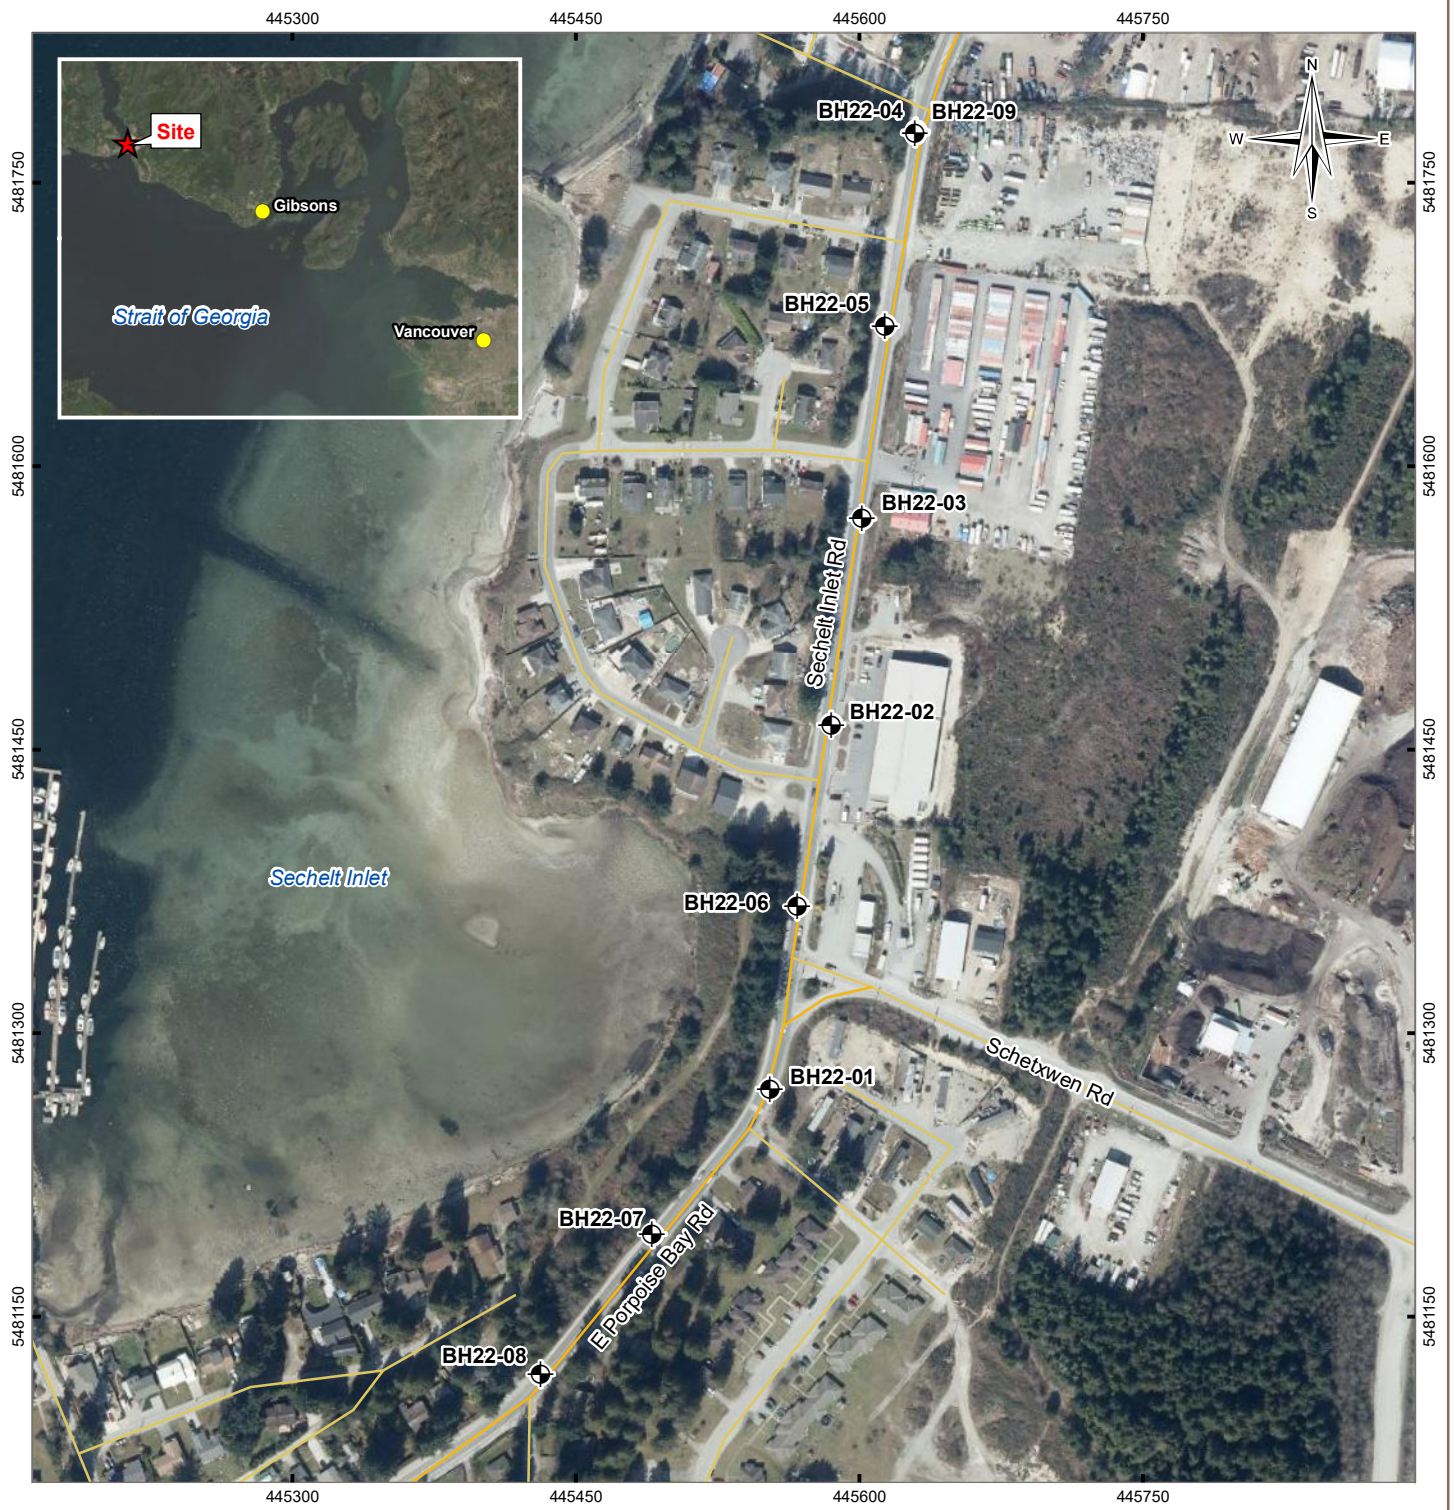
SITE PLAN SHOWING LOCATION OF BOREHOLES

This report provides the findings of Tetra Tech's field exploration, data review and rehabilitation recommendations. A Site Plan showing the borehole location and general location of the project roadway segment is included as Figure 1.
