East Porpoise Bay Road Sechelt Inlet Road Improvements

Environmental Overview Assessment

Prepared for:

[BC Ministry of Transportation and Infrastructure](#)

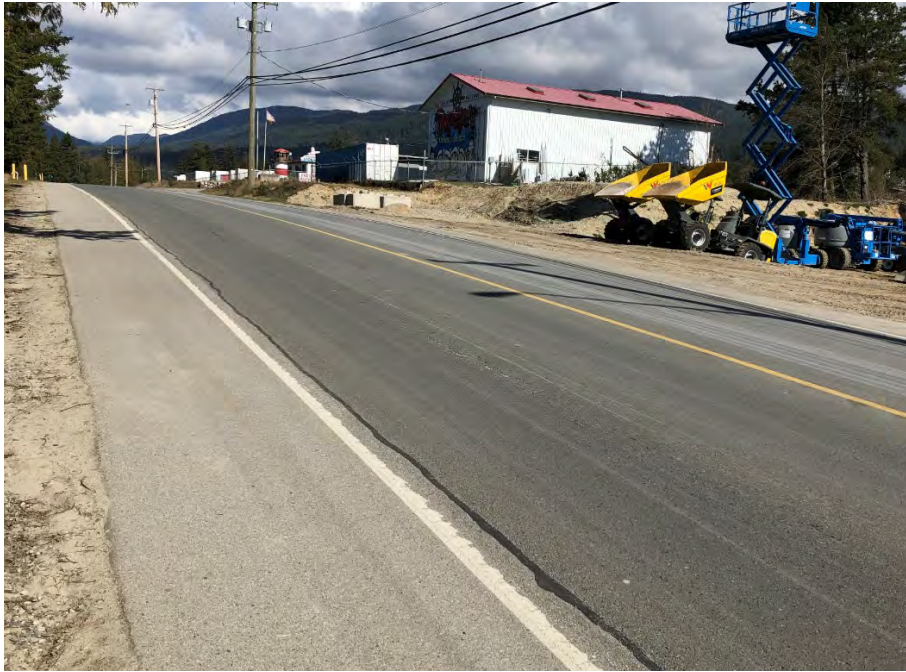
Photo 1 Sechelt Inlet Road, facing northeast.

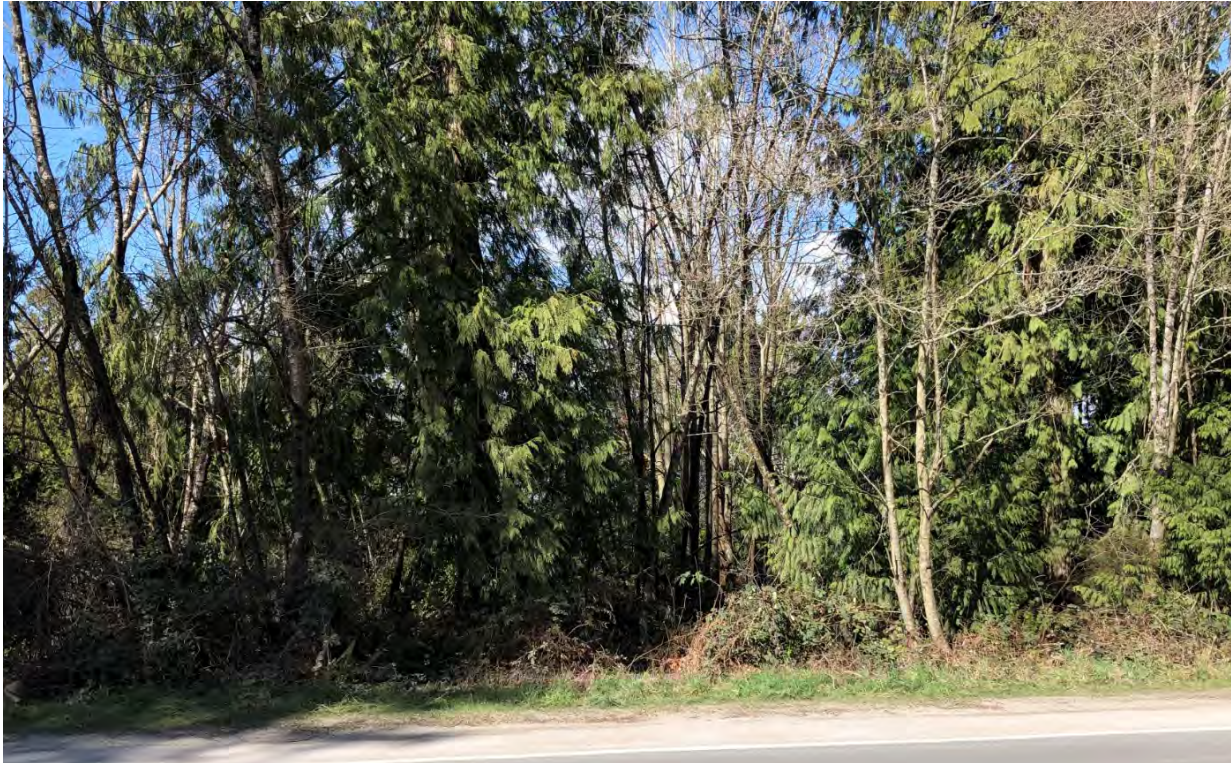
Photo 2 Typical representation of western side of Sechelt Inlet Road. Photo taken at 100+90 near Sechelt Inlet Road and Xenichen Avenue, facing west.

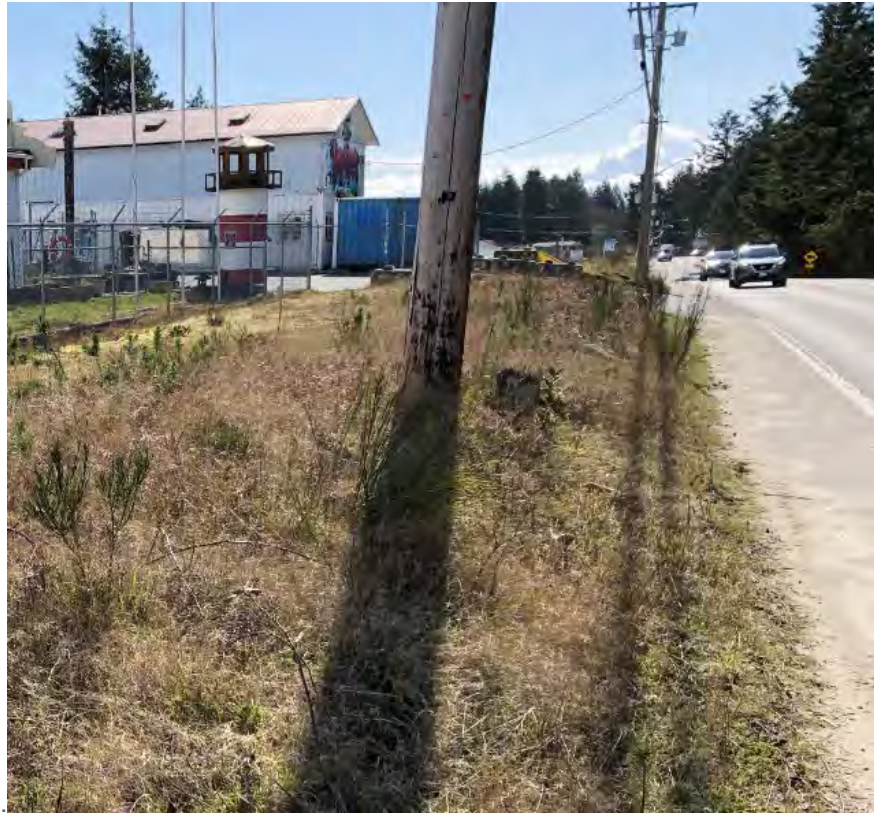
Photo 3 East side of Sechelt Inlet Road is sparsely vegetated. Photo taken facing south.

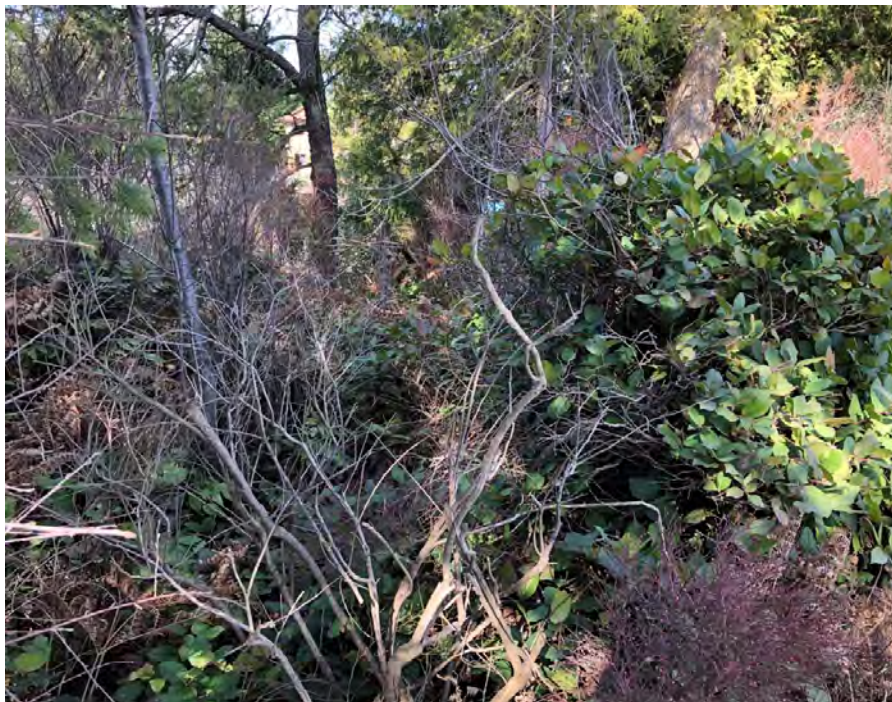
Photo 4 Dense understory coverage observed in wooded area along the western side of Sechelt Inlet Road. Photo taken approximately 50 m north of the intersection with Kunut Avenue, facing northwest.

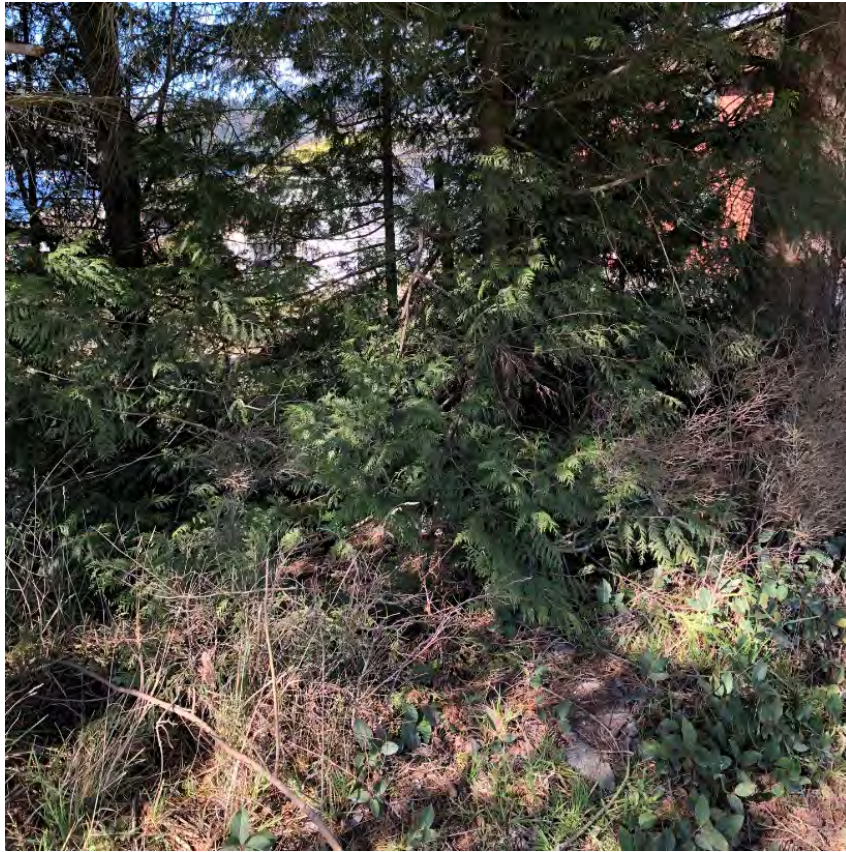
Photo 5 Dense understory cover observed along western side of Sechelt Inlet Road. Photo taken facing west, approximately 40 m south of the intersection with Kunut Avenue.

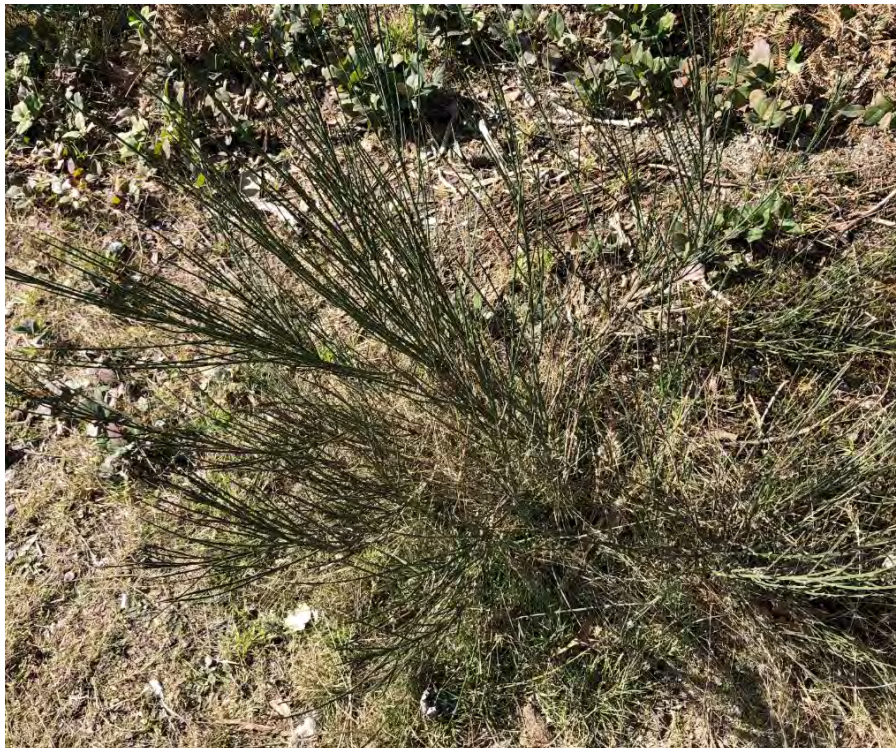
Photo 6 Scotch Broom plant growing on the west side of Sechelt Inlet Road. Photo taken facing southwest.

- › All noxious weed material must be placed into impermeable plastic bags and tightly secured;
- › Remove noxious weeds by manual and hand methods. Do not use machinery, burning or herbicides to control noxious weeds;

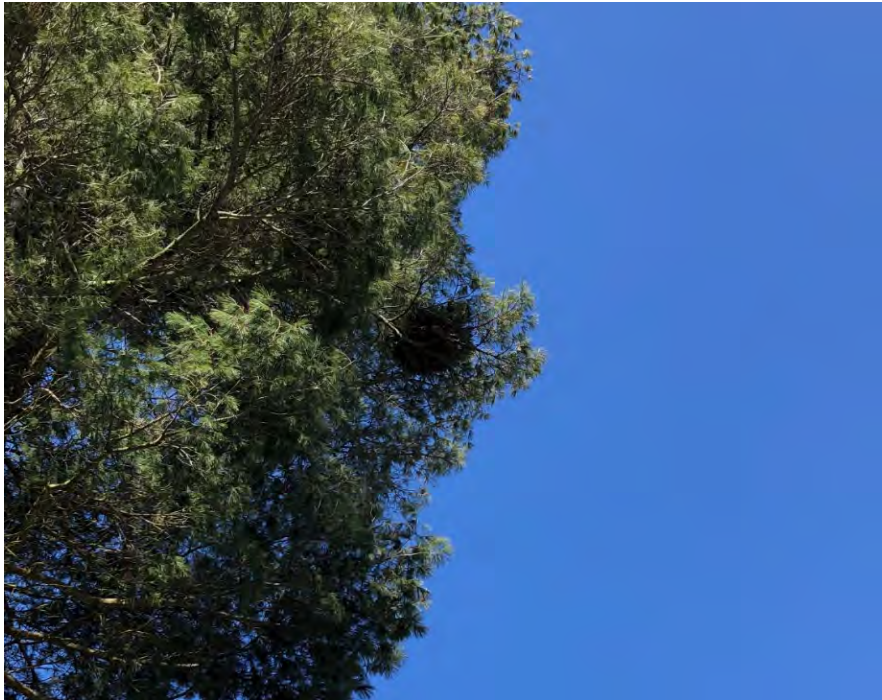
Photo 7 Inactive American crow nest located on the western side of Sechelt Inlet Road, near the intersection with Slim Street, at 101+80 (facing west)

- › The songbird nesting season in zone A1 occurs between March 16 and August 15 (ECCC, 2021);
- › Project works such as vegetation clearing and tree removal, are recommended to take place outside of this period. If works are required within this period, bird nest surveys may be required;
- › The regional least-risk window for fish for the South Coast Region occurs between August 1 and September 15 (BC MoE, 2006); and
- › If feasible, conduct Project works within this period.

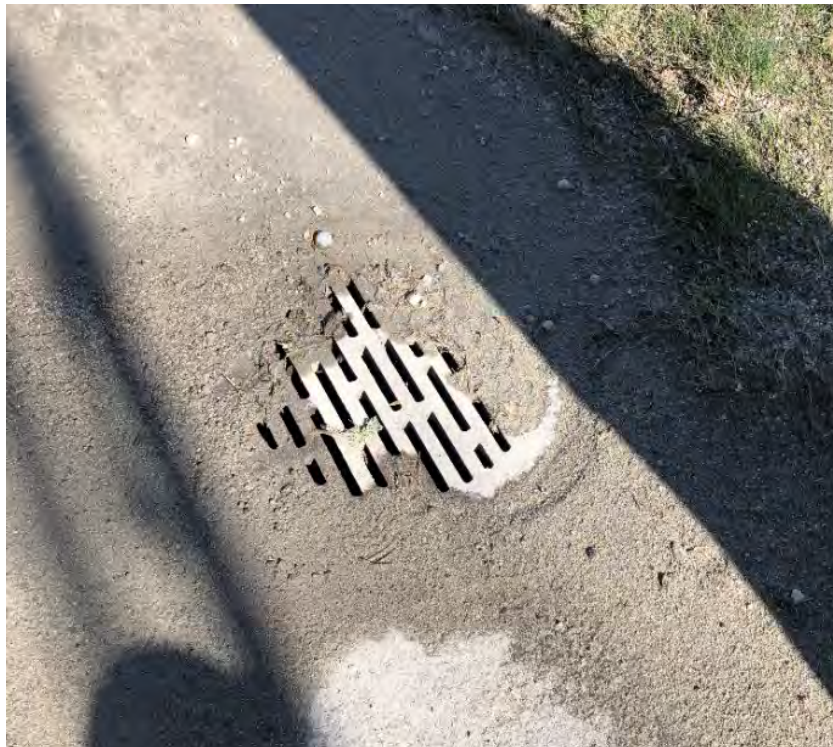
Photo 8 Catch basin located on the western shoulder of Sechelt Inlet Road, in front of Columbia Fuels at 103+40. Photo taken facing northeast.

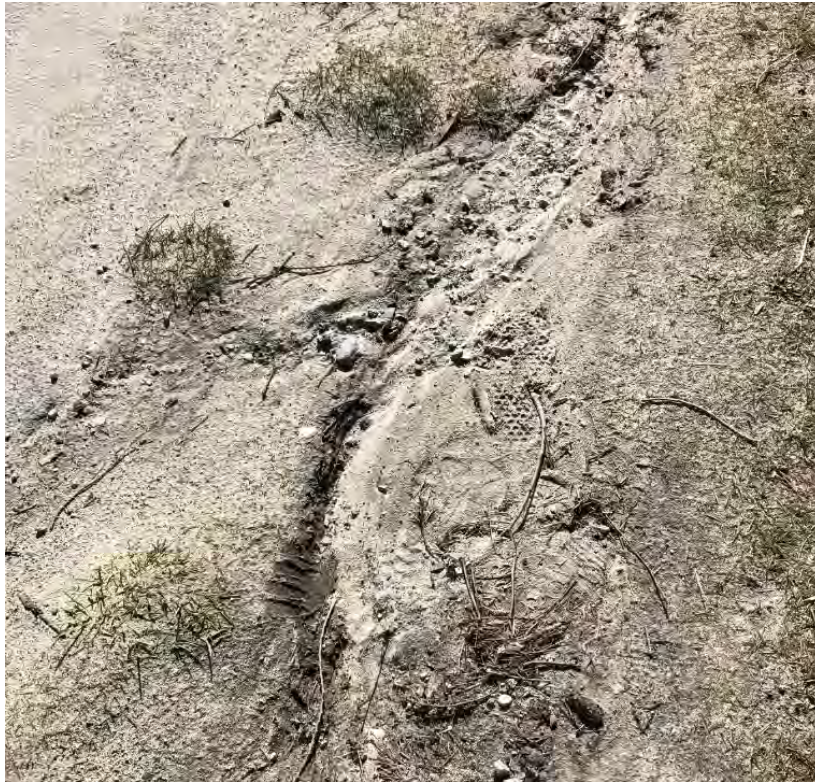
Photo 9 Evidence of north to south drainage along the west side of Sechelt Inlet Road. Photo taken facing south near the intersection with Tsulich Drive at 104+60.

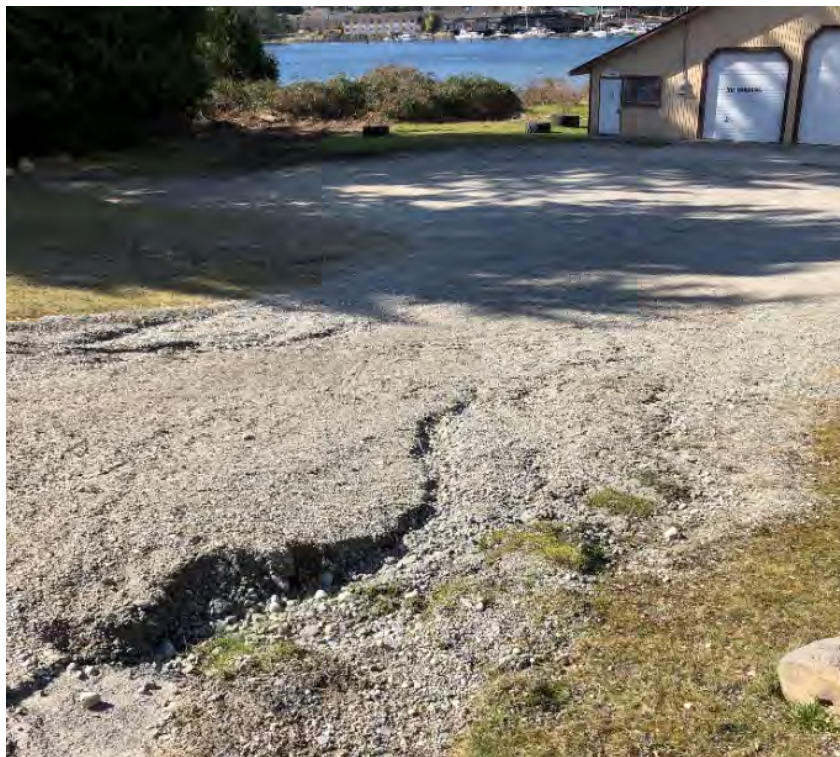
Photo 10 Surface drainage from Sechelt Inlet Road westwards down a gravel driveway approximately 3 meters south of the intersection with Tsulich Drive.

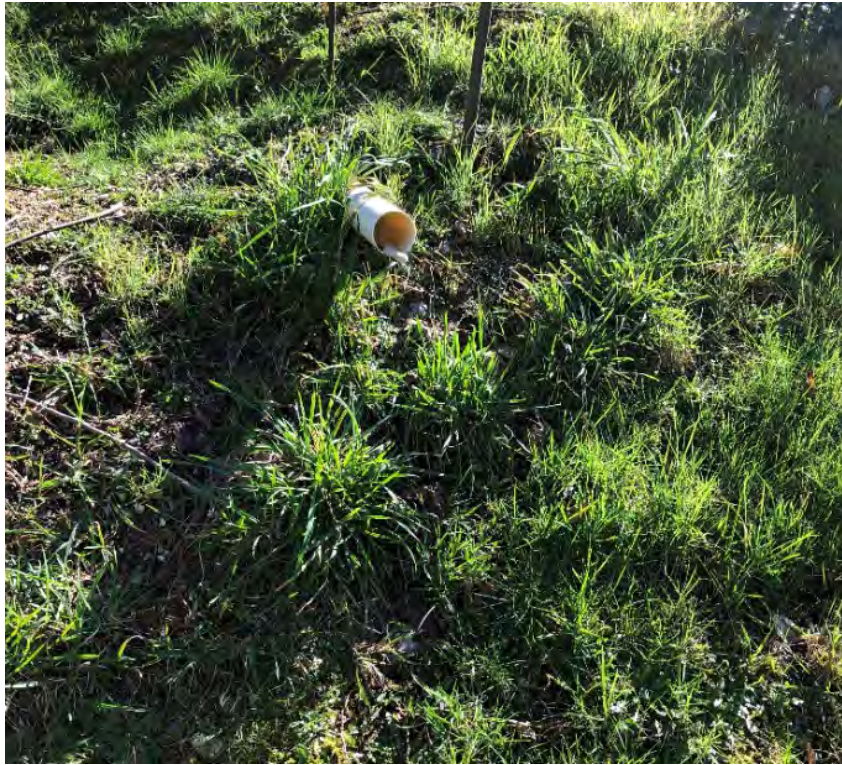
Photo 11 A drainage pipe observed conveying water from a residential property on the eastern side of Sechelt Inlet Road. Photo taken at 100+90 near Sechelt Inlet Road and Xenichen Avenue, facing east.

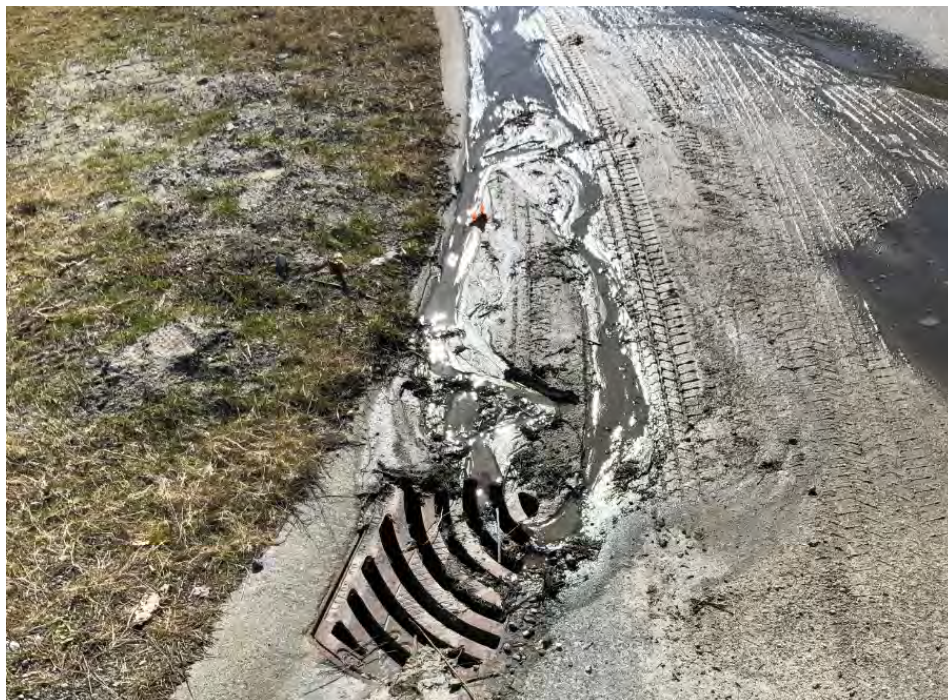
Photo 12 Catch basin located at Ikat Drive visibly receiving runoff from Sechelt Inlet Road via Tsulich Drive. Photo taken facing south.

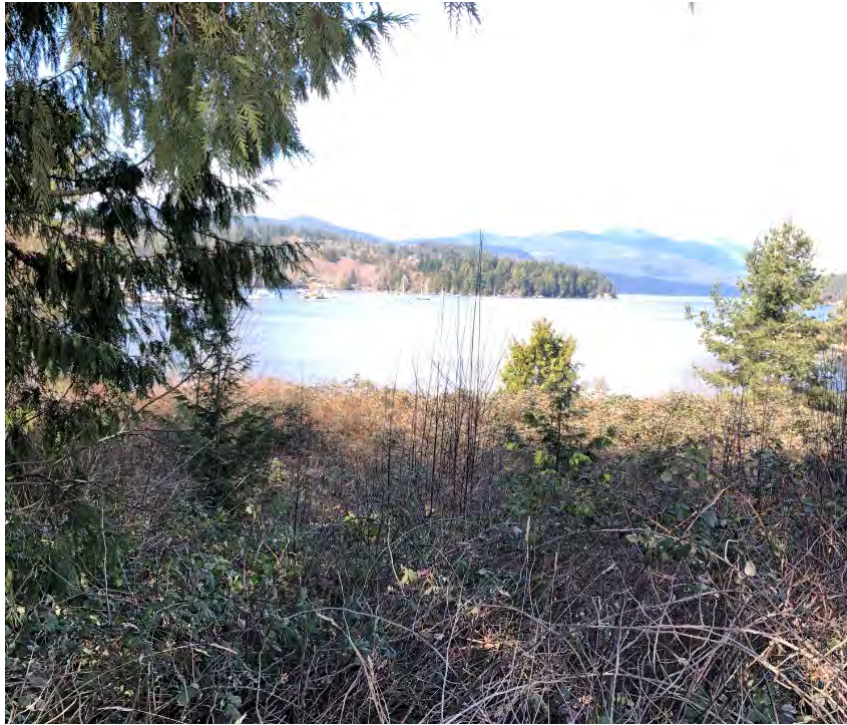
The Project Area is located within 50 m of Porpoise Bay (Photo 13, Appendix II), which is a regionally important fish-bearing waterbody that supports ecologically significant species of management concern. Several fish-bearing watercourses, outside of the Project Area, flow into Porpoise Bay, including Cook Creek (1.2 km west of the Project Area), Irgens Creek (approximately 1.2 km north of the Project Area), Burton Creek (approximately 1.5 km north of the Project Area), Burnet Creek (approximately 1.6 km north of the Project Area), an unnamed creek (approximately 2 km north of the Project Area) and Angus Creek (approximately 2.5 km north of the Project Area). Additionally, Sechelt Marsh is located approximately 270 m west of the southwestern limits of the Project Area.

Photo 13 Porpoise Bay, visible from Sechelt Inlet Road. Photo taken at 101+80 near the intersection with Slim Street, facing northwest.

- › The portion of the Site between 100+20 and 105+00 is within close proximity (between 50 and 100 m) to Porpoise Bay, upslope of Porpoise Bay. It is recommended that silt fencing and/or berms are implemented along the western boundary of the Project along this section of Sechelt Inlet Road during works if works are taking place during heavy precipitation or a risk of runoff flowing towards Porpoise Bay otherwise exists;

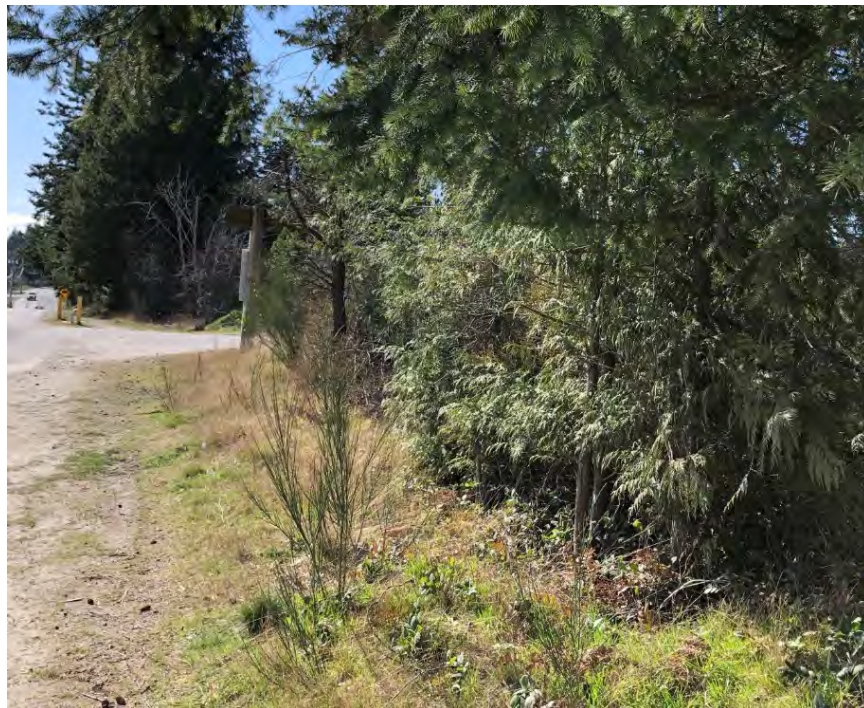
Photo 14 Western side of Sechelt Inlet Road, facing southeast. Photo taken north of the intersection with Kunut Avenue (visible in Photo).
