January 11, 2017

Reference: 16-6985

Re: Geotechnical Exploration Report
Proposed Storage for Your Life Facility – Phase II
33433 North Railway Avenue, Mission, BC

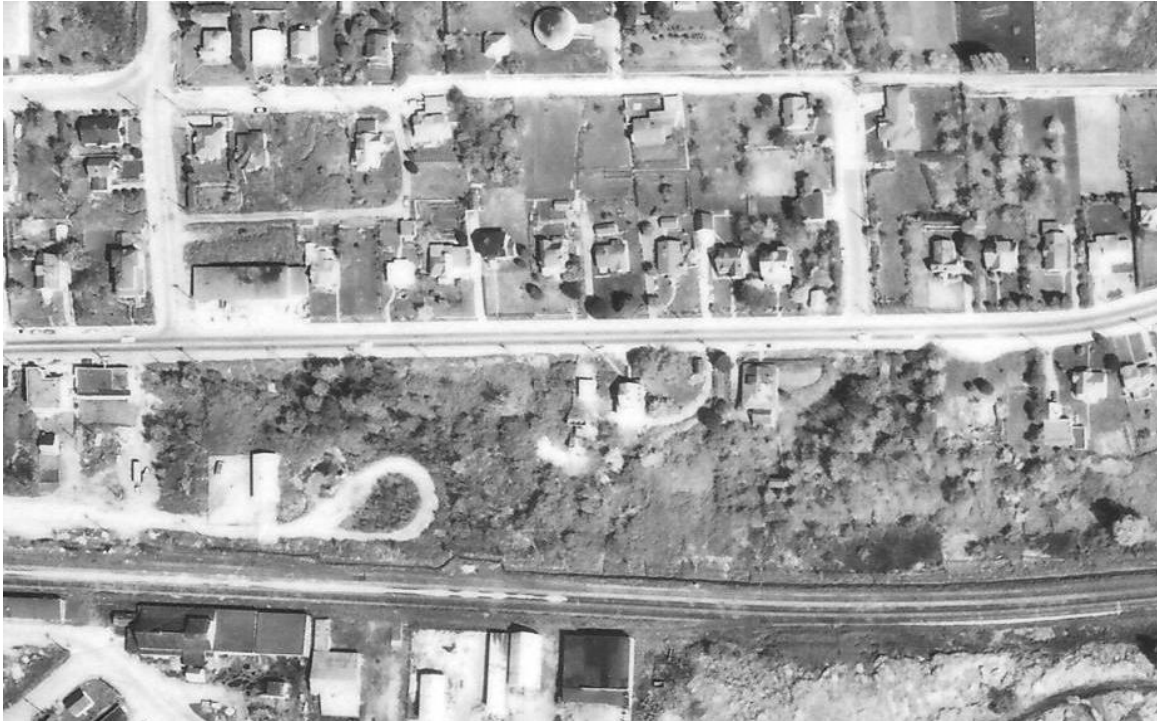
Plate 2 - 1963 Air Photo of the Subject Site

- The 1963 air photo shows visible evidence of onsite dwellings on the north east corner of the subject site (see Plate 2). These dwellings appear to be accessed from Lougheed Highway and it is inferred that the original properties slope down to the south to meet CP Rail track grades. The North Railway Avenue roadway is not visible. The 1963 air photo also shows evidence of the historical east creek channel to the south of Lougheed Highway.
- A subsequent air photo from 1979 no longer contained evidence of the onsite dwellings. The site was cleared and some re-grading activity is evident on the photo (See Plate 3). It is inferred from the air photo that some re-grading of the Lougheed Highway roadway embankment (ie. Grade steepening) and modification of the historical creek channels was

completed. A ditch appeared to be excavated onsite as a drainage capture for upslope seepage flows. The current alignment of North Railway Avenue is visible.

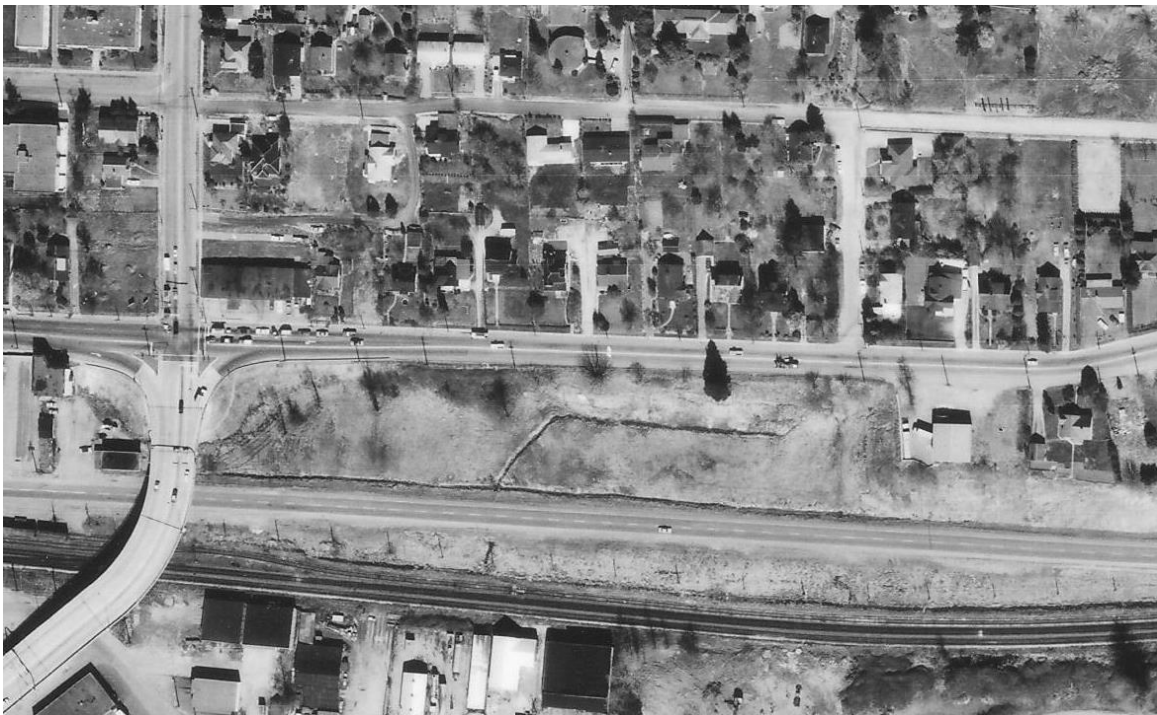
Plate 3 - 1979 Air Photo of the Subject Site

It is understood from interview information that natural gravelly soils were excavated to construct North Railway Avenue in the 1970's (as noted previously - see Plate 3)

In summary, the air photo review noted evidence of historical onsite dwellings, re-grading and clearing activities and modifications to historical drainage channels. The air photo review indicated that the historical east creek channel does not intercept the proposed Phase II expansion building footprint. However, excavation in this area may encounter deep stream channel fill and channel seepage similar to conditions that were encountered at the western historical channel alignment during the excavation for the Phase I building.

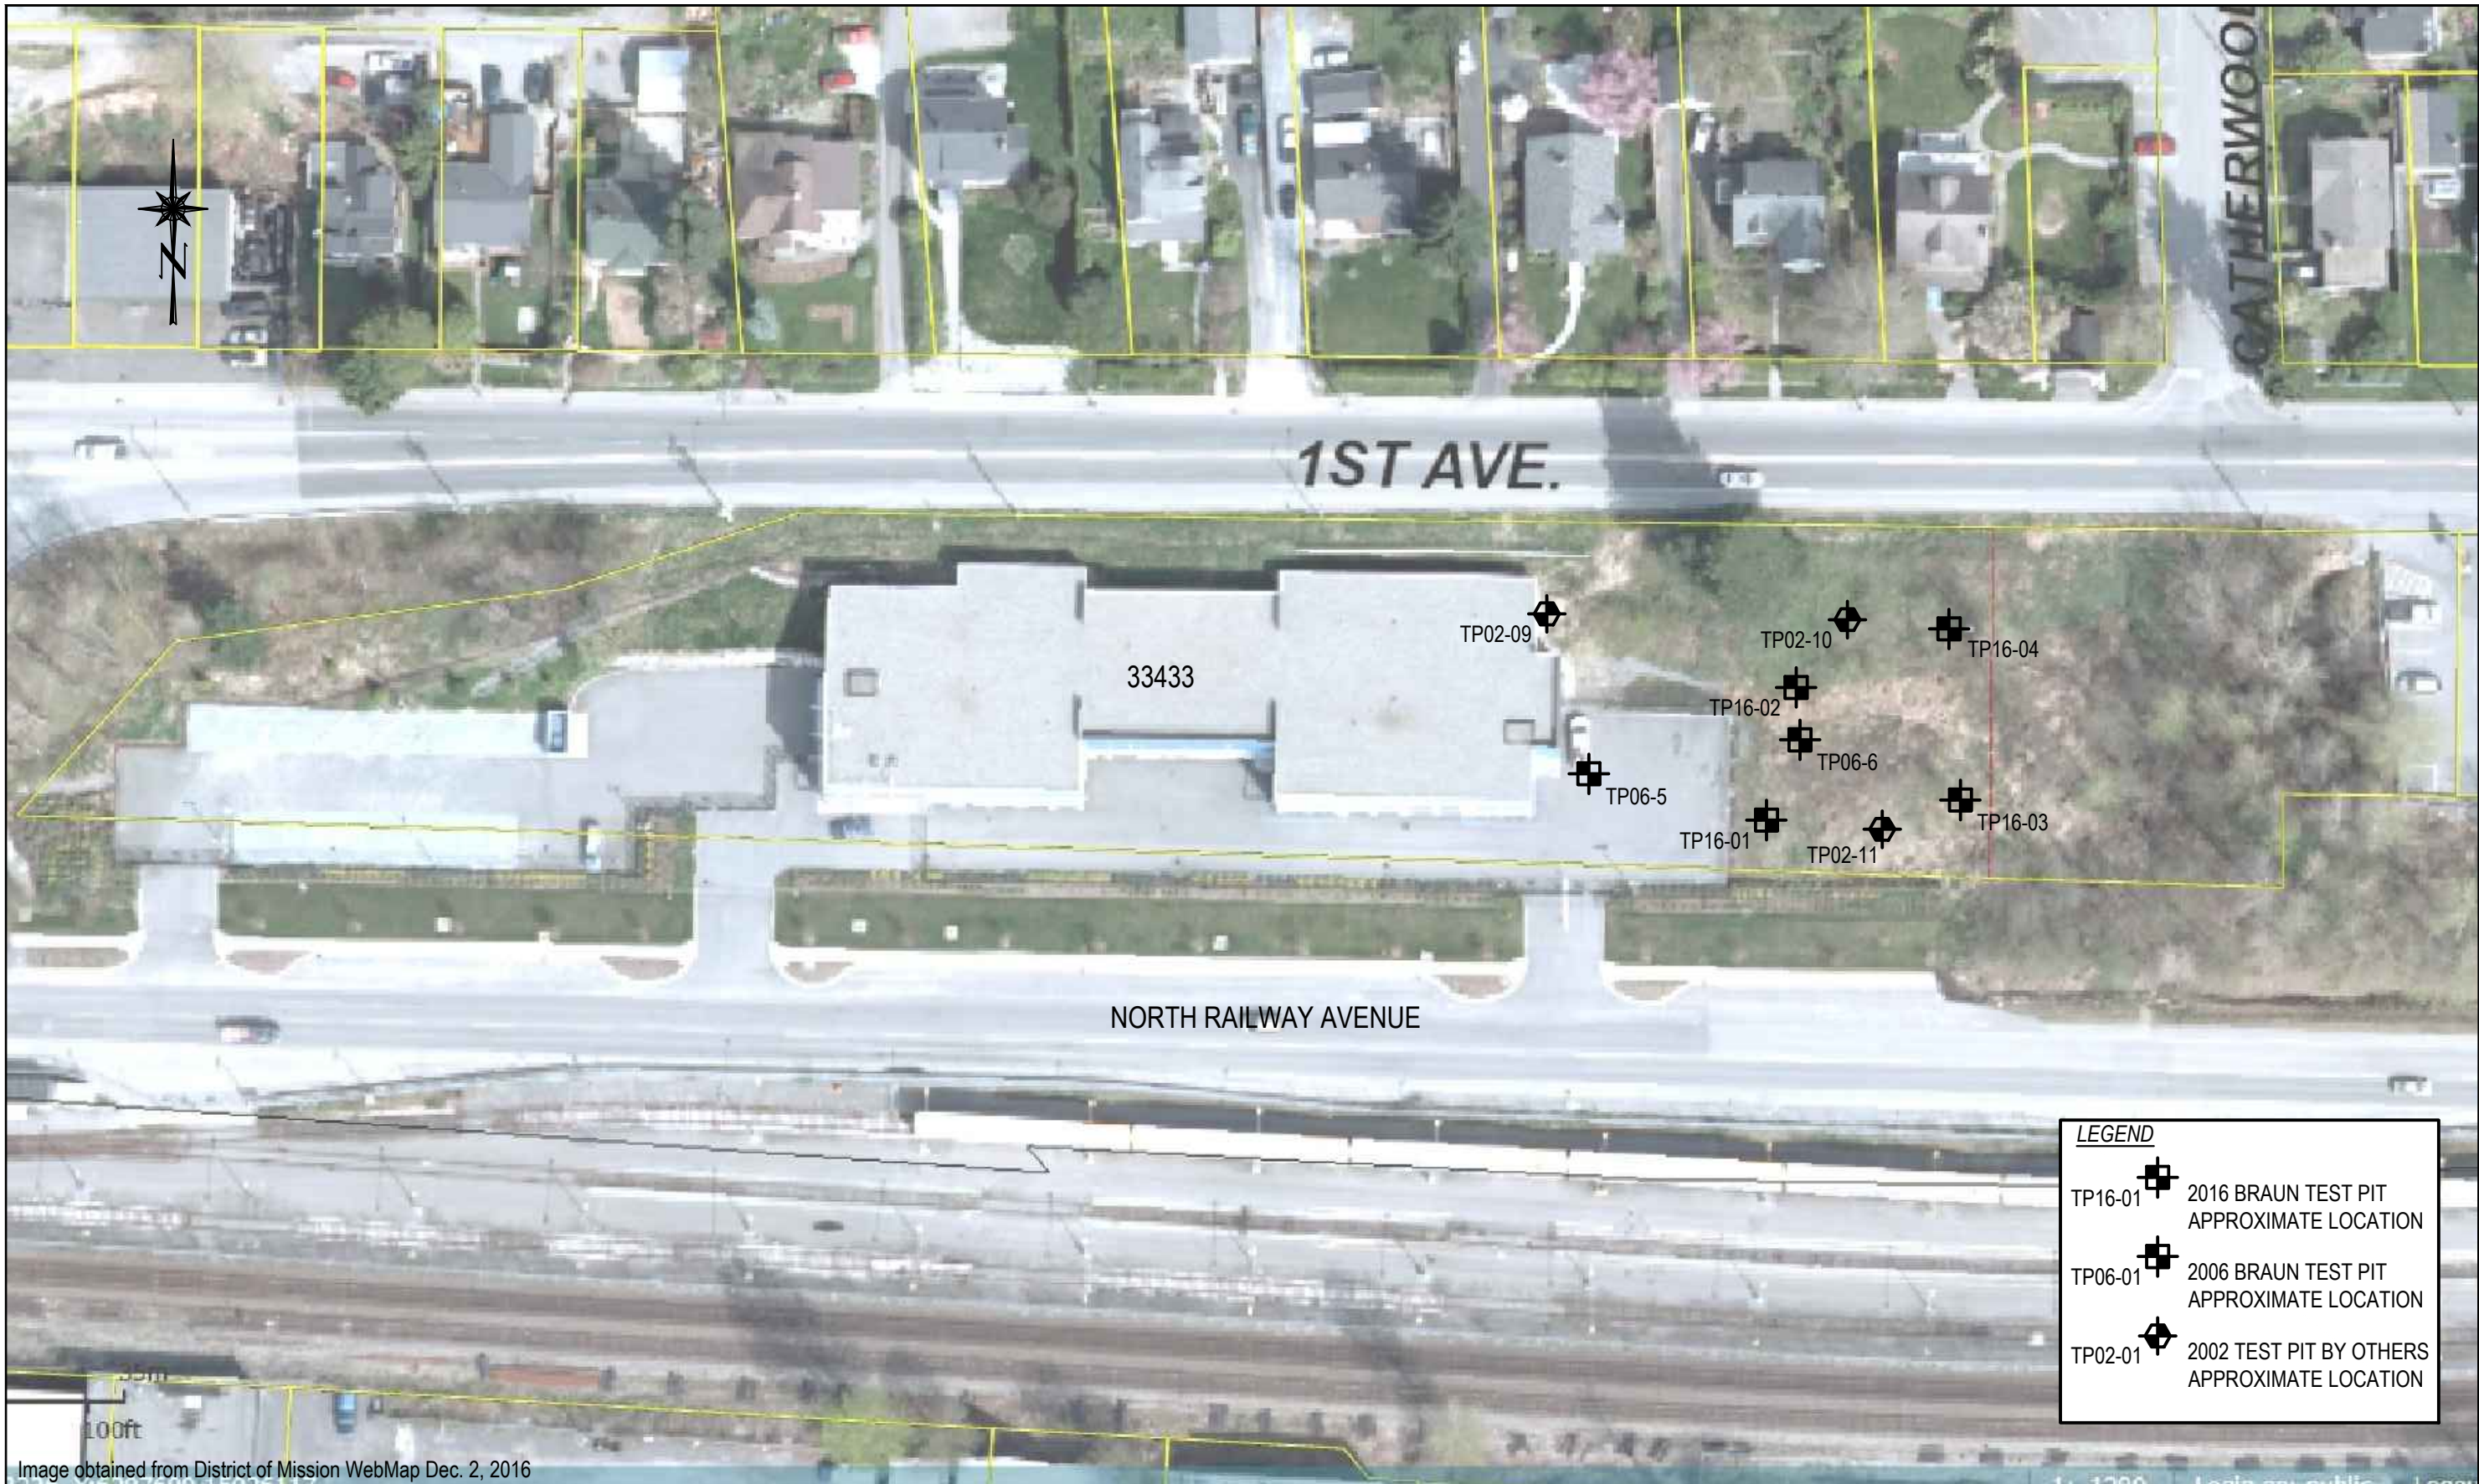
LEGEND	
TP16-01	2016 BRAUN TEST PIT APPROXIMATE LOCATION
TP06-01	2006 BRAUN TEST PIT APPROXIMATE LOCATION
TP02-01	2002 TEST PIT BY OTHERS APPROXIMATE LOCATION

Four test pits, TP16-01 and TP16-04, were excavated on December 9, 2016 using a tracked mini excavator under subcontract to Braun to a maximum depth of 2.0m. The soil conditions were logged in the field by an Engineer from Braun Geotechnical.

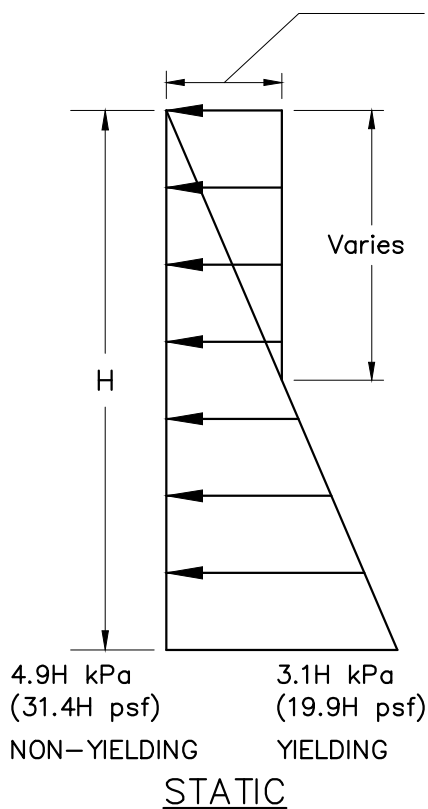
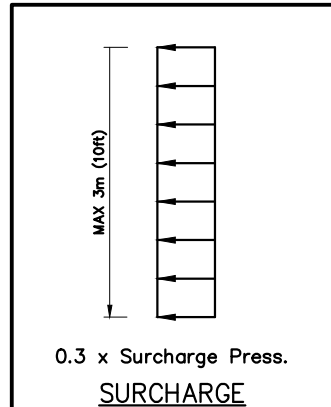
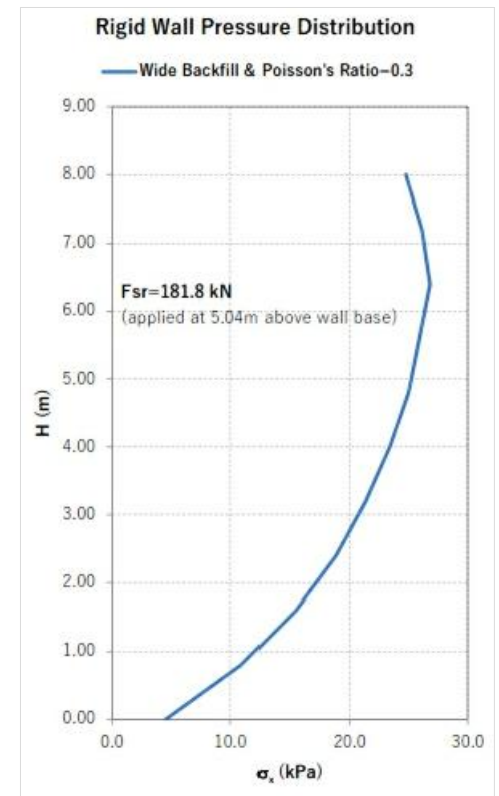
- 30% sloping backfill lightweight aggregates backfill (10kn/m³ unit weight).
- Active loading conditions (i.e. top of wall is free to rotate 0.1% of wall height). Other conditions subject to review by Braun Geotechnical.
- Fully drained backfill.
- Seismic peak ground acceleration of 0.284g.
- All surcharge loads to be reviewed by Braun Geotechnical.

- Compaction Induced Pressure of 15kPa (300psf).
- A lower value may be feasible based on review of compaction equipment and procedure
- Compaction pressure need only be used for structural design not overall stability

See Table for Wall Pressure Based on Tolerable Displacement of Wall away from Soil Backfill

(Based on Richard & Elms Procedure)

SEISMIC-YIELDING

SEISMIC-NON-YIELDING

Under static loading conditions, walls may be designed using the loads provided on the attached Horizontal Wall Loading Diagram (Dwg. 16-6985-02). The lateral wall pressures assume horizontal backfill that consists of an approved, free draining, granular material with no hydrostatic water pressure against the basement walls.

For preliminary design purposes, foundation walls may be designed for the seismic load indicated on the Horizontal Wall Loading Diagram. The seismic wall loading estimated using the pseudo-static approach is significant. The reason is that foundation walls are anticipated to be relatively unyielding due to the presence of floor diaphragms. Considerably lower wall loading may be achieved if the structural designs can accommodate some relative movement of the foundation walls away from backfill.

Surcharge loading above the fill zone, adjacent to foundation walls should be assessed as per the Horizontal Wall Loading diagram attached to this geotechnical report.
