**H7/H11 TRUCK ROUTE INTERSECTION  
IMPROVEMENTS**

**MISSION, BC  
GEOTECHNICAL REPORT**

Date: October 12, 2023  
File: 35221

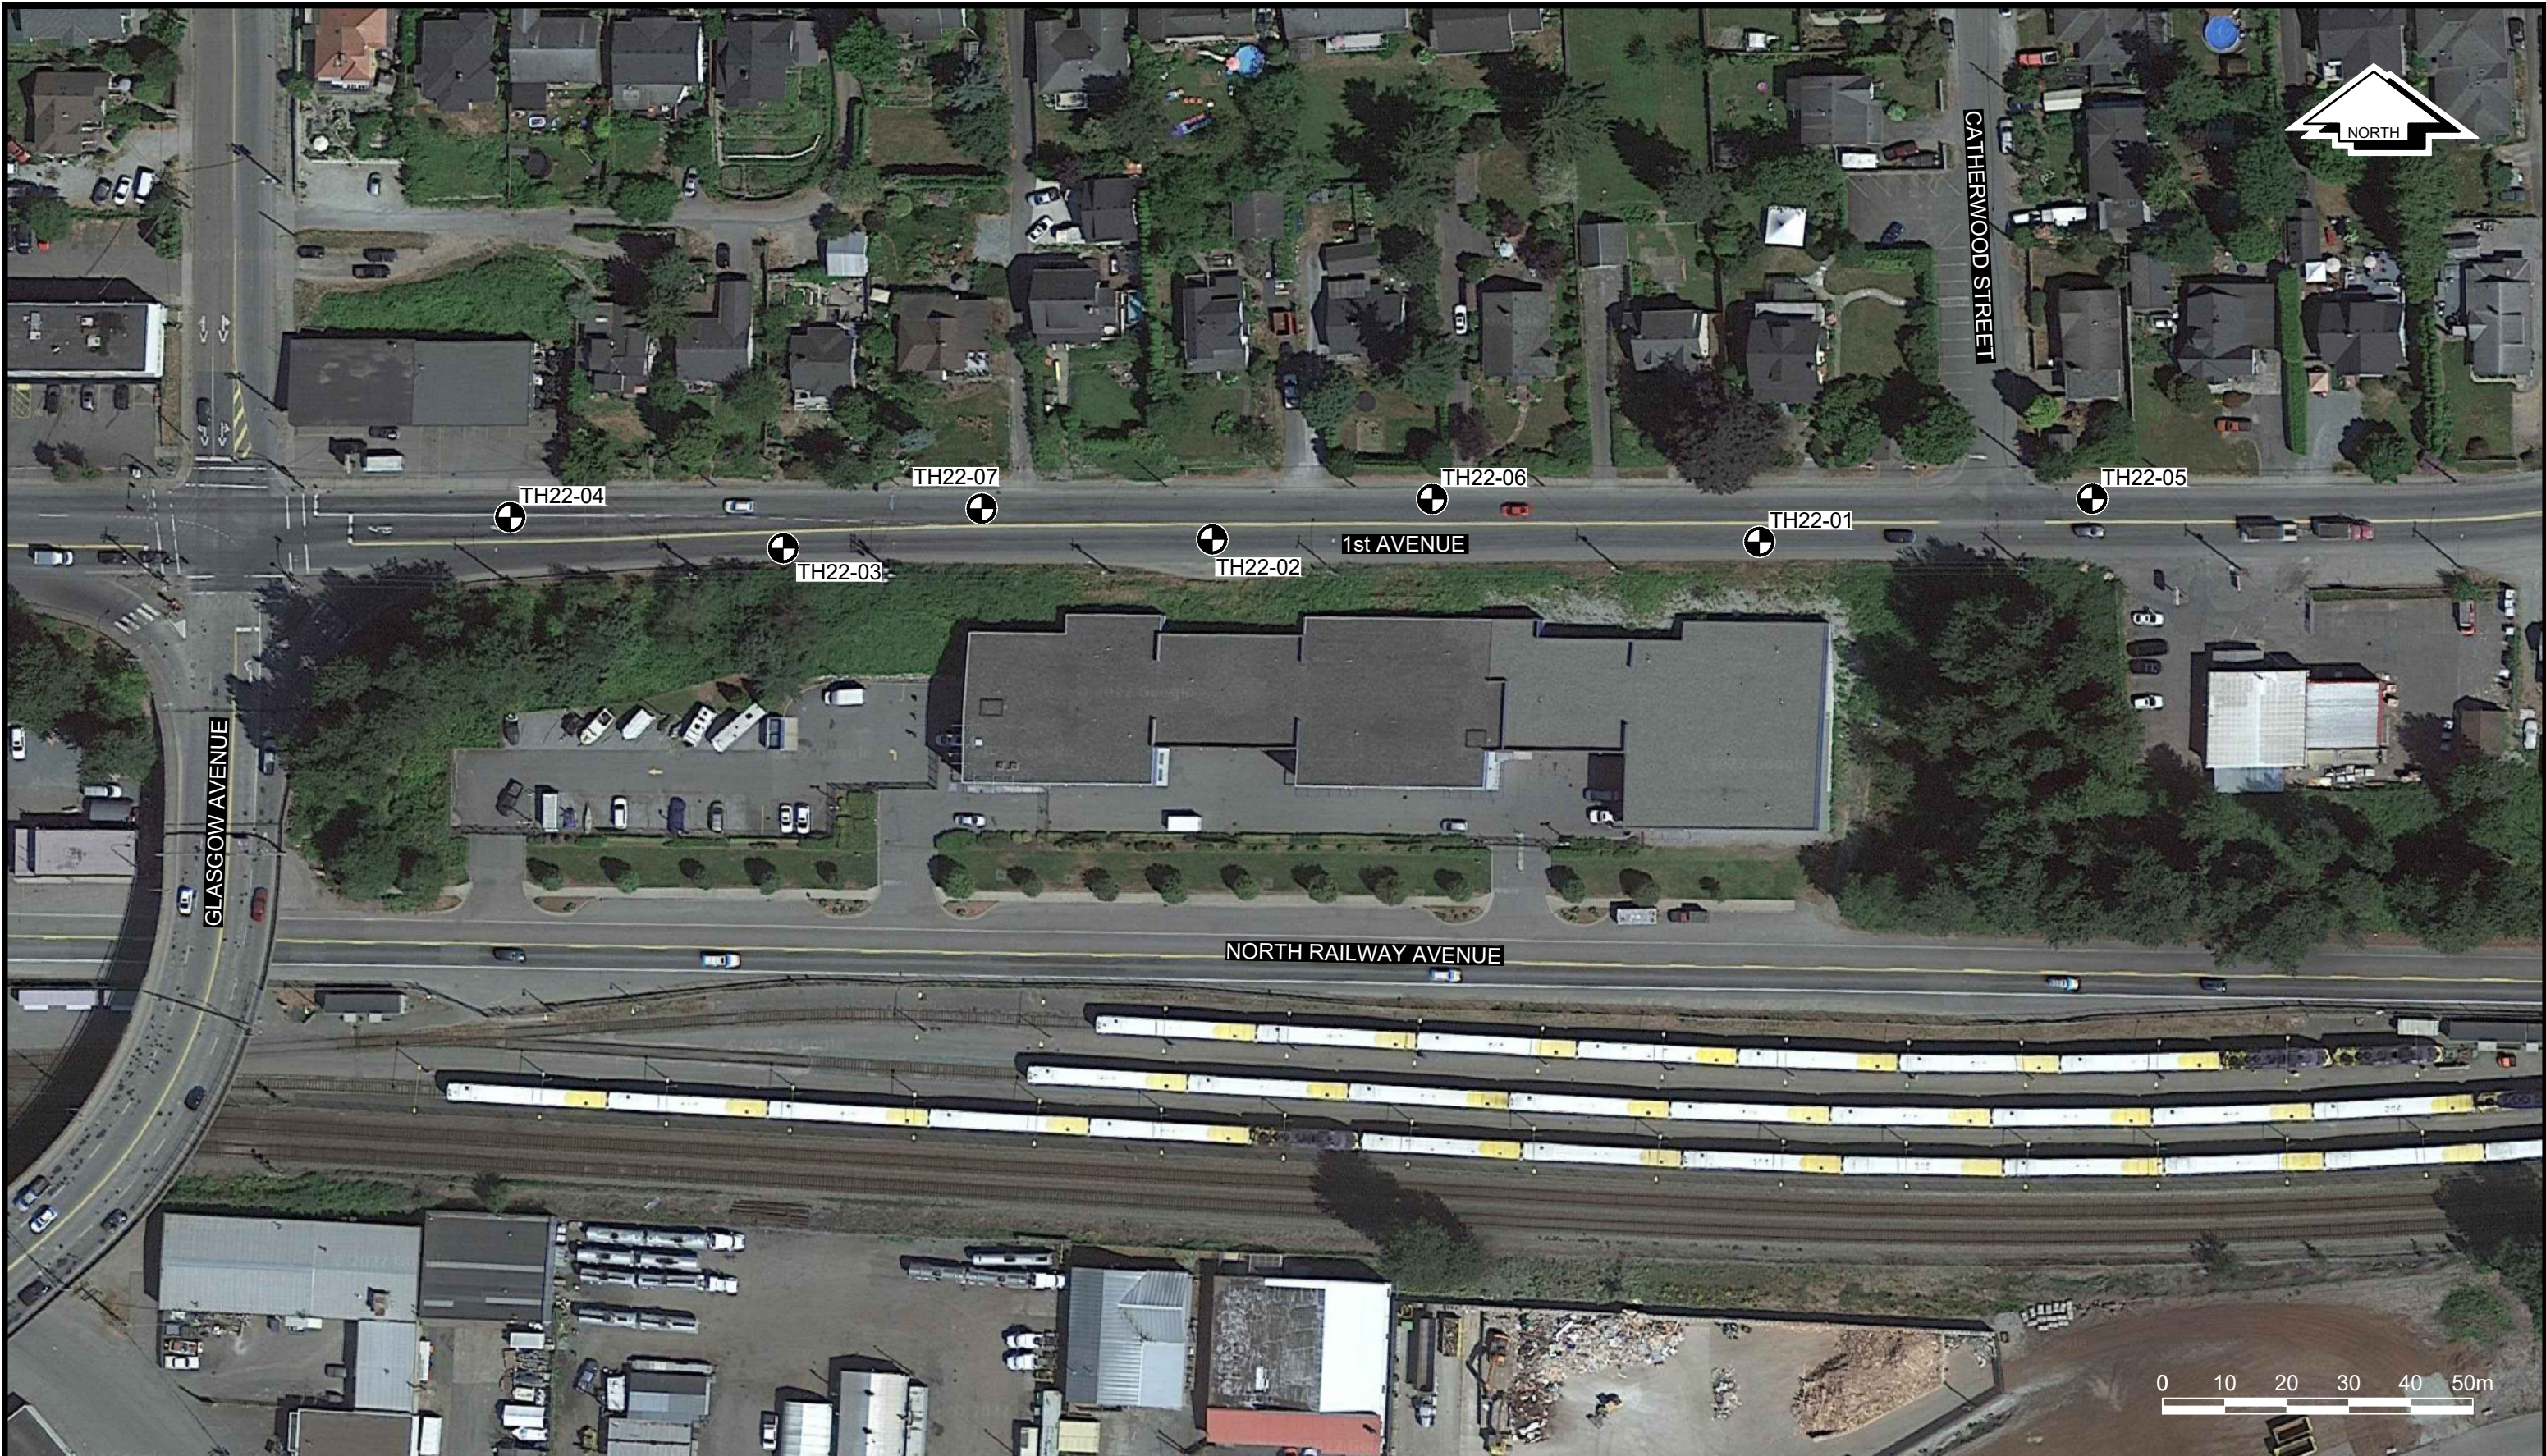
MINISTRY OF TRANSPORTATION AND INFRASTRUCTURE						
<b>TEST HOLE LOCATION PLAN (KEY PLAN)</b>						
H7 / H11 MISSION TRUCK ROUTE INTERSECTION IMPROVEMENTS						
MISSION, BC						
DESIGNED	DRAWN	APPROVED	DATE	SCALE	PROJECT No.	DWG. NO.
MWA	MOM	JSP	DEC. 22, 2022	1:2000	35221 - 1	REV. 0

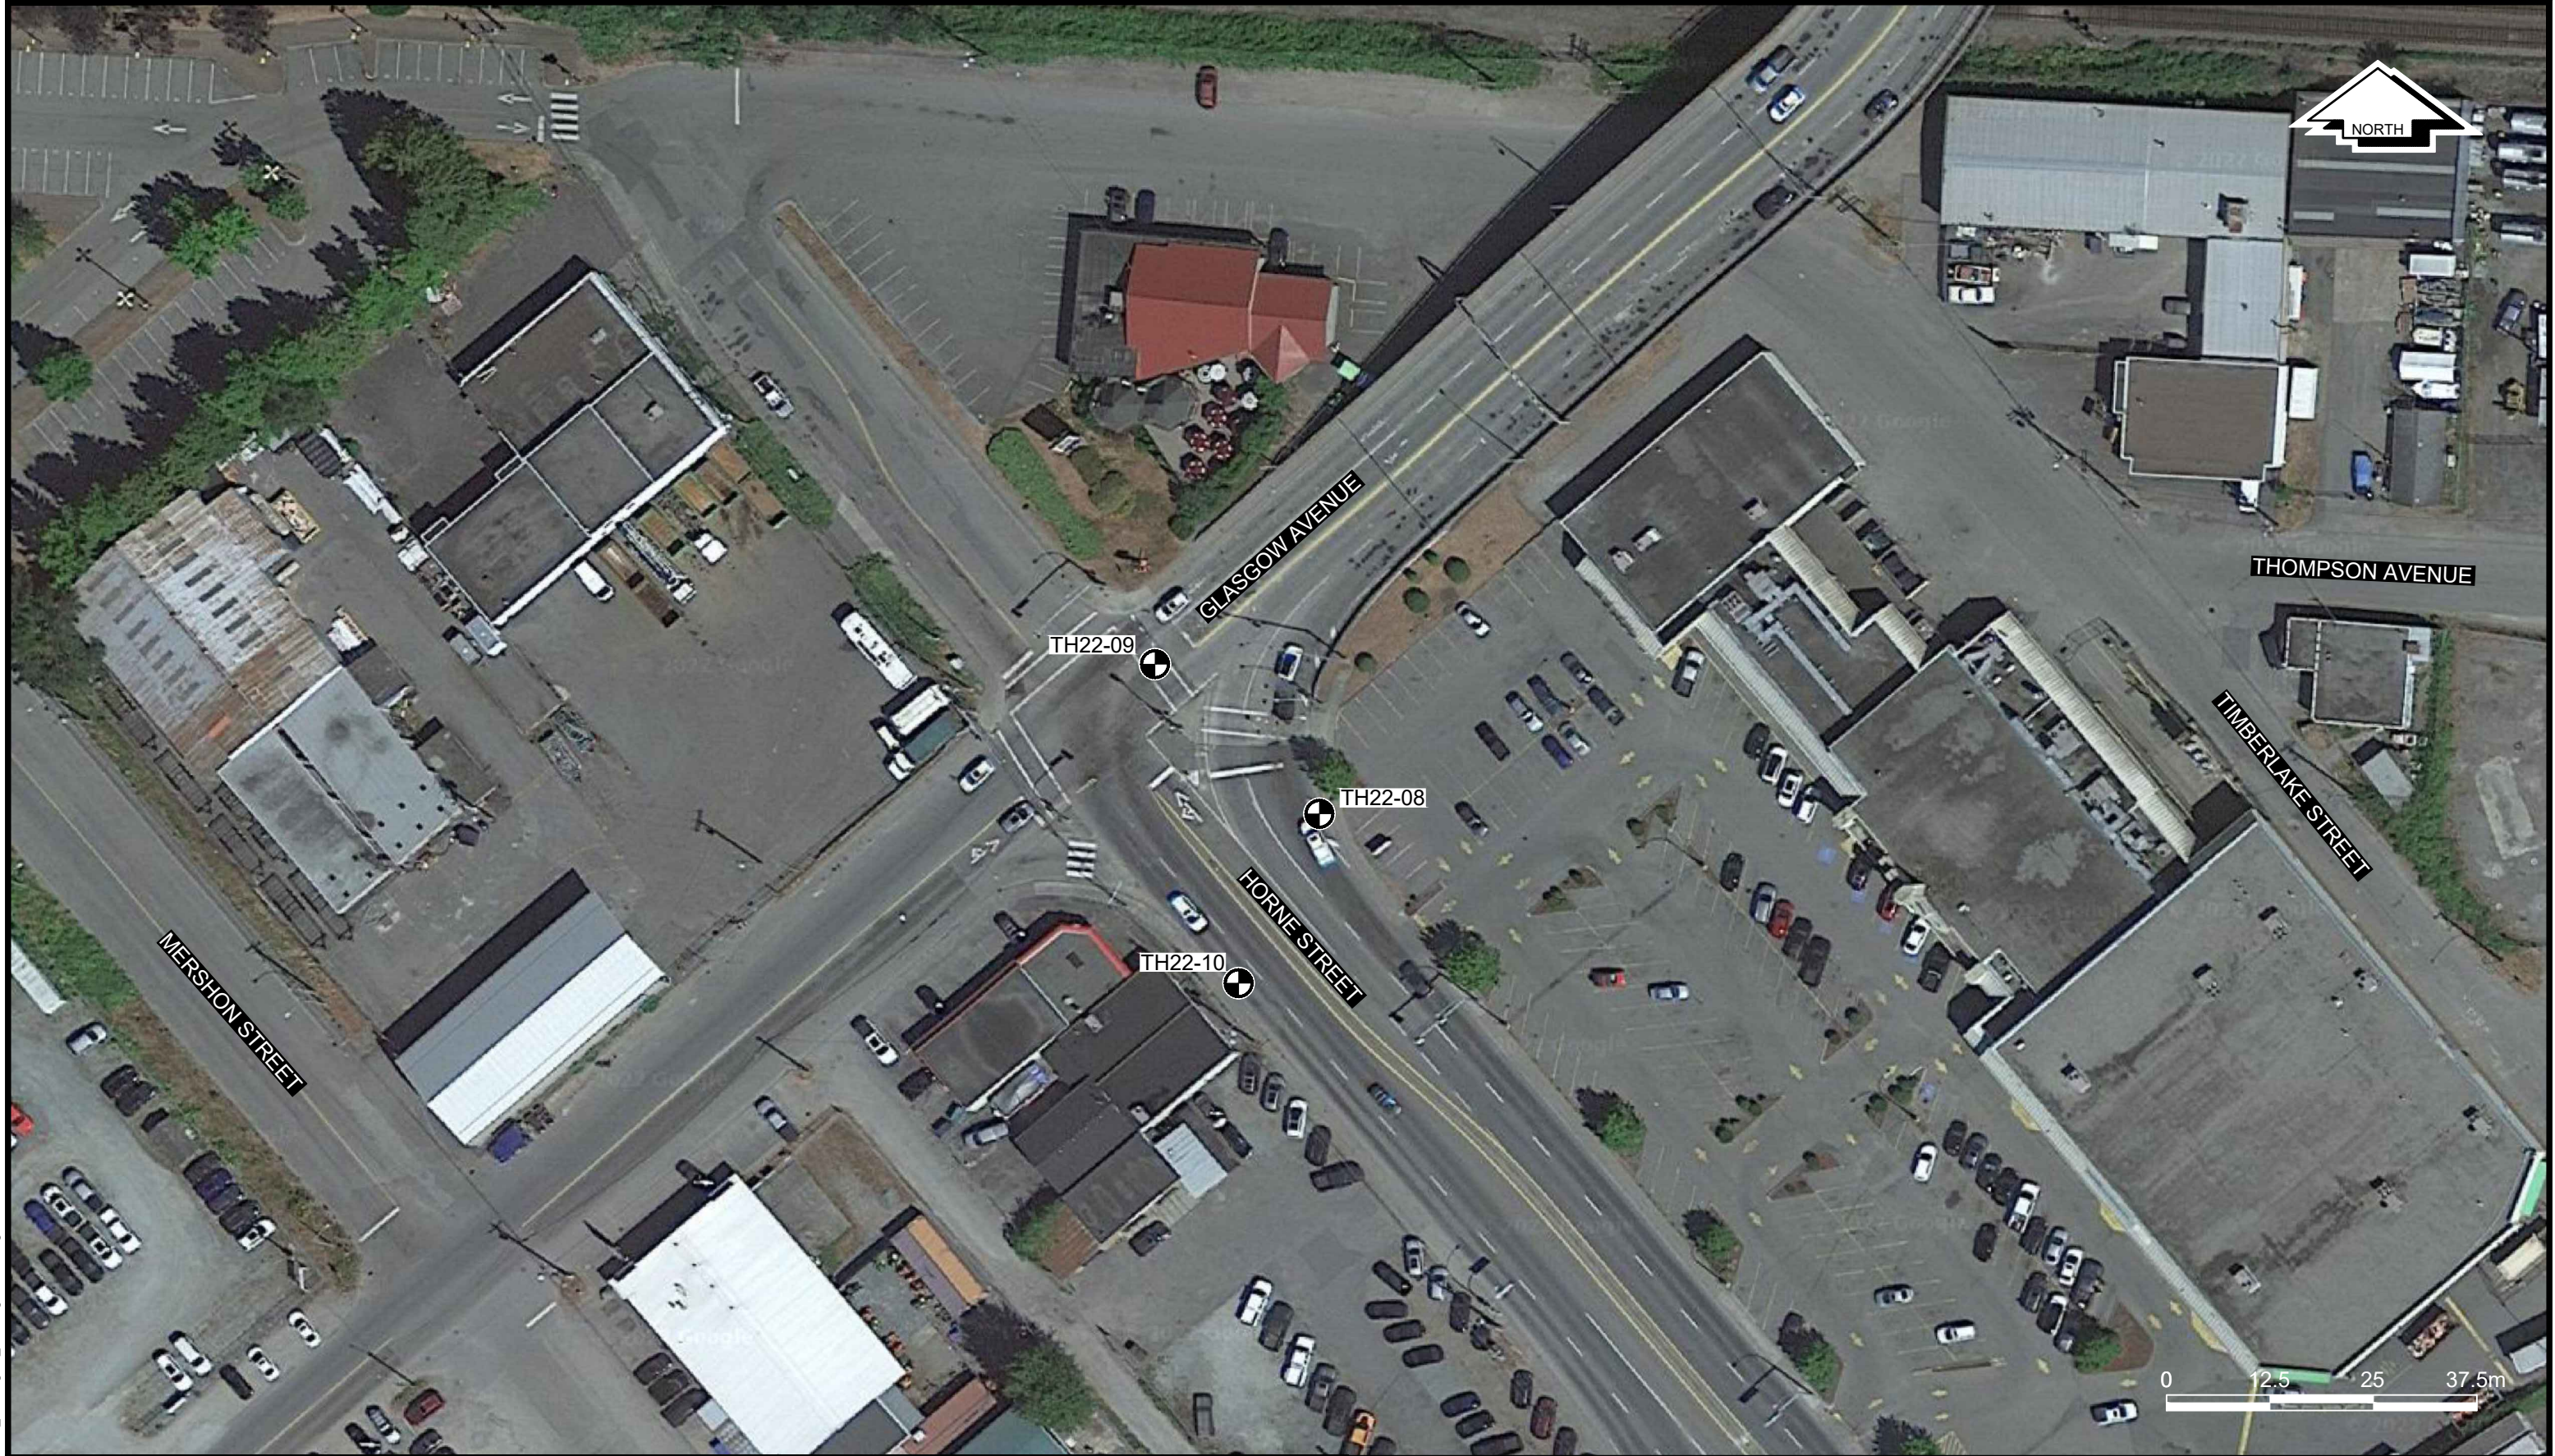
MINISTRY OF TRANSPORTATION AND INFRASTRUCTURE					
<b>TEST HOLE LOCATION PLAN (1st AVENUE WORK ZONE)</b>					
H7 / H11 MISSION TRUCK ROUTE INTERSECTION IMPROVEMENTS					
MISSION, BC					
DESIGNED	DRAWN	APPROVED	DATE	SCALE	PROJECT No.   DWG. NO.   REV.
MWA	MOM	JSP	DEC. 22, 2022	1:1000	35221 - 2   0

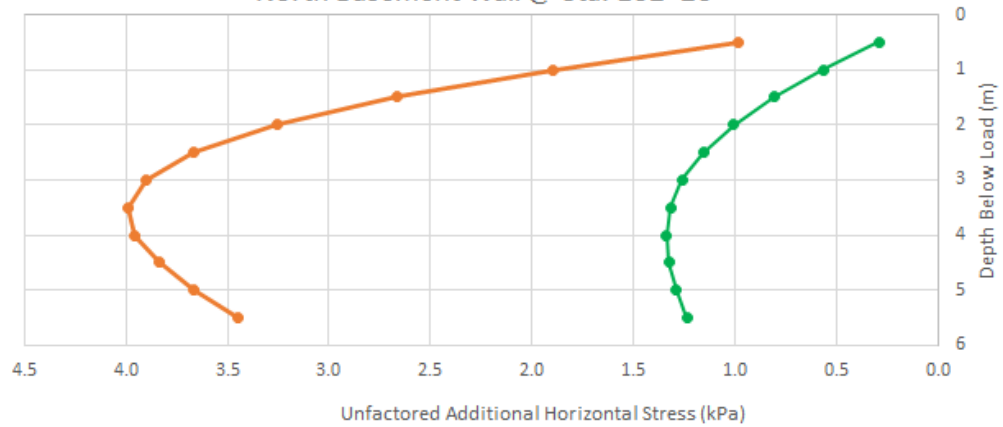
Estimated Added Horizontal Stress 33433 N. Railway Ave., Mission  
North Basement Wall @ Sta. 102+20

Notes:  
Soil load at approx. El. 18.2 m  
Traffic load at approx. El. 19 m  
Plotted loads not applicable at elevations above soil backfill against foundation wall  
Plot represents only additional stress increase due to road widening

The unfactored horizontal stress increase due to soil surcharge and traffic loading from widening of Highway 7, was estimated at the north foundation wall of the building at 33433 North Railway Avenue at the following locations:

The estimated unfactored horizontal stress increase was evaluated only for the additional load due to road widening for this project. Our analyses did not address pre-existing horizontal loads to which the building has been or is being subjected. We understand, the Ministry retained a structural engineer, SNC-Lavalin, to complete a structural analysis of building foundation wall.

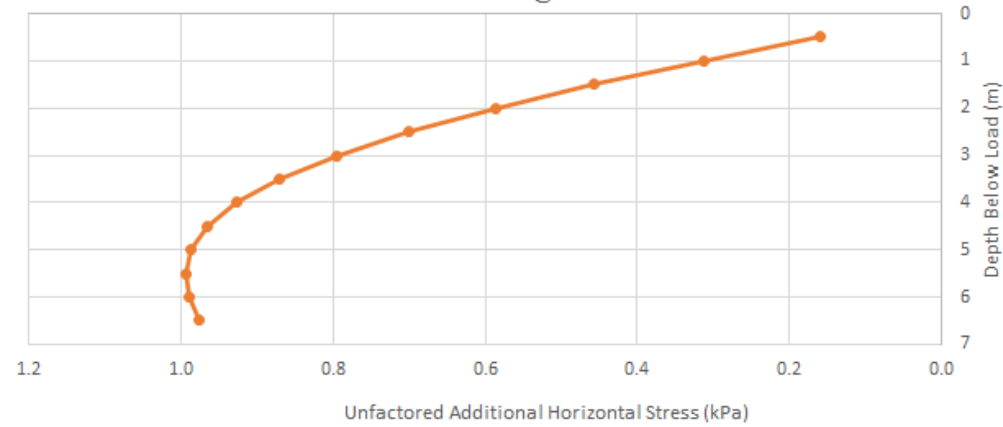
Estimated Added Horizontal Stress 33433 N. Railway Ave., Mission  
North Basement Wall @ Sta. 102+80

Notes:  
Soil load at approx. El. 20.2 m  
No additional traffic load considered as inside of concrete barrier matches existing EOP  
Plotted loads not applicable at elevations above soil backfill against foundation wall  
Plot represents only additional stress increase due to road widening

The proposed concrete barrier at Sta. 102+80 is shown on the 90% design cross-sections in line with the existing edge of pavement. Therefore, we expect that wheel loads cannot come any closer to the basement wall than existing conditions allow for. On this basis, no additional traffic load is shown at Sta. 102+80.

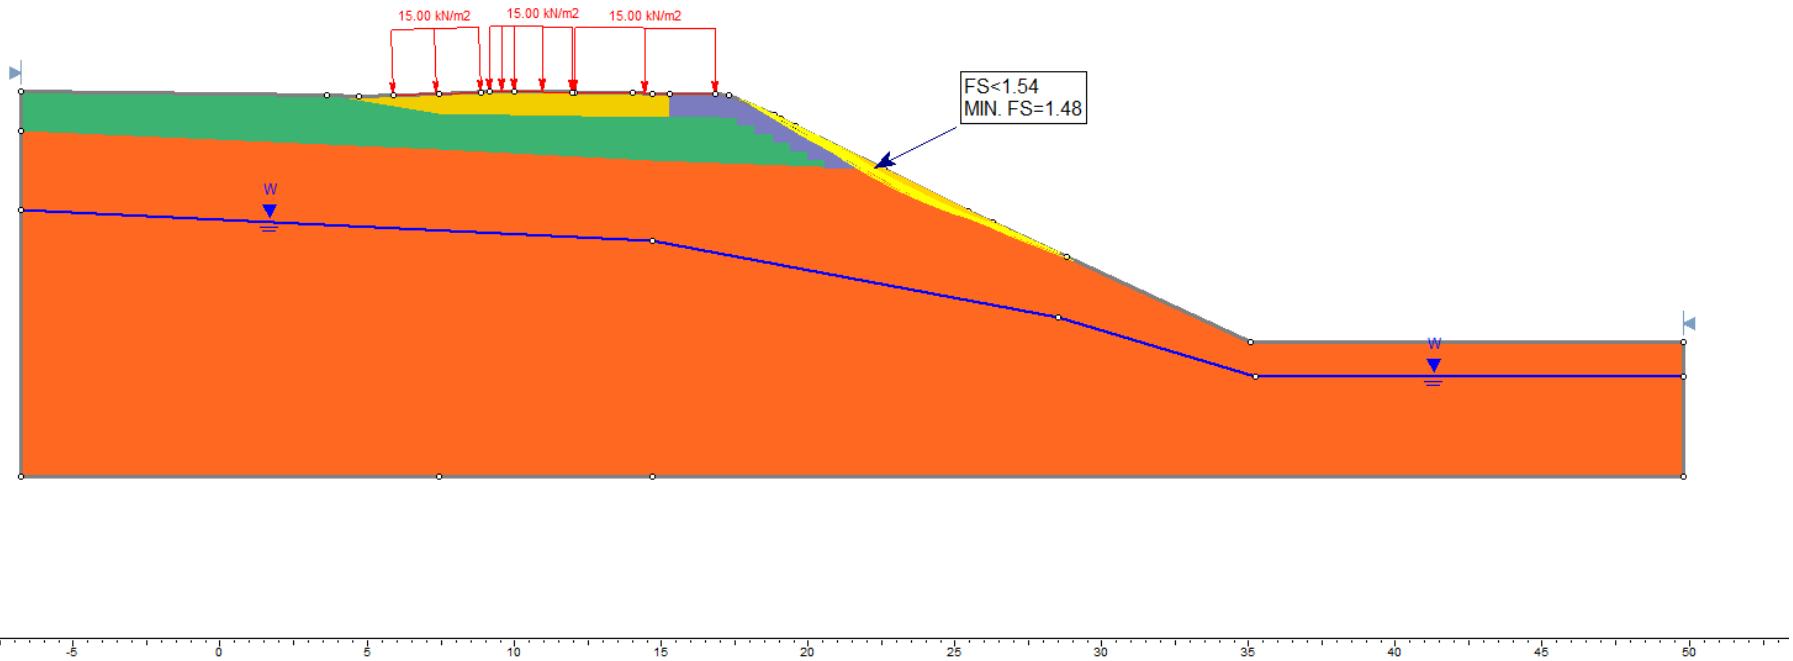
STA. 101+80  
STATIC ANALYSIS  
GLE/MORGENSTERN-PRICE

Material Name	Color	Unit Weight (kN/m <sup>3</sup> )	Strength Type	Cohesion (kPa)	Phi (deg)
GRAVEL FILL	Yellow	20	Mohr-Coulomb	0	35
LOOSE SANDY SILT / SILTY SAND	Green	18	Mohr-Coulomb	0	30
SAND AND SILT (SUMAS DRIFT)	Orange	20	Mohr-Coulomb	0	36.5
CRUSHED GRAVEL	Purple	21	Mohr-Coulomb	0	37.5

To increase the FS where the slope is being modified west of Sta. 101+93, we recommend that soft / loose soils be excavated and replaced to approximately 2 m back from the face of the slope. The downslope extent of embankment reconstruction will need to be confirmed in the field. To evaluate stability, we have assumed embankment reconstruction extends approximately 6 m downslope. Thurber should review the exposed subgrade prior to embankment reconstruction. Embankment reconstruction should be per Section 8.4.

While the above-recommended embankment reconstruction is expected to eliminate instability through the pavement surface, slip surfaces with a FS < 1.54 are anticipated at the slope face in this area, as shown in Figure F1 in Appendix F at Sta. 101+80. The minimum FS at the slope face is estimated to be approximately 1.48. We expect that these slip surfaces correlate with a risk of ongoing relatively shallow slough-type movement at the slope face. MoTI should maintain the slope face as part of ongoing maintenance efforts, ensuring vegetation is retained to reduce the risk of surficial sloughing. Alternatively, design solutions such as a reinforced soil slope could be explored.

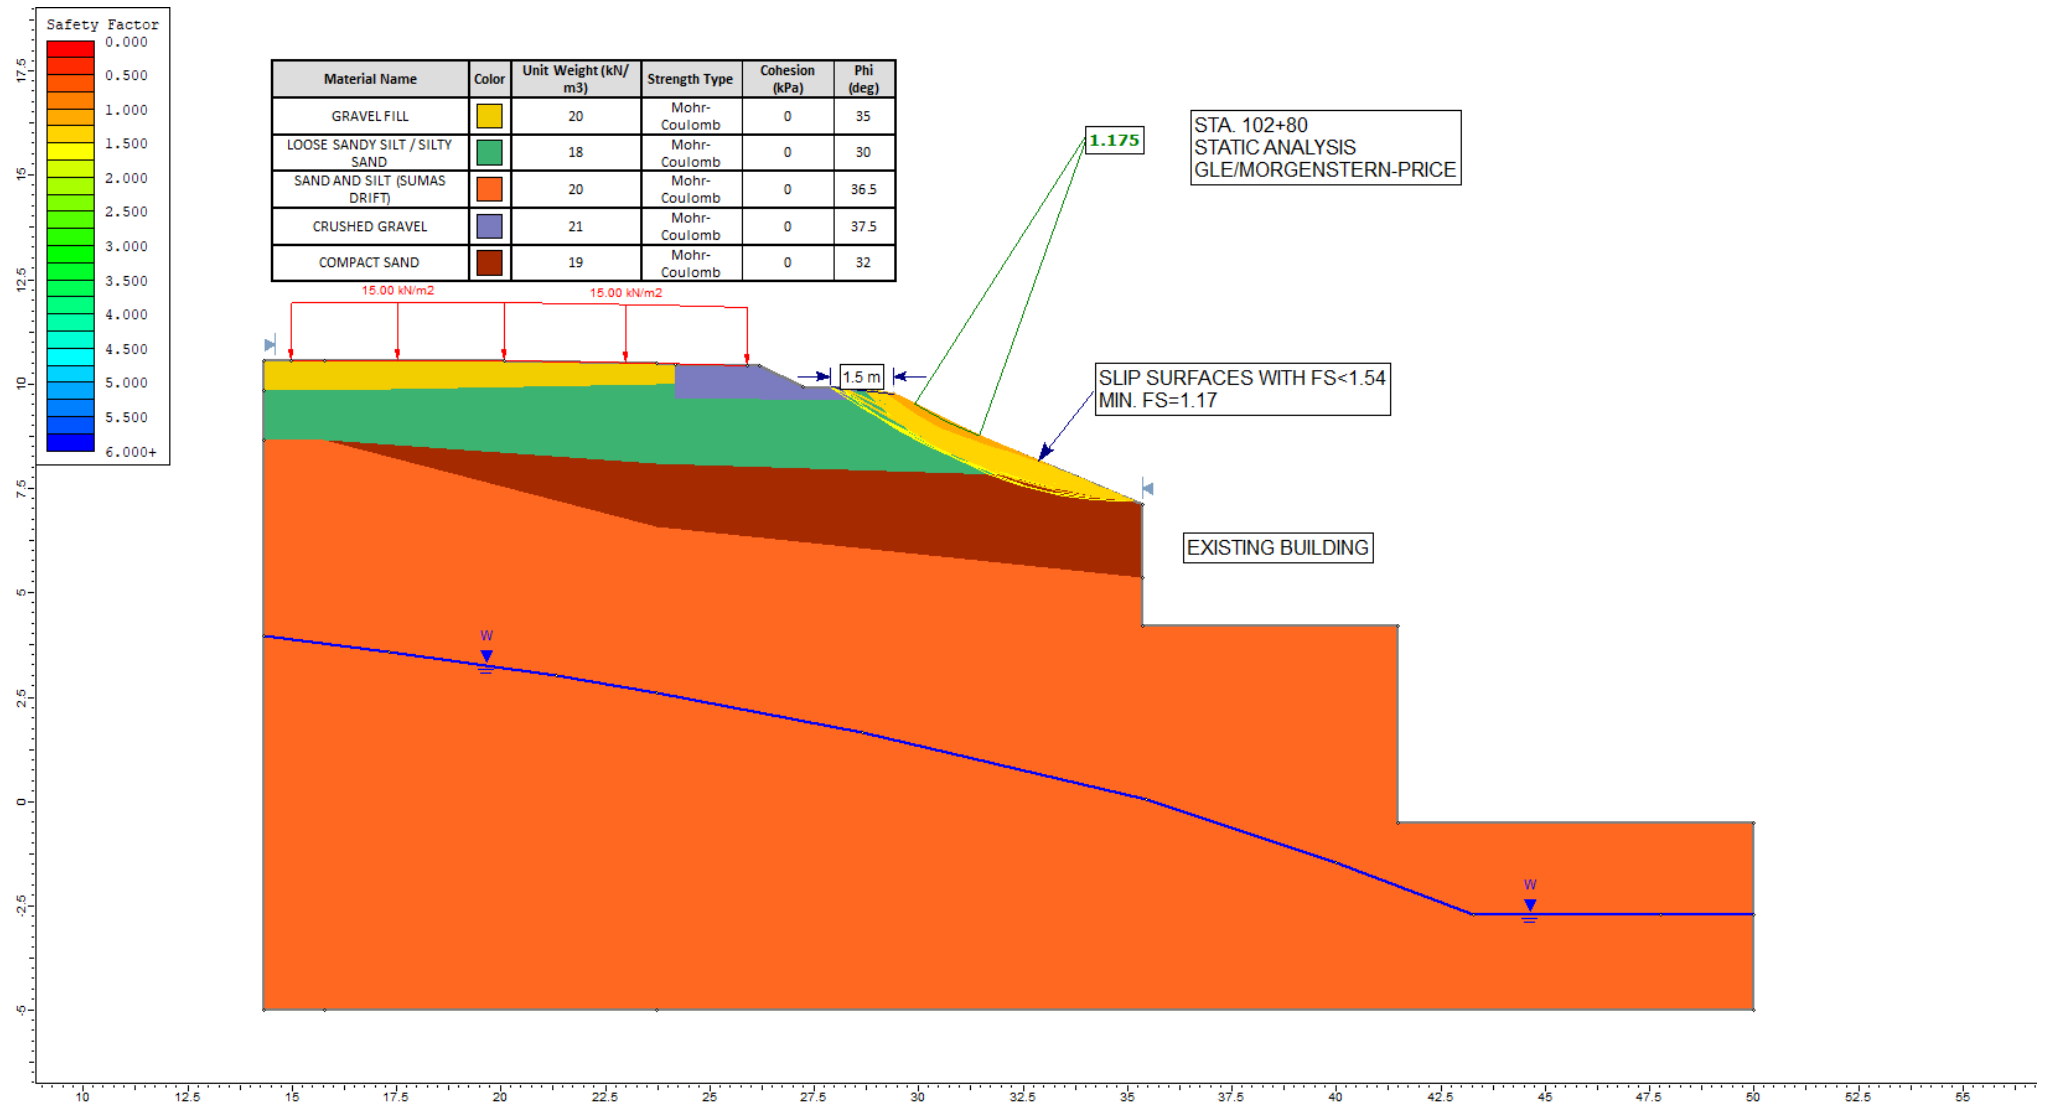
Material Name	Color	Unit Weight (kN/m <sup>3</sup> )	Strength Type	Cohesion (kPa)	Phi (deg)
GRAVEL FILL	Yellow	20	Mohr-Coulomb	0	35
LOOSE SANDY SILT / SILTY SAND	Green	18	Mohr-Coulomb	0	30
SAND AND SILT (SUMAS DRIFT)	Orange	20	Mohr-Coulomb	0	36.5
CRUSHED GRAVEL	Purple	21	Mohr-Coulomb	0	37.5
COMPACT SAND	Brown	19	Mohr-Coulomb	0	32

STA. 102+80  
 STATIC ANALYSIS  
 GLE/MORGENSTERN-PRICE

The slope stability around Sta. 102+80 is not expected to be negatively impacted by the proposed works (i.e., slip surfaces with a FS < 1.54 are considered to be a pre-existing condition). Additionally, no signs of ongoing slope instability, such as tension cracking, sloughing, etc. were observed around Sta. 102+80 at the time of our site review. If slope in vicinity of Sta. 102+80 must meet FS requirements for slope stability, regrading of the slope to 3H:1V in this area is recommended. We expect that this would require regrading on private property.
