Technical Memorandum

January 11, 2023
File No. 22.0059

Re: Post-Construction EM Review of Instream Works Culvert Crossing of Gough Creek on Day Road

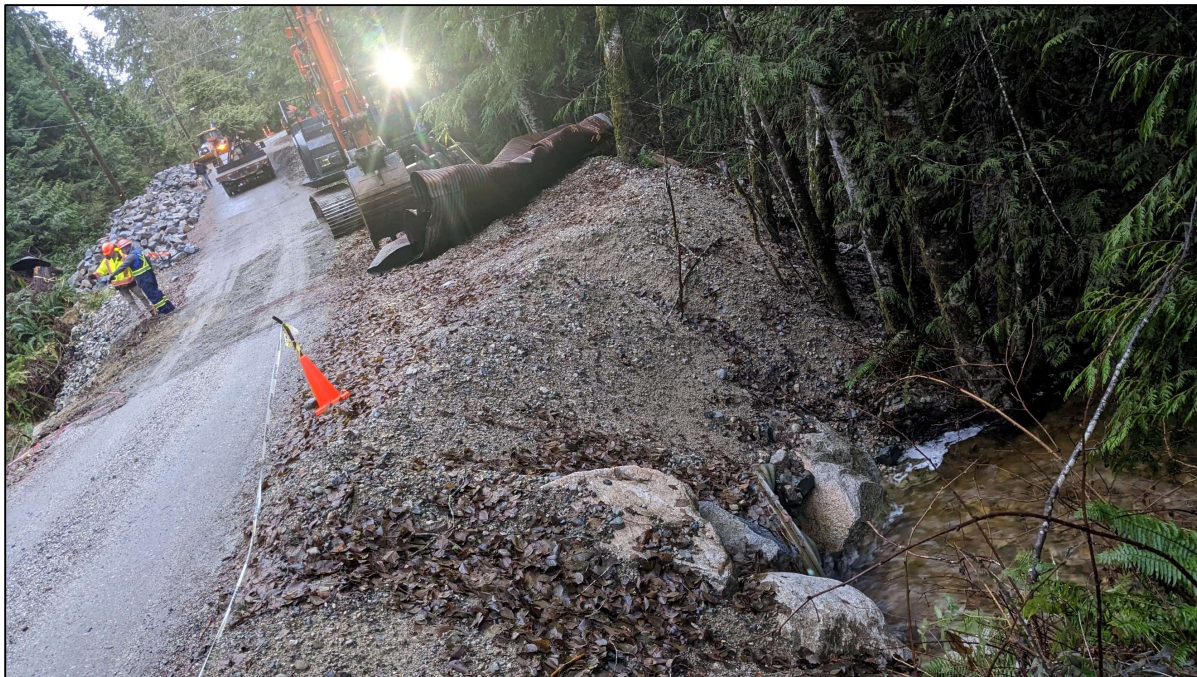
1 Upstream End -- Pre-Construction Site Photo

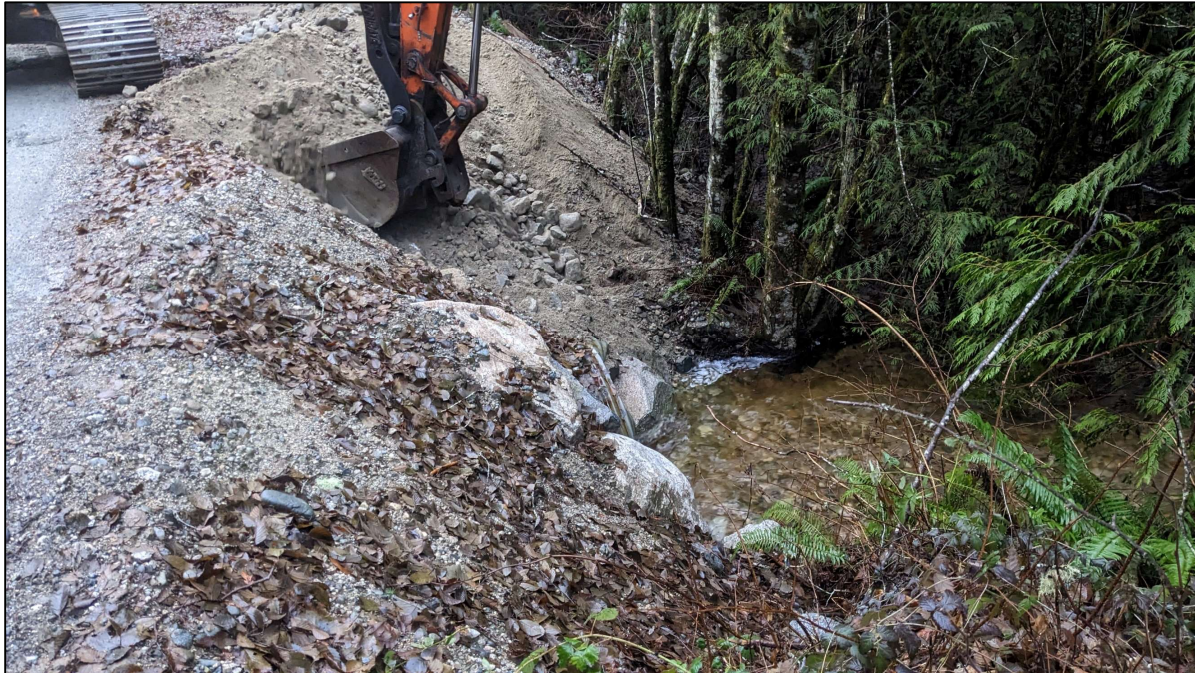
Dakota meticulously removed sand and gravel from the over-steepened banks on each side of the road adjacent to the culvert in order to establish a grade to work from. A negligible amount of sand unraveled into the creek creating a sediment plume no greater than 0.20 cm^2 which dissipated in under a minute.

2 Upstream End -- Establishing the Grade

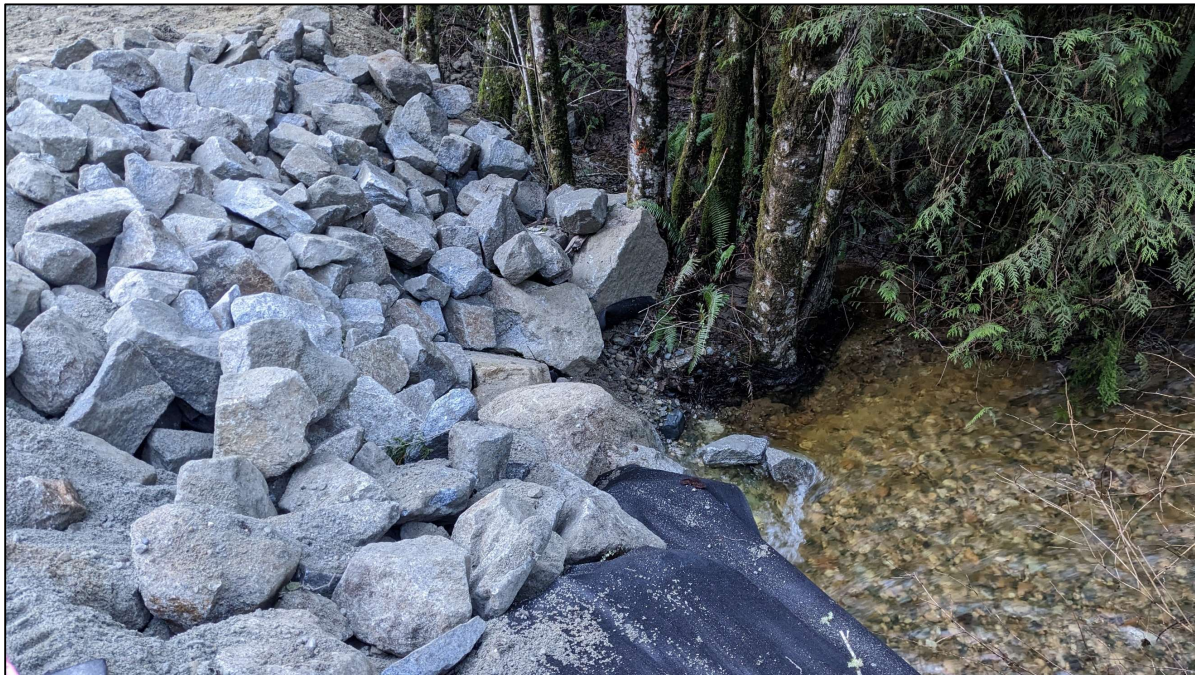
Once the grade was established Capilano placed geotextile down and Dakota commenced to apply rip rap.

3 Upstream End -- Post-Construction Photo

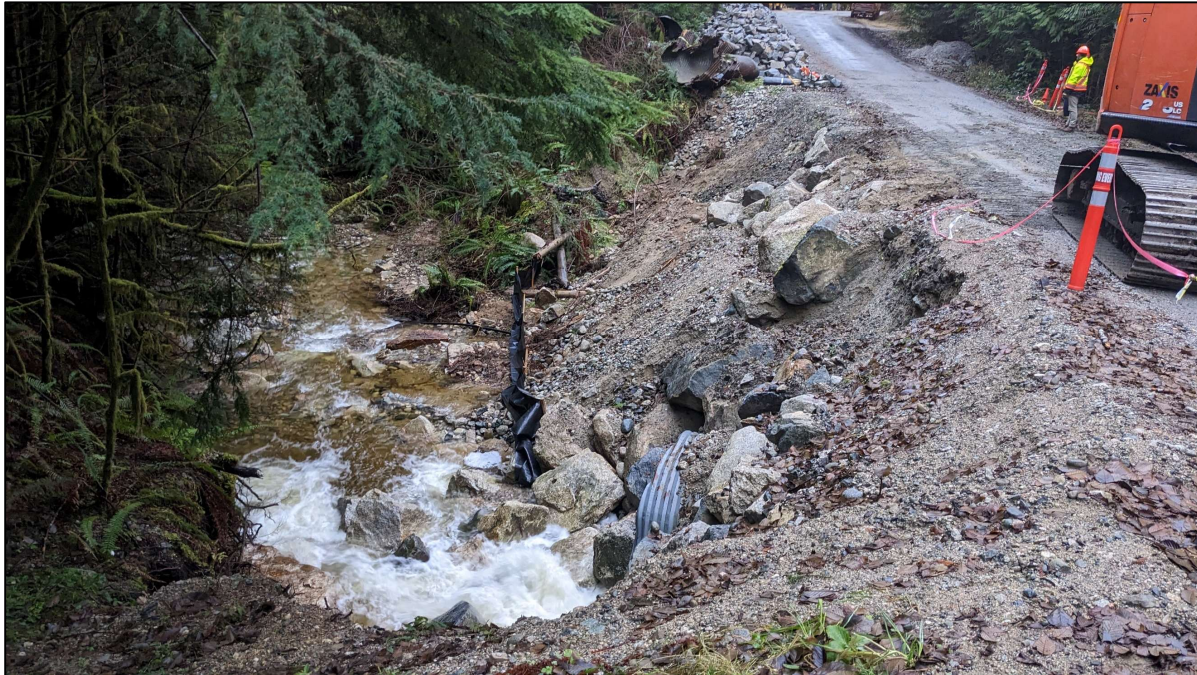
4 Downstream End -- Pre-Construction Site Photo

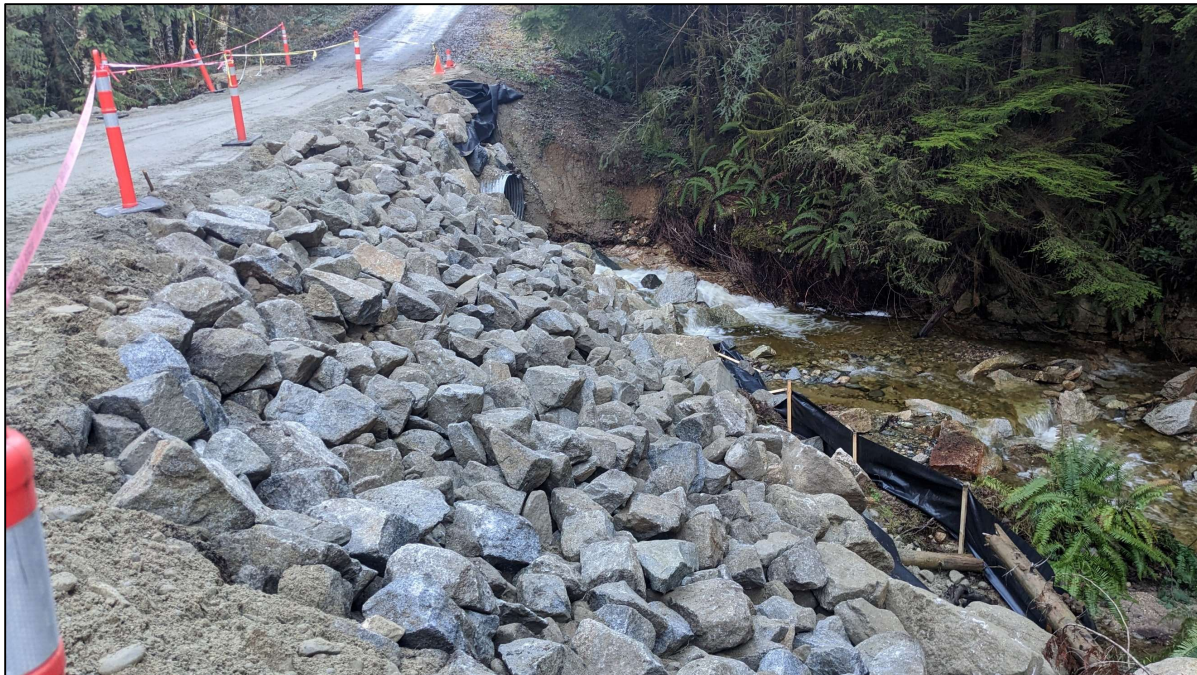
Capilano installed a sediment control fence at the extent of the work zone on the downstream side of Day Road. The fence was installed above the present high-water zone.

5 Downstream End -- Post-Construction Photo
