Kenyon Creek at Redrooffs Road  
Sechelt, BC

# Environmental Overview Assessment

The Ministry of Transportation and Infrastructure (MOTI) retained PGL Environmental Consultants (PGL) to complete an Environmental Overview Assessment (EOA) of proposed flood damage remediation works (the Project) to Redrooffs Road at Kenyon Creek on the Sunshine Coast (the Site; Figure 1). The Site is located within the territories of the shíshálh Nation.

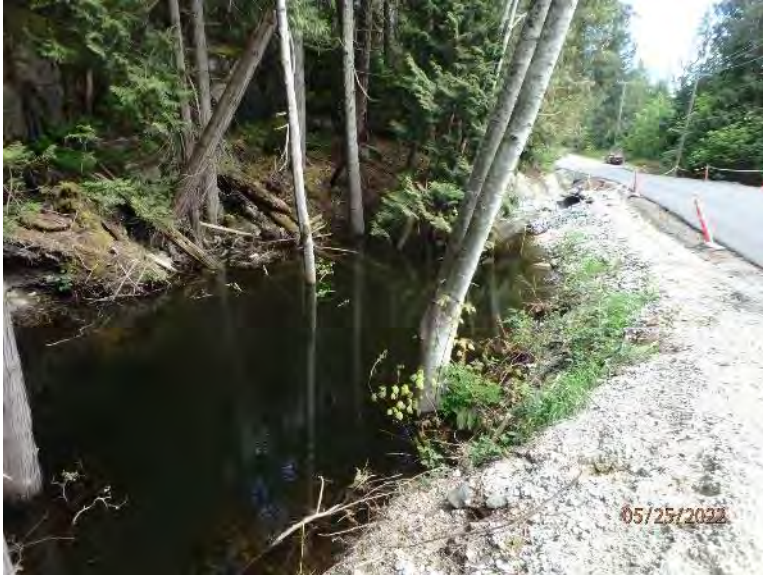
**Photograph 1:**

**View facing northeast (upstream side) from Redrooffs Road. Extreme flooding due to insufficient outflow from temporary culverts (May 25, 2022)**

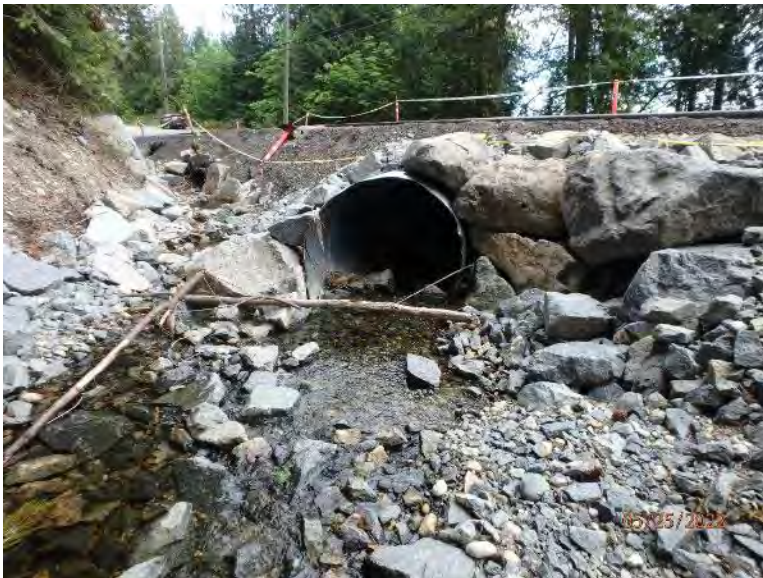
**Photograph 2:**

**Temporary culverts from upstream side, facing downstream (May 25, 2022)**

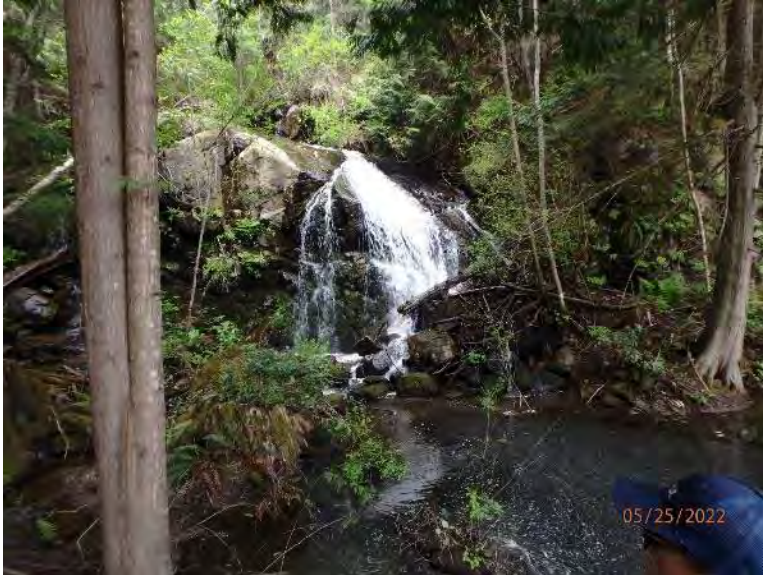
**Photograph 3:**  
**Waterfall to the north**  
**(May 25, 2022)**

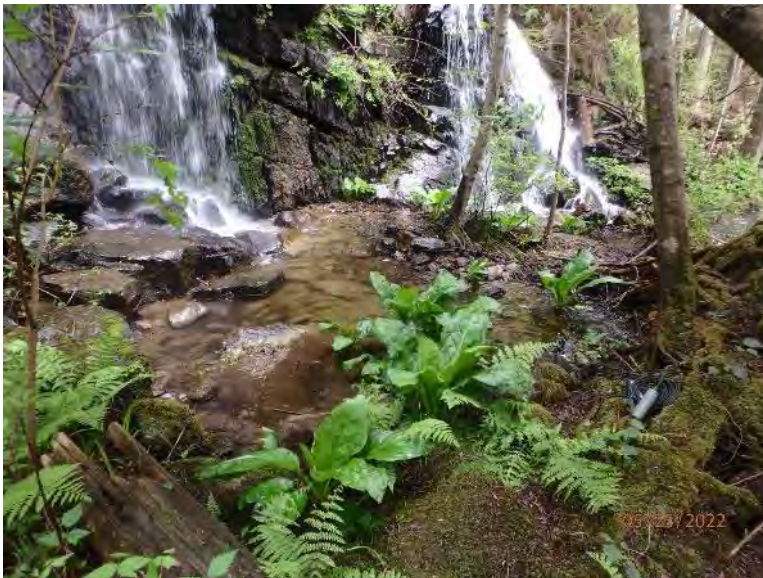
**Photograph 4:**  
**The base of the waterfall to the**  
**north (May 25, 2022)**

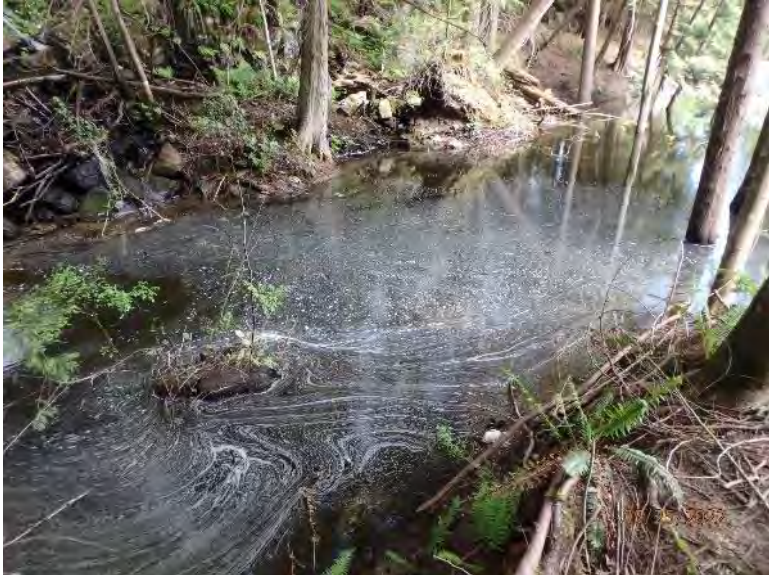
**Photograph 5:**

**Watercourse impounded by a deep pool on the upstream side of Redrooffs Road. Trees are sitting in approximately 2m of standing water (May 25, 2022)**

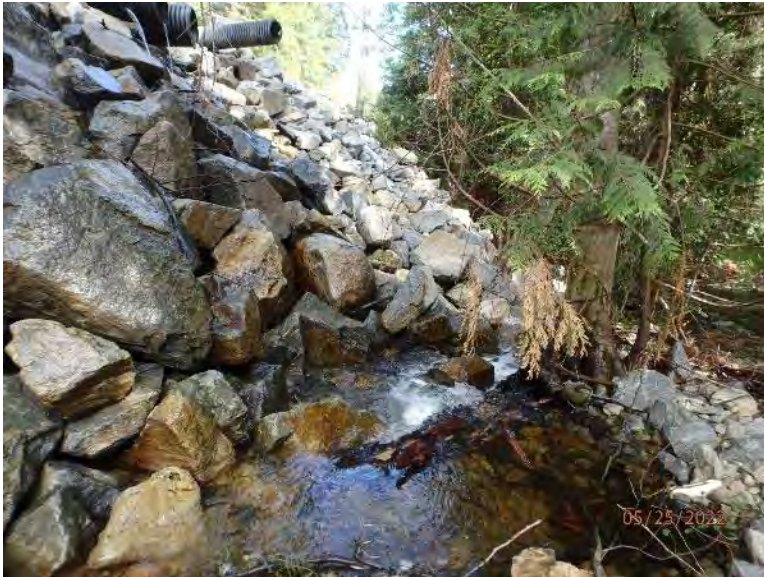
**Photograph 7:**

**View facing downstream from the base of the riprap and structural road fill that is supporting temporary road access (May 25, 2022)**

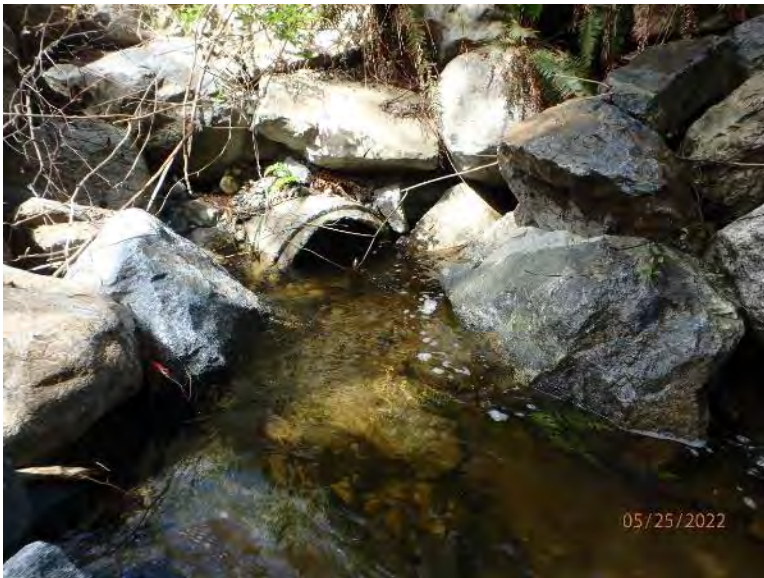
**Photograph 8:**

**Additional (concrete) culvert from downstream side, facing upstream. Culvert is almost completely submerged with very slow outflow (May 25, 2022)**

The existing 700m concrete culvert is undersized and at a nearly 6.5% slope under Redrooffs Road, which creates a barrier to upstream fish movement in Kenyon Creek. Non-anadromous salmonids have been observed above the barrier, though these records are dated and unreliable (ENV, 2022). Fish occurrences within Kenyon Creek that have been documented include steelhead (*Oncorhynchus mykiss*), stickleback (*Gasterosteus* sp.), and cutthroat trout (*Oncorhynchus clarkii*) (ENV, 2022). The lower reaches of Kenyon Creek are fish accessible from Sargeant Bay up to Redrooffs Road. Cobbles, boulders, and large woody debris provide optimal fish habitat downstream of Redrooffs Road, in addition to dense canopy cover (>60%). Fish habitat below Redrooffs Road is considered suitable year-round and likely supports resident or anadromous fish species. During survey work in the fall of 2022, engineering crews observed fish within the Project footprint downstream of Redrooffs Road; however, the species of fish was not confirmed.

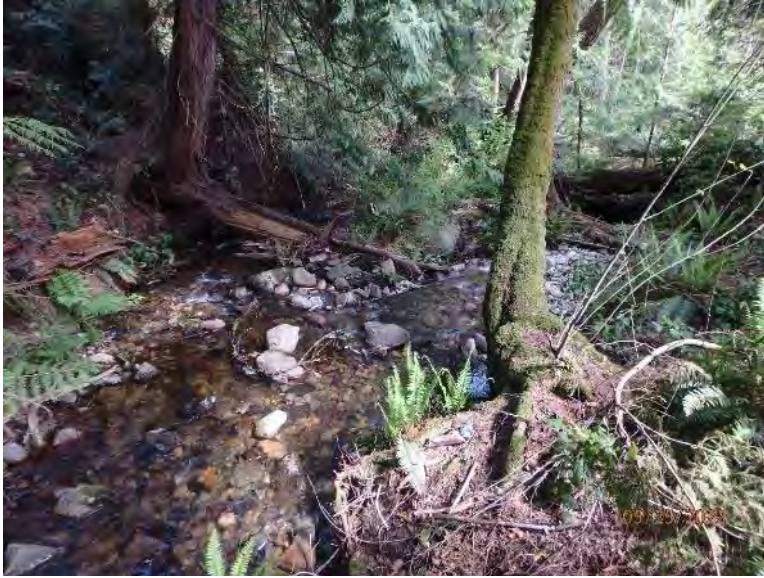
**Photograph 9:**

**Downstream of temporary culverts, view facing downstream. Native channel, not influenced by emergency works (May 25, 2022)**
