# PROVINCE OF BC COLUMBIA VALLEY HIGHWAY STREAM CROSSING FLOOD REPAIRS CONSTRUCTION ENVIRONMENTAL MANAGEMENT PLAN (CEMP)

Ministry of Transportation and Infrastructure | Final Report

**Columbia Valley Highway Stream Crossing Flood Repairs  
CONSTRUCTION ENVIRONMENTAL MANAGEMENT PLAN (CEMP)**

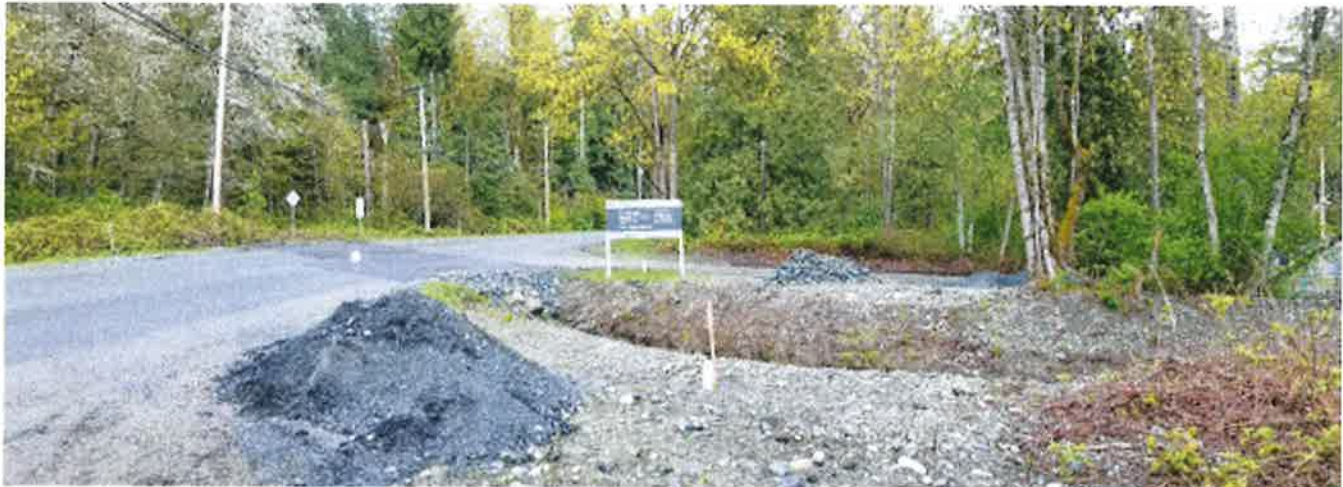
### 5.1 Site 1 – Hatchery Creek (Sweltzer Creek Tributary) at Lakeshore Drive

Site 1 is located on Hatchery Creek below Lakeshore Drive with emergent fish present during investigation. The assessed section is a low gradient reach that flows into Sweltzer Creek with no permanent barriers observed downstream. The culvert bottom has collapsed on itself and is currently operating at reduced capacity. Flows were moderate and water was clear, however substrate was packed with fine silts and organic composite indicative of recent disturbance.

- Sediment release downstream during flood event
- Fish presence and potential habitat for Species at Risk (SAR): Coastal Giant Salamander, Coastal Tailed Frog
- Dredged channel
- Culvert is collapsing, with rusted out bottom

- Q200 flow design
- Culvert fish passage considerations
- Culvert embedment with weirs
- Inlet/Outlet erosion protection
- Restoration of channelized riffle downstream of crossing
- Invasive plant species management
- Riparian restoration planting

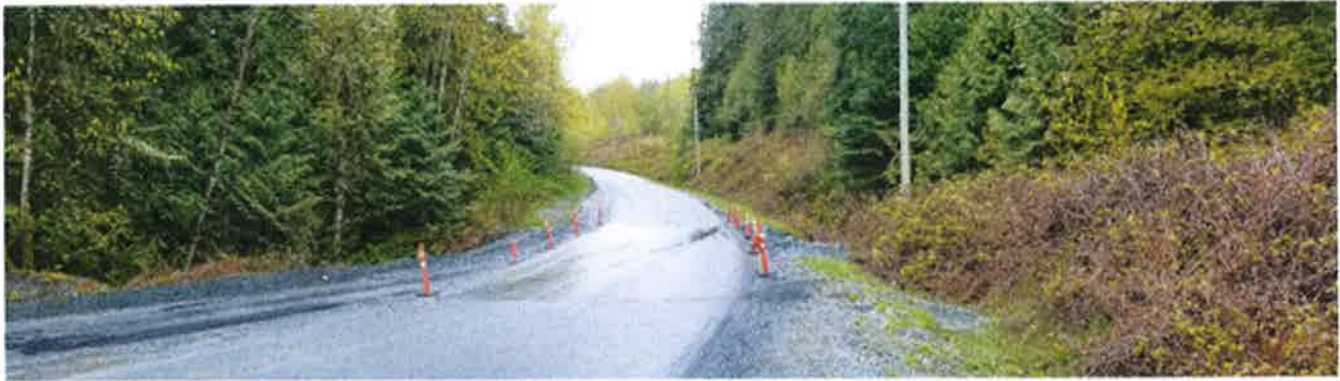
## 5.2 Site 2 – Sweltzer Tributary at Parmenter Road

Site 2 is located on Hatchery Creek at Parmenter Road. The crossing has been replaced with a temporary CSP, which would appear undersized for Q200 discharge. Both the temporary and existing culvert are well elevated above the channel bed. The site would appear to have been the location of a natural cascade, which would have been a barrier to anadromous fish access. The potential for upstream resident fish presence needs to be investigated. Invasive *Lamium* sp. was observed in the forest immediately adjacent to the temporary crossing.

- Sediment release downstream during construction to fish habitat and potential SAR (Coastal Giant Salamander, Coastal Tailed Frog, Red-legged Frog, and Trowbridge Shrew) habitat.
- Fish salvage is required (at least at the downstream outlet)
- Resident fish may be present and this needs to be investigated.
- Invasive plant *Lamium* sp.

- Q200 flow design
- Inlet/outlet erosion protection
- Riparian restoration plan

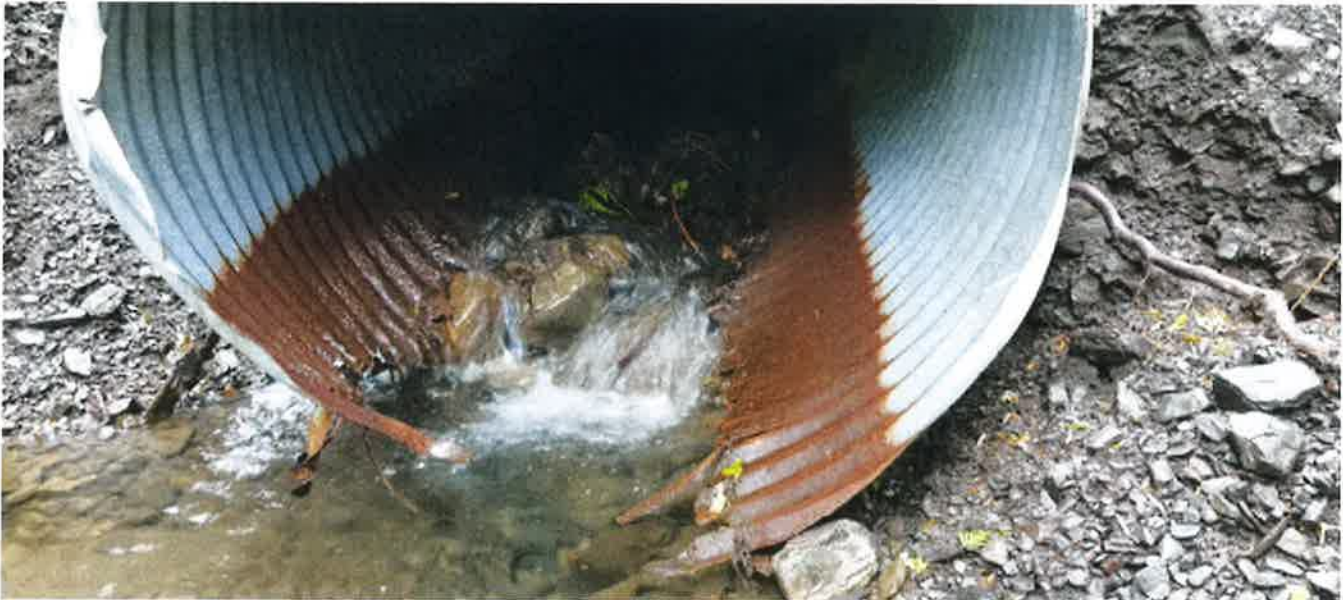
## 5.3 Site 3 – Hwy Culvert adjacent to Delta Grove Campground

Site 3 is a moderately sized (3 m wide) seasonal to ephemeral stream that flows into Sxótsaqel (Cultus Lake) through the Deltagrove Campground. The stream was entering its seasonal dry period in April, with reaches downstream of the Columbia Highway exhibiting only intermittent discharge. Upstream from the lake 60 m the stream channel was entirely dry. The potential for this stream to support fish or species at risk is very limited because of the lack of scour at the beach combined with what appears to be extended dry periods (May through to October).

- Sediment dredging from channel
- Existing or possible partial replacement
- CSP and concrete
- Seasonal to ephemeral discharge
- Access restrictions related to downstream culverts, rip rap and natural dissipation of water volume through the alluvial/colluvial fan

- Q200 flow design
- Inlet/Outlet erosion protection
- Riparian planting
- Consider this stream to be insignificant for fish habitation, but some culvert embedment appropriate for small mammal passage

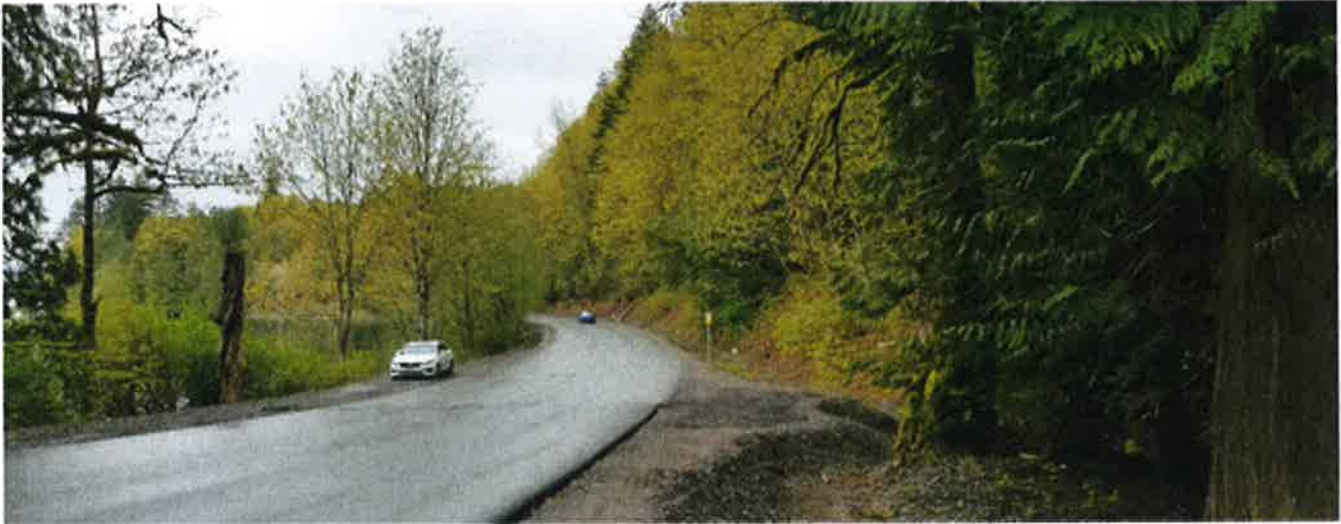
## 5.4 Site 4 – Culvert at Teapot Hill Parking Area

Site 4 is a small <1.5 m wide stream that flows into Sxótsaqel (Cultus Lake). The highway culvert is elevated above the outlet stream and the plunge pool is insufficient in this small stream to facilitate upstream fish passage. Upstream of the highway there is only a short (<20 m long) section of low gradient stream channel. Upstream of this point the stream bifurcates and these two <0.75 m wide channels are on slopes well in excess of 20%.

- Sediment accumulations dredged from channel.
- No fish passage upstream of existing structure.
- Fish friendly design would not offer significant fish habitat improvements given short length of low gradient channel.
- Sediment release downstream during construction to fish habitat and potential SAR: Oregon Forestsnail, Red-legged Frog, and Trowbridge Shrew) habitat.

- Q200 flow design
- Inlet/Outlet erosion protection
- Avoid wildlife tree (Class 4) removal.
- Mitigation Class 1 Wildlife Tree root damage.
- Riparian restoration planting

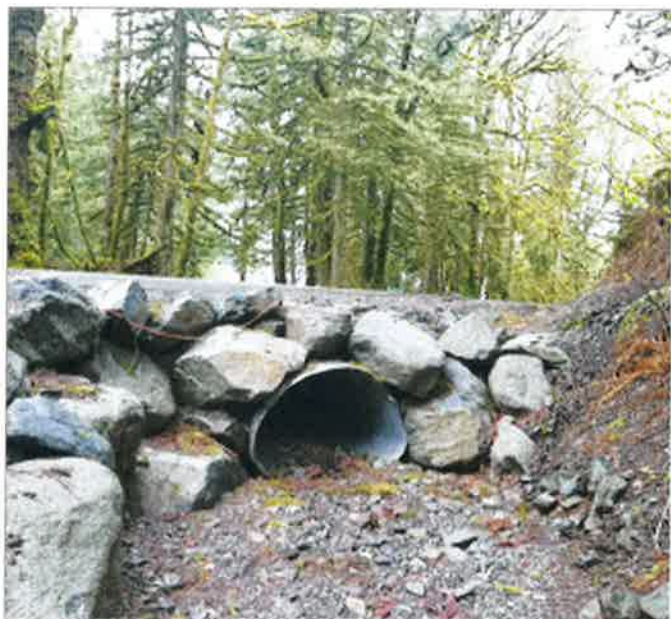
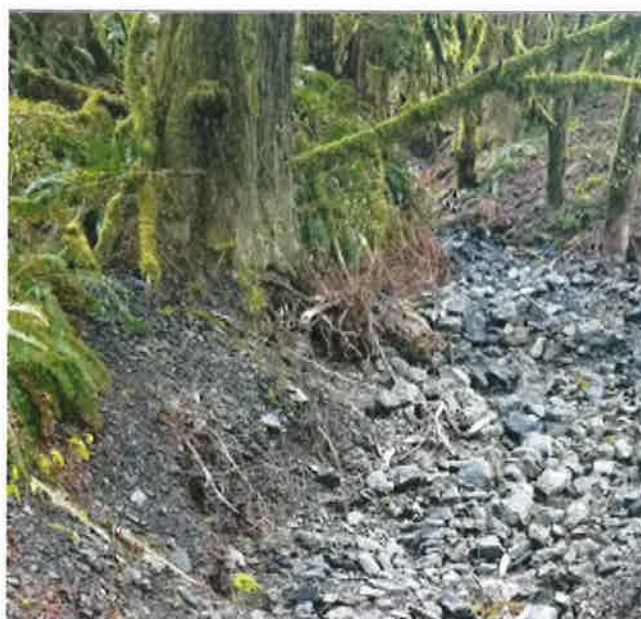
## 5.5 Site 5 – Culvert at Teapot Hill/Honeymoon Bay Campground

Site 5 is a moderately sized channel that was completely dry during investigation. This ephemerally wetted channel may be an avulsion of another stream channel (wetted at the time of assessment) that is approximately 200 m south of this location. This avulsion channel likely only forms a connection to Sxótsaqel (Cultus Lake) during rare peak flow events, providing no potential use for fish at the elevation of the highway.

- Appears to have been formed from a partial channel avulsion
- Sediment accumulation and removal during flood event
- Replacement CSP and rock stack headwall
- Dry steep (12%), ephemeral bony channel unsuitable for fish habitation

- Q200 flow design for replacement culvert
- No fish passage requirement
- Inlet/Outlet erosion protection
- Riparian restoration planting

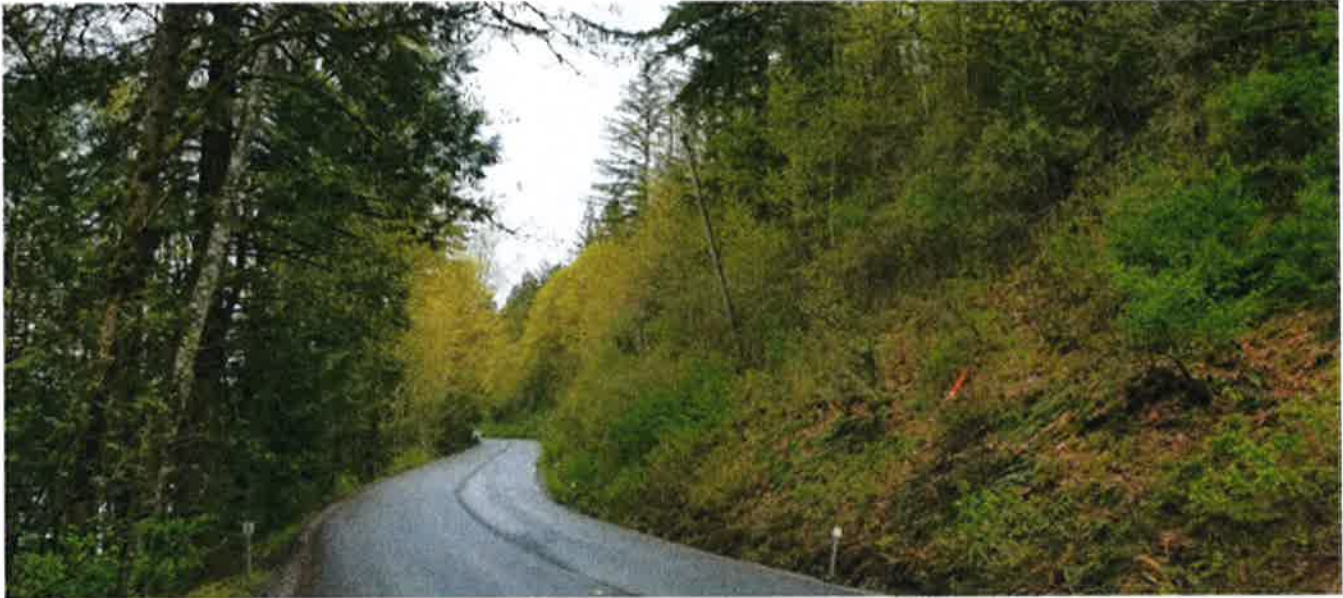
## 5.6 Site 6 – Culvert at Maple Bay

Site 6 is a very small <1 m wide ditch that collects slope seepage and drains it across the road to a small low gradient stream that has poor connectivity to Sxótsaqel (Cultus Lake). Poor connectivity is due to the observation that the discharge dissipates into the gravel beaches and there is very limited scour that flows into Cultus Lake and provides relief from significant rock seepage upstream. Gradient at the road prism exceeds 35%, so the 'stream' at the level of the road is not one where fish passage is required.

- Really just shallow ditch relief from east road edge
- Too steep for fish passage

- Q200 flow design for replacement culvert
- No fish passage requirement
- Inlet/Outlet erosion protection

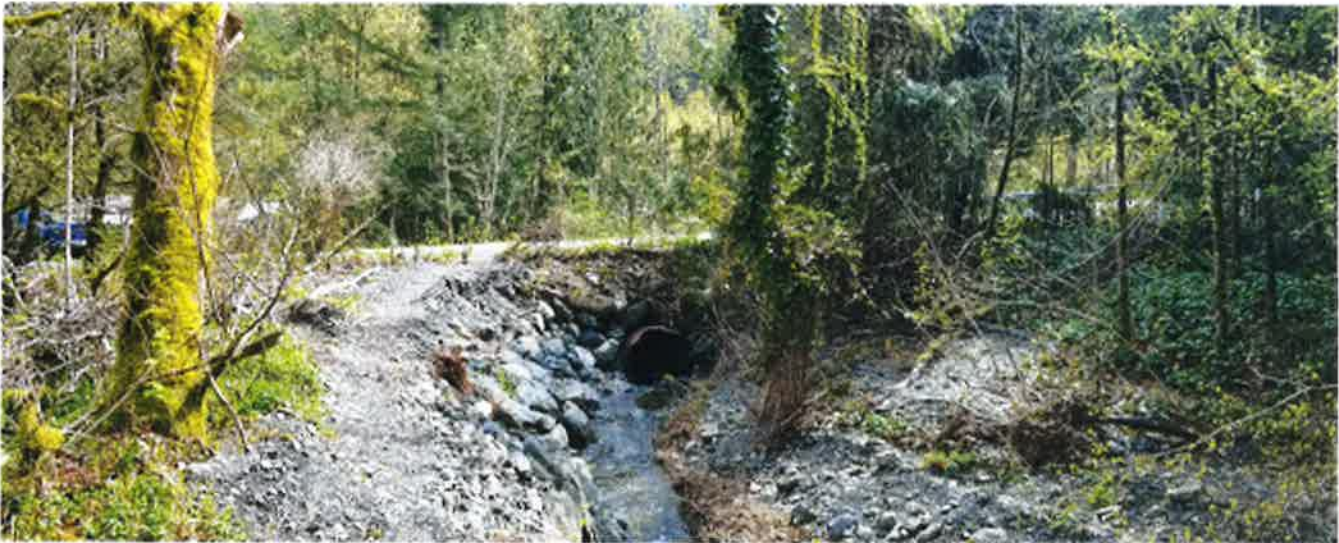
## 5.7 Site 7 – Leisure Valley Trailer Park Frosst Creek Tributary

Site 7 is an unnamed tributary to Frosst Creek that has undergone significant recent channel dredging due to flooding. The existing culvert is elevated well above the channel at the existing culvert outlet. There is no potential for fish passage here given the grade change at the highway. At the time of the assessment there was significant water within the channel and there may be potential for resident fish habitation. This will be investigated, during upcoming environmental assessment.

- Sediment release downstream during flood event
- Dredged channel
- Fish presence at downstream end of culvert
- Potential for resident fish populations upstream need to be investigated
- Potential SAR habitats
- Invasive English Ivy

- Q200 flow design
- No fish passage considerations natural gradient suggestive of a falls cascade at this location historically
- Culvert embedment with weirs
- Inlet/Outlet erosion protection
- Riparian restoration planting
