ROCKWELL DRIVE RECOVERY PROJECT SITE DF3 WATER SUSTAINABILITY ACT CHANGE APPROVAL APPLICATION

ROCKWELL DRIVE RECOVERY PROJECT SITE DF3 *WATER SUSTAINABILITY ACT* CHANGE APPROVAL APPLICATION

MOT110866
VERSION 2.0

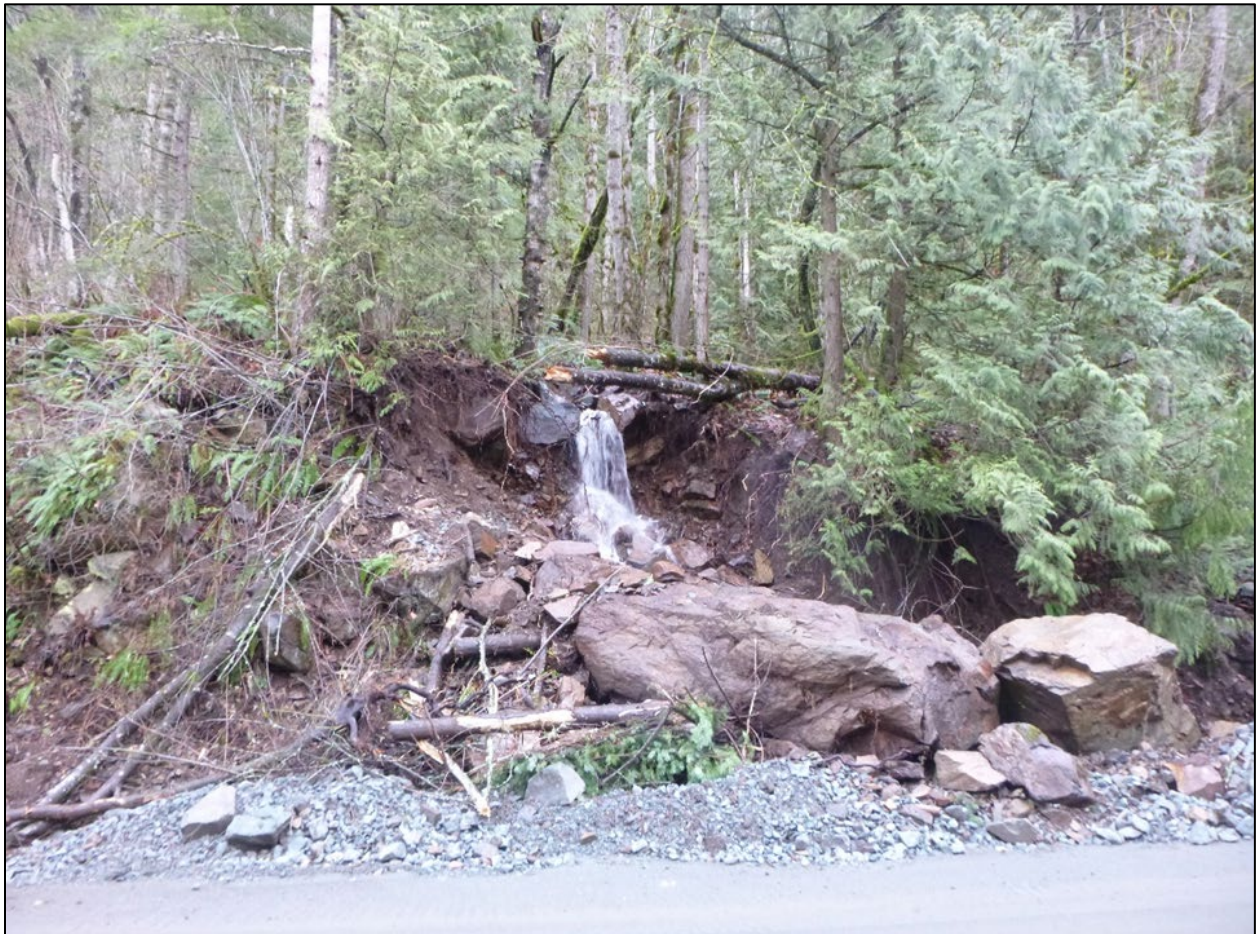
Figure 2 Watercourse avulsion at Site DF3 (December 14, 2021).

Channel armouring to approximately 50 m upstream of the new culvert is required to prevent a future channel avulsion and/or erosion within the existing channel during a flood event. Channel armouring will include the installation of grouted riprap (50 kg), including the installation of a check dam to reduce water

velocity approximately 32 m upstream of the culvert inlet. Design drawings prepared by R.F. Binnie & Associates are provided in Appendix A2.

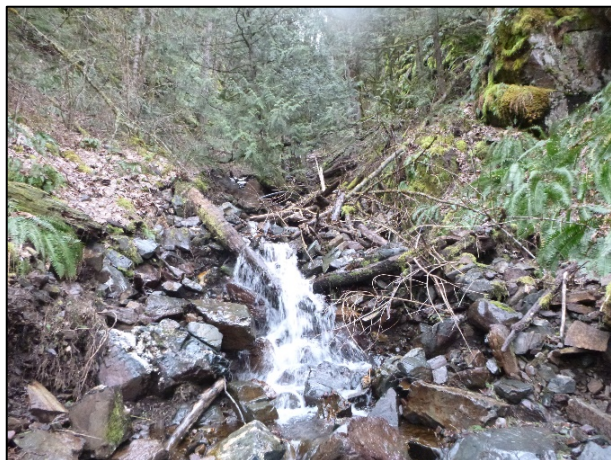
Figure 3 **Photographs of site DF3 (March 30, 2022).**

Upstream view of the site DF3 watercourse upstream of Rockwell Drive.

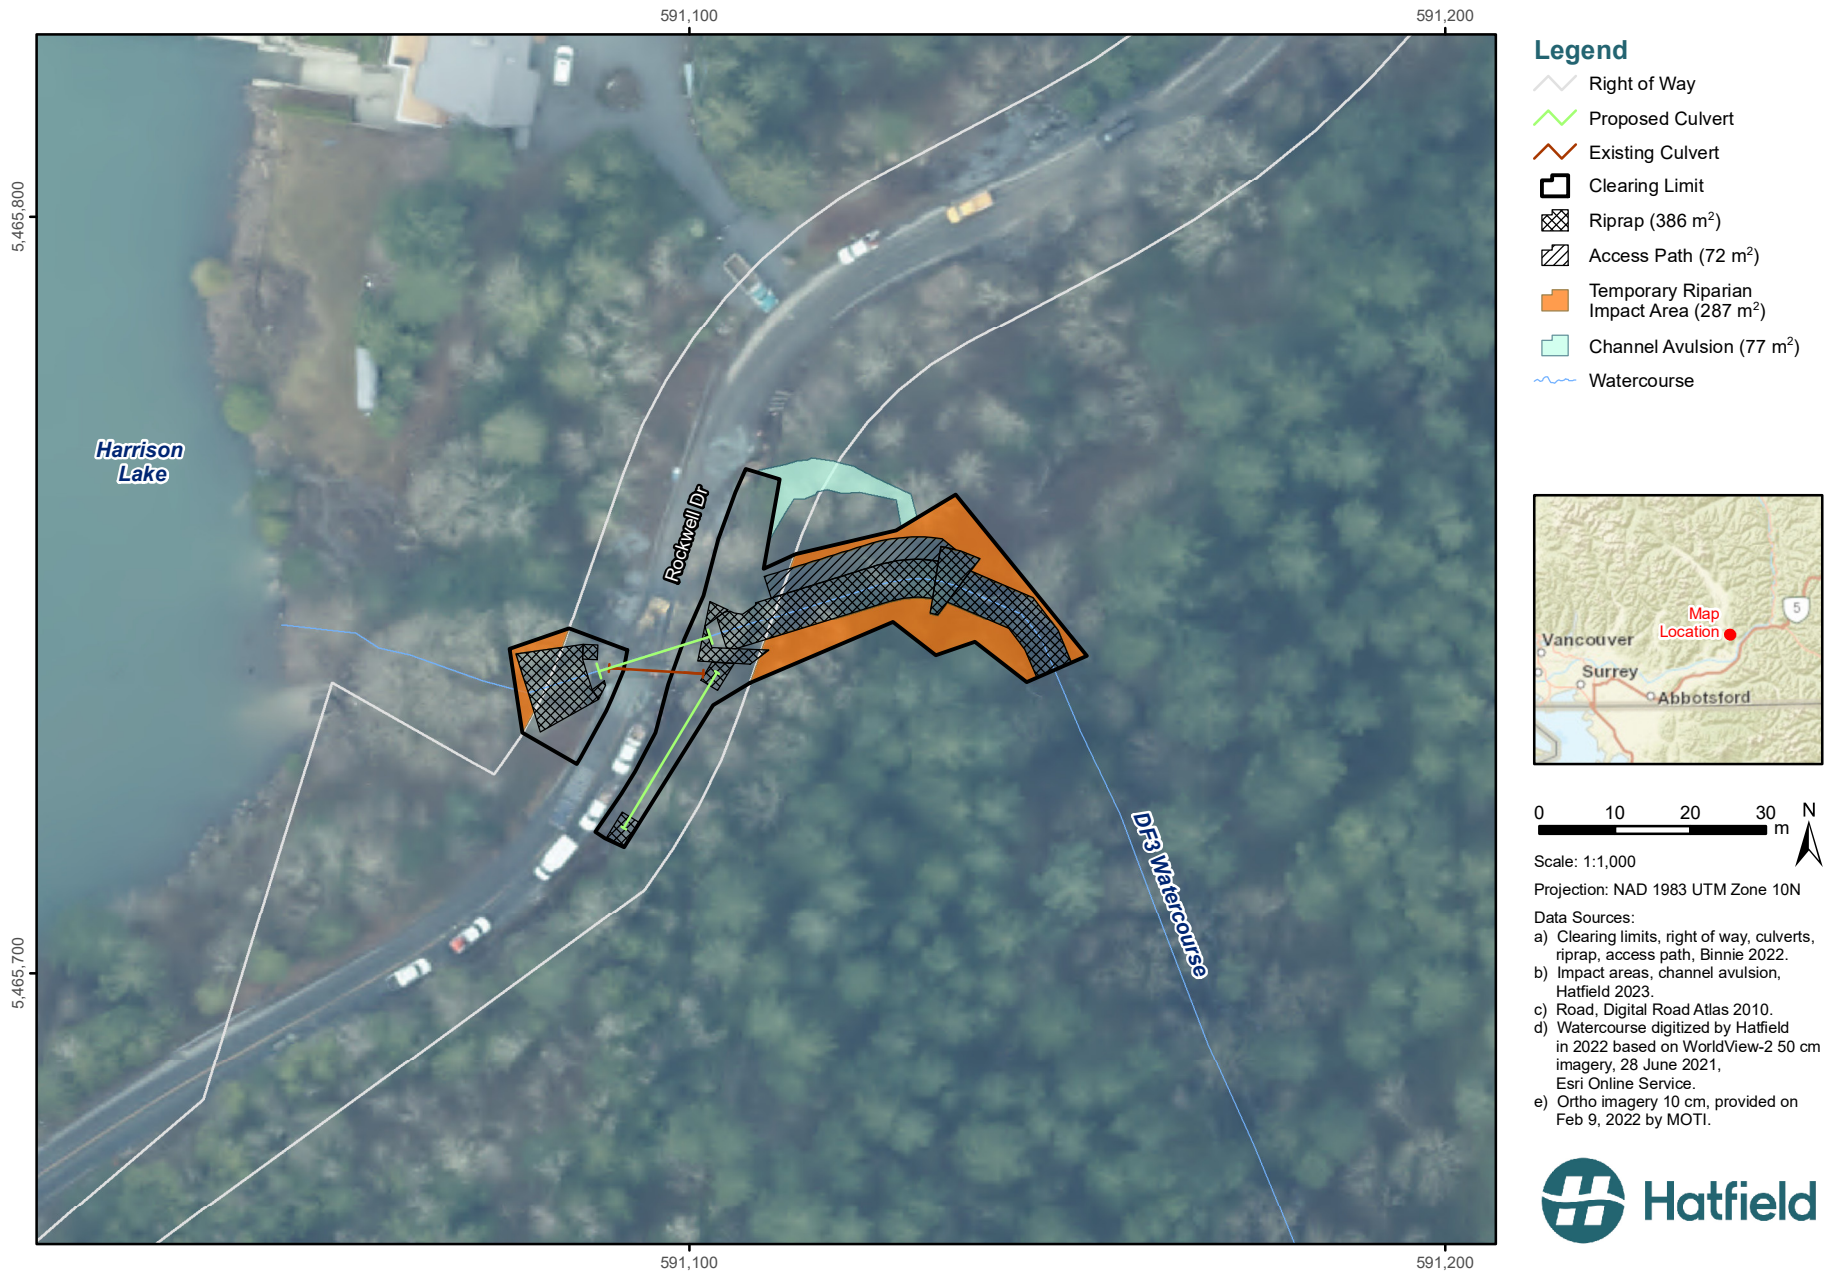
Figure 4 Assessment of impacts for site DF3, Rockwell Drive Recovery Project.

The channel avulsion that occurred as a result of the 2021 flood event damaged approximately 77 m² of riparian habitat (Figure 4) which will be regraded to pre-flood conditions and revegetated per Section 4.1.1 below.

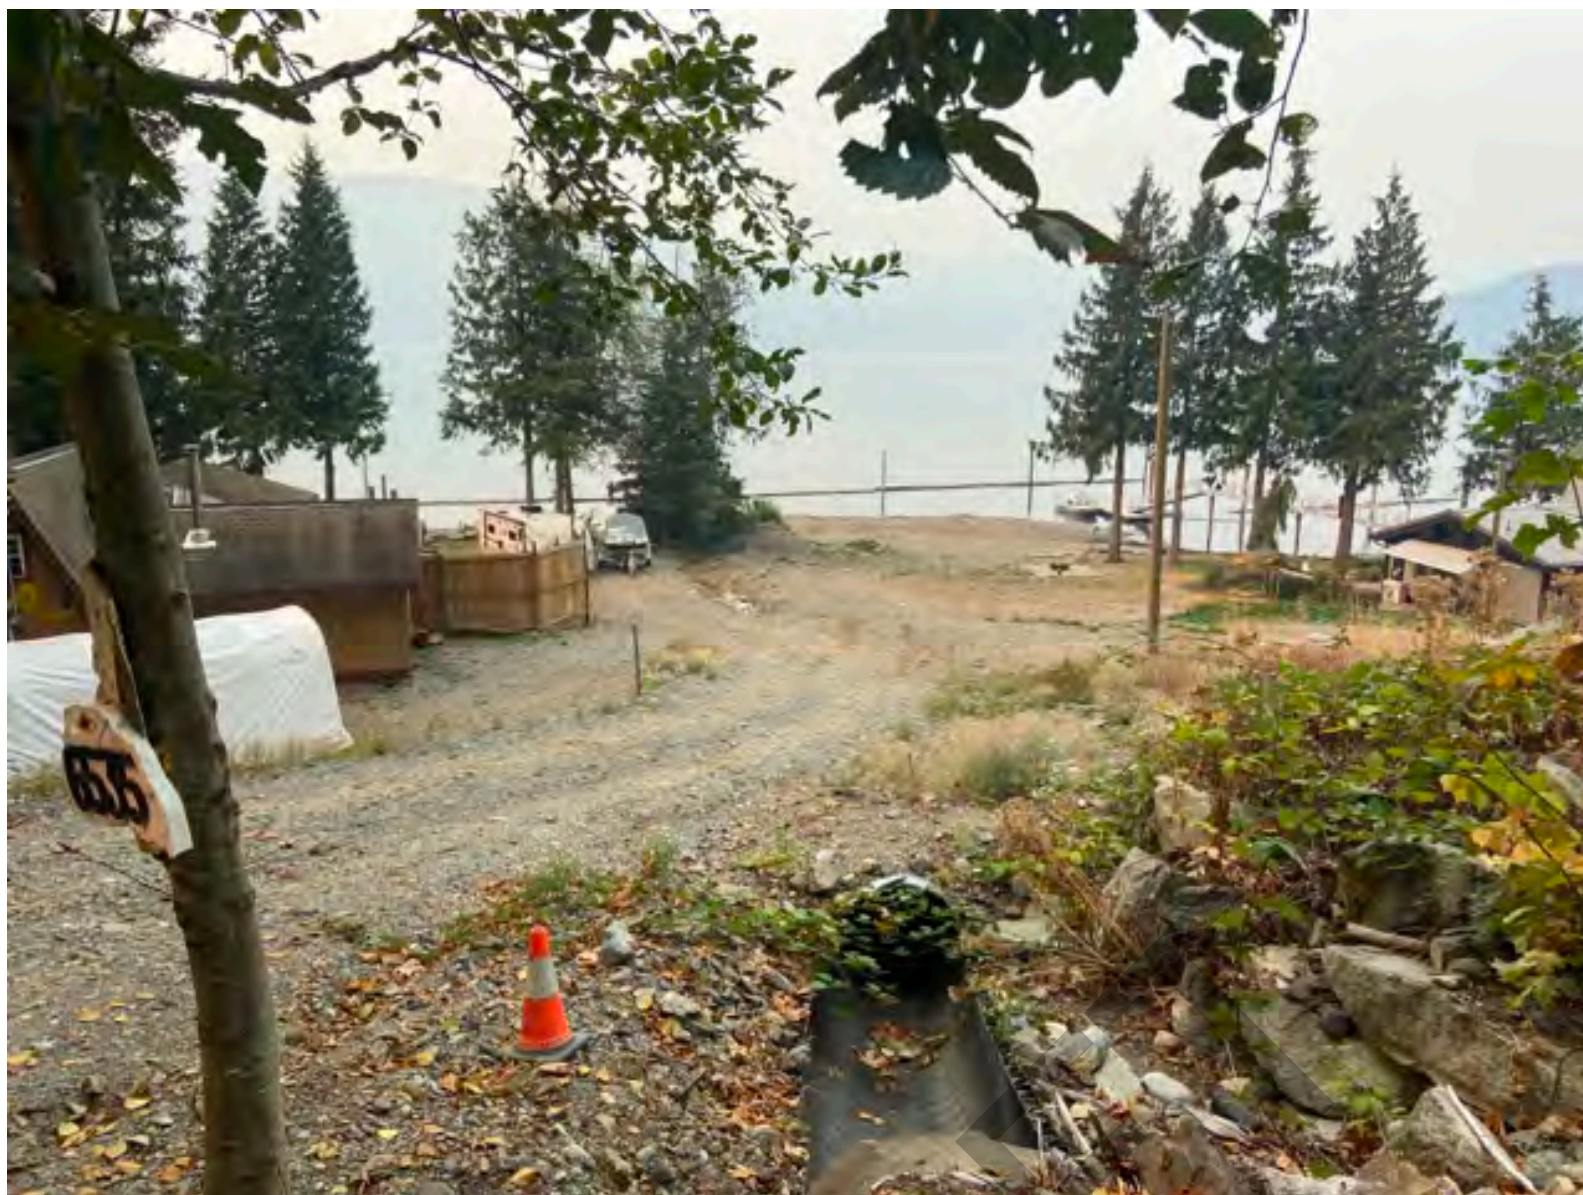
Photo 1 DF1-View west of culvert outlet showing the sloping terrain toward the lake and property development on the west side of Rockwell Drive

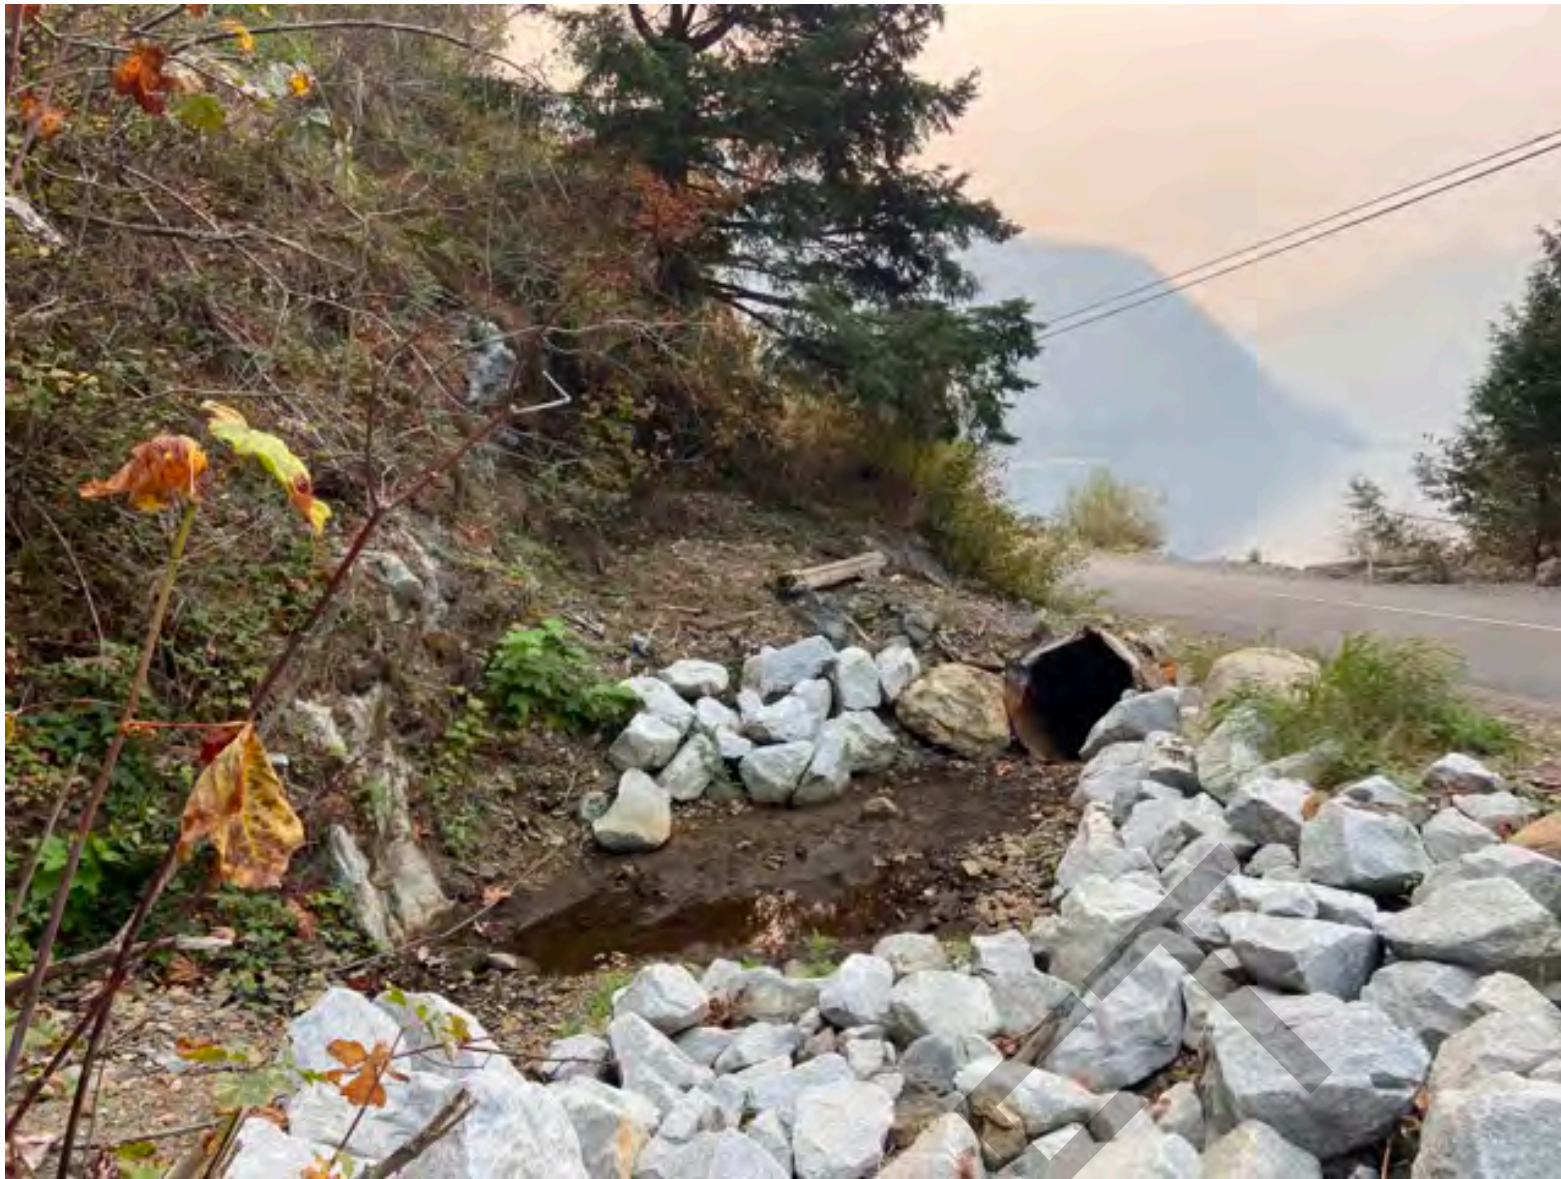
Photo 3 DF2 - View west-southwest of the culvert input on the east side of Rockwell Drive showing sloping terrain to the south and temporary works including installation of riprap.

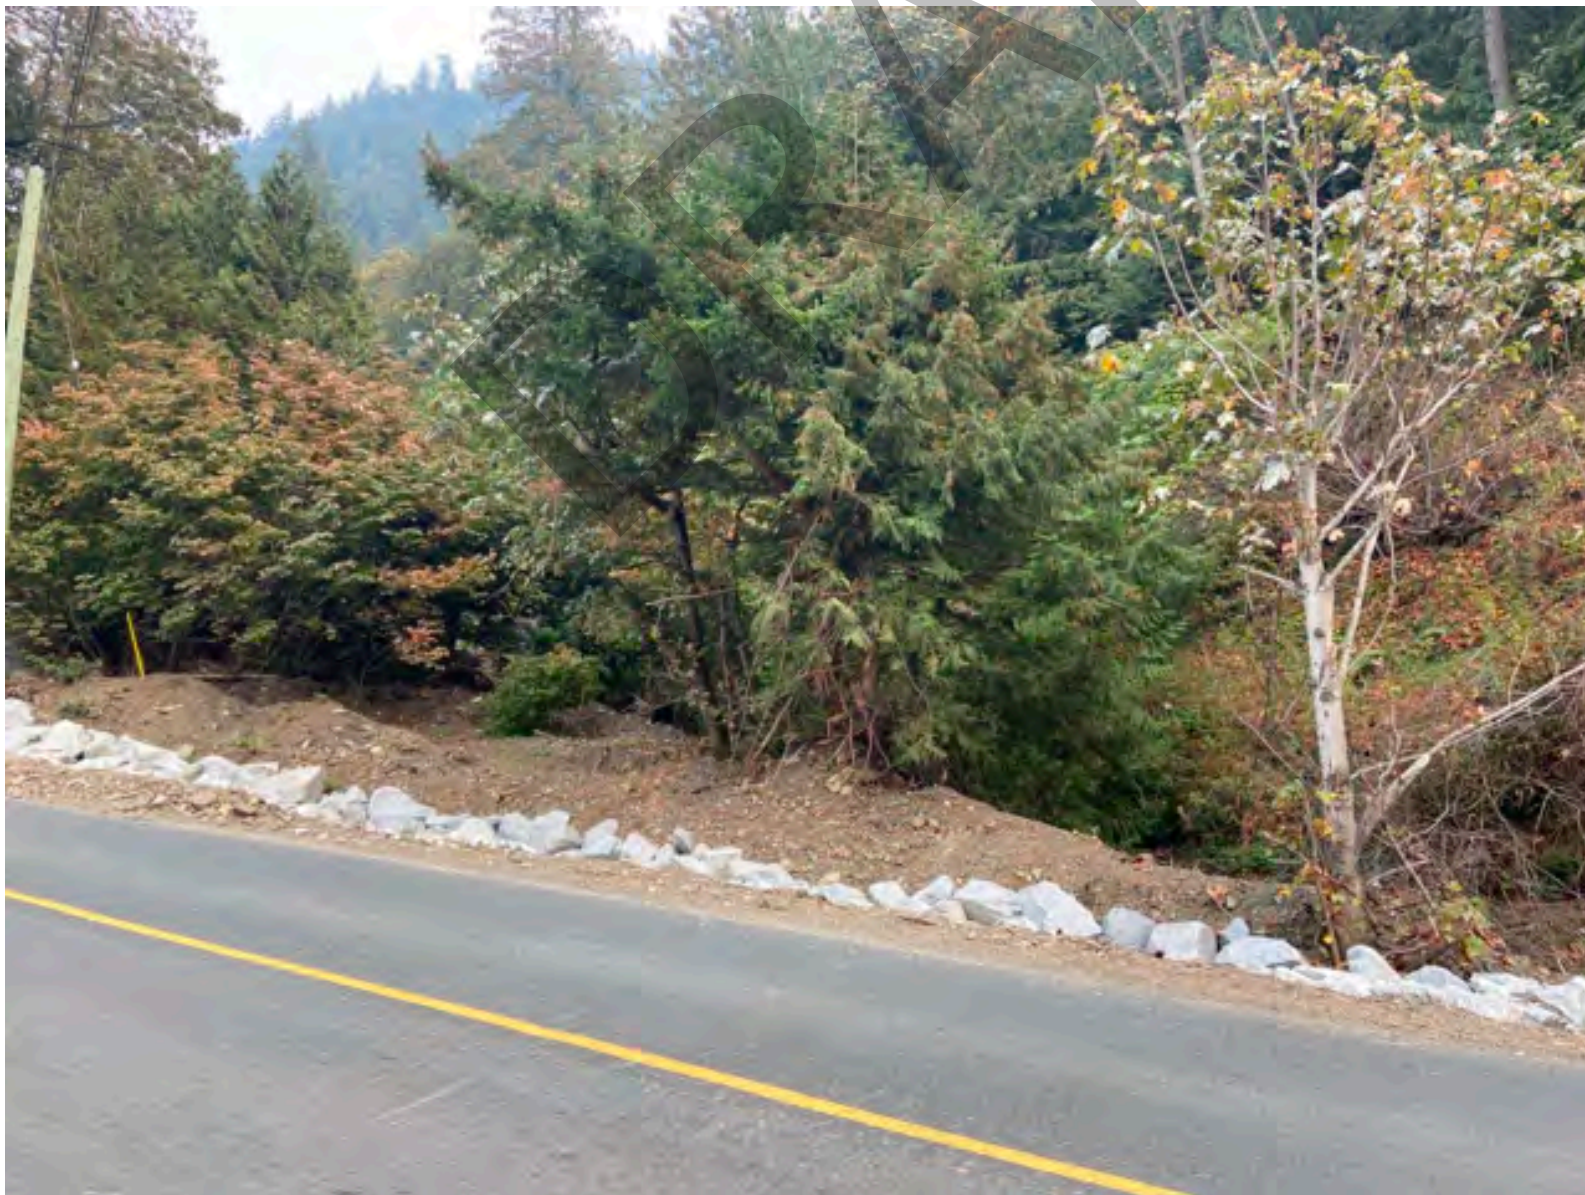
Photo 4 DF2 - View east-northeast of washout debris on an existing berm on the east side of Rockwell Drive.

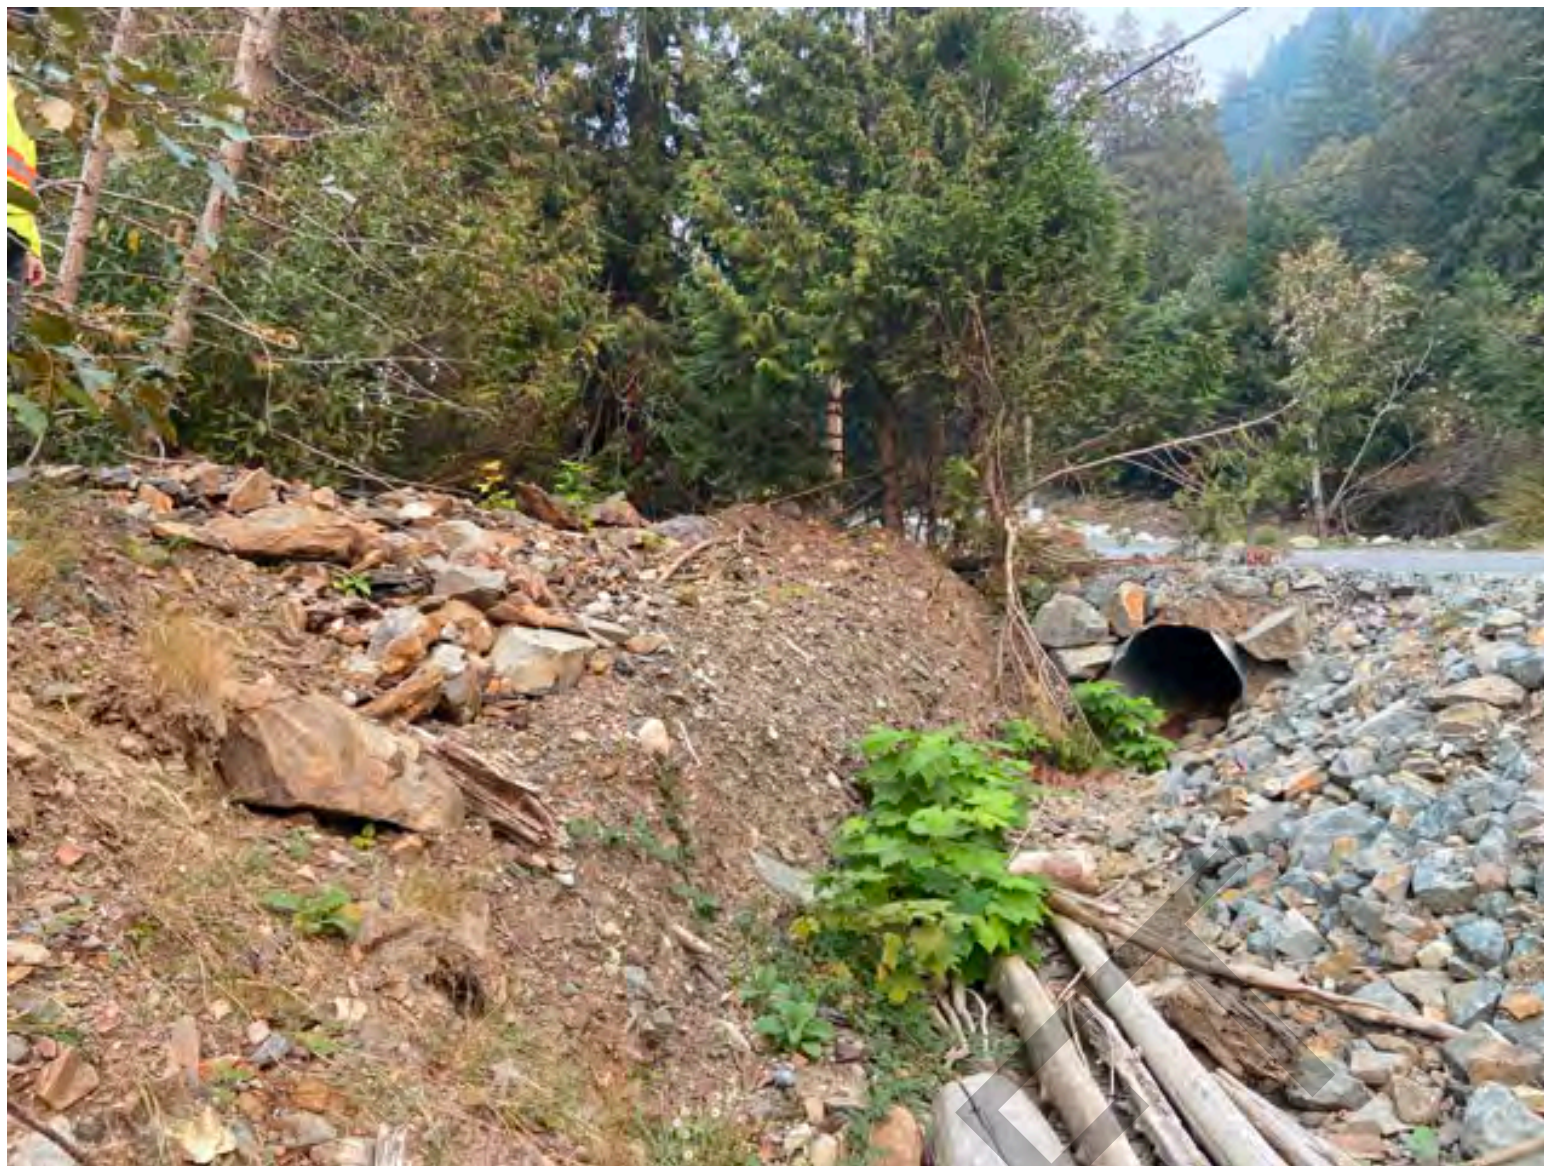
Photo 5 DF2-View northeast of the culvert output on the west side of Rockwell Drive showing the berm to the left and the built up elevation of Rockwell Drive

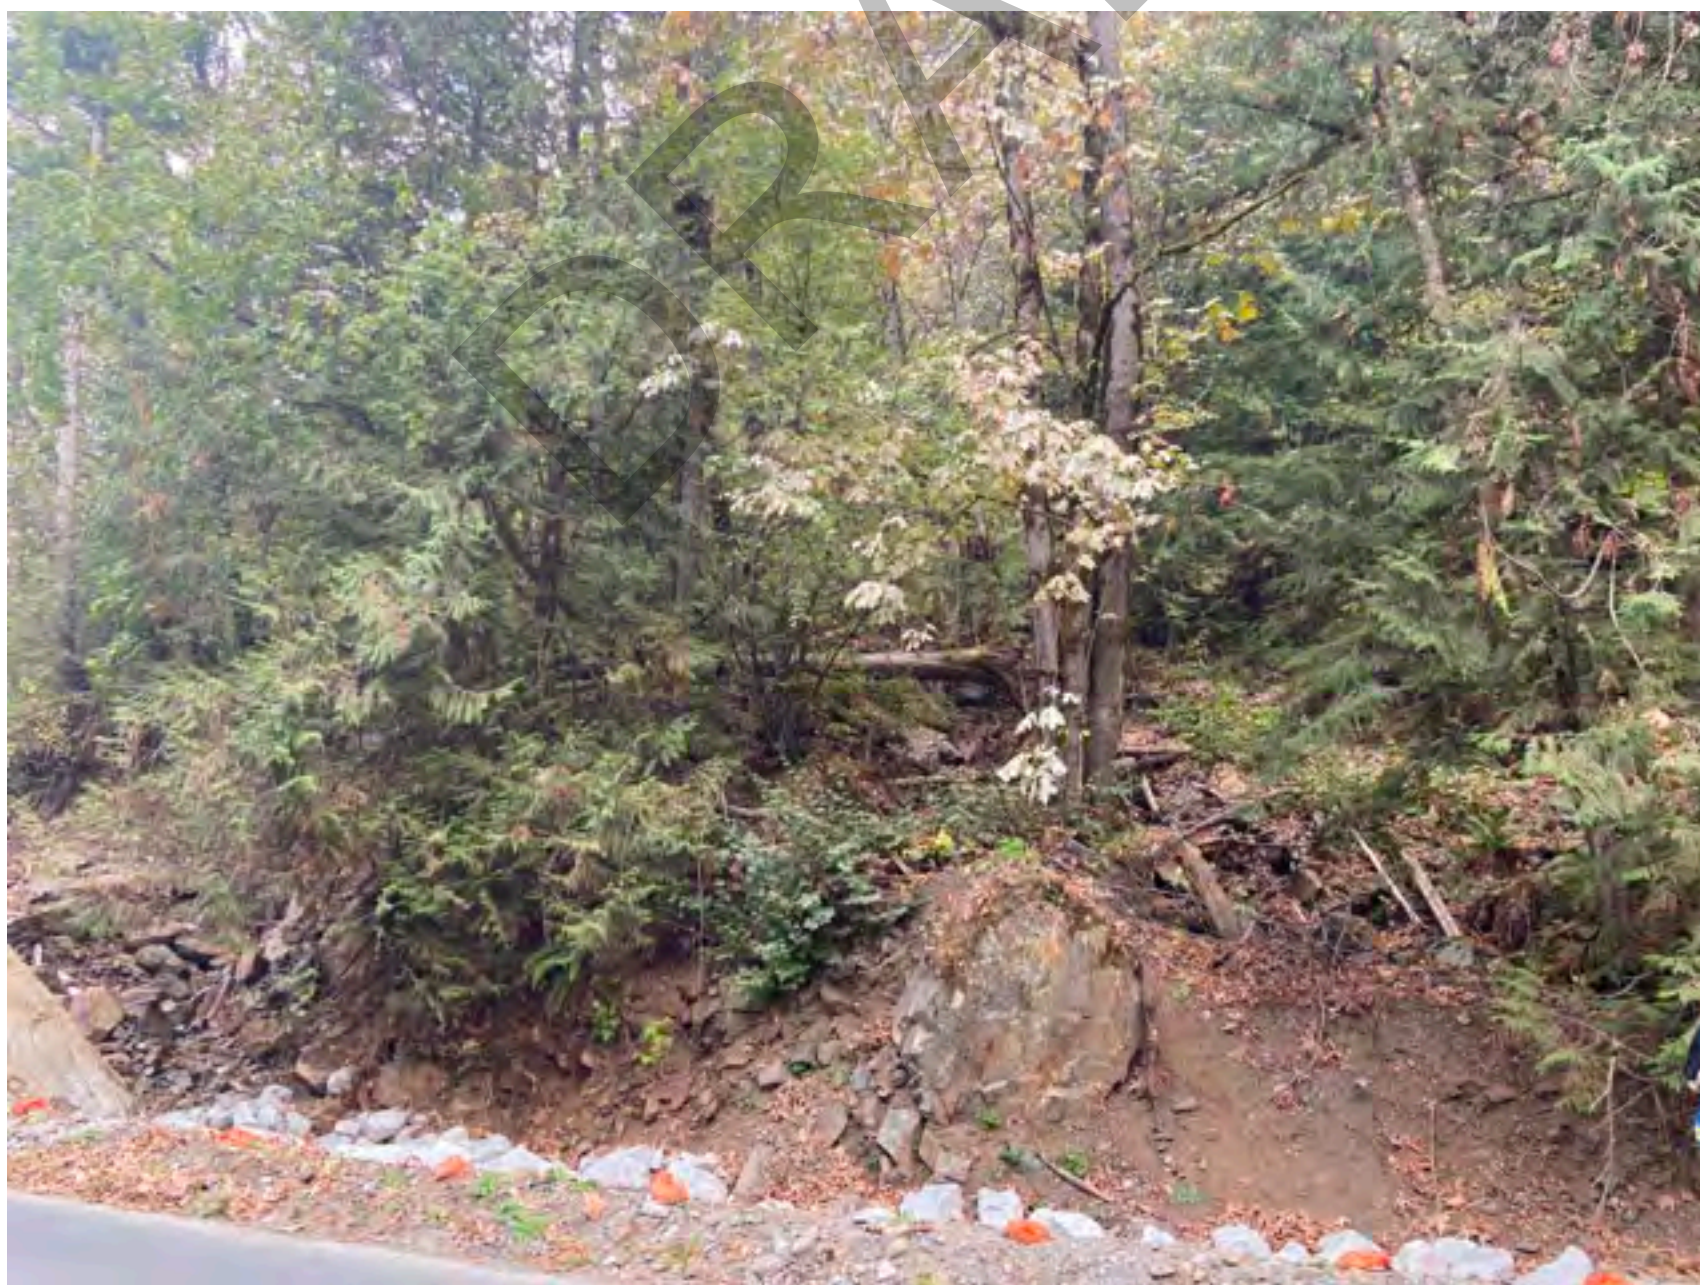
Photo 6 DF3-View east-northeast of terrain on the east side of Rockwell Drive and temporary works including ditching and riprap installation following the 2021 atmospheric river event

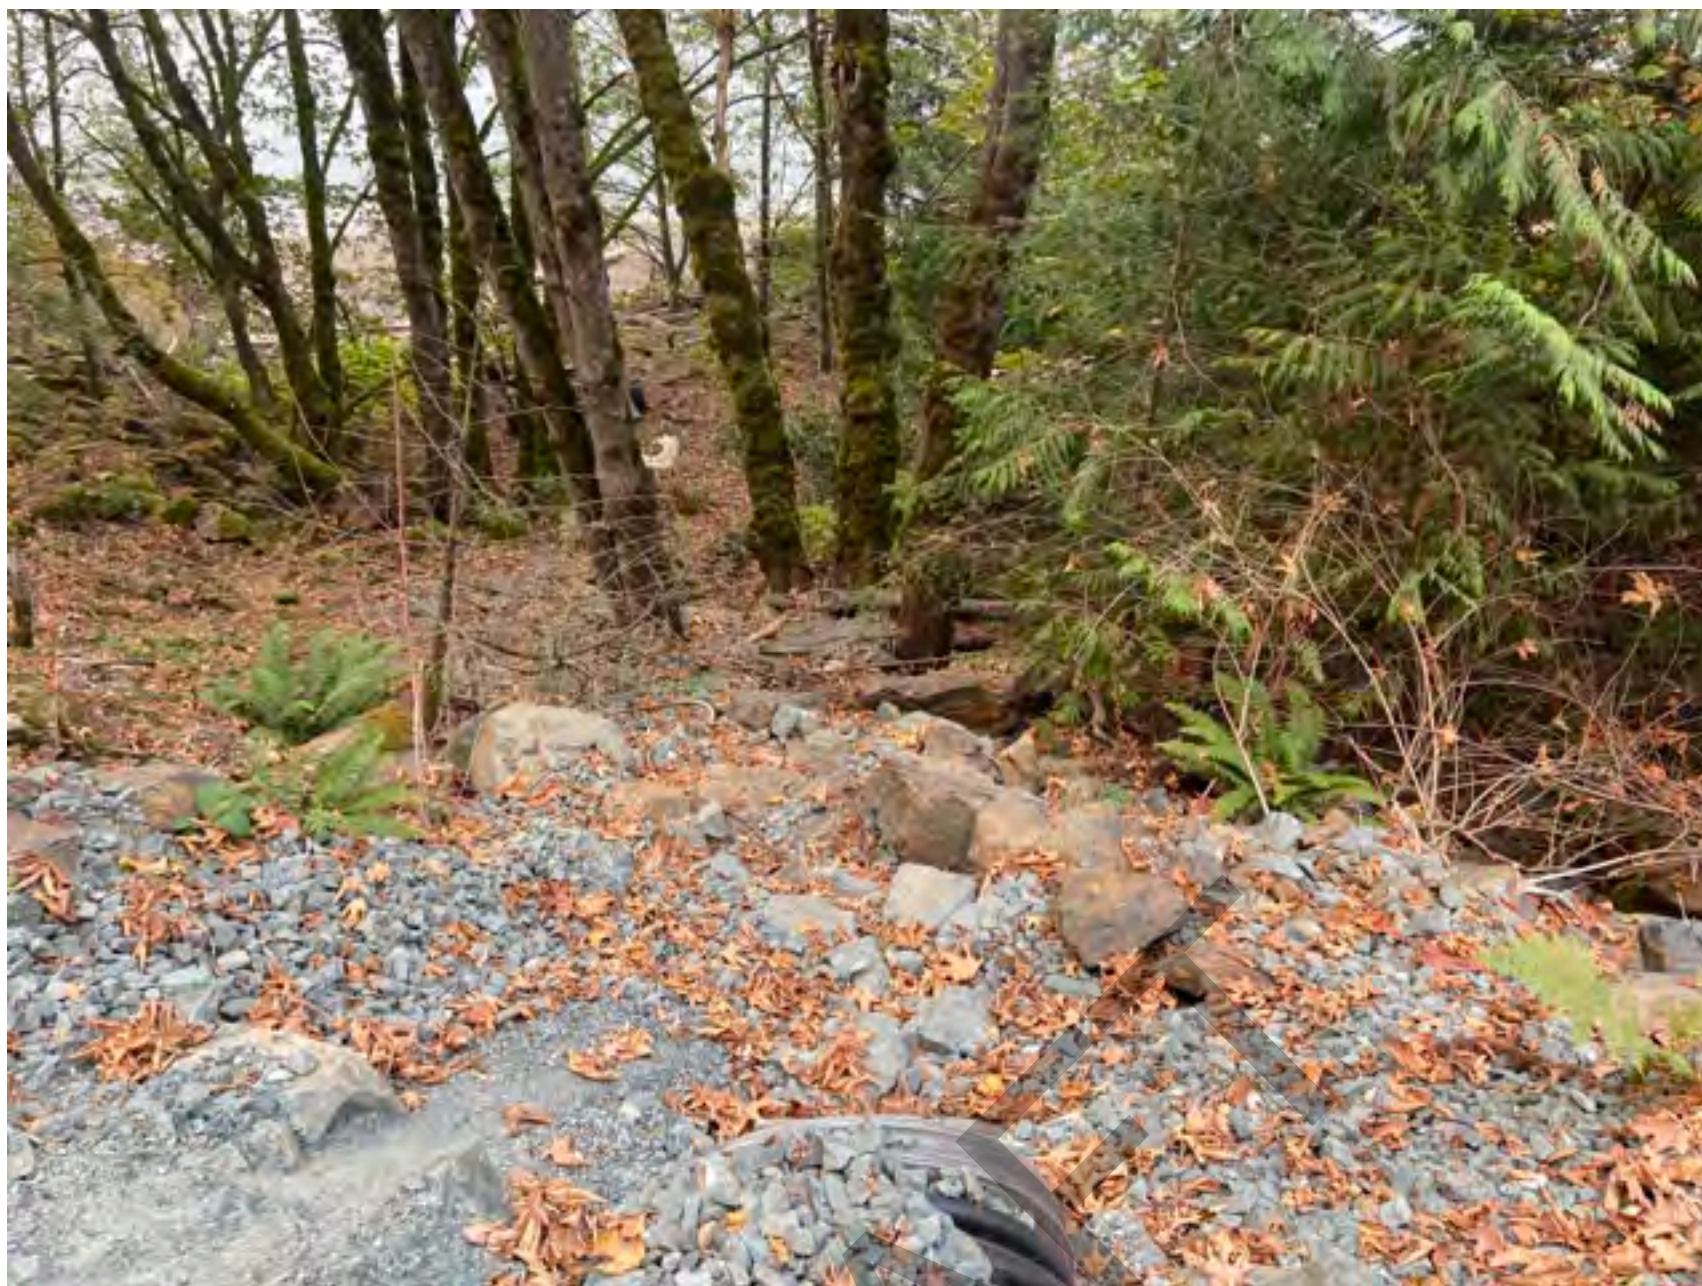
Photo 7 DF3-View west-southwest of culvert outlet and steep terrain descending to Harrison Lake on the west side of Rockwell Drive

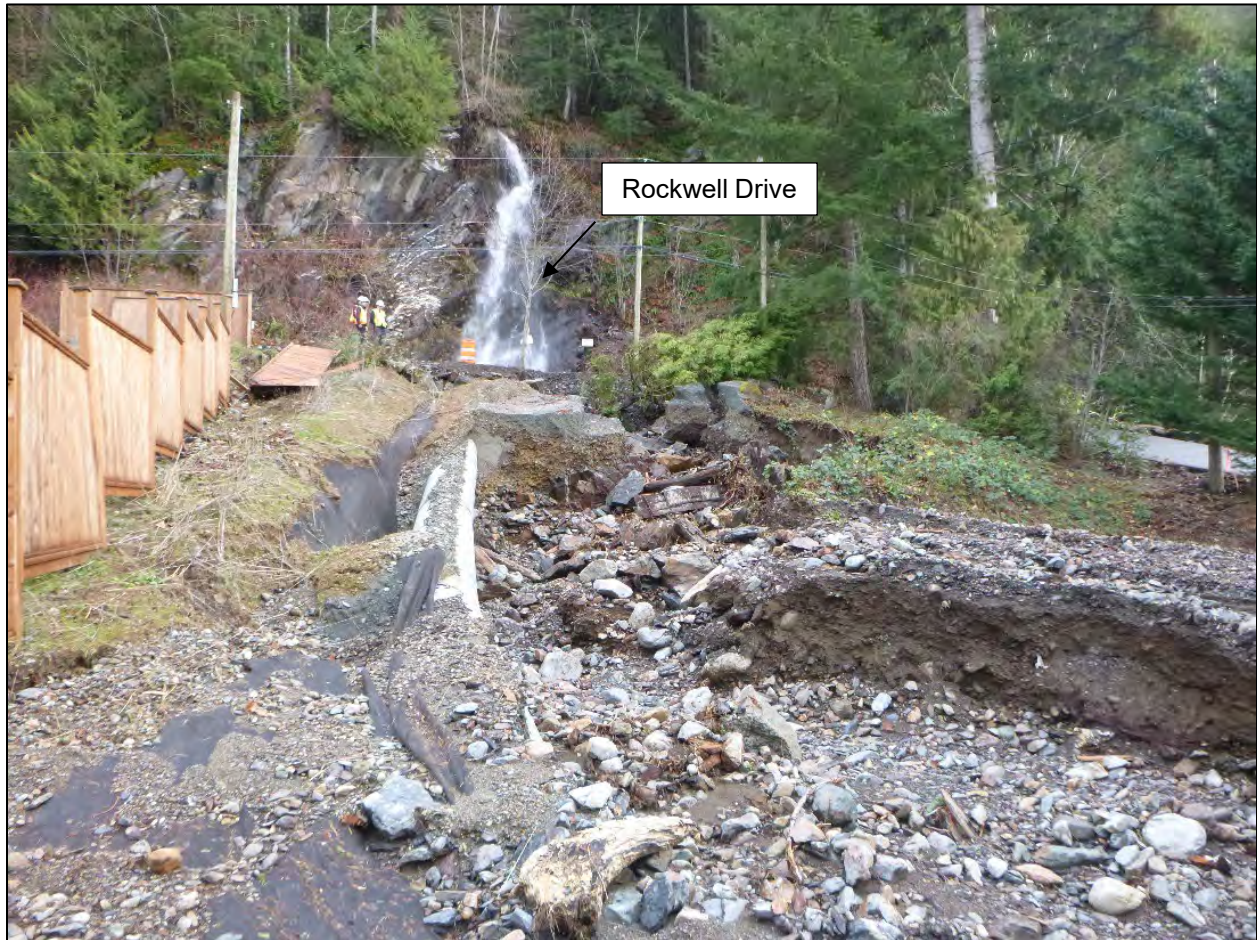
Figure 1 Upstream view of site DF1 from within the 6535 Rockwell Drive property (December 14, 2021).

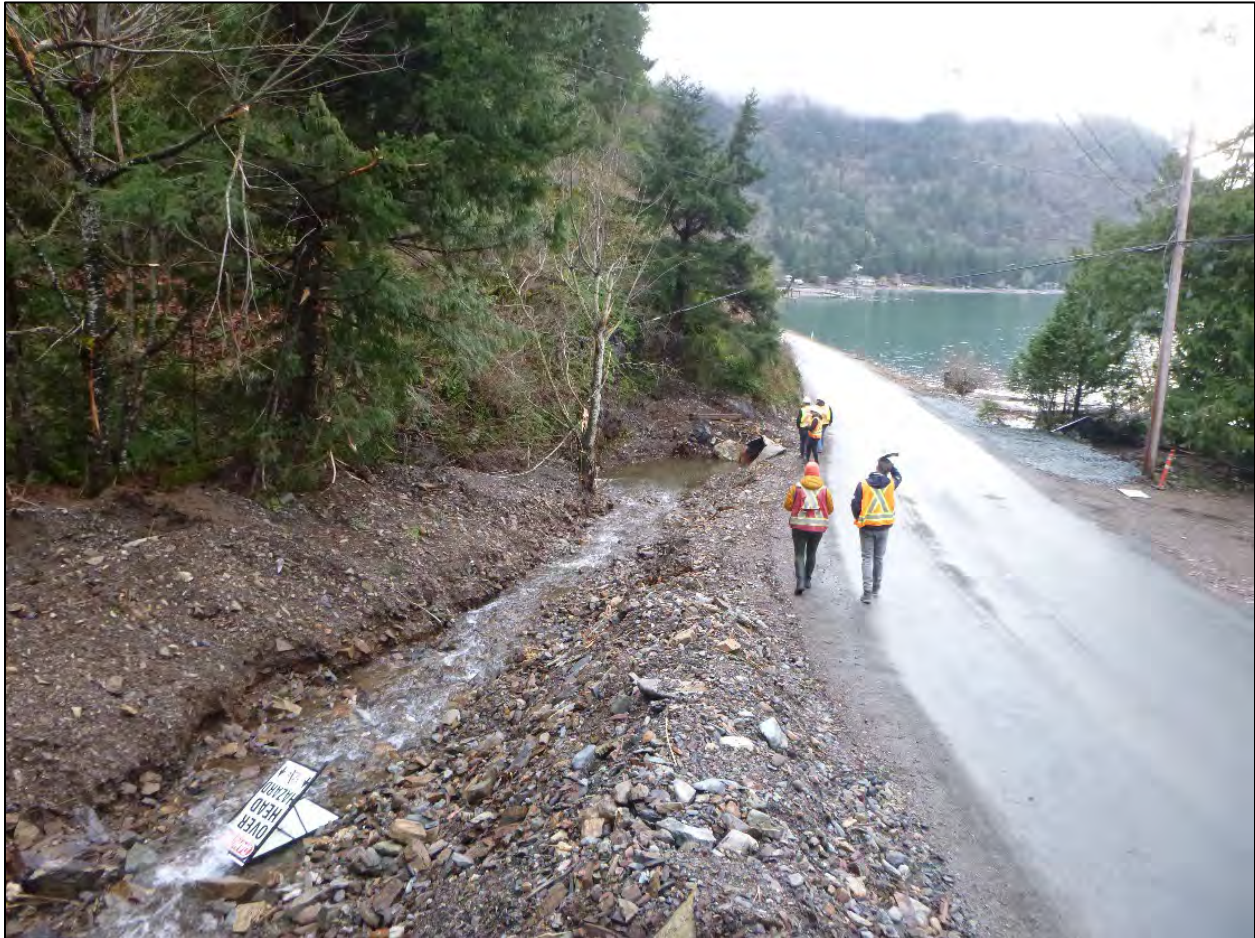
Figure 2 Downstream view of site DF2 showing erosion and debris along Rockwell Drive (December 14, 2021).

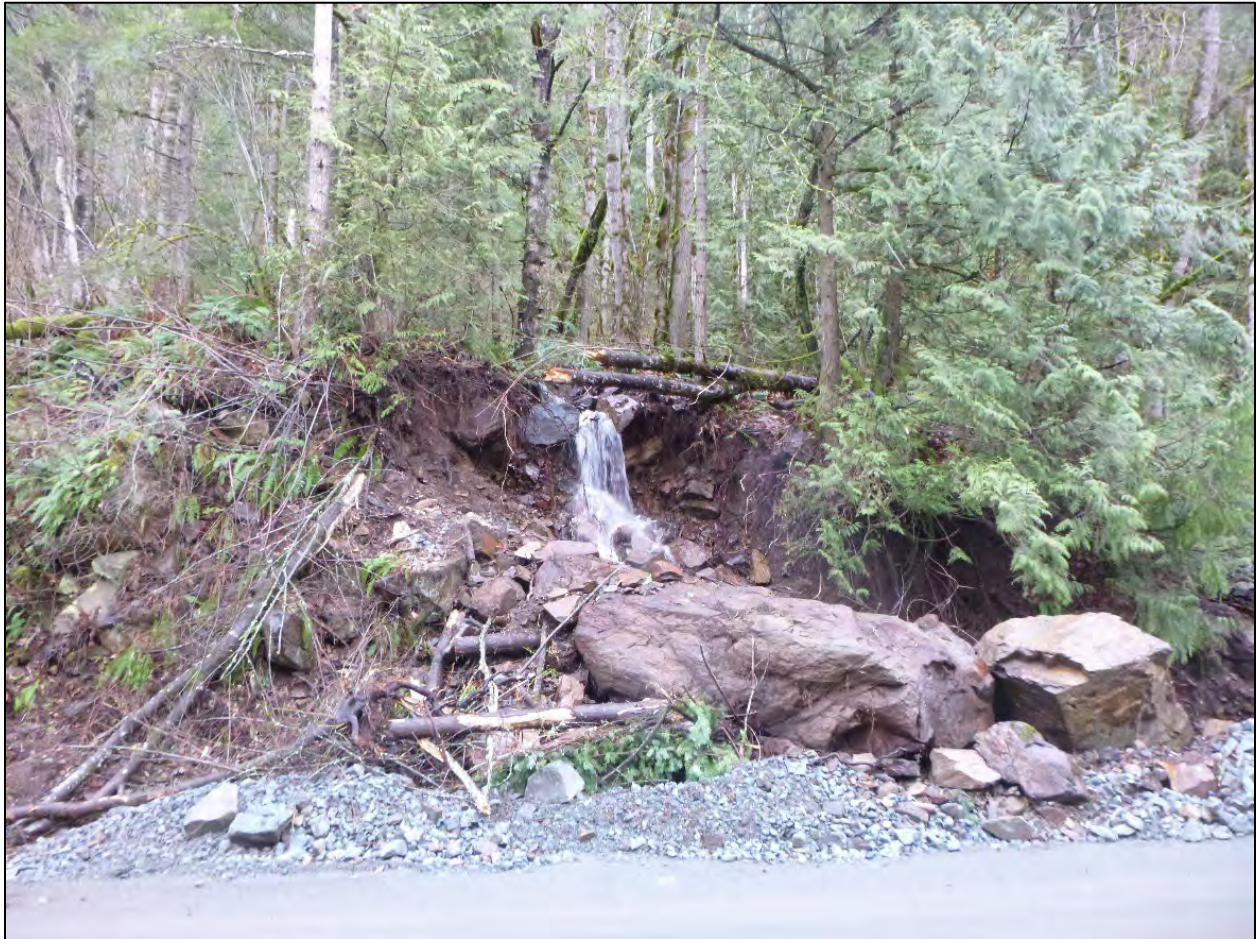
Figure 3 **Watercourse avulsion at site DF3 (December 14, 2021).**

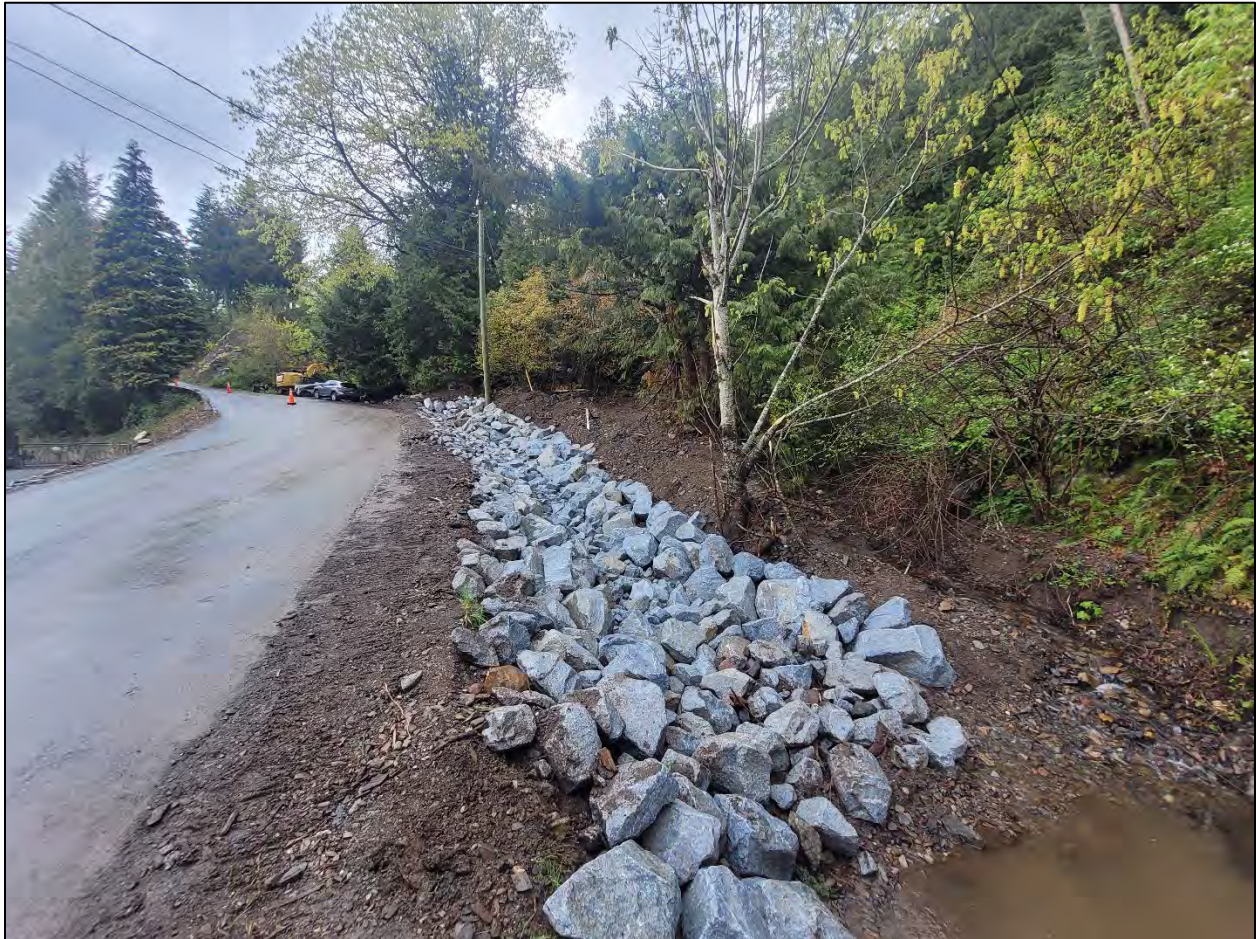
Figure 7 Short-term recovery works at site DF2 (April 26, 2022).
