ROCKWELL DRIVE RECOVERY PROJECT ENVIRONMENTAL OVERVIEW ASSESSMENT DF1 – 3

BC Ministry of Transportation and Infrastructure

MOTI 10866
VERSION 2.0

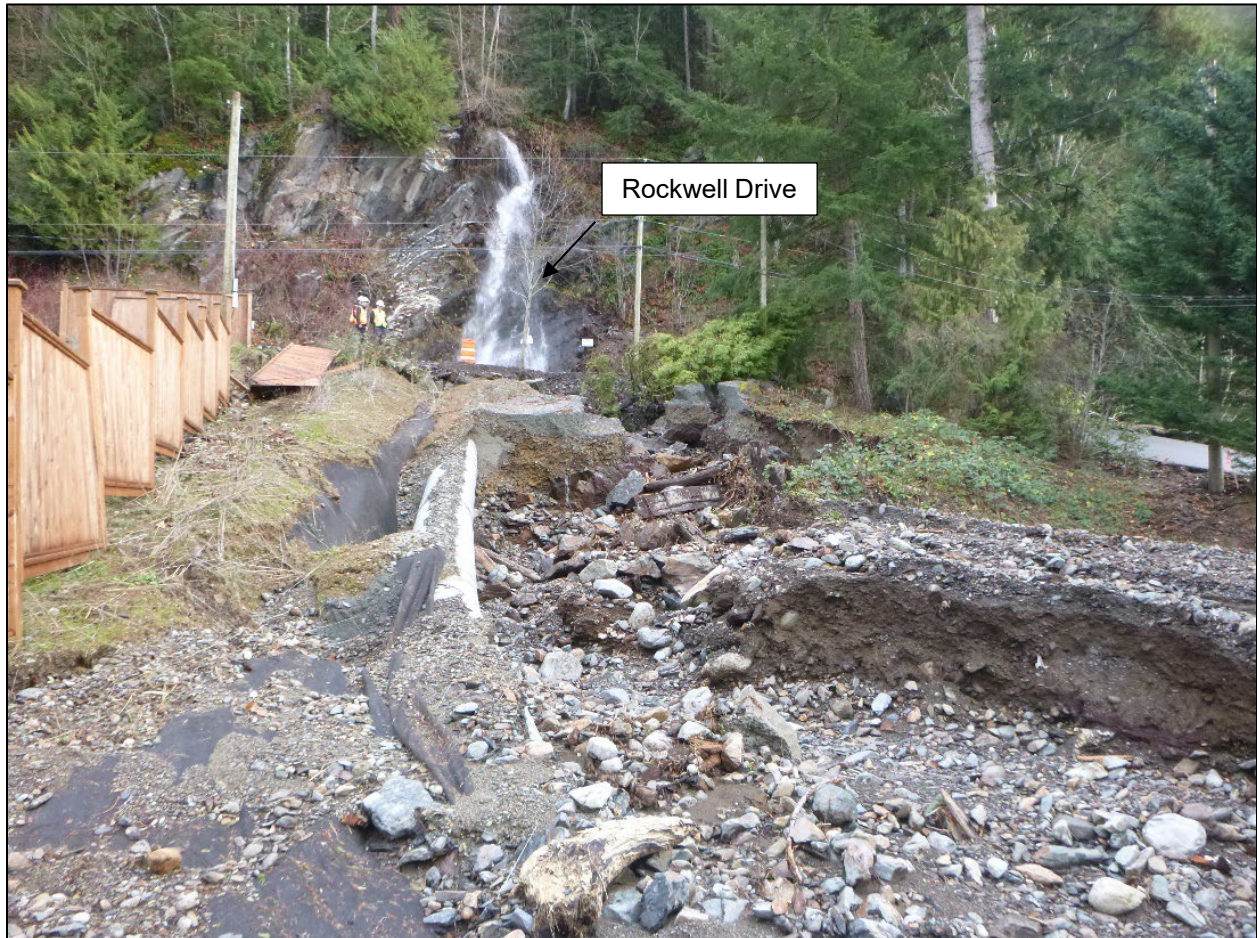
Figure 1 Upstream view of site DF1 from within the 6535 Rockwell Drive property (December 14, 2021).

At site DF1, the existing Rockwell Drive culvert was overwhelmed by an unnamed watercourse due to the heavy mountain runoff, resulting in excess water running over the road, which eroded the roadway embankment and private property lands downstream of Rockwell Drive, including the culverted portion of the watercourse within the property (Figure 1). Short-term emergency/recovery works included the removal of debris, channel grading, and placement of riprap adjacent to the private residence. The options analysis for the permanent long-term design includes repairing the existing culvert, upsizing and replacement of the existing culvert, and updating the roadway geometry (Binnie 2022b). Currently, the preferred option includes upsizing and replacement of the existing culvert; however, the design team is still reviewing the preferred option which may include a “Flat Debris Flow Breaker or similar structure with open grid deck” to address debris control at Site DF1 (Binnie 2022b).

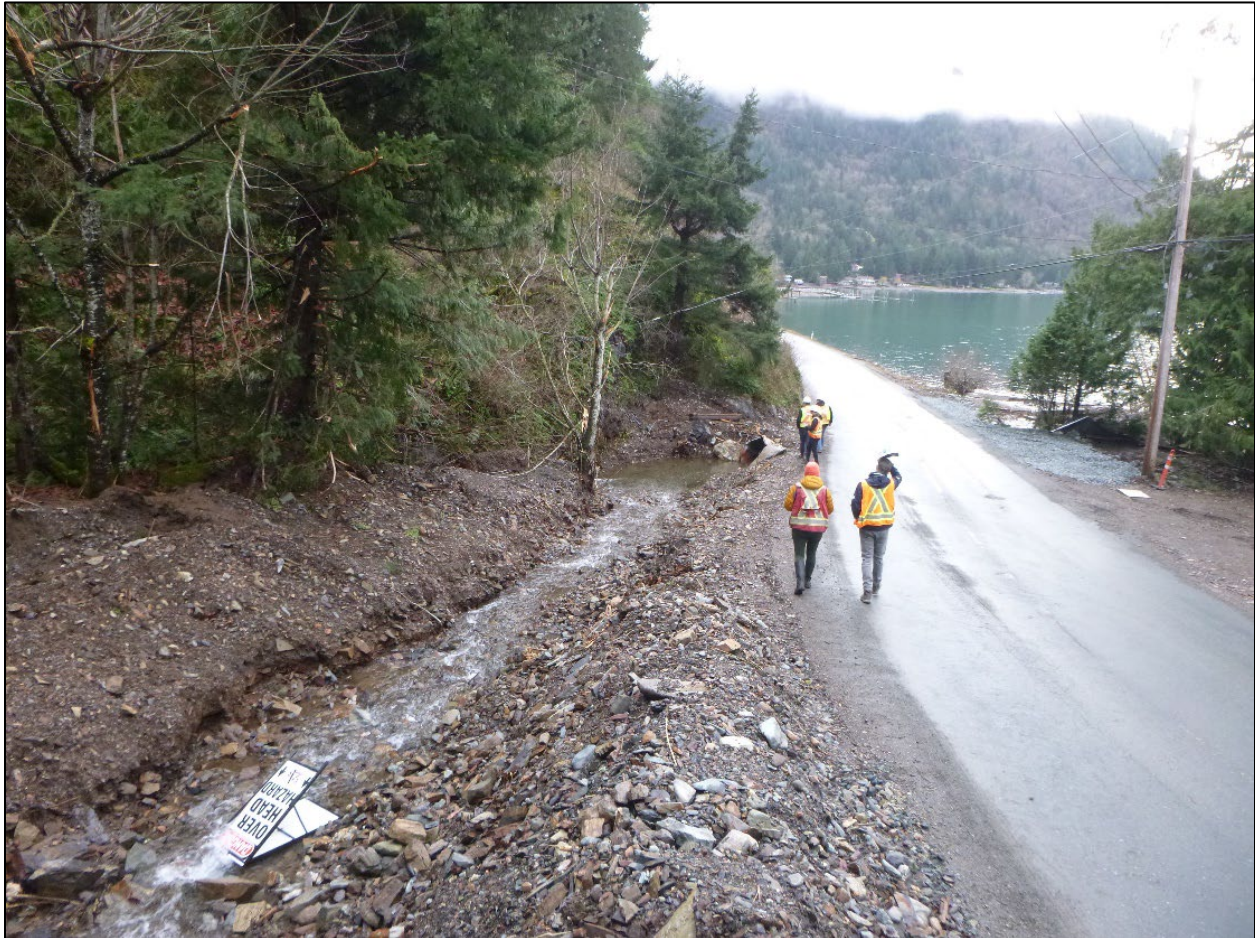
Figure 2 Downstream view of site DF2 showing erosion and debris along Rockwell Drive (December 14, 2021).

At site DF2, a debris flow associated with an unnamed watercourse above a private residential access road located at 6969 Rockwell Drive deposited debris and incised a new stream channel in what was previously a driveway. The debris flow damaged the Rockwell Drive roadside drainage ditch and culvert inlet crossing Rockwell Drive which discharges to Harrison Lake (Figure 2). Emergency and short-term recovery works included removal of debris deposited on Rockwell Drive, regrading and armouring the roadside ditch, and armouring the Rockwell Drive culvert inlet with riprap (Binnie 2022a). The options analysis for the permanent long-term design includes repairing the existing culvert, upsizing and replacement of the existing culvert, and updating the roadway geometry (Binnie 2022b). Currently, the preferred option includes upsizing and replacement of the existing culvert (Binnie 2022b).

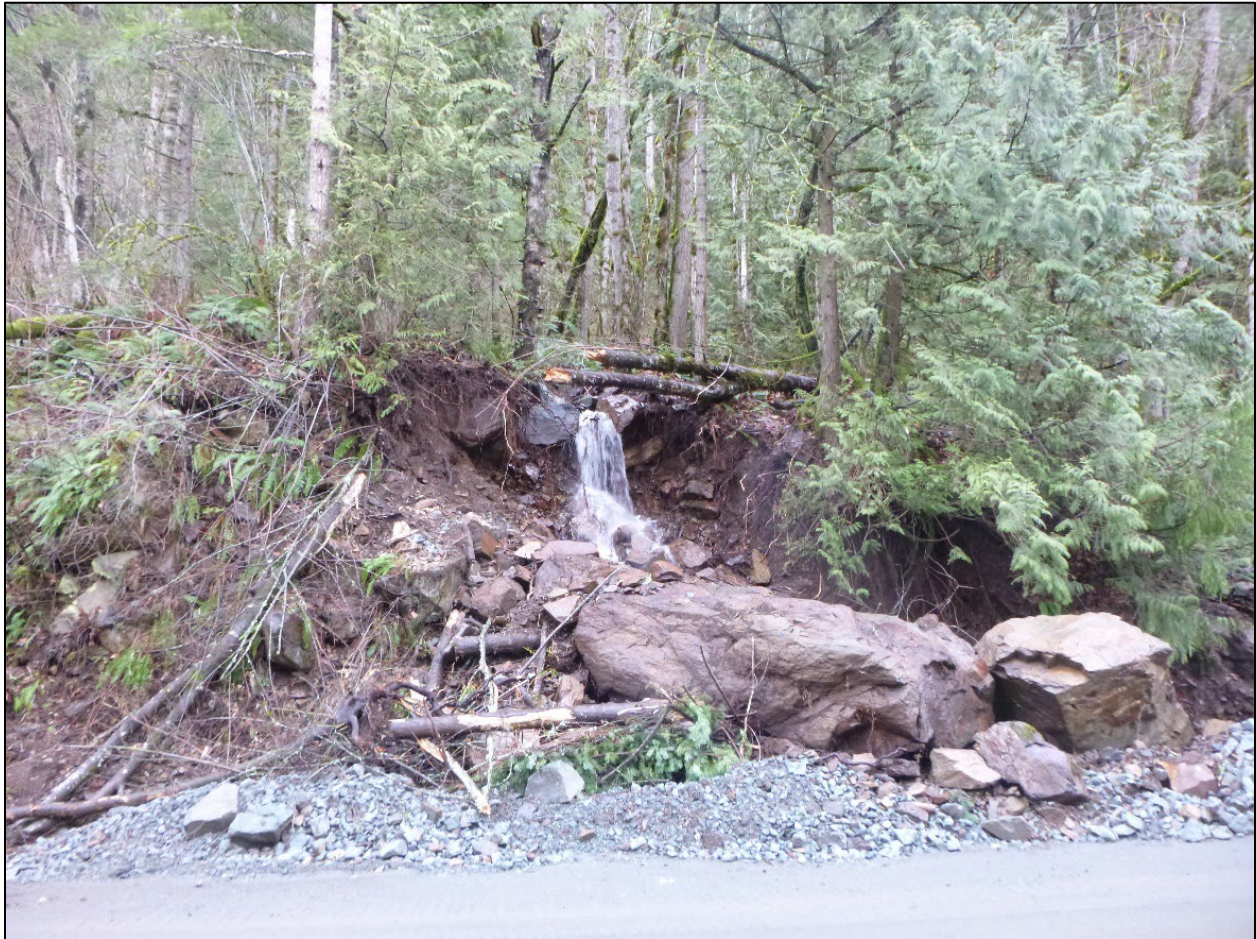
Figure 3 **Watercourse avulsion at site DF3 (December 14, 2021).**

The November 2021 atmospheric river resulted in a watercourse avulsion upstream of Rockwell Drive at site DF3 (Binnie 2022a). The avulsion resulted in the deposition of debris onto Rockwell Drive and the redirection of flows to the north (Figure 3). No drainage system has previously been constructed to accommodate water flow to the north, and as such flooding of private residences downstream of Rockwell Drive subsequently occurred. Emergency works included re-establishing the road shoulder and installing a catch basin near the eastern edge of the road to direct flows to the western roadside ditch away from the private residences. Short-term recovery works included the construction of an asphalt curb (Binnie 2022b). The options analysis for the permanent long-term design includes repairing the existing culvert, upsizing and replacement of the existing culvert, and updating the roadway geometry (Binnie 2022b). Currently, the preferred option includes upsizing and replacement of the existing culvert and redirecting the ditch back into the existing channel to avoid crossing Rockwell Drive at an unfavourable location (Binnie 2022b).

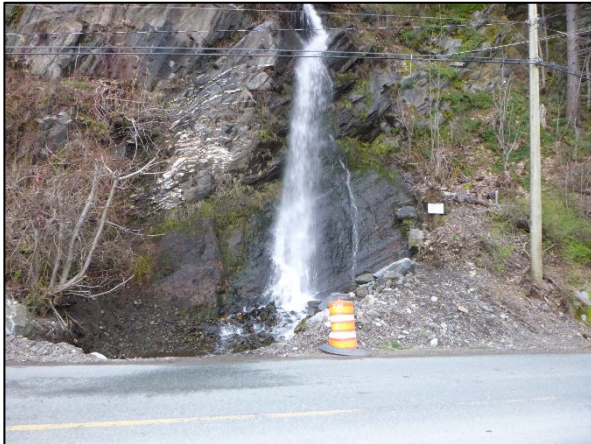
The site DF1 watercourse originates from Bear Lake and conveys flows west down the steep mountain slopes upstream of Rockwell Drive. At Rockwell Drive, the site DF1 watercourse is characterized by a large waterfall and plunge pool immediately upstream of the Rockwell Drive culvert (Figure 5). The November 2021 atmospheric river and subsequent emergency works to remove debris from the culvert inlet has disturbed riparian vegetation surrounding the watercourse upstream of Rockwell Drive; however, due to the primarily bedrock nature of the watercourse at site DF1, riparian vegetation was likely limited prior to the flood event as well. Water temperature, pH, dissolved oxygen, and conductivity within the pool upstream of Rockwell drive were 6.4°C, 6.2, 12.4 mg/L, and 75 us/cm, respectively, during the March 30, 2022 site assessment.

Photo 1: DF1 waterfall upstream of Rockwell Drive.

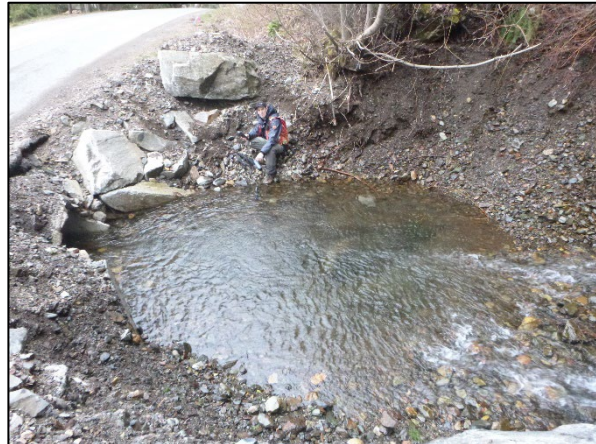
Photo 2: Large pool at the Rockwell Drive culvert inlet.

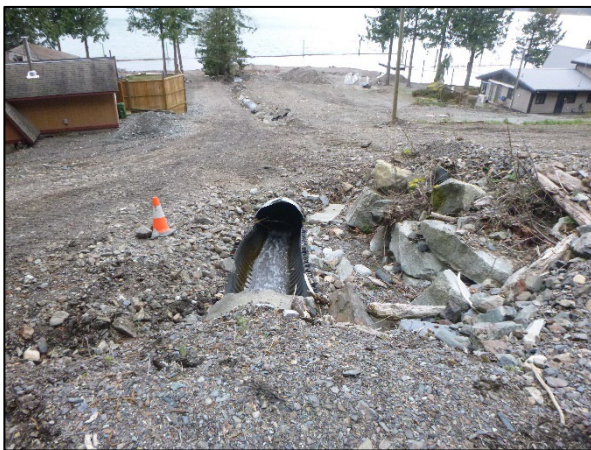
Downstream of the Rockwell Drive culvert, flows are conveyed within private property (6535 Rockwell Drive) via a short section of flume to a buried culvert that ultimately daylights approximately 20 m upstream of Harrison Lake (Figure 5). Given the extensive culverting within 6535 Rockwell Drive and the large waterfall upstream of Rockwell Drive, the DF1 watercourse is considered non-fish bearing and provides limited food and nutrient inputs to the larger fish-bearing Harrison Lake during periods of surface flow.

Photo 3: Downstream of Rockwell Drive the DF1 watercourse is culverted on private property.

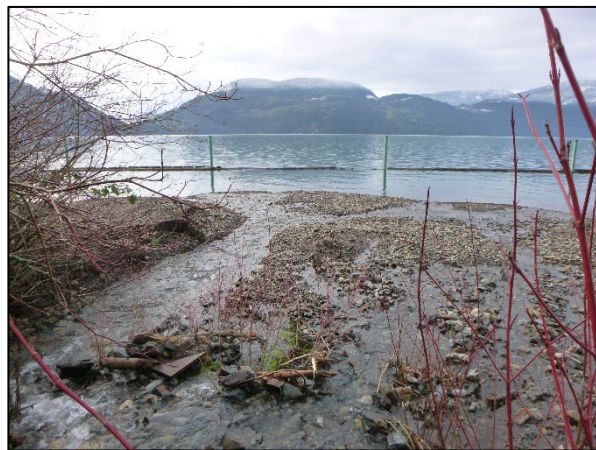
Photo 4: DF1 watercourse outlet at Harrison Lake.

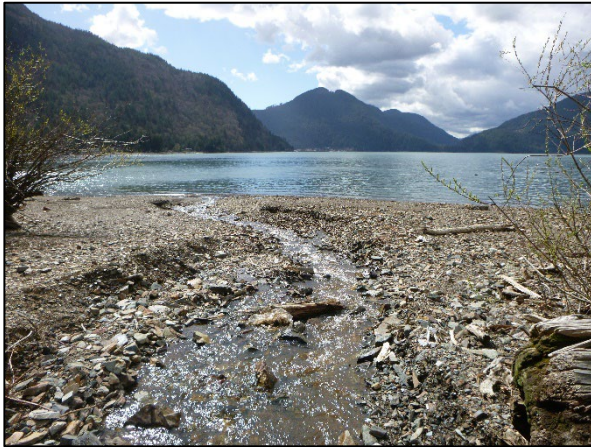
Downstream of Rockwell drive the site DF2 watercourse is conveyed for approximately 40 m over a gravel shoreline to Harrison Lake (Figure 6). A summary of fish habitat features at site DF2 is provided in Table 1. Water temperature, pH, dissolved oxygen, and conductivity at site DF2 were 7.6°C, 6.6, 12.1 mg/L, and 89 µs/cm, respectively, during the March 30, 2022 site assessment.

Photo 1: Terminus of the DF2 watercourse at Harrison Lake.

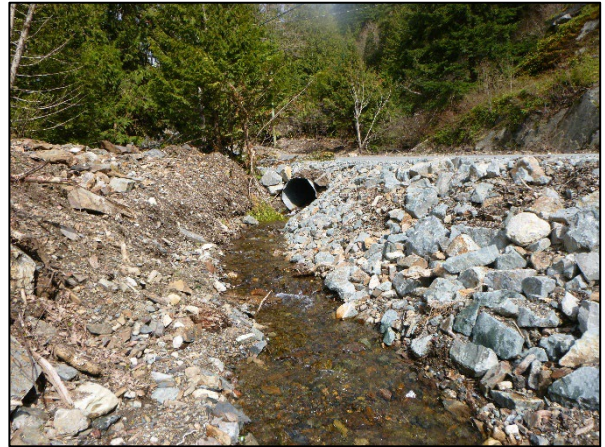
Photo 2: Upstream view of the Rockwell Drive culvert outlet.

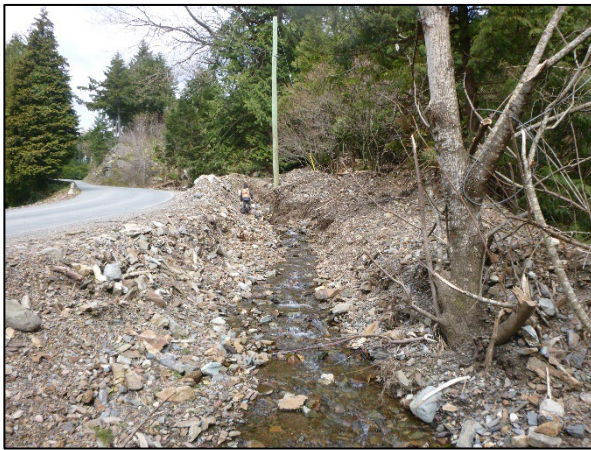
Photo 3: Upstream view of the roadside ditch along Rockwell Drive upstream of the culvert.

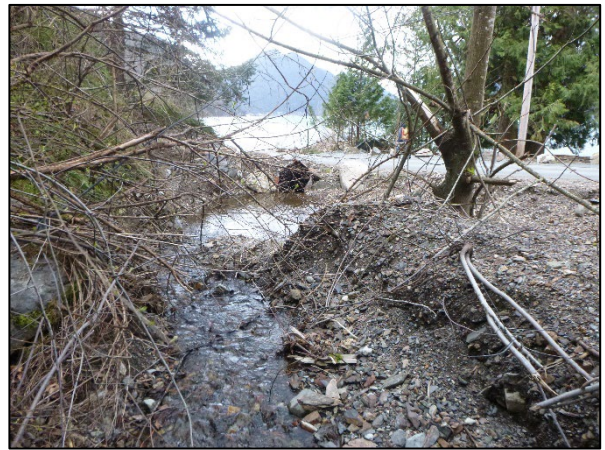
Photo 4: Downstream view of the Rockwell Drive culvert inlet where the roadside ditch and altered channel converge.

Due to the steep culvert gradient at Rockwell Drive (i.e., approximately 50% at the inlet) and gradients upstream of Rockwell Drive, the site DF2 watercourse is considered non-fish bearing upstream of Rockwell Drive; however, there is the potential for fish access from Harrison Lake upstream to the culvert outlet during periods of sufficient surface flow (Figure 6).

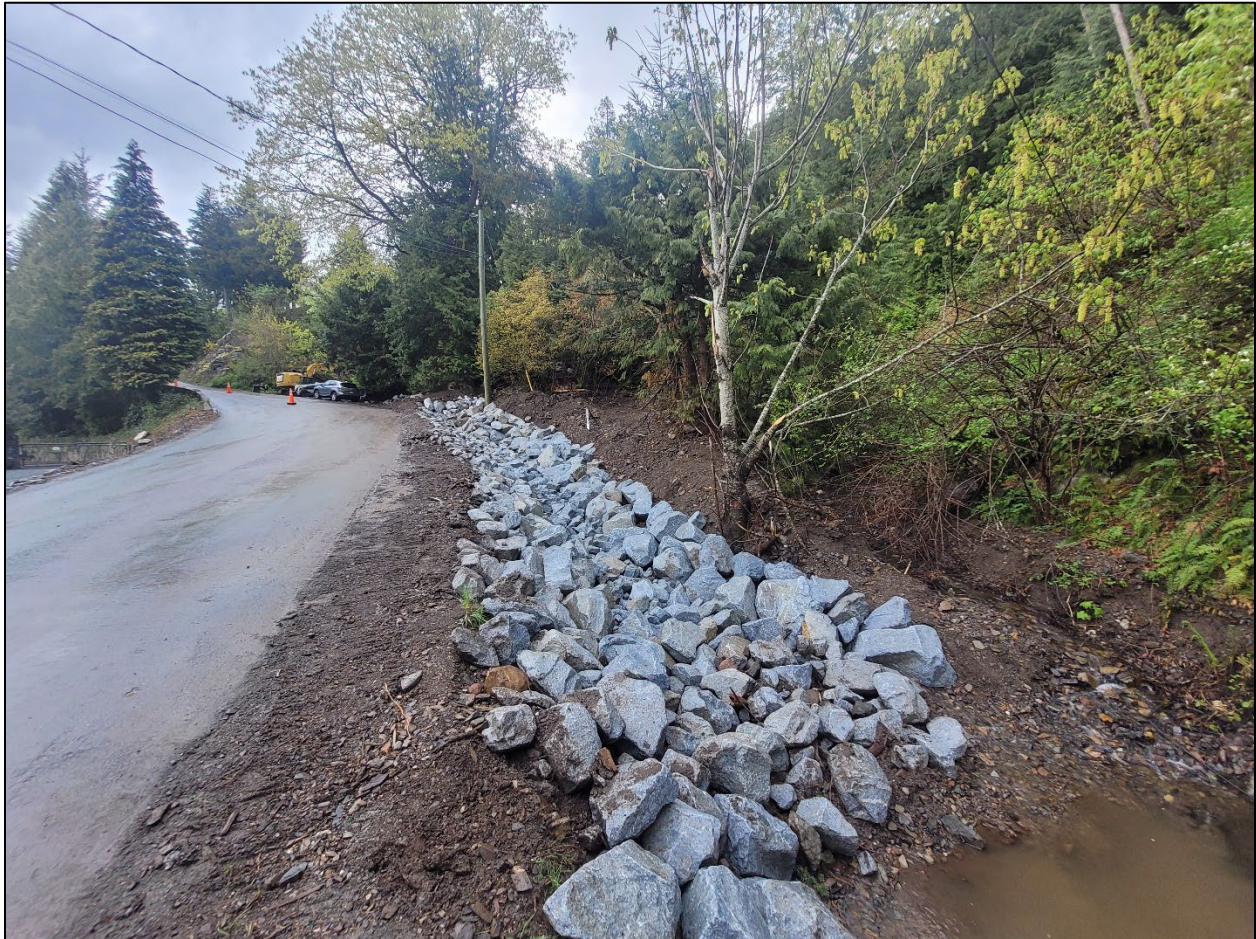
Figure 7 Short-term recovery works at site DF2 (April 26, 2022).

Upstream of Rockwell Drive the site DF2 watercourse has been historically altered within the private property located at 6969 Rockwell Drive. Prior to the November 2021 flood event, the watercourse was directed around the private residence to a corrugated steel pipe (CSP) culvert located at Rockwell Drive. Following the flood event, a portion of the watercourse incised a new stream channel in what was previously a driveway conveying flows to the roadside ditch north of the Rockwell Drive culvert. Both the original altered stream channel and newly incised flood channel converge at the Rockwell Drive culvert inlet (Figure 6). Short-term recovery works in April 2022 included armoring the roadside ditch with riprap to prevent further erosion during spring freshet (Figure 7).

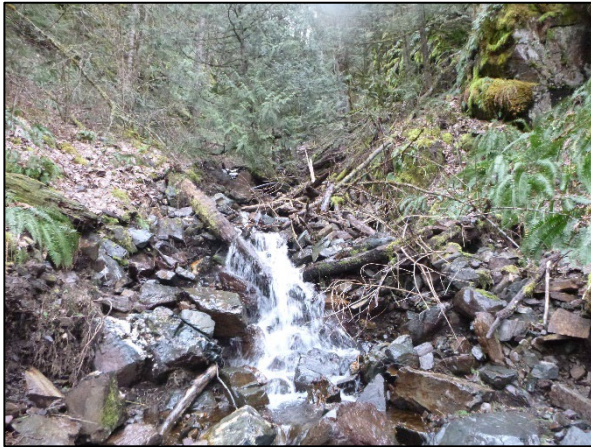
Upstream of Rockwell Drive, the site DF3 watercourse is conveyed down steep slopes (>45%) in a poorly defined channel with an average channel width and wetted width of 4.0 m and 0.75 m, respectively (Figure 8). Substrates are comprised primarily of boulders and cobbles. During the November 2021 flood, the channel avulsed just upstream of Rockwell Drive causing a new channel to form to the north of the existing channel. At Rockwell Drive flows were directed back to the south within the existing roadside ditch as part of emergency works (Figure 8). Flows are conveyed across Rockwell Drive via a corrugated polyvinylchloride (PVC) culvert that appears to have been recently installed as part of flood emergency works (Figure 8). The culvert outlets to a steep riprap road fill slope (approximately 35% gradient) west of Rockwell Drive ultimately draining to Harrison Lake across a gravel beach and private boat launch associated with 7370 Rockwell Drive (Figure 8). Water temperature, pH, dissolved oxygen, and conductivity at site DF3 were 7.7°C, 6.5, 12.2 mg/L, and 76 us/cm, respectively, during the March 30, 2022 site assessment.

Photo 1: Upstream view of the site DF3 watercourse upstream of Rockwell Drive.

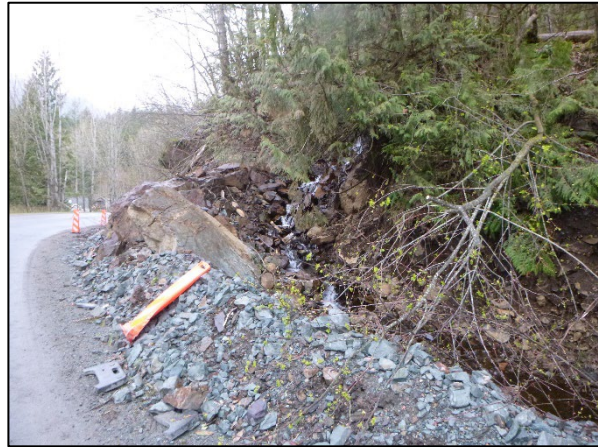
Photo 2: Creek avulsion directed back to the south via a berm along Rockwell Drive.

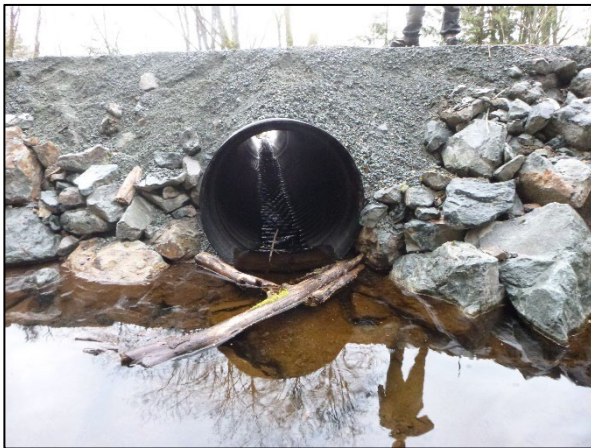
Photo 3: Rockwell Drive culvert inlet.

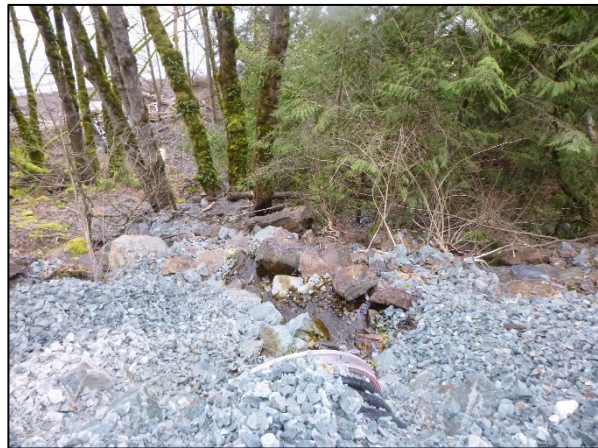
Photo 4: Rockwell Drive culvert outlet.
