ROCKWELL DRIVE RECOVERY PROJECT DF4 ENVIRONMENTAL OVERVIEW ASSESSMENT

January 2023

BC Ministry of Transportation and Infrastructure

Hatfield Consultants LLP

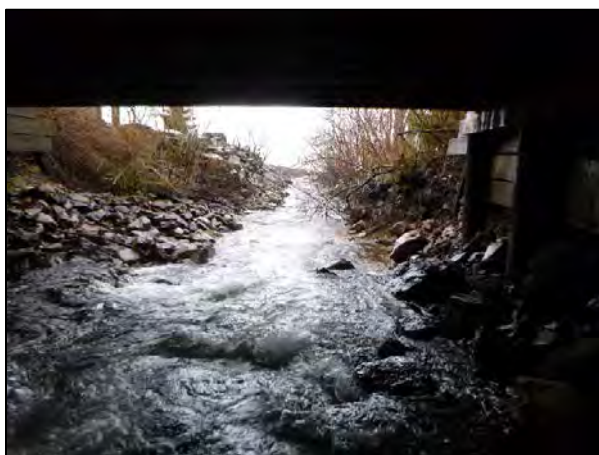
Figure 3 2018 to 2022 photographic comparison of the site DF4 study area.

Photo 1 Downstream (west) view showing the pre-flood clearance under Green Point Bridge. (March 26, 2018).

Fish habitat within the study area has been heavily disturbed by the floods and provides limited opportunity for salmonid rearing or spawning given the change in channel morphology and substrate composition, infilling of pools, and displacement of riparian vegetation with riprap scour protection; however, this habitat is likely suitable for longnose dace (*Rhinichthys cataractae*) and sculpin (*Cottus* sp.) previously captured further upstream in 2017 (Appendix A2). Chum salmon (*Oncorhynchus keta*) were observed spawning within Trout Lake Creek during previous surveys in November 2017 downstream of Hicks Lake Road; however, much of the suitable gravel spawning substrate has been displaced downstream to the lower reaches of Trout Lake Creek at Harrison Lake. Similar to the previously perched culvert at site DF4 (Figure 3), the current crossing structure is a barrier to fish passage. A summary of fish habitat measurements from the 2022 habitat transects (Figure 4) is provided in Table 1.

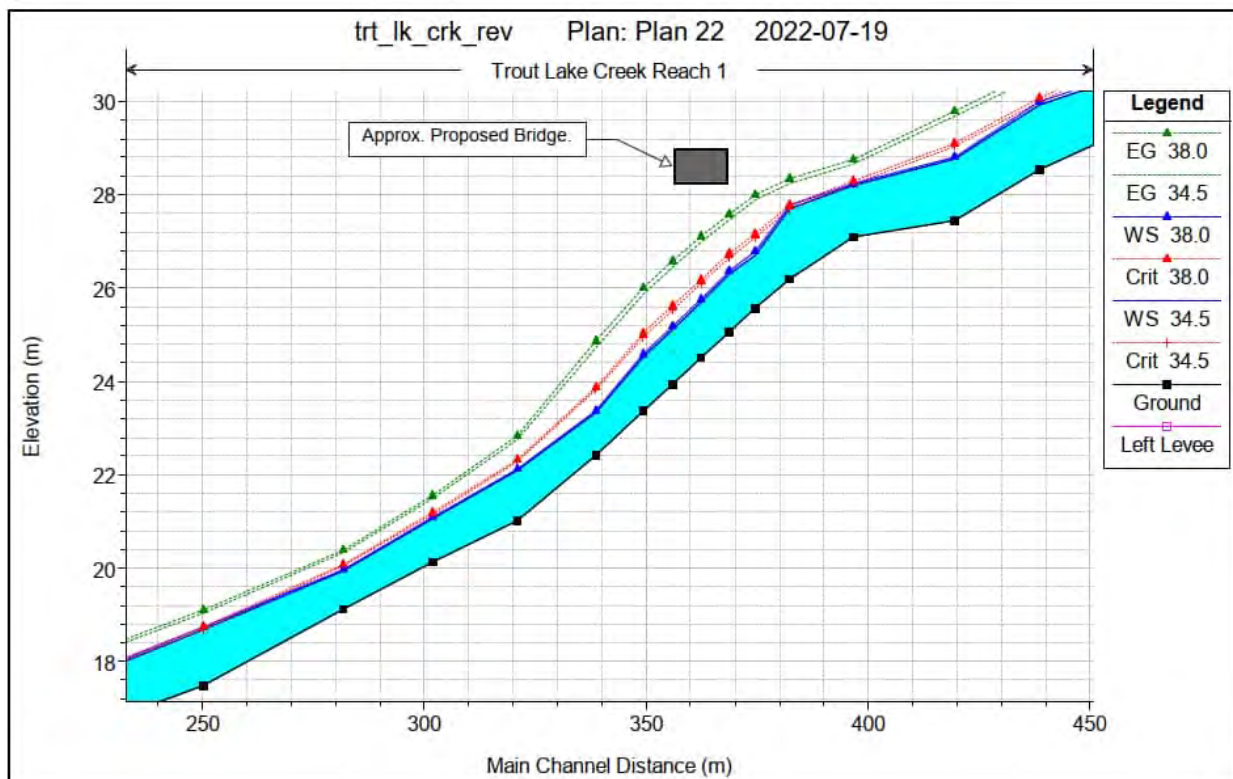
Figure 2-3
 Profile of Proposed Bridge Channel

Figure 2-3 below shows the design water surface elevation through the bridge opening for both the clearwater flow and debris flood scenarios:

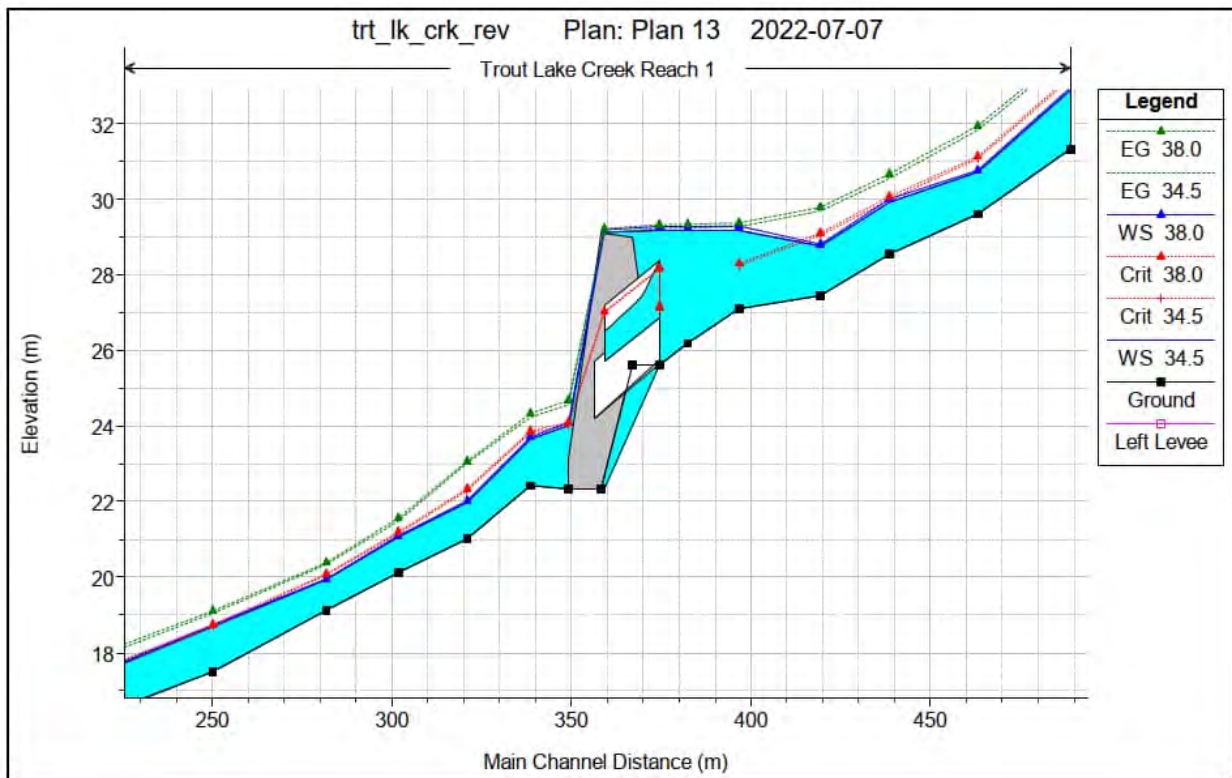
Figure 2-4
 Existing Culvert Profile Showing Overtopping of Hick’s Lake Road

Based on the survey data provided, we also developed an existing condition HEC-RAS model of the 4 HDPE culverts. The modelling results indicate that Hick’s Lake Road would overtop during the design flow event under existing conditions.

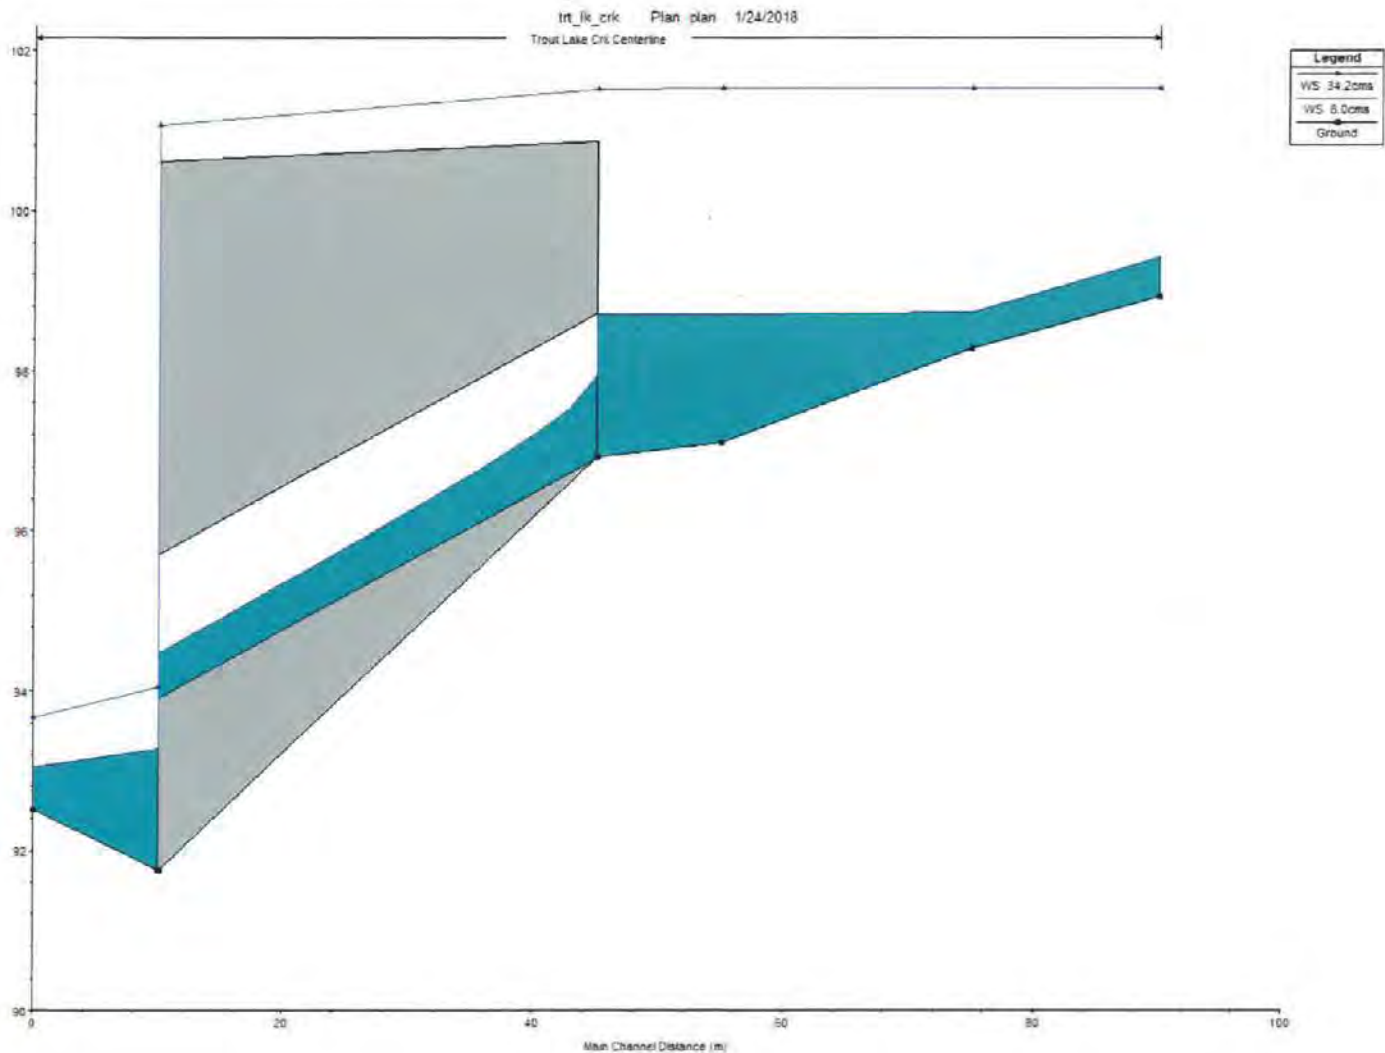
Figure 4-1
100-Year Peak HGL Profile – Existing Culvert

The model results indicate that 100-year peak water level overtops the road by approximately 800 mm at the culvert inlet as shown in Figure 4-1. Note that the existing pipe culvert has a hydraulic capacity of approximately 8.0 m³/s, which approximately corresponds to the 2-year return period flow.

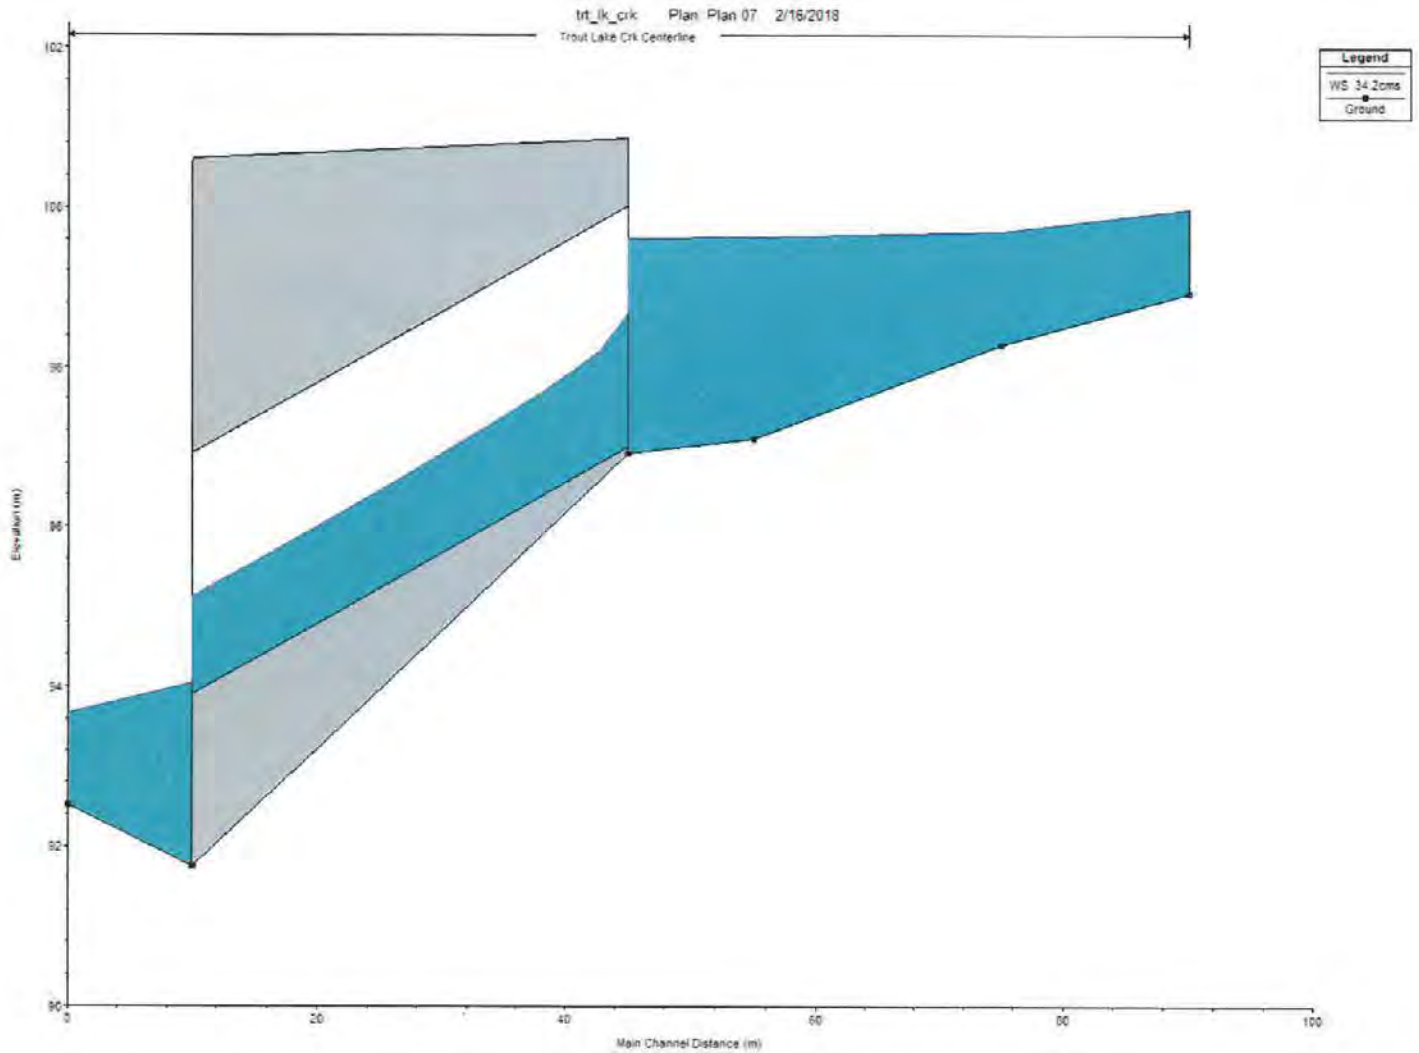
Figure 4-2
100-Year Peak HGL Profile – Proposed Culvert

An open bottom arch culvert with 5 m span and approximately 3.2 m rise hydraulic opening (i.e. not including depth of embedment of footings etc.), is required to convey the 100-year design peak flow with approximately 0.4 m freeboard to allow passage of debris at the inlet. The Canadian Highway Bridge Design Code (CHBDC) specifies freeboard requirements to be no less than 1.0 m for bridges on freeways, arterials, and collector roads, and not less than 0.3 m on other roads (i.e. low volume). Given that the culvert is on a low volume road and freeboard requirements are not

specifically applied at culvert, we feel that a minimum of 0.3 m freeboard is adequate for the proposed culvert. Figure 4-2 shows the hydraulic model results. The culvert is at approximately a 9% grade. For bottom stability, step pools will likely be required.

We estimate that 1000 kg riprap will be required for a step pool arrangement in the culvert, and the channel upstream and downstream. If a continuously sloped channel is employed, which is not conducive to fish passage, then heavier riprap will be required. Lessening the culvert grade to accommodate fish passage will produce a larger drop at the outlet that will need to be overcome with additional channel works.

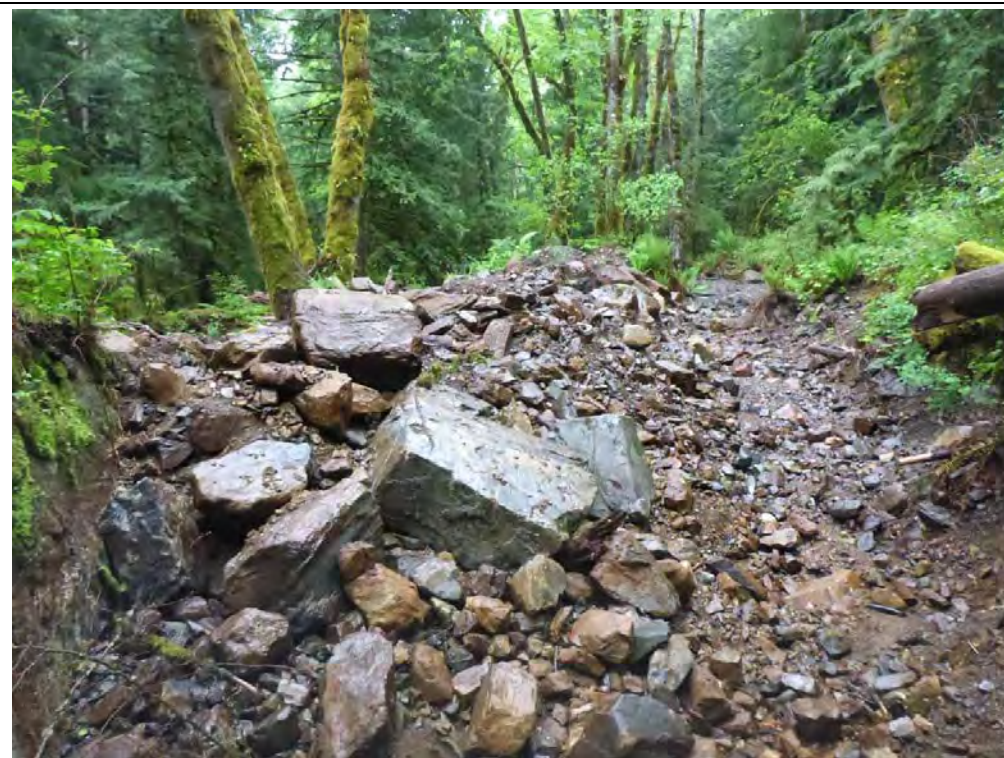
Photo 4 – Recent debris deposit at the Stream 2 outlet by Wpt 011.

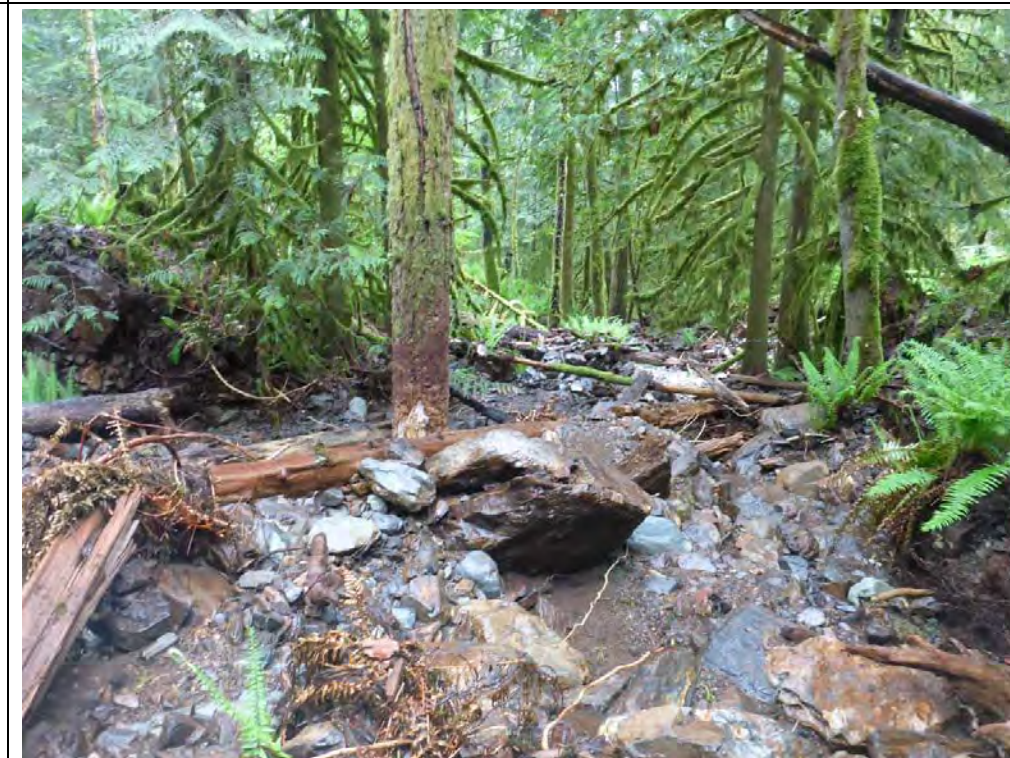
Photo 5 – Looking downstream (north) at the avulsion in Stream 1 near Wpt 035. The berm to the left has been repaired after the breach in February 2020.

Westrek has also noted that there is a serious public safety concern related to the unregulated berm which forms part of a diversion of flows from a historic channel to the north into Trout Lake Creek. This issue was also identified by Westrek as part of the 2020 Preliminary Hydrogeomorphic Assessment.

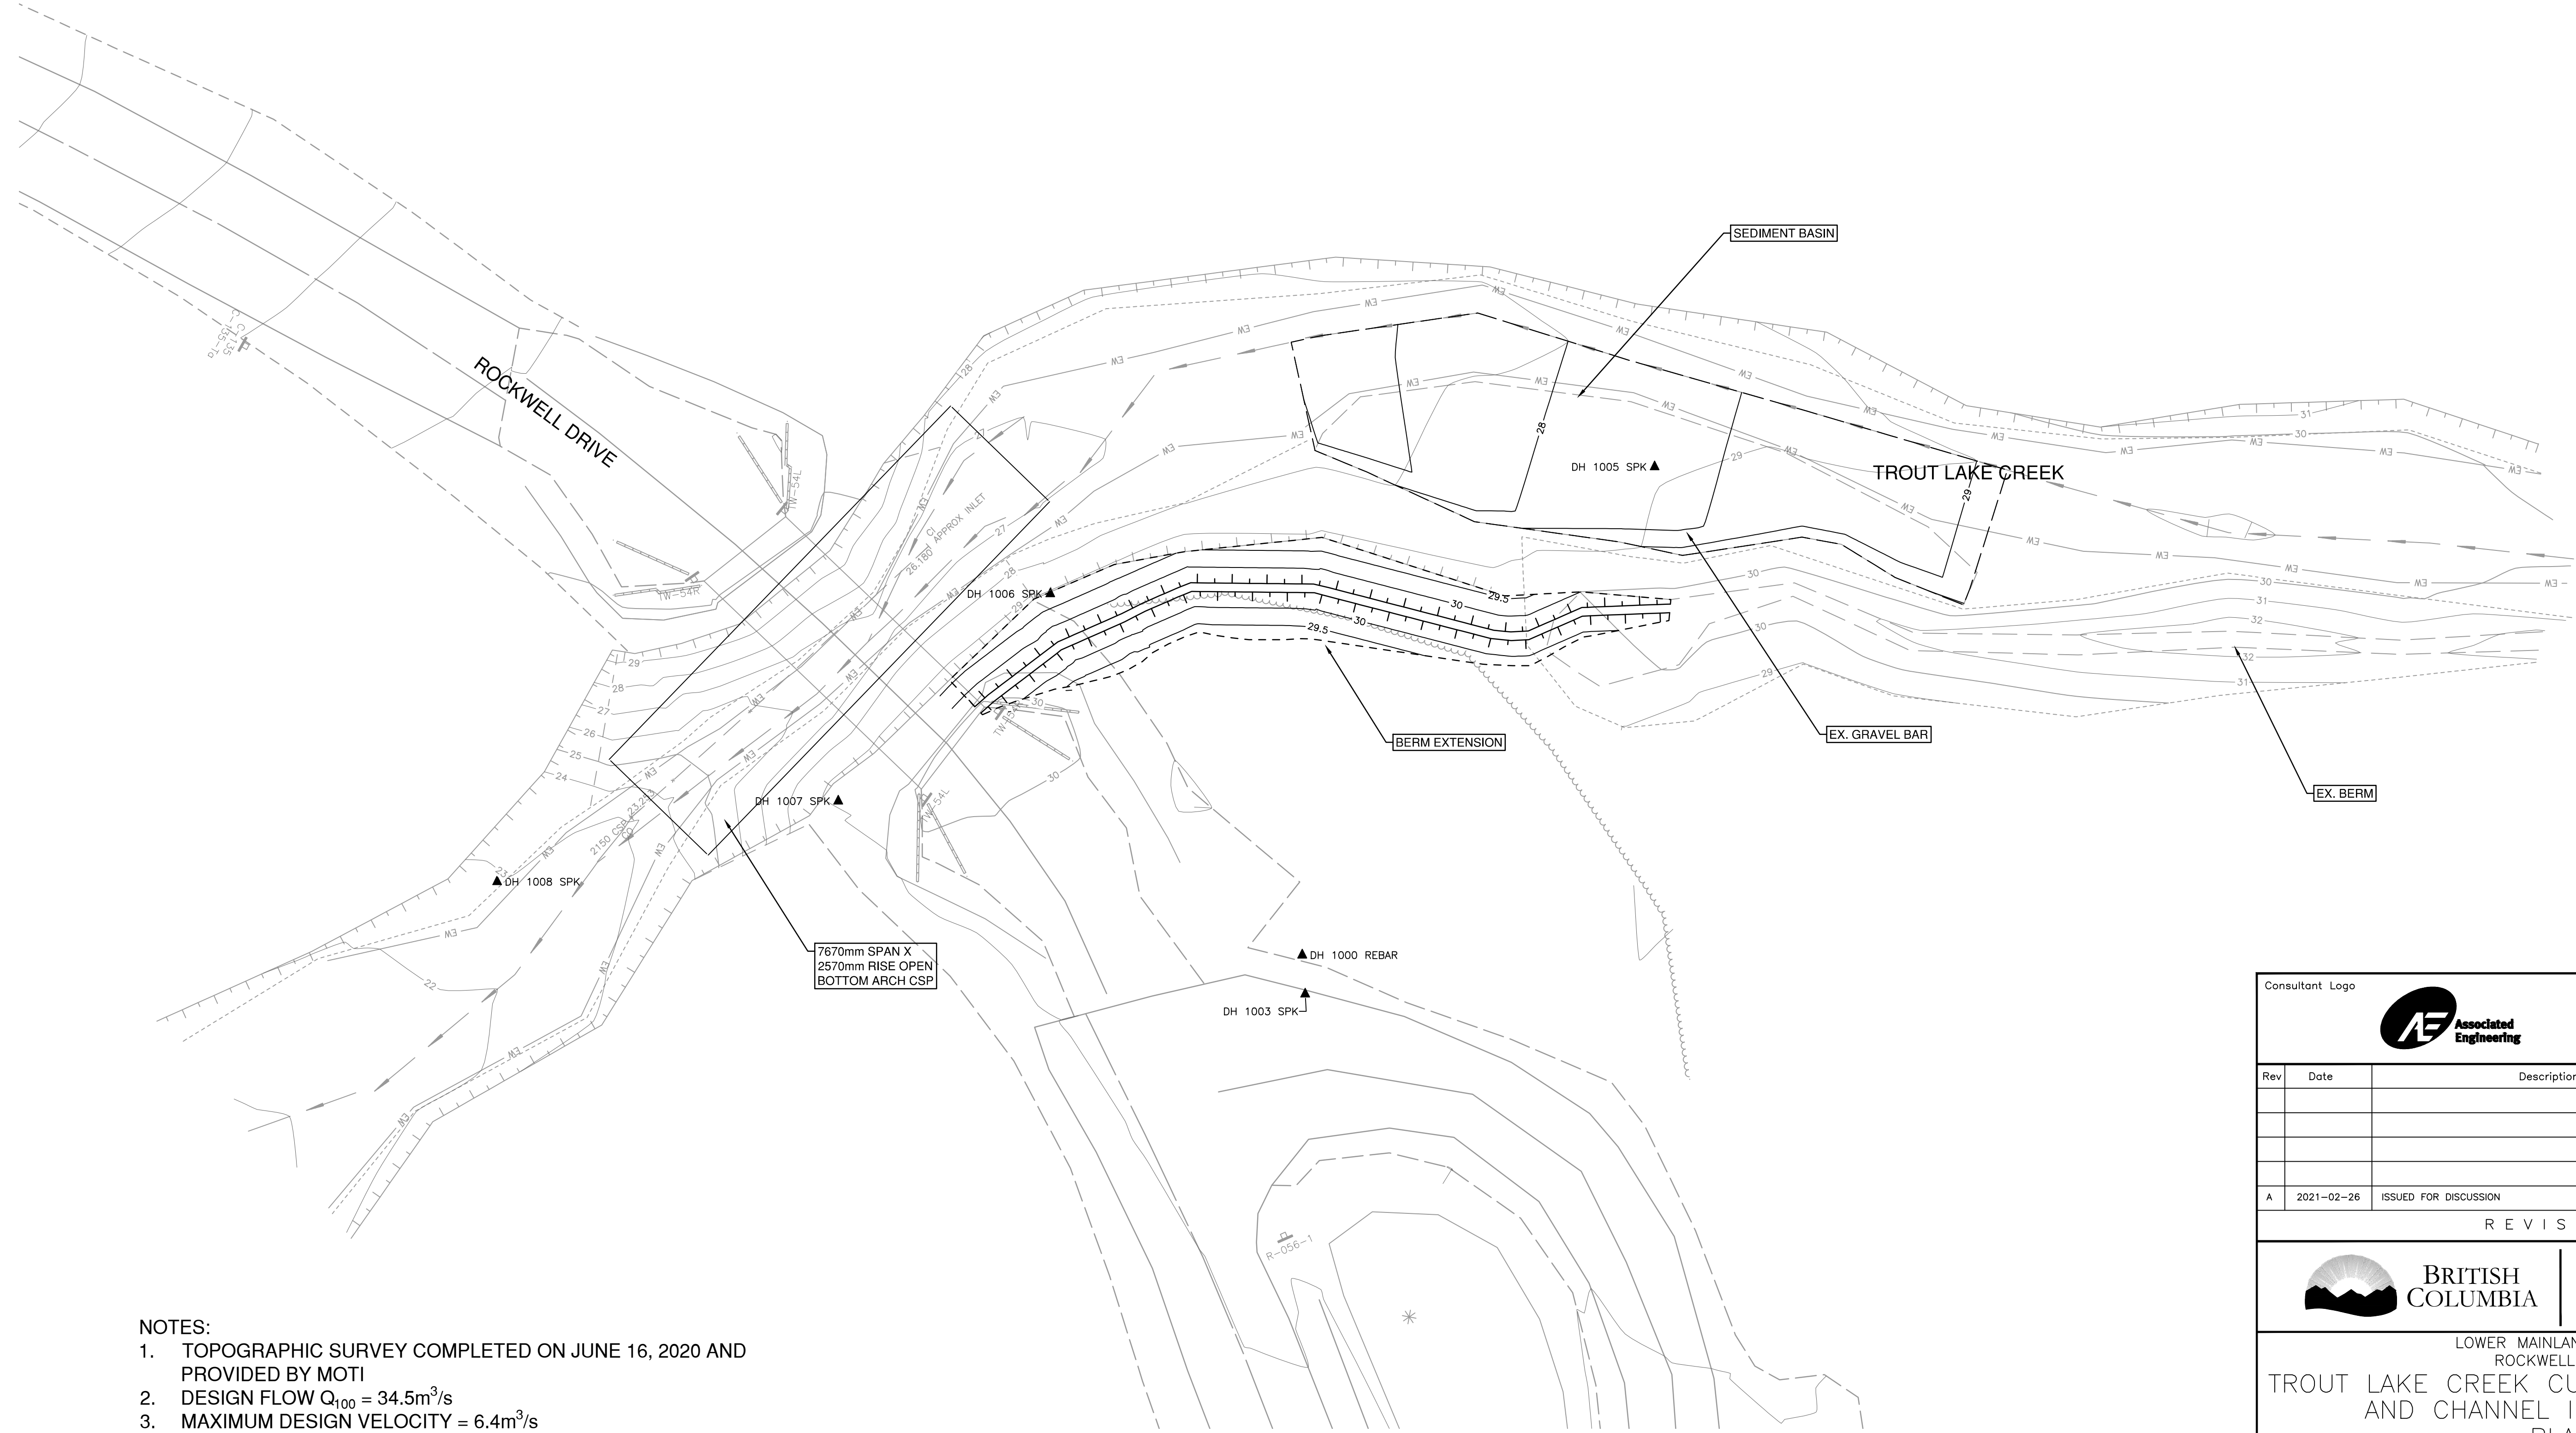
- NOTES:
1. TOPOGRAPHIC SURVEY COMPLETED ON JUNE 16, 2020 AND PROVIDED BY MOTI
 2. DESIGN FLOW $Q_{100} = 34.5\text{m}^3/\text{s}$
 3. MAXIMUM DESIGN VELOCITY = $6.4\text{m}^3/\text{s}$
 4. SEDIMENT BASIN VOLUME = 120m^3

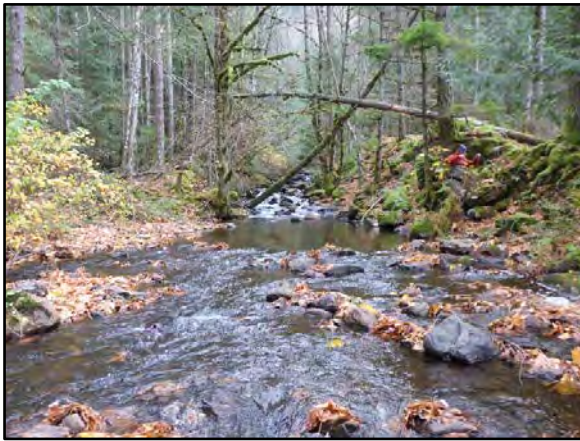
Pre-flood conditions (2017)

Riffle-pool habitat and berm upstream of Rockwell Drive (upstream view).

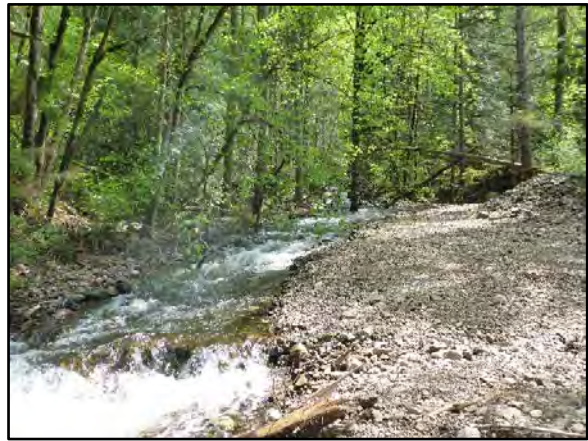
Post-flood conditions (2020)

Channel constriction and gravel deposition located upstream of Rockwell Drive (upstream view).

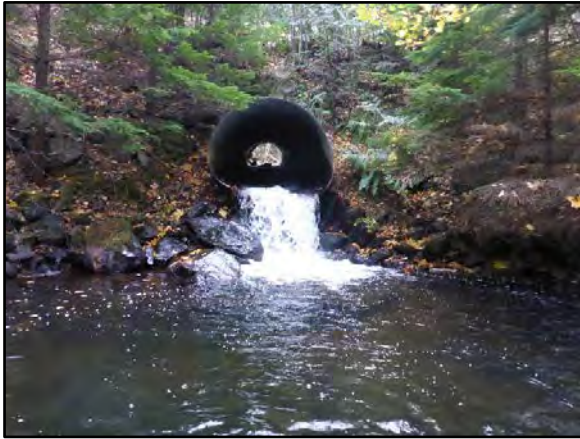
Pre-flood conditions (2017)

Plunge-pool downstream of Rockwell Drive (upstream view).

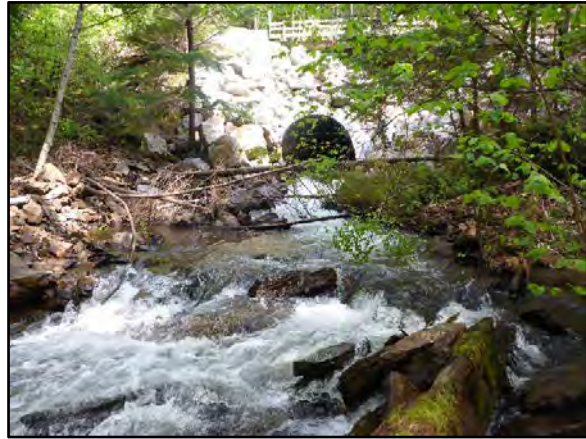
Post-flood conditions (2020)

Riffle and cascade downstream of Rockwell Drive (upstream view).

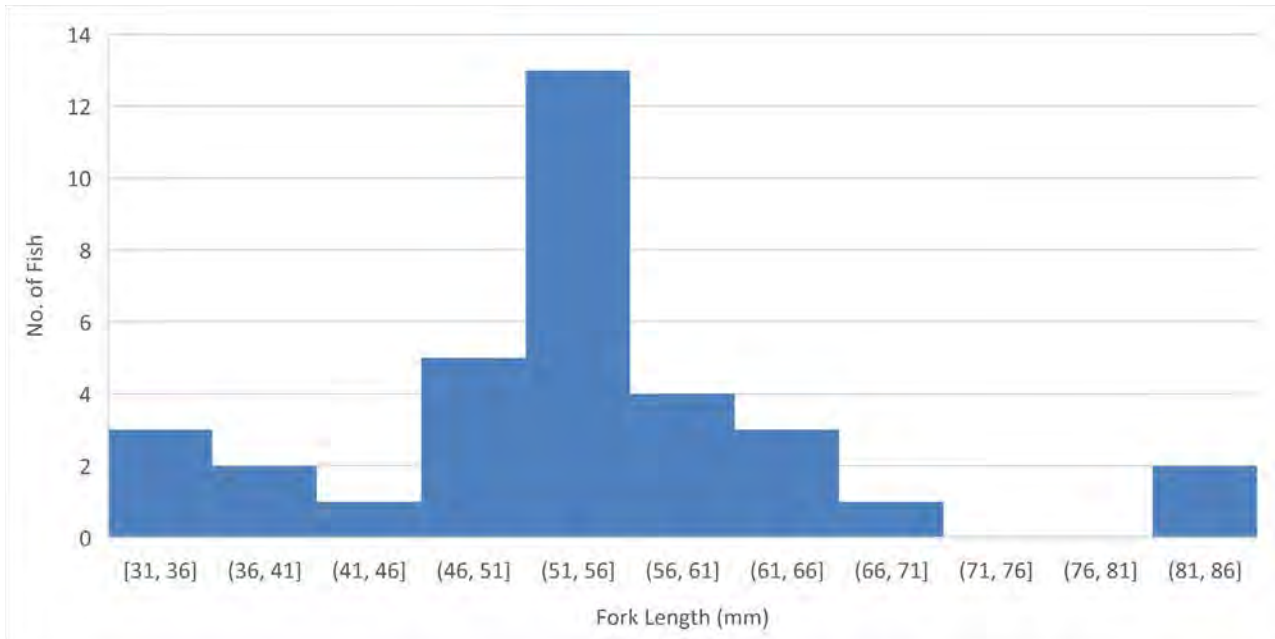
Figure 2 Length-frequency histogram for prickly sculpin captured in Trout Lake Creek, March, 2018.

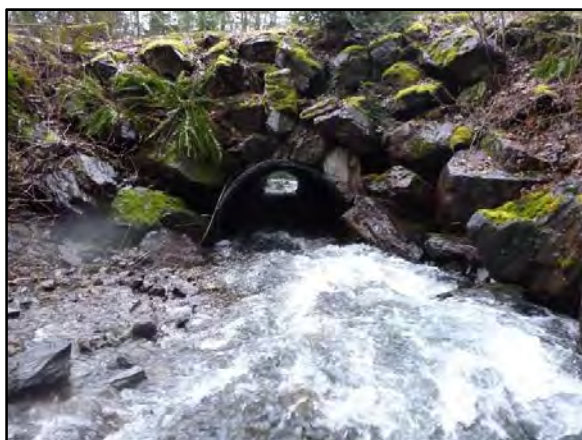
High flow velocity observed at the Rockwell Drive culvert inlet.

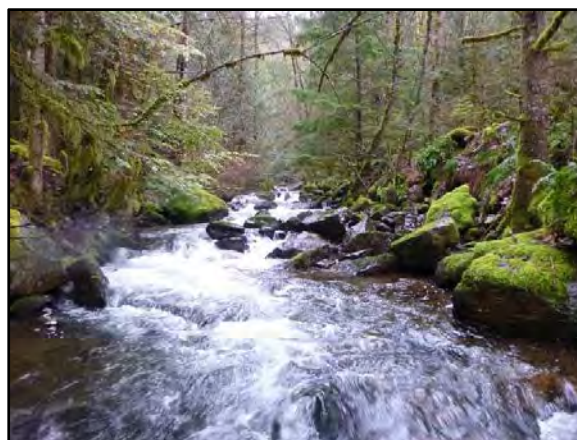
Riffle-pool habitat located upstream of Rockwell Drive.

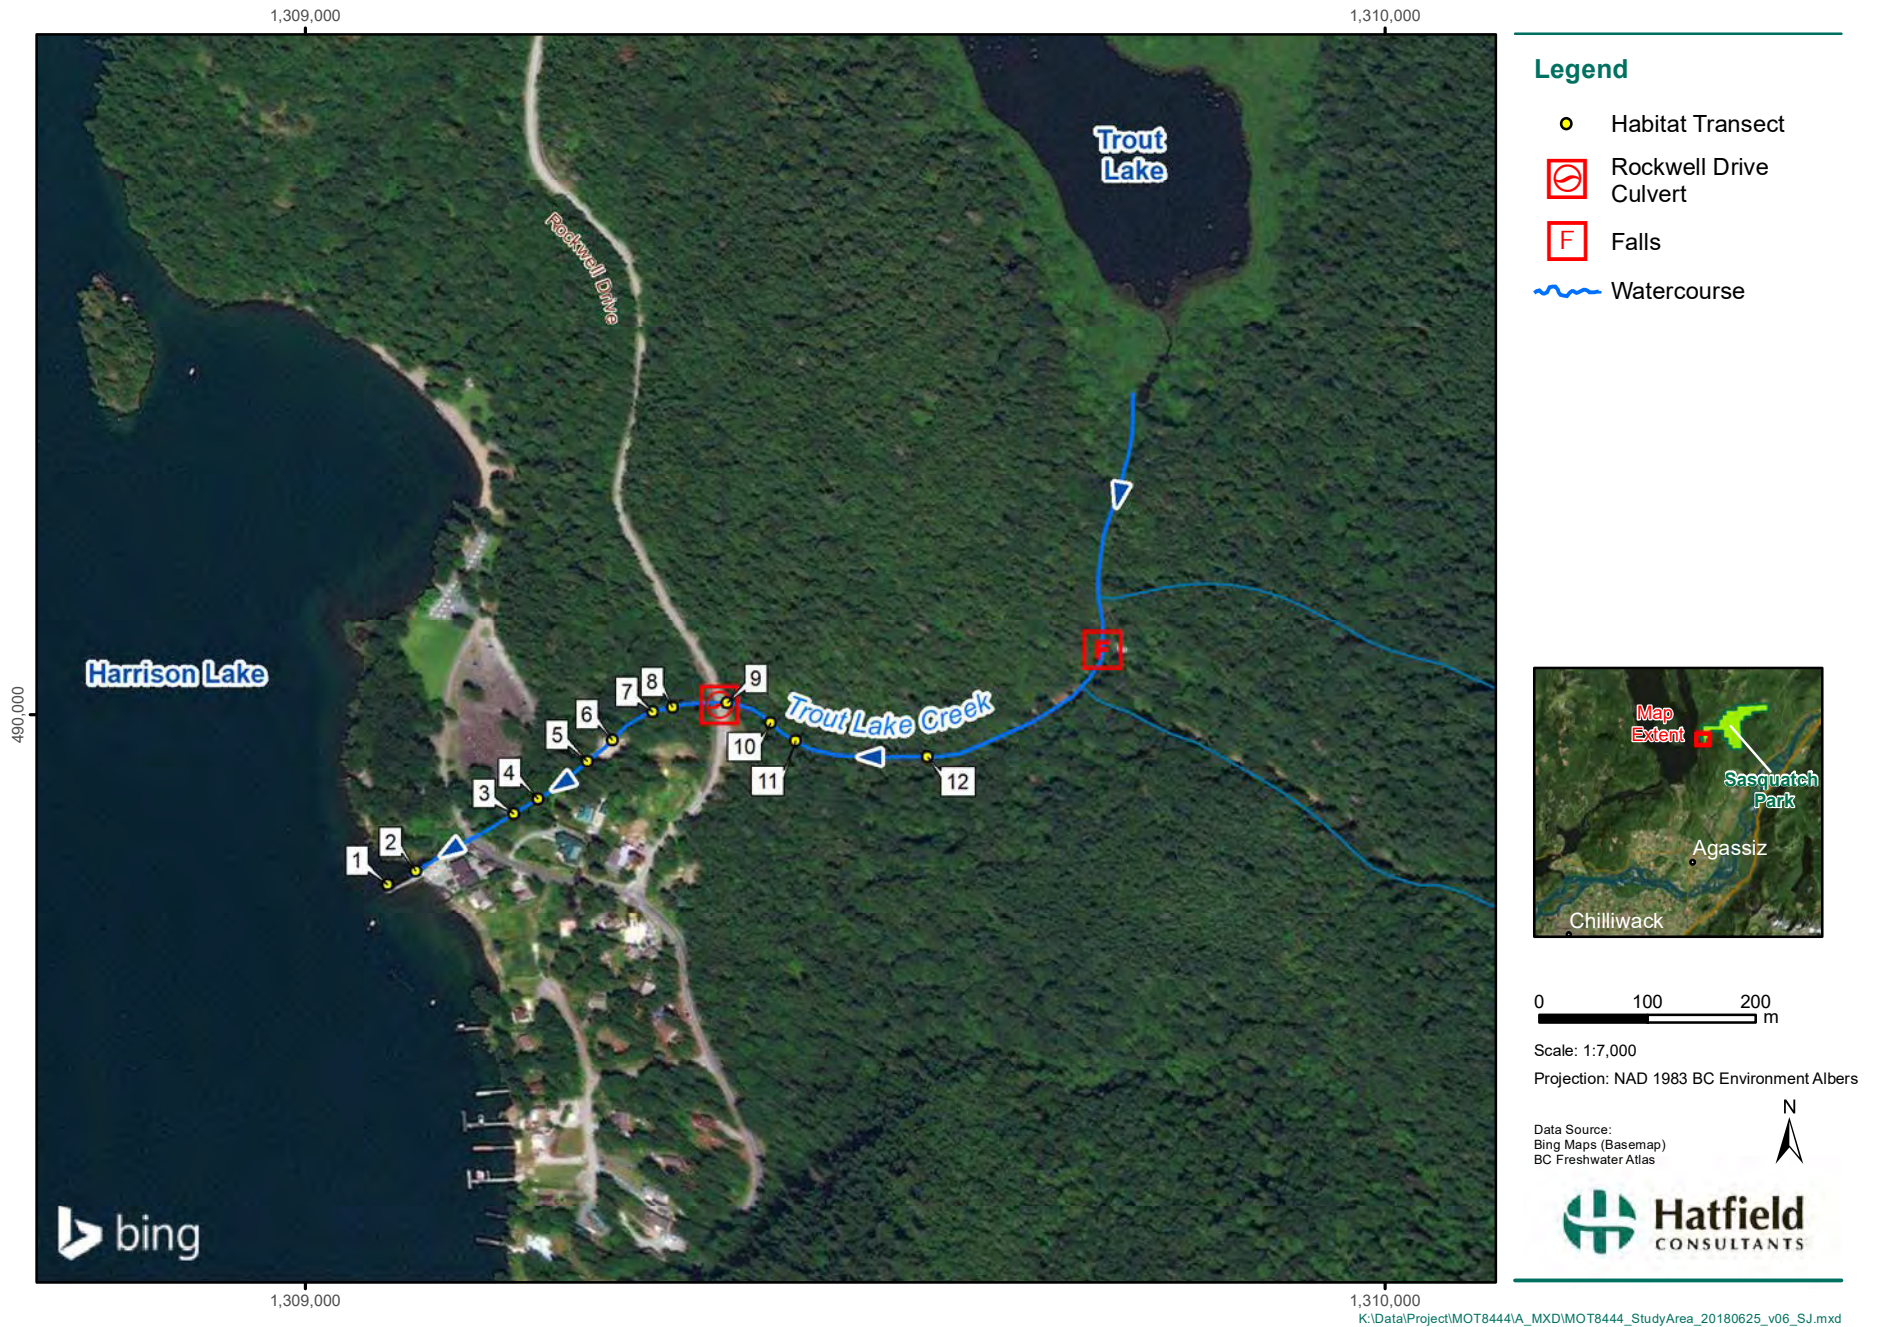
Figure 6 Locations of Trout Lake Creek habitat transects, March 2018.
