MEMO

TO: Scott Cosman. P ENG.
COMPANY: BC MOTI
FROM: Bob Forsyth
DATE: 21 November 2022
CC: Wayne Byczek, P Eng, Johnathan Tillie, Michael Carreira, P Eng.
PROJECT NO.: VG07794.310
SUBJECT: Silver Skagit Road, South of Hope, BC
Debris Flood Repair at km 28.7
Project Number: 14143, Site ID: SA07 150-31

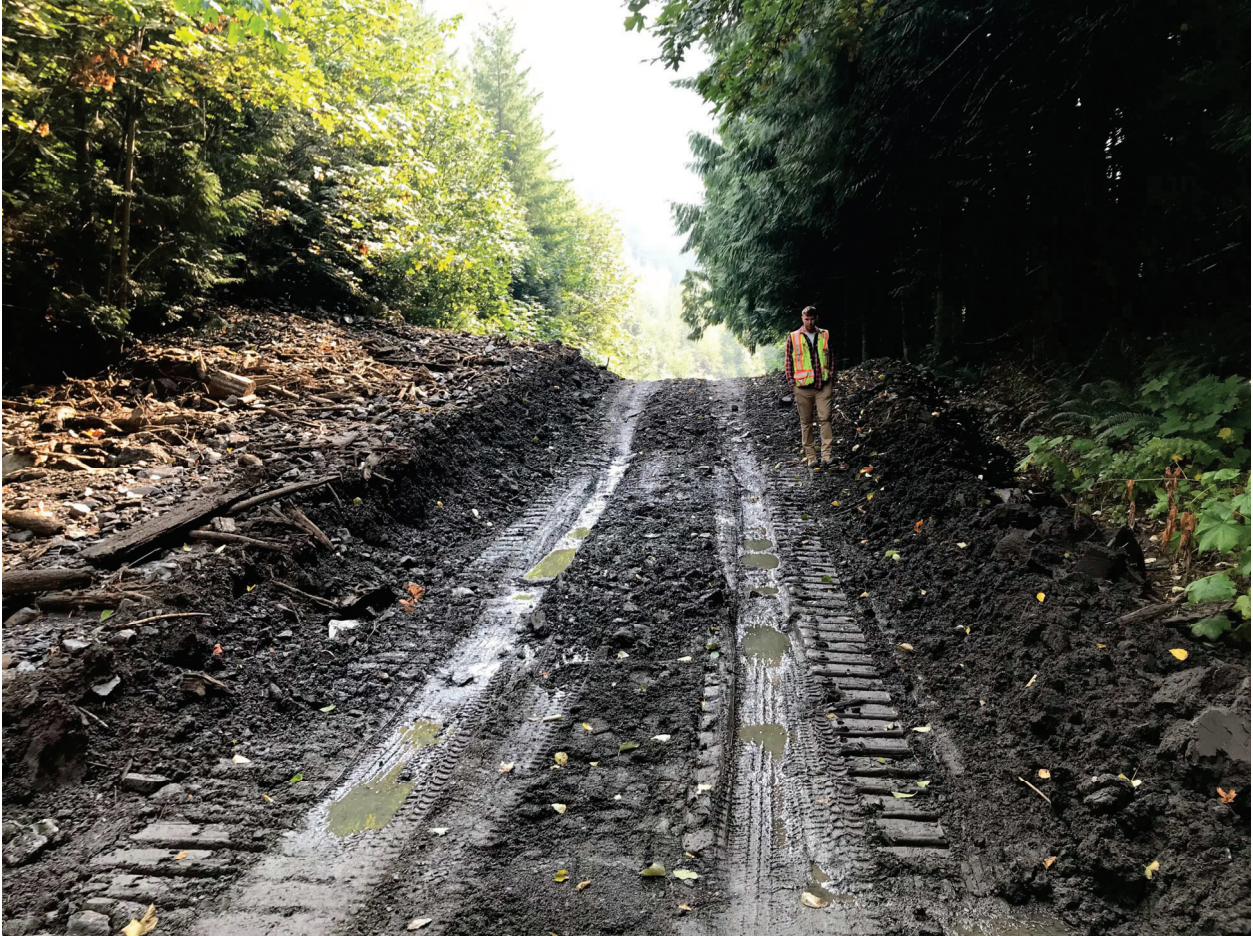
Photo 1: Looking east at the debris fan deposited on the road, Sept 14, 2022.

The debris fan was removed from the road in October 2022.

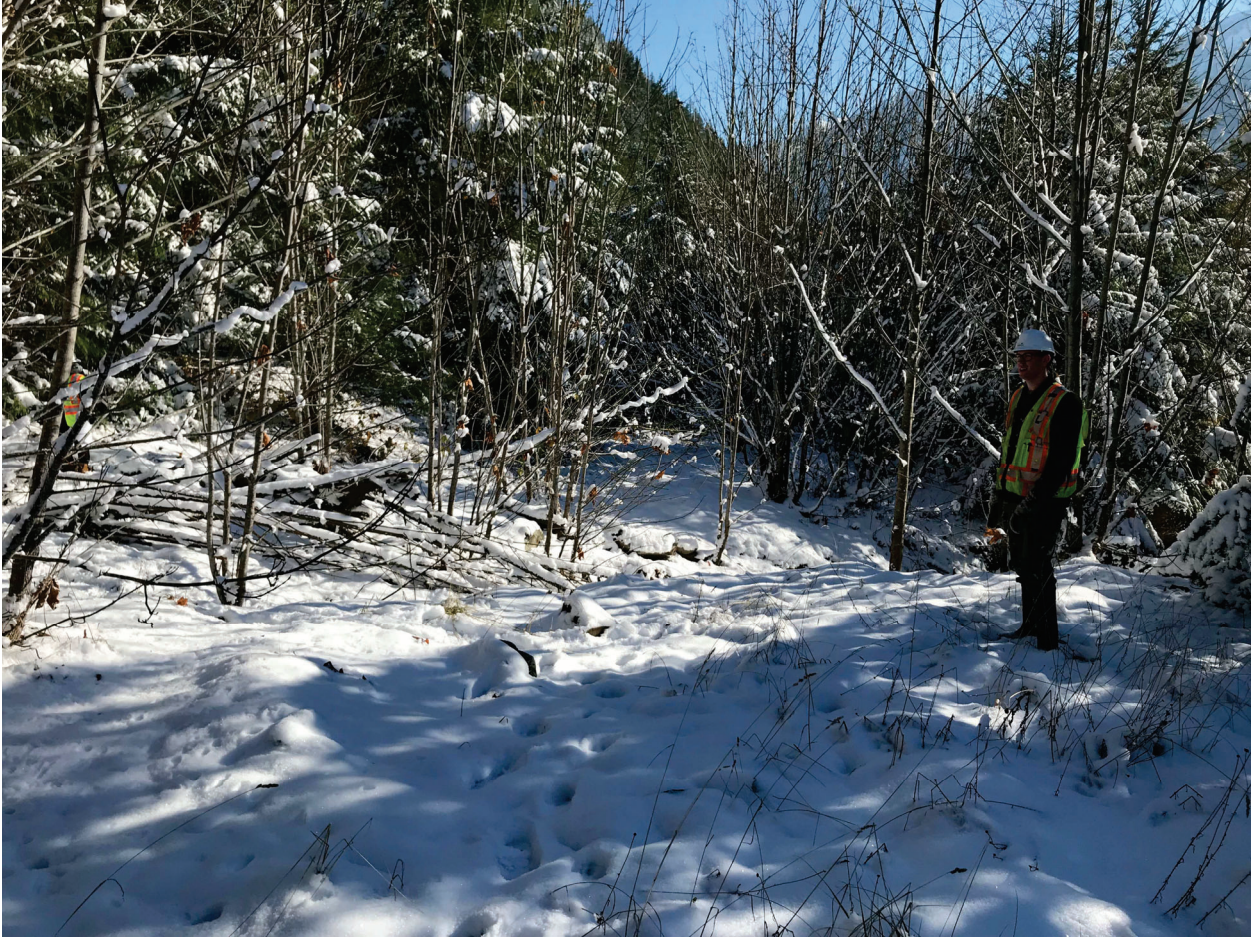
Photo 2: Looking east along the overgrown old logging road. The debris channel crosses the road in the foreground.

An old logging road, now partially overgrown with vegetation and small to mid size trees, diverges from the Silver Skagit Road about 100 m east of the debris channel and trends westward up the slope. The debris channel was observed, during our site visit of November 9, 2022, to cut across the old logging road such that the blockage is upslope of the logging road.

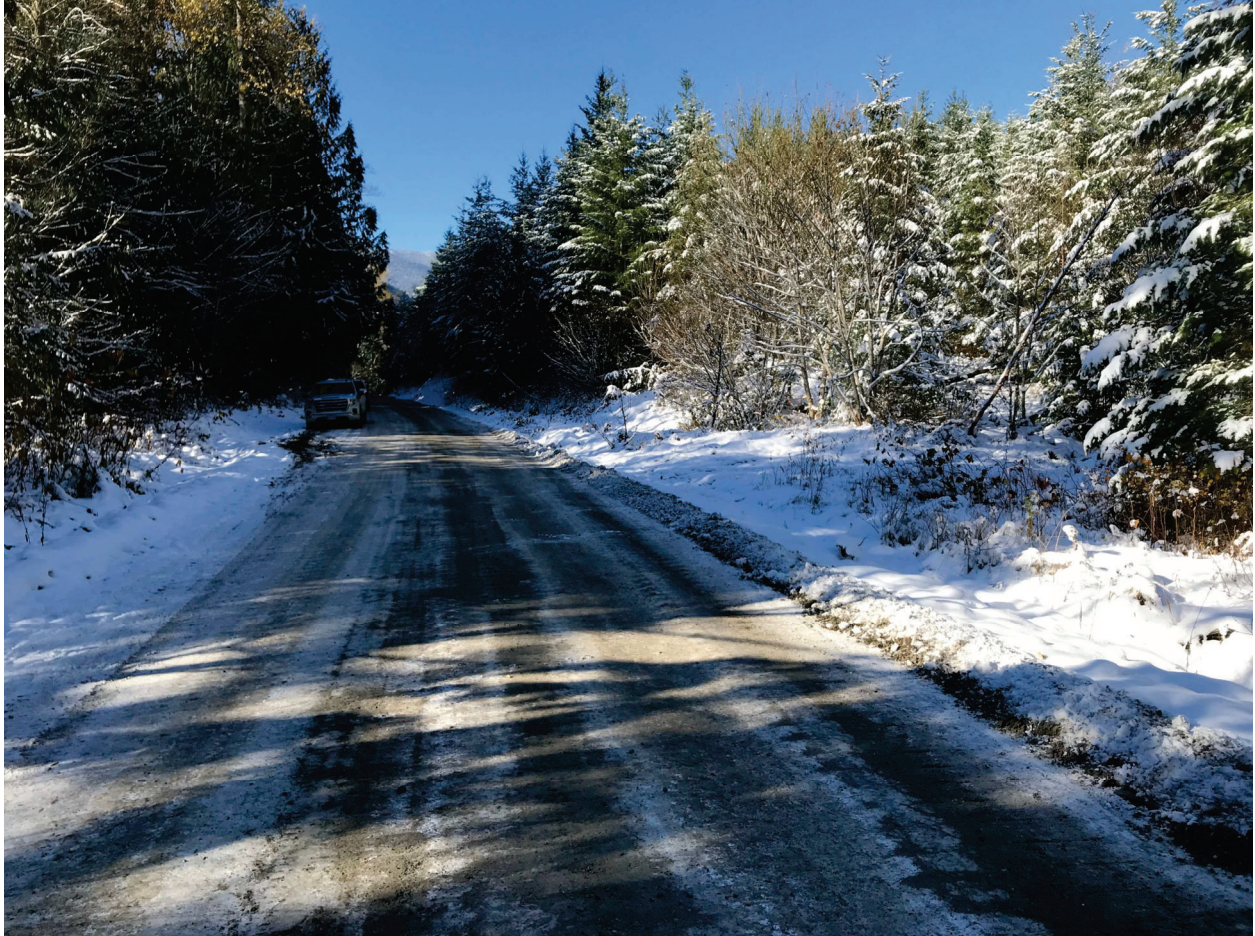
Photo 3: Looking west along the Silver Skagit Road at about km 28.8, on Nov 9, 2022. The approximate location of the D 17 line is in the foreground. The old logging road, grown with trees, meets the Silver Skagit Road near this location. Note that the debris fan has been removed from the road at this time.

The point where the old logging road meets the Silver Skagit Road is a local topographic low. It is the location of the proposed D17 line in the design drawings. To the south of the road, there is a relatively flat wooded area beyond which, about 30 m south of the road, is a pond.

- A roadside ditch will run along the north side of the road from the debris channel to the D17 line.
- At the D17 line, a channel will be constructed upstream for a distance of 25 m to the northwest from the road (along the approximate alignment of the old logging road).
- The channel will cross under the Silver Skagit Road through a 1.2 m diameter culvert which will discharge into the wooded area about 10 m south of the road edge.
- The roadside ditch will connect into the D17 channel at a convenient location upstream of the culvert inlet.
- The ground adjacent to the culvert inlet and outlet will be protected with riprap.
- The road pavement structure will consist of High Fines Surfacing Aggregate (HFSA), underlain by Well Graded Base Course (WGB) then Select Granular Subbase (SGSB). The design for the pavement structure is shown below.
