BC Ministry of Transportation and Infrastructure

Highway 28 Cervus Creek Bridge Replacement Environmental Assessment

JANUARY 2023

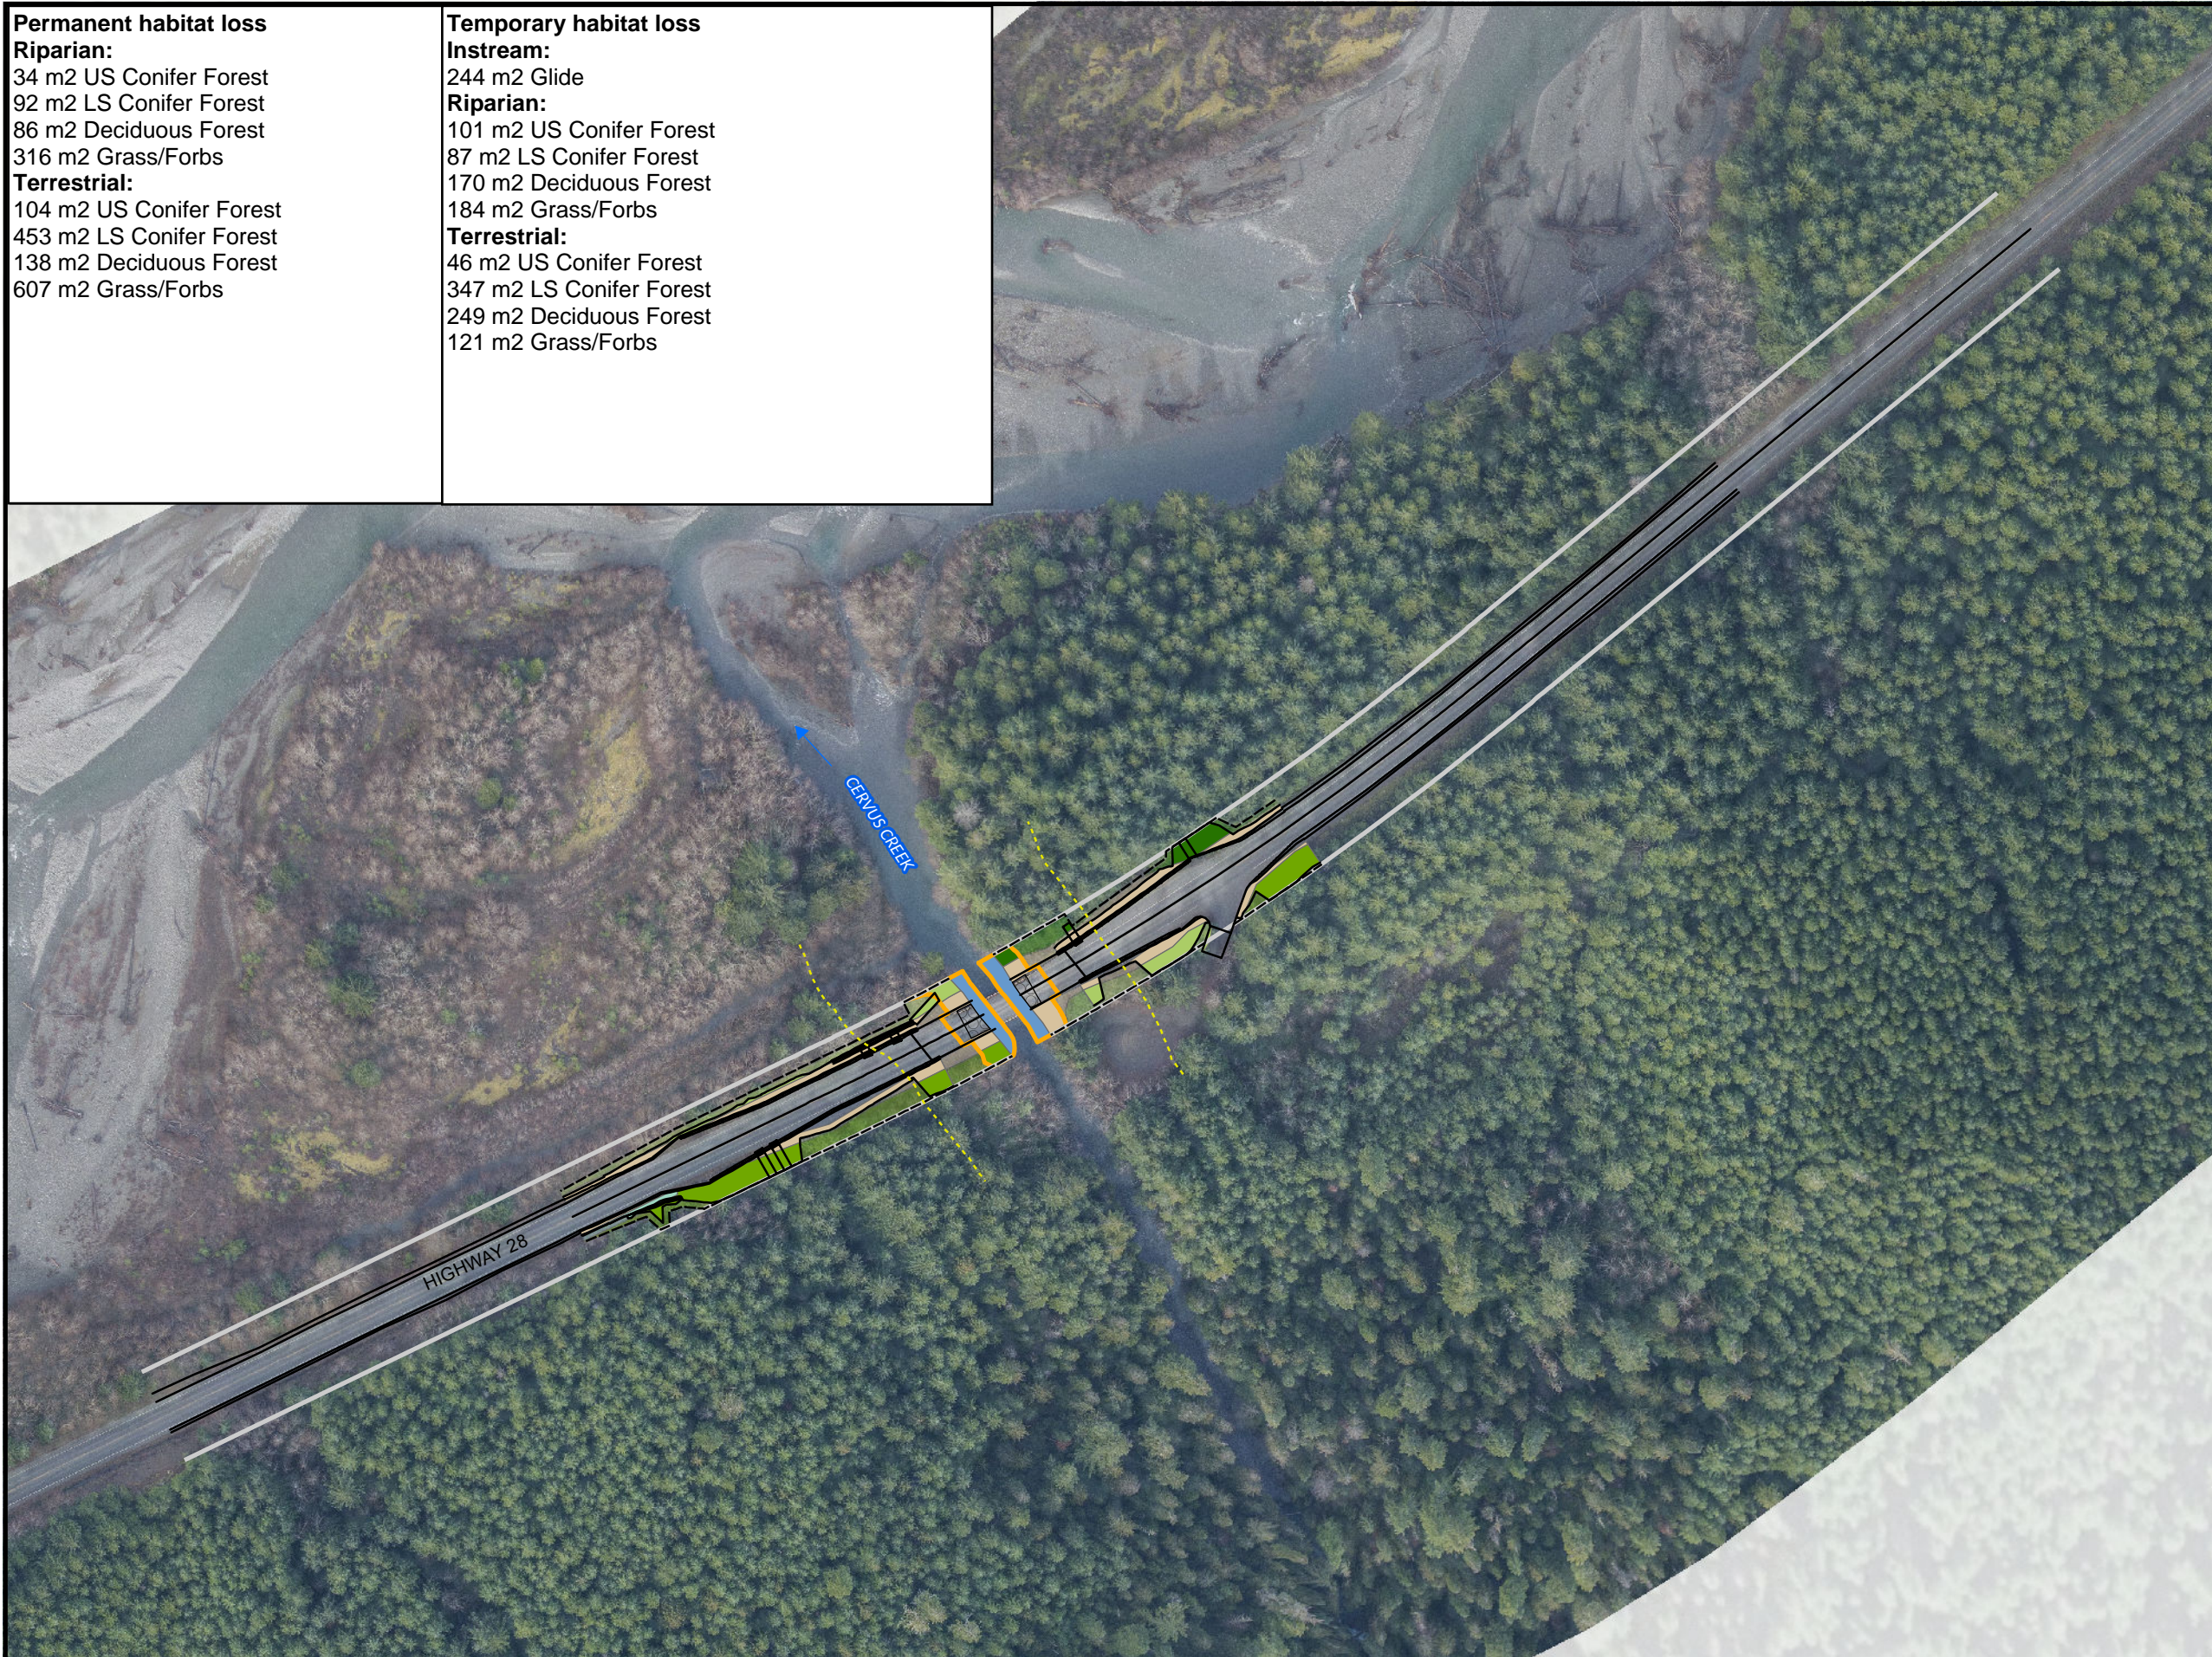
FIGURE A-3
Environmental Impacts

Permanent habitat loss

- 46 m2 US Conifer Forest
- 347 m2 LS Conifer Forest
- 249 m2 Deciduous Forest
- 121 m2 Grass/Forbs

Permanent riparian habitat loss comprises approximately 316 m² of disturbed grass (60%), 34 m² upper slope coniferous forest (7%), 92 m² lower slope coniferous forest (17%) and 86 m² deciduous forest (16%). Of the 542 m² of riparian habitat temporarily lost during construction, approximately 34% consists of disturbed grass (184 m²), 31% is deciduous forest (170 m²), 19% is upper coniferous forest (101 m²) and 16% lower coniferous forest (87 m²).

To install the new riprap along either bank of Cervus Creek, the existing riprap will be removed, and bank grading and shaping will be required. These works will include some instream works (i.e., below the high-water mark) along the banks and channel margins down to toe of slope. The fish habitats affected include the channel margins of primarily existing riprap glide habitats adjacent to other previously disturbed slopes of highway ROW, or under the bridge, and therefore the magnitude of these effects is considered low. For work within and adjacent to existing riprap areas, the potential adverse effects will be temporary during construction for the replacement with new riprap. The temporary instream areas impacted comprise approximately 244 m² of existing and new riprap proposed for below the HWM. Instream impact areas are shown in Figures 5-1, 5-2, 5-3 and Appendix A, Figure A3.

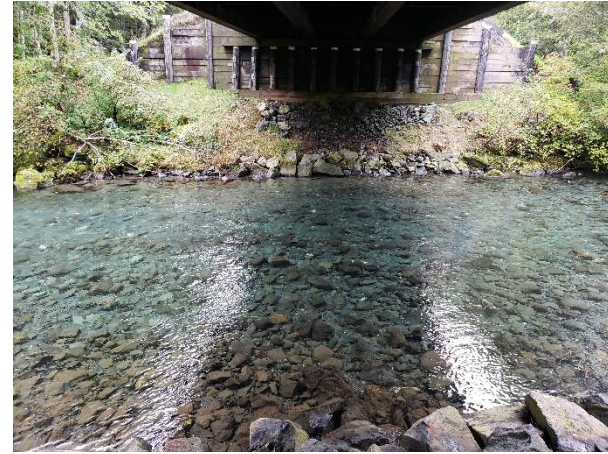
Photo 2: Cervus Creek looking west towards the west bank underneath the existing bridge.

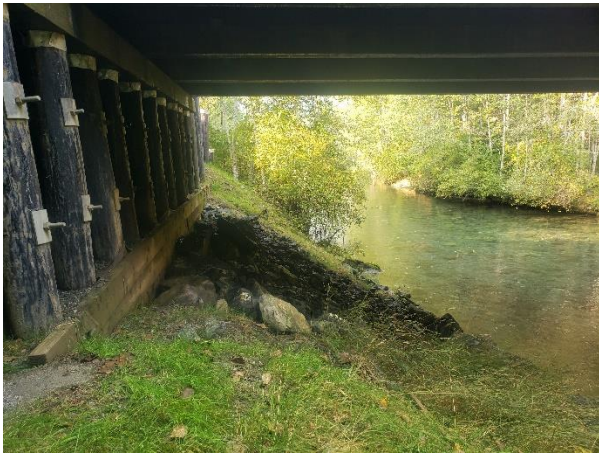
Photo 3: Cervus Creek looking north along west bank under existing bridge.

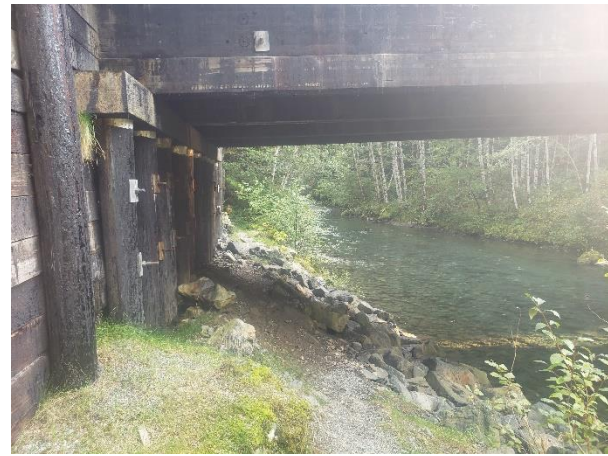
Photo 4: Cervus Creek looking south along east bank under existing bridge.

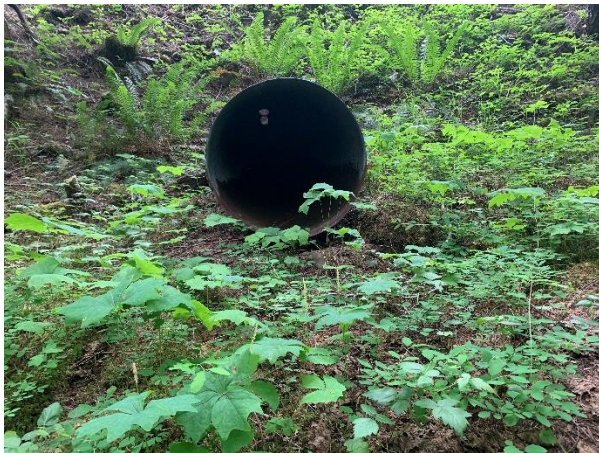
Photo 15: Dry culvert conducting surface drainage under Highway 28, approximately 300 m east of the bridge crossing
