Hwy 4 Hydro Hill Slope Stability Project

LKI Seg 2383 65.48 km

Geotechnical Design Report

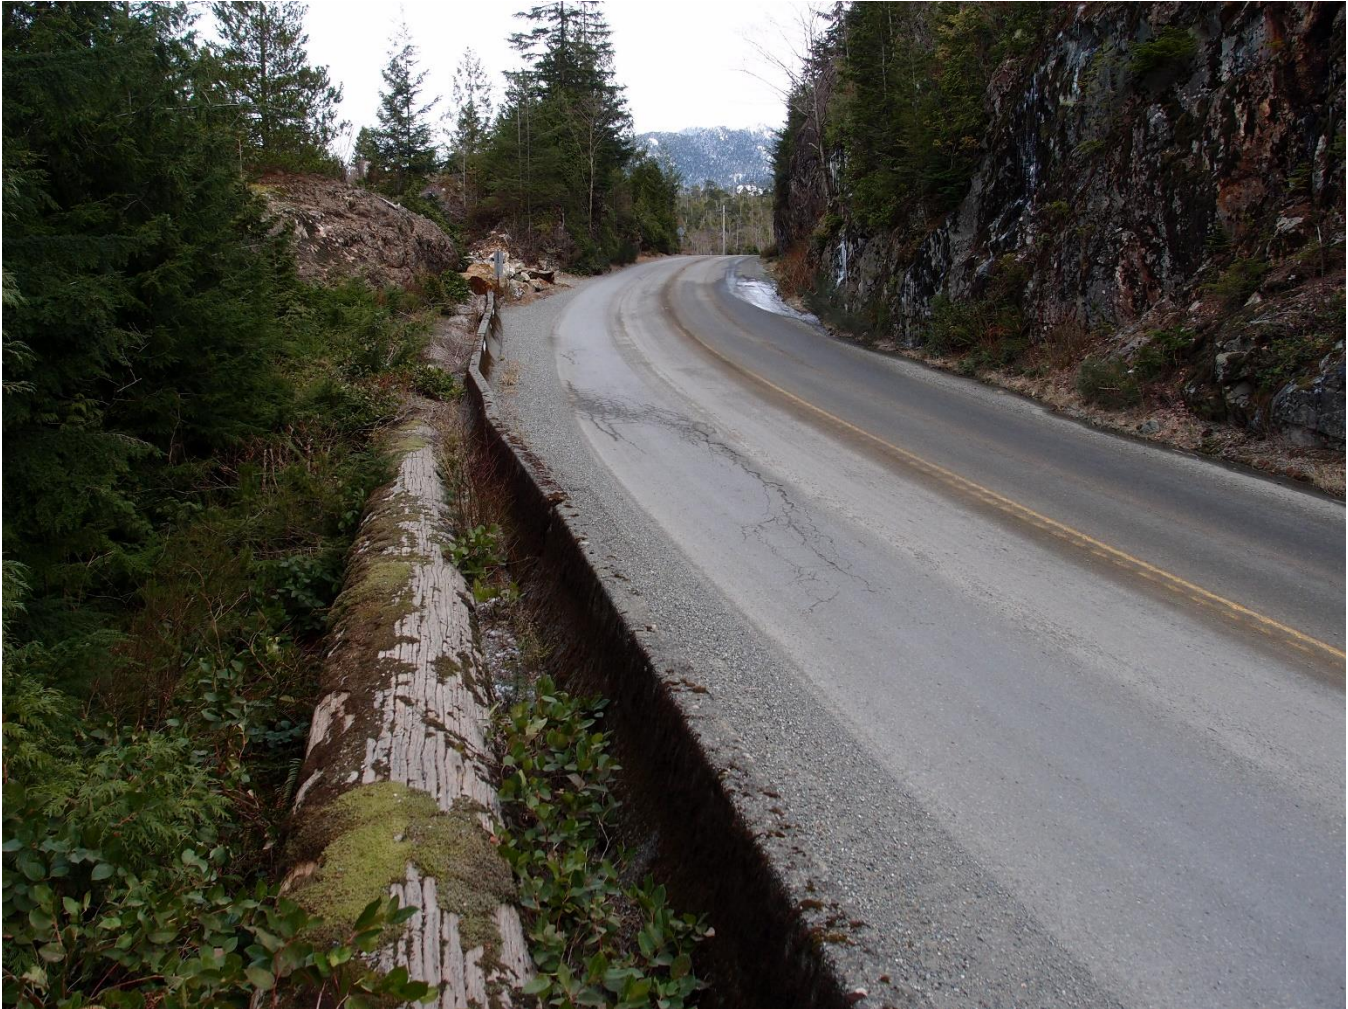
Figure 2: March 2017 Pavement Distress, Looking East

- An approximate 17 m long distressed area of the pavement structure was observed, which had settled by up to 40 cm or more as of January 2017.
- Pavement distress is located between the pullout from the westbound lane to BCHydro Pole 58/3 (east of site) and the cast in place (CIP) retaining wall 3429R (south of site). The pullout is constructed as a full bench rock cut, and the eastbound side of wall 3429R abuts into full bench rock cut construction.

Additional pavement distress and deformation has been observed since the 2017 memo. It is understood that the Maintenance Contractor has been patching the area as required. A photo showing the pavement distress from March 2017 is shown in Figure 2.

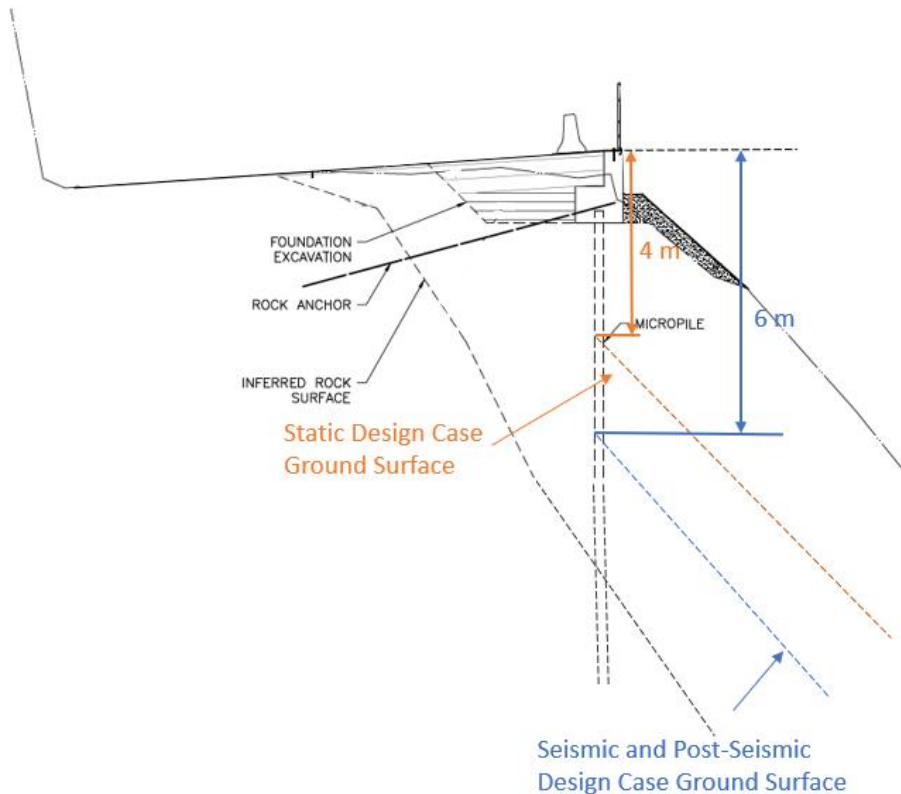
Figure 4: Design Cases – “Effective Wall Height” Schematic (not to scale)

A back-analysis was completed using limit equilibrium method (LEM) to estimate the “effective wall height” in the static case and to confirm appropriate engineering parameters. The “effective wall height” is the height from the top of grade beam to the soil surface. A 6 m wall height was adopted for the “effective wall height” when the downslope soils fail or deform in the seismic event and is carried forward for the post seismic design case. The “effective height” considers the results of the static back-analysis and short critical “wall” width which was inferred from the depth to bedrock encountered in the site investigation.

A summary of the three design load cases considered in the geotechnical analysis for the structure is shown in Table 1 and illustrated in Figure 4.

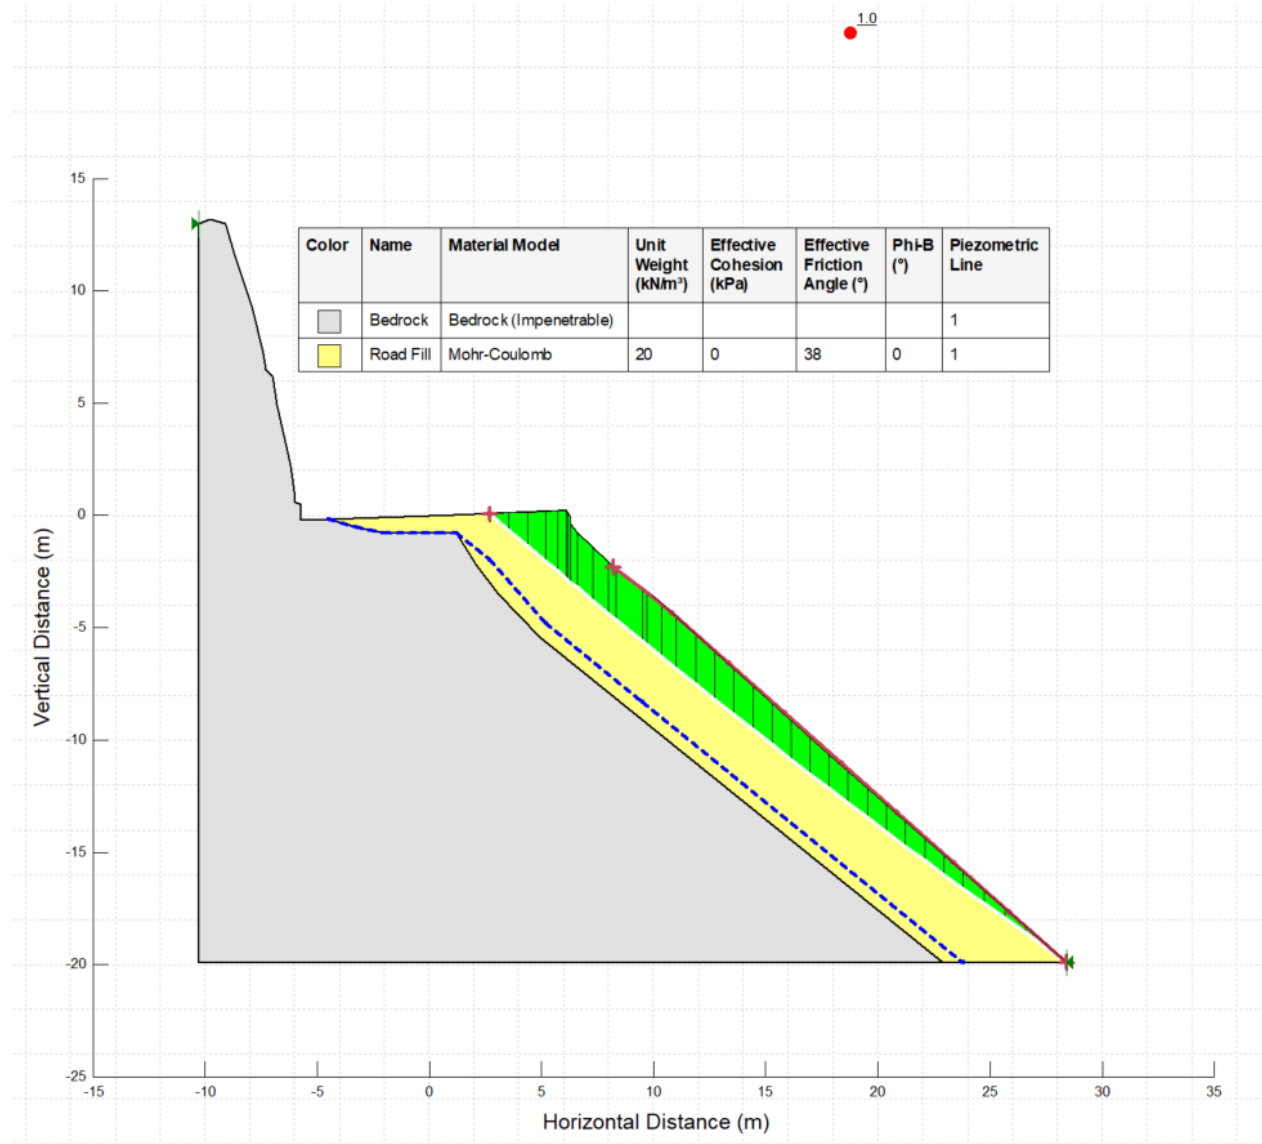
SLOPEW Back Analysis Results

A back analysis was completed using Geostudio SLOPE/W for the distress observed at site. One soil unit was modelled due to the similar nature of the native colluvial soils and the blast rock fill materials, and the uncertainty of the depth of transition between those two materials. Blast rock fill underlain by bedrock was considered an appropriate depiction of site conditions at the location of the observed distress due to our understanding of site conditions. The back analysis was completed to inform the engineering properties of the fill materials. Results of the back analysis are shown in Appendix D.

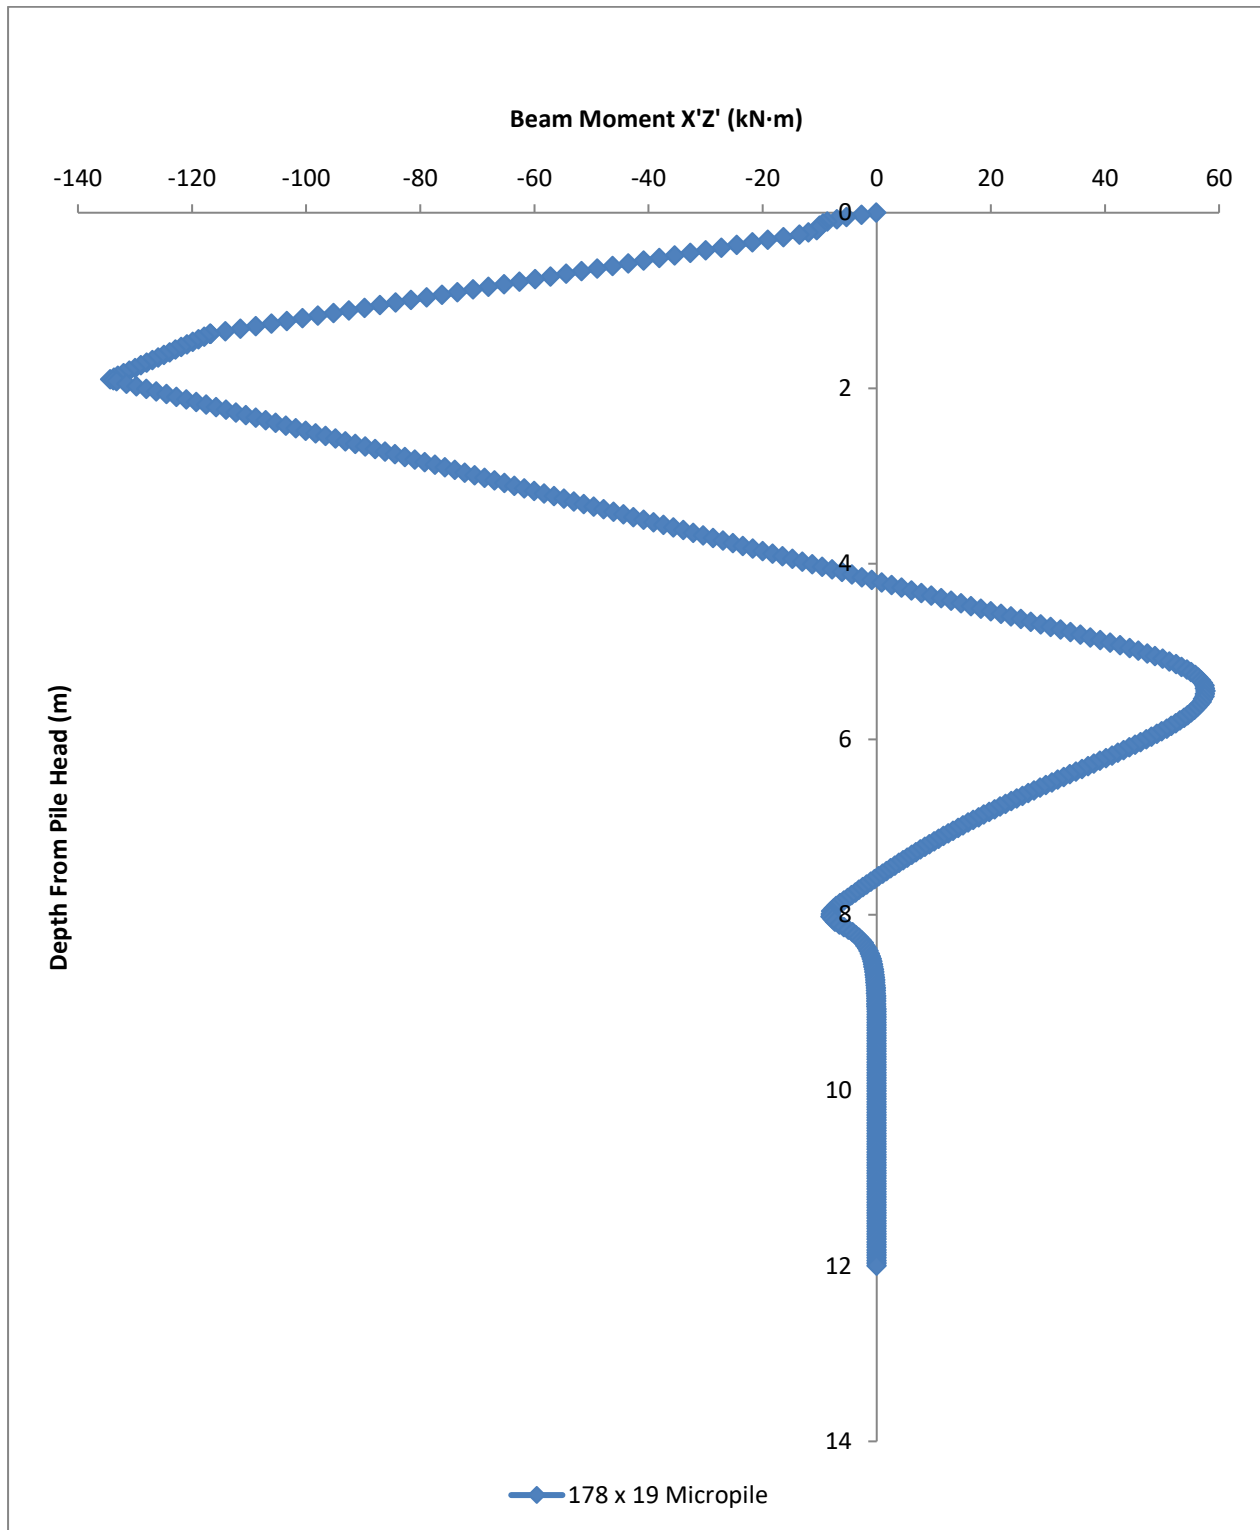
Beam Moment Diagram - With Tie-Back Force

Note: Datum adjusted for lateral pile analysis. A depth of 0 m in the lateral analysis represents the location of the tieback force, which is equivalent to 1.1 m below ground surface.

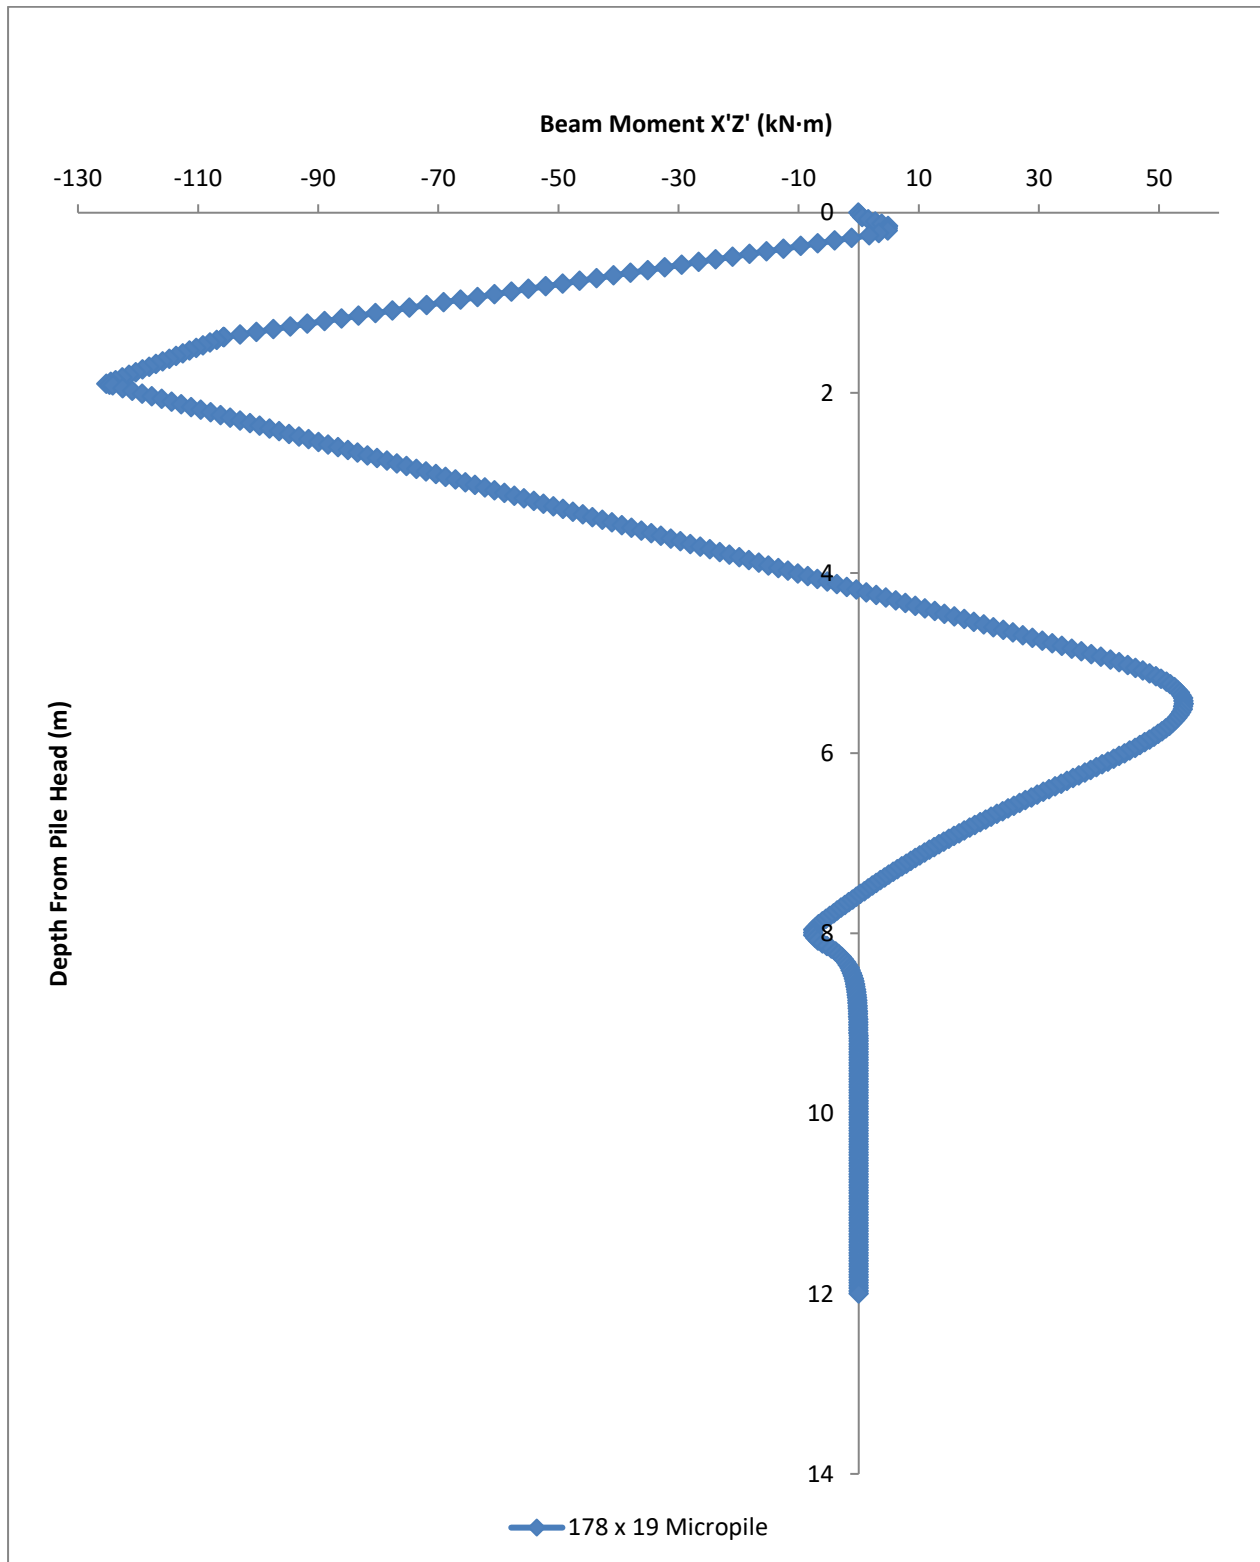
Beam Moment Diagram - Without Tie-Back Force

Note: Datum adjusted for lateral pile analysis. A depth of 0 in the lateral analysis represents the location of the tieback force, which is equivalent to 1.1 m below ground surface.

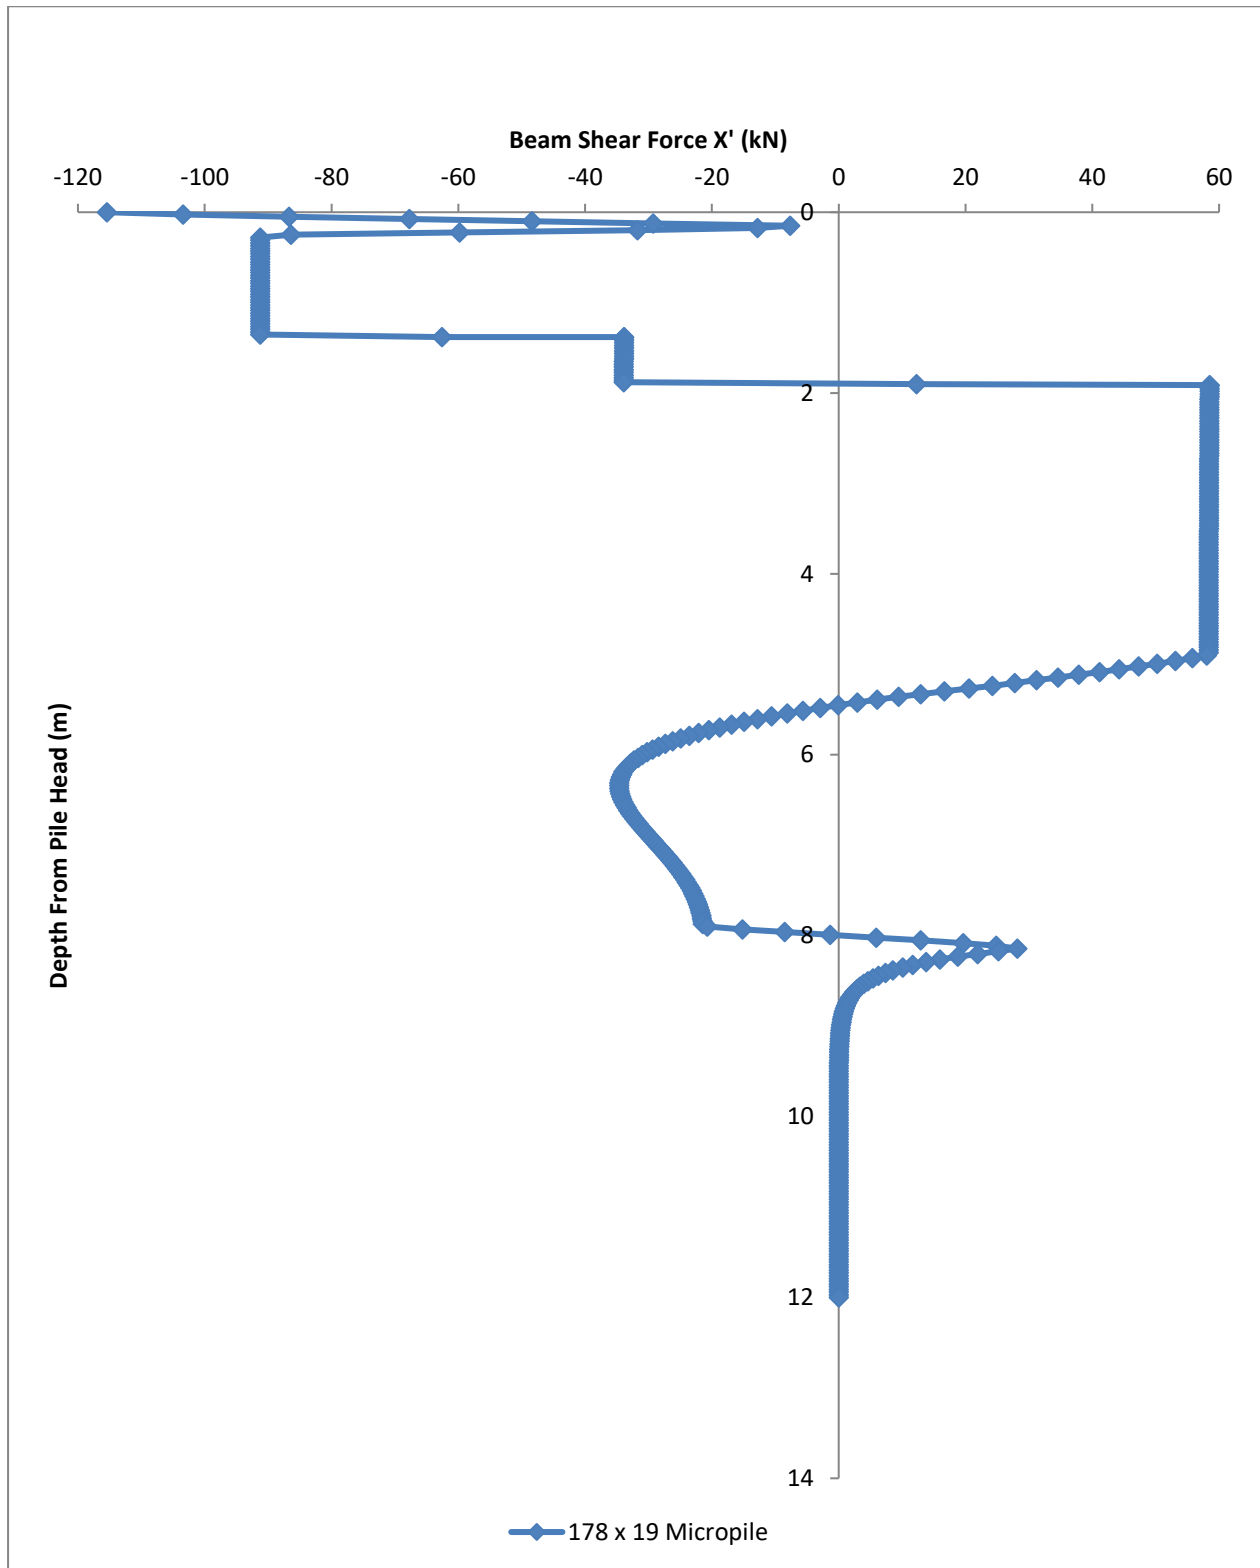
Beam Shear Diagram - With Tie-Back Force

Note: Datum adjusted for lateral pile analysis. A depth of 0 m in the lateral analysis represents the location of the tieback force, which is equivalent to 1.1 m below ground surface.

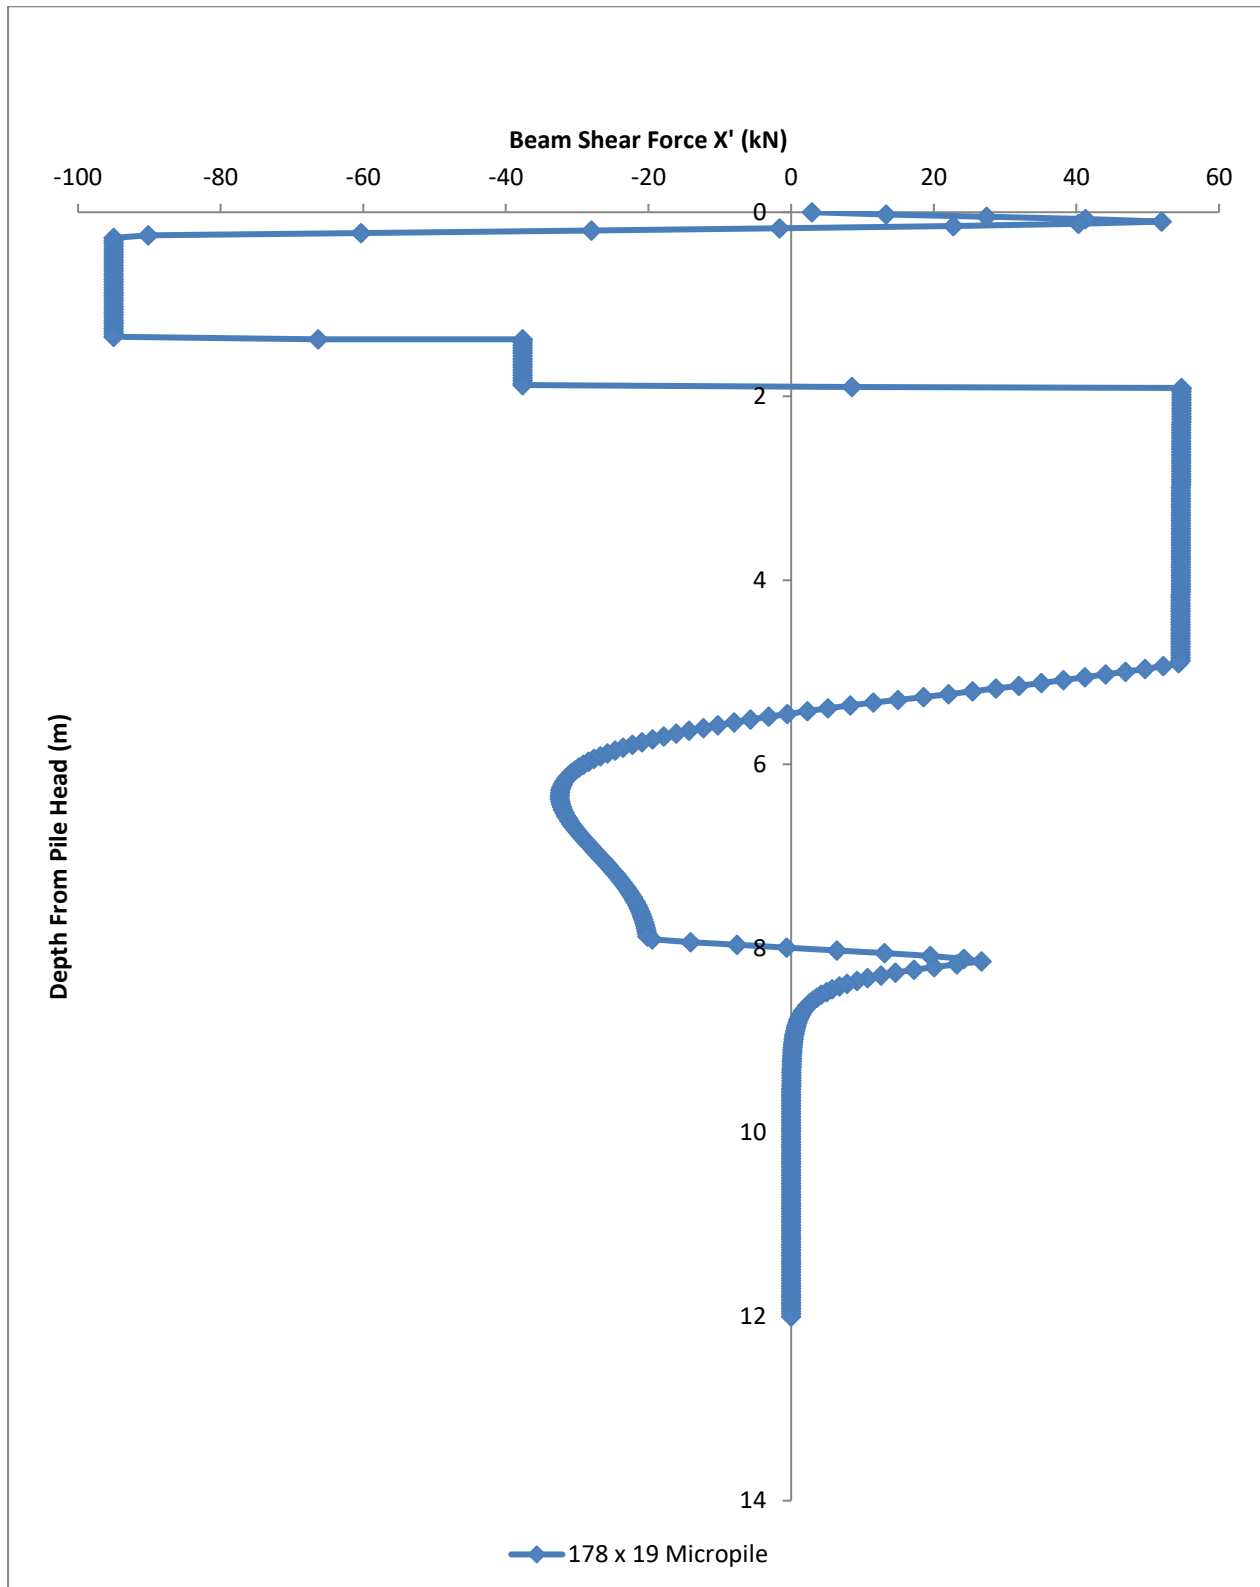
Beam Shear Diagram - Without Tie-Back Force

Note: Datum adjusted for lateral pile analysis. A depth of 0 m in the lateral analysis represents the location of the tieback force, which is equivalent to 1.1 m below ground surface.
