Environmental Overview Assessment Colquitz River Bridges Widening and Upgrades Highway 1, Saanich, BC

PRESENTED TO
BC Ministry of Transportation and Infrastructure

SEPTEMBER 5, 2023
ISSUED FOR USE
FILE: 704-ENW.VENW03225-24

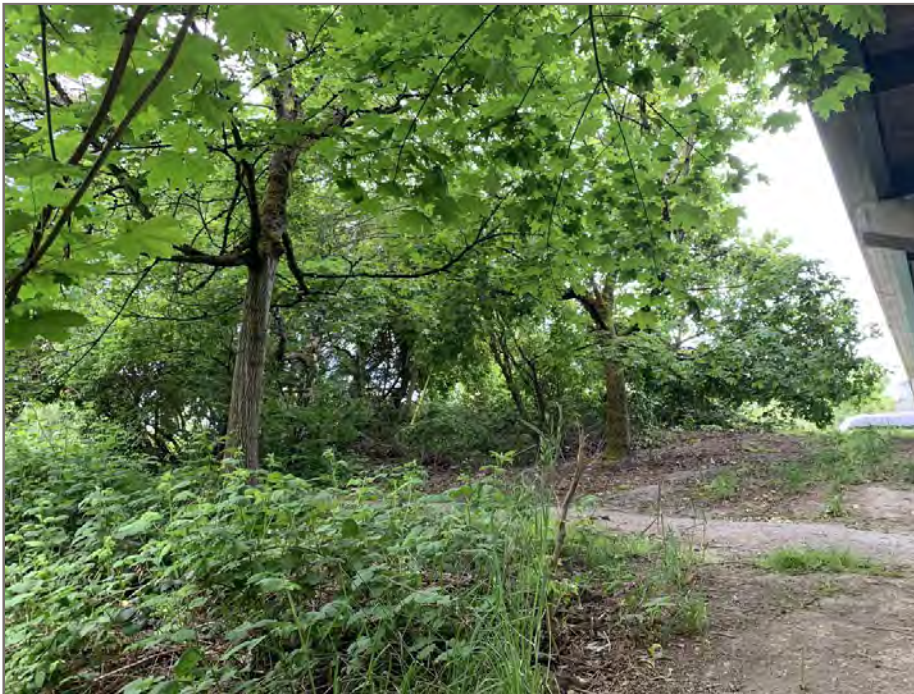
Photo 4: View of pedestrian path on the east side of the Colquitz River. Burnside Road is above the crest of the slope. Vegetation in photo is a stand of predominantly bigleaf maple beside and between the two bridges.

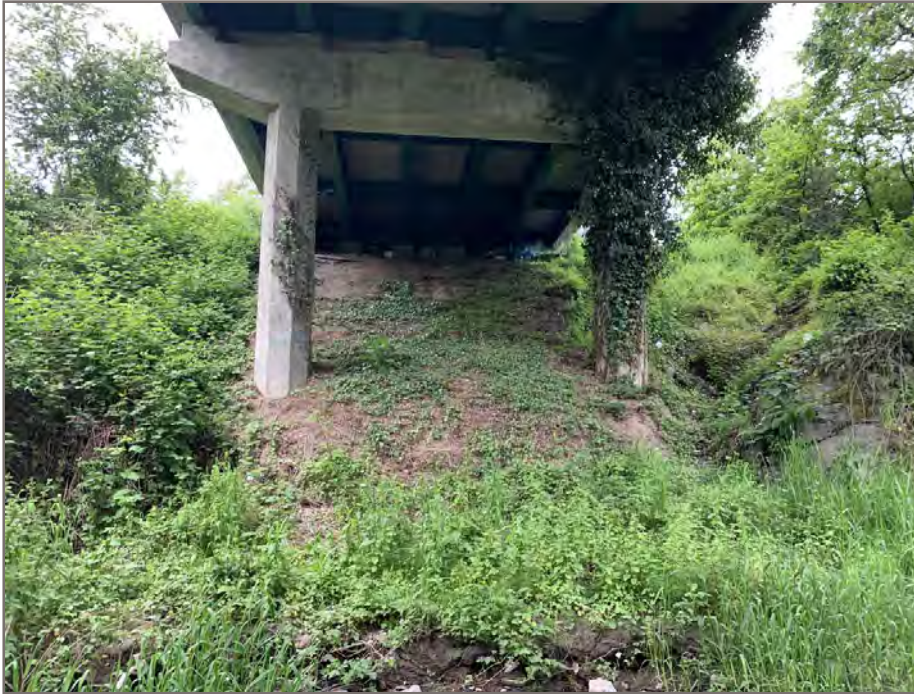
Photo 6: Representative substrates within the Colquitz River below the north-bound bridge. Salmonid fry are present in this photo but they are indiscernible.

According to iMapBC and Habitat Wizard, twelve species of fish are known to occur in the Colquitz River (Table 5-4). Mapped fish occurrences were identified upstream and downstream of the Project area (Figure 2). Juvenile salmonid fry were observed below the north-bound bridge during the May 2022 site visit (Figure 3; photo 6).

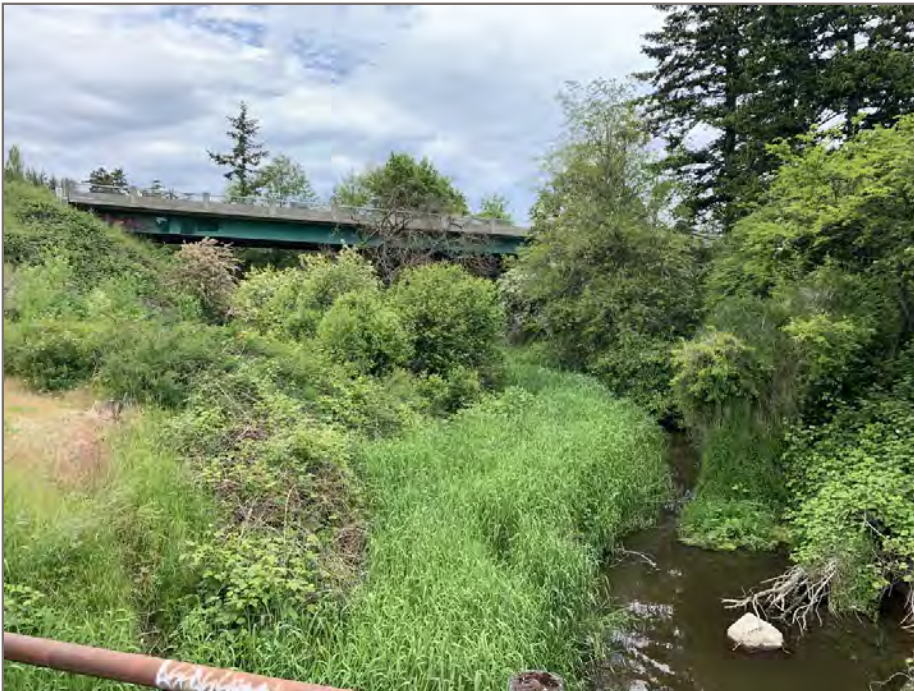
Photo 7: West bank of Colquitz River below north-bound bridge depicting some exotic vegetation (English ivy, reed canary grass, Himalayan blackberry). An American Mink (*Neogale vison*) was observed scurrying across this bank.

During the site visit by Tetra Tech field staff on May 31, 2022, two wildlife species were identified on-site. One great blue heron (*Ardea herodias fannini*) was observed in flight above the area surrounding the Project, and one American mink (*Neogale vison*) was observed in the vegetated riparian slopes underneath the north-bound bridge.

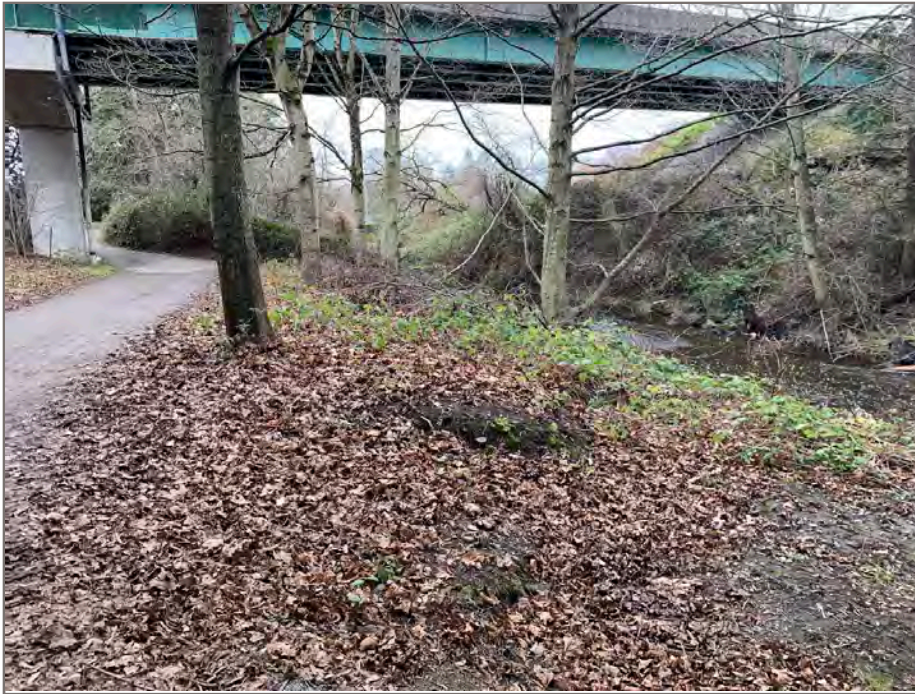
Photo 12: View of bigleaf maple directly north of the south-bound bridge that may need to be removed to accommodate construction.

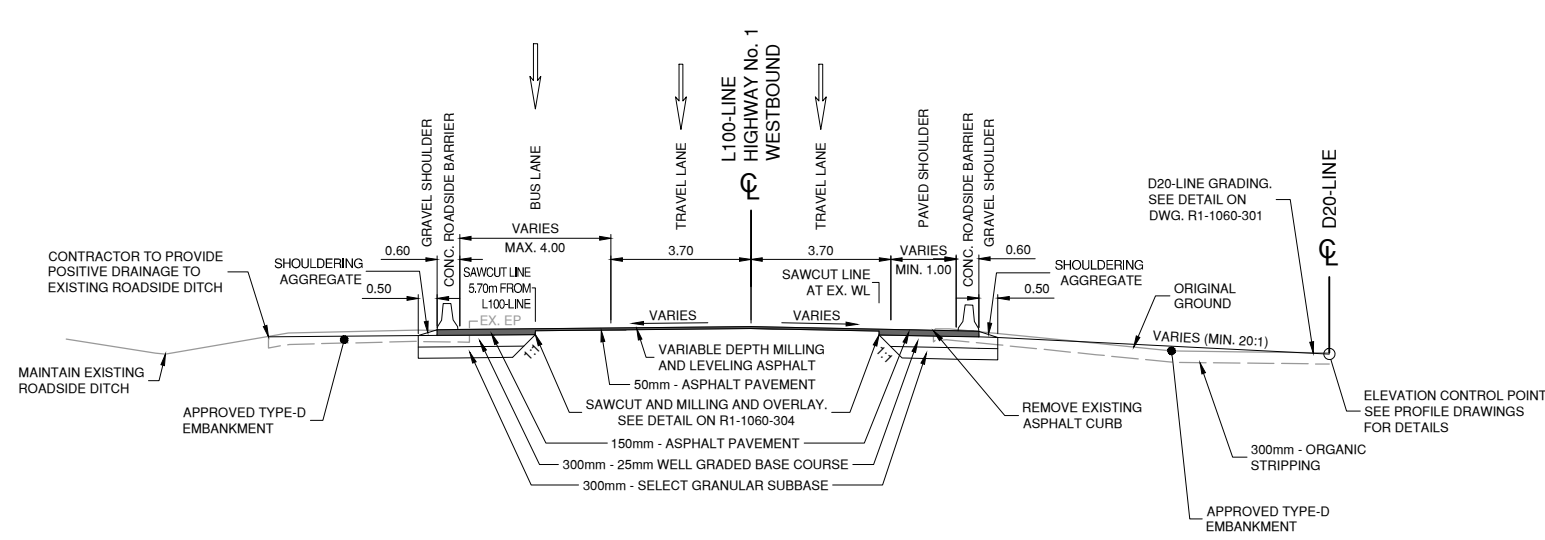
HIGHWAY No. 1 WESTBOUND (L100-LINE) - TYPICAL SECTION
SHOULDER WIDENING - BOTH SIDES - WITH BARRIER
 STA. 103+82.931 LT TO STA. 104+73.000 LT
 STA. 103+82.931 RT TO STA. 104+78.000 RT
