TECHNICAL MEMORANDUM

Reference No. 22525903-008-TM-Rev0

MARINE SUBTIDAL HABITAT SURVEY FOR THE FAIRBANKS ROAD FLOOD RESPONSE PROJECT, COWICHAN BAY, BC

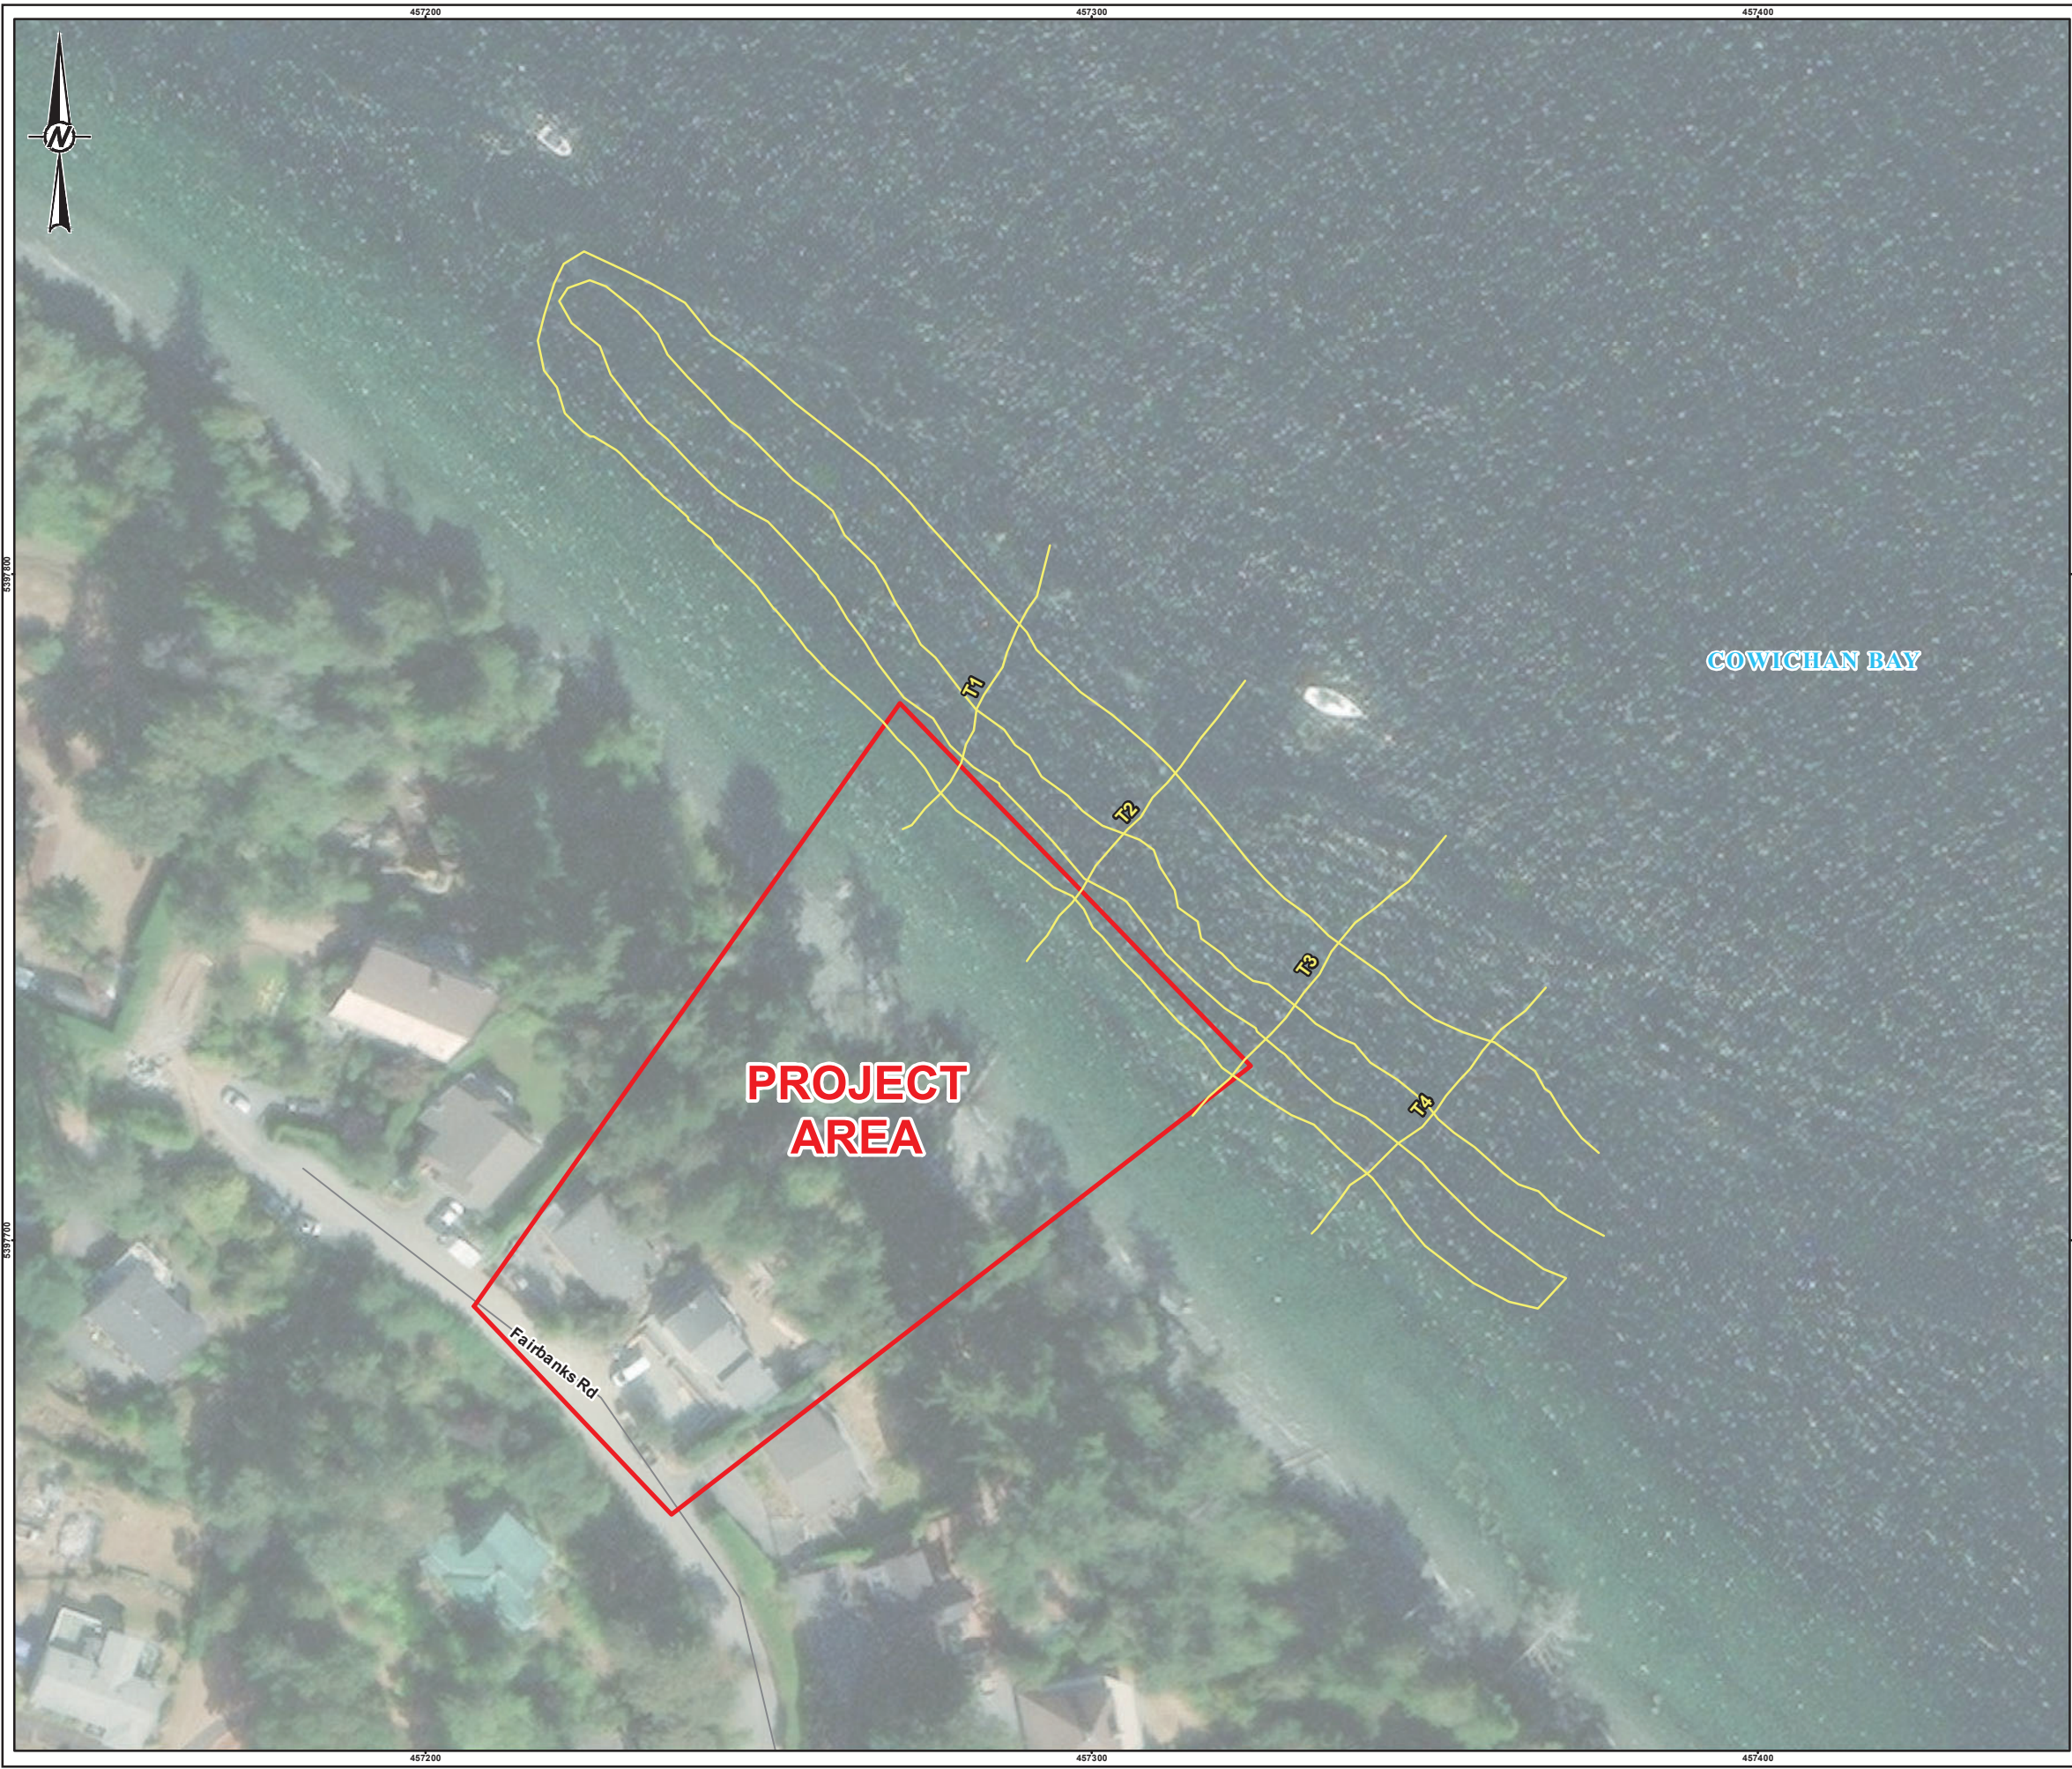
FIGURE
2

An underwater towed video survey was undertaken by a three-person WSP team aboard WSP's 8-m vessel, 'the Salish GAL' on 23 August 2023. Towed video footage was recorded along the majority of the Site's shallow subtidal shoreline (Figure 2). The survey was conducted using a system consisting of a high-resolution video camera with integrated Wide Area Augmentation System (WAAS)-enabled Global Positioning System (GPS) Garmin 60CXs¹ video overlay. The video system was operated by trained personnel using a real-time monitor set-up on the deck of the vessel. Vessel positioning during the towed video survey was monitored and recorded using on-board Lowrance HDS-12 navigational software.

A total of four shore-perpendicular transects were surveyed between approximately -15 m Chart Datum (CD) and +1.5 m CD with additional shore-parallel transects conducted to map and delineate marine vegetation. The survey vessel was operated at approximately 1 to 2 km/h with the camera suspended approximately 0.3 m to 1 m above the seafloor to allow for suitable visibility of the substrate and vegetation during the surveys. During the towed video surveys qualitative observations of kelp and eelgrass coverage were recorded and the extent of the kelp and eelgrass habitats were mapped. Opportunistic fish sightings and important habitat features were recorded.

TOWED VIDEO SURVEY TRACKS

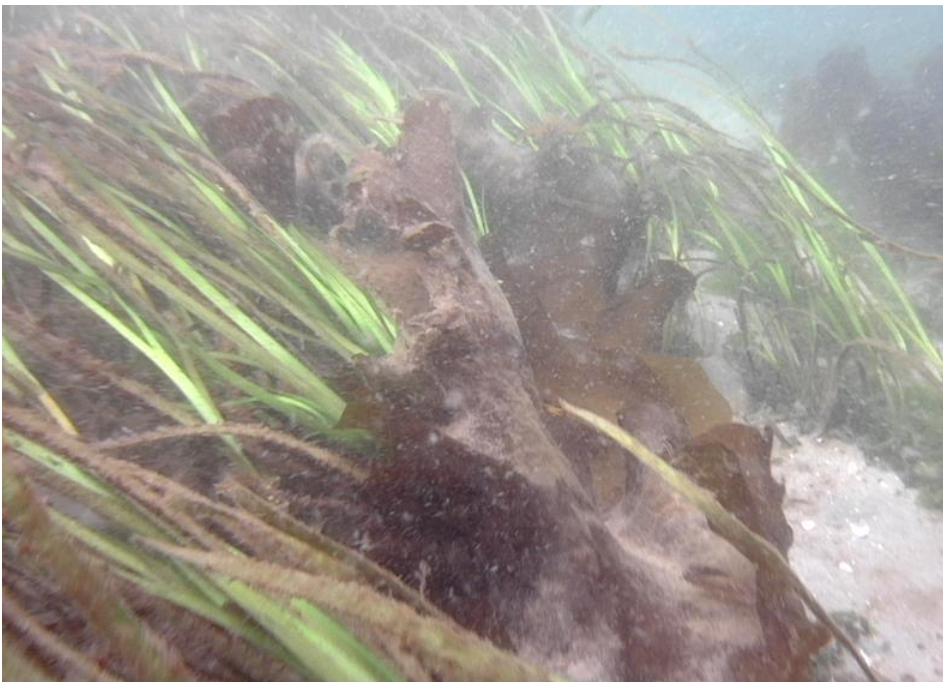
Photo 1: Eelgrass (*Zostera marina*) and sugar kelp (*Saccharina latissima*) in the upper subtidal zone, 23 August 2023.

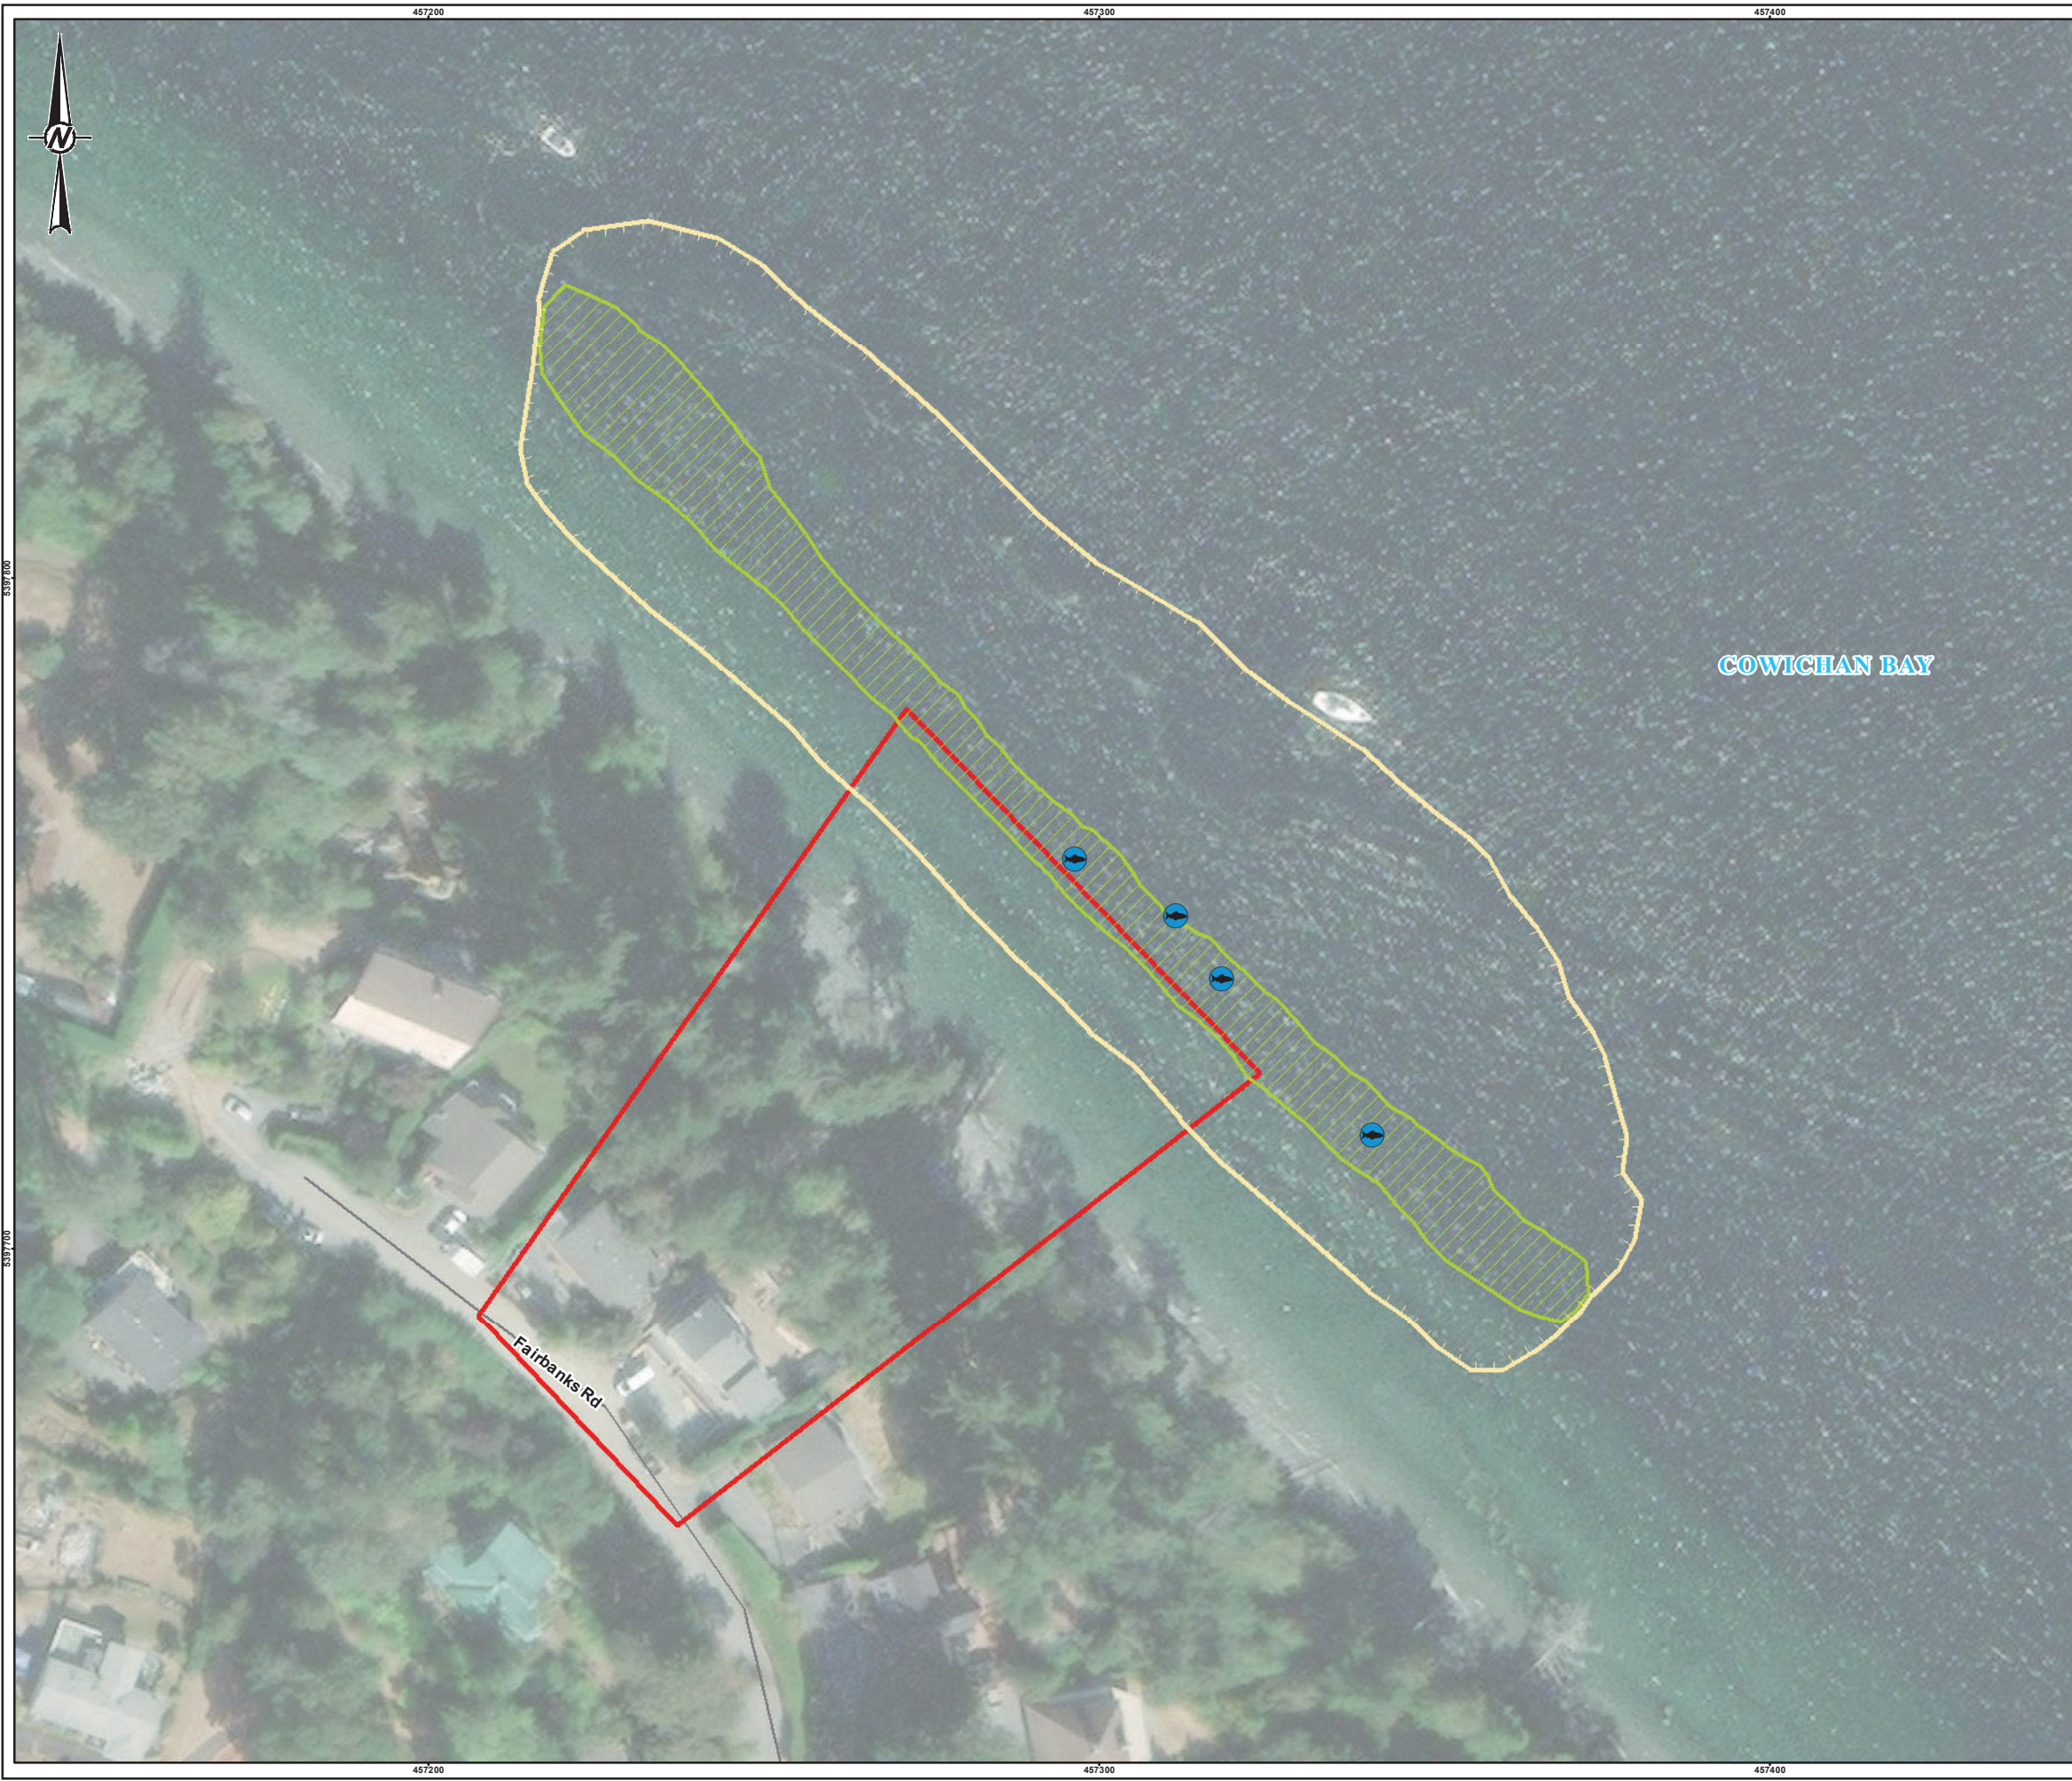
PROJECT NO.	CONTROL	REV.	FIGURE
22573043	8004	0	3

The majority of substrates within the subtidal areas were a mix of sand, with scattered gravel, cobble and shell debris (Figure 3). No evidence of bedrock or boulders were observed within the survey area.

A variety of macroalgae were observed in the subtidal areas within the adjacent foreshore to the proposed Project area, including eelgrass and understory kelp species. Eelgrass was observed between 0 m and -2.1 m CD and was generally observed at 50-100% areal coverage throughout the survey area within that depth range (Figure 3; Photo 1). Sugar kelp (*Saccharina latissima*), an understory kelp species, was observed in a few locations at between 10 and 50% areal coverage, co-located with eelgrass, primarily between -1.0 and -2.0 m CD. No understory kelp greater than 10% areal coverage was observed outside of areas where eelgrass was observed and delineated. Other macroalgae species observed included sea lettuce (*Ulva* sp.) at depths between 0 m and +1.5 m CD, and unidentified red foliose and red bladed algae (e.g., *Rhodomenia* sp. and *Chondracanthus* sp.). No evidence of canopy forming kelp or potentially suitable abalone habitat² was observed in the surveyed areas.

A few small schools of shiner perch (*Cymatogaster aggregata*) were observed in areas vegetated with eelgrass (Figure 3). Several Dungeness crabs (*Metacarcinus magister*) were observed along with plumose anemones (*Metridium* spp.) attached to gravel and cobble. One harbor seal (*Phoca vitulina*) was observed during the survey as well as a double-crested cormorant (*Nannopterum auritum*).

TITLE
MARINE SUBTIDAL HABITAT

Based on the results of the marine subtidal habitat survey, the proposed Project activities, including temporary barge ramp installation (i.e., use of a spudded-down barge and/or installation of temporary pilings to convey materials to/from Site), have the potential to affect fish and fish habitat. If spuds, anchors, or pilings are placed on sensitive fish habitat, such as areas vegetated with eelgrass, the habitat could be altered/disturbed/destroyed which could be considered a harmful alteration, disruption, or destruction (HADD) of fish habitat under the *Fisheries Act*. If it is considered a HADD, an authorization and offsetting would be required by DFO. WSP recommends that the use of a spudded-down barge and/or installation of temporary pilings is designed to avoid placement within the 0 to -2.1 m CD bathymetry contour to avoid a HADD. Increased turbidity and/or total suspended solids (TSS) concentrations in the water column generated during construction activities could also result in a disruption of feeding by visual predators such as juvenile salmon (Berg and Northcote 1985) and could cause gill abrasions (Birtwell 1999; Servizi and Martens 1987) and respiratory distress in fish (Berg and Northcote 1985). Depending on the construction activities selected, measures to protect fish habitat from increased sedimentation and physical disturbance would need to be developed and implemented.

It is recommended that mitigation measures be developed to protect areas where fish habitat has been identified and that activities that have the potential to disturb fish habitat (e.g., areas with delineated eelgrass and understory kelp beds), not be permitted prior to receiving the outcome of DFO's review of the Request for Review package.
