Technical Summary

November 2024

Pit Name: Happy's Gulch

Provincial Pit Number: 0573

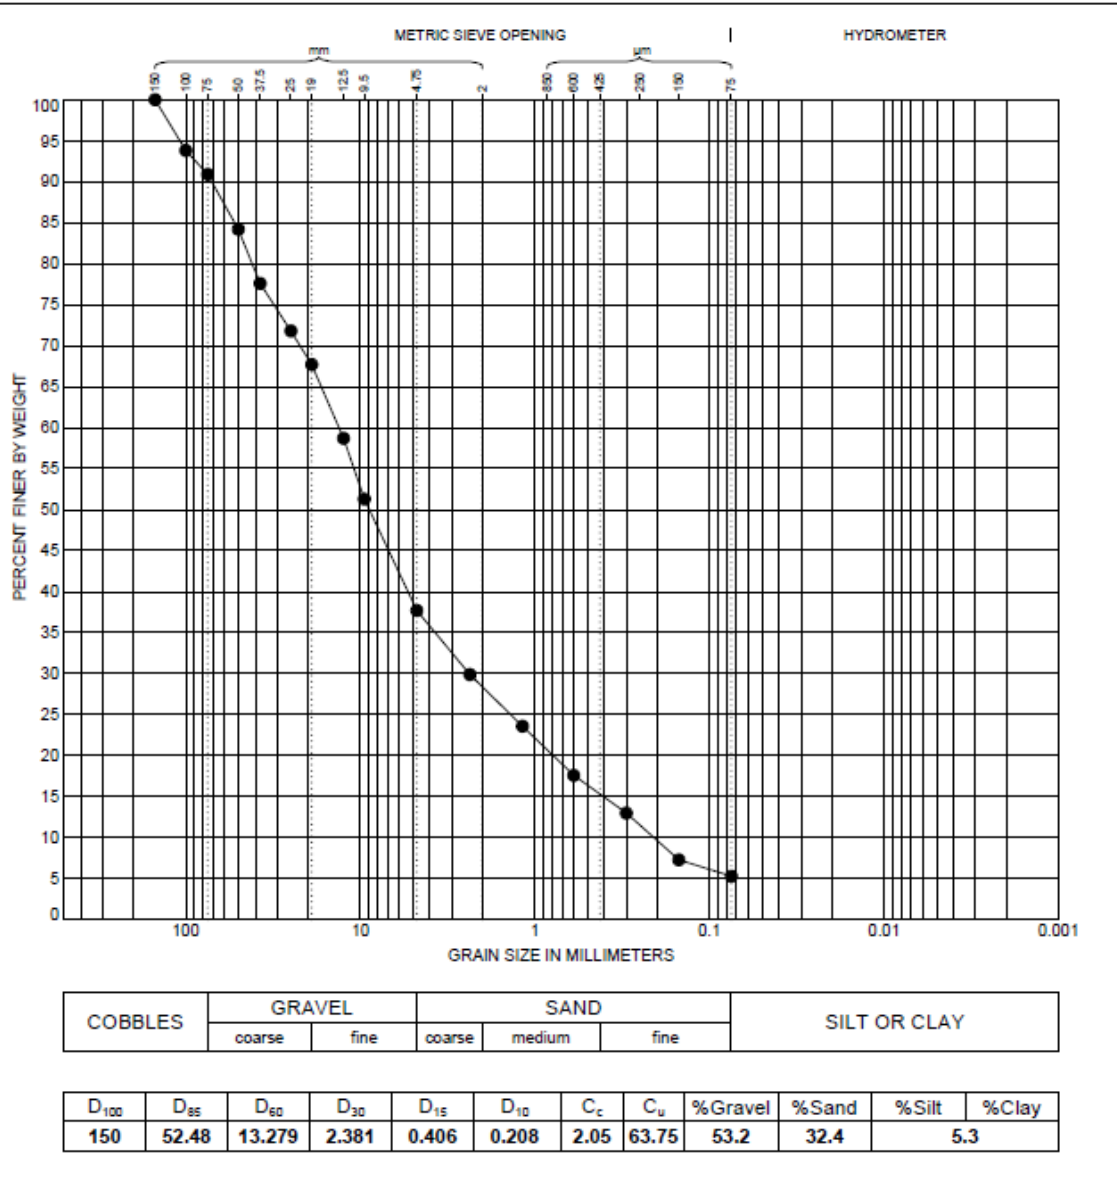
GRAIN SIZE DISTRIBUTION ASTM C136

Sample Location/Source: Existing embankment material - in-situ north of bridge

Description: 150 mm(-) Sandy GRAVEL, trace cobbles, trace fines

Comments: Cobbles = 9.1%.

Material was imported into Happy's Gulch Pit and placed on the mining area in 2024. Results from these sieves are included in the 2024 Sieves section at the end of this report.

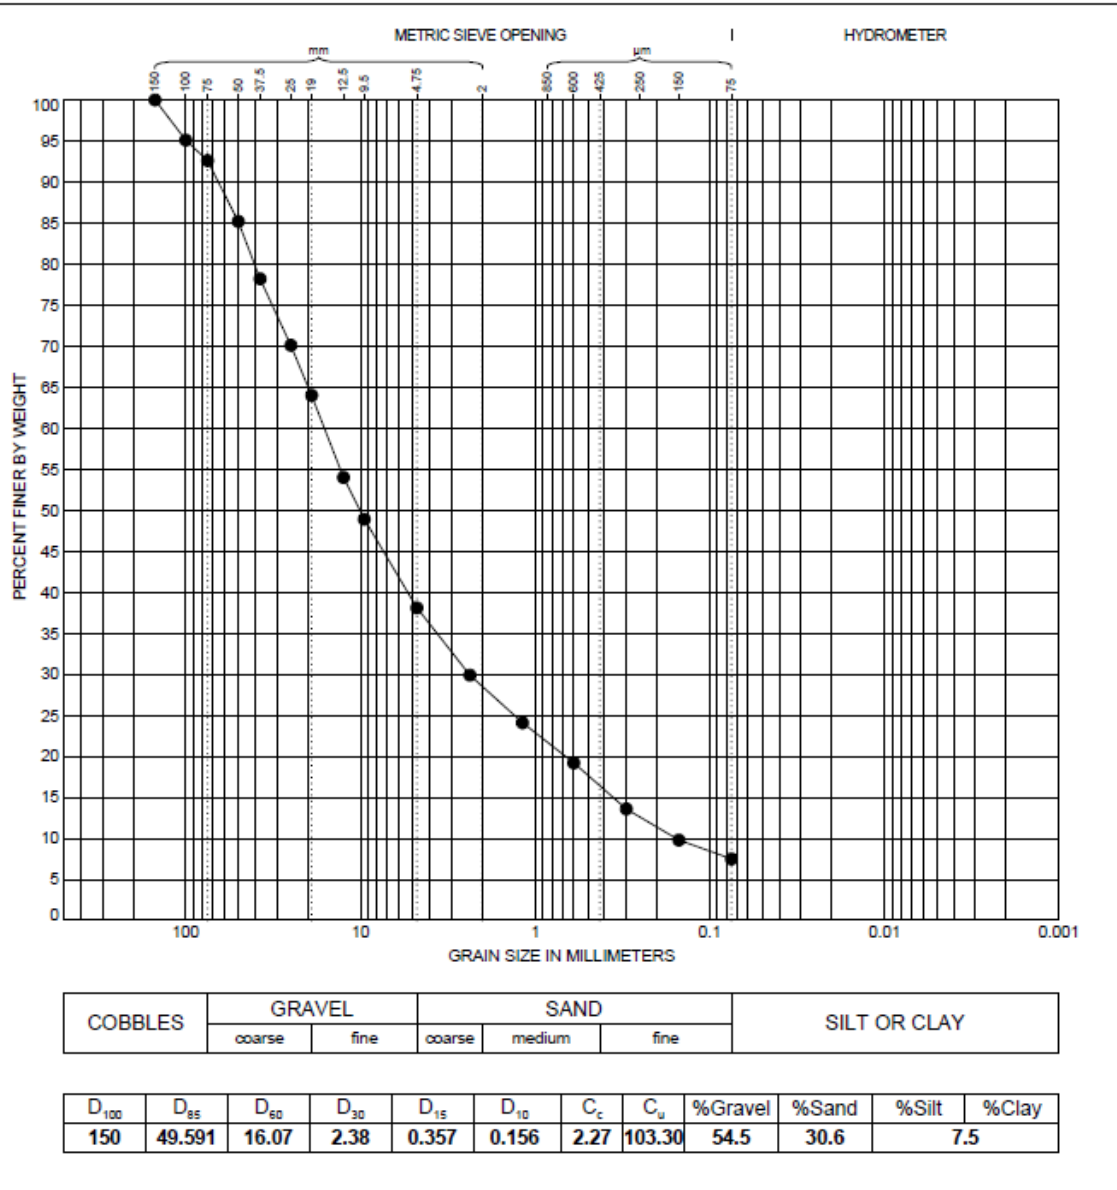
GRAIN SIZE DISTRIBUTION ASTM C136

Project: Nicomen Bridge
 Location: Hwy 1, Lytton, BC
 Source: Existing material from North MSE wall

Description: 150mm(-) Sandy, GRAVEL, trace Fines
 Natural Moisture Content: 5.4 %
 Material Specification: N/A
 Intended Use: Structural backfill
 Comments: Actual +19mm rock content = 38%

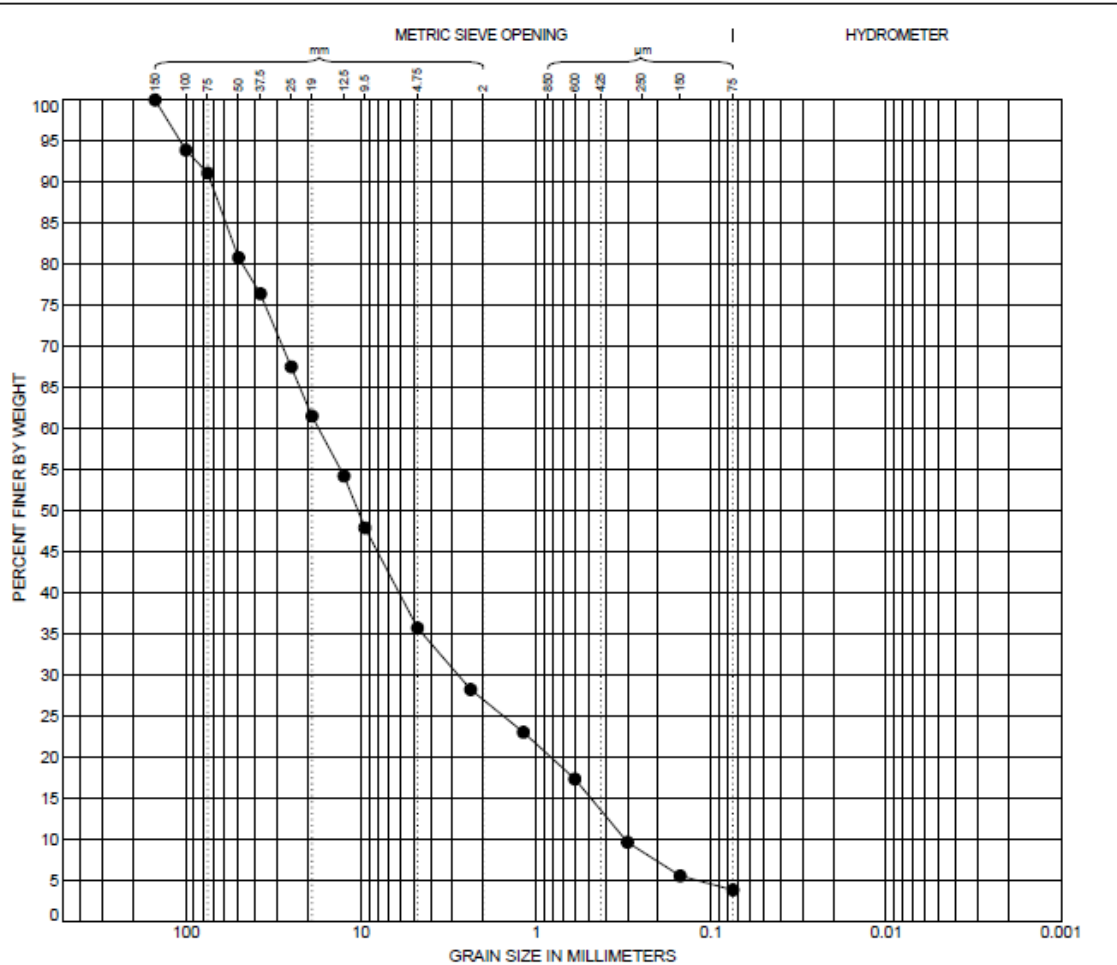
GRAIN SIZE DISTRIBUTION ASTM C136

Sample Location/Source: Site Stockpile / Existing Material Excavated from North MSE Wall Location.

D ₁₀₀	D ₈₅	D ₆₀	D ₃₀	D ₁₅	D ₁₀	C _c	C _u	%Gravel	%Sand	%Silt	%Clay
150	58.989	17.434	2.791	0.488	0.311	1.44	56.06	64.3	31.9		3.8

Description: 150 mm (-) GRAVEL, sandy, trace fines
 Natural Moisture Content: 2.8 %
 Material Specification: N/A
 Intended Use: Structural Fill
 Comments: N/A

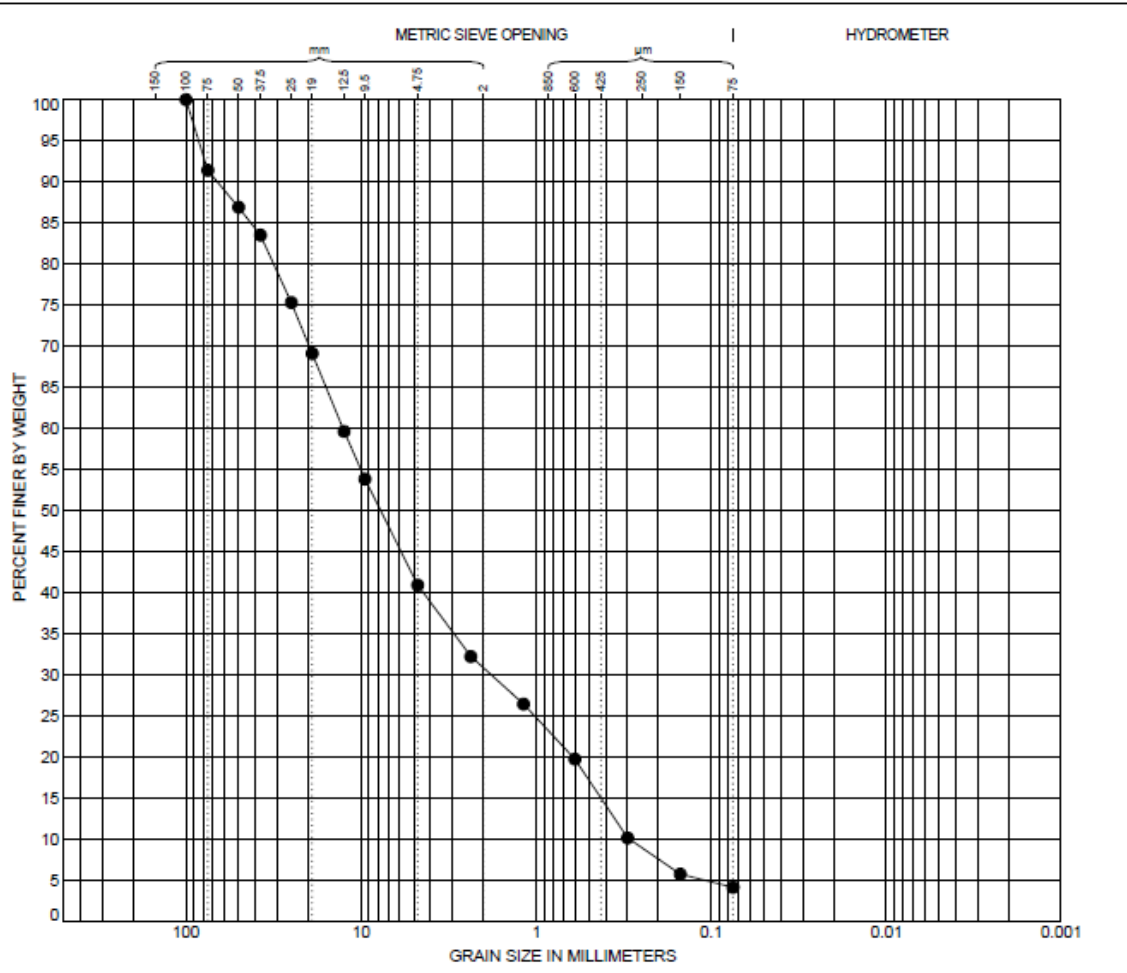
GRAIN SIZE DISTRIBUTION ASTM C136

Sample Location/Source: Site Stockpile / Existing Material Excavated from South MSE Wall Location

D ₁₀₀	D ₈₅	D ₆₀	D ₃₀	D ₁₅	D ₁₀	C _c	C _u	%Gravel	%Sand	%Silt	%Clay
100	42.575	12.722	1.814	0.427	0.295	0.88	43.08	59.1	36.8		4.1

Description: 100 mm (-) GRAVEL and SAND, trace fines
 Natural Moisture Content: 1.8 %
 Material Specification: N/A
 Intended Use: Structural Fill
 Comments: N/A

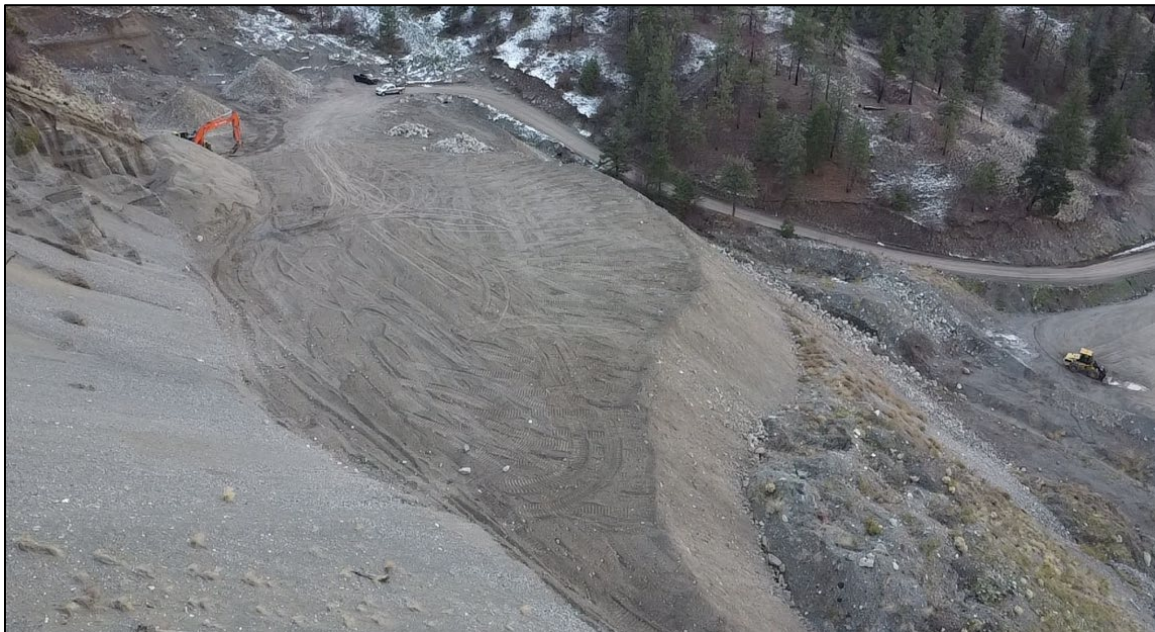
View of mining area and lower bench/crusher setup area to the right (November 2024).

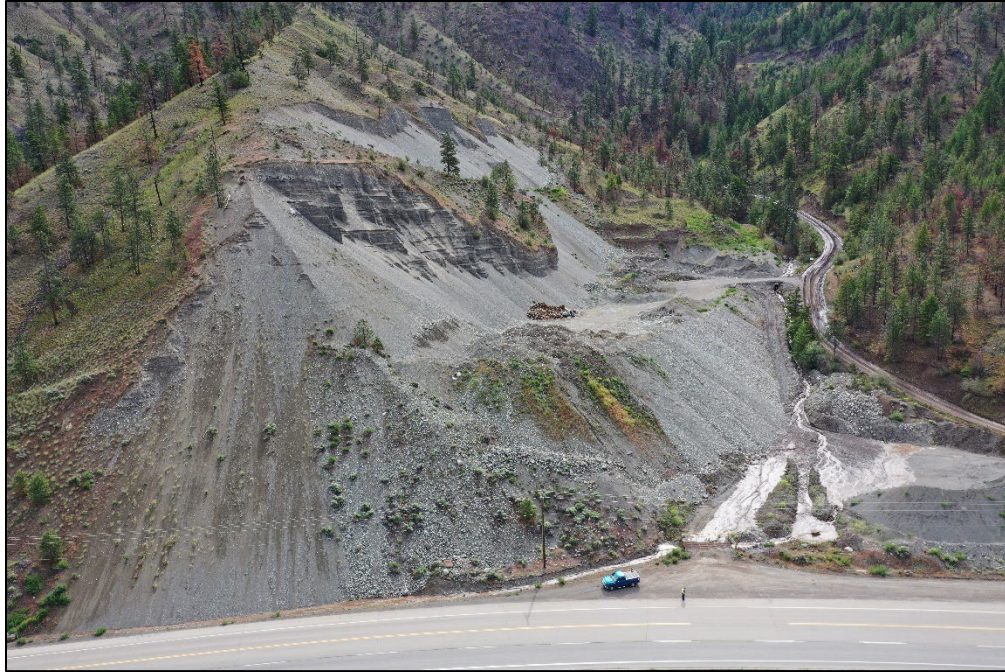
View east: steep ridge, bench on stockpiled material, and pit floor (June 2022).

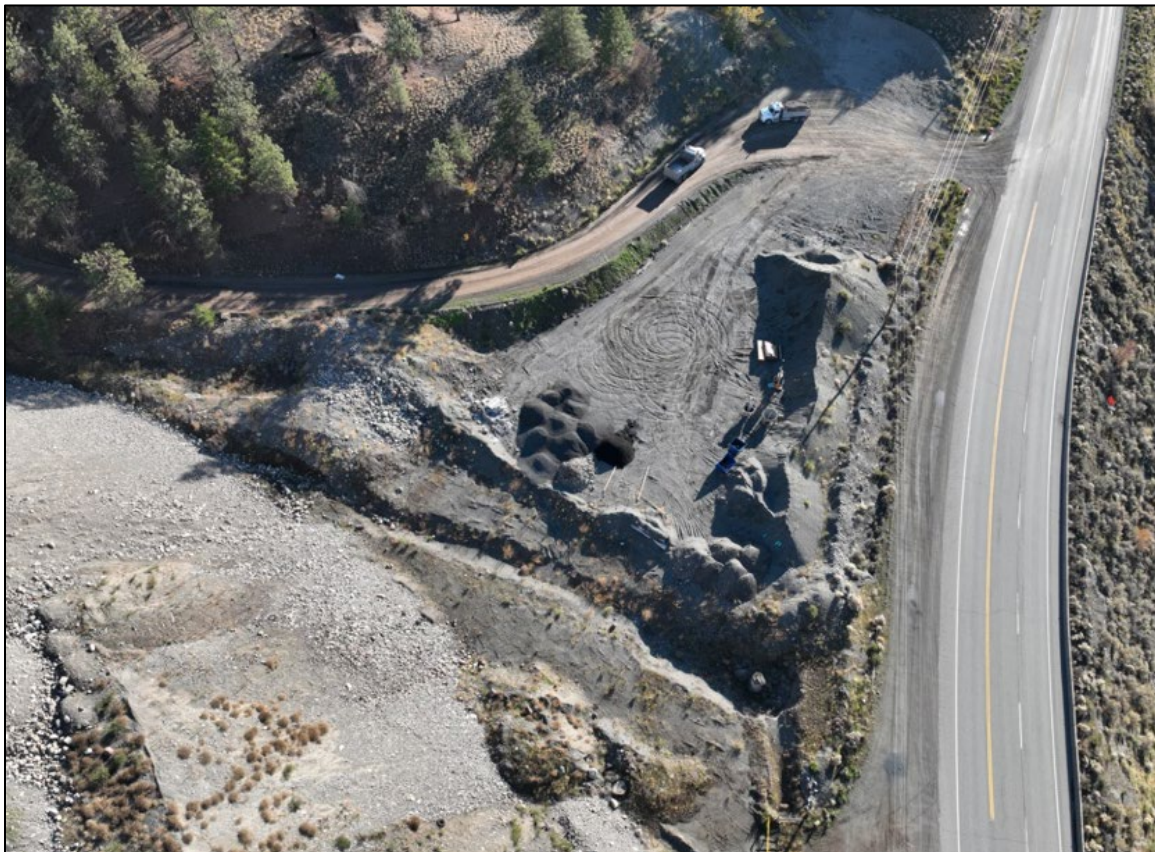
View of lower bench/crusher setup area, and access (November 2024).
