# Highway 1 - Selkirk Mountain 4 Laning - Quartz Creek Rest Area

## *Geotechnical Investigation Factual Report*

19136159-046-R-Rev0-2500

23 March 2023

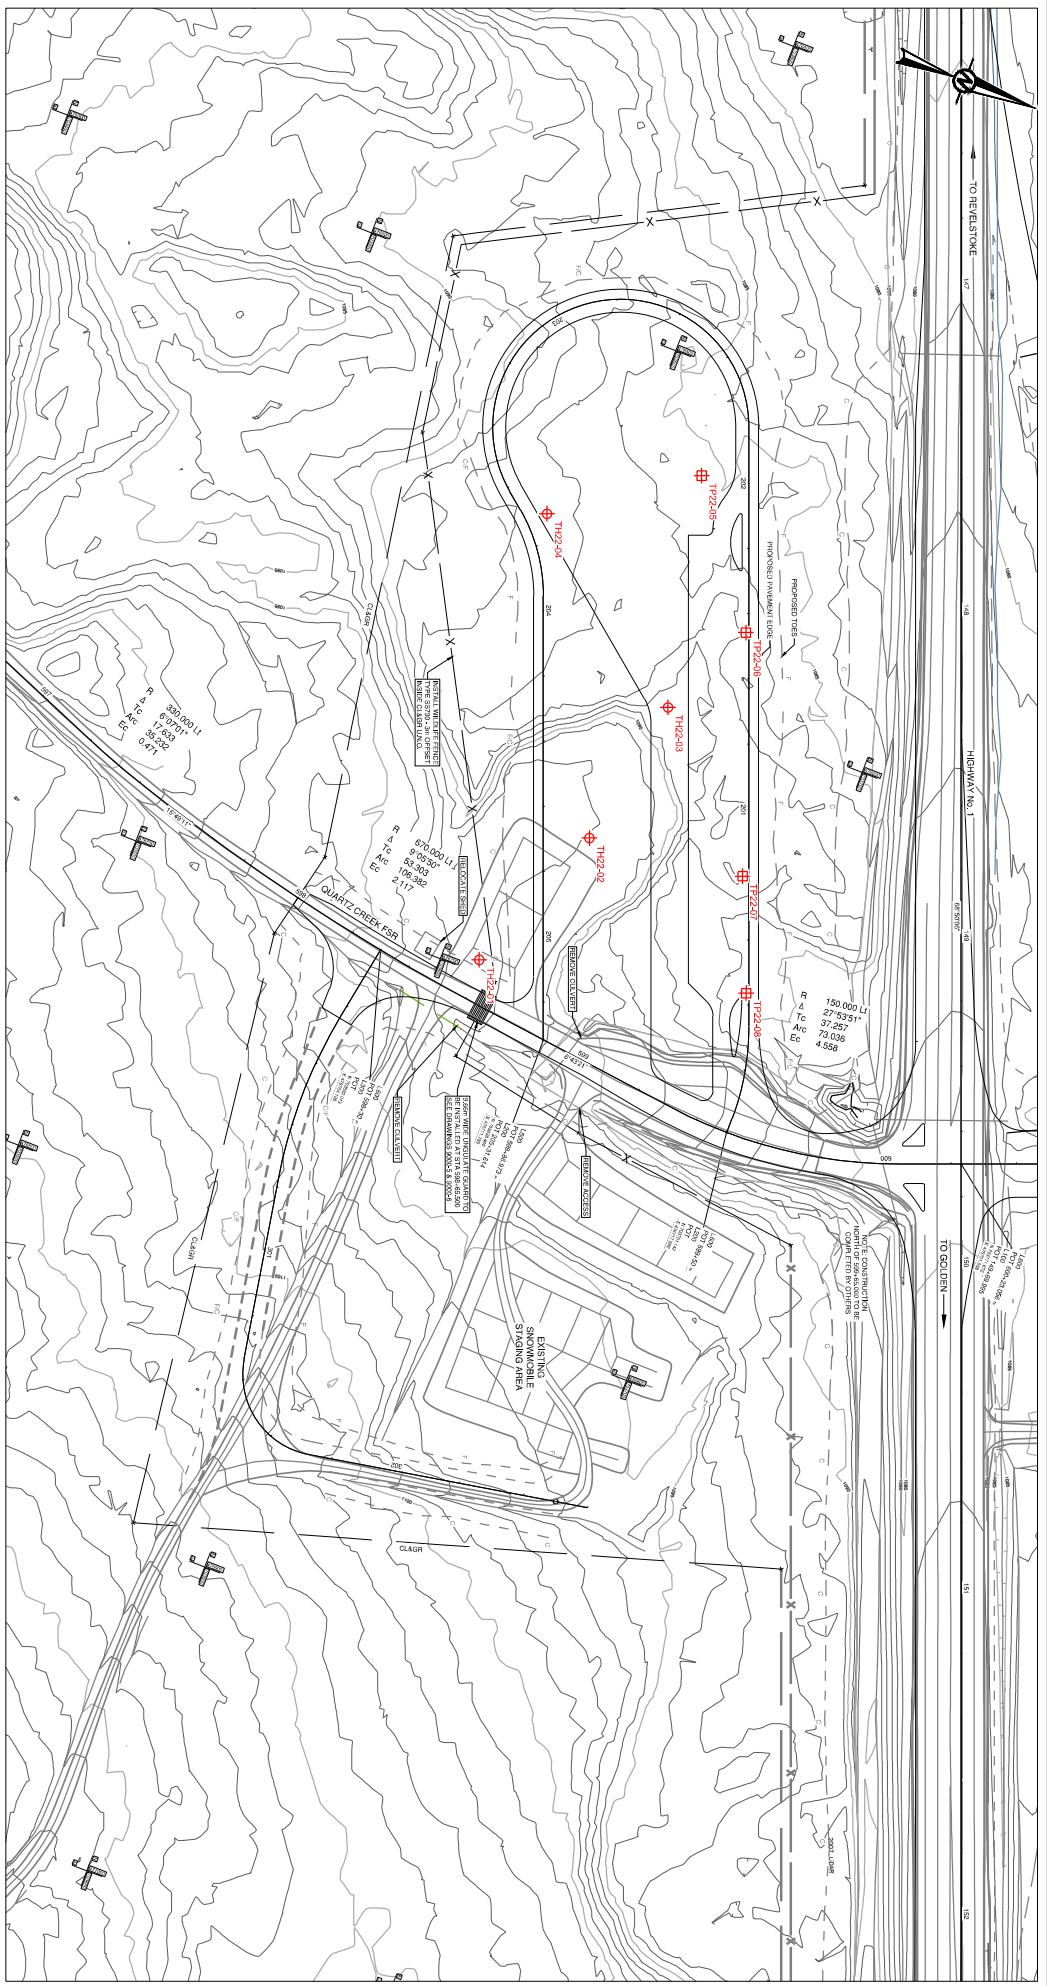
Figure 1: Site Plan

- NOTES)**
1. ALL DIMENSIONS IN METERS UNLESS OTHERWISE NOTED.
  2. ELEVATION ARE RELATIVE TO GEODETIC DATUM.
  3. ALL TEST HOLE LOCATIONS AND ELEVATIONS HAVE BEEN SURVEYED USING HANDHELD GPS/ACQUACCT 0.7M ± 5 CM.

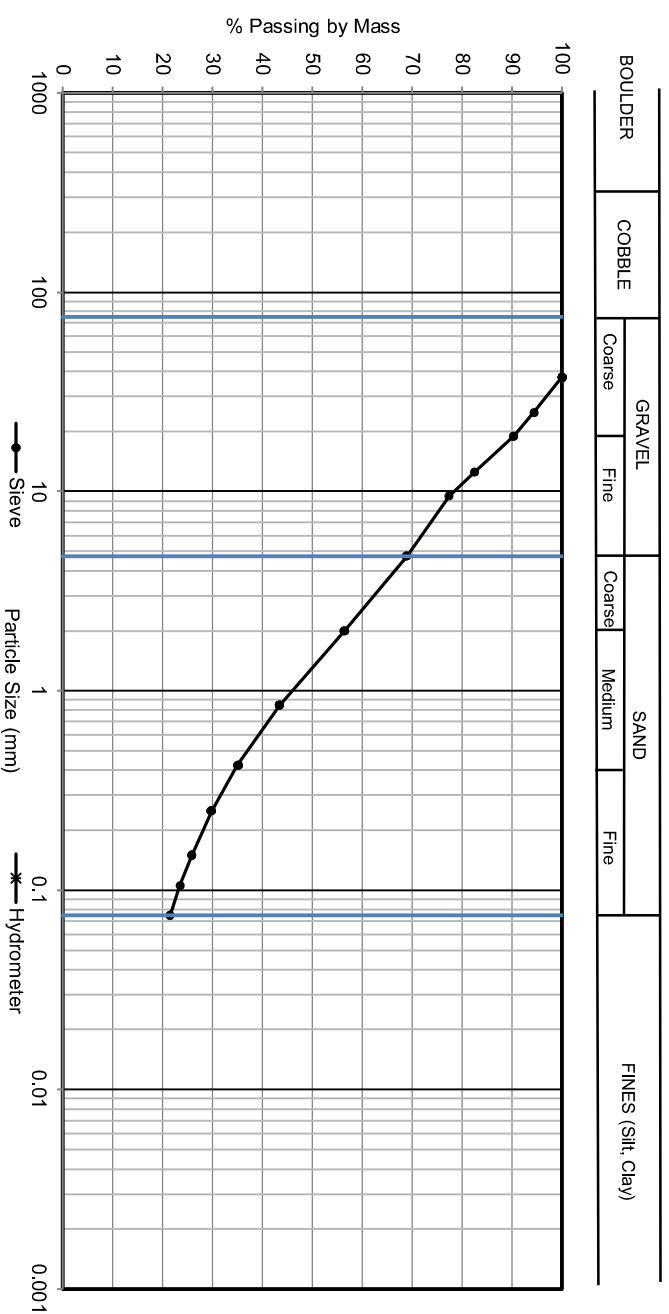
Grain Size Distribution (%)  
 BOULDER: 31.1  
 GRAVEL: 47.4  
 SAND: 21.5  
 FINES (Silt, Clay)

Sieve			Hydrometer Sedimentation	
Sieve No.	Particle Size mm	% Passing	Particle Size mm	% Passing
1 1/2"	37.5	100.0		
1"	25	94.4		
3/4"	19	90.3		
1/2"	12.5	82.5		
3/8"	9.5	77.4		
#4	4.75	68.9		
#10	2	56.4		
#20	0.85	43.4		
#40	0.425	35.1		
#60	0.25	29.8		
#100	0.15	25.9		
#140	0.106	23.5		
#200	0.075	21.5		
			0.005 mm	
			0.002 mm	
			D60	2.57
			D30	0.26
			D10	
			Cu	
			Cc

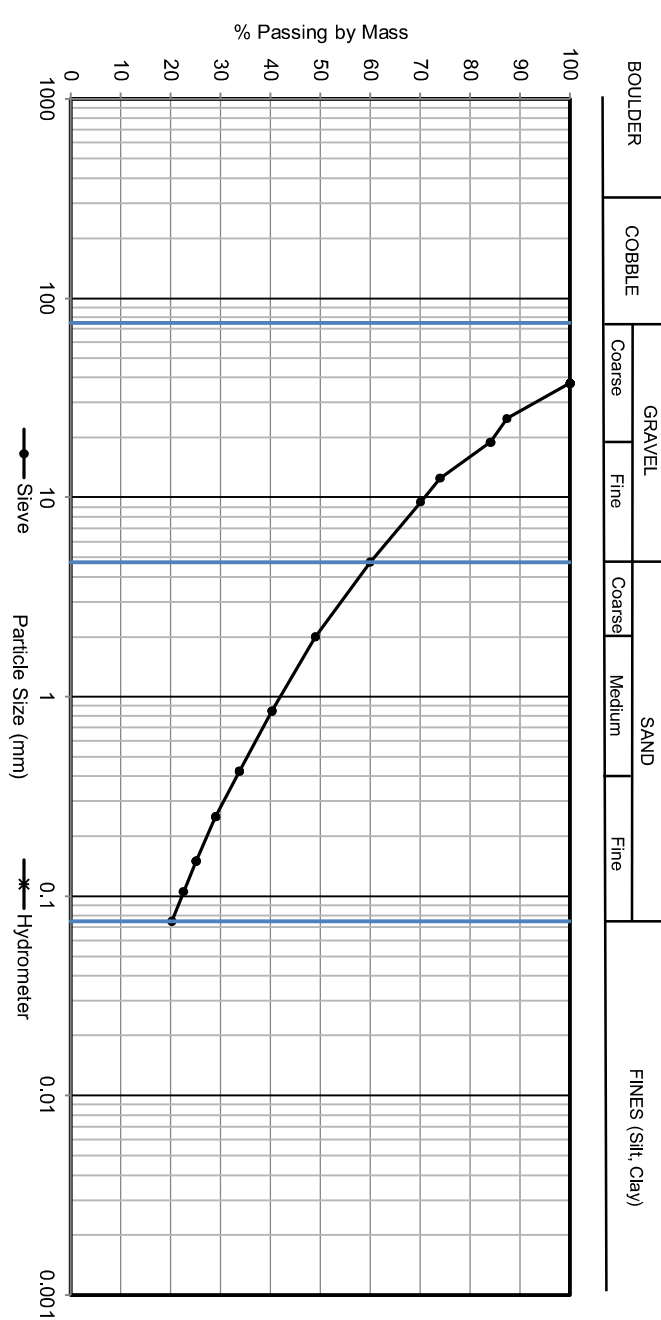
Test Request #	K22-160	Project Number:	19136159 (2000/2500)
Client:	Ministry of Transportation	Project Location:	Donald, BC
Project Name:	Quartz Creek Rest Area	Sample Location:	TH22-02
Source:	Native	Sample No.:	3
Soil Description:	SILTY SAND and GRAVEL, brown	Type:	SS
Specimen Reference	NA	Depth (m):	4.57 - 5.18
Specimen Description	NA	Date of Test	11/10/2022

Grain Size Distribution (%)	GRAVEL		SAND		FINES (Silt, Clay)
	Coarse	Fine	Coarse	Medium	Fine
Boulder					
Cobble					
	40.0		39.8		20.2

Sieve	Sieve No.	Particle Size mm	% Passing	Hydrometer Sedimentation
	1 1/2"	37.5	100.0	
	1"	25	87.4	
	3/4"	19	84.1	
	1/2"	12.5	74.0	
	3/8"	9.5	70.1	
	#4	4.75	60.0	
	#10	2	49.0	
	#20	0.85	40.3	
	#40	0.425	33.8	
	#60	0.25	29.0	
	#100	0.15	25.1	
	#140	0.106	22.6	
	#200	0.075	20.2	
				0.005 mm
				0.002 mm
				D60
				D30
				D10
				Cu
				Cc

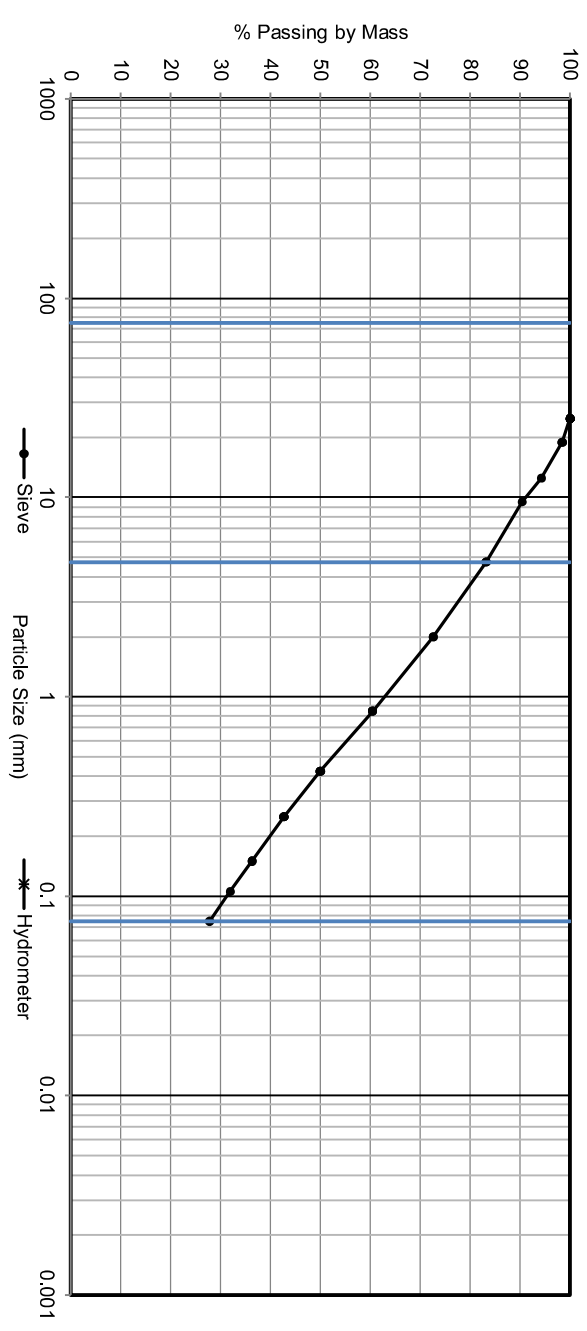
Grain Size Distribution (%)	GRAVEL		SAND		FINES (Silt, Clay)
	Coarse	Fine	Coarse	Medium	Fine
BOULDER					
COBBLE					
	16.8		55.4		27.8

Sieve	Particle Size mm	% Passing	Hydrometer	Particle Size mm	% Passing
1"	25	100.0			
3/4"	19	98.5			
1/2"	12.5	94.3			
3/8"	9.5	90.4			
#4	4.75	83.2			
#10	2	72.6			
#20	0.85	60.5			
#40	0.425	50.0			
#60	0.25	42.7			
#100	0.15	36.3			
#140	0.106	31.9			
#200	0.075	27.8			
				0.005 mm	
				0.002 mm	
				D60	0.82
				D30	0.09
				D10	
				Cu	
				Cc

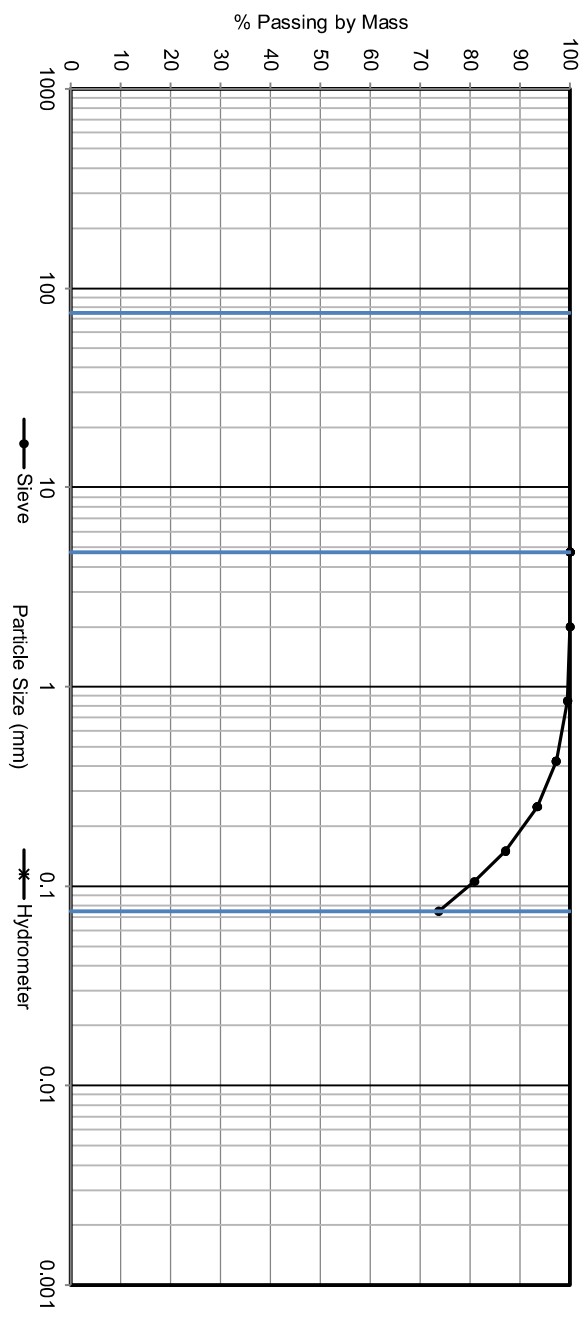
Boulder	Cobble	Gravel		Sand		Fines (Silt, Clay)
		Coarse	Fine	Coarse	Medium	Fine
		0.0		26.3		73.7

Sieve	Sieve No.	Particle Size mm	% Passing	Hydrometer Sedimentation
	#4	4.75	100.0	
	#10	2	100.0	
	#20	0.85	99.5	
	#40	0.425	97.3	
	#60	0.25	93.5	
	#100	0.15	87.1	
	#140	0.106	80.9	
	#200	0.075	73.7	
				0.005 mm
				0.002 mm
				D60
				D30
				D10
				Cu
				Cc

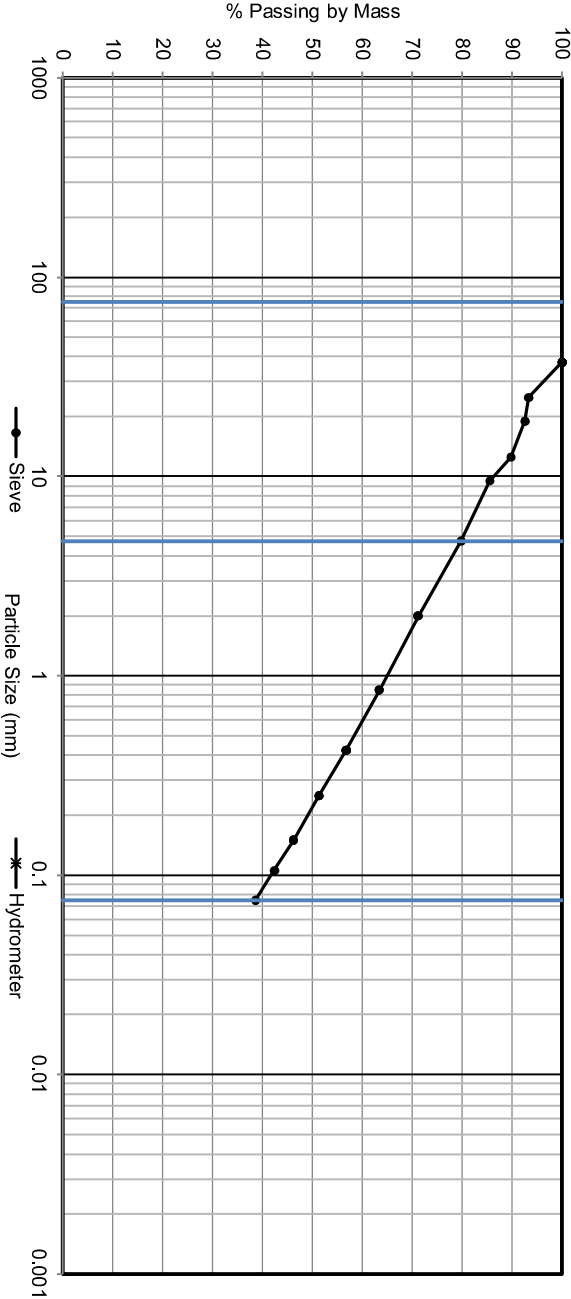
BOULDER	COBBLE	GRAVEL		SAND		FINES (Silt, Clay)
		Coarse	Fine	Coarse	Medium	
		20.2		41.2		38.6

Sieve			Hydrometer Sedimentation	
Sieve No.	Particle Size mm	% Passing	Particle Size mm	% Passing
1 1/2"	37.5	100.0		
1"	25	93.4		
3/4"	19	92.6		
1/2"	12.5	89.8		
3/8"	9.5	85.5		
#4	4.75	79.8		
#10	2	71.2		
#20	0.85	63.4		
#40	0.425	56.8		
#60	0.25	51.3		
#100	0.15	46.2		
#140	0.106	42.4		
#200	0.075	38.6		
			0.005 mm	
			0.002 mm	
			D60	0.60
			D30	
			D10	
			Cu	
			Cc

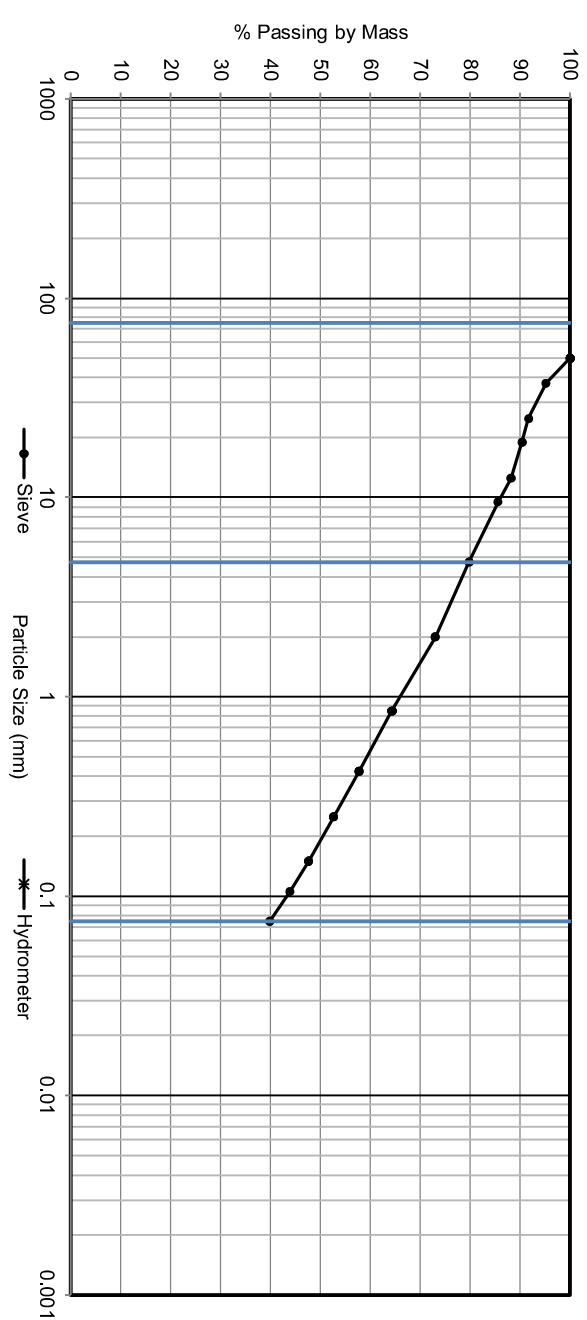
Test Request #	K22-040	Project Number:	19136159 (2000/2500)
Client:	Ministry of Transportation	Project Location:	Donald, BC
Project Name:	Quartz Creek Rest Area	Sample Location:	TP22-07
Source:	Native	Sample No.:	2
Soil Description:	gravelly CLAYEY SAND, greyish brown	Type:	GS
Specimen Reference	NA	Depth (m):	2.30 - 2.70
Specimen Description	NA	Date of Test	4/25/2022

Grain Size	GRAVEL		SAND		FINES (Silt, Clay)
Distribution (%)	20.2	39.9	39.9		
BOULDER					
	COBBLE				
		Coarse	Fine	Coarse	Medium
				Medium	Fine

Sieve	Sieve No.	Particle Size mm	% Passing	Hydrometer	Particle Size mm	% Passing
	2"	50	100.0			
	1 1/2"	37.5	95.2			
	1"	25	91.7			
	3/4"	19	90.4			
	1/2"	12.5	88.2			
	3/8"	9.5	85.6			
	#4	4.75	79.8			
	#10	2	73.0			
	#20	0.85	64.3			
	#40	0.425	57.8			
	#60	0.25	52.7			
	#100	0.15	47.7			
	#140	0.106	43.9			
	#200	0.075	39.9			
					0.005 mm	
					0.002 mm	
					D60	0.54
					D30	
					D10	
					Cu	
					Cc

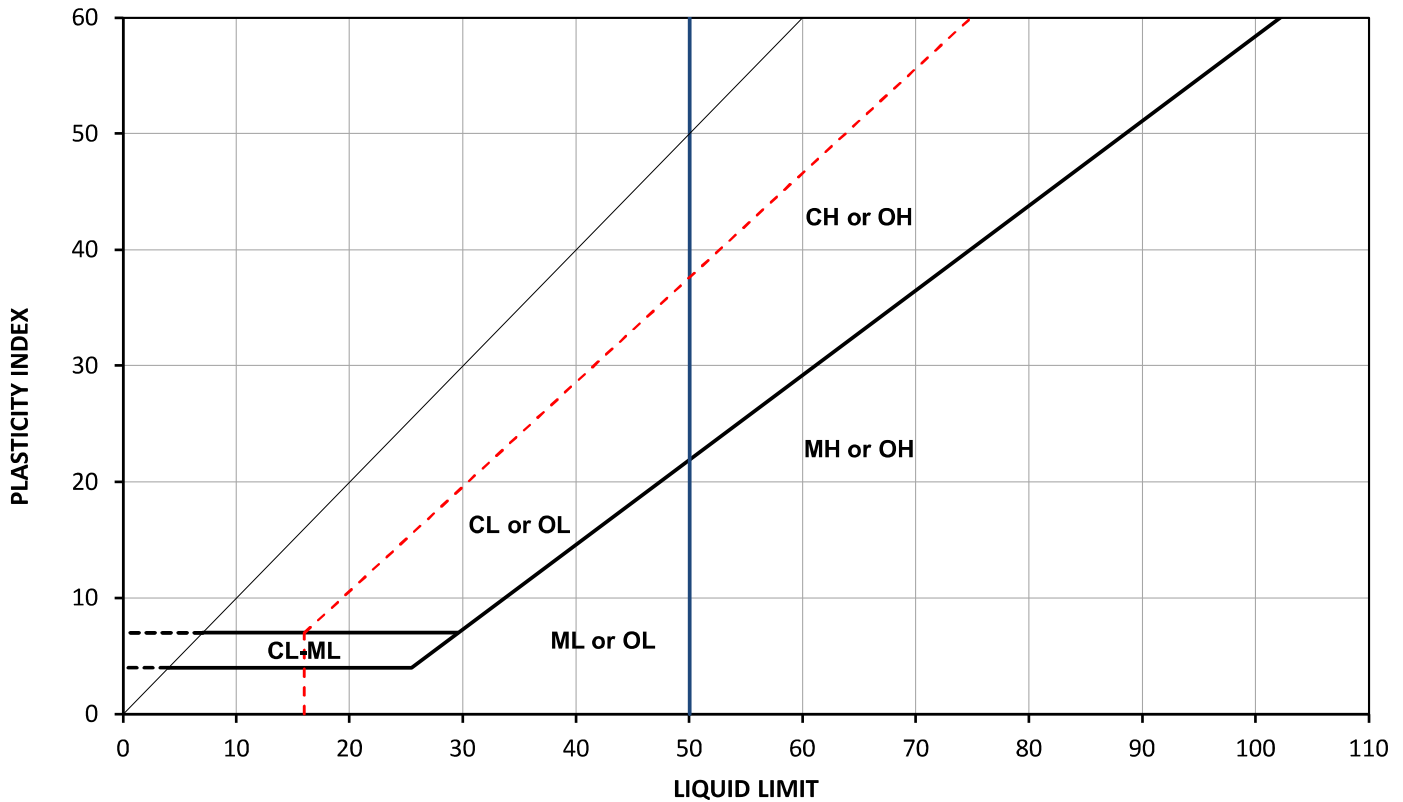
Test Request #	K22-160	Project Number:	19136159 (2000/2500)
Client:	Ministry of Transportation	Project Location:	Donald, BC
Project Name:	Quartz Creek Rest Area	Sample Location:	TH22-01
Source:	Native	Sample No.:	1
Soil Description:	SILT, light brown	Type:	SS
		Depth (m):	1.52 - 2.13

Sample Location	Sample / Specimen Number	Top Depth (m)	Base Depth (m)	Percent Passing #40 Sieve	Natural Water Content (%)	Liquid Limit	Plastic Limit	Plasticity Index	Liquidity Index
TH22-01	1	1.52	2.13	ND	23.6		NP

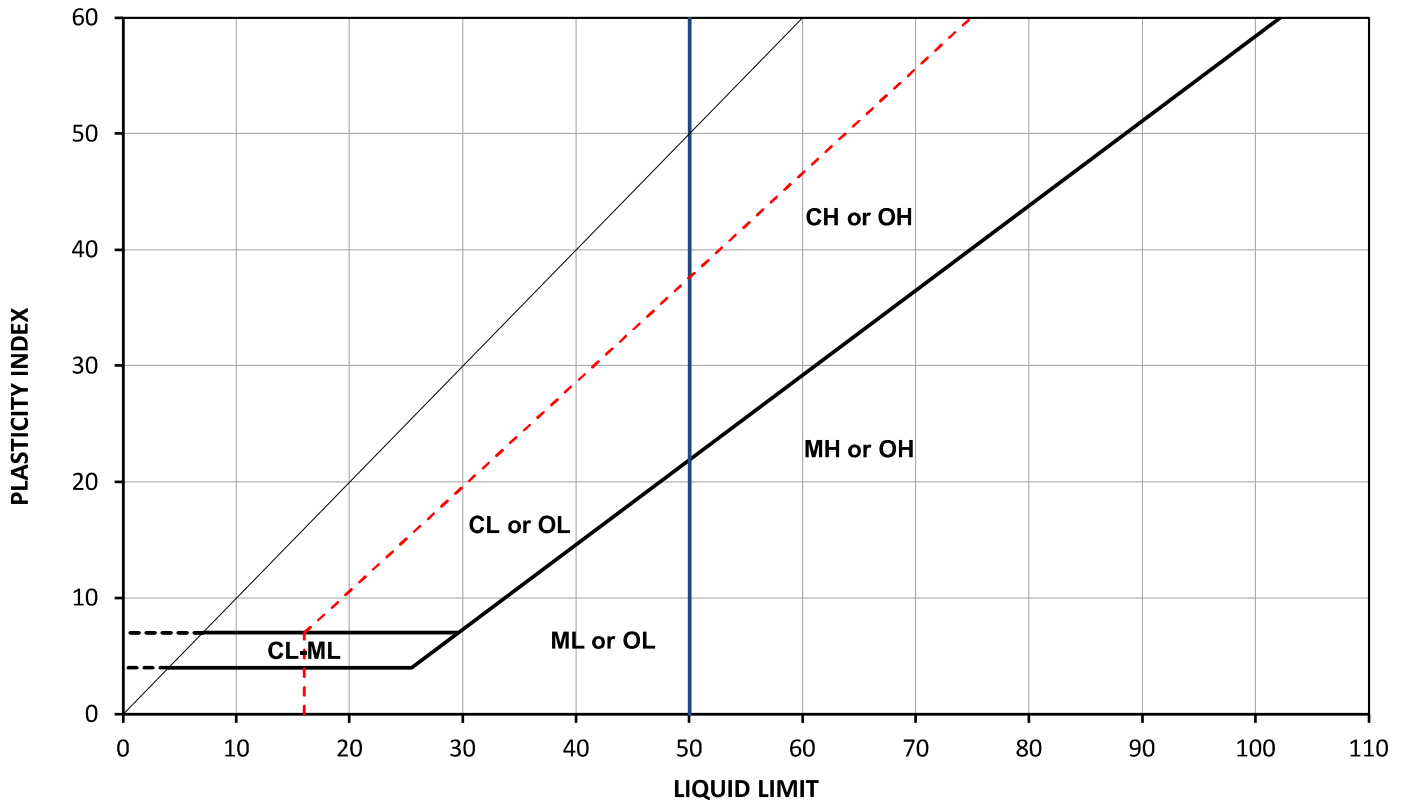
Test Request #	K22-160	Project Number:	19136159 (2000/2500)
Client:	Ministry of Transportation	Project Location:	Donald, BC
Project Name:	Quartz Creek Rest Area	Sample Location:	TH22-02
Source:	Native	Sample No.:	4
Soil Description:	SILT, some sand, light brown	Type:	SS
		Depth (m):	6.10 - 6.71

Sample Location	Sample / Specimen Number	Top Depth (m)	Base Depth (m)	Percent Passing #40 Sieve	Natural Water Content (%)	Liquid Limit	Plastic Limit	Plasticity Index	Liquidity Index
TH22-02	4	6.10	6.71	ND	39.1		NP

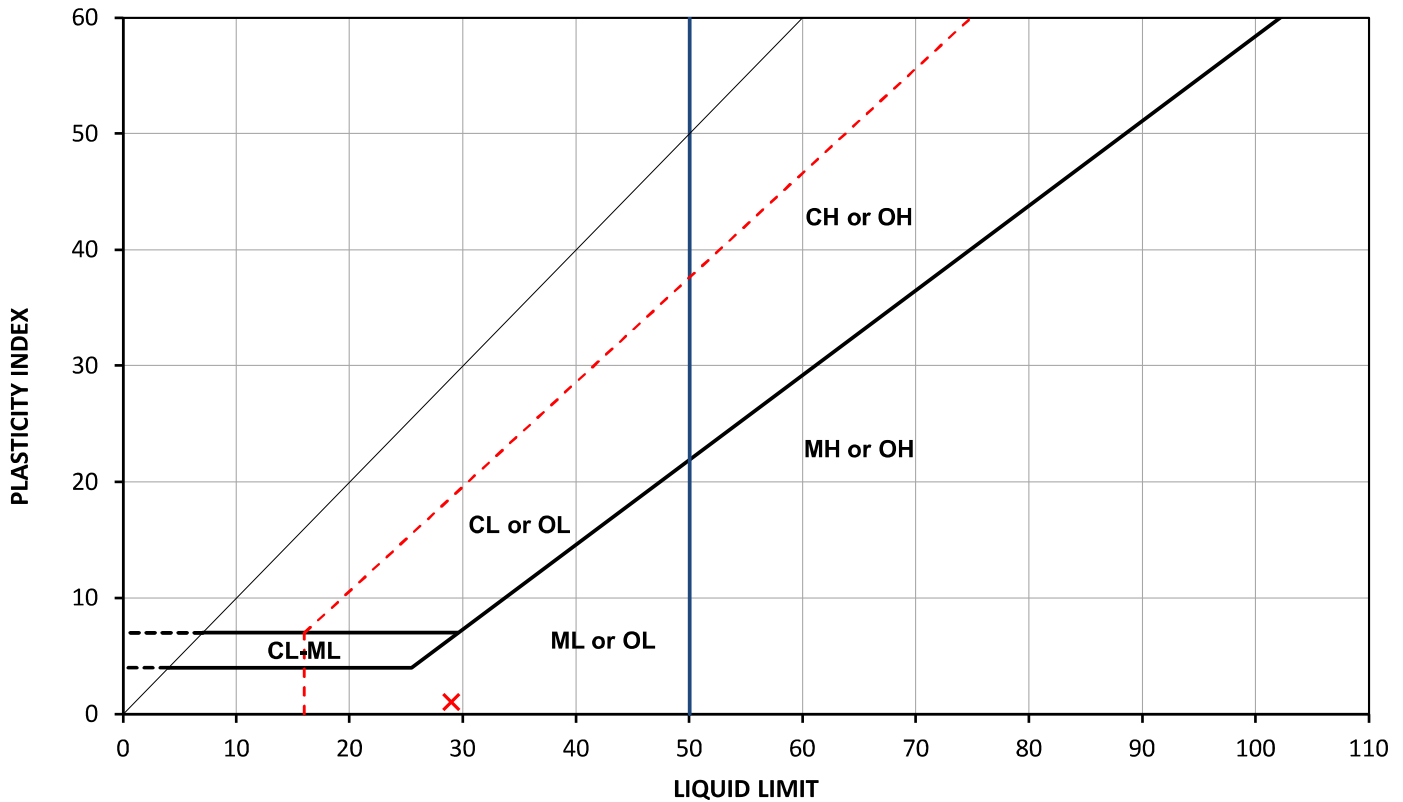
Test Request #	K22-160	Project Number:	19136159 (2000/2500)
Client:	Ministry of Transportation	Project Location:	Donald, BC
Project Name:	Quartz Creek Rest Area	Sample Location:	TH22-02
Source:	Native	Sample No.:	6
Soil Description:	CLAYEY SILT, light brown	Type:	SS
		Depth (m):	9.14 - 9.75

Sample Location	Sample / Specimen Number	Top Depth (m)	Base Depth (m)	Percent Passing #40 Sieve	Natural Water Content (%)	Liquid Limit	Plastic Limit	Plasticity Index	Liquidity Index
TH22-02	6	9.14	9.75	100	31.5	29	28	1	3.50

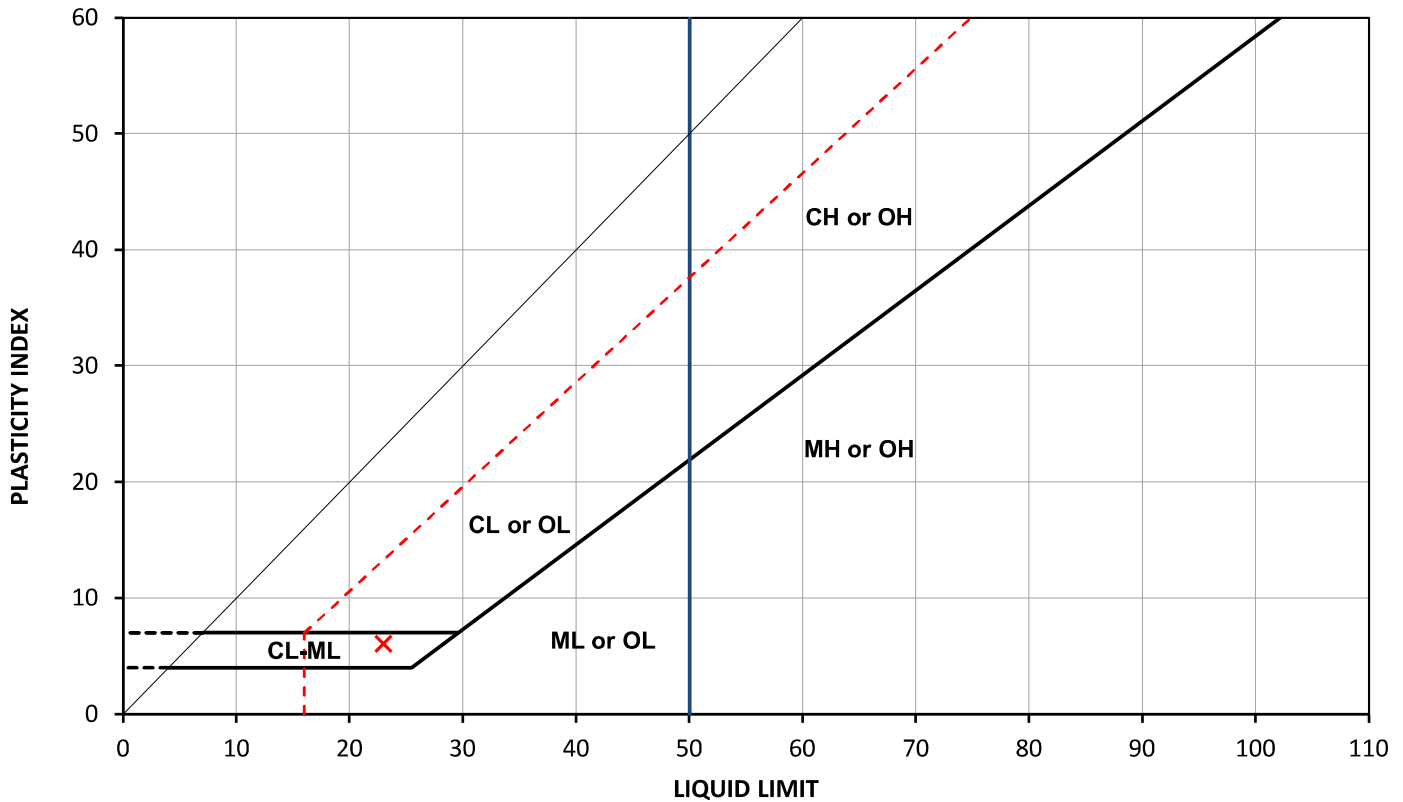
Test Request #	K22-040	Project Number:	19136159 (2000/2500)
Client:	Ministry of Transportation	Project Location:	Donald, BC
Project Name:	Quartz Creek Rest Area	Sample Location:	TP22-07
Source:	Native	Sample No.:	2
Soil Description:	gravelly CLAYEY SAND, greyish brown	Type:	GS
		Depth (m):	2.30 - 2.70

Sample Location	Sample / Specimen Number	Top Depth (m)	Base Depth (m)	Percent Passing #40 Sieve	Natural Water Content (%)	Liquid Limit	Plastic Limit	Plasticity Index	Liquidity Index
TP22-07	2	2.30	2.70	62	11.9	23	17	6	-0.85
