**Highway 1 - Selkirk Mountain 4 Laning - Quartz Creek  
Rest Area**

*Geotechnical Investigation Factual Report*

19136159-046-R-Rev0-2500

23 March 2023

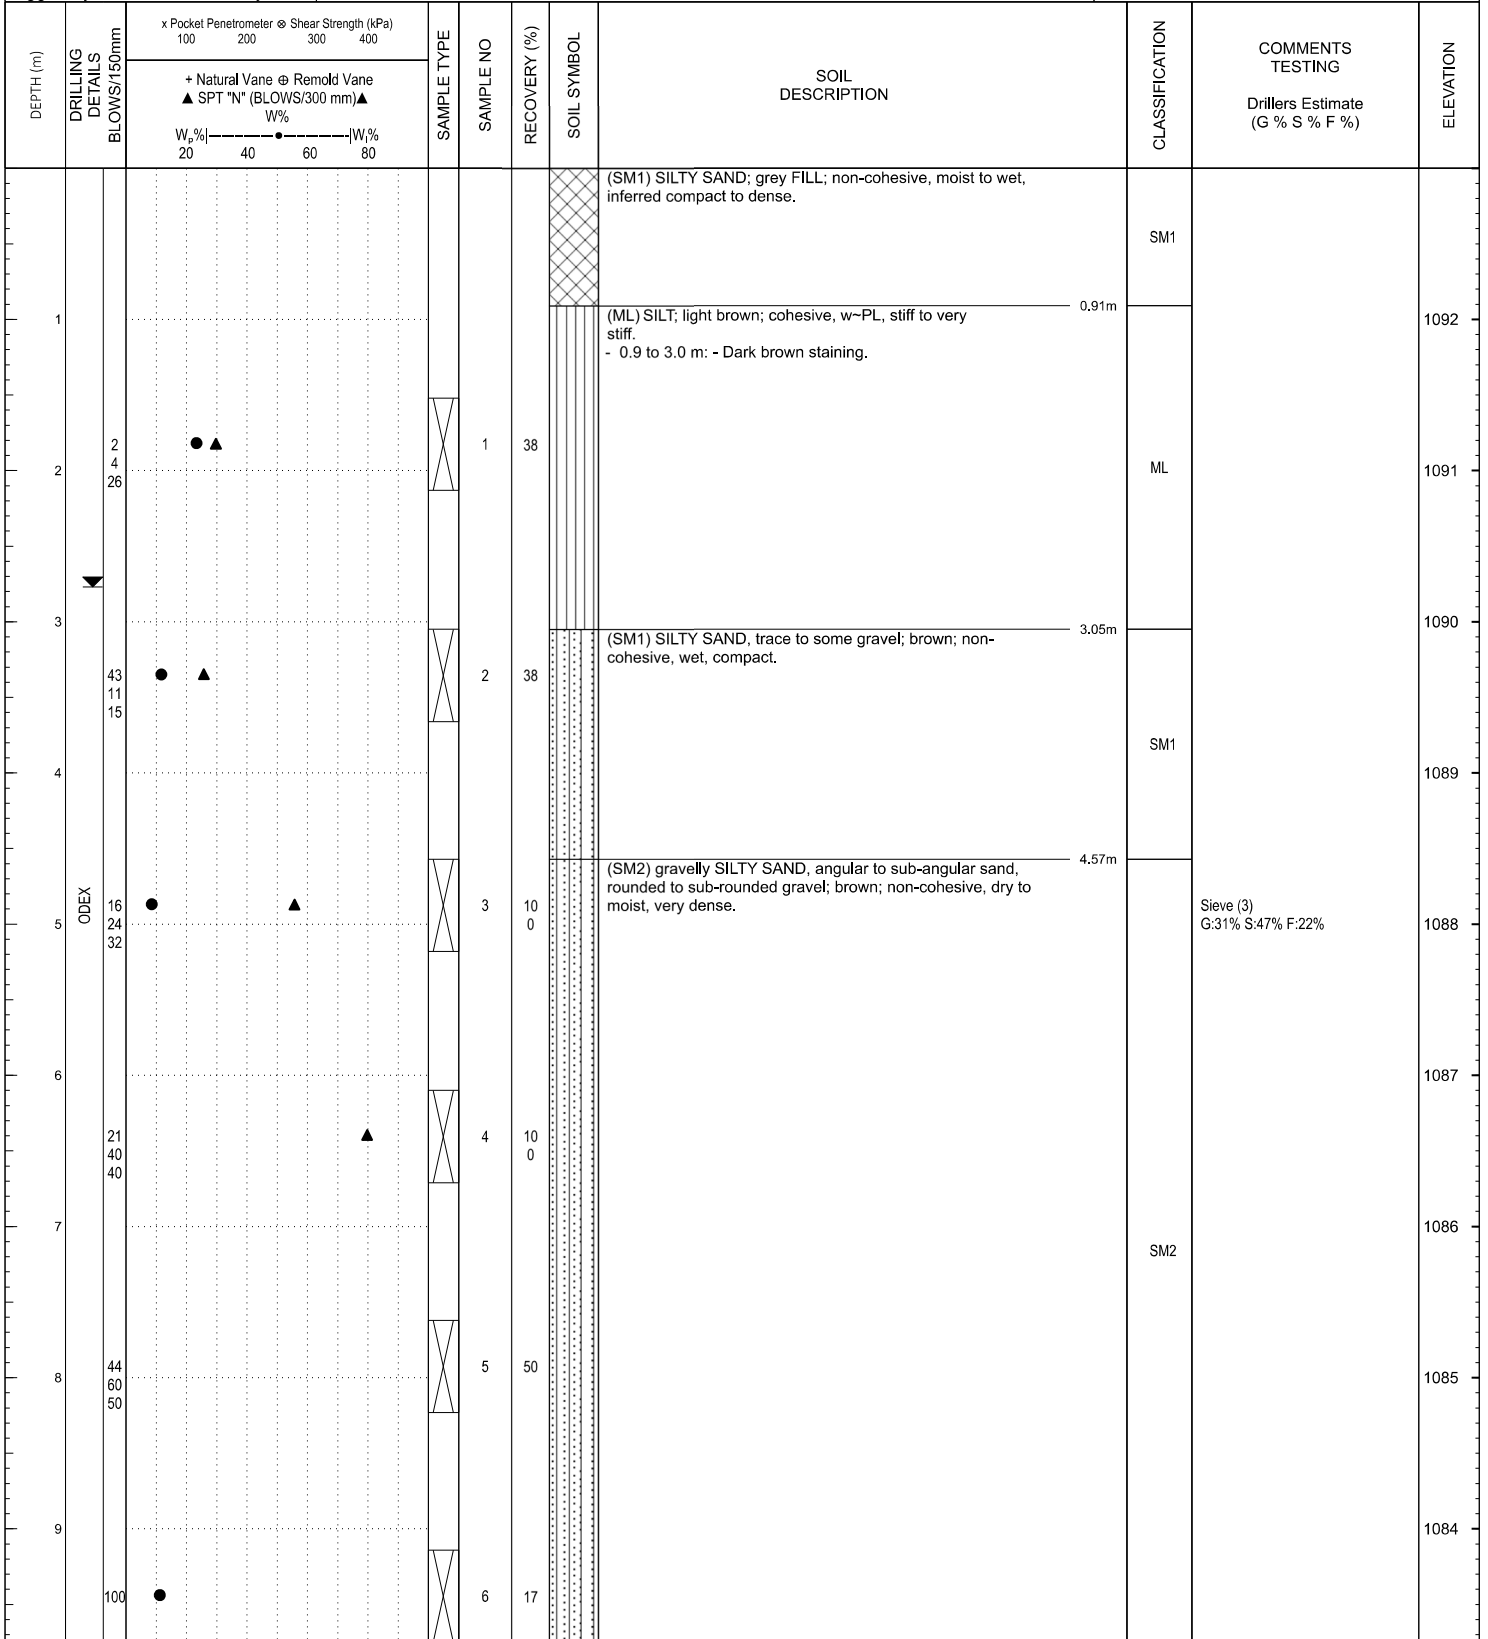
End of hole at 9.75 m.

Backfilled with bentonite chips.

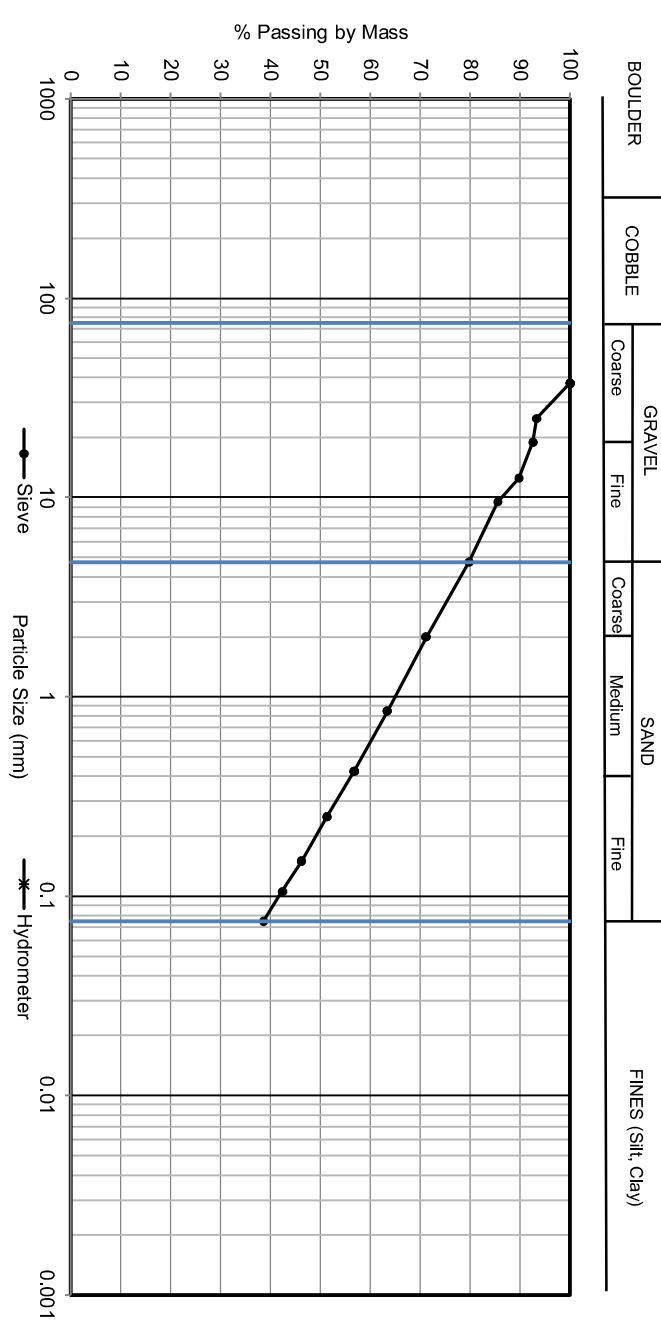
Test Request #	K22-040	Project Number:	19136159 (2000/2500)
Client:	Ministry of Transportation	Project Location:	Donald, BC
Project Name:	Quartz Creek Rest Area	Sample Location:	TP22-06
Source:	Native	Sample No.:	3
Soil Description:	gravelly SILTY SAND, brown	Type:	GS
Specimen Reference	NA	Depth (m):	3.40 - 3.80
Specimen Description	NA	Date of Test	4/25/2022

Grain Size	GRAVEL		SAND		FINES (Silt, Clay)
Distribution (%)	Coarse	Fine	Coarse	Medium	Fine
Boulder					
Cobble					
	20.2		41.2		38.6

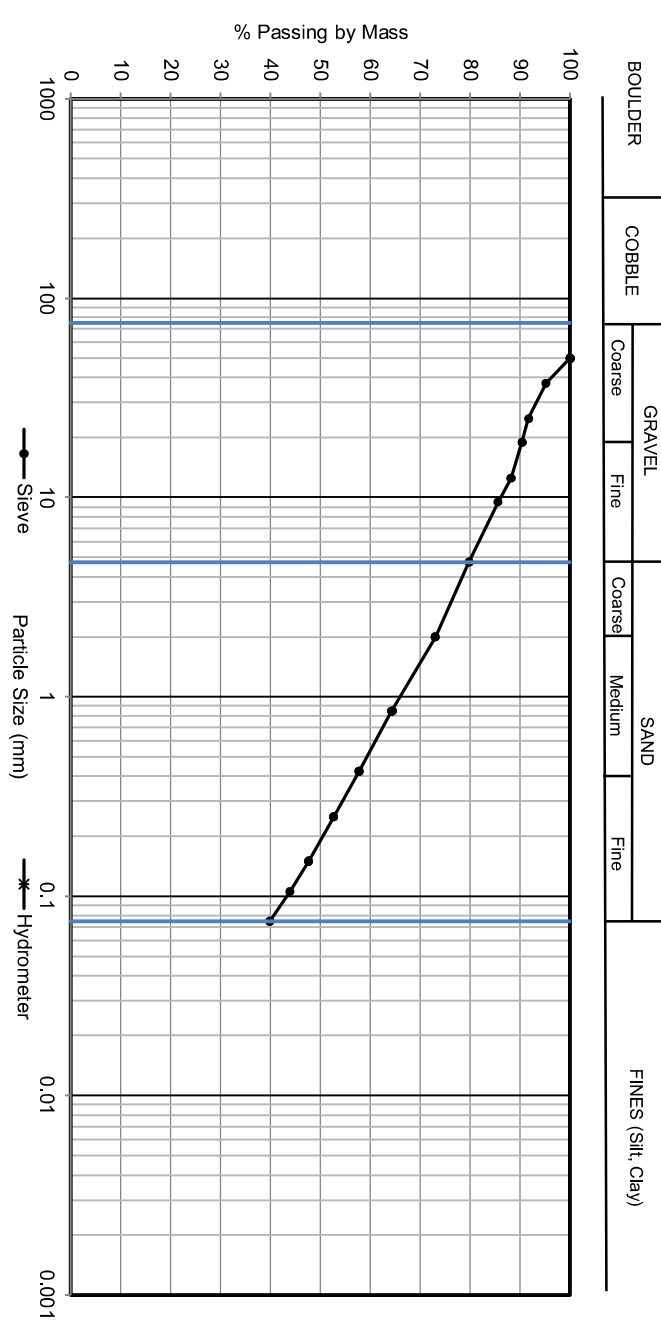
Test Request #	K22-040	Project Number:	19136159 (2000/2500)
Client:	Ministry of Transportation	Project Location:	Donald, BC
Project Name:	Quartz Creek Rest Area	Sample Location:	TP22-07
Source:	Native	Sample No.:	2
Soil Description:	gravelly CLAYEY SAND, greyish brown	Type:	GS
Specimen Reference	NA	Depth (m):	2.30 - 2.70
Specimen Description	NA	Date of Test	4/25/2022

Grain Size Distribution (%)		GRAVEL		SAND		FINES (Silt, Clay)	
Boulder	Cobble	Coarse	Fine	Coarse	Medium	Fine	
		20.2		39.9		39.9
