Geotechnical and Materials Engineering

Hankey Darby Pit No. 0429

2022 Technical Information Report

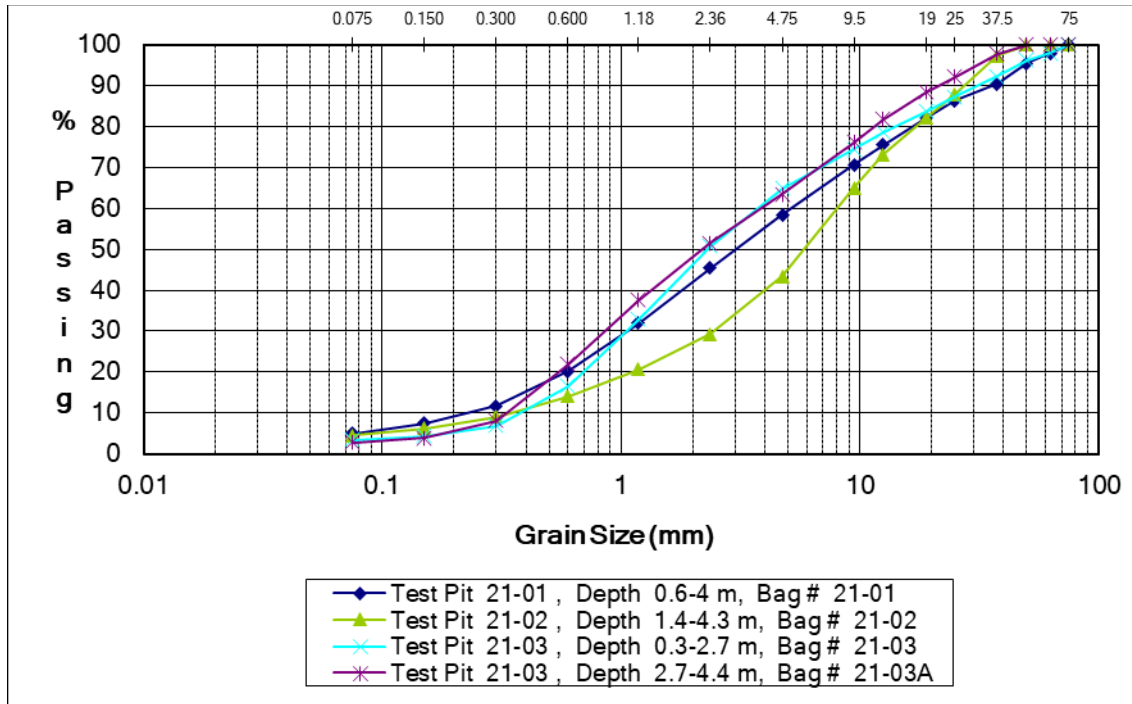
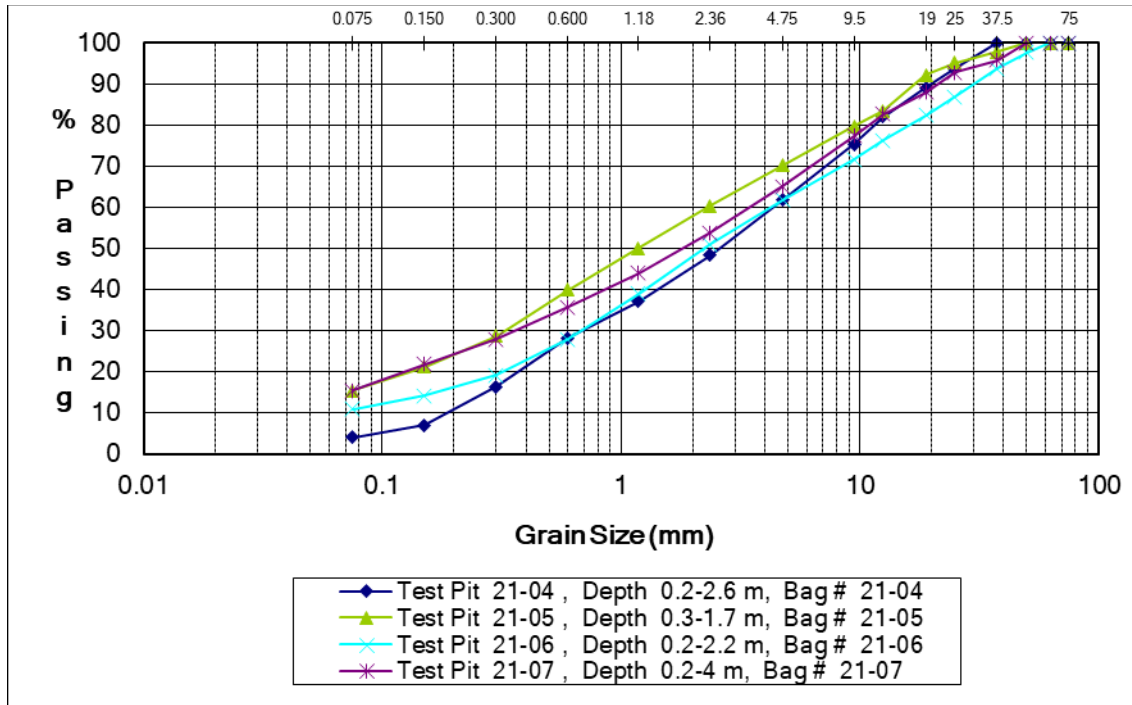
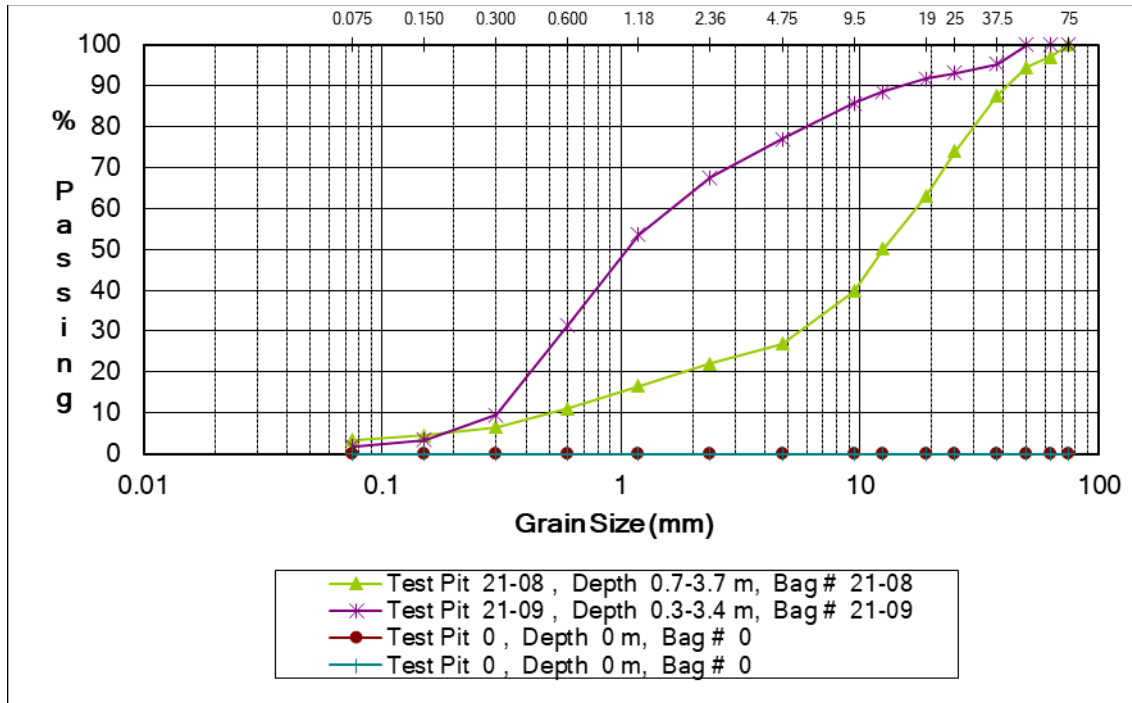
Aggregate Gradation Chart:

Gradation: The average and range of laboratory samples as well as oversize rock field estimates for material from the 2021 testing program at Hankey Darby Pit are as follows:

Classification	Average (%)	Range (%)
Gravel (4.75-75mm)	40.75	23.1-73
Sand (0.075-4.75mm)	52.61	23.5-75.1
Fines (<0.075mm)	6.64	1.8-15.4

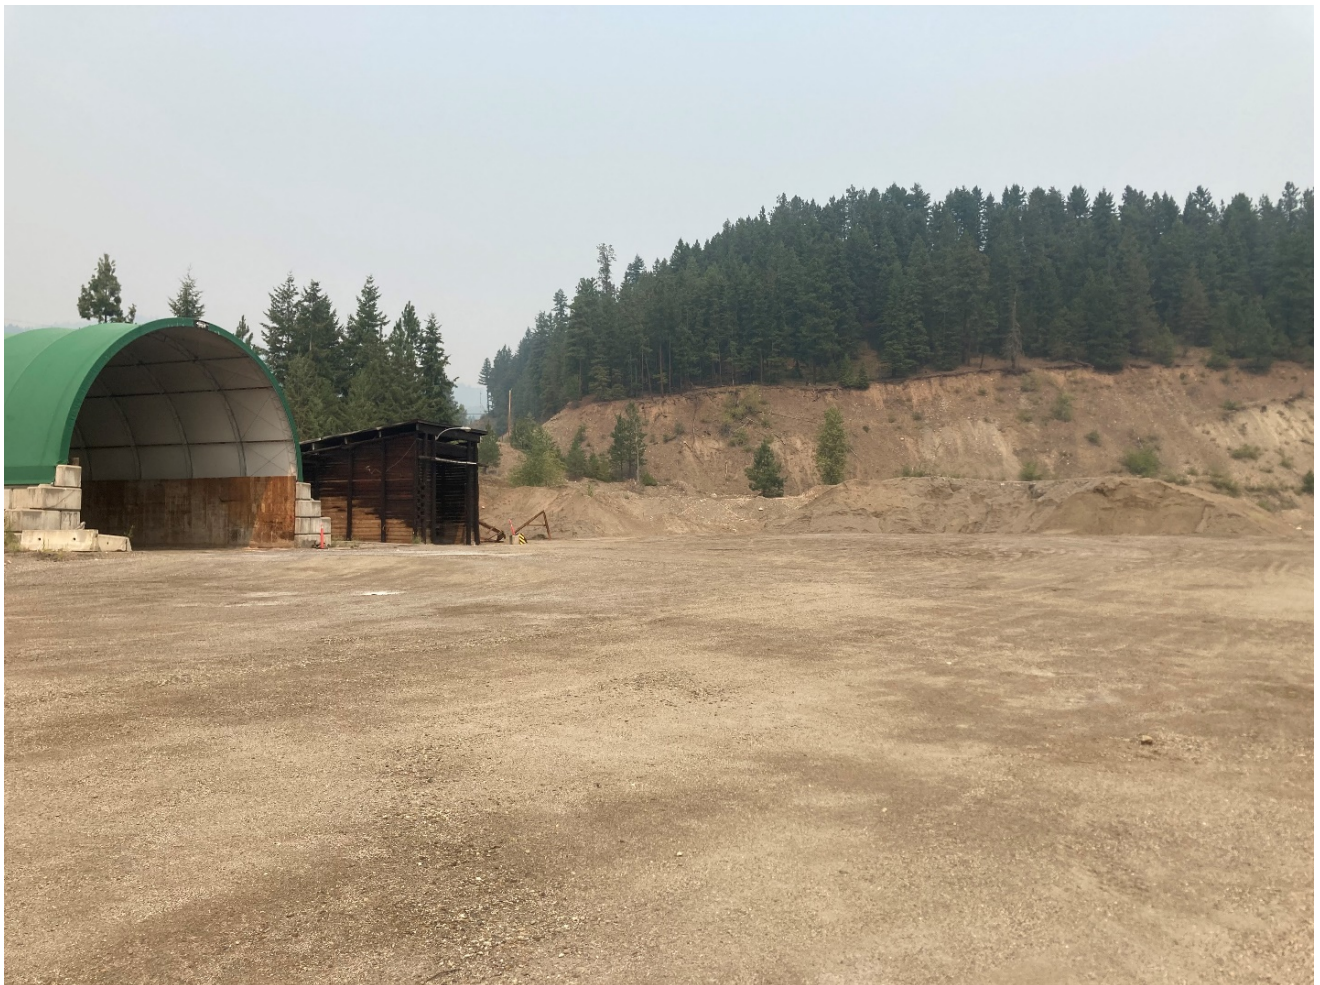
View with crusher set up area in foreground to the right, July 2021.

- Processed aggregate may be stockpiled south of the crusher set up area where space permits and as indicated on the Pit Development Plan.
- At the completion of mining, active pit faces shall be sloped to a minimum of 1 ½:1 with pit run granular material.
- **All reject materials resulting from aggregate production are to be placed in separate stockpiles free from deleterious material and in an easily accessible location. No stockpiling against the pit face is permitted without the permission from the Aggregate Resource Manager.**

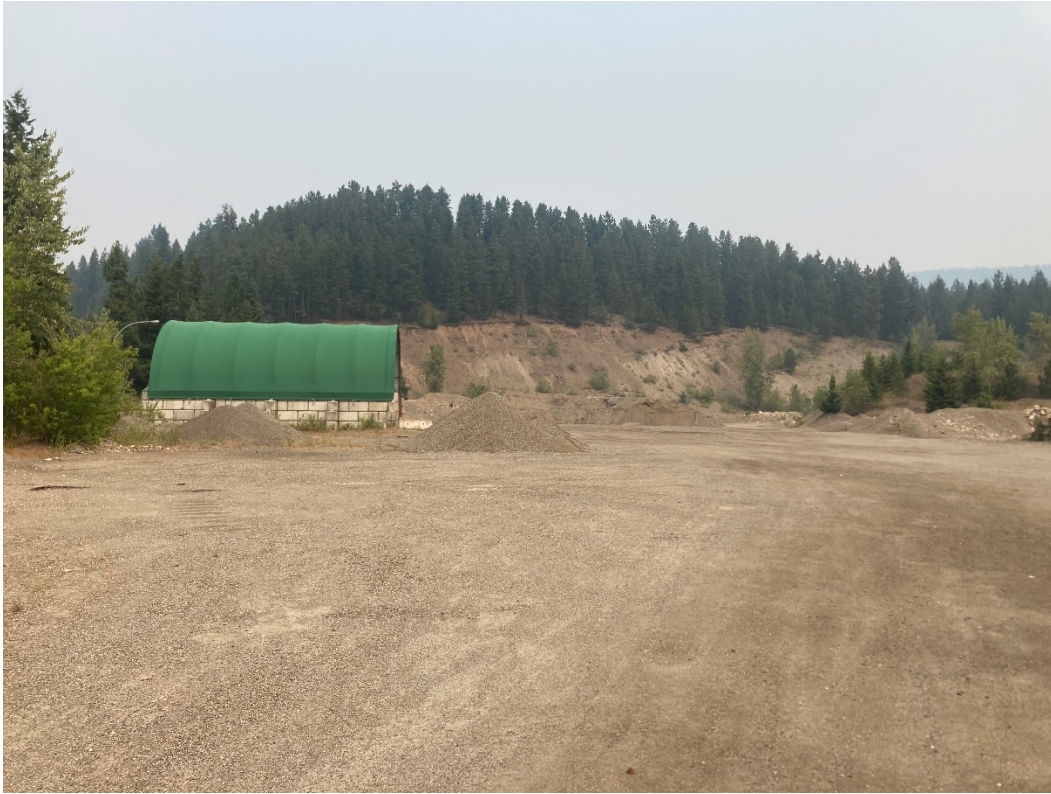
Crusher set up in background right of the salt shed, stockpile space at left. July 2021.

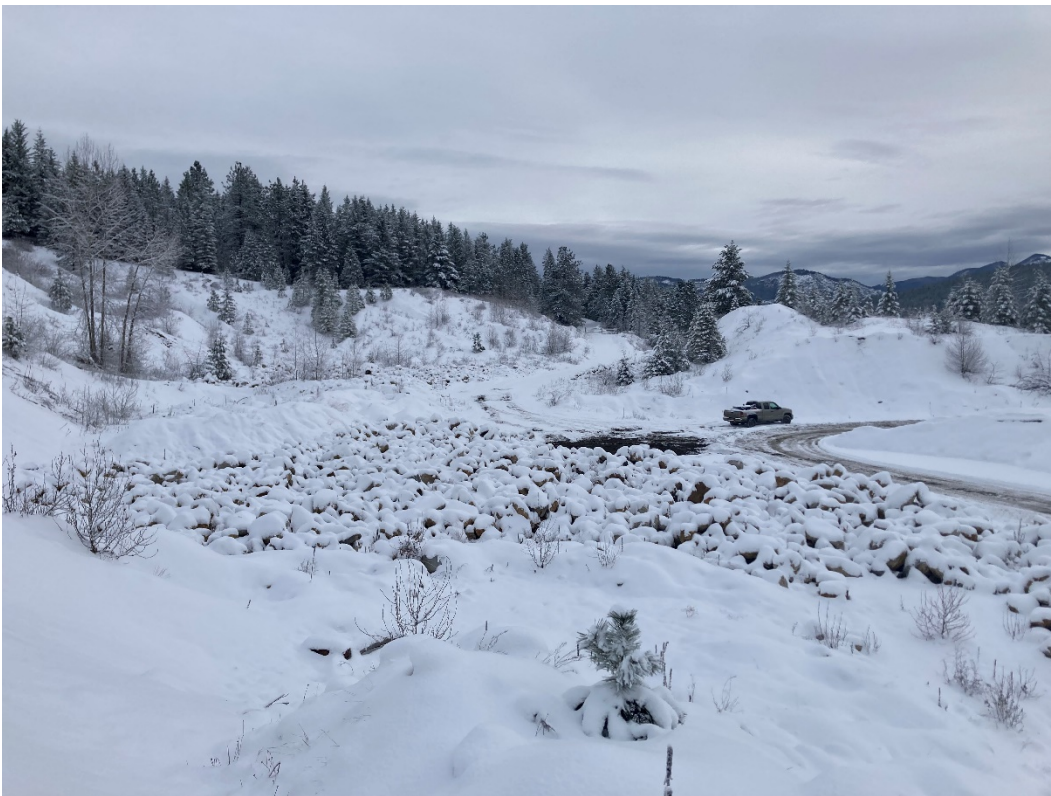
View looking east at riprap and ditching that needs to be moved to mine the suitable material underneath. December 2021.

- The mining area has been previously developed by the Ministry of Transportation and Infrastructure (MoTI). Any additional development will be the responsibility of the contractor and shall be completed as per the pit development plan or as directed by the Ministry Representative.
- Previous riprap and winter sand stockpiles will need to be relocated (they were on and in front of the pit face and suitability area as of December 2021) in order to mine the suitability area.
- The crusher is recommended to be located east of the salt shed structure, as identified on the Pit Development Plan, with mining proceeding in a northern direction as indicated.

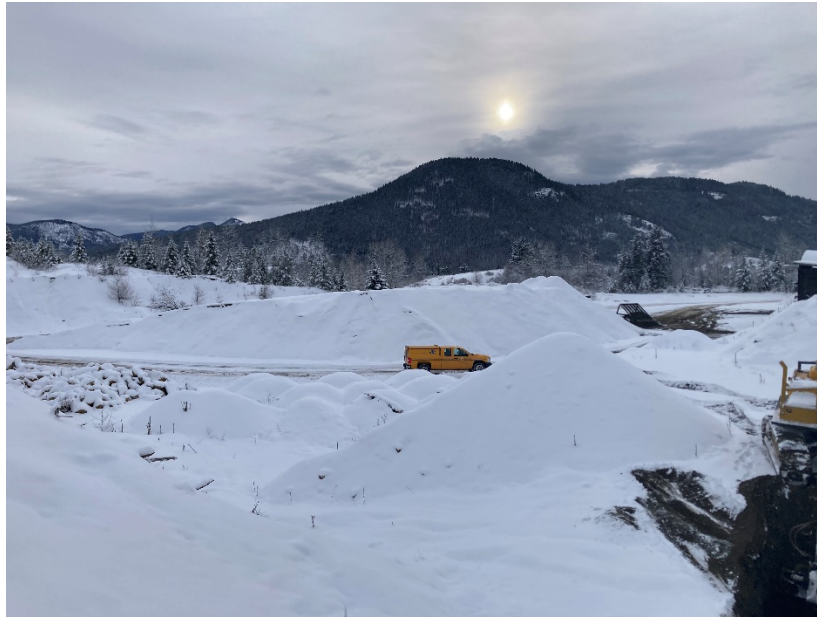
View looking south onto suitability area in front of winter sand stockpile (to be moved prior to mining),
December 2021.

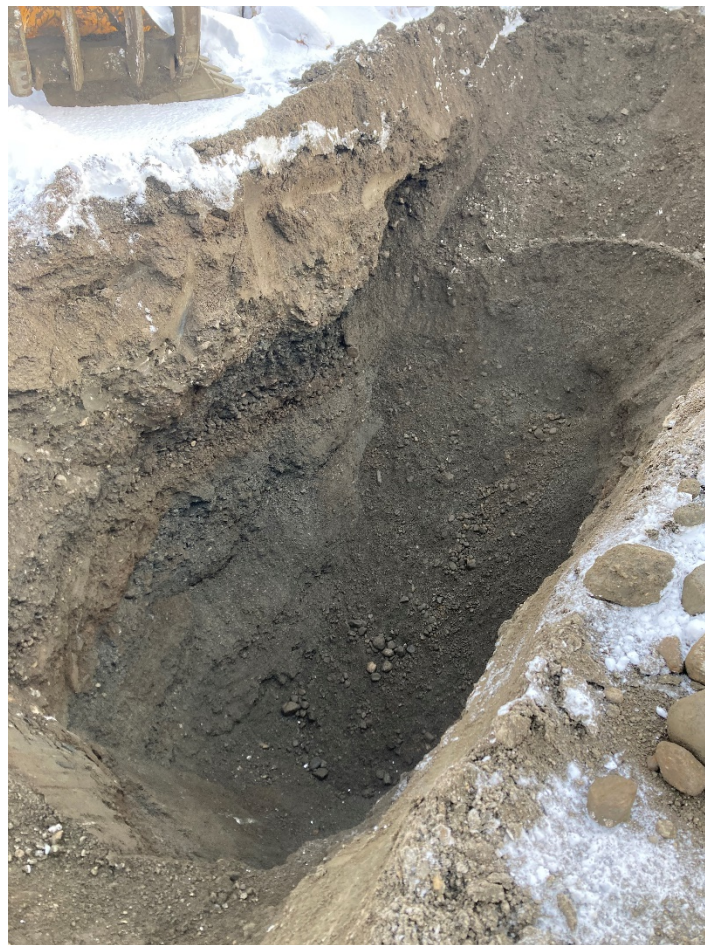
TP 21-01, December 2021.

AGGREGATE LOG															
PROJECT:		Hankey Darby Pit				SAMPLED BY:		Samantha Kinniburgh							
PIT #:		429				METHOD:		Excavator							
DISTRICT:		Okanagan Shuswap				DATE:		December 9th 2021							
TEST PIT NO.	DEPTH		SAMPLE BAG NO.	SOILS CLASS	ESTIMATED GRADATION			ESTIMATED ROCK 75mm				SAND TYPE			REMARKS
	FROM	TO			G	S	F	MAX SIZE	75mm - 150mm	150mm - 375mm	>375mm	F	M	C	
														Lab Sieve	
21-01	0	0.6		SP-SM										*Packed down floor in the top 0.6m Good looking gravelly sand under packed floor, not much OS, sloughing at 2m.

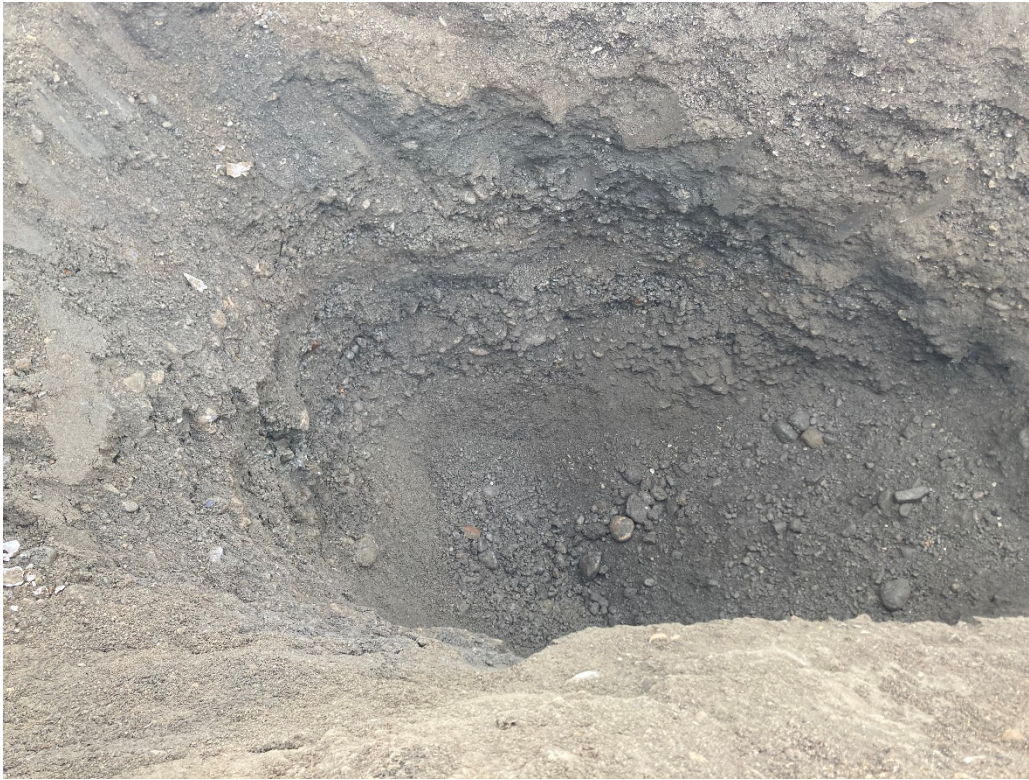
TP 21-02, December 2021.

0.6	4	21-01	SP	46	50	4	160	3	1	0	M			
				SPSM	41.5	53.5	5								
21-02	0	1.4		SP	37	60	3							Sand seam that dips N to S, more OS here than 21-01, wet-looking silts Top layer is sandy with the seam, not much OS

1.4	4.3	21-02	GPGM	57	36	7	160	8	2	0	M-C			
				GW	56.7	39	4.4								
21-03	0	0.3		Floor										Gravel layer, larger rock overlying finer sand layer Two samples taken on this TP

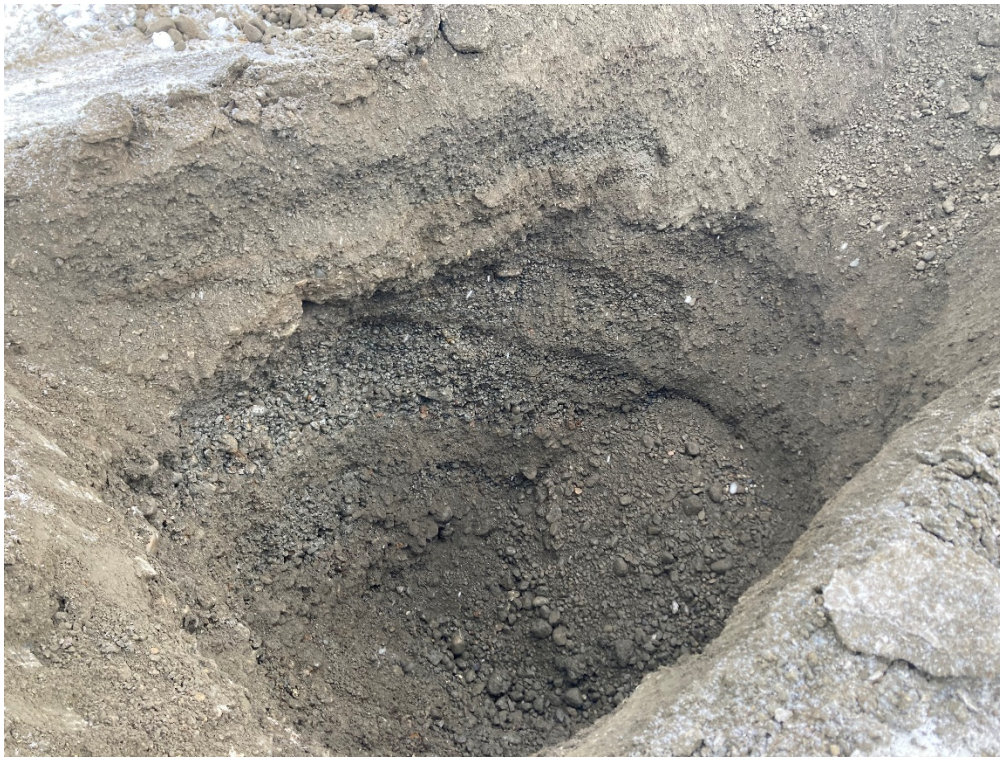
TP 21-08, December 2021.

0.2	4	21-07	SP	45	51	4	180	2	1	0	M-C			
				SM1	35	49.7	15.3								
21-08	0	0.7		Floor										Lots of bigger, rounded gravel, bonier at the bottom of the TP, sloughing at 1.5m, dirty material.

0.7	3.7	21-08	GM1	63	25	12	230	12	5	0	M-C			
				GP	73	23.5	3.4

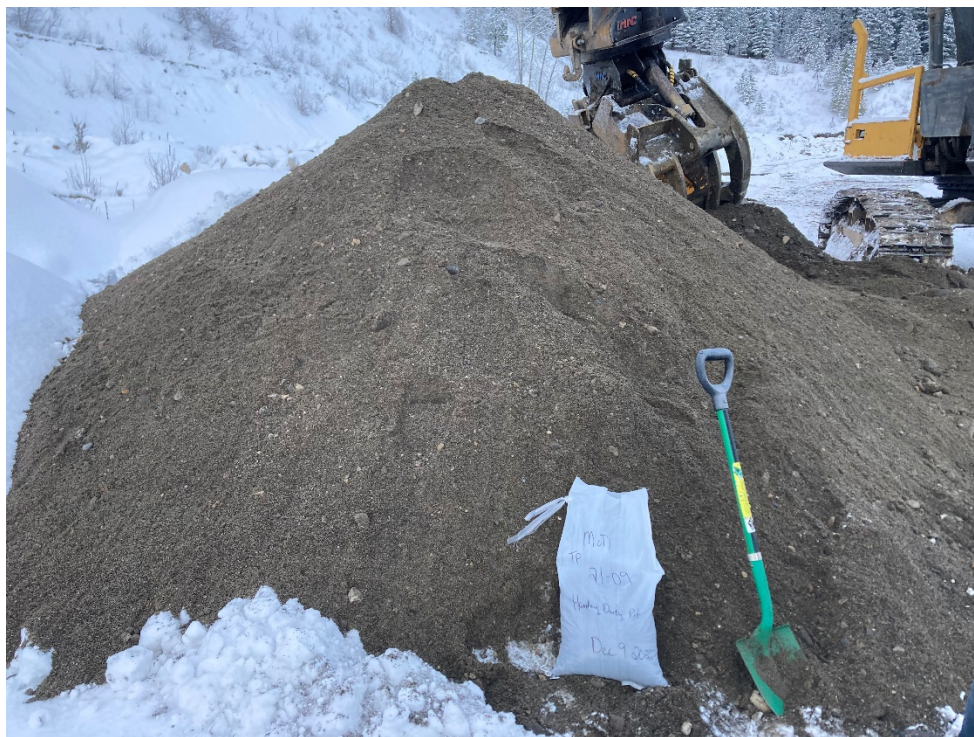
TP 21-09 Spoil, December 2021.

AGGREGATE LOG													
PROJECT: Hankey Darby Pit				SAMPLED BY: Samantha Kinniburgh									
PIT #: 0429				METHOD: Excavator									
DISTRICT: Okanagan Shuswap				DATE: Dec 9th 2021									
TEST PIT NO.	DEPTH		SAMPLE BAG NO.	SOILS CLASS	ESTIMATED GRADATION			ESTIMATED ROCK 75mm				SAND TYPE F M C	REMARKS
	FROM	TO			G	S	F	MAX SIZE	75mm - 150mm	150mm - 375mm	>375mm		
21-09	0	0.3		Floor									
	0.3	3.4	21-09	SP	32	65	3	80	2	0	0	M	Uniform sand, with some rock, no sloughing, beach sand type material.
				SP	23.1	75.1	1.8
