**Ministry of Transportation and Infrastructure**

Geotechnical and Materials Engineering

## Lynes Pit No. 1488

### 2022 Technical Information Report

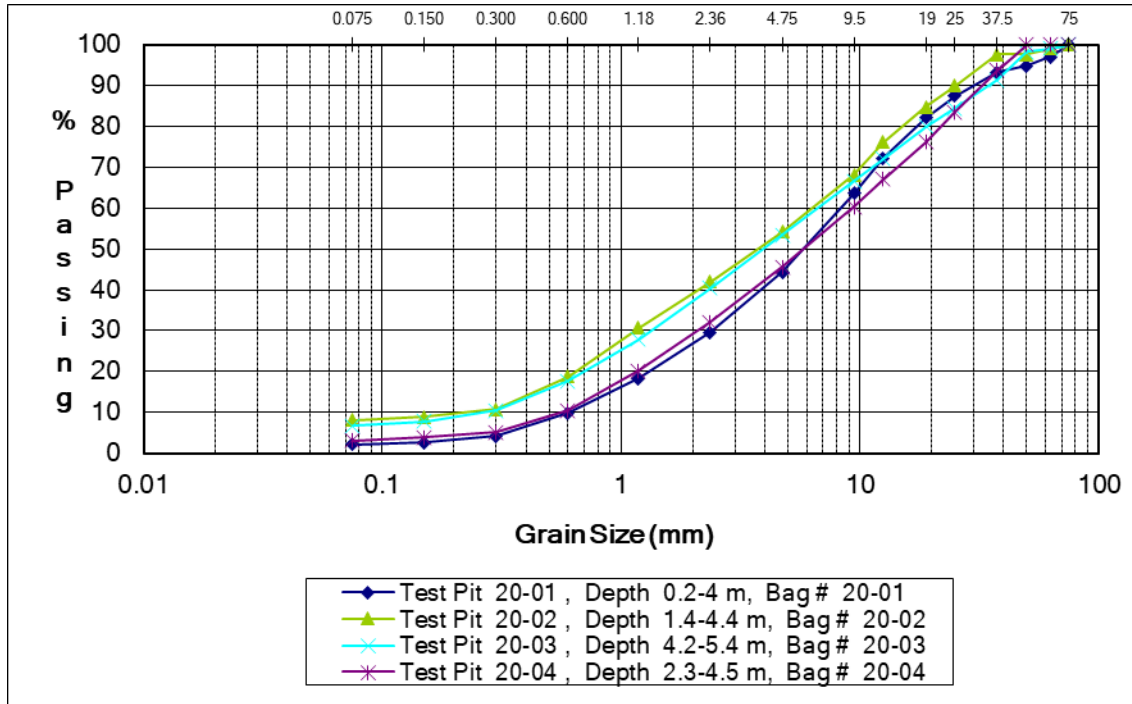
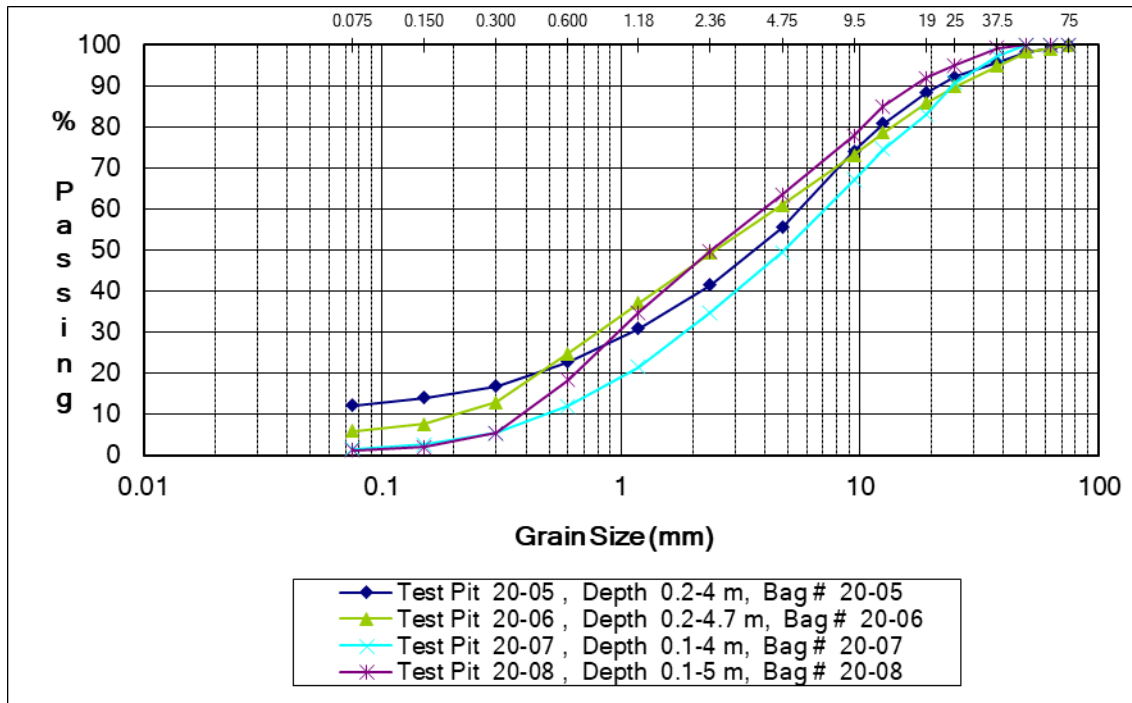
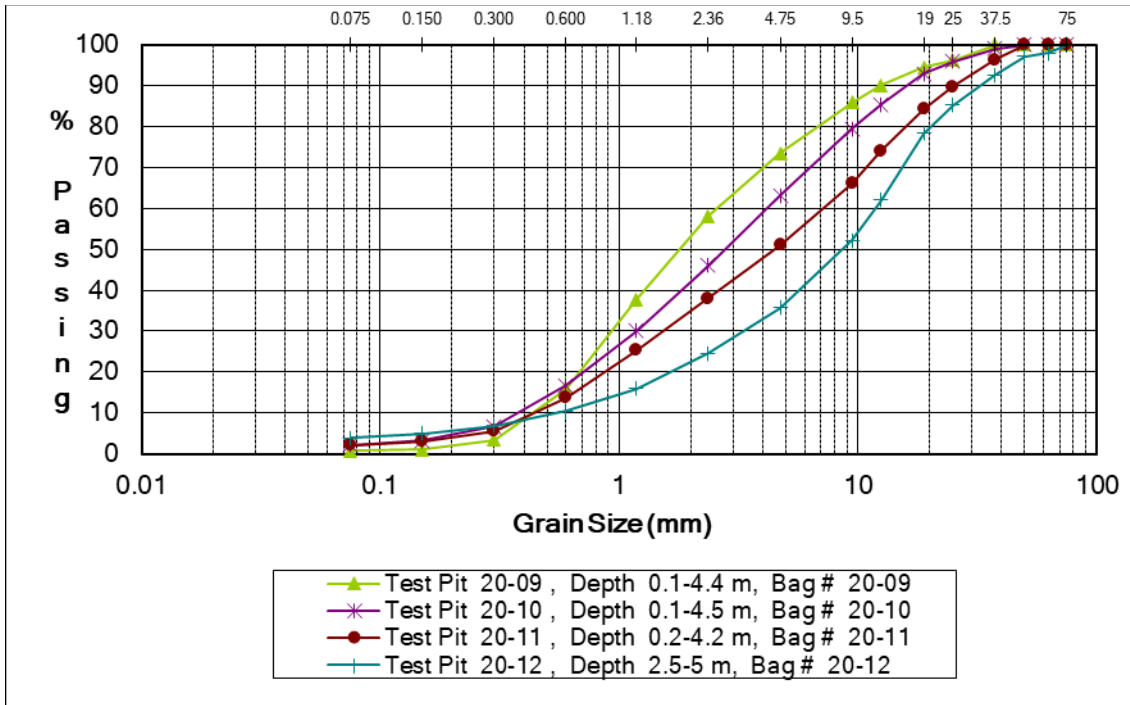
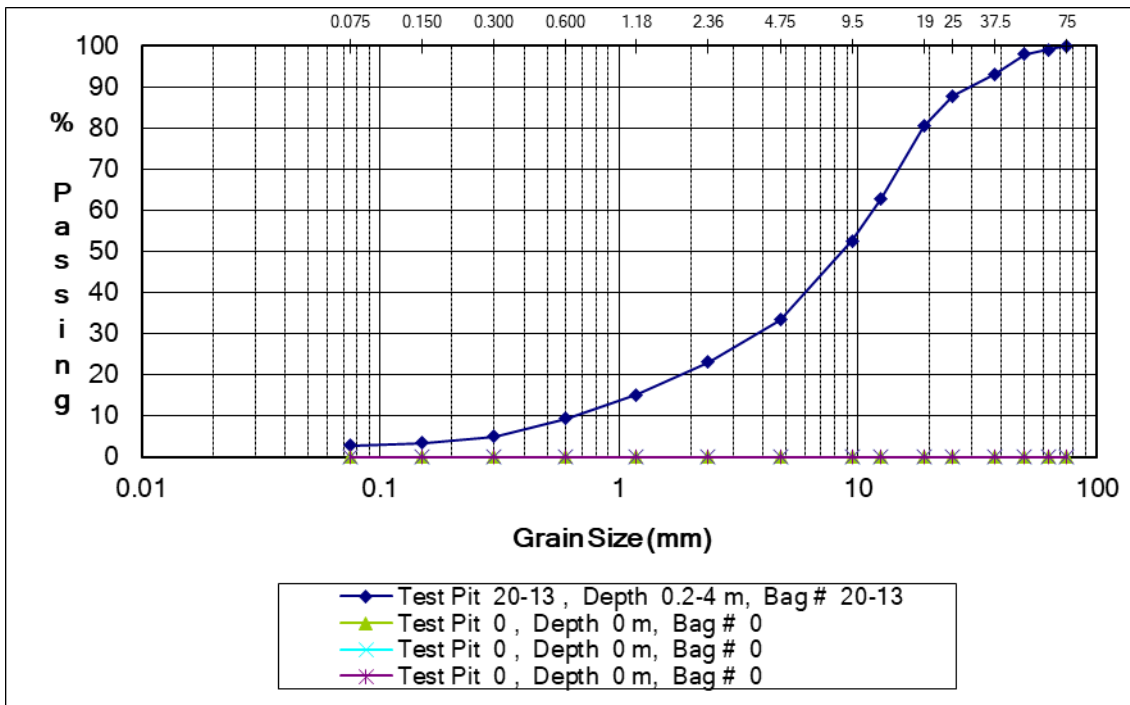
**Aggregate Gradation Charts:**

**Gradation:** The average and range of laboratory samples as well as oversize rock field estimates for material from the 2020 testing program at Lynes Pit are as follows:

Classification	Average (%)	Range (%)
Gravel (4.75-75mm)	43.1	26.5-66.6
Sand (0.075-4.75mm)	48.5	30.6-72.8
Fines (<0.075mm)	4	0.7-12

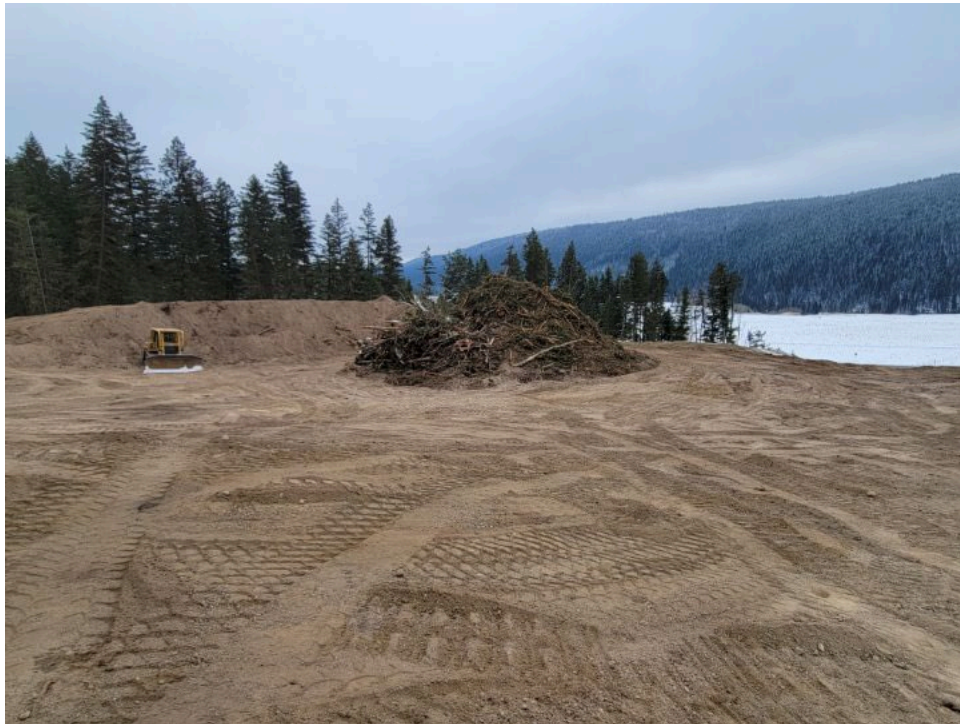
View of potential crusher set up area, looking southwest, December 2022.

- The crusher is recommended to be located as identified on the Pit Development Plan, or if there is not sufficient room in Lynes Pit No. 1488 for the contractor's liking, crusher can be set up in Mountain House Pit No. 1876.

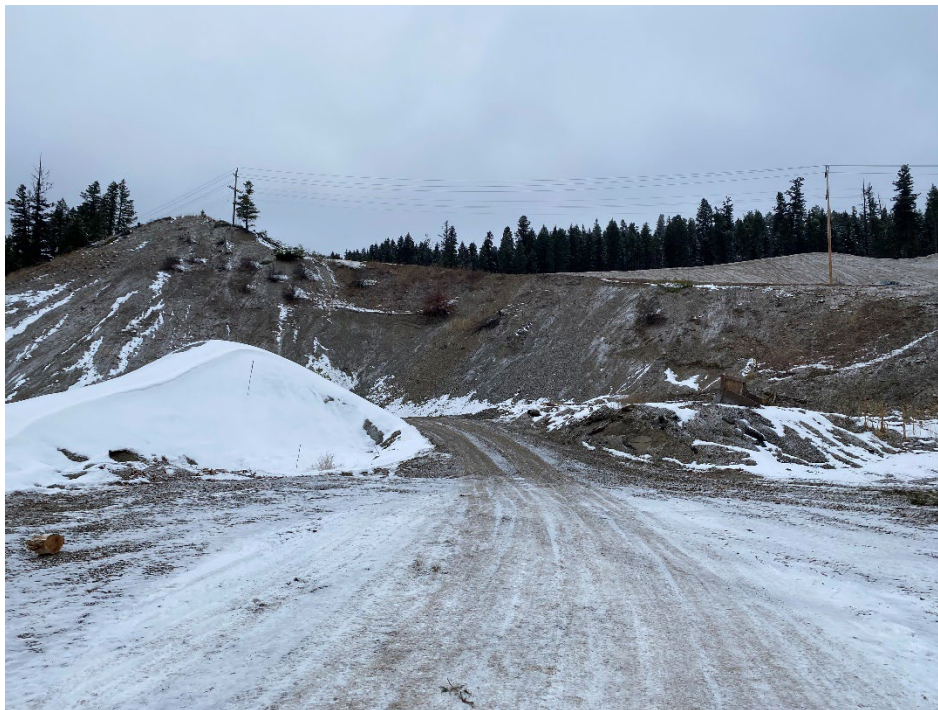
Looking northeast at mining area, December 2022.

- Mining in Lynes Pit shall proceed in an east and northeast direction as indicated.
- Processed aggregate may be stockpile where space permits, and as indicated on the Pit Development Plan. If insufficient room in Lynes Pit, then Mountain House Pit shall be used to stockpile aggregates. There is currently minimal room on the Lynes pit floor for more than 5,000m<sup>3</sup> of stockpiled material.

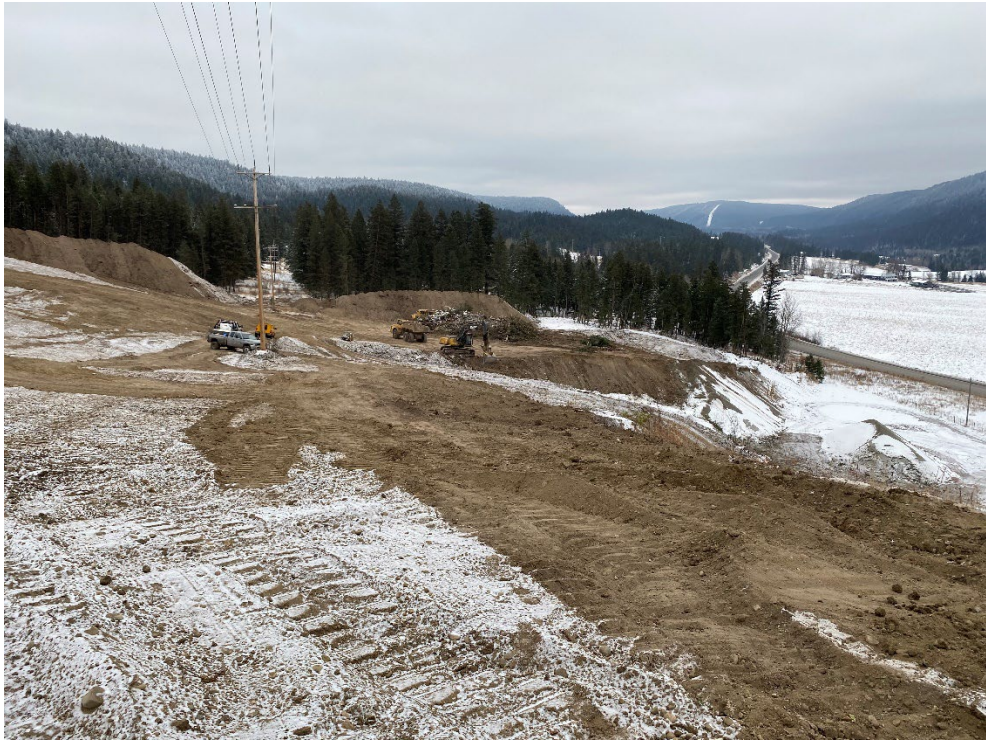
Looking south onto mining area with potential crusher set up on the right, December 2022.

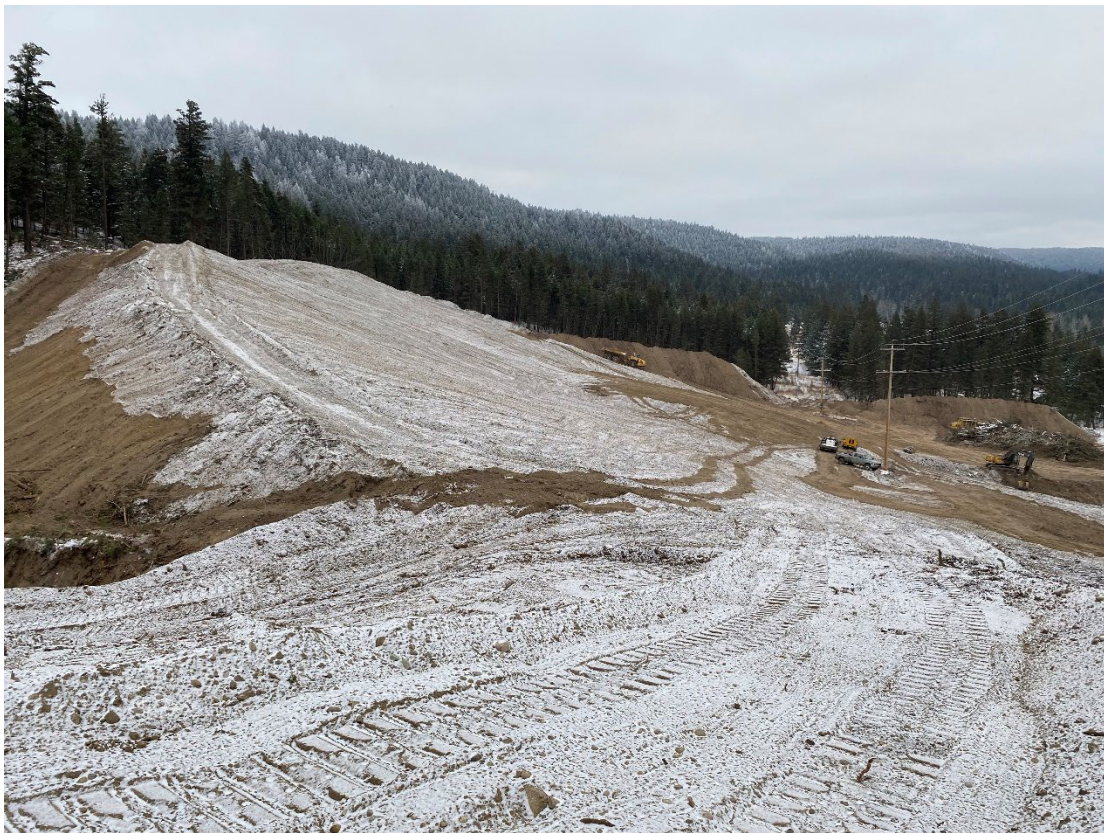
View looking southeast of developed mining area north of the hydro line, December 2022.

- It may be necessary to bulldoze granular material to the production site from above the BC Hydro transmission line in order to mitigate excessively high pit faces and continuous mining under the hydro lines. **The contractor is responsible to obtain a 30M33 Permit before stripping the overburden and pushing material through the Right of Way.** Access to and along the power line Right of Way must be maintained at all times.

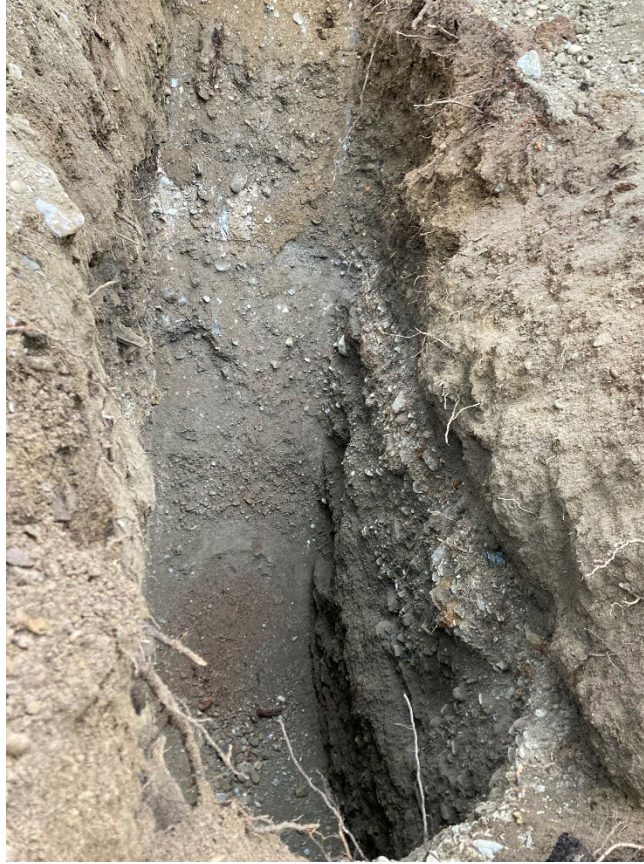
TP 20-02, December 2020.

0.2	4	20-01	GP	60	37	3	250	10	2	0	C-M	
				<b>GW</b>	<b>55.7</b>	<b>42.2</b>	<b>2.1</b>						
20-02	0	0.1		TS									No sloughing but material felt clean Sandier than TP 20-01

0.1	1.4		SPSM	22	70	8						
	1.4	4.4	20-02	GP	58	40	2	280	10	3	0	C-M	
			<b>SPSM</b>	<b>45.8</b>	<b>46.2</b>	<b>8.1</b>							
20-03	0	0.3		TS									Gravel seam @4.2m, thick sand and fines layer, dirty beach sand texture

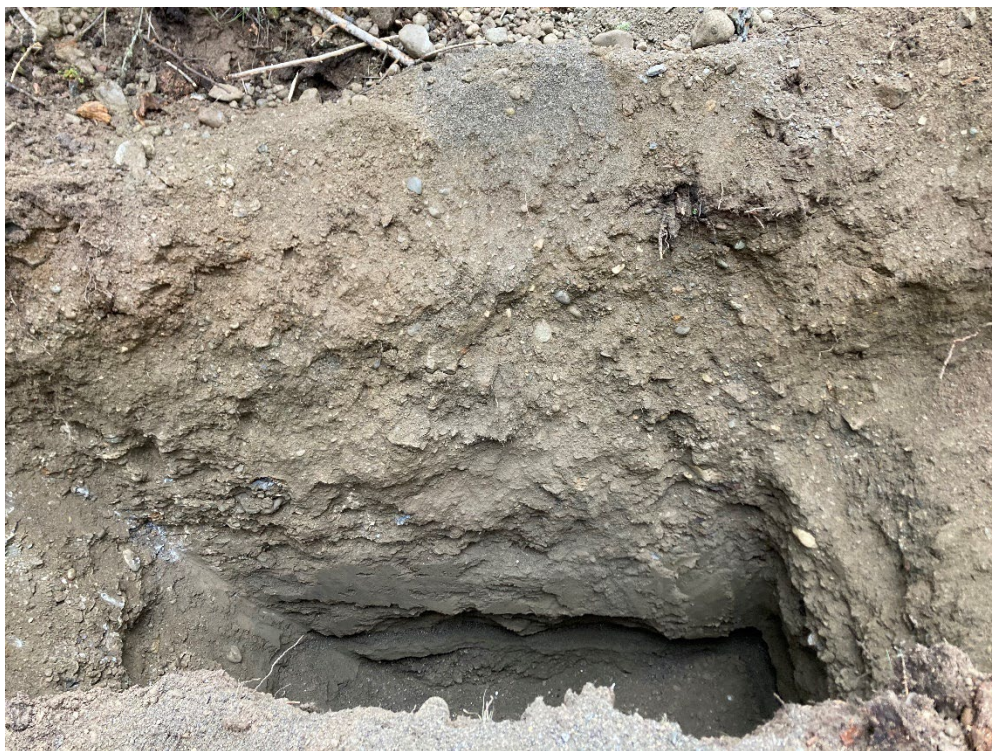
TP 20-05, December 2020.

0.2	2.3		SPSM	11	80	9						
	2.3	4.5	20-04	GP	58	38	4	150	5	1	0	C-M	
			<b>GP</b>	<b>54.5</b>	<b>42.4</b>	<b>3.1</b>							
20-05	0	0.2		TS									Dirty sand layer until gravel seam below 4m, cleaner gravel below 4.2m

0.2	4	20-05	SP	40	56	4						
	4	5.2		GP	55	42	3	180	3	1	0	M	
			<b>GM1</b>	<b>44.5</b>	<b>43.4</b>	<b>12</b>							
20-06	0	0.2		TS									Sloughing at 0.5m, sandy and consistent with sandier seams below 2m, bands at 0.3-0.5m

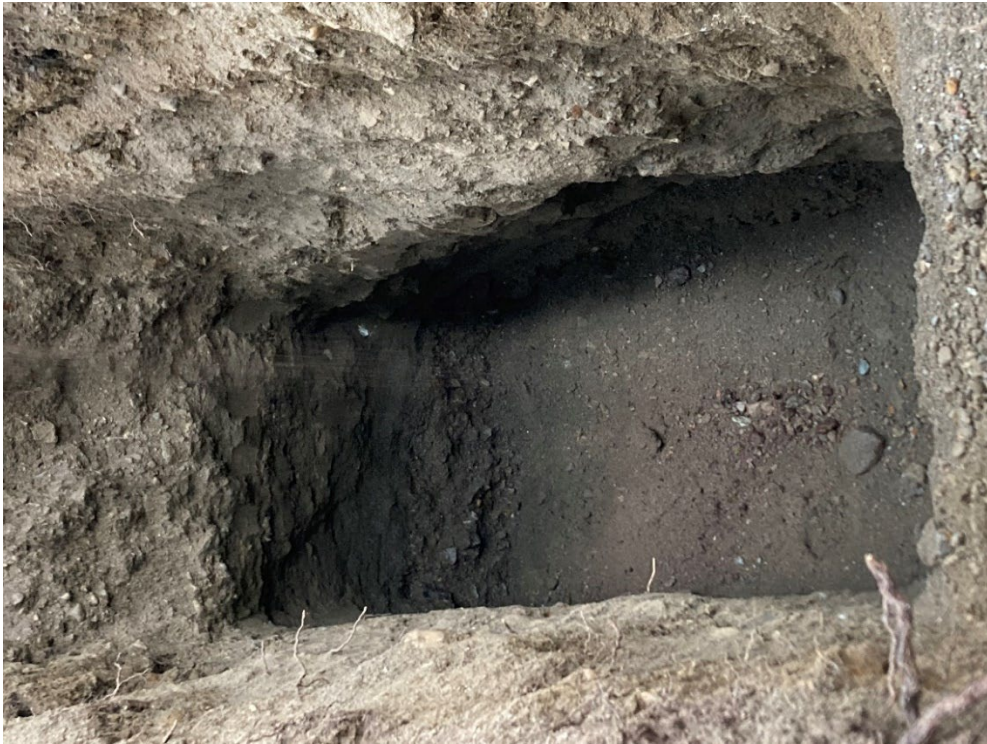
TP 20-06, December 2020.

0.2	4.7	20-06	SP	43	55	2	160	6	1	0	C-M	
				<b>SPSM</b>	<b>39</b>	<b>55.3</b>	<b>5.8</b>						
20-07	0	0.1		TS									TP on the triangular slope in NW corner of the pit, S of powerline, consistent and sloughing badly

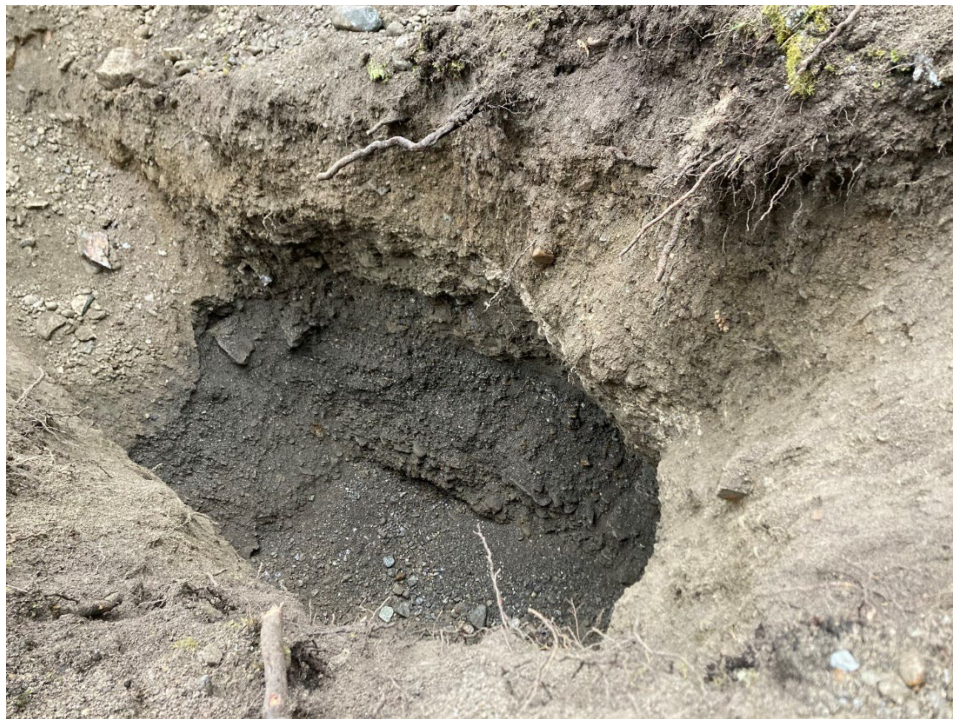
TP 20-12, December 2020

0.2	4.2		SP	45	52	3	180	5	2	0	C-M	
					GPSP	48.9	48.9	2.2					
20-12	0	0.2	20-12	TS									Most OS in a TP yet, sloughing below 1.5m, gravelly sand overlying gravel layer

0.2	2.5		SP									
	2.5	5		GP	62	34	4	160	10	3	0	C	
					GW	64.3	31.8	3.9					
20-13	0	0.2	20-13	TS									Good gravel after 1m, lots of OS Sloughing badly at 1m
