Client & Project

Assessment Summary

Project Area Description

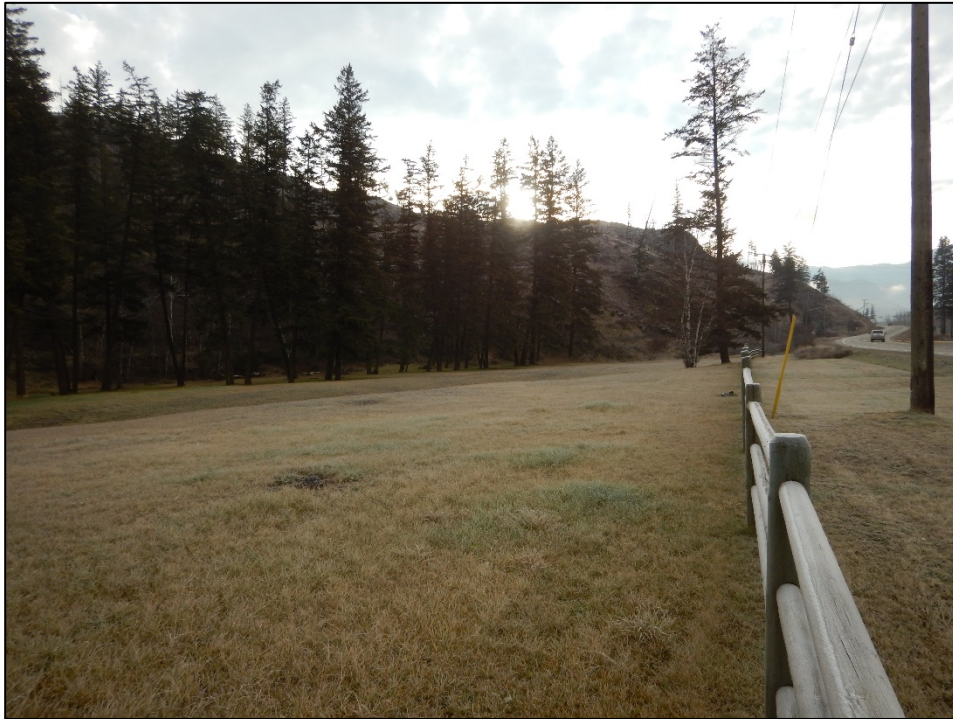
Photo 1: South-southeastern view showing the flat, level, and terraced terrain associated with AAP 5 and the northern portion of the study area.

The construction of a highway passing lane and a CVSE pullout has the potential to alter undiscovered archaeological sites within AAPs 1–9 unless these lands are avoided. It is recommended that MoTI avoid AAPs 1–9 through project redesign. Avoidance can be achieved through the exclusion of these areas from development activities. To determine the feasibility of avoidance during project design discussions, MoTI has been provided with the geospatial data for delineating the features. If avoidance of these locations is not feasible, an AIA incorporating deep, auger testing and shovel testing is recommended prior to development to determine the presence of any undocumented archaeological sites within the study area.

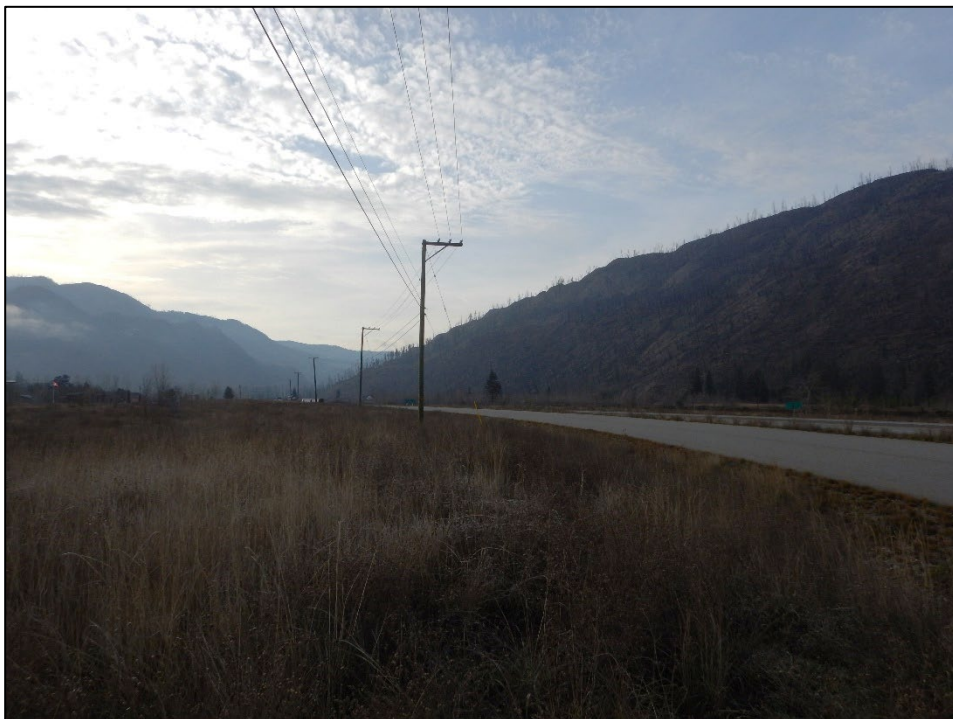
Photo 2: Southwestern view showing the flat, leveled terrain adjacent to Enterprise Way in the southern portion of the Highway 5 passing lane.

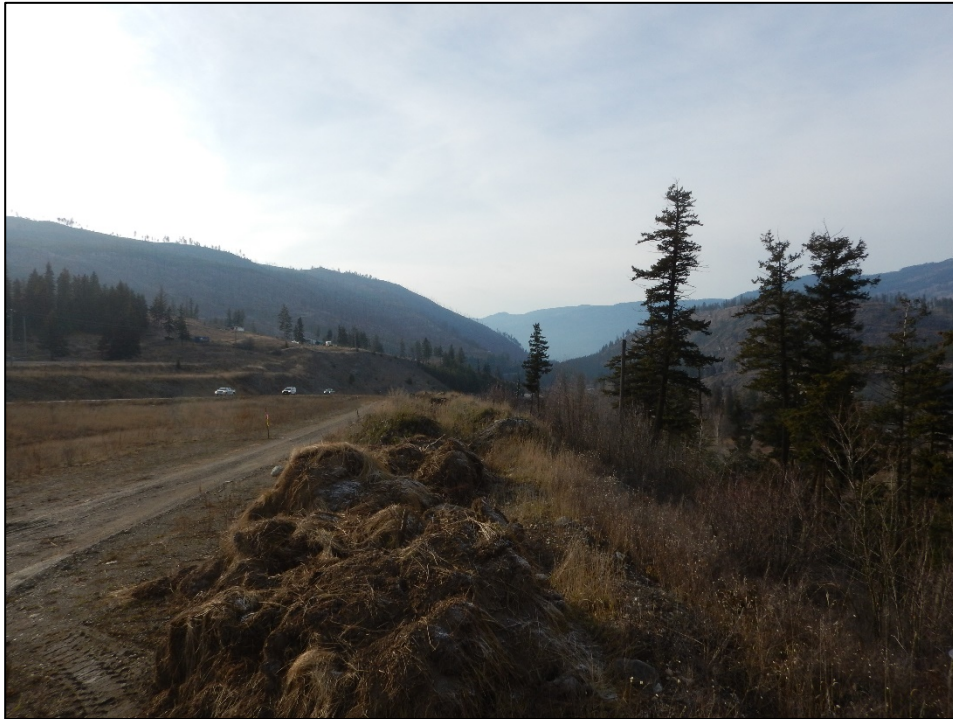
The entirety of the proposed Highway 5 passing lane and the CVSE pullout were subject to pedestrian survey (Figures 2–5). The northern portion of the study area is characterized by flat and level terraced terrain. A lower terrace is situated within the western and northernmost portions, elevated 30 m +/- 10 m above the NTR (Figures 2 and 4; Photo 1; AAPs 5–7), and an upper terrace, which is elevated an additional 20 m, is aligned parallel to the highway (Figures 2 and 3; AAPs 1–4). The central portion of the study area is situated on gently sloping and undulating terraced terrain with intermittent rocky bluffs and has a general western aspect. The southern portion of the passing lane is situated on flat, rocky, and heavily disturbed terrain (Figure 4; Photo 2; AAP 8). The CVSE pullout area is situated on a remnant glacial landform that has been heavily impacted from road construction activities (Figure 5; Photo 3; AAP 9).

Photo 3: Southwestern view showing the heavily disturbed terrain associated with the proposed CVSE pullout. Stockpiled sediments and debris can be seen center frame.

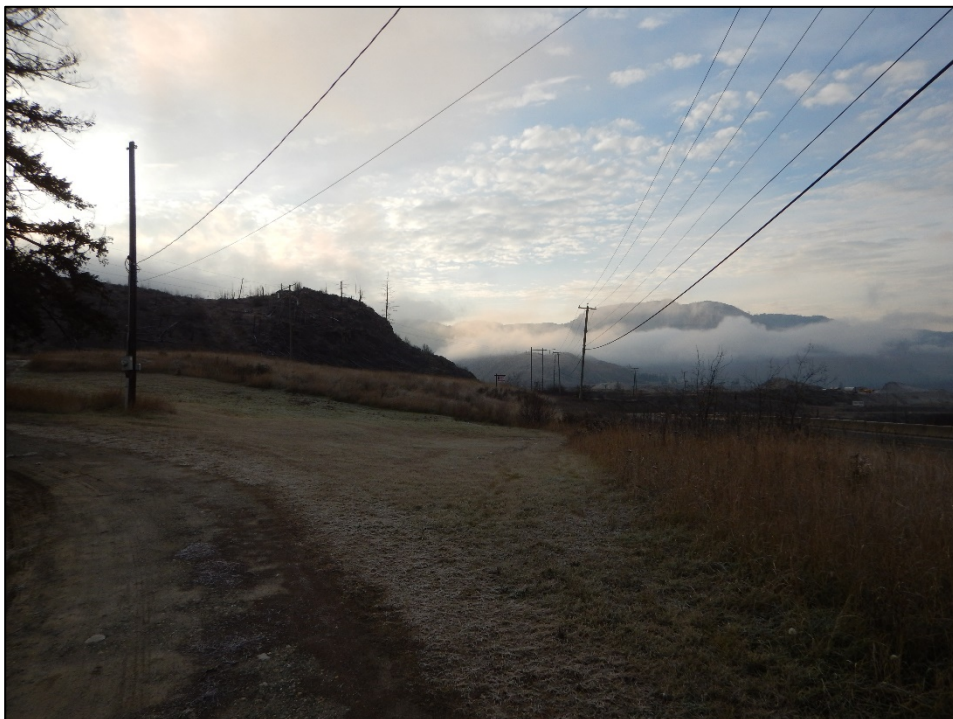
Photo 4: South-southeastern view showing the flat, relatively level terrain associated with AAP 2. Residential development has caused minor impacts to the feature.

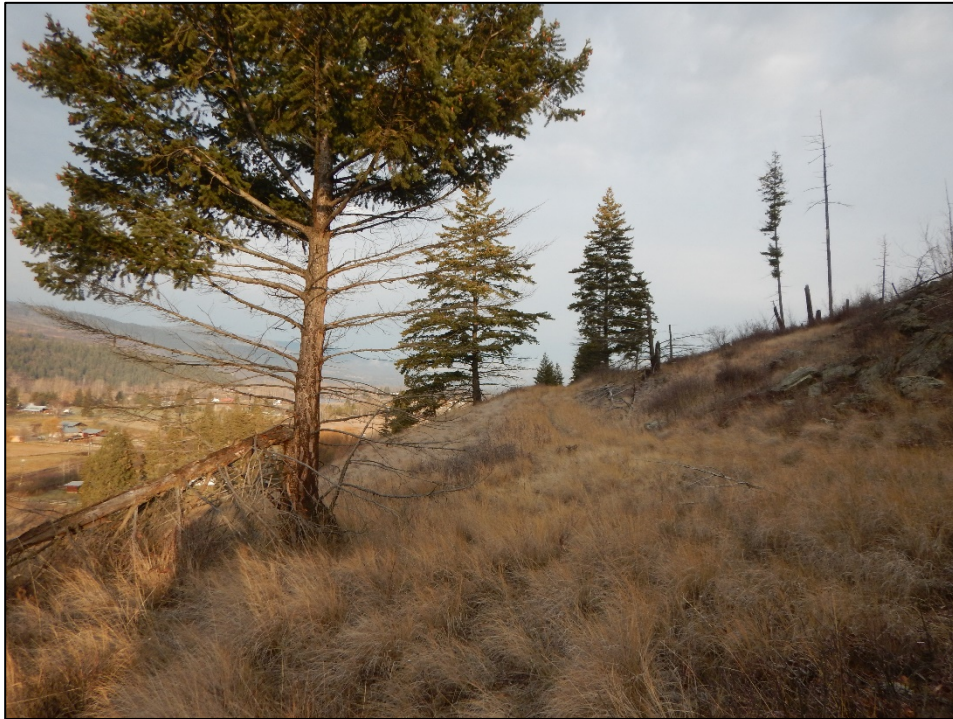
Photo 5: North-northwestern view of AAP 4 showing the flat to gently sloping terrain associated terrace.

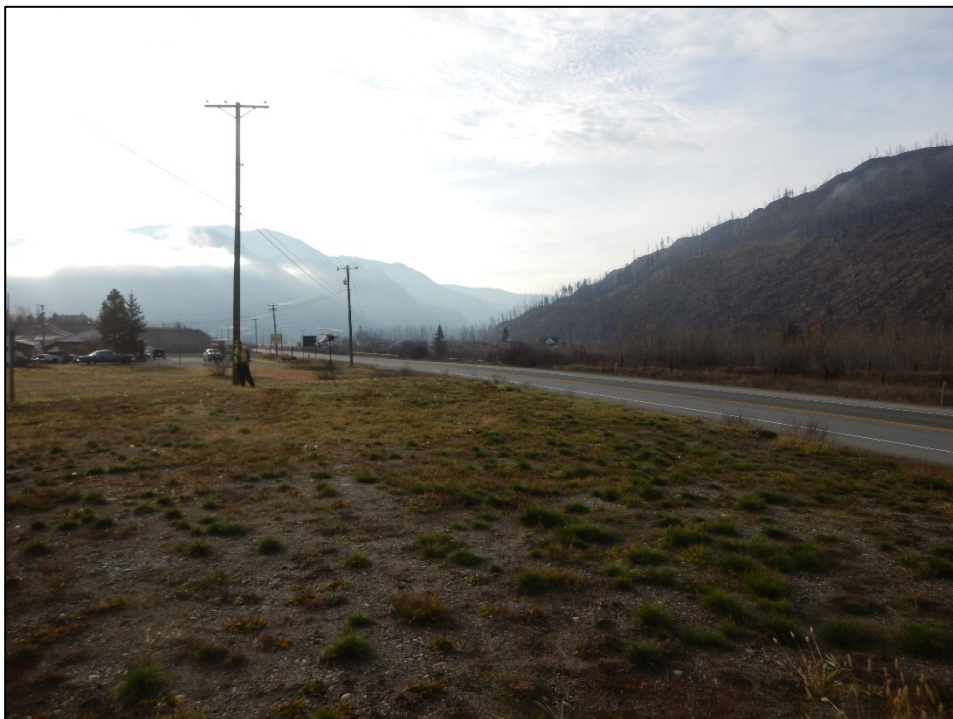
Photo 6: Southern view showing the elevated and elongated feature associated with AAP 8. Exposed gravels and heavily disturbed terrain were observed in this area.

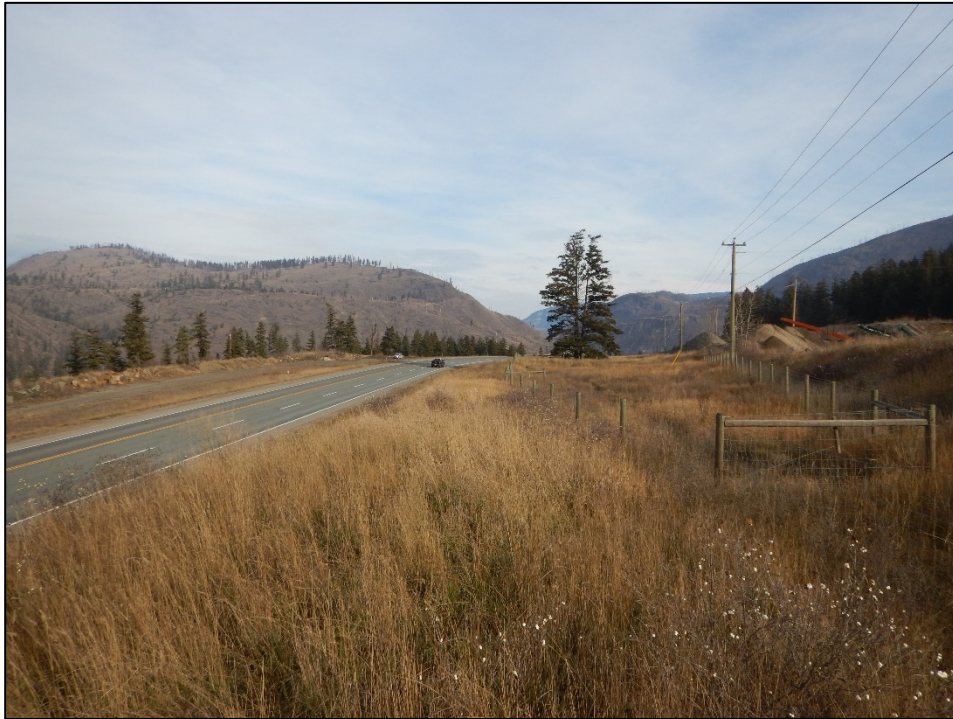
AAP 9	0.10	This area consists of a narrow, flat, and well-drained portion of a remnant glacial kame (Photo 7). The western and eastern margins of the feature are heavily impacted from construction of Highway 5 and the construction of a fence line paralleling the highway right-of-way.	5

Photo 7: Northeastern view of AAP 9 showing the remnant landform associated with a glacial feature. A fence line bounds the feature to the east and highway development has impacted the western margin of the feature.
