Ministry of Transportation
and Infrastructure

Highway 97 Cache Creek Culvert
Replacement

Environmental Impact Assessment

August 14, 2023

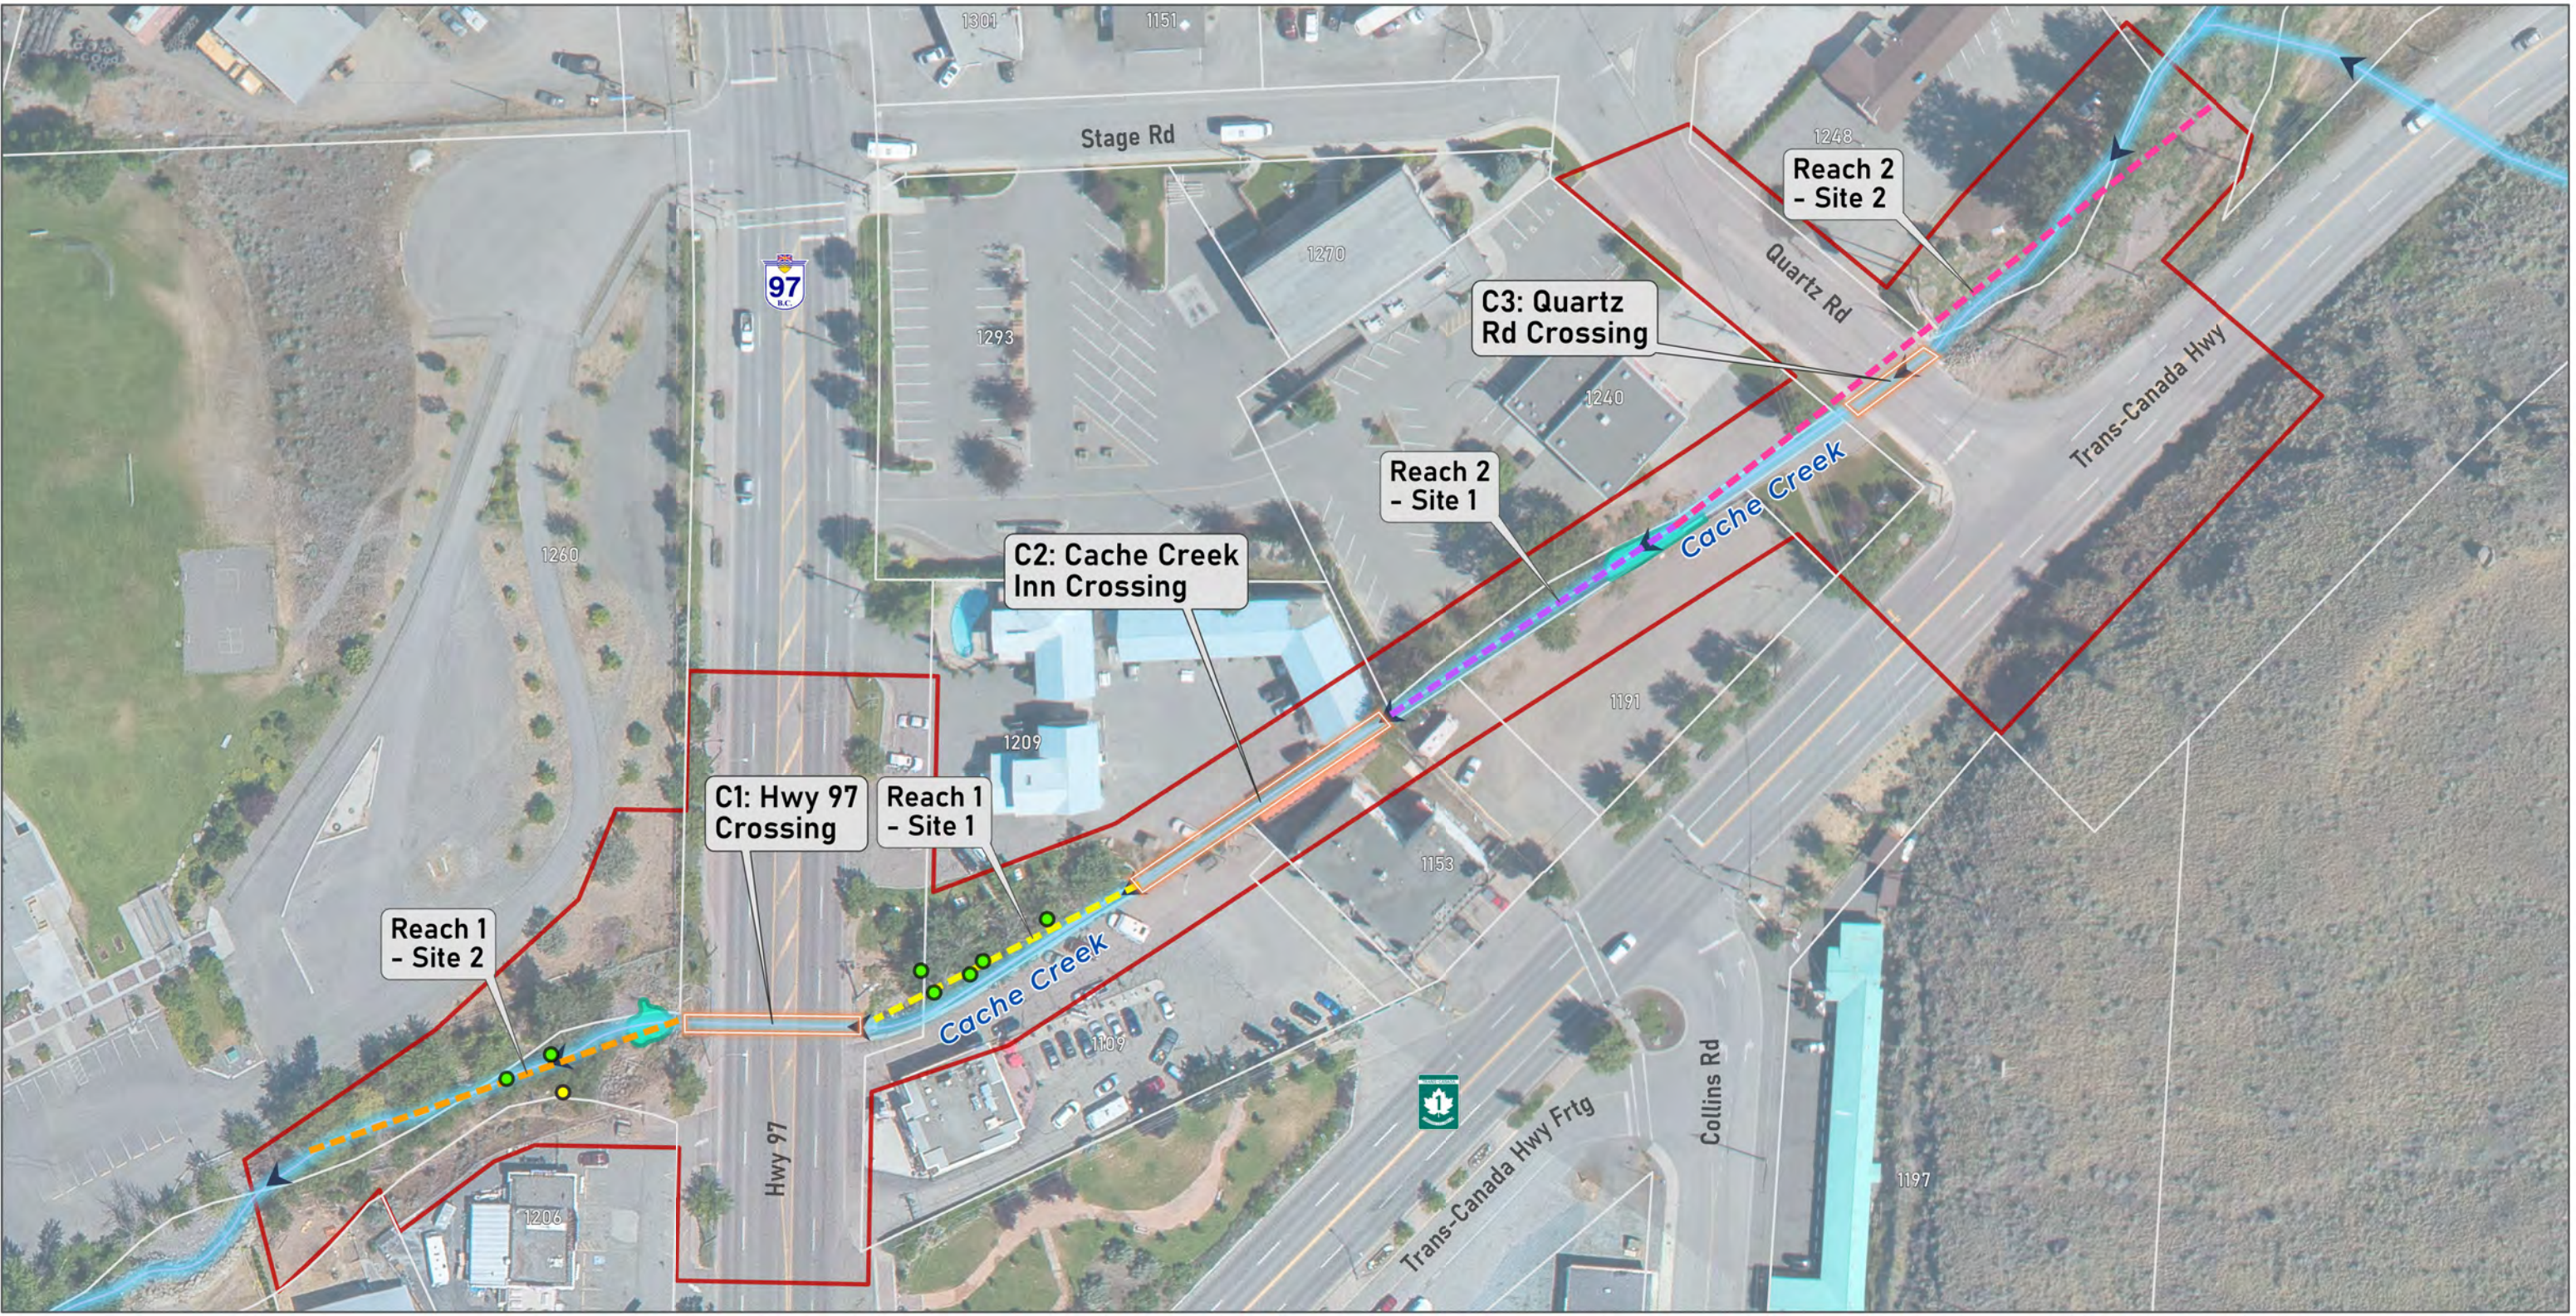
Ministry of Transportation and Infrastructure
Hwy 97 Cache Creek Culvert Replacement
FIGURE 2.1
Fish Habitat Assessment Reach

A Fish Habitat Assessment was completed for the project area. Site visits were conducted on June 21st and July 14th, 2023. The fish and fish habitat assessment followed the standards and procedures outlined in the BC Resources Inventory Standards Committee (RISC) Reconnaissance (1:20 000) Fish and Fish Habitat Inventory (RISC 2001). Areas surveyed for the Fish Habitat Assessment were broken into two reaches each of which were divided into two sites. Reach 1 - Site 1 is the 40 meters of Cache Creek upstream of the Hwy 97 culvert while Reach 1 - Site 2 is the 60 meters of Cache Creek downstream of the Hwy 97 culvert. Reach 2 – Site 1 starts at the outlet of the Cache Creek Inn culvert and runs for 60 m of creek upstream of the Cache Creek Inn culvert, whereas Reach 2 – Site 2 runs the remaining 105 m of creek channel in the project area (Figure 2.1).

Instream habitat complexity within Reach 1 of Cache Creek was low, with each site consisting of a pool formed at the outlet of a culvert outlet followed by extensive riffle. Habitat complexity, quality, and value increased downstream of the Hwy 97 culvert as a result of trace amounts of large woody debris and overhanging vegetation. Potential spawning habitat is present within Reach 1 – Site 2, as gravel is the dominant substrate. In addition to the fish habitat observations, it was noted that the existing Hwy 97 culvert features a 75 cm drop where the new culvert extension was fastened to the old culvert. This drop is a potential barrier to fish at current flow levels and may not be passable by juvenile salmonids at any flow level. The replacement of the culvert with a clearspan bridge will eliminate this issue.

Within both sites in Reach 2, instream habitat complexity within Cache Creek was low, with each site consisting of a small number of pools within extensive riffle. Habitat complexity, quality, and value was higher for Reach 2 – Site 1 than for Reach 2 – Site 2, which is the result of the presence of crown closure in Reach 2 – Site 1. No significant spawning potential was observed in Reach 2. In addition to the fish habitat observations for Reach 2, it was noted that the existing Cache Creek Inn culvert provides no fish habitat. Daylighting this section of the creek will allow for a significant opportunity to improve overall fish habitat quality in Cache Creek.

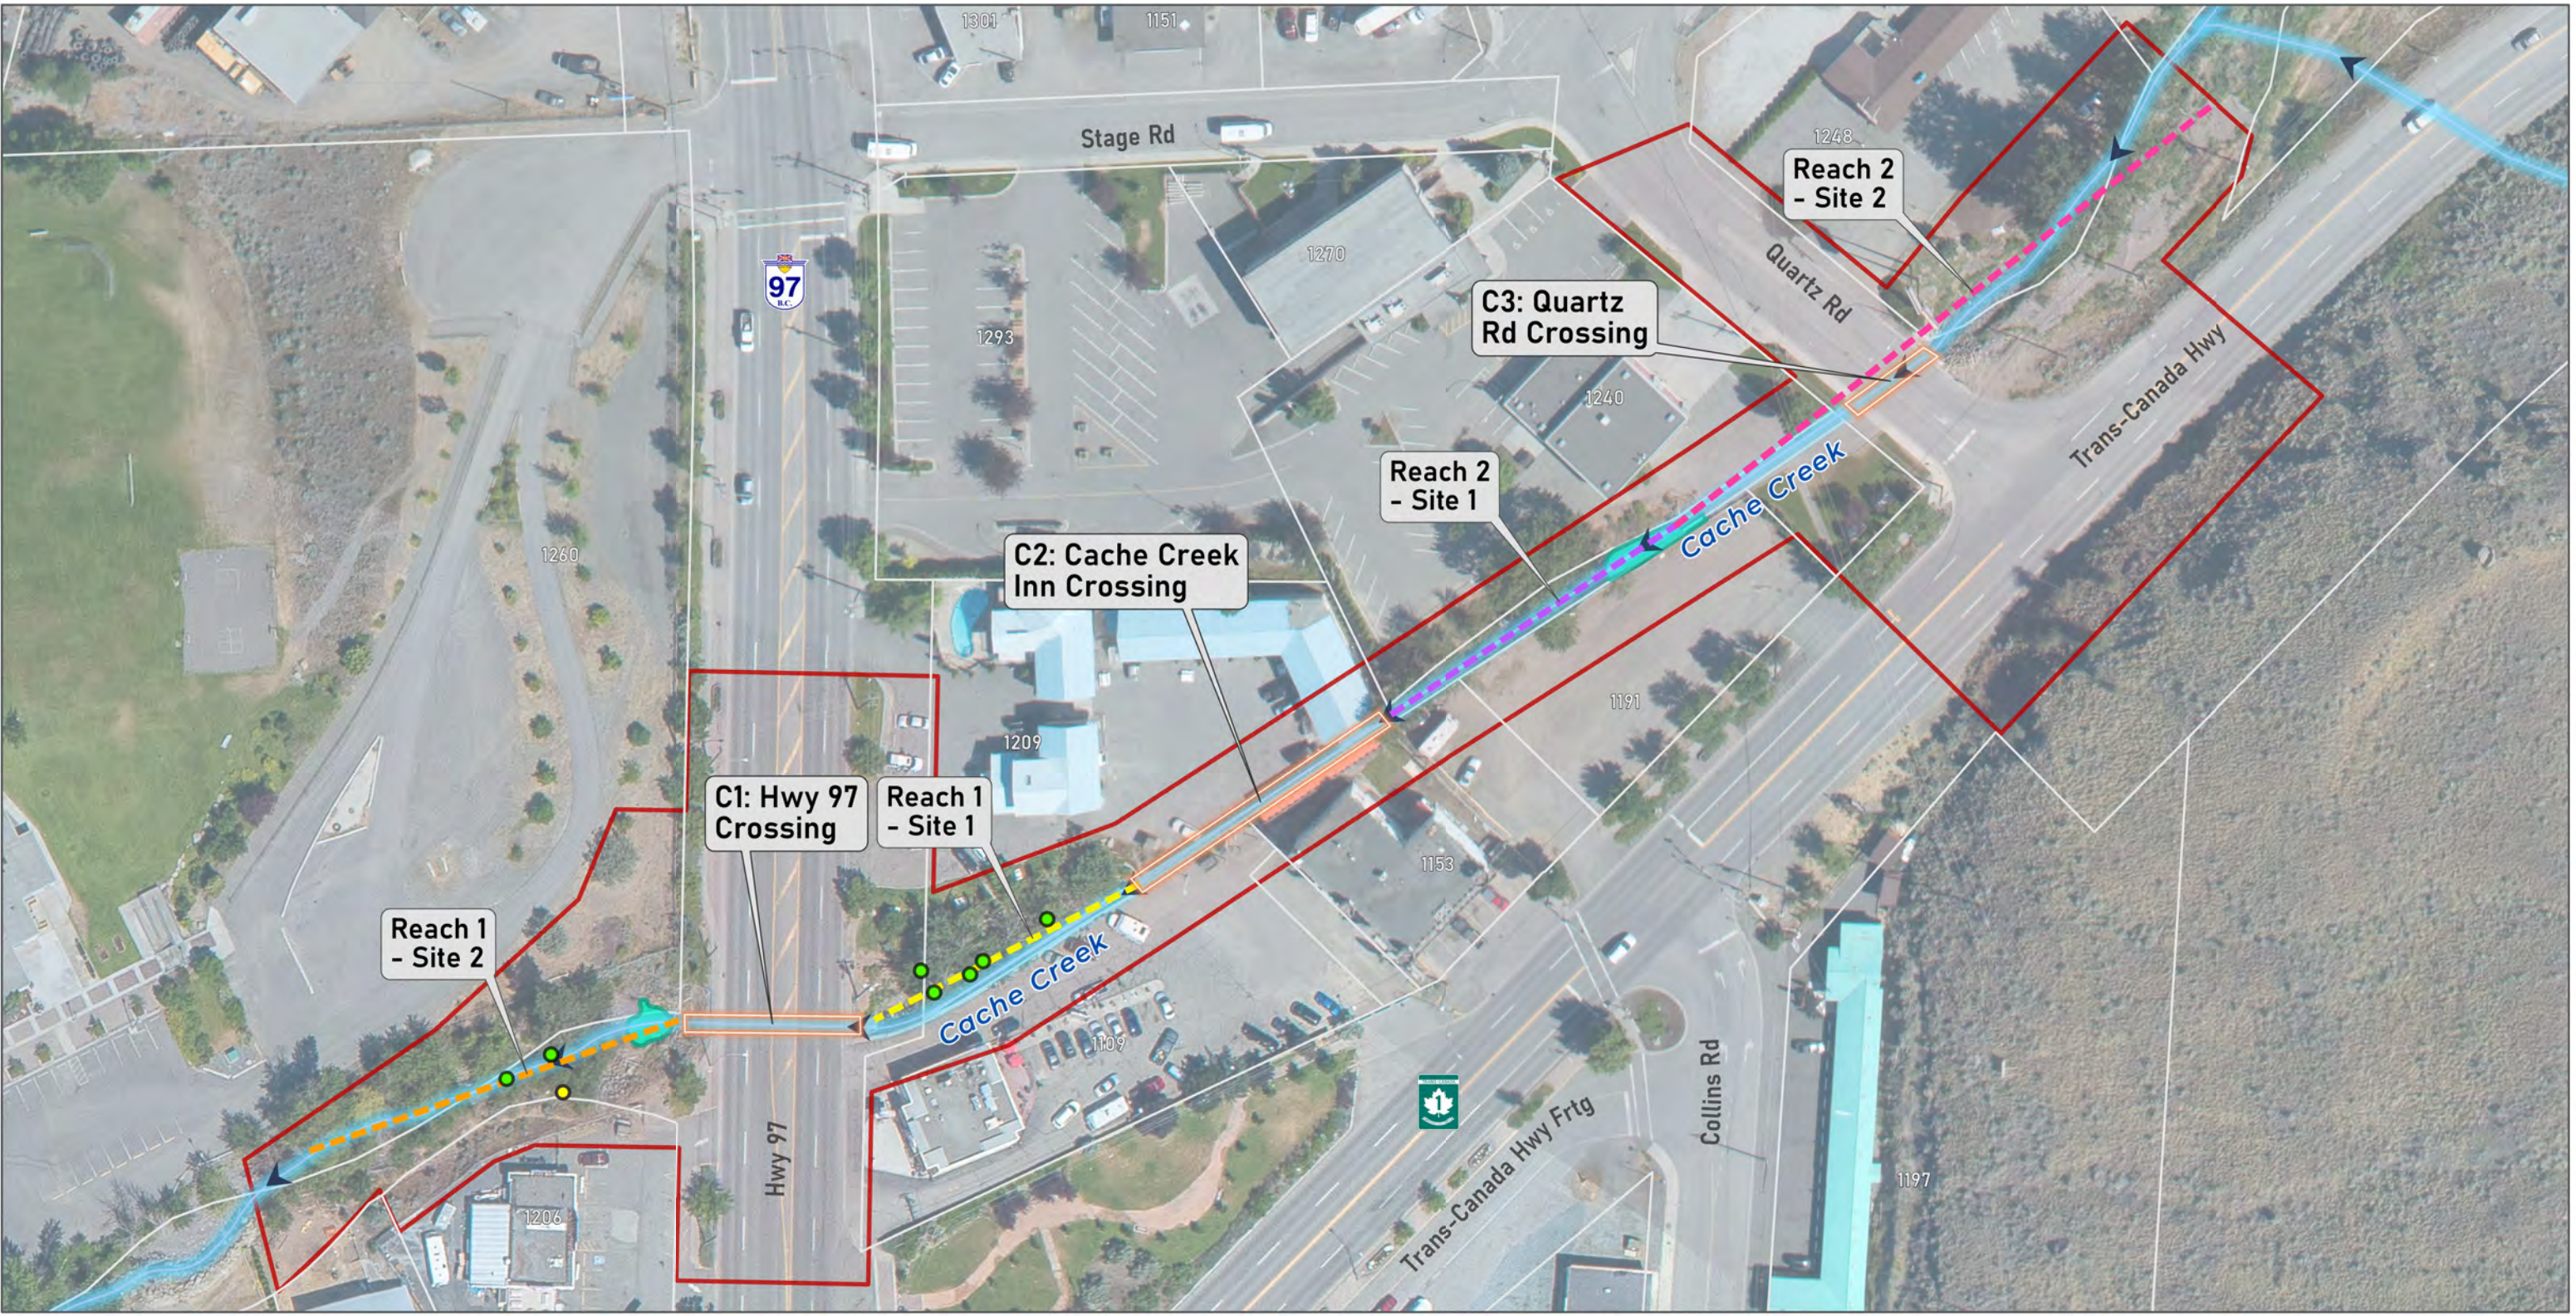
Ministry of Transportation and Infrastructure
Hwy 97 Cache Creek Culvert Replacement
FIGURE 2.1
Fish Habitat Assessment Reach

Three Urban Systems personnel, including a Senior Fisheries Biologist, assessed the fish habitat within Reach 1 on June 21st, 2023, and Reach 2 on July 14th, 2023. Site descriptions, along with a high-level summary of observed findings, are outlined in Section 2.1.1.

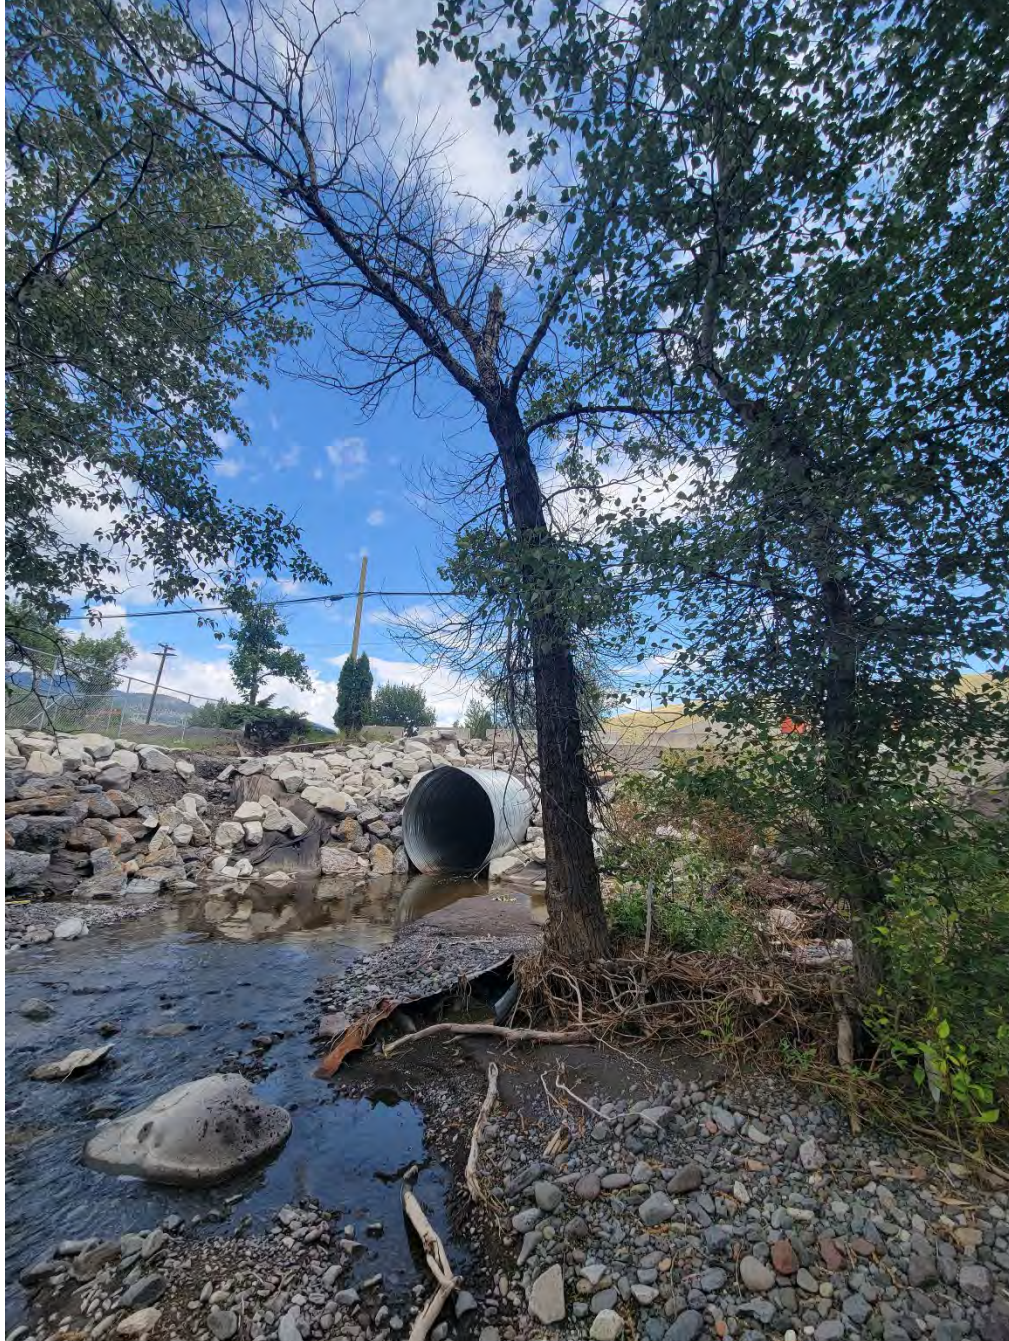
Highway 97 culvert and Reach 1 Site 2 deep pool-facing northeast.

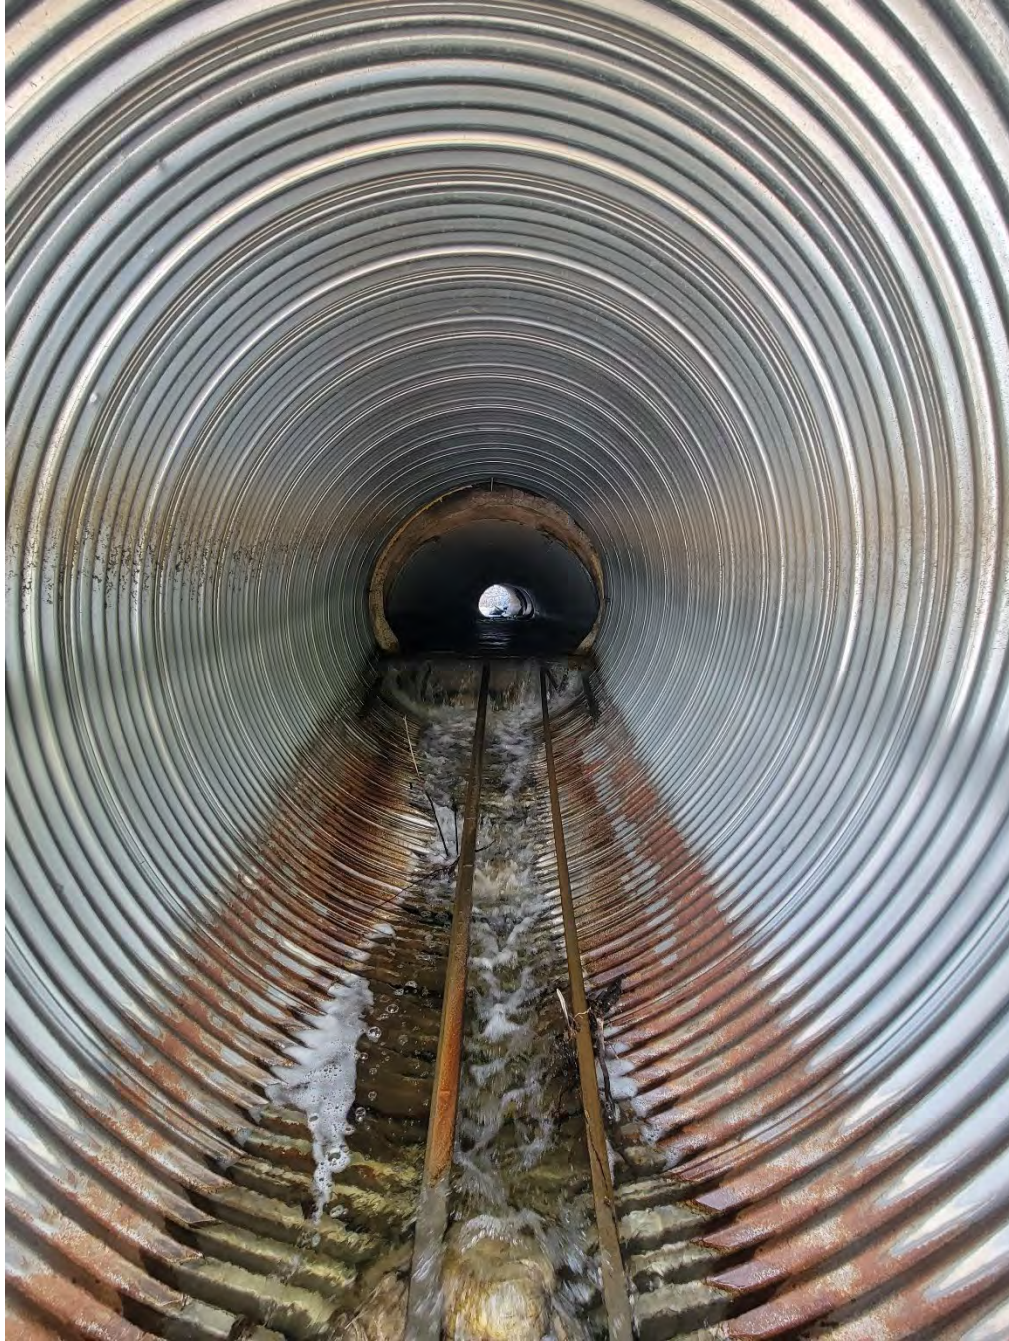
Highway 97 culvert facing upstream-northeast.

C1 – Hwy 97 Crossing - a 1900 mm x 2400 mm diameter culvert currently exists allowing Cache Creek to flow beneath the highway. However, this culvert is undersized for high flows, particularly during freshet, which has repeatedly resulted in overland flooding and erosion. To resolve this issue, a 14 m long clearspan bridge is being designed to replace the culvert. To accommodate the bridge structure and hydraulic capacity requirements, widening and re-profiling of approximately 80 m of the creek channel is required. To mitigate for working within the stream channel, a Habitat Enhancement Plan is included in the C1 works. If the other two projects proceed, this will be expanded to include those areas. The structural and riprap drawings are included in Appendix A.

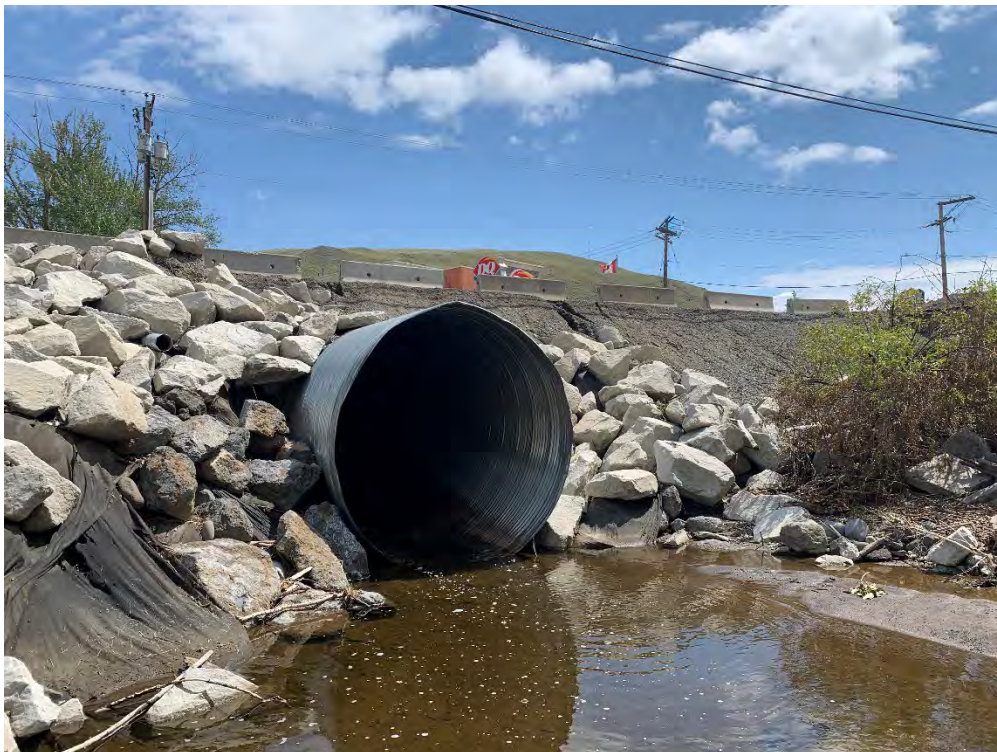
Reach 1 Site 2 deep pool – overwintering habitat – facing northeast.

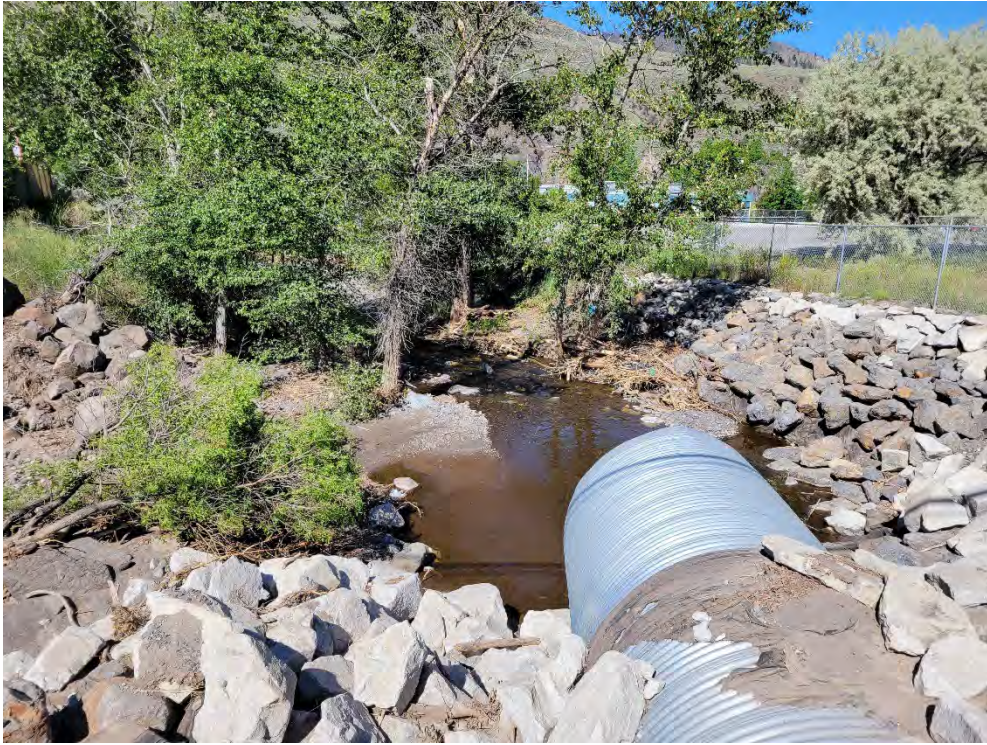
Reach 1 Site 2 deep pool – overwintering habitat – facing southwest.

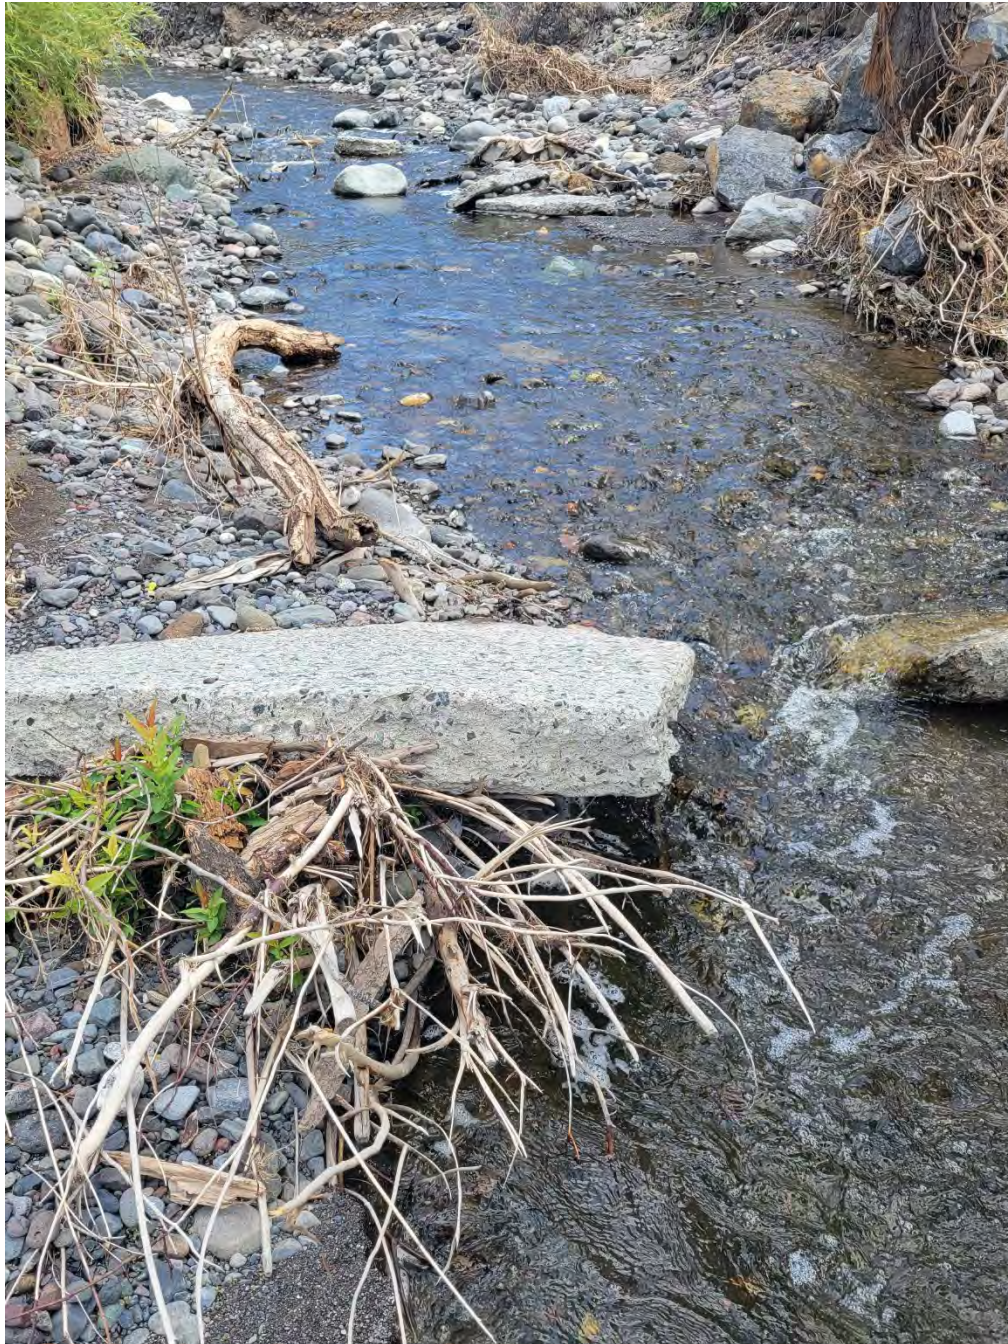
Reach 1 Site 2 fish habitat cover.

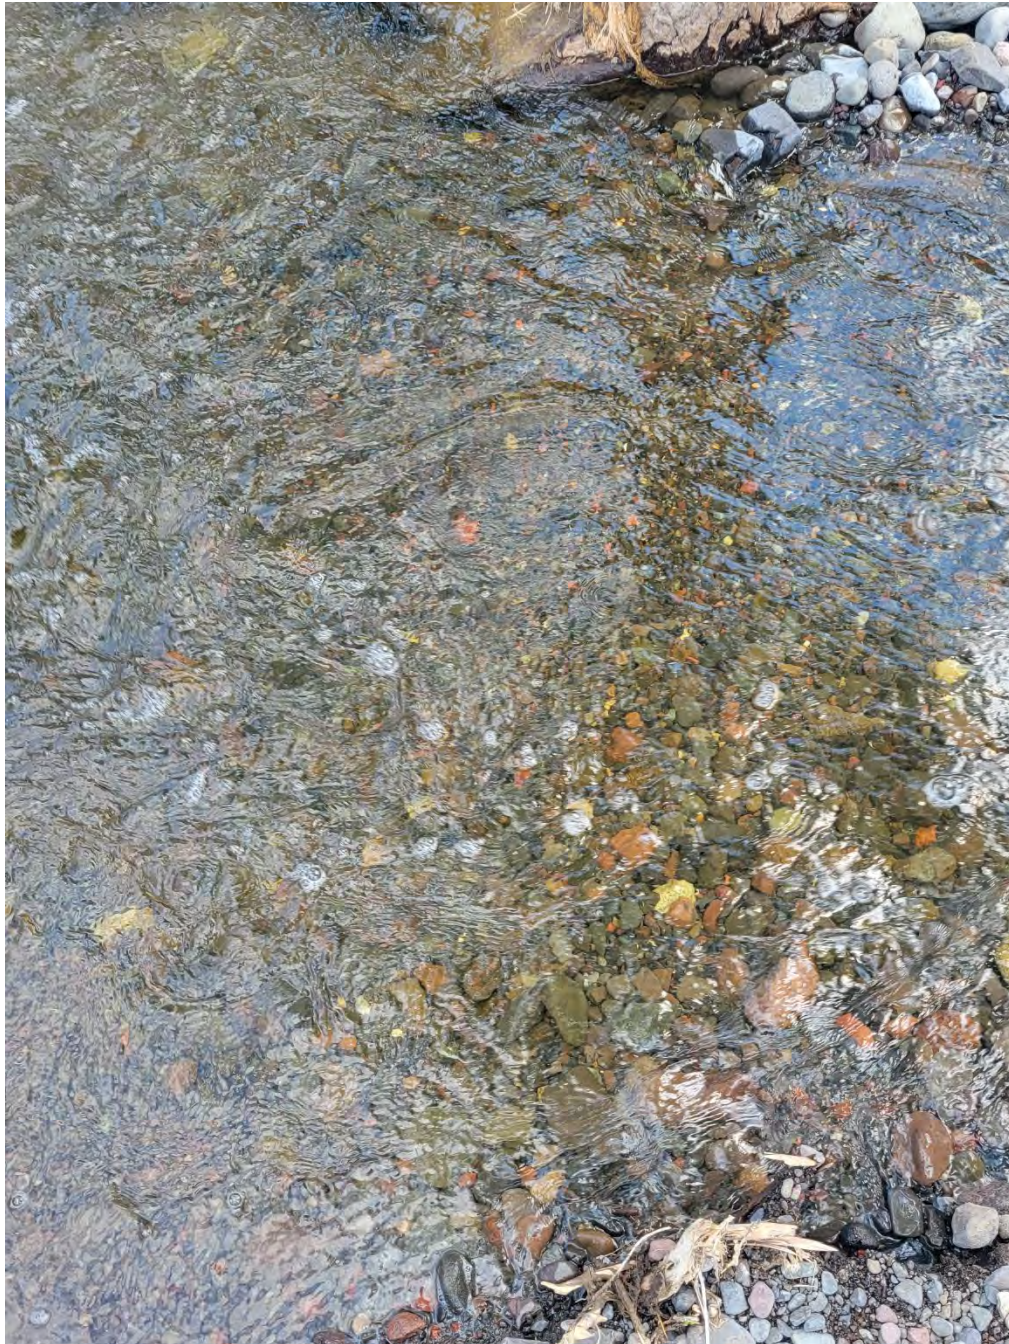
Reach 1 Site 2 spawning gravel.

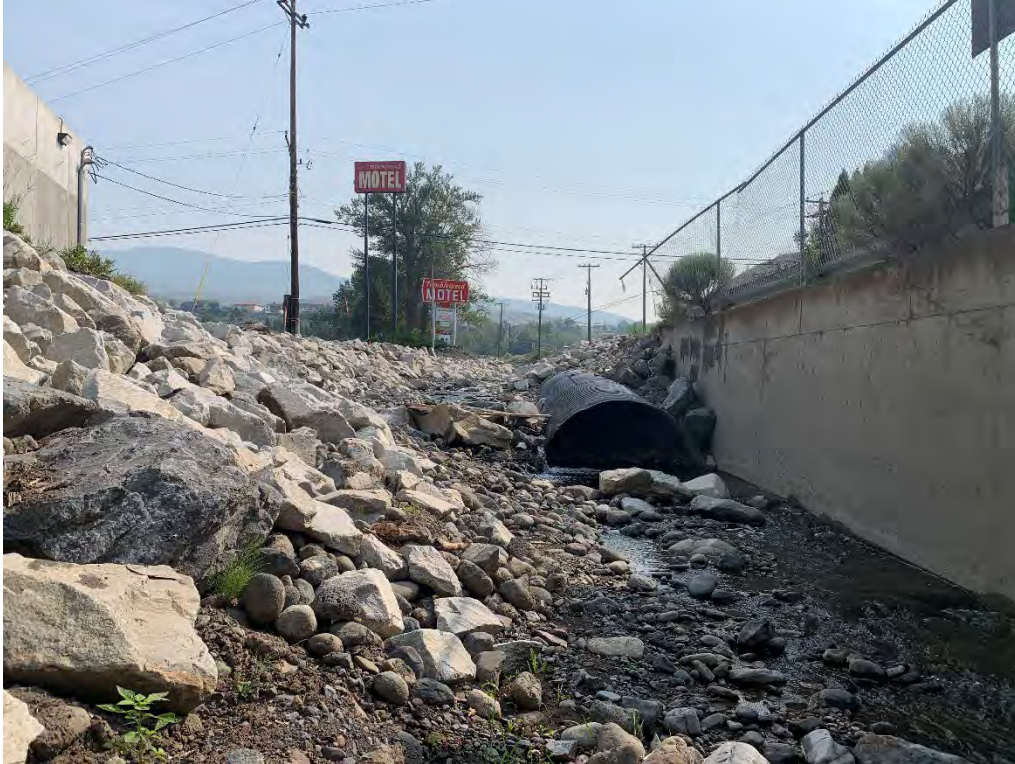
Reach 2 Site 1 washed out Quartz Rd culvert and emergency riprap.

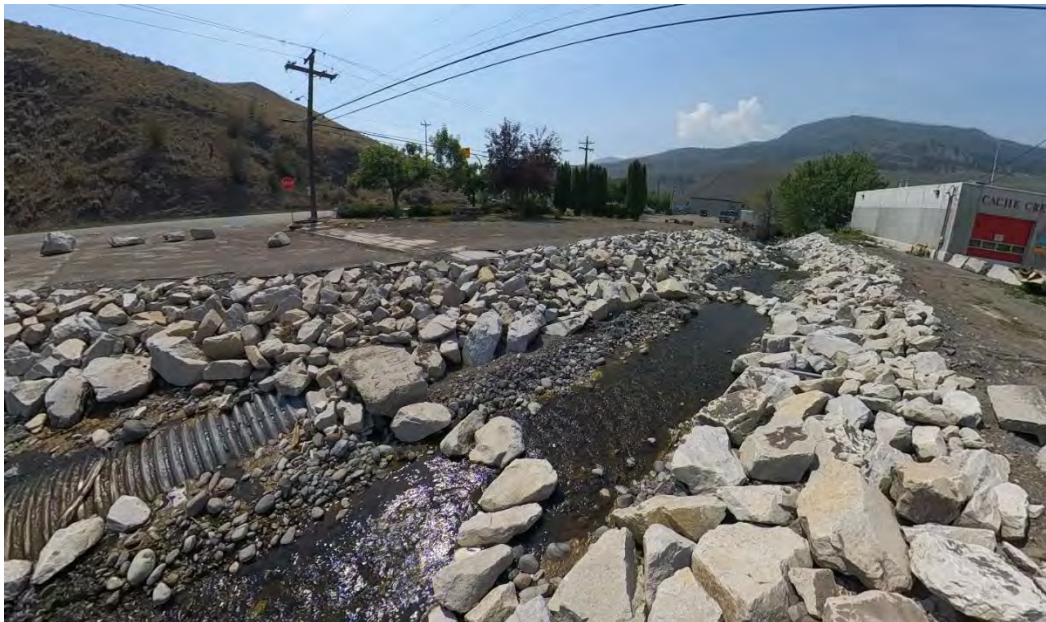
Reach 2 Site 2 destroyed former Quartz Rd facing downstream.
