# MINISTRY OF TRANSPORTATION AND INFRASTRUCTURE – HWY 97 CACHE CREEK CULVERT REPLACEMENT

## ENVIRONMENTAL MANAGEMENT PLAN

August 14, 2023

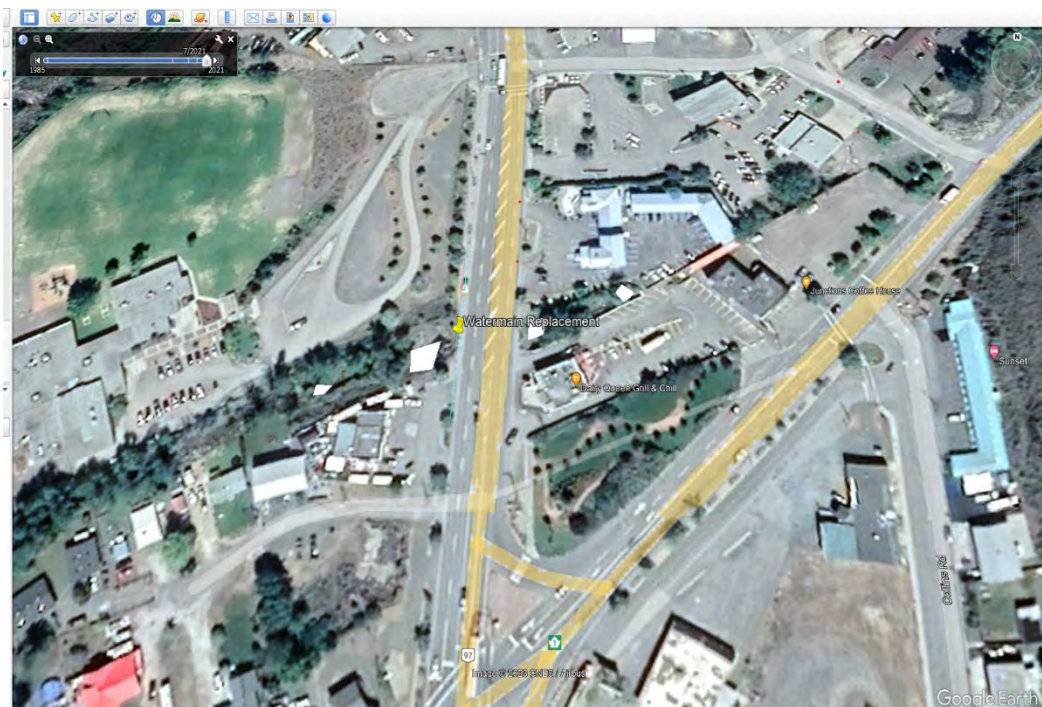
**Figure 1 – Proposed Spawning Deterrent Locations**

Spawning deterrent mats are to be placed from the upstream end of the Cache Creek Inn culvert to the project boundary approximately 80-meters downstream of the Highway 97 culvert. Mats will be placed within these boundaries where the gravel, water depth and velocity fit the definition of suitable spawning requirements for the fish species listed above as per the Department of Fisheries and Oceans Canada (approximate locations shown on Figure 1). Notably, spawning deterrents will be placed within the creek at the outflow pools of both the Cache Creek Inn and Highway 97 culverts. Spawning deterrents are not to be removed until all spawning activity, if any, has ceased within Cache Creek. Installation and removal of the spawning deterrents will occur by hand. All materials used for the installation of the spawning deterrents are to be removed once spawning season has been completed.

Urban Systems will install the spawning deterrents in early August with use of J-hooks or Wooden stakes pinning the mats to the creek bed as well as boulders or sandbags on top of the mats to ensure it remains flat on the creek bed and does not obstruct the movement of fish through the water column. Once installed, the spawning deterrents will require regular monitoring by a Qualified Environmental Professional (QEP) to ensure they are not obstructing fish passage, effectively preventing fish spawning, and remain stable and laying flat on the creek bed. The spawning deterrents will be strategically placed in areas of suitable spawning habitat within Cache Creek based on the results of the Fish Habitat Assessment, as well as with guidance from Urban Systems' senior fisheries biologist.

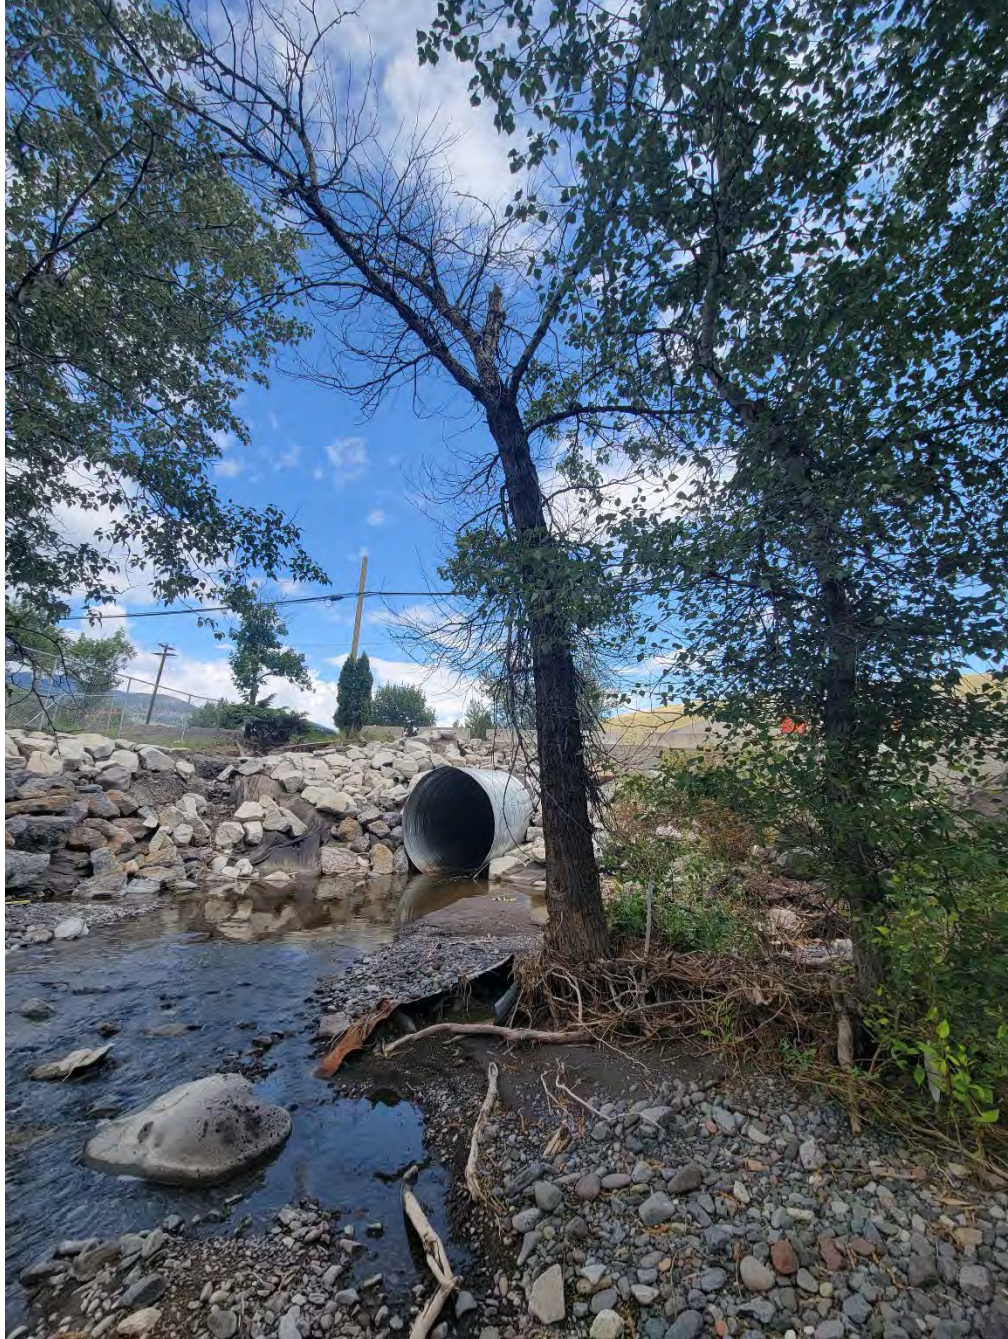
Highway 97 culvert and Reach 1 Site 2 deep pool-facing northeast.

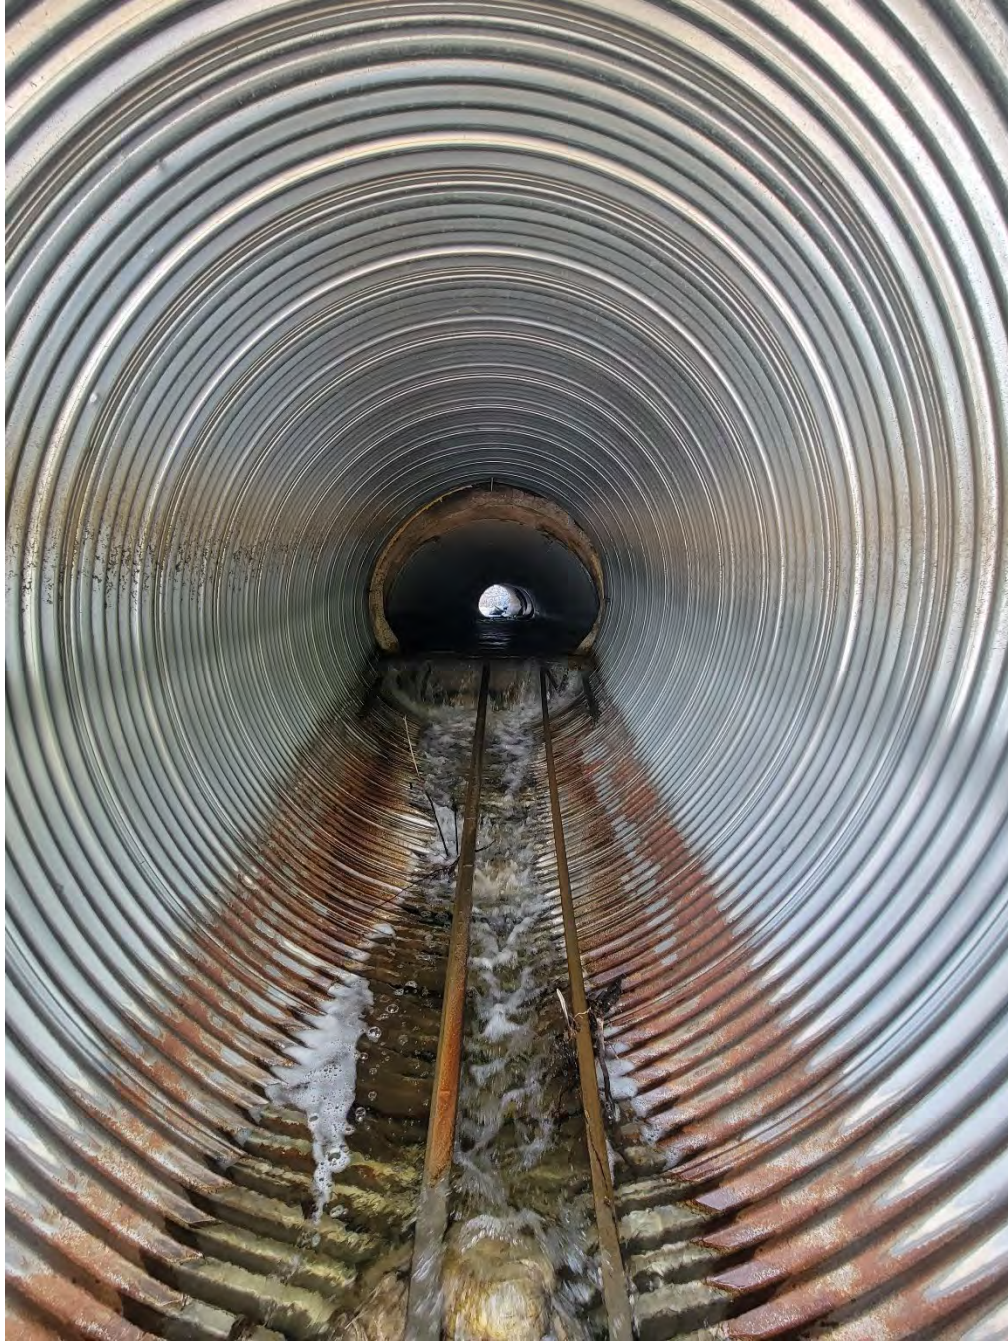
Highway 97 culvert facing upstream-northeast.

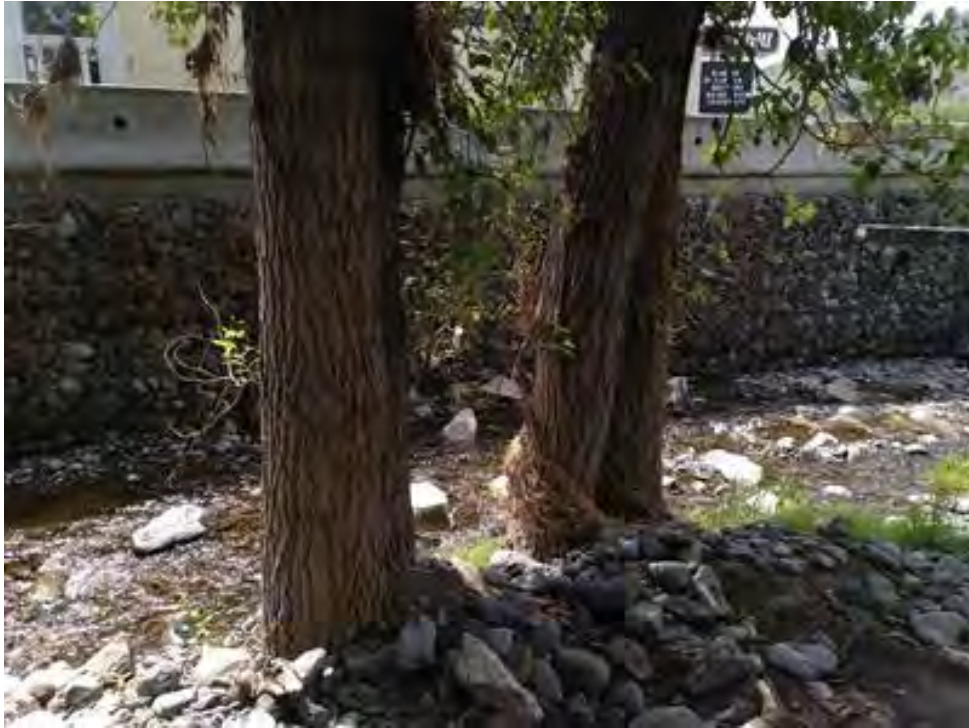
Reach 1-Site 1 cottonwood bunch 1 – to be removed.

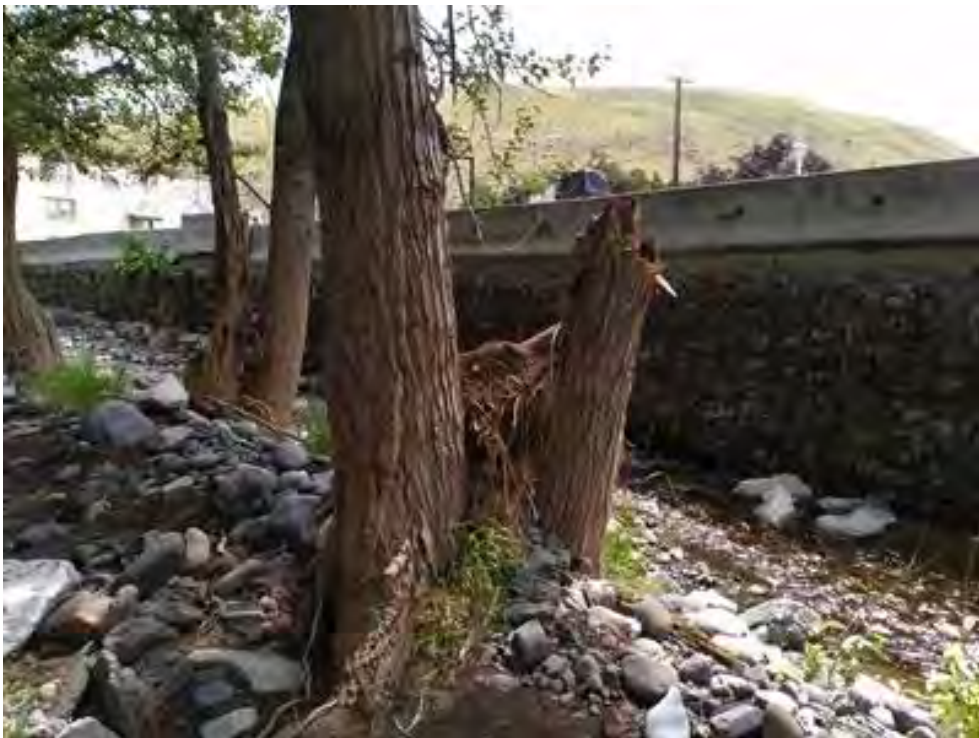
Reach 1 Site 1 cottonwood bunch 2 – to be removed.

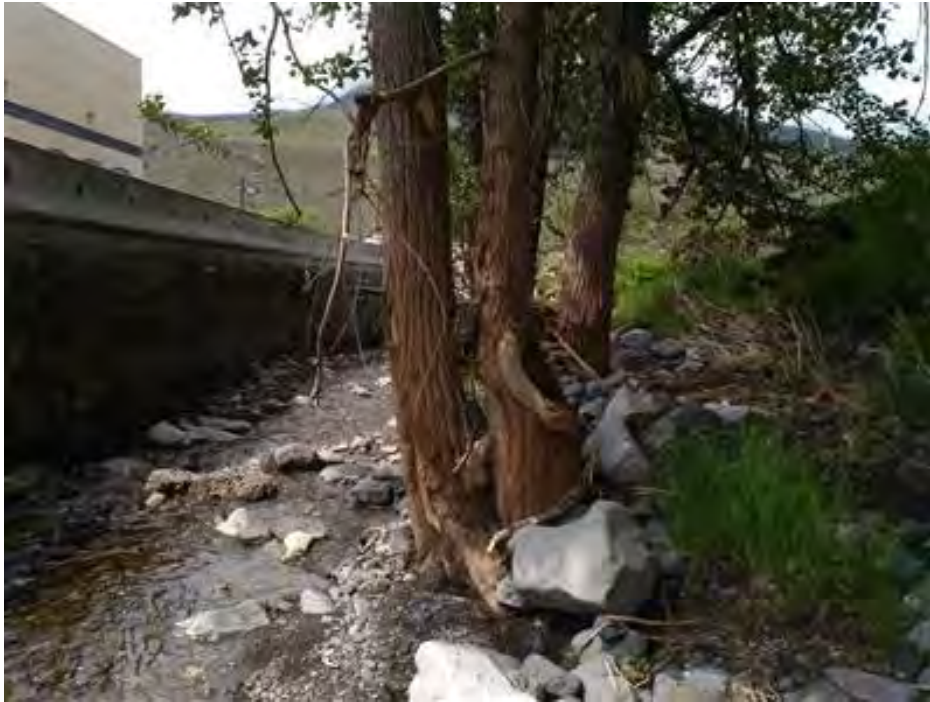
Reach 1 Site 1 cottonwood bunch 3 - to be removed.

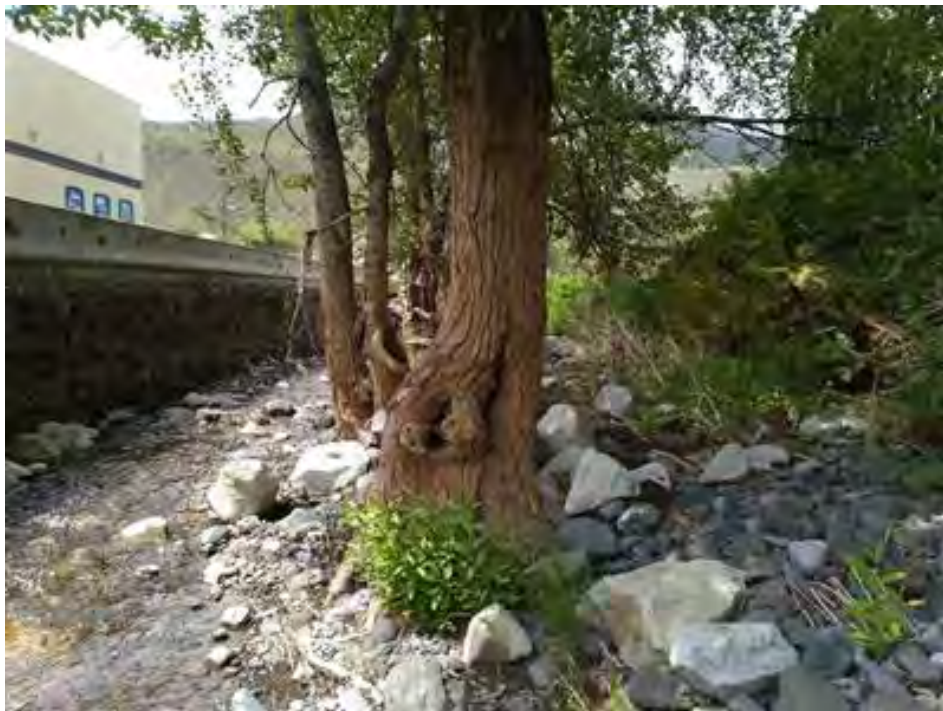
Reach 1 Site 1 cottonwood bunch 4 – to be removed.

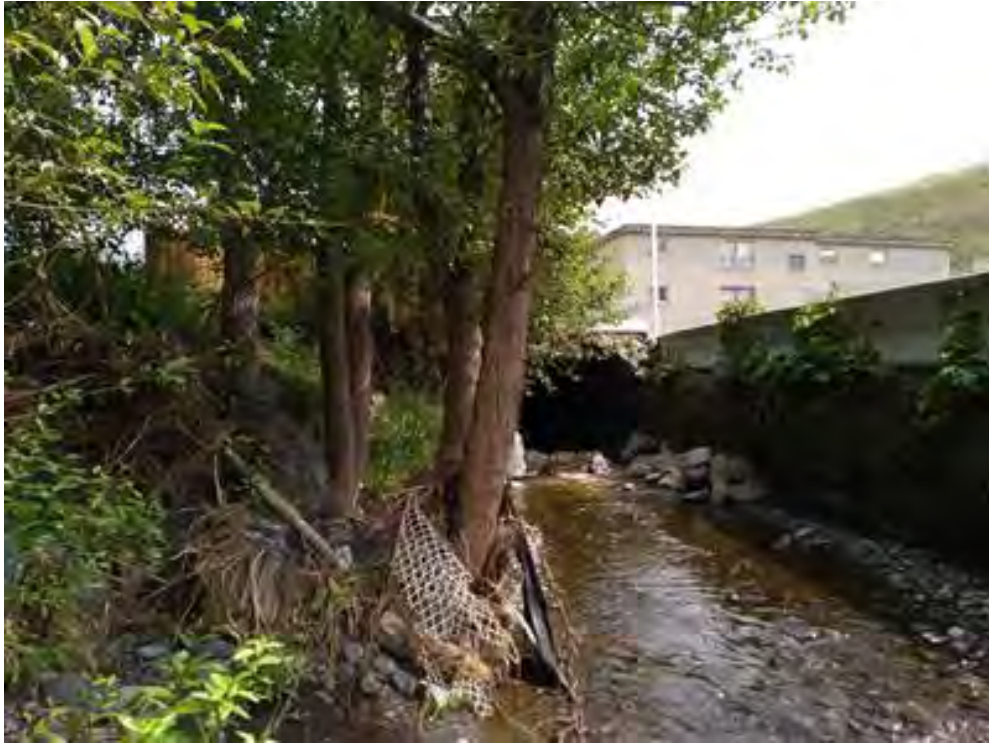
Reach 1 Site 1 cottonwood bunch 5 – to be removed.

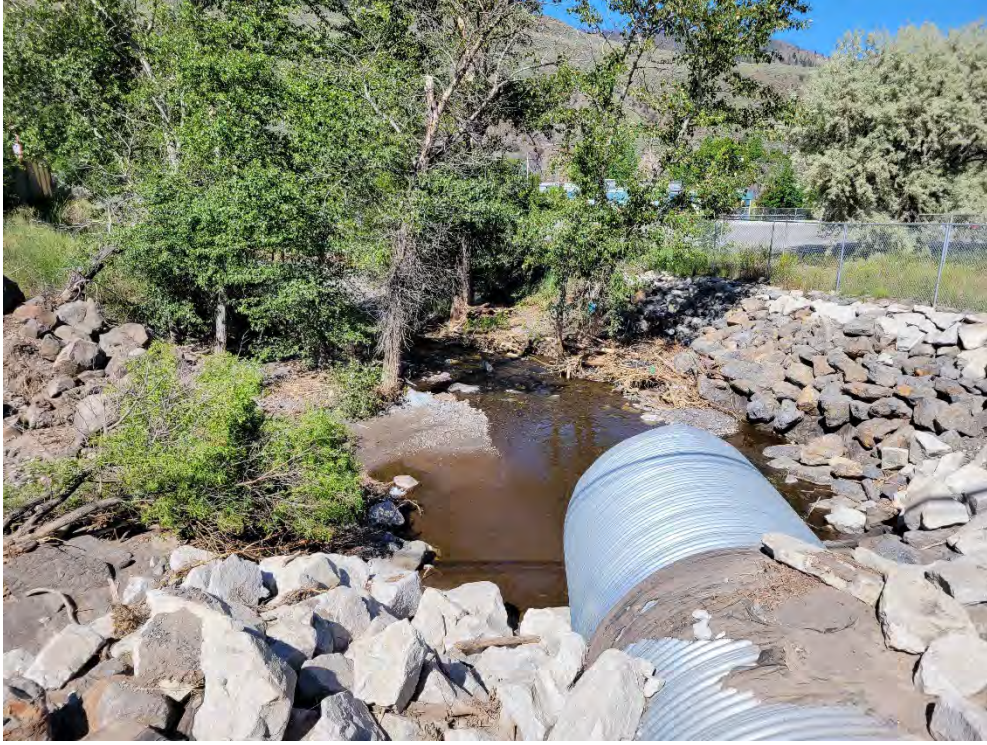
Reach 1 Site 2 deep pool – overwintering habitat – facing southwest.

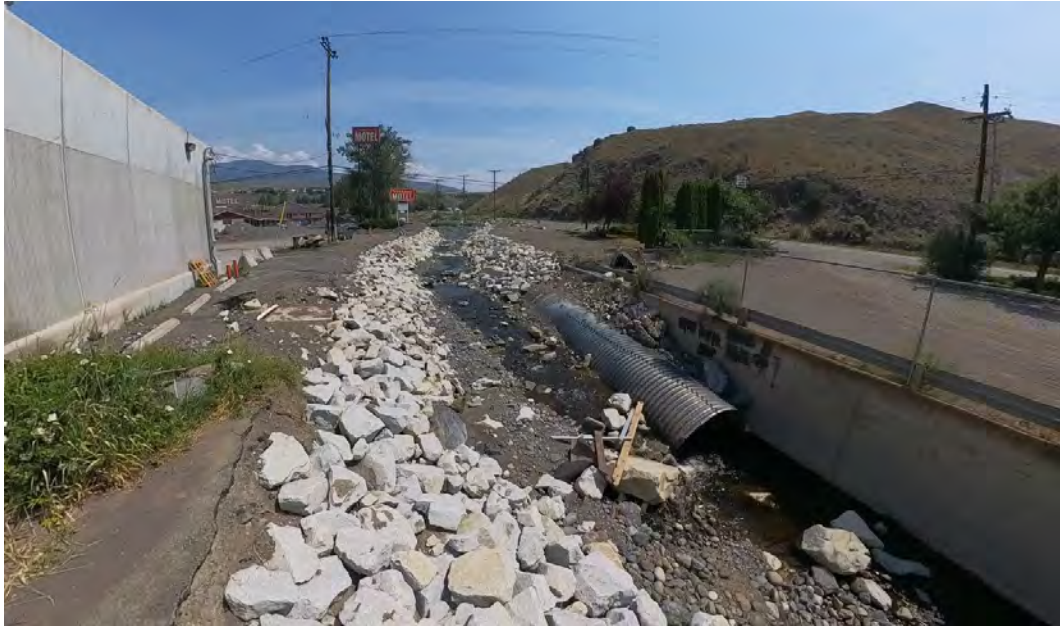
Reach 2 damaged former Quartz Rd culvert and emergency riprap.

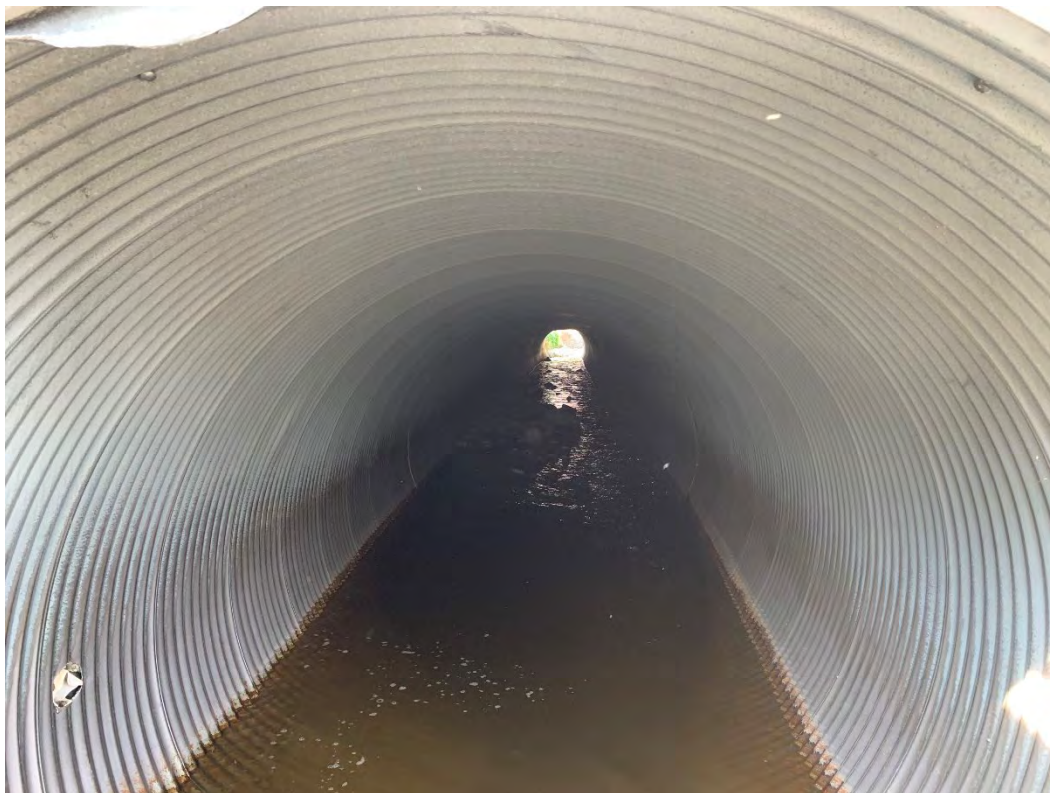
Reach 2 Site 1 Cache Creek Inn culvert – facing downstream.

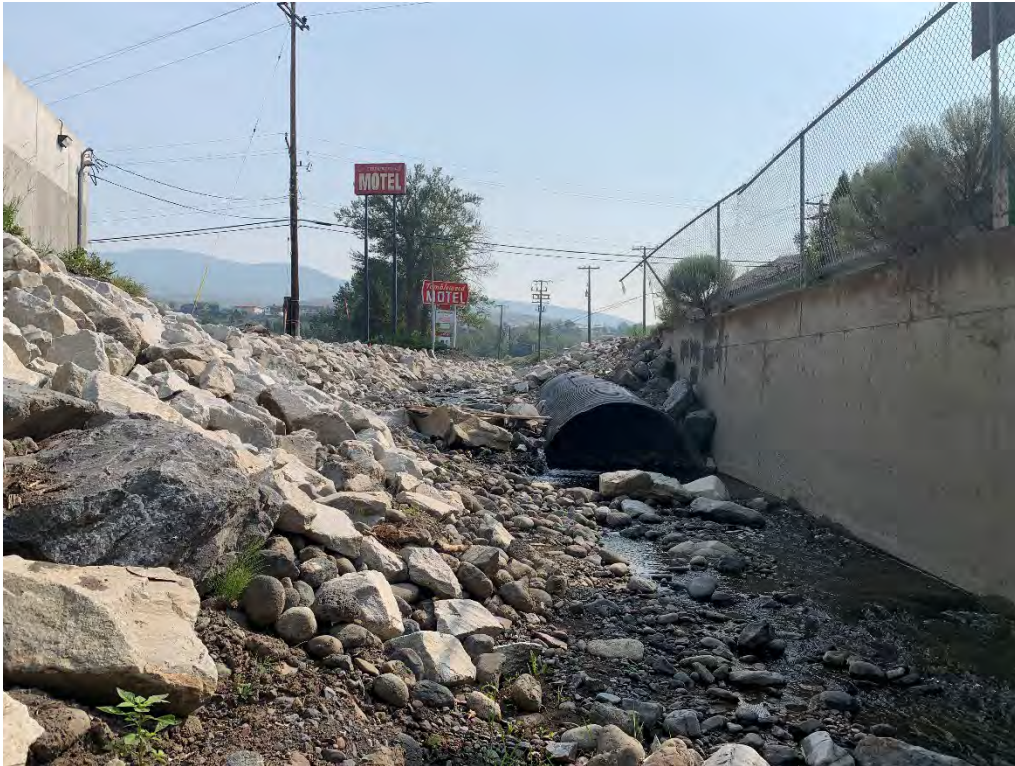
Reach 2 Site 1 washed out Quartz Rd culvert and emergency riprap.

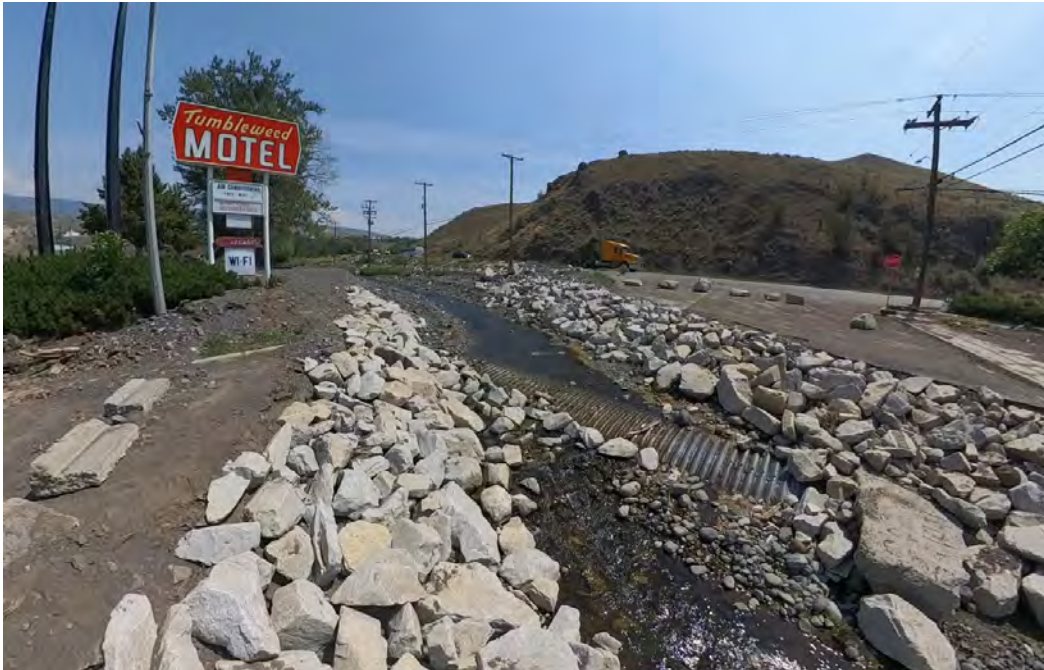
Reach 2 Site 1 destroyed former Quartz Rd facing upstream.
