Trembley Pit No. 2878

December 2023 Technical Information Report

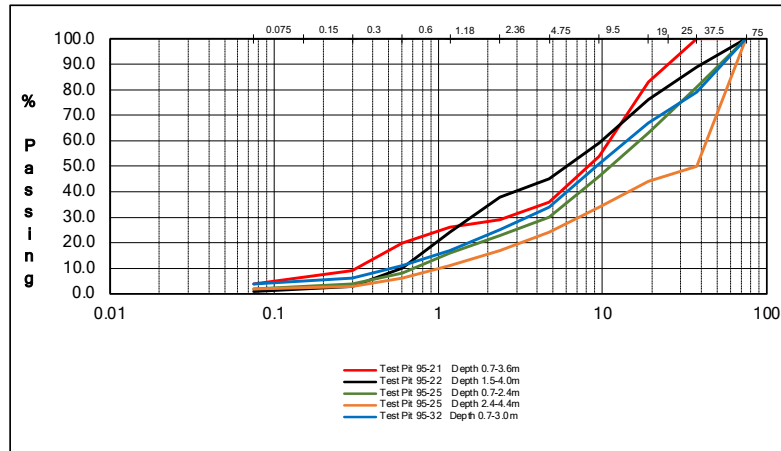
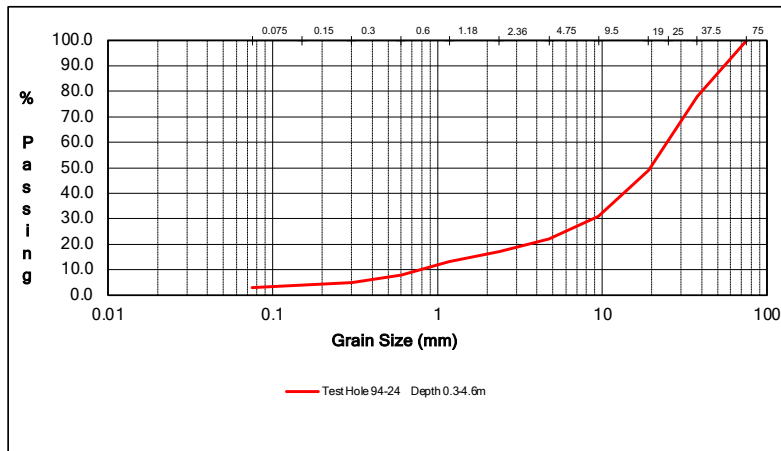
Pit Run Gradation Charts (Not corrected for overdose rock (>75mm)):

Test Pit/Hole	Sample Information	Percent Passing									
		Pit Run Sieve Sizes (mm)									
		75	37.5	19	9.5	4.75	2.36	1.18	0.6	0.3	0.075
Test Pit 95-21	Depth 0.7-3.6m	100.0	83.0	54.0	36.0	29.0	26.0	20.0	9.0	4.0	1.0
Test Pit 95-22	Depth 1.5-4.0m	100.0	89.0	76.0	59.0	45.0	38.0	24.0	10.0	3.0	1.0
Test Pit 95-25	Depth 0.7-2.4m	100.0	81.0	63.0	46.0	30.0	23.0	16.0	8.0	4.0	2.0
Test Pit 95-25	Depth 2.4-4.4m	100.0	50.0	44.0	34.0	24.0	17.0	11.0	6.0	3.0	2.0
Test Pit 95-32	Depth 0.7-3.0m	100.0	79.0	67.0	51.0	34.0	25.0	17.0	11.0	6.0	4.0
Test Hole 94-24	Depth 0.3-4.6m	100.0	78.0	49.0	31.0	22.0	17.0	13.0	8.0	5.0	3.0
	MAXIMUM	100	89.0	76.0	59.0	45.0	38.0	24.0	11.0	6.0	4.0
	MINIMUM	100	50.0	44.0	34.0	24.0	17.0	11.0	6.0	3.0	1.0
	AVERAGE	100.0	76.7	58.8	42.8	30.7	24.3	16.8	8.7	4.2	2.2

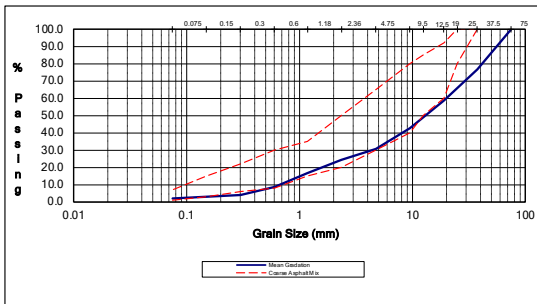
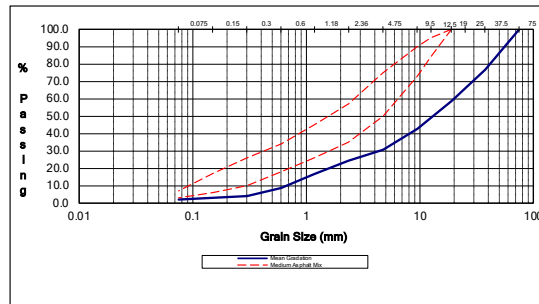
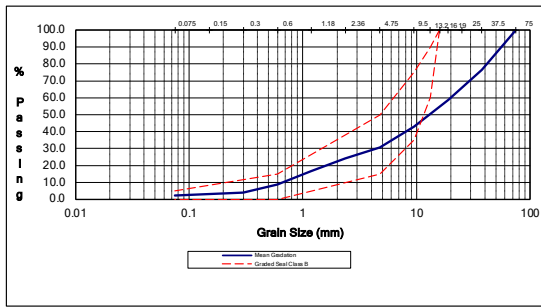
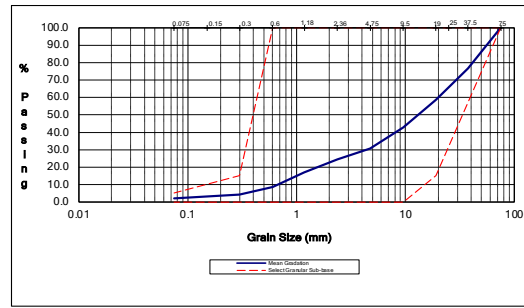
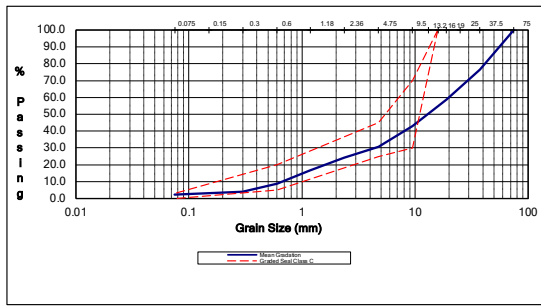
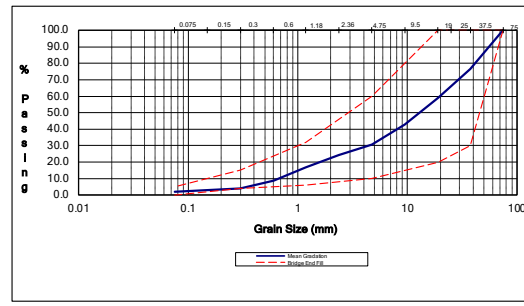
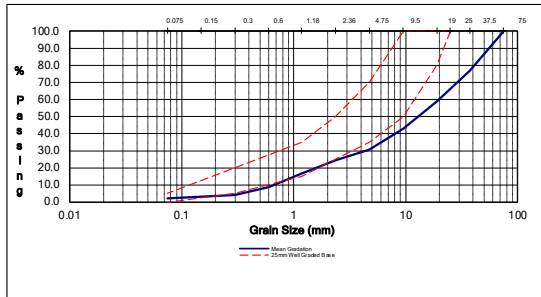
Mean Gradations vs End Product Gradation Specifications:

- Coarse Asphalt Mix
- Medium Asphalt Mix
- Graded Aggregate Seal Class B and C
- 25mm Well Graded Base
- Select Granular Sub base
- Bridge End Fill

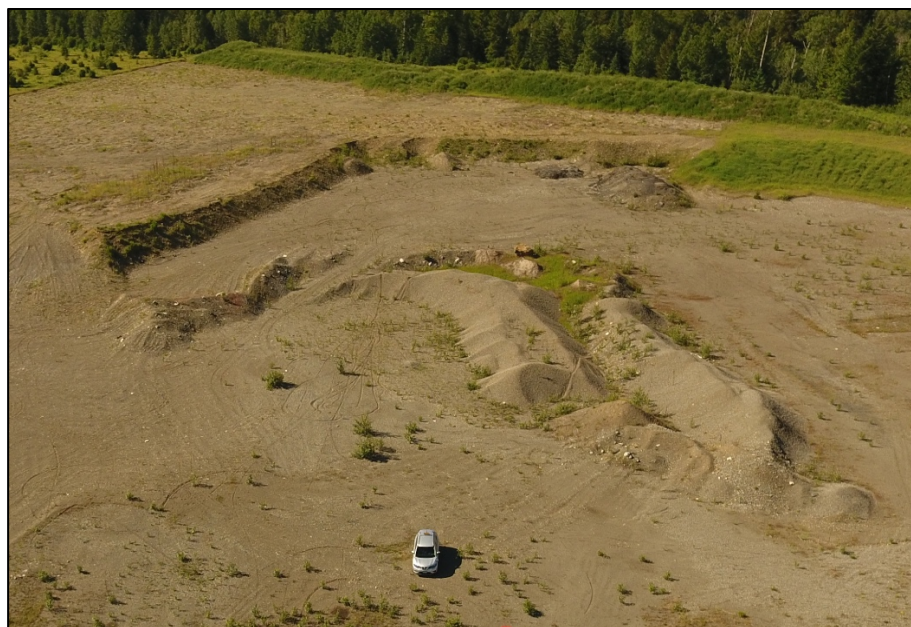
March 2015 Stripped Area Looking South

- The pit was stripped in March of 2015. The pit may require minor clearing of grass or brush that has been established since 2015.
- The crusher is recommended to be located on the existing pit floor northwest of Test Pit 95-25 with mining in a southeast direction.
