Technical Circular T-03/20 Step A Screening Summary – Cariboo Road Recovery Project: Cottonwood Hill Area (the “Site”)

McElhanney Ltd. was retained by the BC Ministry of Transportation and Infrastructure (MOTI) to complete a Step A Screening Summary Letter in accordance with *Technical Circular T-03/20¹* for the Cariboo Road Recovery Project (the Project): Cottonwood Hill Area near Quesnel, BC (the Site).

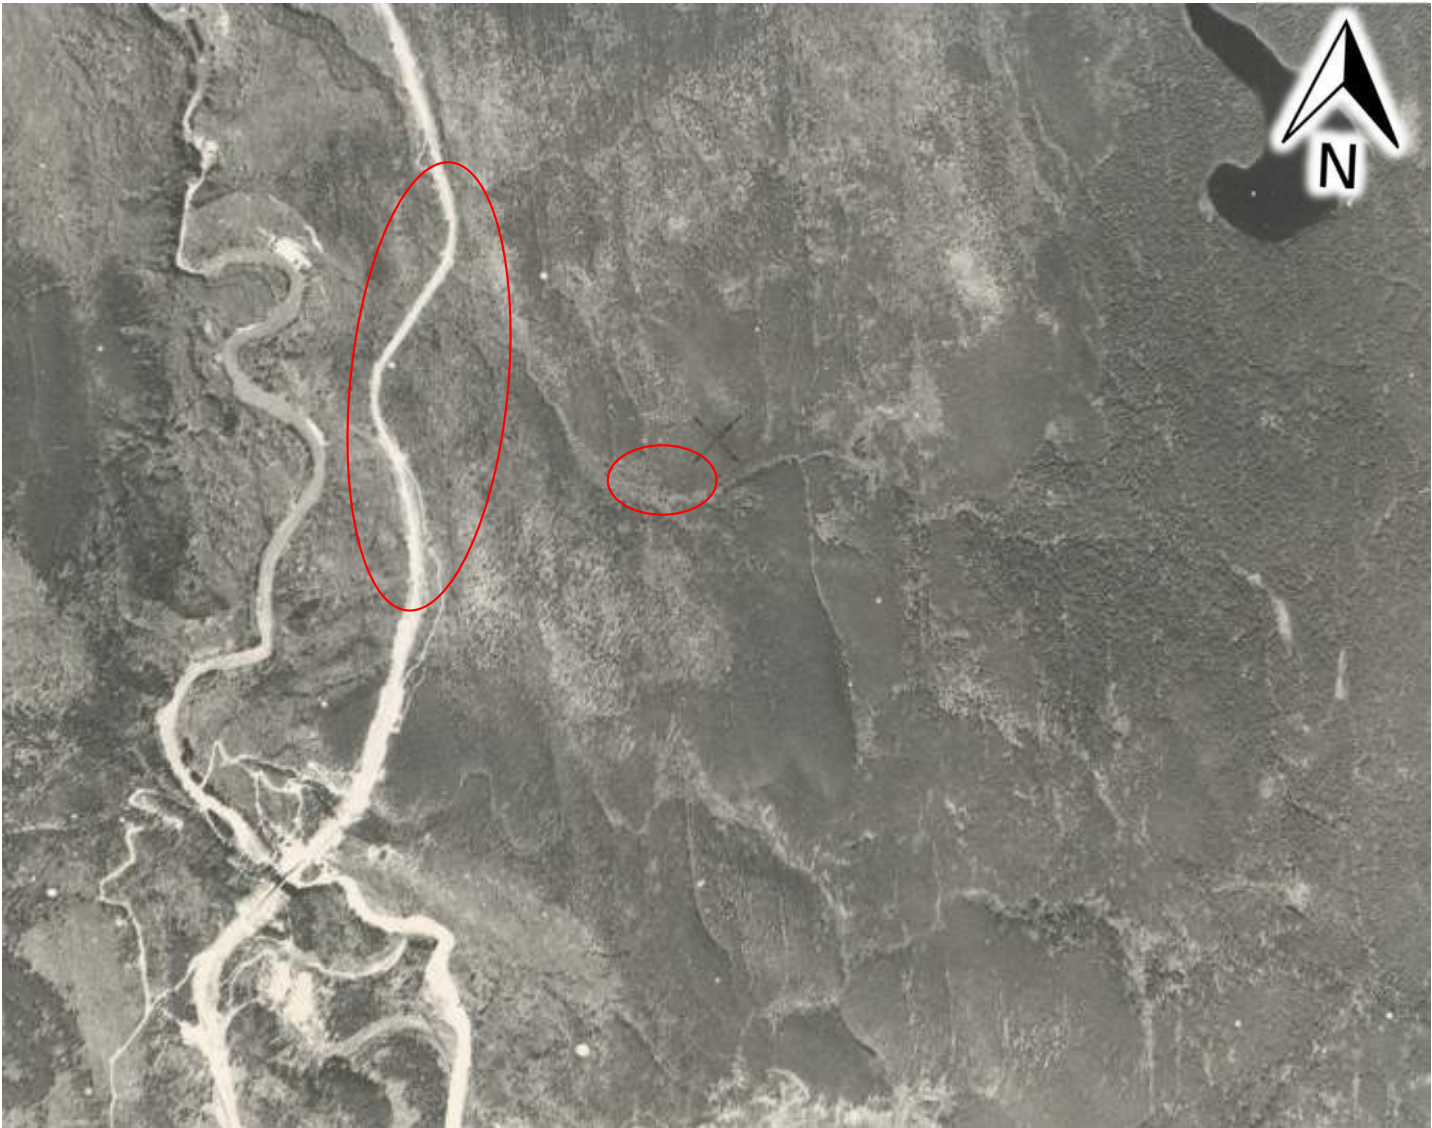
Photograph Reference: 1953 BC1641-1
Photograph Year: 1953
Interpreted by: A. Bergen
Reviewed by: Gary Lin

The Site: Highway 97 has been developed and is outlined in red. The Umiti Pit Road Area has not been developed

The Surrounding Area: Cottonwood River is visible to the west of the Site. The surrounding area is forested

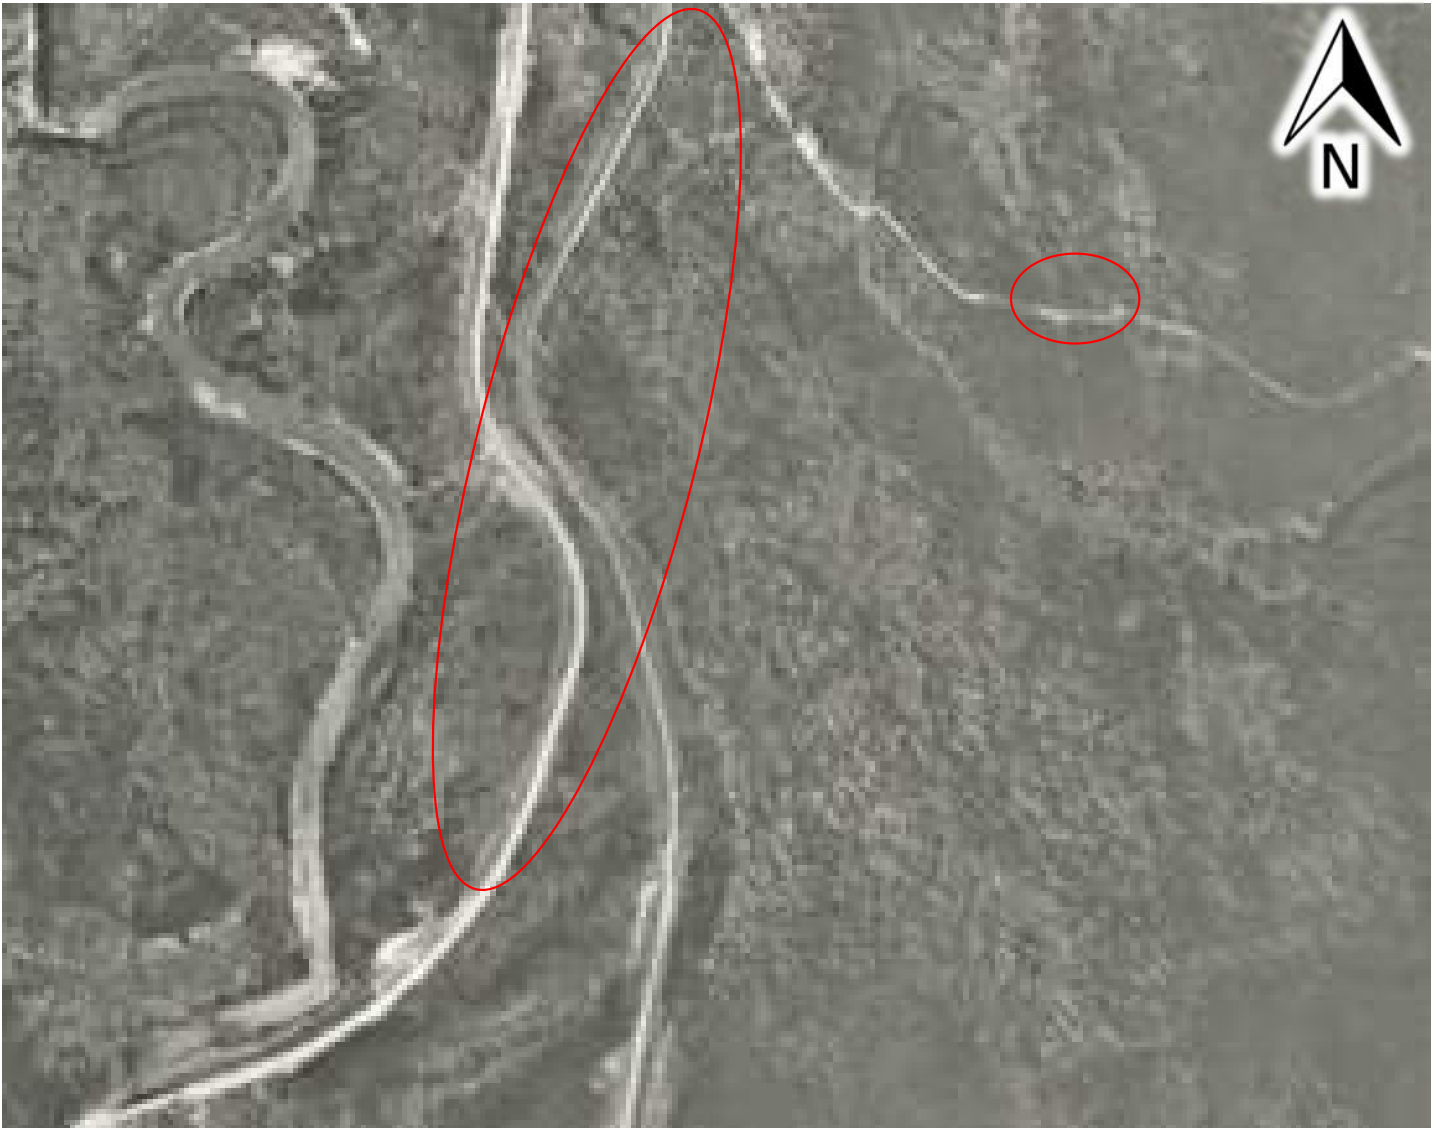
Photograph Reference: 1963-BC5067-4

The Site: The Site remains similar to previous photos.

The Surrounding Area: A power line ROW has been constructed, running from the southwest to the northeast.

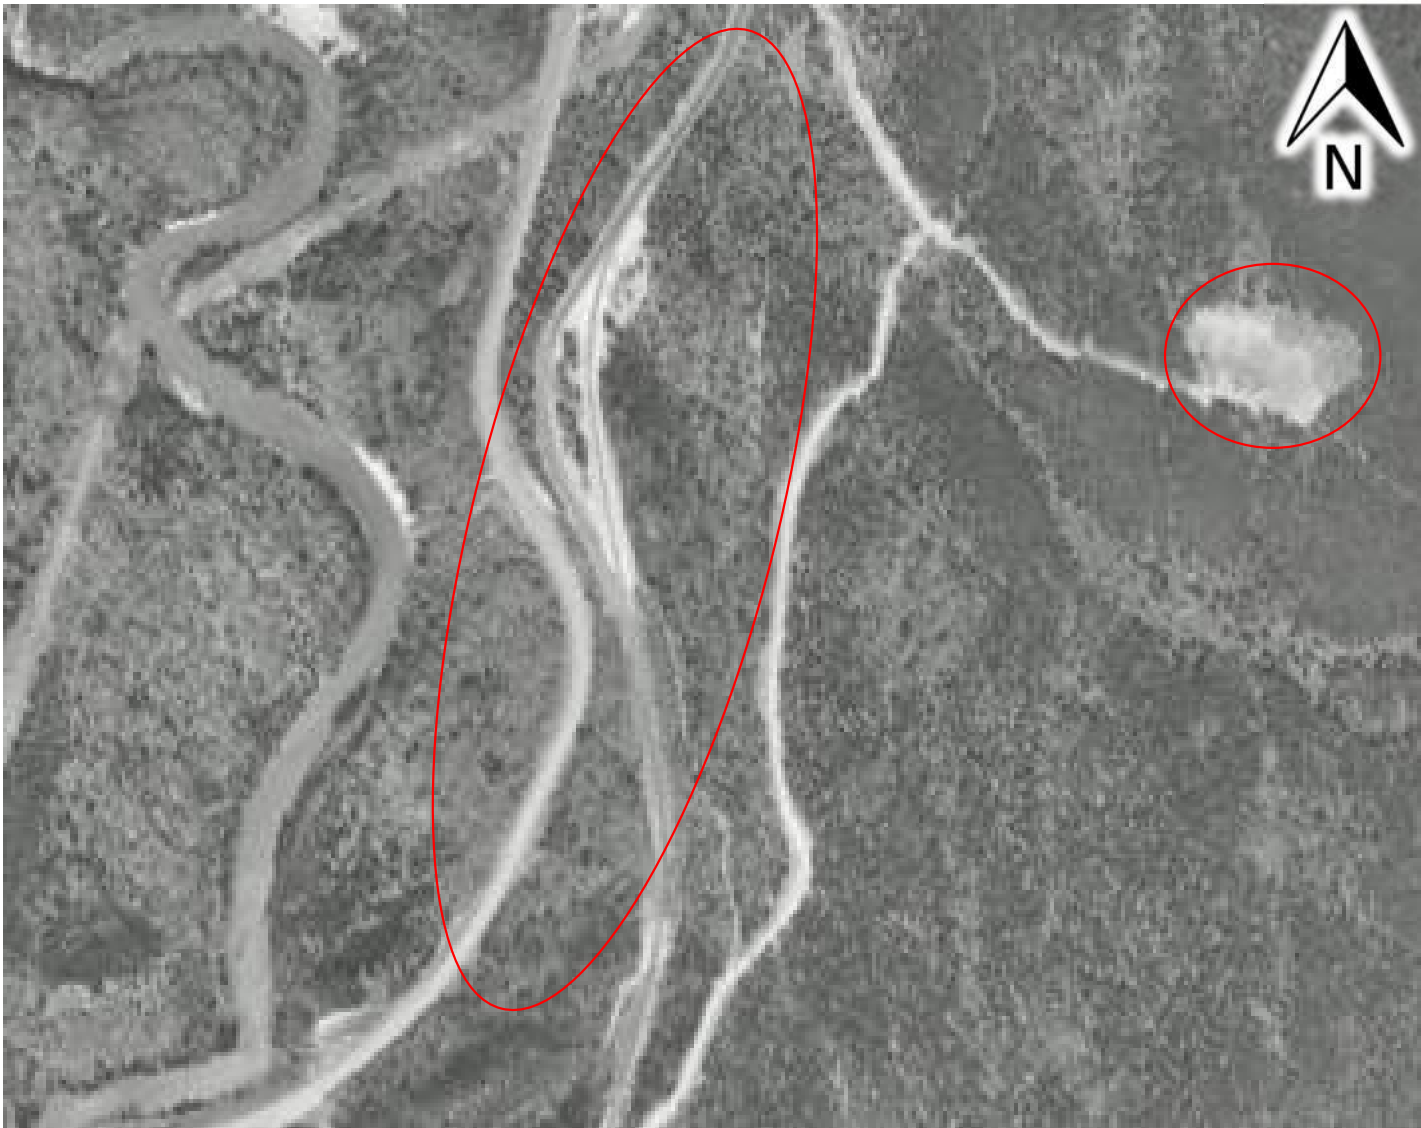
Photograph Reference: 1980-30BC80014-037

The Site: The Highway 97 area remains similar to previous photos. The Umiti Pit Road area has been cleared.

The Surrounding Area: The CN Railway has had a new junction put in. A new road is visible running north to south from Umiti Pit Road.

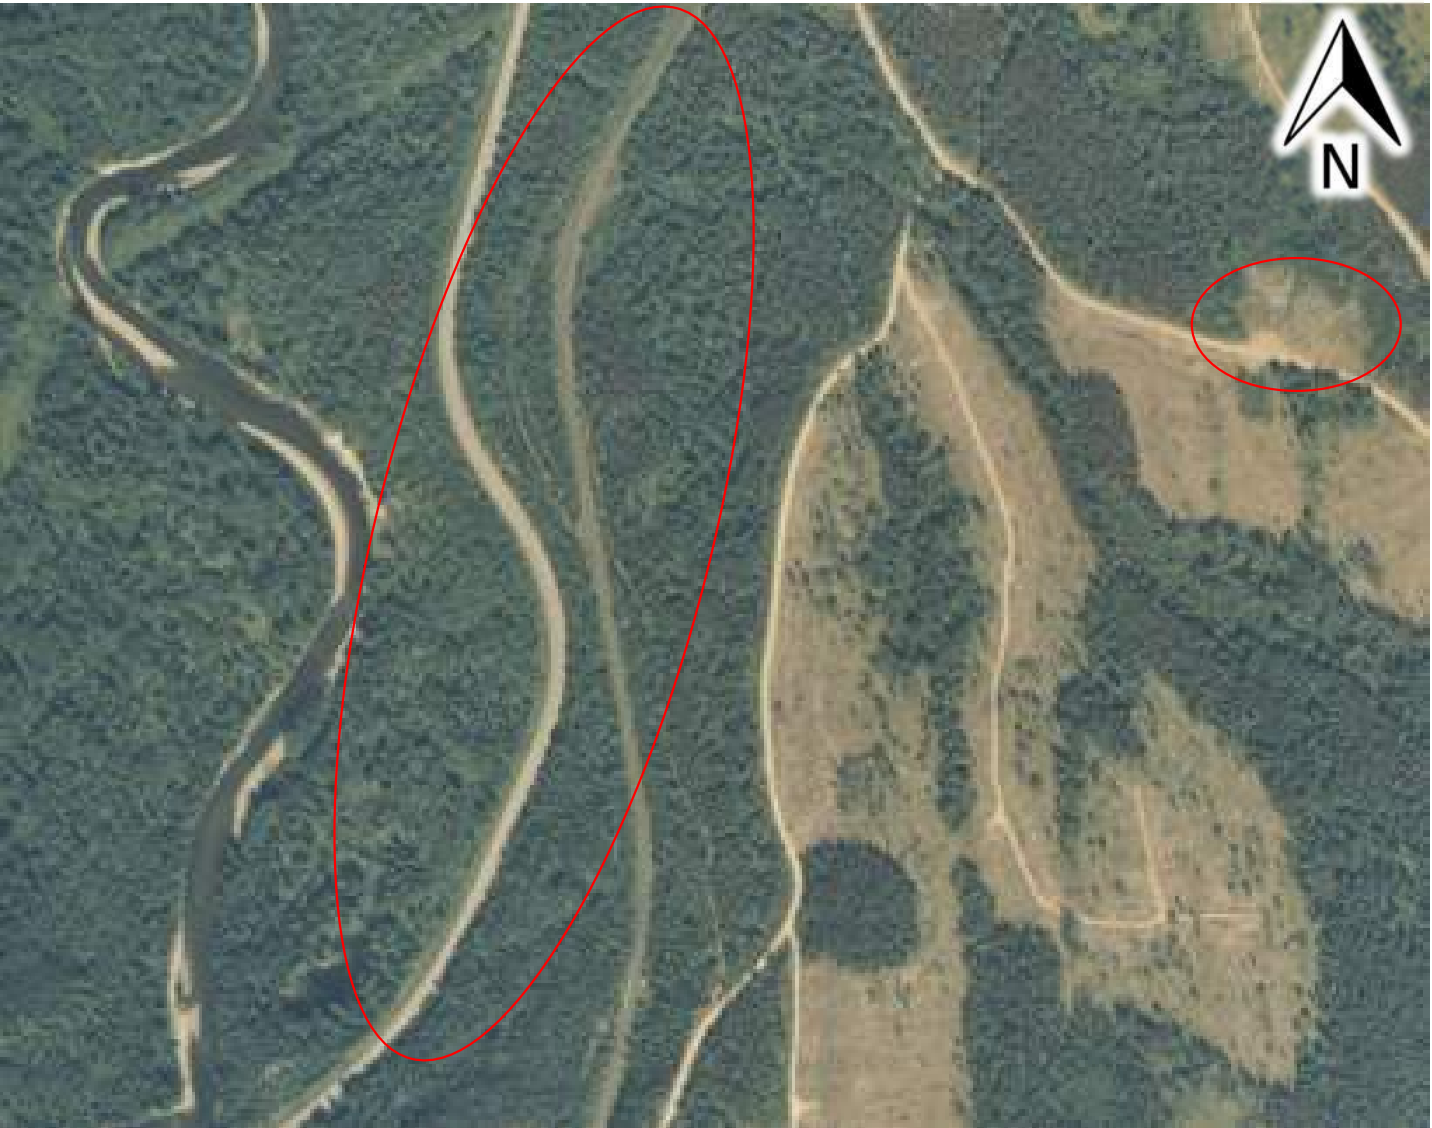
Photograph Reference: 2005-30BCC05060-099

The Site: The Site remains similar to previous photos.

The Surrounding Area: There is new clearing south of the Umiti Pit Road area, and several offshoots from the main road..

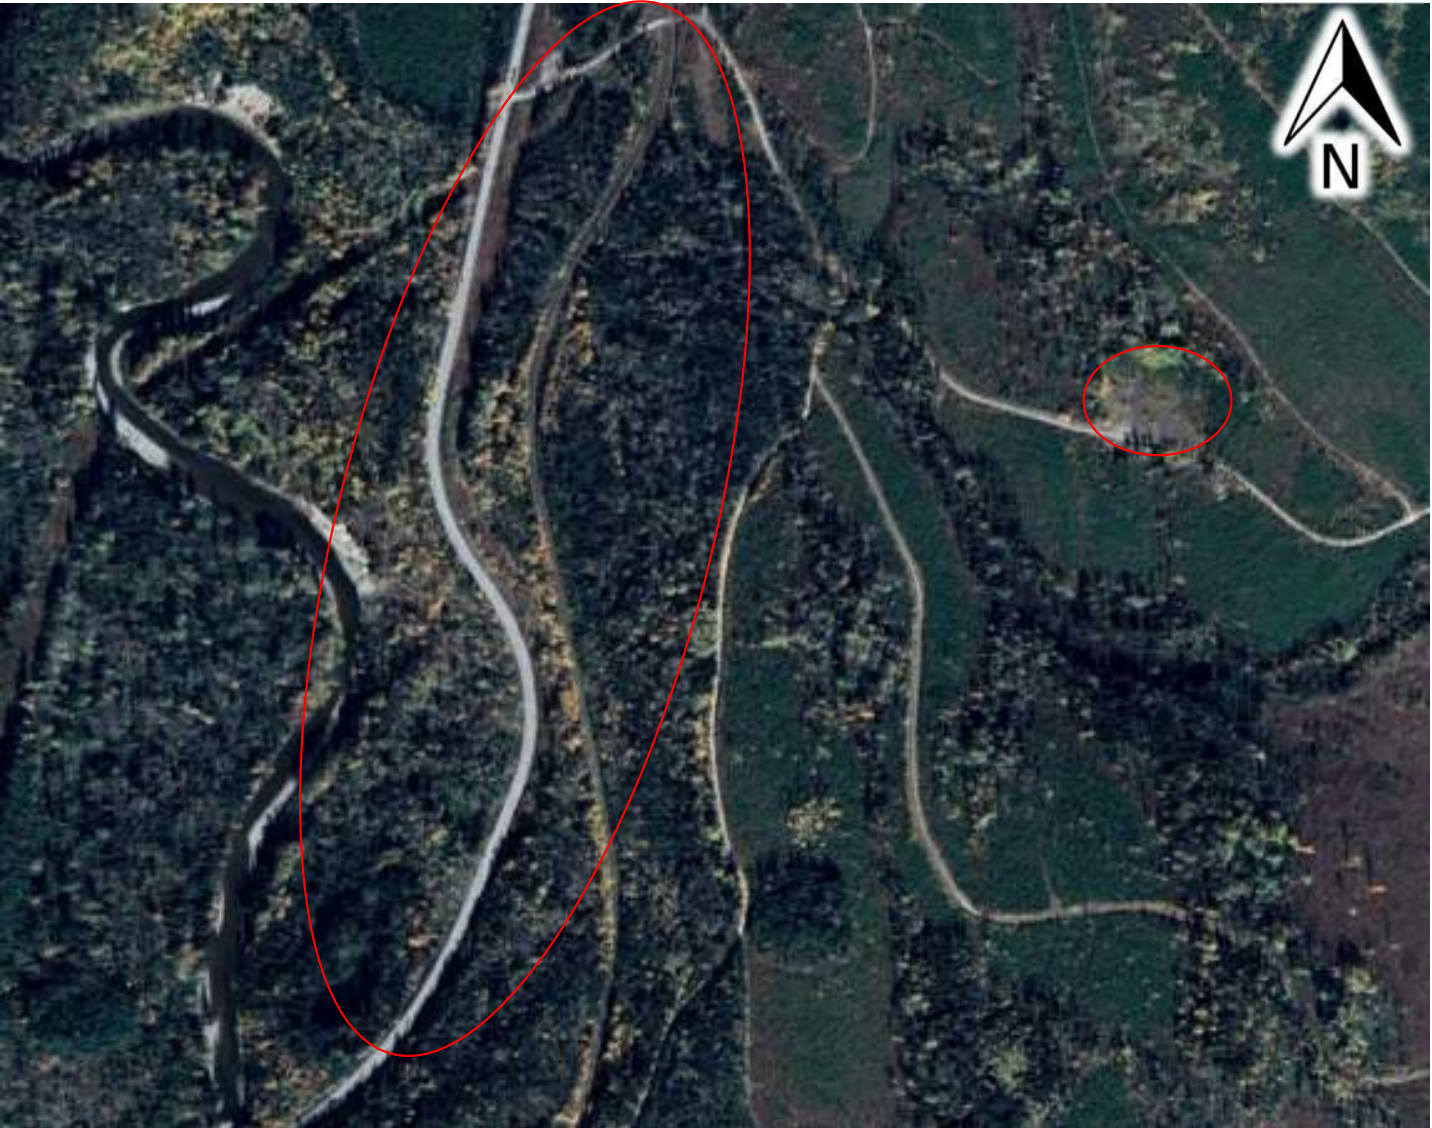
Photograph Reference: Google Earth 2018
Photograph Year: 2018
Interpreted by: A. Bergen
Reviewed by: Gary Lin

The Site: The Site remains similar to previous photos.

The Surrounding Area: The surrounding area remains similar to previous photos.

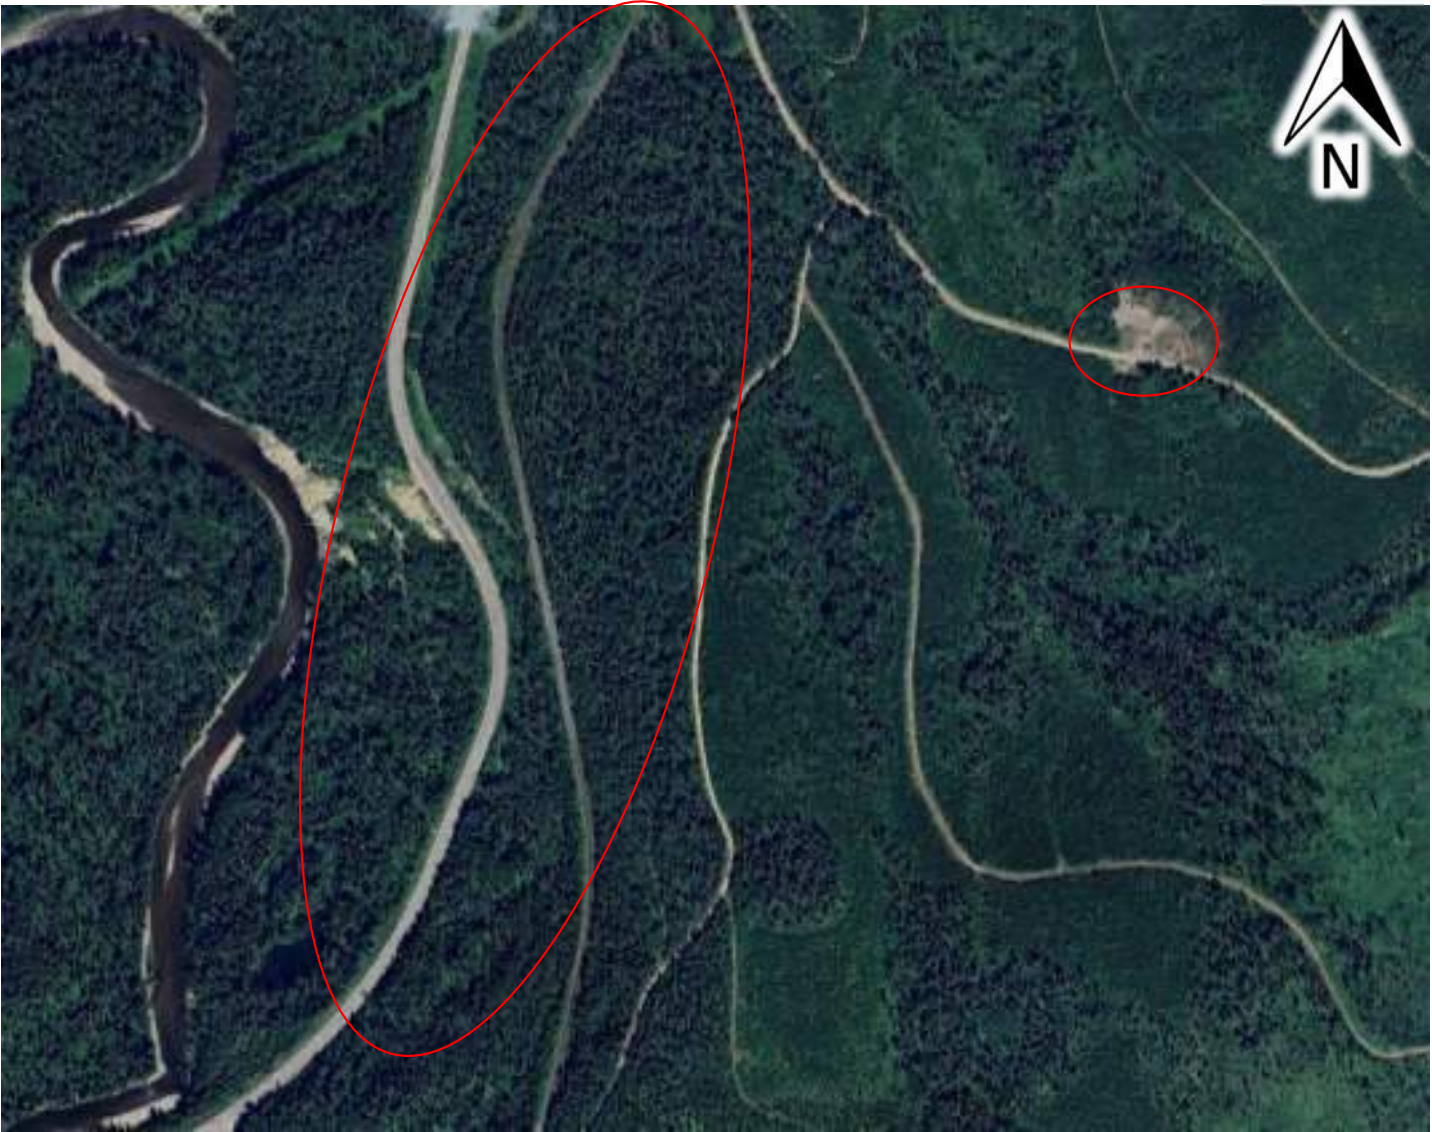
Photograph Reference: Google Earth 2022
Photograph Year: 2022
Interpreted by: A. Bergen
Reviewed by: Gary Lin

The Site: The Site remains similar to previous photos.

The Surrounding Area: The surrounding area remains similar to previous photos.

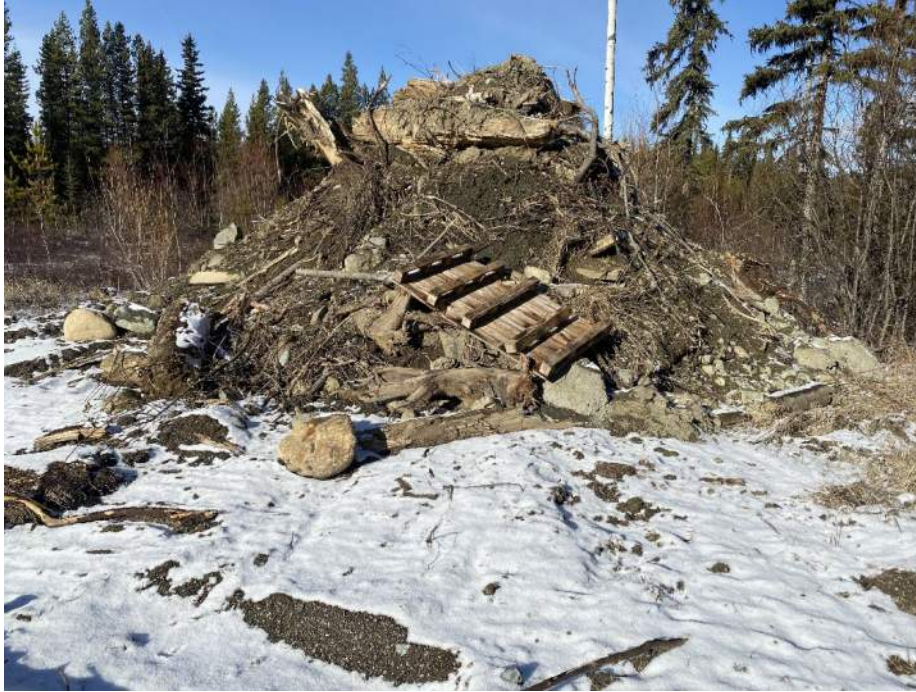
Photo 1: View of soil stockpiled west of the Highway 97 Area as a result of clearing. No evidence of contamination is visible. (February 9, 2024).

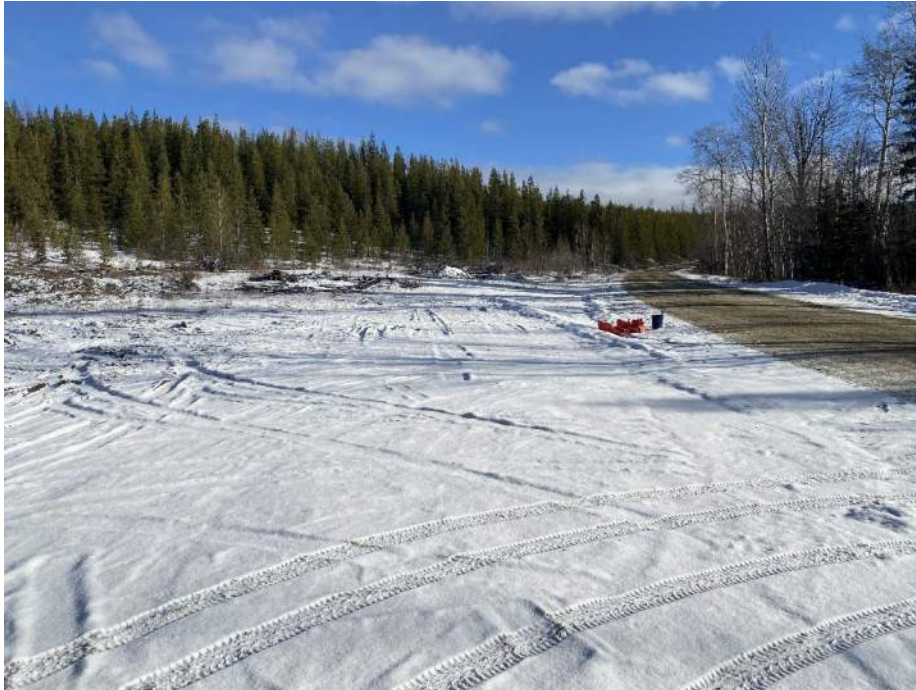
Photo 2: View of Umiti Pit Road clearing area with some debris visible, facing east. (February 9, 2024).

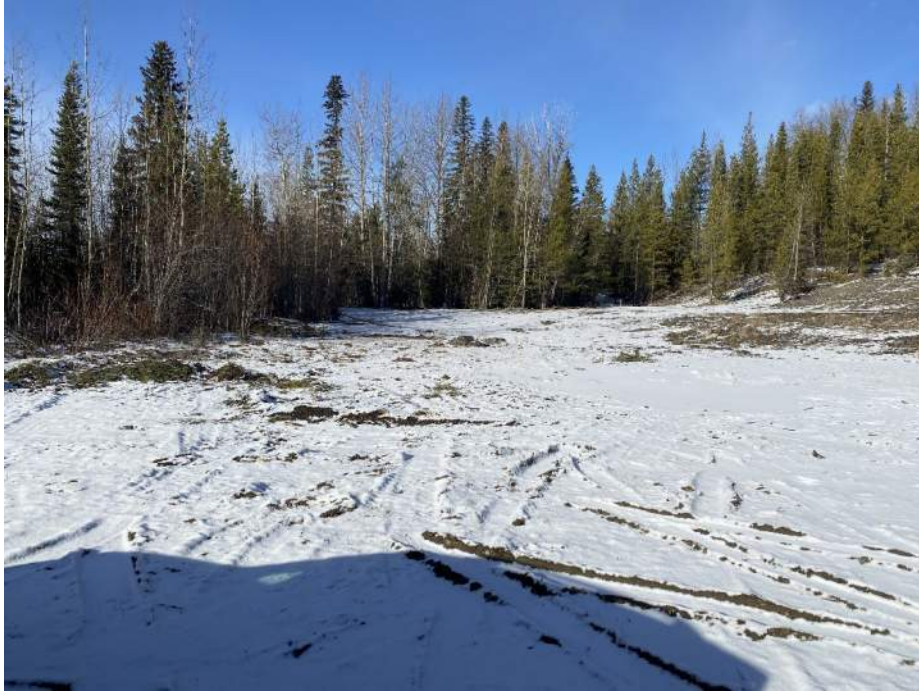
Photo 3: View of Umiti Pit Road clearing area, facing west-northwest. (February 9, 2024).

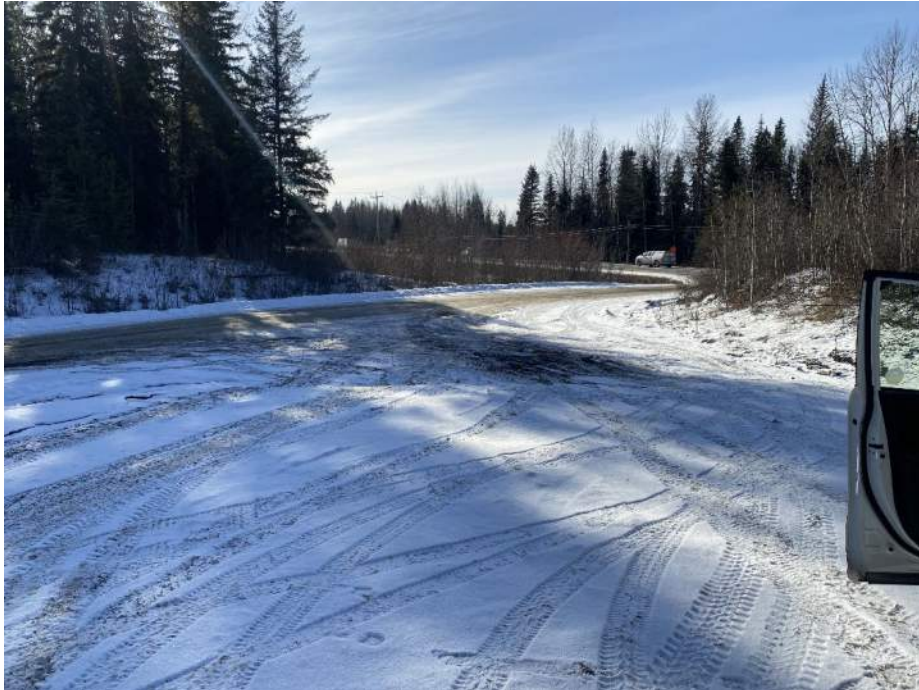
Photo 4: View of Highway 97 from Umiti Pit Road Entrance, facing southwest. (February 9, 2024).
