**BC MINISTRY OF TRANSPORTATION AND
INFRASTRUCTURE**

DUNN LAKE ROAD

**HYDROTECHNICAL AND GEOMORPHIC
ASSESSMENT**

DATE: May 14, 2021

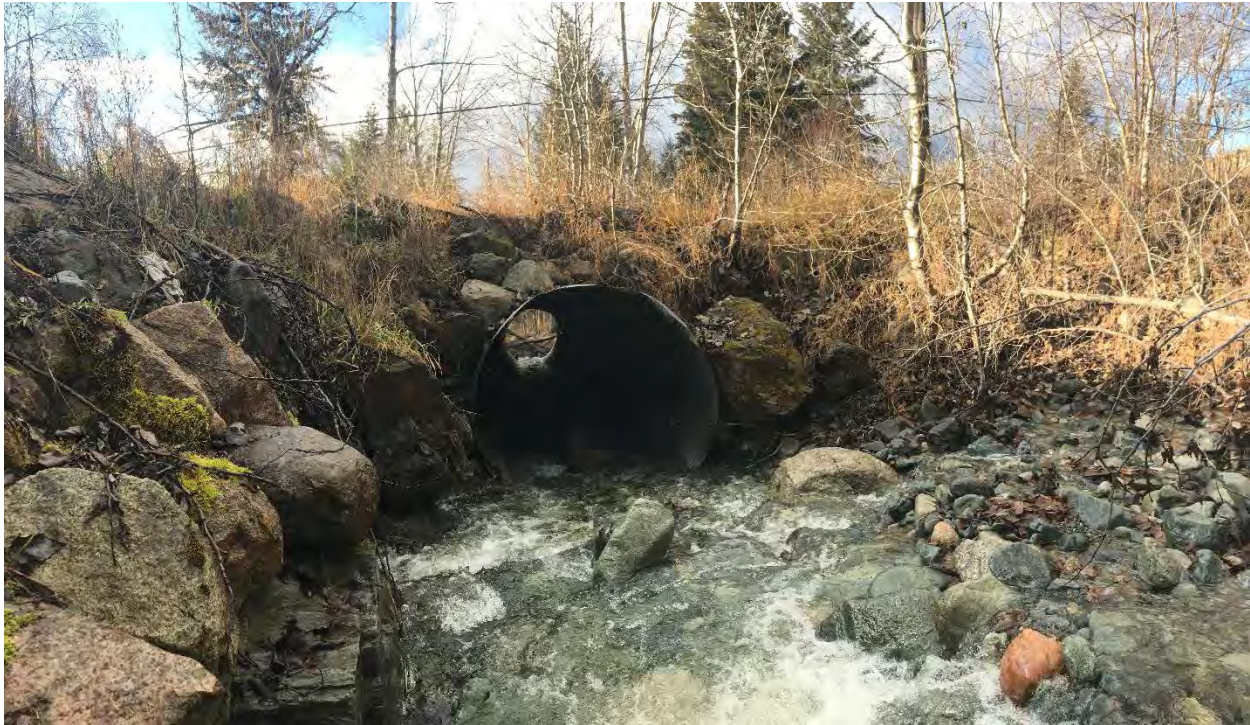
Figure 2-4. Downstream view of 1.8 m diameter CSP culvert inlet on Newhykulston Creek at Dunn Lake Road. BGC photograph of November 28, 2018.

Newhykulston Creek currently crosses Dunn Lake Road at an approximate elevation of 415 m. Here, the creek discharges through a 1.8 m diameter corrugated steel pipe (CSP) culvert (Figure 2-4). A 1 m vertical drop is located at the culvert outlet (Figure 2-5). Downstream at the railway crossing, three culverts have been installed through the rail grade (Figure 2-6). The middle box culvert is the original culvert, with newer steel culverts installed on either side likely to increase flow capacity during peak runoff events. BGC did not visit this lower crossing, so the size of the culverts or date of installation is not known.

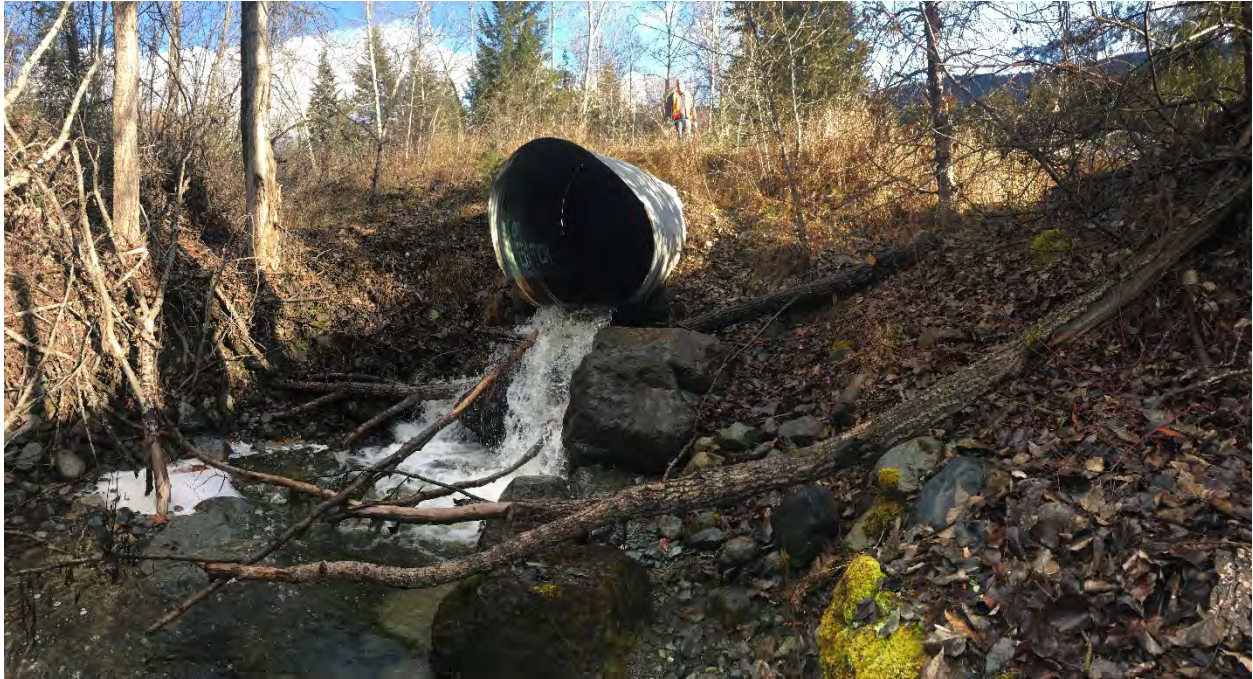
Figure 2-5. Upstream view of Newhykulston Creek culvert outlet at Dunn Lake Road. Note the approximate 1 m drop. BGC photograph of November 28, 2018.

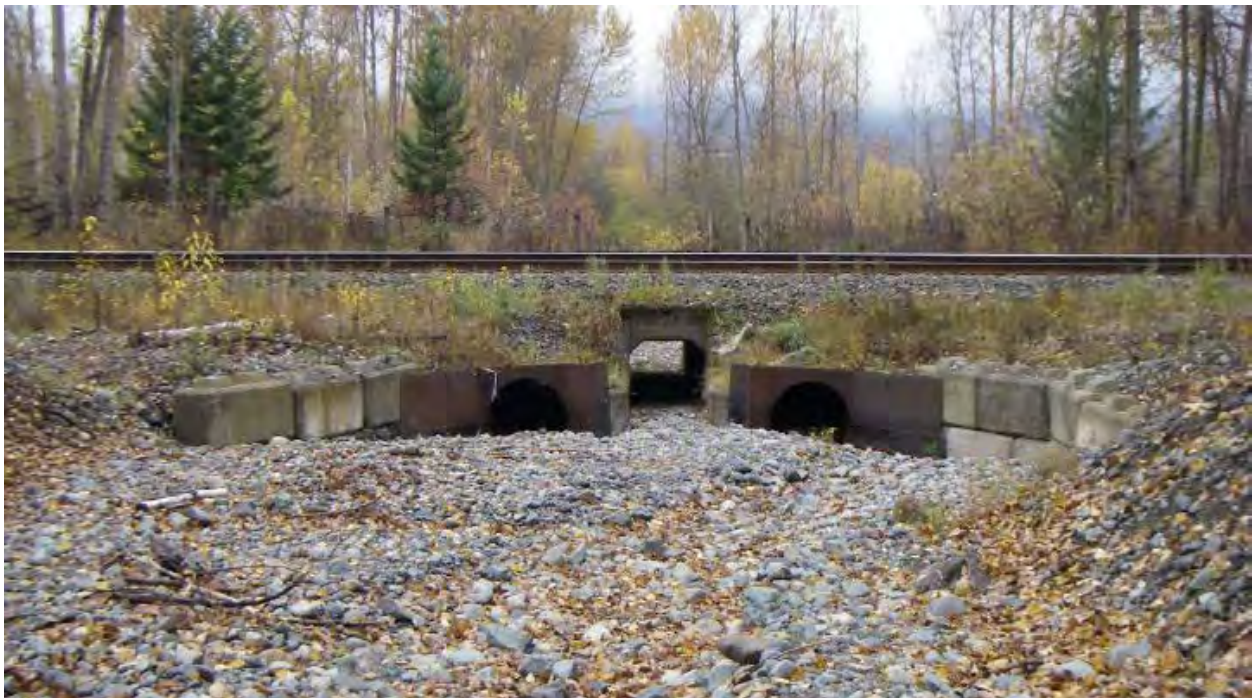
Figure 2-6. Downstream view of Newhykulston Creek at the CN Rail crossing (from M.J. Milne & Associates Ltd., 2012). Channel aggradation appears to be occurring upstream of the crossing.

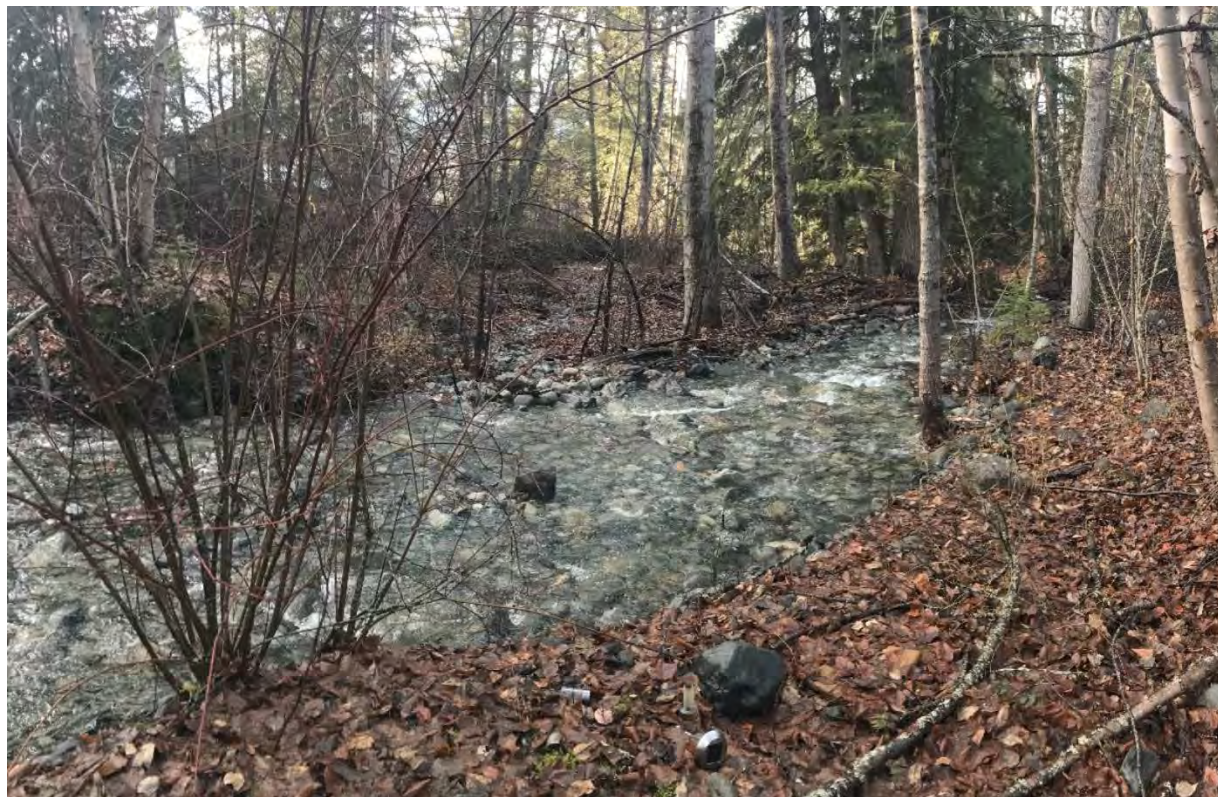
Figure 2-7. Downstream view of Newhykulston Creek approximately 100 m upstream of Dunn Lake Road. BGC photograph of November 28, 2018.

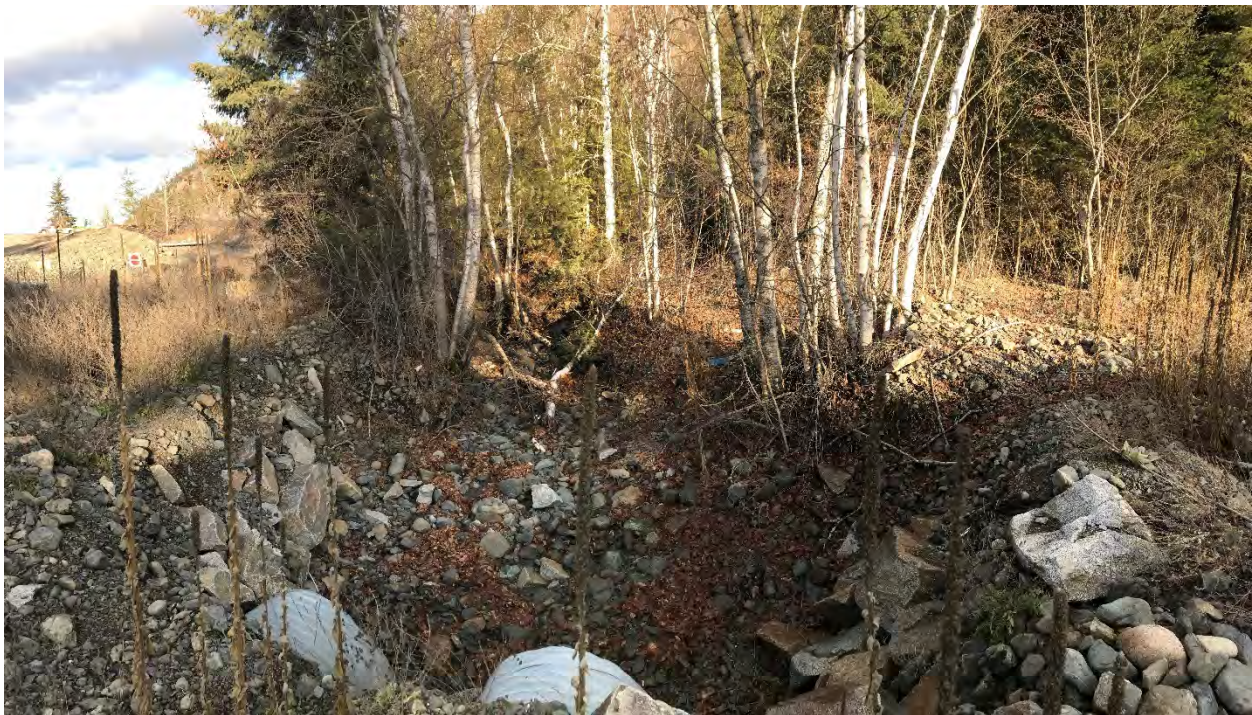
Figure 2-8. Upstream view of Skwootum Creek at Dunn Lake Road. BGC photograph of November 28, 2018.

The quarry occupies more than half of the fan and is located to the north of the creek. At Dunn Lake Road, the creek flows through two 1.2 m diameter steel corrugated steel culverts (Figure 2-8 and Figure 2-9). During BGC's November 28, 2018 site visit, the creek was dry at the Dunn Lake Road crossing but flowing near the fan apex. Between the road and the fan apex, Skwootum Creek is typically 2 m wide.

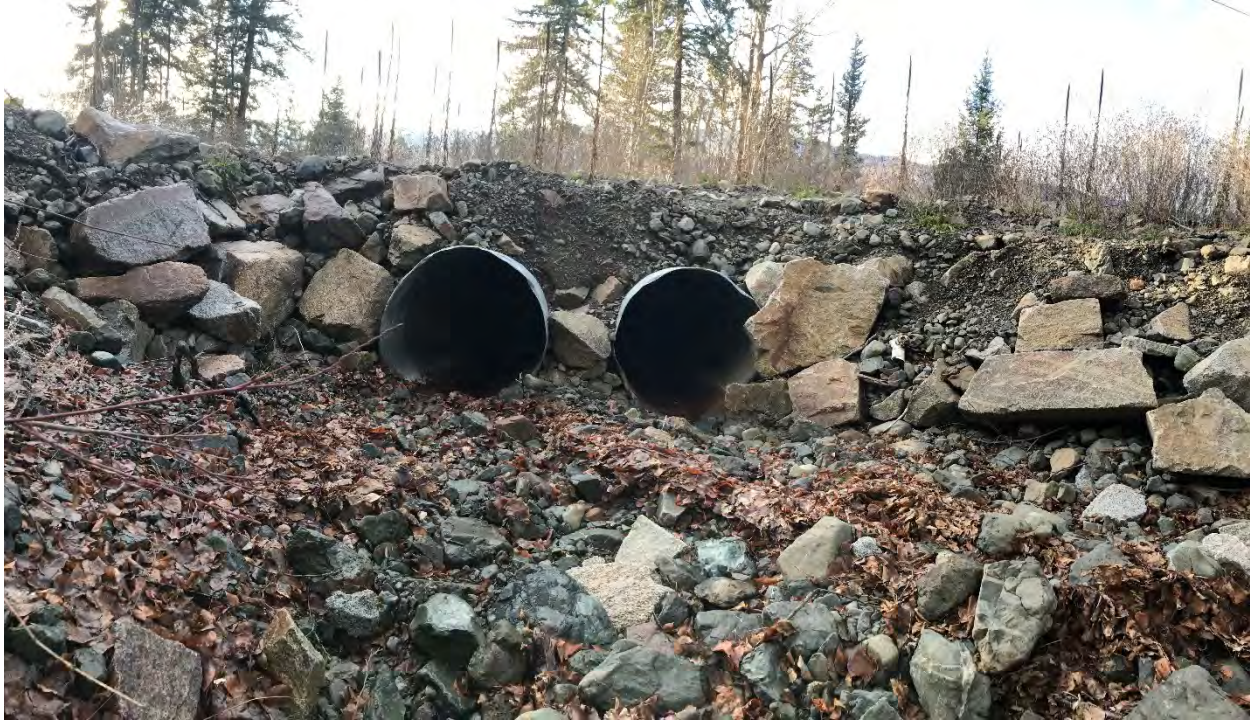
Figure 2-9. Downstream view of Skowootum Creek twin 1.2 m CSP culvert inlets at Dunn Lake Road. BGC photograph of November 28, 2018.

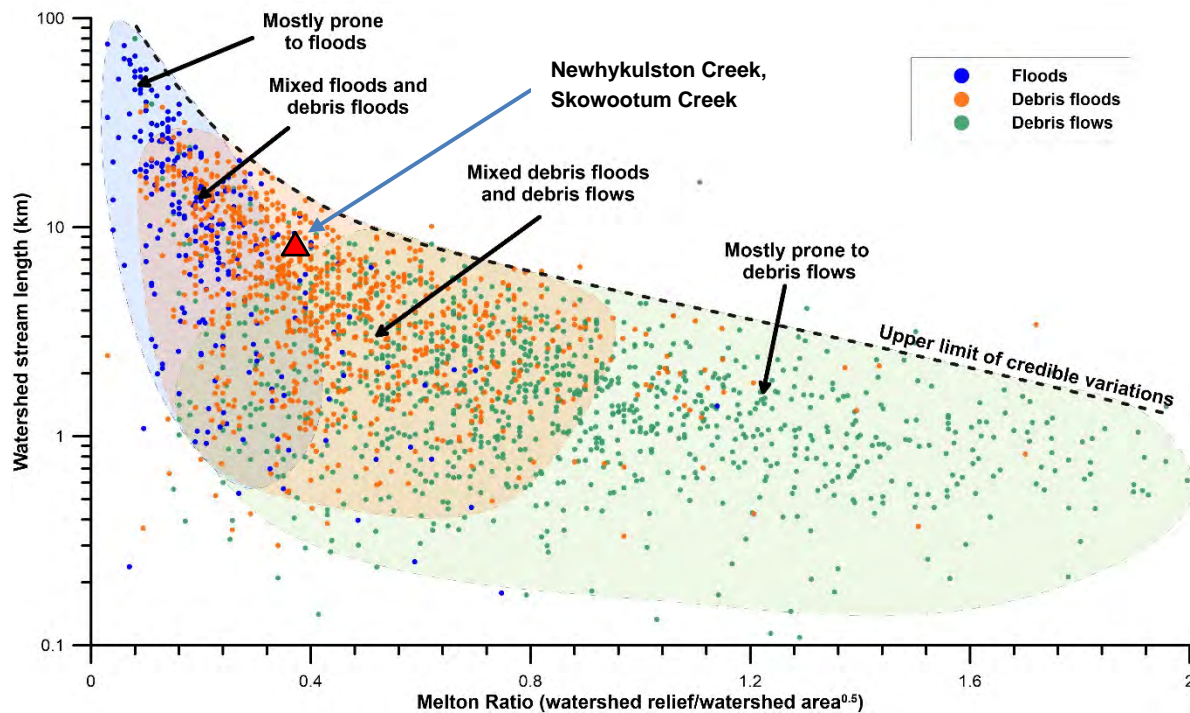
Figure 3-2. Steep creek processes as a function of Melton ratio and stream length. Data points and process boundaries are derived from 2,258 steep creeks in mountainous regions of Alberta and British Columbia (Holm et al., 2016; Lau, 2017; BGC data).

Although there is overlap, creeks with the highest Melton ratio and shortest watershed stream length are mostly prone to debris flows, and those with the lowest Melton ratio and longest watershed stream lengths are mostly prone to floods. Debris floods fall between these types.

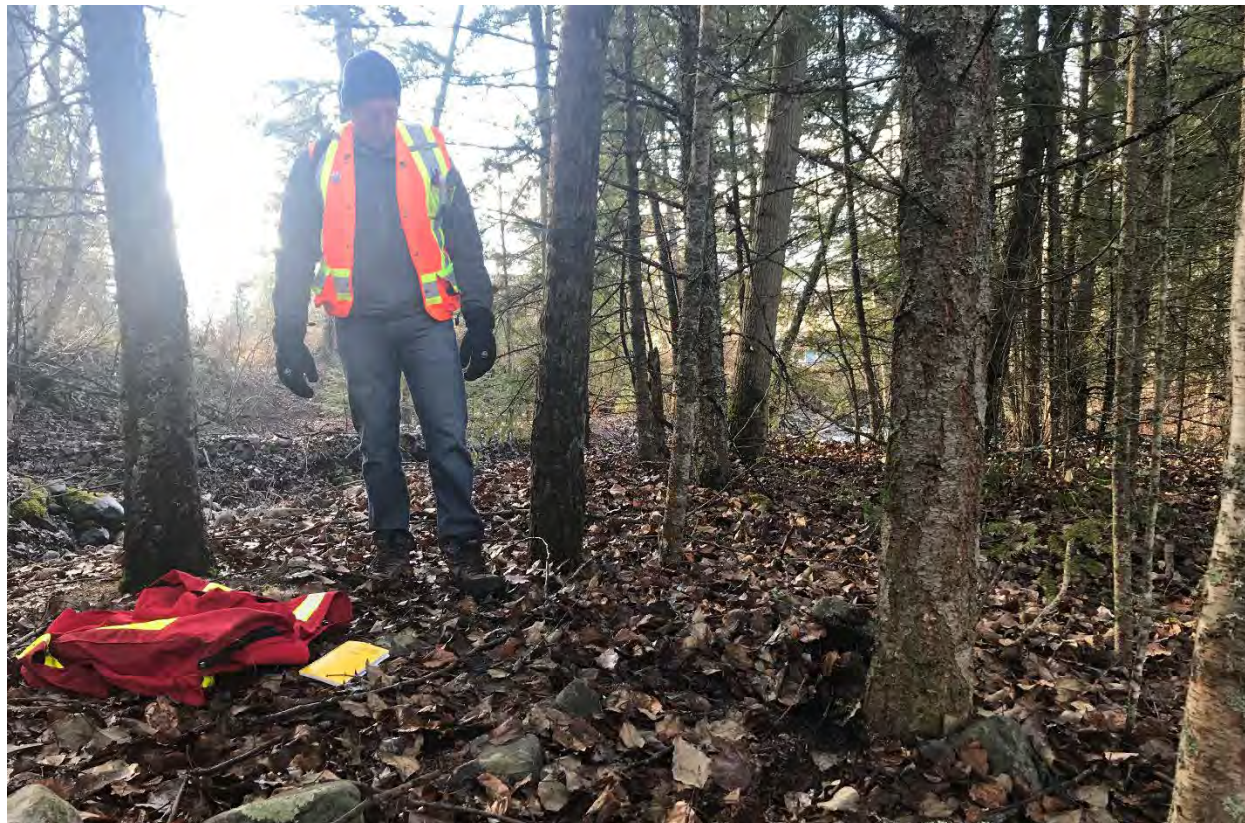
Figure 3-3. Buried conifer tree bases on the right bank of Newhykulston Creek approximately 50 m above Dunn Lake Road (site WP 1, Drawing 02). BGC photograph of November 28, 2018.

- Buried tree bases were observed within the active channel zone upstream of Dunn Lake Road (Figure 3-3).

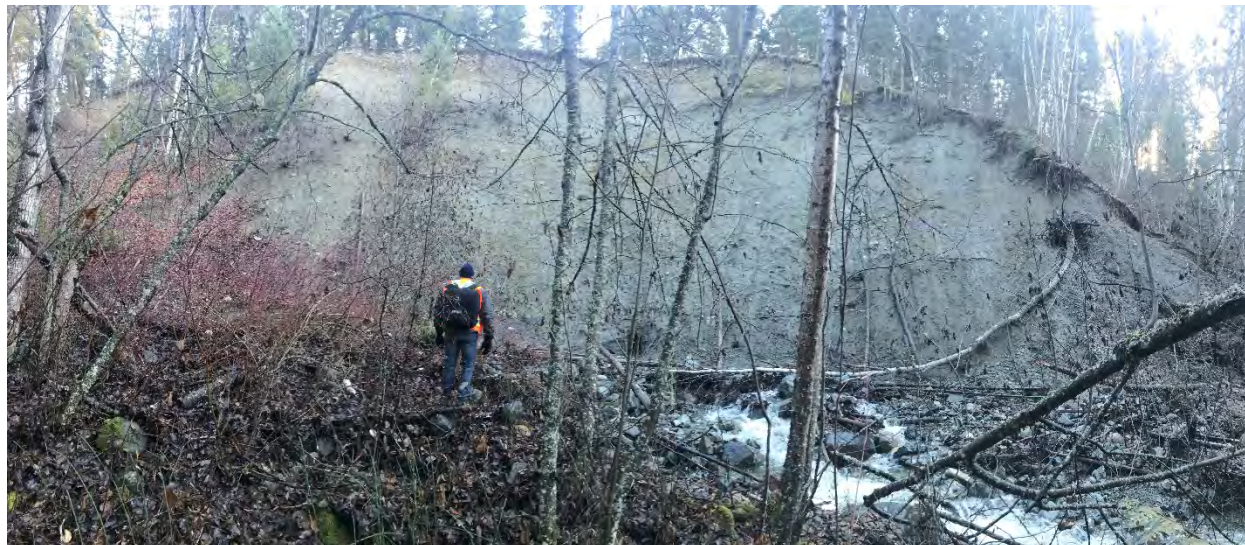
Figure 3-4. Unstable valley slope on south side of Newhykulston Creek (site WP 6, Drawing 03). BGC photograph of November 28, 2018.

Debris floods on Newhykulston Creek most likely occur during extreme floods (>50-year return period) when a critical shear stress is reached that mobilizes the D_{84} grain sizes. When this occurs, most of the stream bed (several grains deep) becomes mobile (Mackenzie, Eaton & Church, 2018). While sediment supply to the creek is not unlimited, there are several slope instabilities between the fan apex and an elevation of 700 m that provide a continuous source of sediment to the creek. One such slope is located on the left bank of the creek below the fan apex (site WP 6, Drawing 03). Here the creek is eroding a 30 m high slope composed of dense till (silt and clay matrix with coarser clasts) (Figure 3-4).

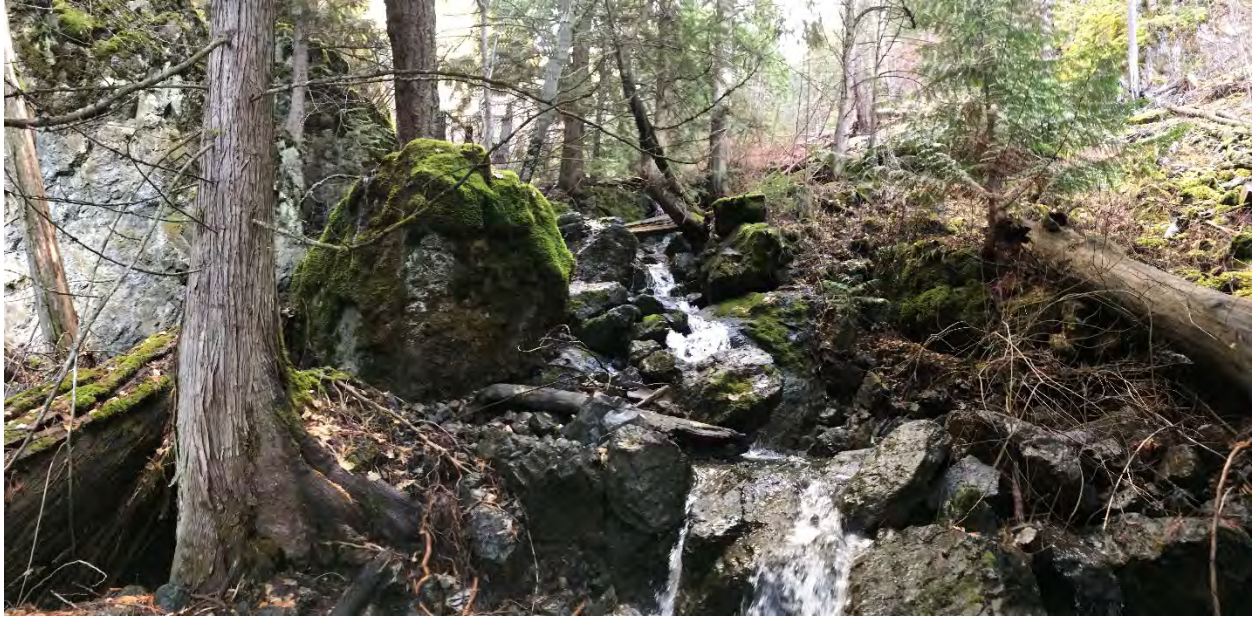
Figure 3-5. Upstream view of Skowootum Creek at site WP 17 (Drawing 03). BGC photograph of November 28, 2018.

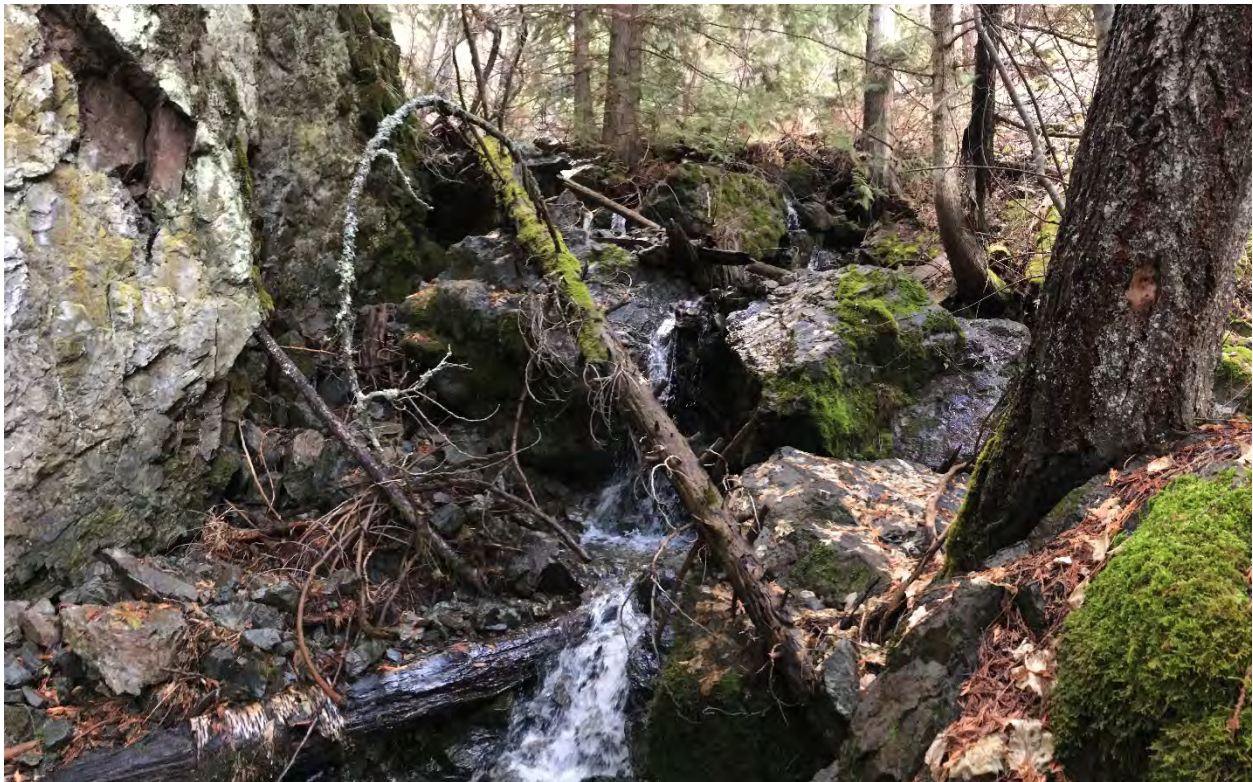
Figure 3-6. Upstream view of Skowootum Creek at site WP 18 (Drawing 03). BGC photograph of November 28, 2018.

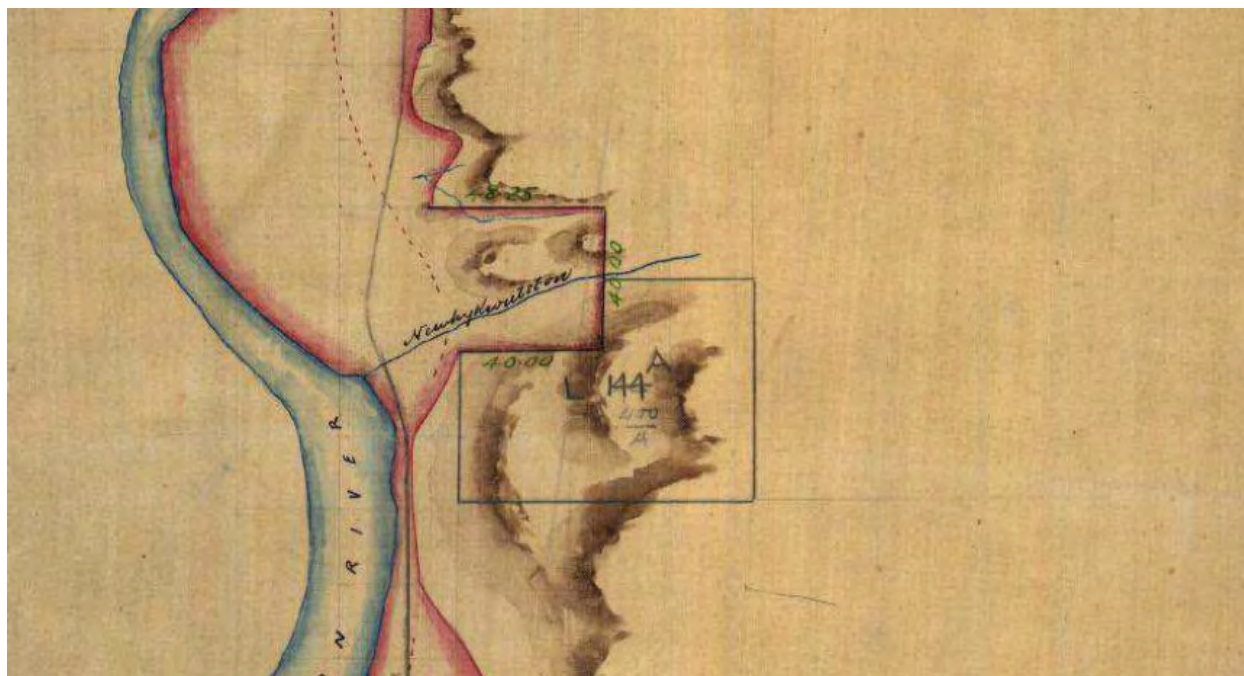
Figure 3-7. July 5, 1877 survey plan of Newhykulston Creek (survey accessed from ParcelMap BC web site).

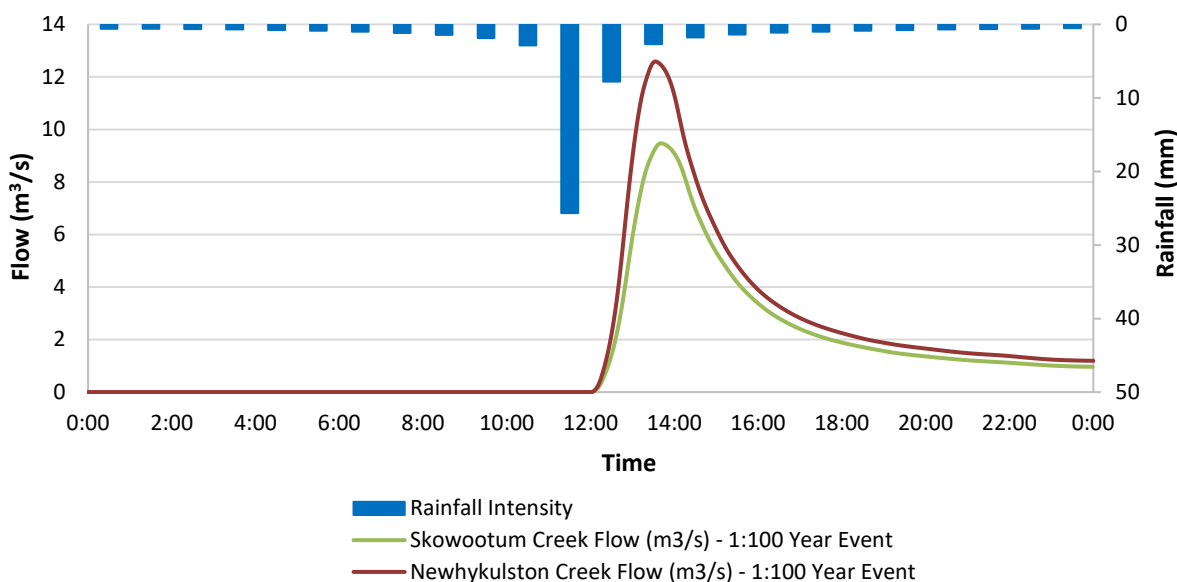
Figure 4-2. Simulated 100-year return period hydrographs for Skowootum Creek and Newhykulston Creek.

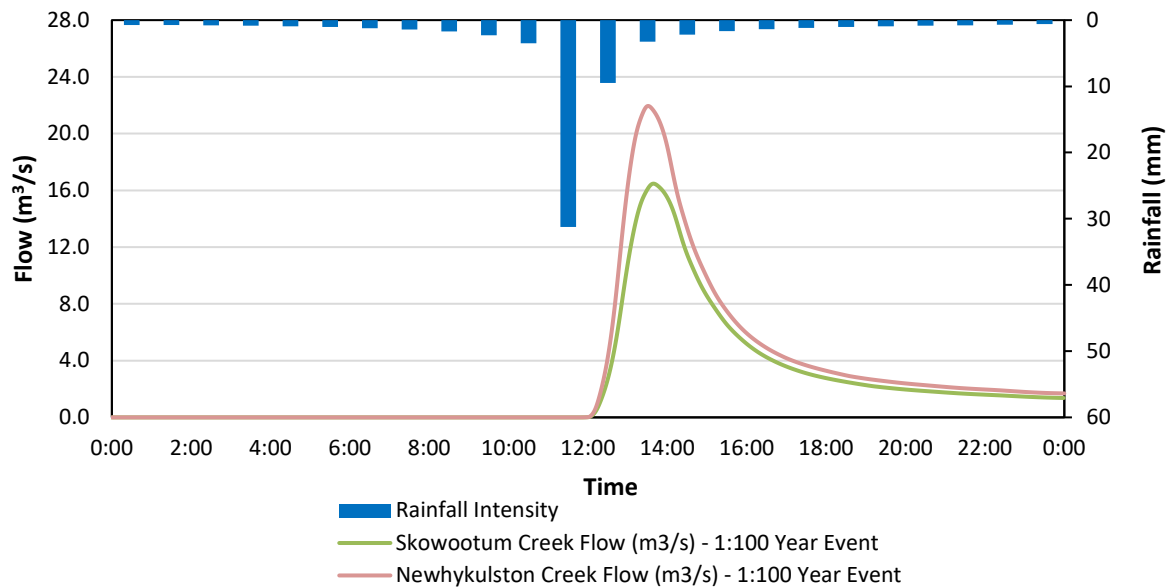
Figure 4-3. Climate change adjusted 100-year return period hydrographs for Skowootum Creek and Newhykulston Creek.

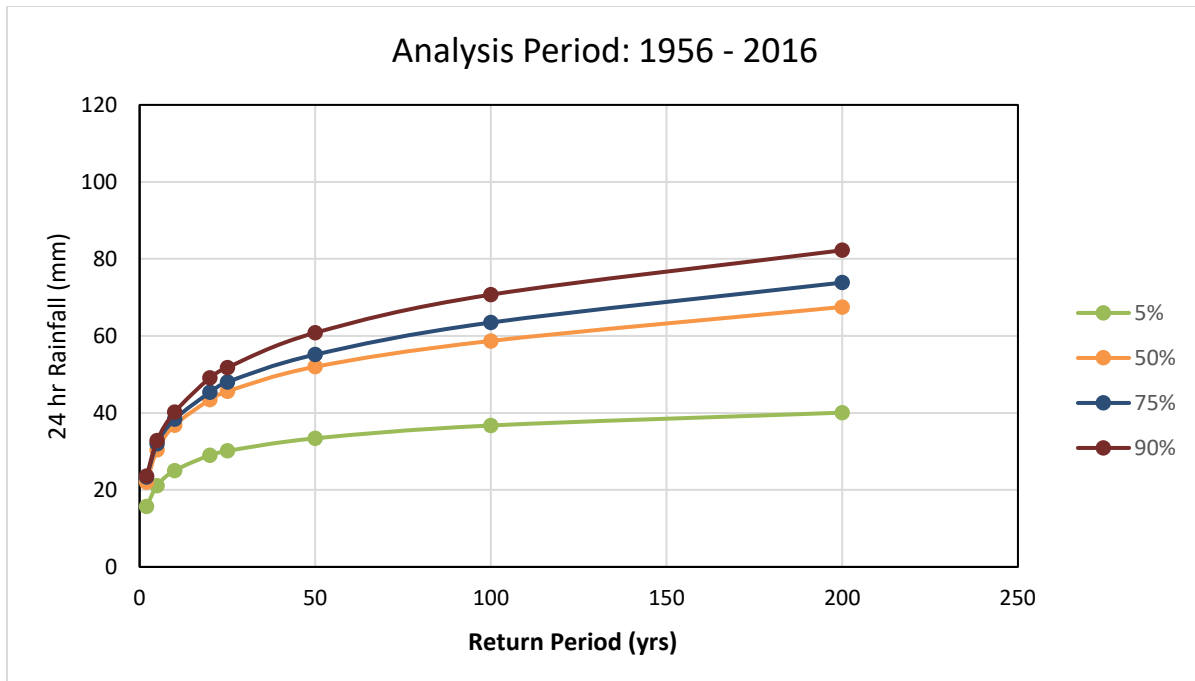
Figure B1. Climate change model ensemble results for the analysis period 1956-2016

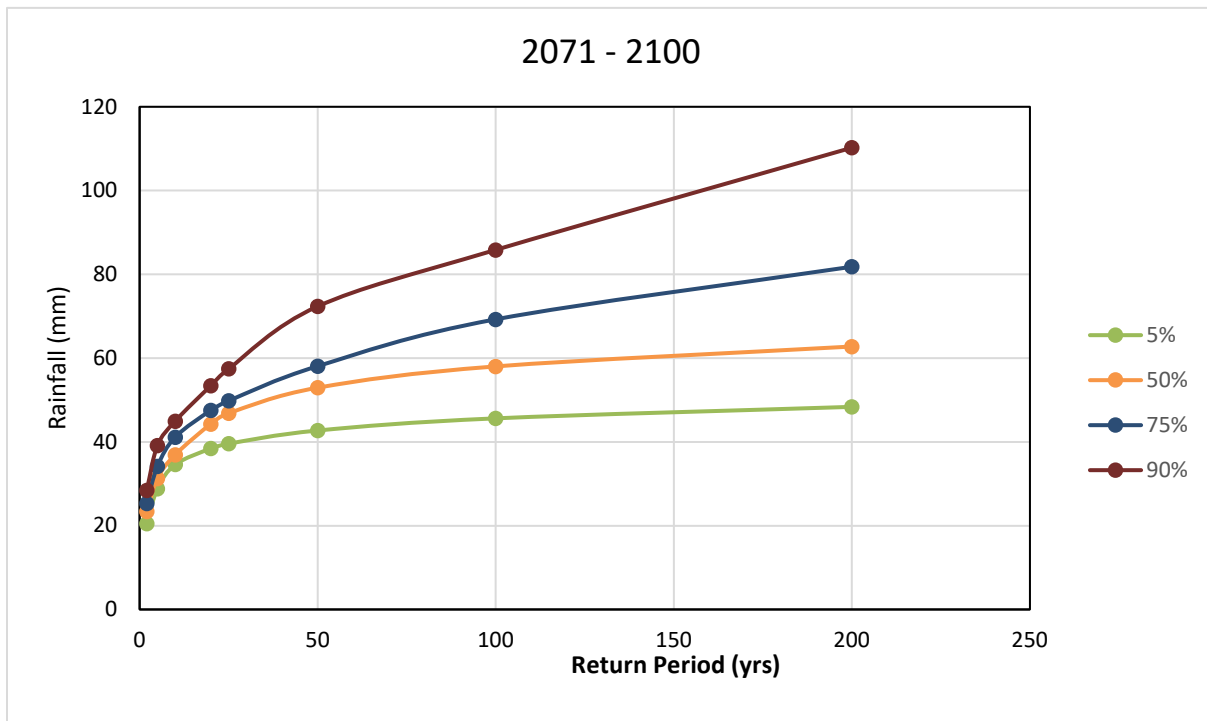
Figure B2. Climate change model ensemble results for the analysis period 2071-2100
