## Dunn Lake Road

# Environmental Overview Assessment

BC Ministry of Transportation and Infrastructure

October 2019

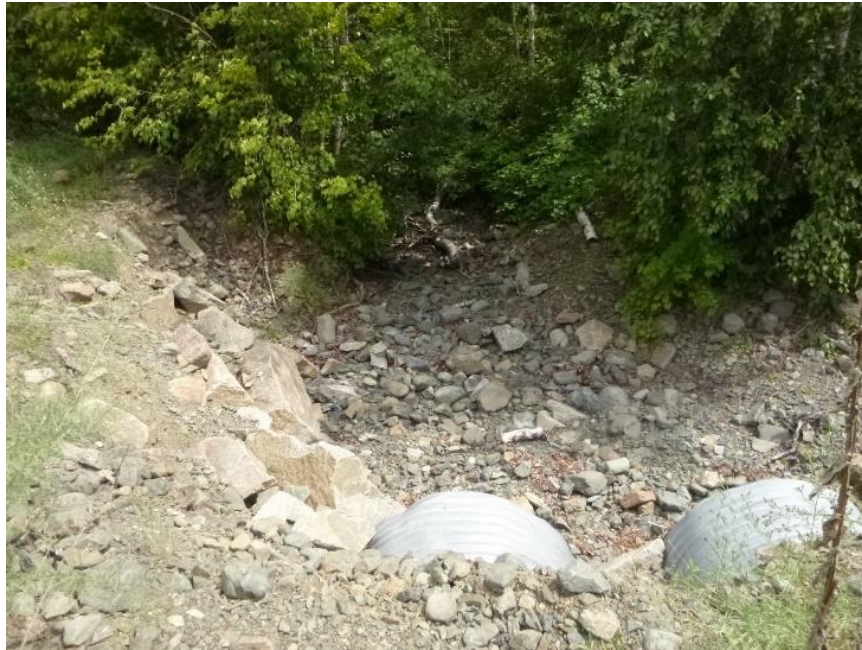
**Photo 1. Upstream view of Skowootum Creek from Dunn Lake Road**

The average channel and wetted widths were 7.0 m and 3.1 m with an average gradient of 6%. Above the existing crossing, spawning habitat was poor as there were limited pockets of suitable substrate. Rearing habitat was poor due to lack of deep pool development and significant instream cover. Cover consisted primarily of boulder riffles

and some SWD. Dominant and sub-dominant bed materials were cobbles and boulders with small pockets of gravels. No overwintering habitat was observed throughout the assessment area. Suspected overwintering habitat upstream of the Project Area likely supports resident Rainbow Trout and could potentially offer additional overwintering habitat to Coho juveniles if the access at Dunn Lake Road were to be improved.

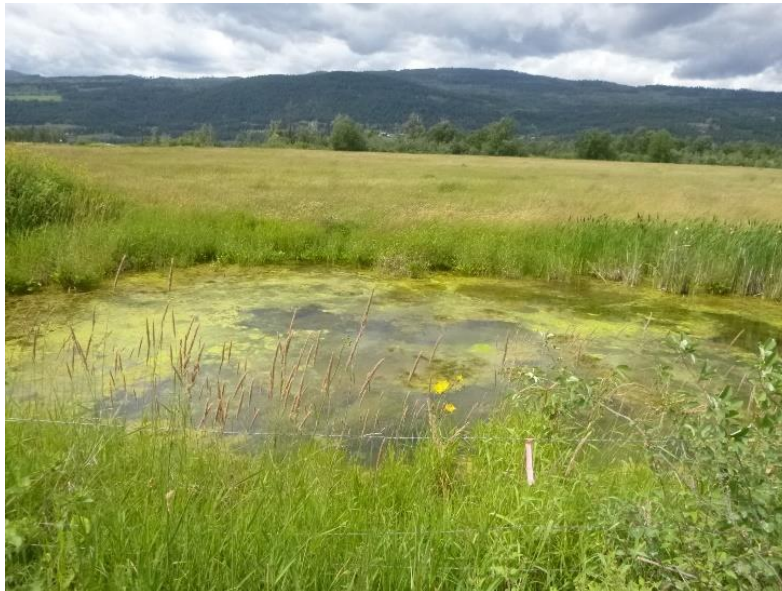
**Photo 3. West view of manmade sump wetland**

A small, manmade sump area has resulted in a wetland pond. It contains a ring of sedges and cattails as well as large amounts of algae in the open water. There is historical information of Western Painted Turtles within the pond and crossing Dunn Lake Road in this area, although no turtles have been recently spotted (pers. comm. Shelly Loring 2019).

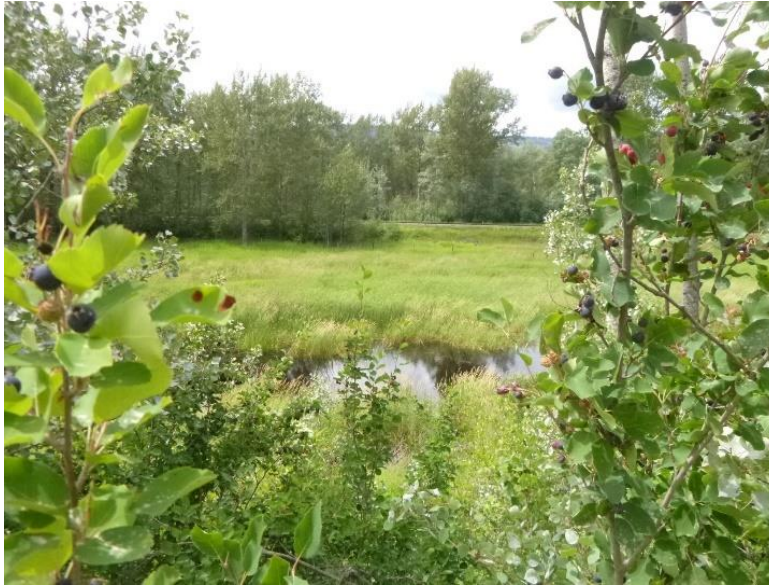
**Photo 4. West view of Frog Pond**

The large wetland north of the old sawmill site is locally known as Frog Pond. The wetland is bordered by Dunn Lake Road to the east and the railway tracks to the west. The approximate size of the area is 5 ha. There is historical information of Western Painted Turtles within the wetland, although no turtles have been recently spotted (pers. comm. Shelly Loring 2019). A high number of songbirds as well as waterfowl and woodpecker activity were noted in this area. Also, Pacific Chorus Frogs (*Pseudacris regilla*) were heard calling during daylight hours, and it is likely that more amphibians use this area.

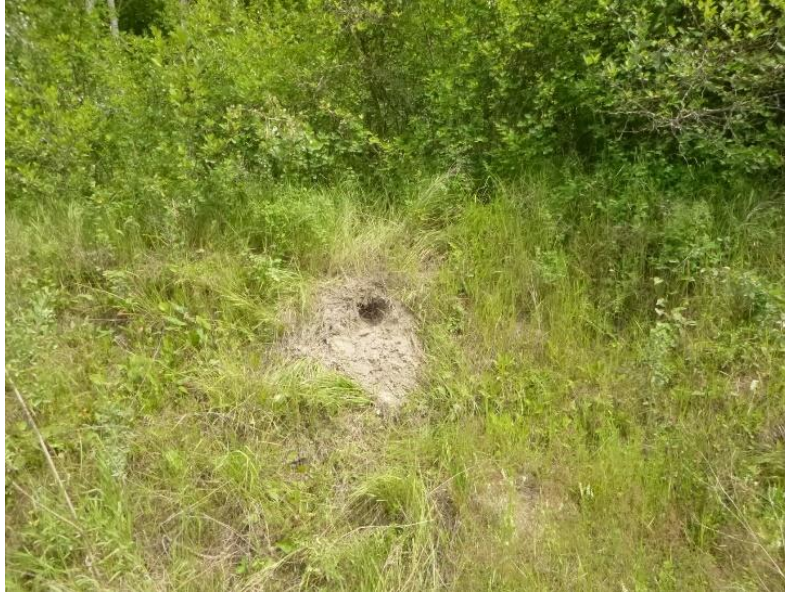
**Photo 5. View of mammal burrow from Dunn Lake Road**

A mammal burrow was observed on the east side of Dunn Lake Road, approximately 400 m north of the old mill site. The burrow does not appear to be in the upside down 'D' shape of an American Badger burrow and did not have deep tunnels from the entrance. It did not appear to be recently used, with no fresh tracks leading to it.

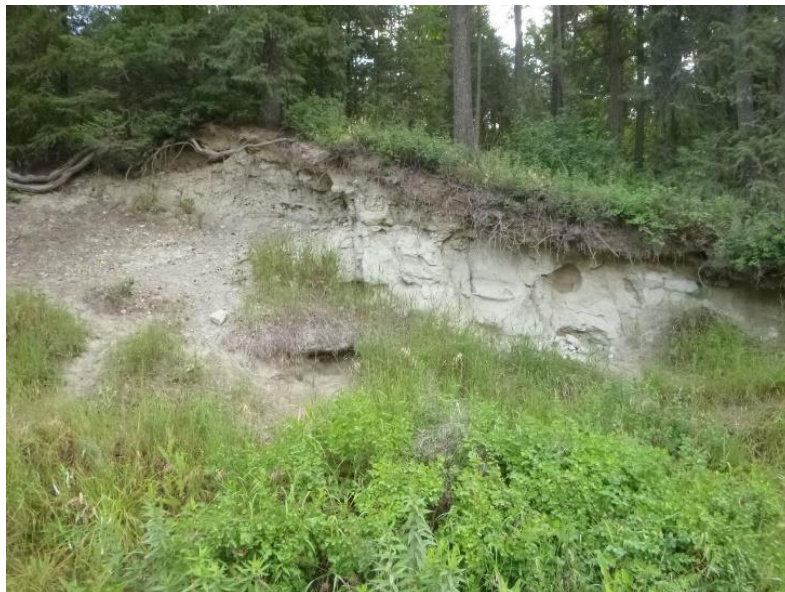
**Photo 6. View of mineral lick from Dunn Lake Road**

The mineral lick was observed on the east side of Dunn Lake Road within 10 m of the road's right-of-way. Evidence of wildlife tracks and trails was observed in and around the immediate area.

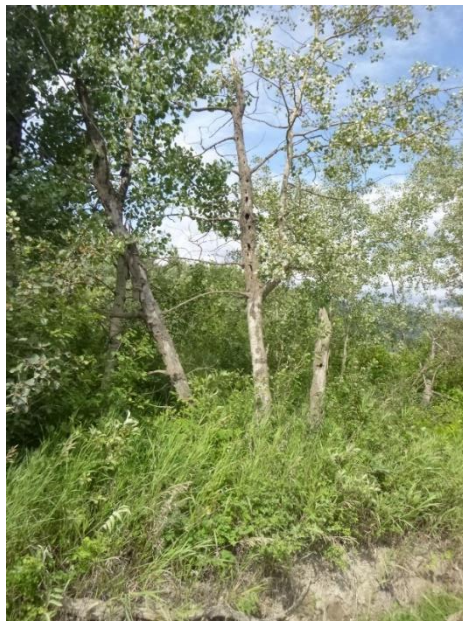
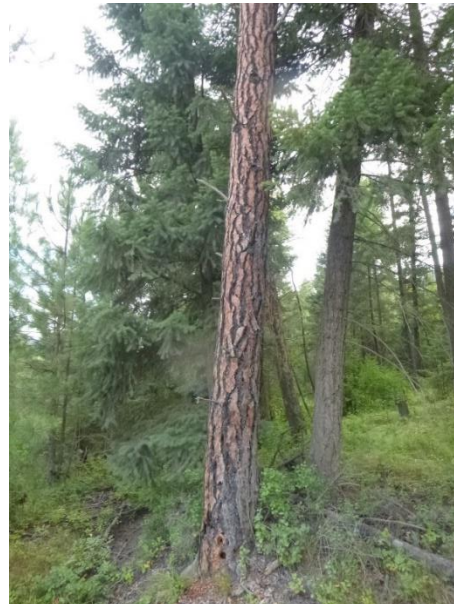
**Photographs 7 and 8. Wildlife trees within Project Area**

Wildlife trees are of high value to birds and mammals. They provide food, nesting sites, roosting and denning sites, as well as hunting and display perches. Numerous wildlife trees were observed in the Project Area consisting of mostly trembling aspen snags, as well as

mature Douglas-fir and ponderosa pine trees with cavities and nests. Most of the wildlife trees were located on the west side of Dunn Lake Road close to the wetland areas.
