# Technical Summary

February 2024

**Pit Name:** Junction Pit

**Provincial Pit Number:** 0999

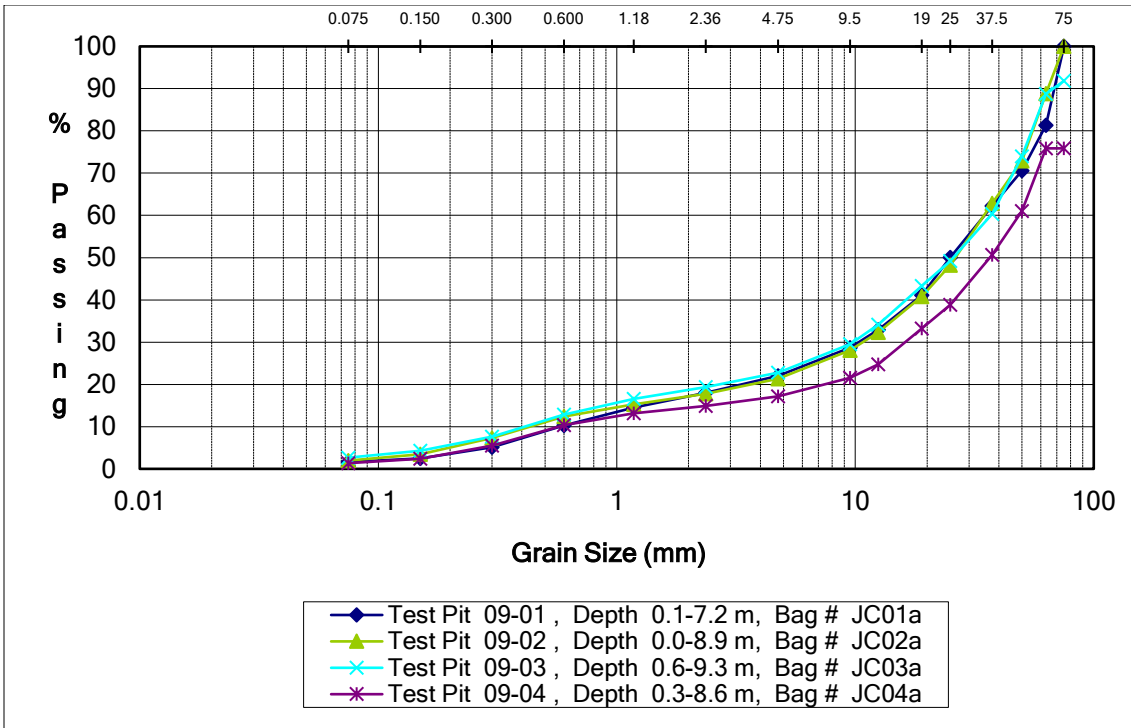
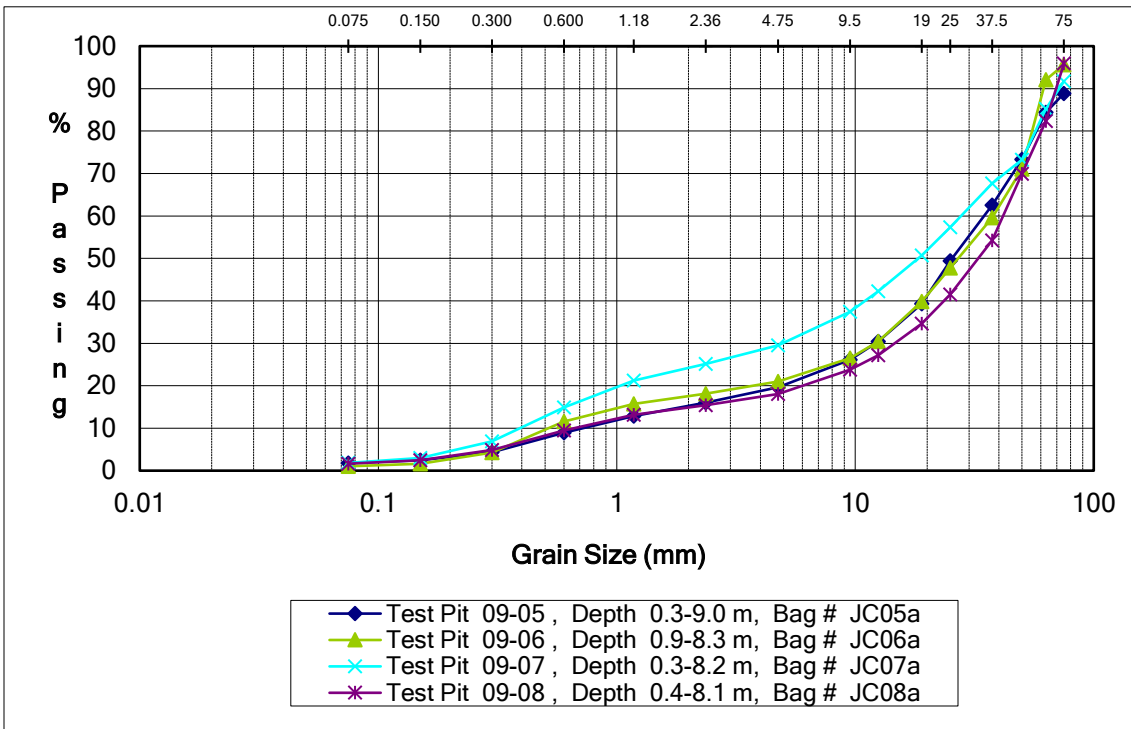
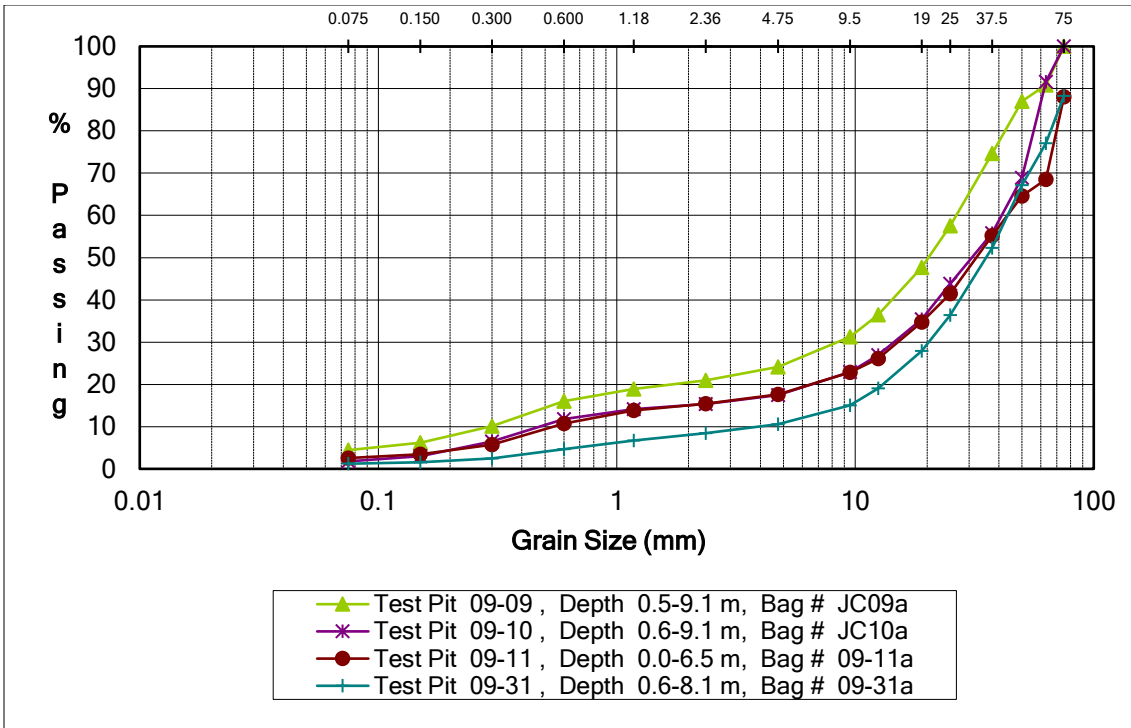
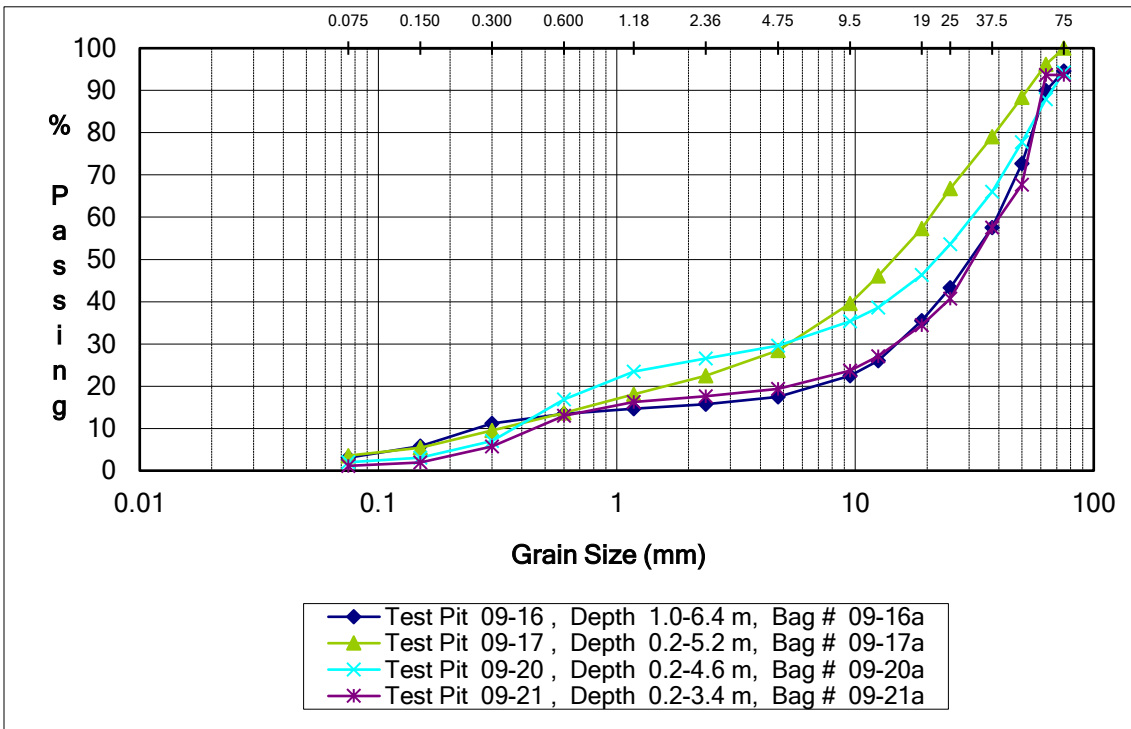
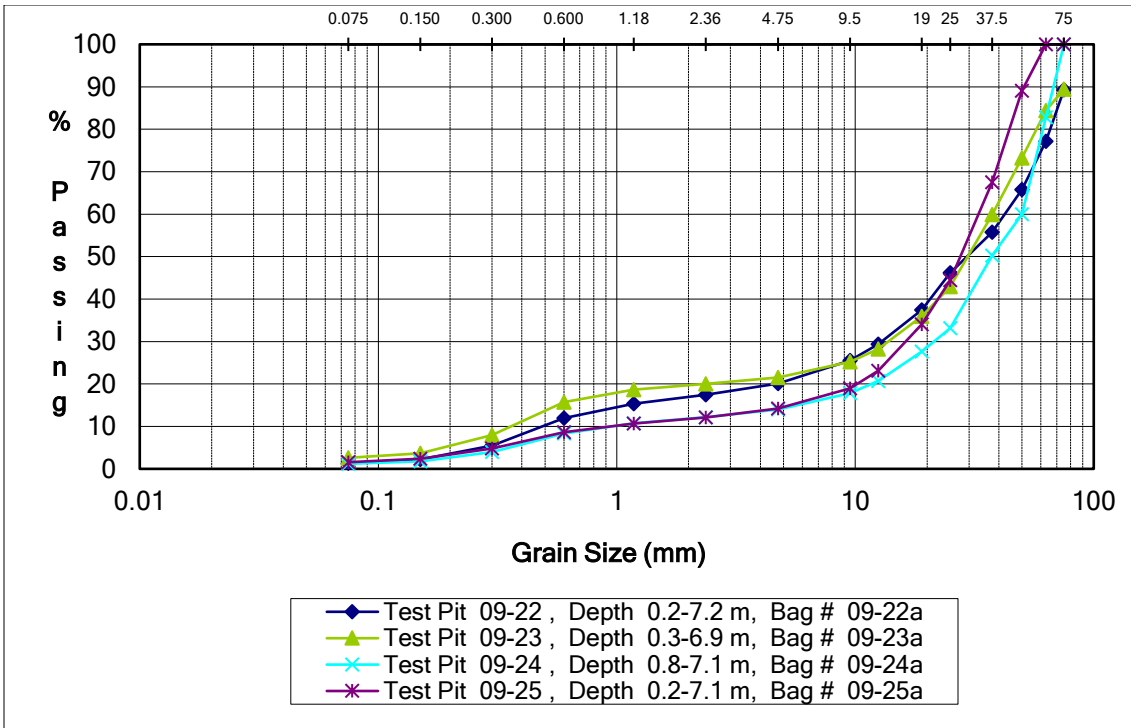
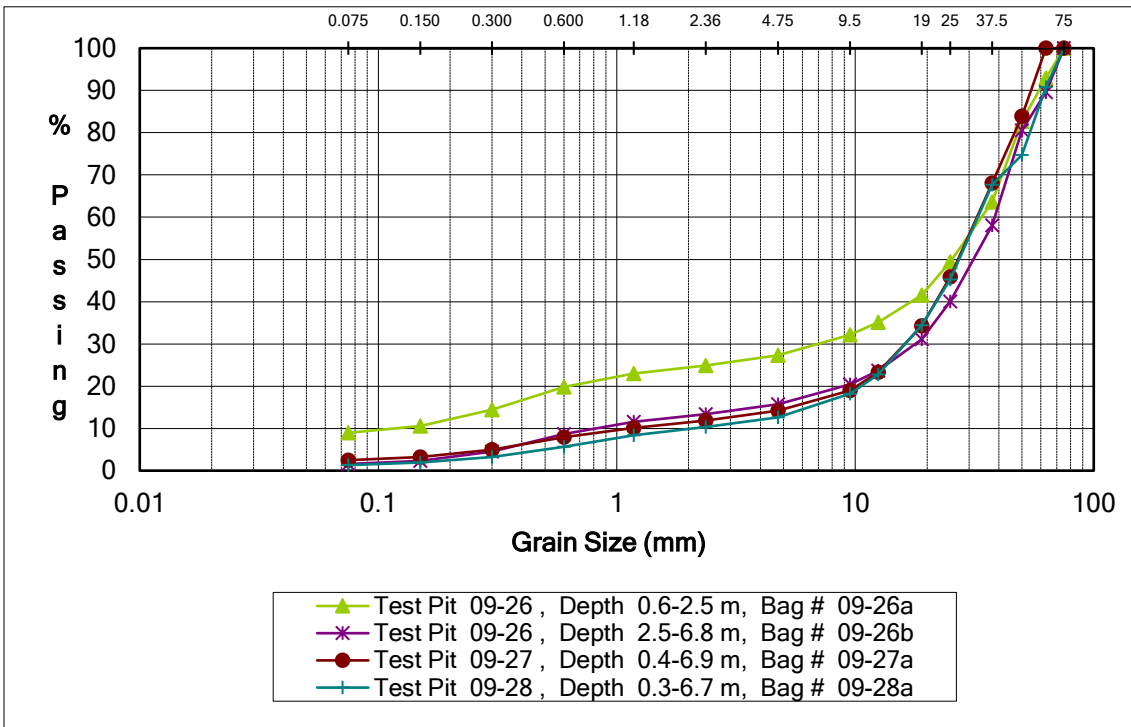
**Test Pit Summaries, Wet Sieve Analysis Summary, Gradation Charts**

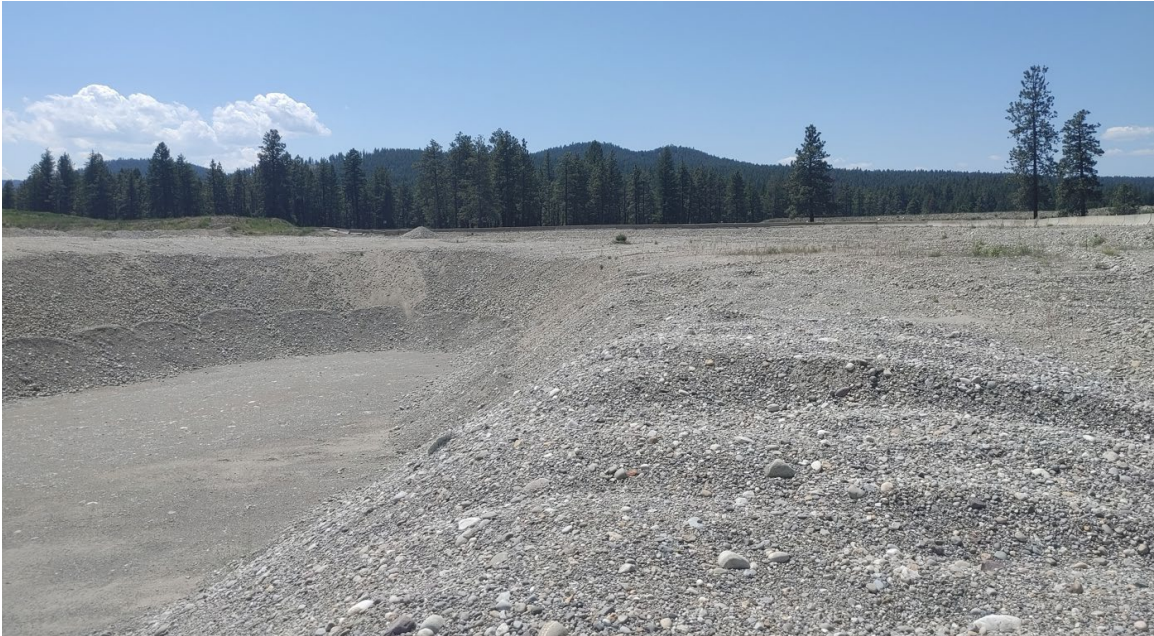
Main face of Suitability Area A, facing west (May 2023).

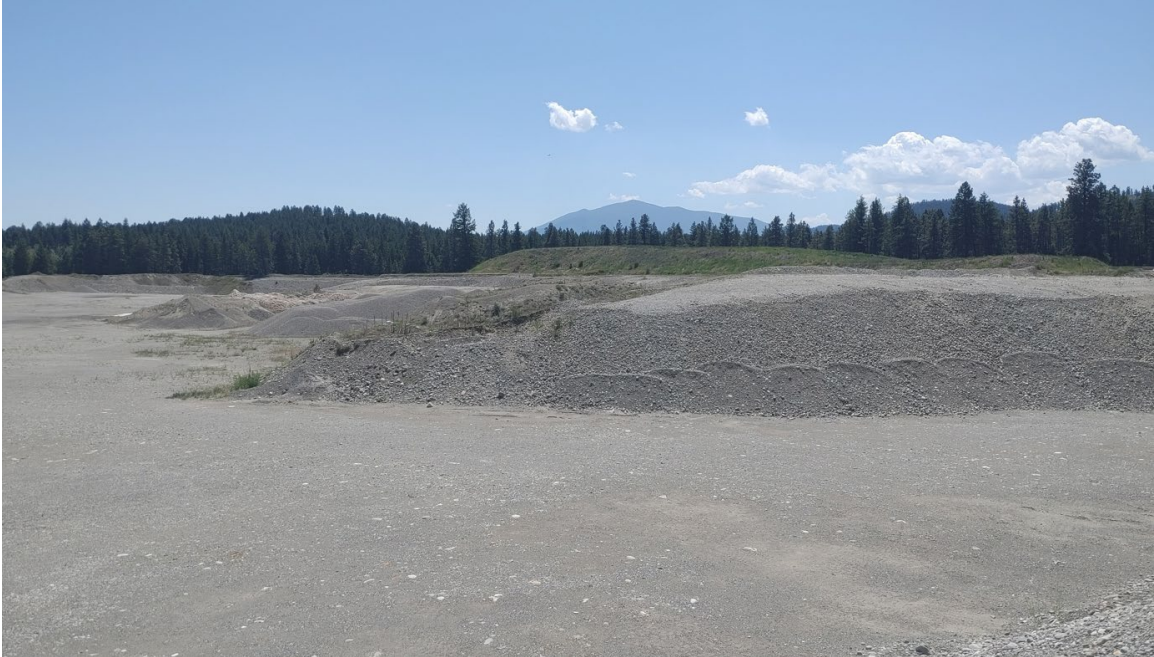
Standing top of face of Suitability Area A, facing south (May 2023).

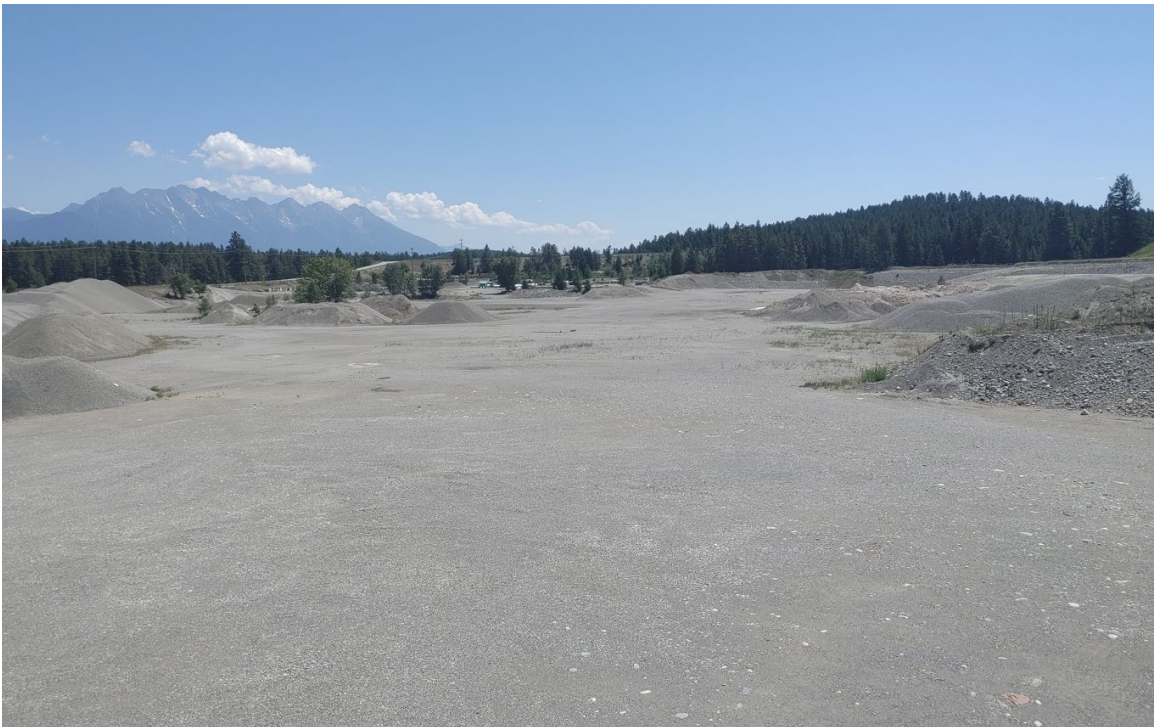
Same location as previous photo, facing southeast. Recommended crusher setup and stockpiling area to south. (May 2023).

- The processing area is recommended to be located on the pit floor as identified on the Pit Development Plan (near TP09-13 or TP09-14) with mining proceeding in a west to northwest direction as indicated.

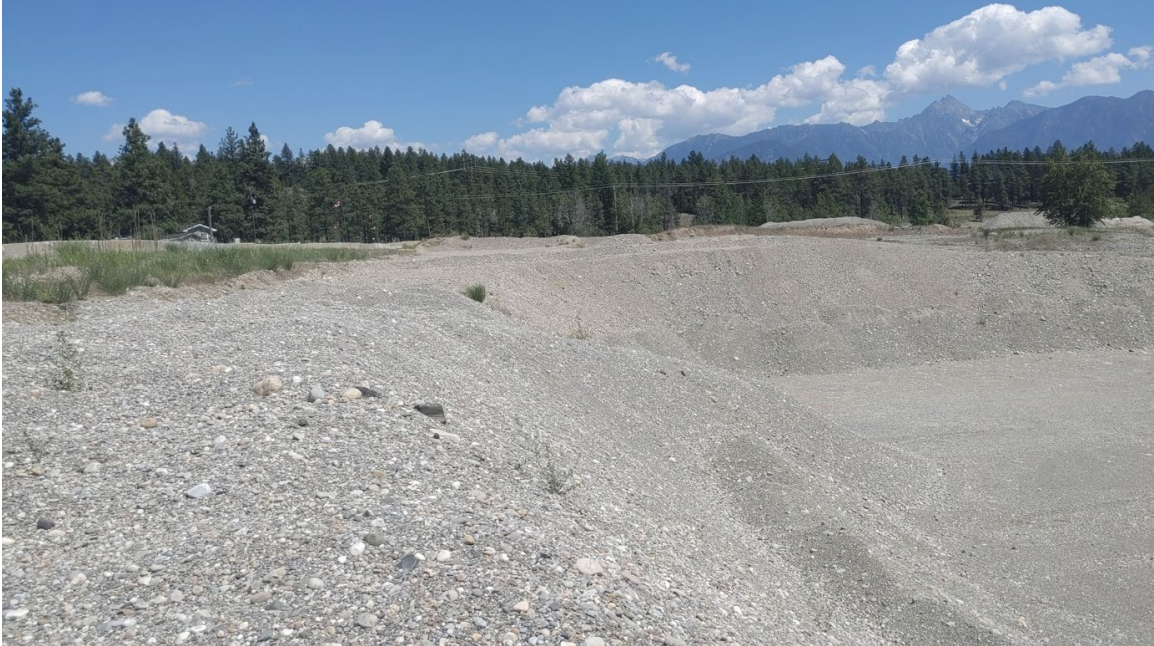
Suitability Area A, facing northeast (May 2023).

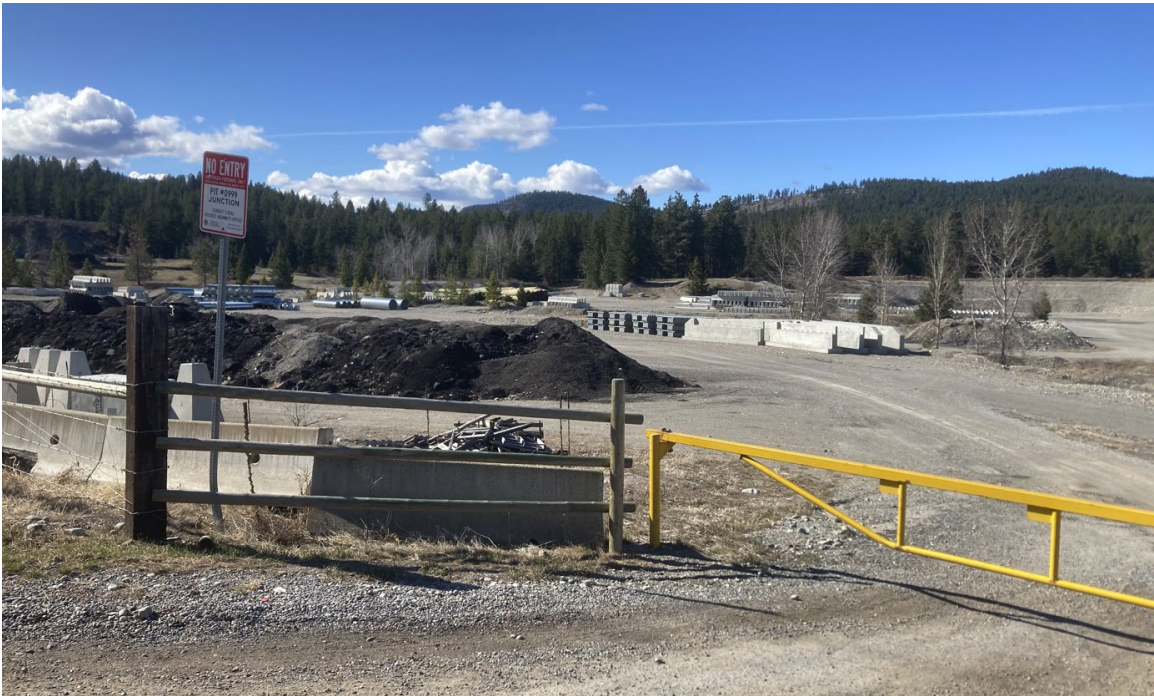
Facing south from pit entrance toward Area B. Materials stored in this area will have to be relocated prior to future mining in this area. (April 2022).

- The pit floor has several existing processed stockpiles throughout. Processed aggregate may be stockpiled in the centre of the south end of the pit where space permits. Stockpile relocation may be required.
