Chenault Pit Technical Summary

February 2025

Pit Name: Chenault Pit

Provincial Pit Number: 0651

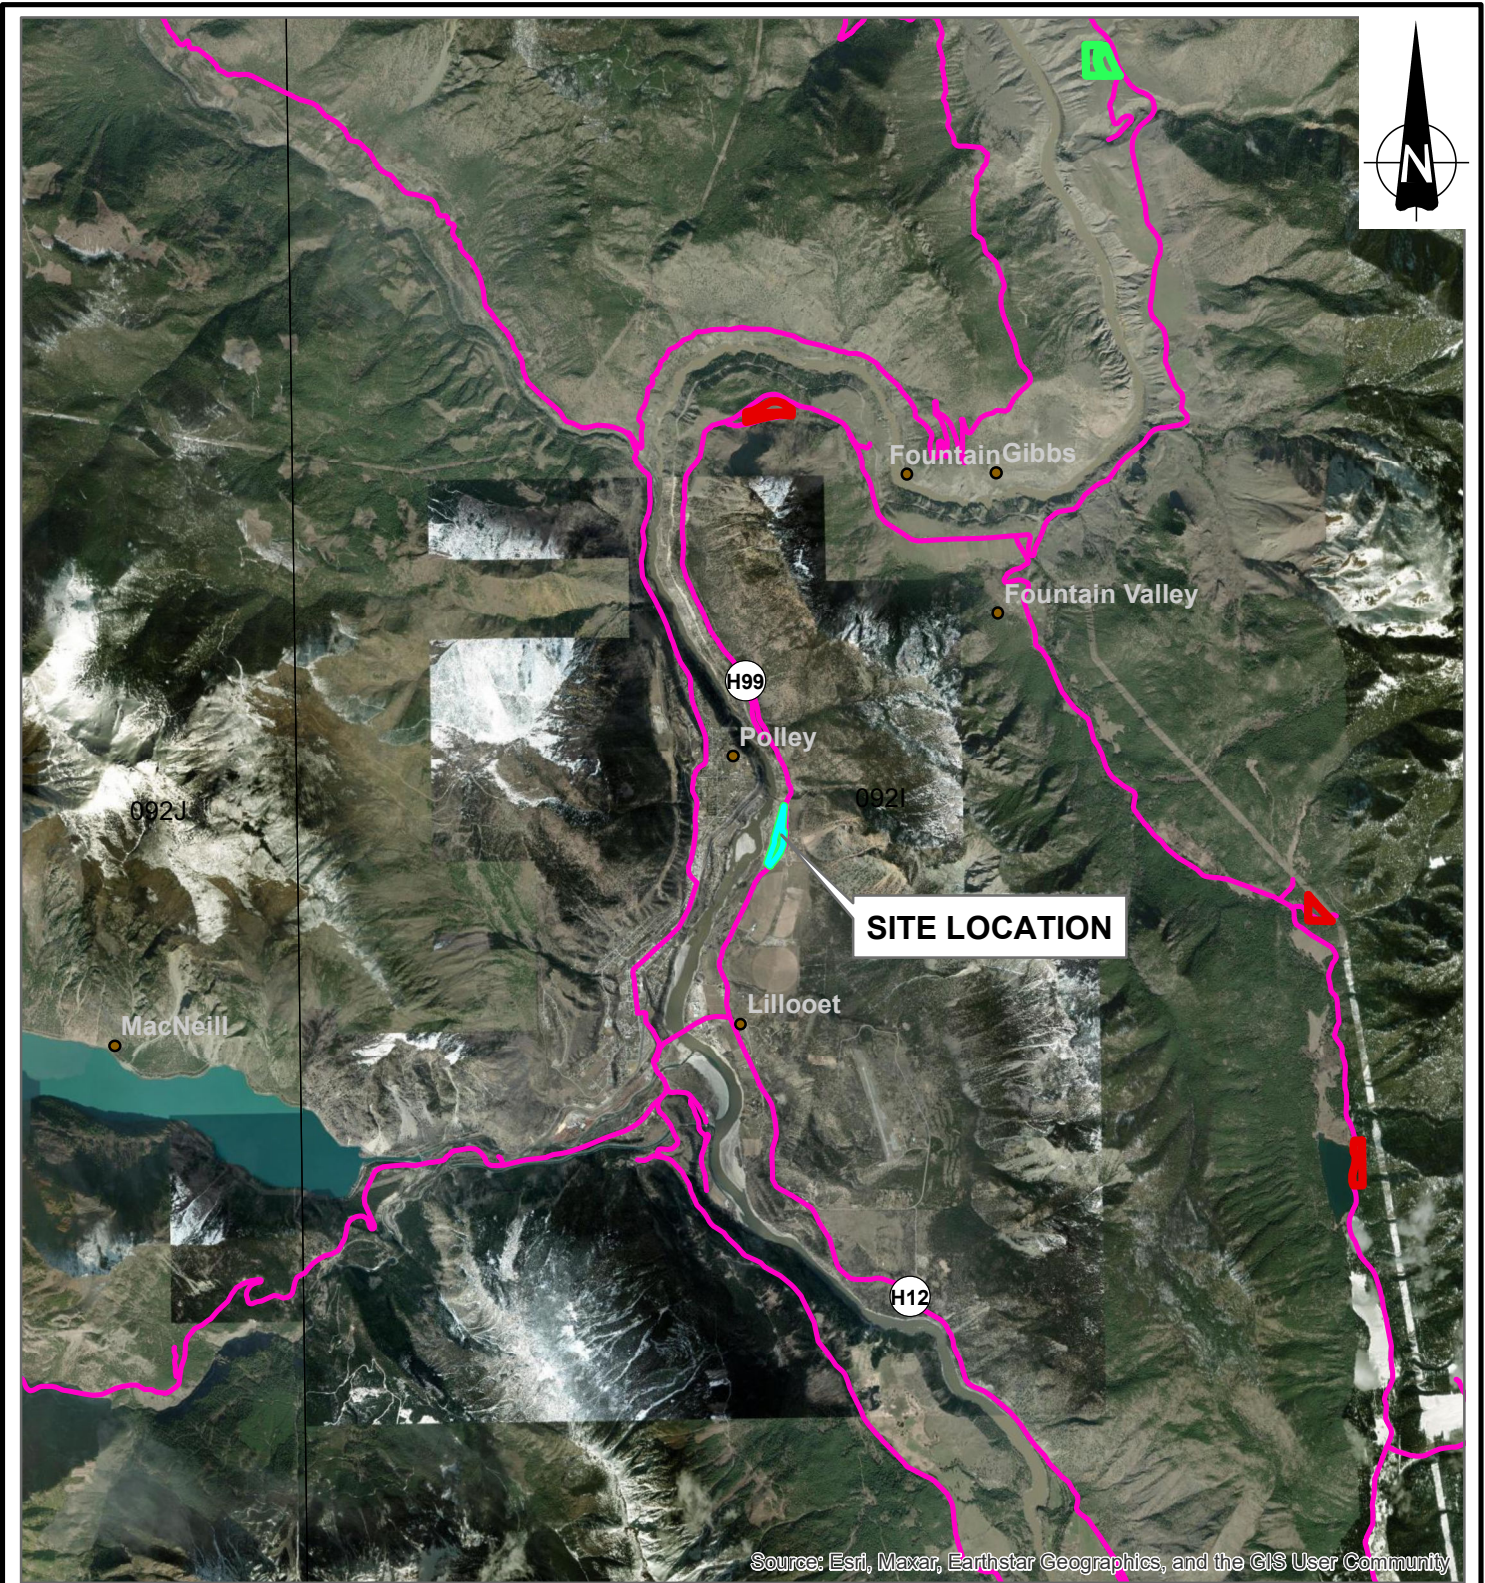
Figure 1 - Location Plan

Location: Chenault Pit is located on Highway 99, approximately 5km north of Lillooet, BC (Figure 1).

LOCATION PLAN (2024) Chenault Pit No. 0651 SA 16 - CARIBOO DISTRICT			
DRAWN BY: LACOURTE	PROJECTION: NAD 1983 UTM Zone 10N	SCALE: As Shown	
CHECKED BY: A. Mitchell	DATUM: NAD 1983 UTM Zone 10N	DATE: 2024-09-04	
File Name: GISTemplate_Gravel_R2_2021-11-18	Geotech Project No:	Reg: 2	Drawing No: FIGURE 1

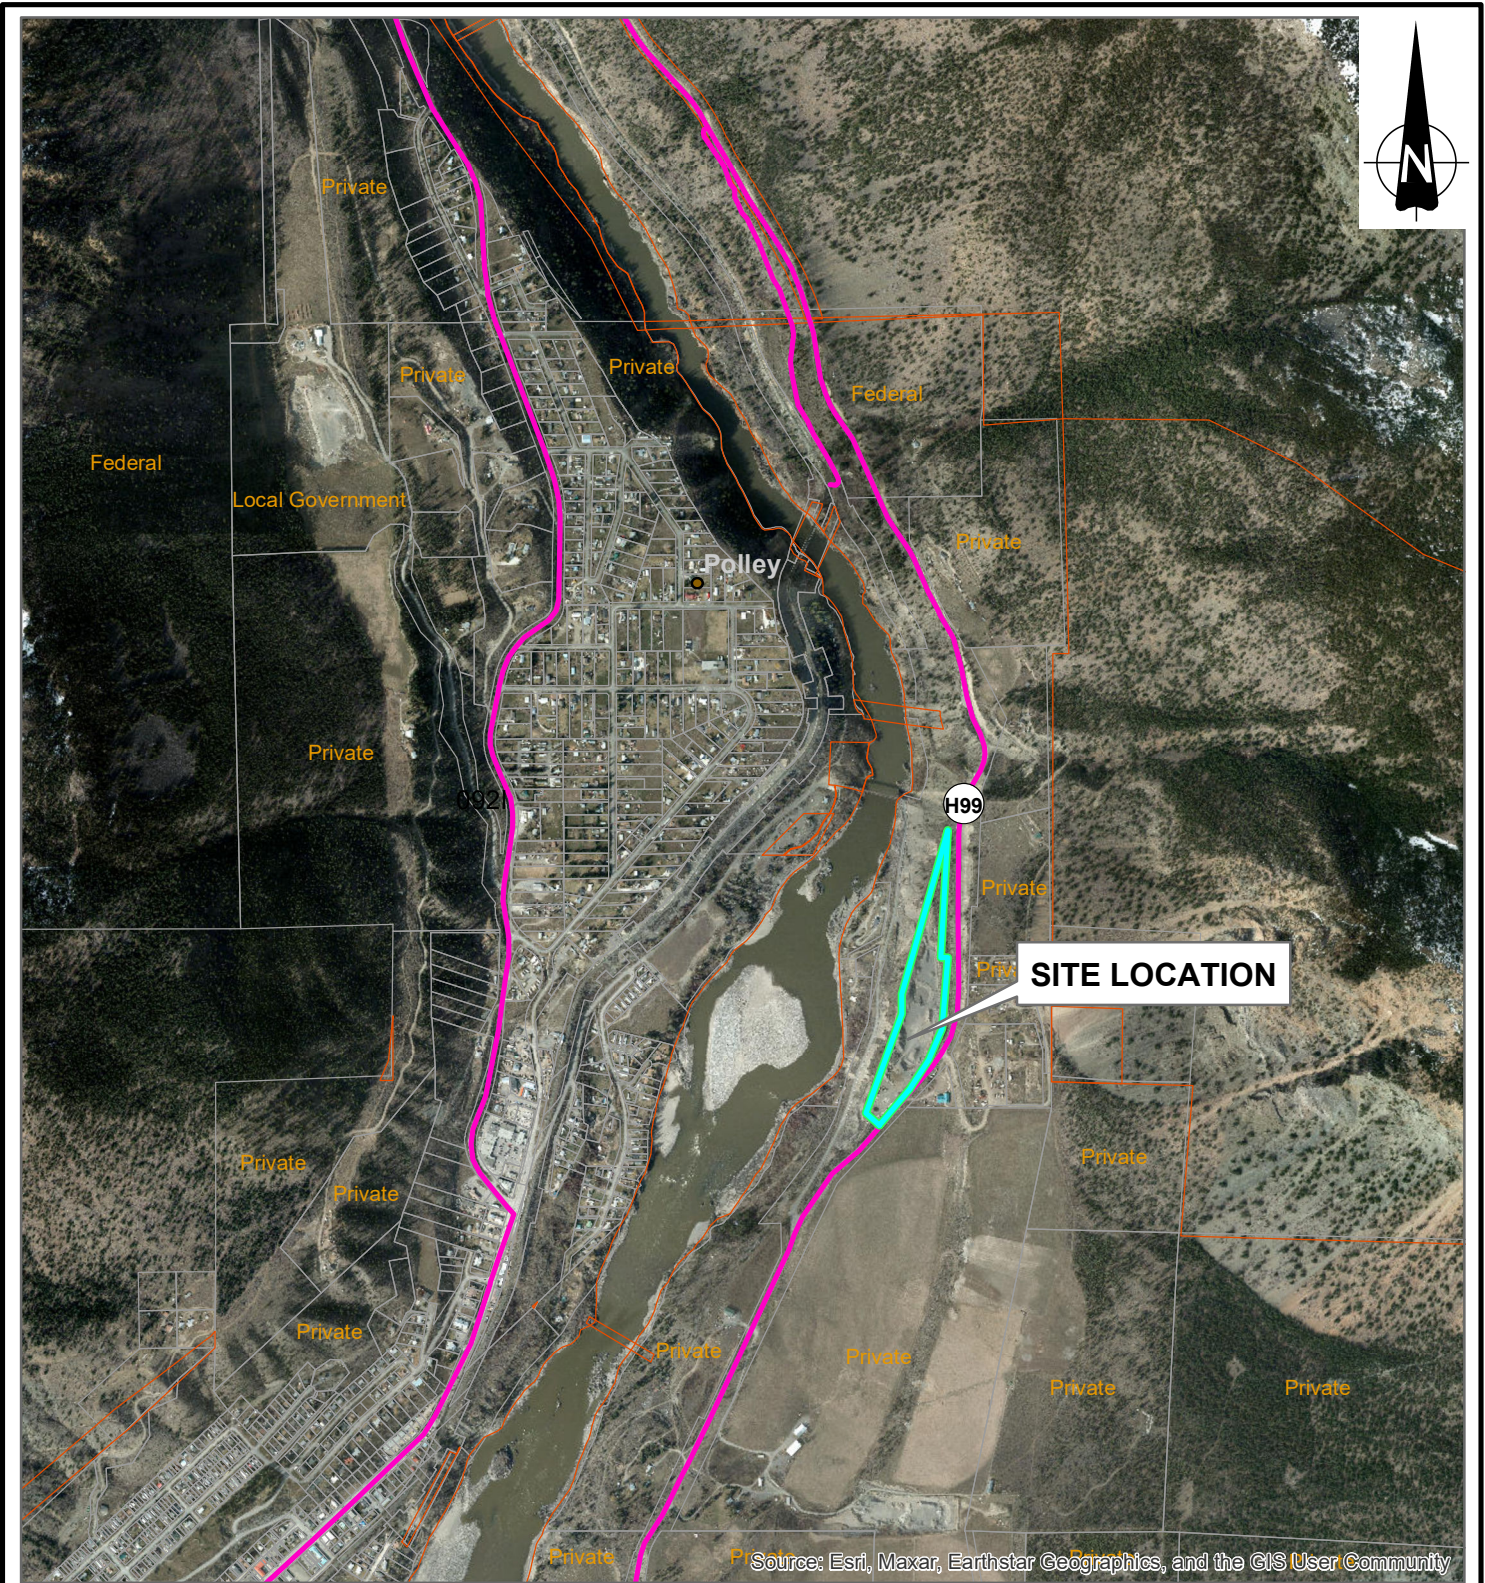
Figure 2 - Pit Plan

Legal Land Description: The site is currently owned by the British Columbia Ministry of Transportation and Transit (BC MoTT). The legal description of the Map Reserve is “that part of District Lot 1294 lying north of District Lot 703 and east of the Pacific Great Eastern Railway Right of Way on Plan A22 Lillooet District, except Plans 33683, H17273 and KAP46682. UTM coordinates for the pit are Grid Zone 10, 576990 Easting, 5617737 Northing.” The layout of the Map Reserve boundary is shown in the pit plan (Figure 2).

LEGAL PLAN (2024) Chenault Pit No. 0651 SA 16 - CARIBOO DISTRICT		
DRAWN BY: LACOURTE	PROJECTION: NAD 1983 UTM Zone 10N	SCALE: As Shown
CHECKED BY: A. Mitchell	DATUM: NAD 1983 UTM Zone 10N	DATE: 2024-09-04
File Name: GISTemplate_Gravel_R2_2021-11-18	Geotech Project No: 	Reg: 2
		Drawing No: FIGURE 2

Based on the results of the 2017 investigation, one (1) suitability area – Area A, has been defined (Figure 3). The detailed results of the subsurface testing are provided in the Test Pit Summaries and test pit locations are shown on the Pit Plan (Figure 2).

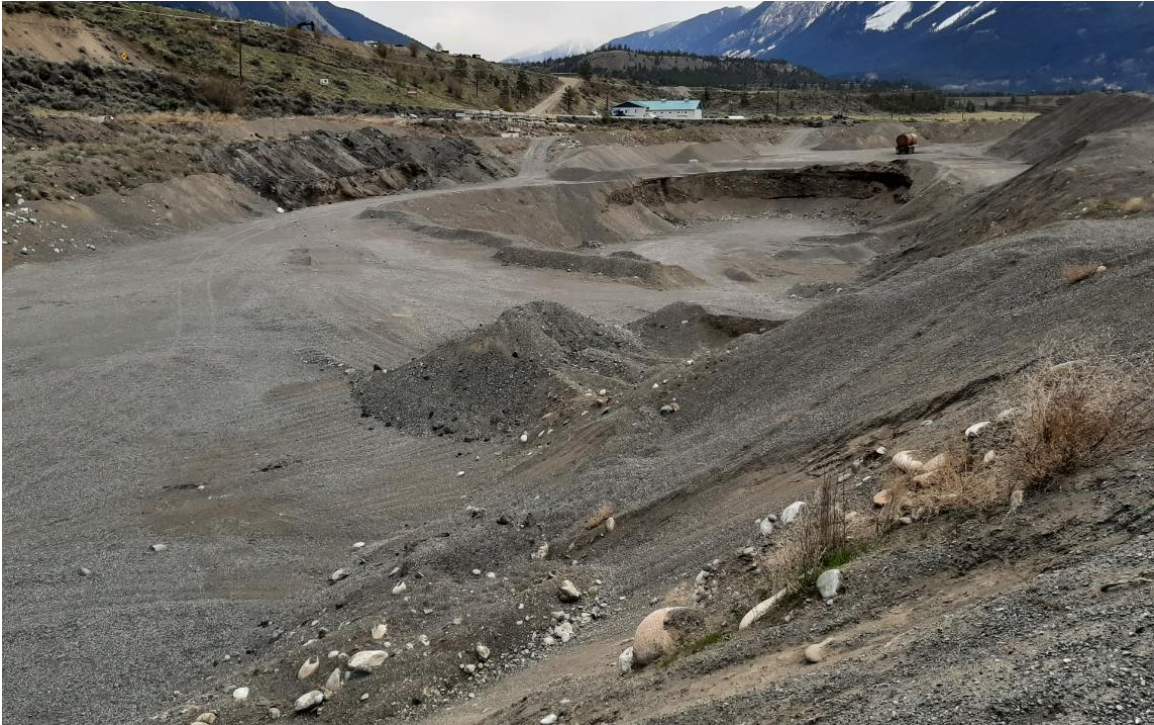
Proposed crusher set up location, looking south. (April 2021)

- The crusher is to be located on the lower pit floor, as indicated on the Pit Development Plan or as space permits. Mining is to proceed in a northerly or southerly direction.

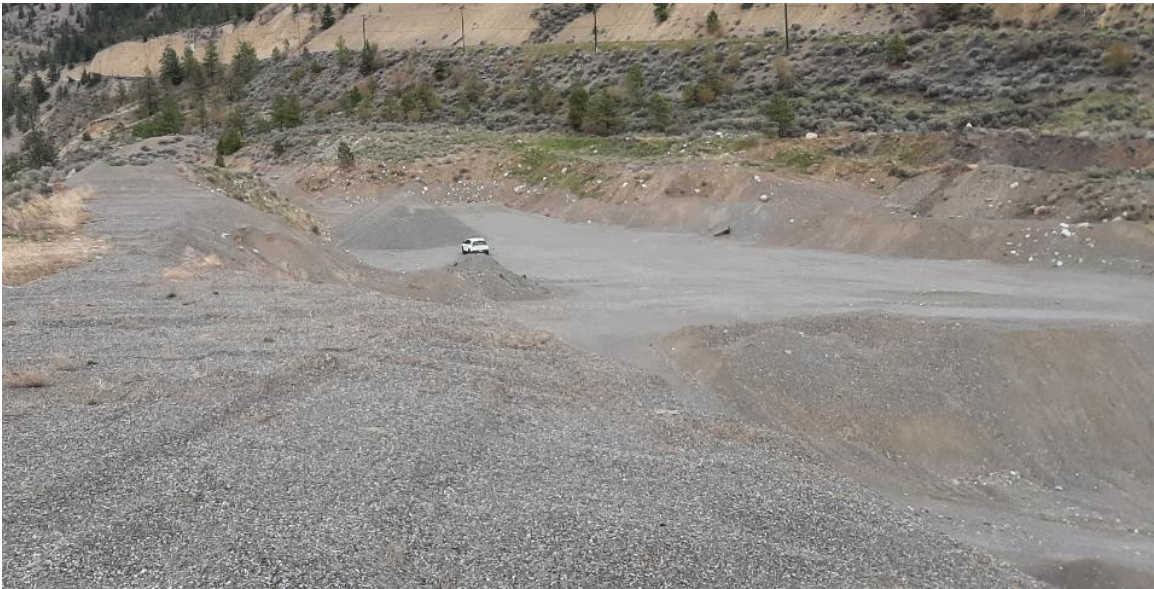
Facing north. (April 2021)

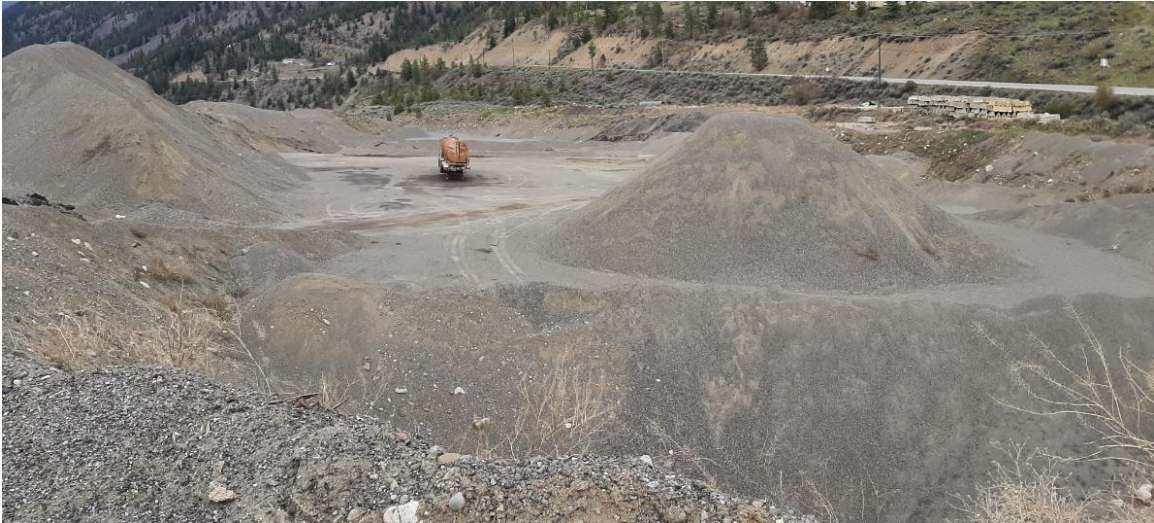
Standing near TP17-19, facing north. (April 2021)

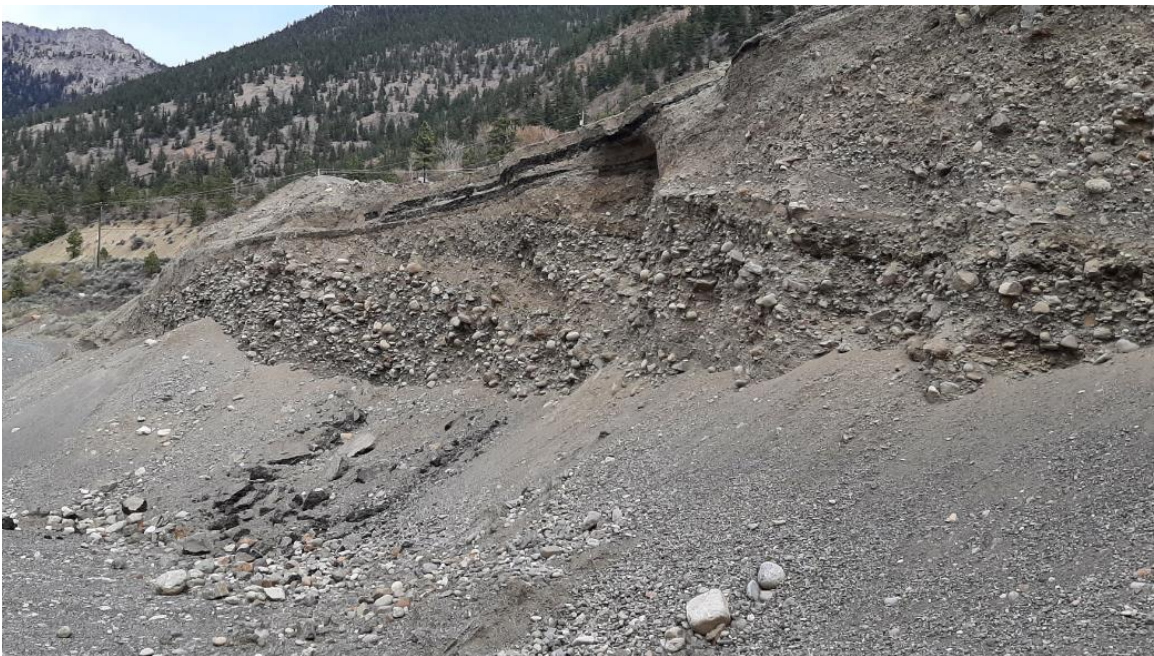
- Evidence of past activity in the pit was discovered; some asphalt layers were identified within the suitability area (see photos). Other undesirable material or objects may be present beneath the surface and may have to be stockpiled separately or disposed of.

Eastern side of lower pit face. Note layers of asphalt product near surface. (April 2021)

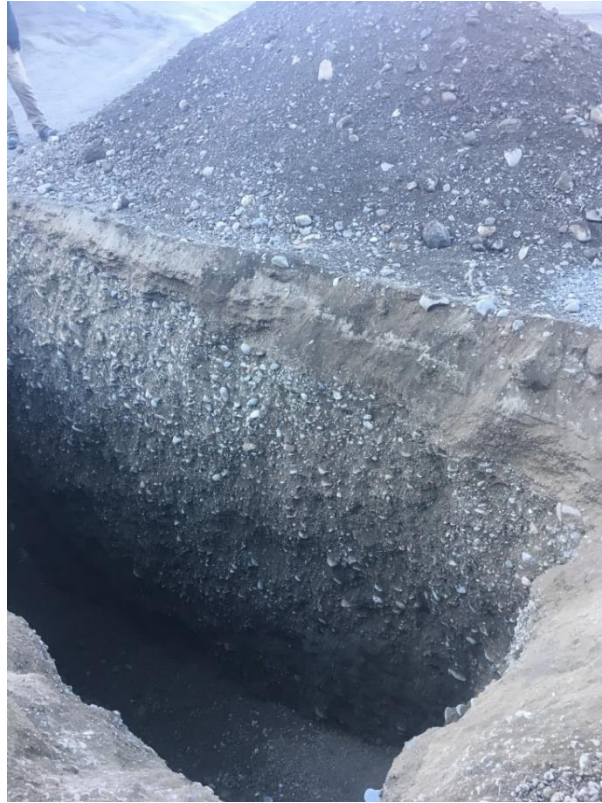
TP17-16, September 2017.

17-16	0	0.2		Floor									
	0.2	4.5	123	GP	53	45	2	210	10	5	0	C	Consistent with 17-15
				GP	50	48.2	1.8						
17-17	0	0.6		SP									Dirty, lots of boulders

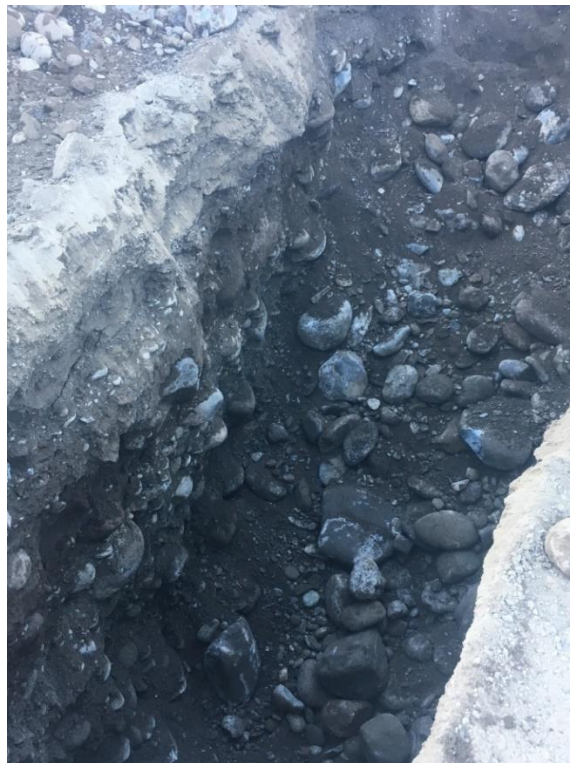
TP17-17, September 2017.

0.6	2.6	124	SP	20	76	4	400	12	10	1	M-F	Will need primary crusher
				GP	53.4	39.3	7.3						
17-18	0	0.6		Floor									Lots of boulders
	0.6	1.3		GP									Dirty, layer of fines

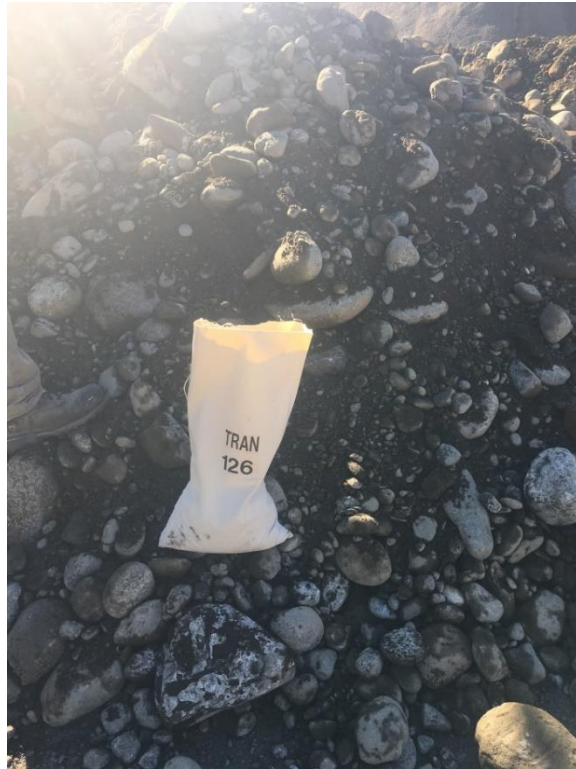
TP17-19 Spoil, September 2017.

0.9	4.8	126	SP	40	57	3	400	15	10	2	C-M	
				GP	49.3	43.5	7.3						
17-20	0	0.25		Floor									Boulders, dirty sand
	0.25	5.1	127	GP	49	48	3	390	20	15	1	C-M	Similar to 17-16 and 17
17-21	0	0.2		Floor

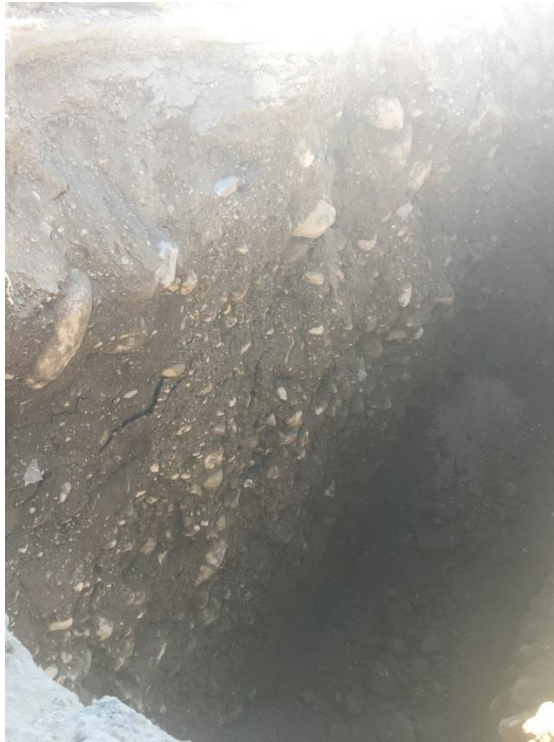
TP17-21, September 2017.

0.2	5	128	GP	55	42	3	270	15	10	0	C-M	Boulders, dirty and gritty
				GP	56.3	38.4	5.3						
17-22	0	0.1		Floor									Sloughing & sandy on W side
	0.1	4	129	SP	47	51	2	320	15	10	0	C-M	Top 2m very sandy
				GP	63.3	31.7	5
