Tatla Lake Pit No. 1928 Technical Summary

June 2025

Pit Name: Tatla Lake Pit

Provincial Pit Number: 1928

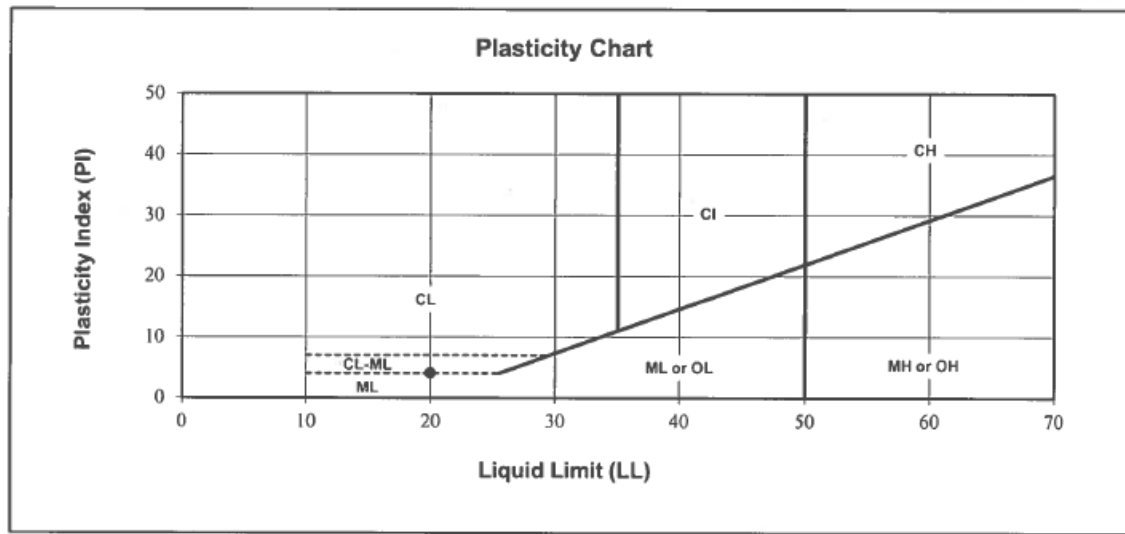
Atterberg Limits Test Report are shown below:

Liquid Limit (LL) :	20	Natural Moisture (%)	9.5
Plastic Limit (PL) :	16	Soil Plasticity:	Low
Plasticity Index (PI) :	4	Mod.USCS Symbol*:	CL-ML

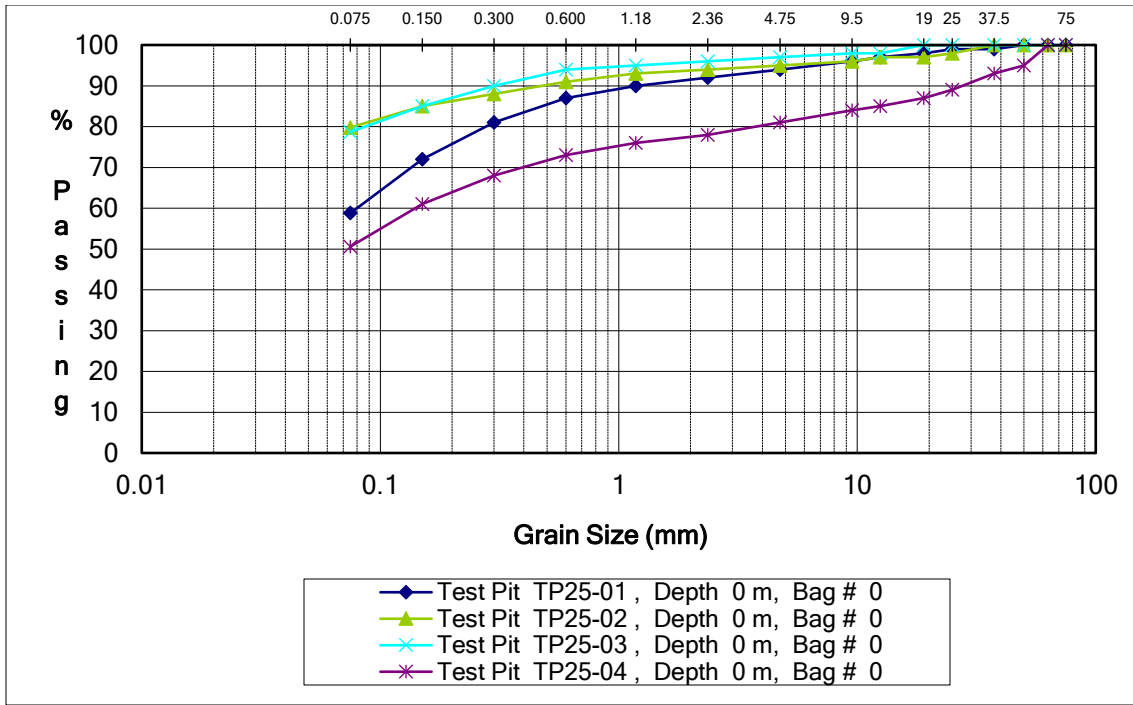
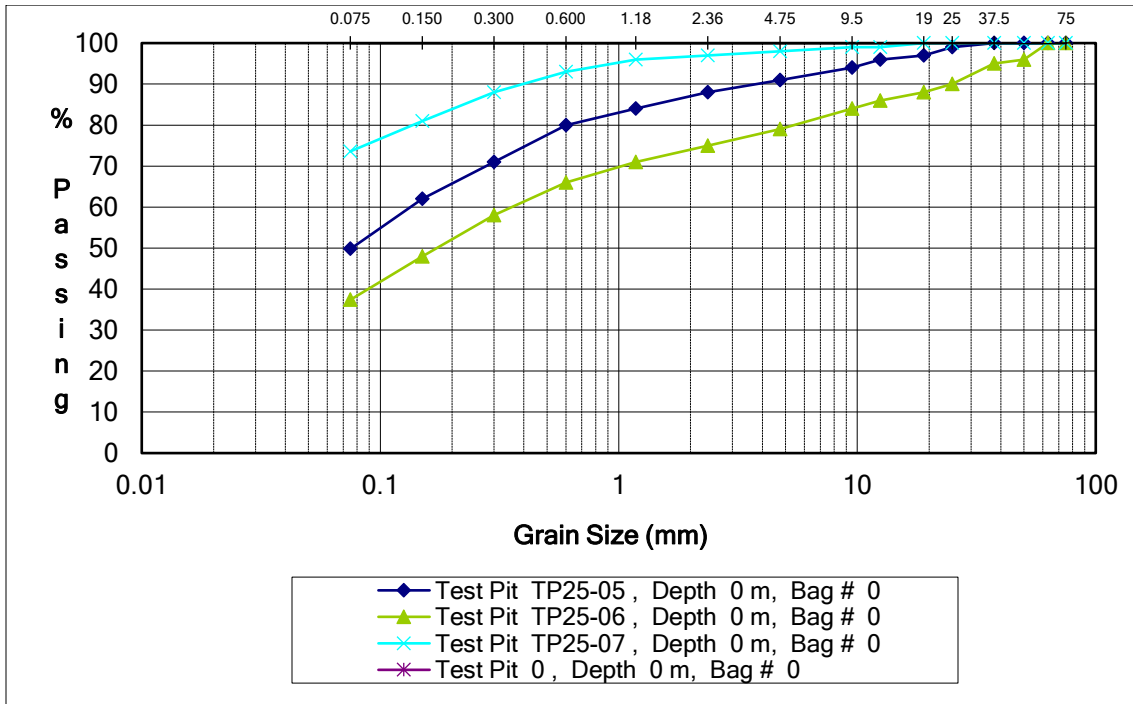
PROJECT REPORT OF				PERCENT PASSING													
SIEVE ANALYSIS SUMMARIES																	
Project:	0			Project No.:												0	
Sample No:	0			Client:												0	
Material:	PIT RUN			Date:												#####	
Test Pit	Percent Passing																
	Pit Run Sieve Sizes (mm)																
	75	63	50	37.5	25	19	12.5	9.5	4.75	2.36	1.18	0.6	0.3	0.15	0.075		
TP25-01	100.0	100.0	100.0	99.0	99.0	98.0	97.0	96.0	94.0	92.0	90.0	87.0	81.0	72.0	58.8		
TP25-02	100.0	100.0	100.0	100.0	98.0	97.0	97.0	96.0	95.0	94.0	93.0	91.0	88.0	85.0	79.8		
TP25-03	100.0	100.0	100.0	100.0	100.0	100.0	98.0	98.0	97.0	96.0	95.0	94.0	90.0	85.0	78.7		
TP25-04	100.0	100.0	95.0	93.0	89.0	87.0	85.0	84.0	81.0	78.0	76.0	73.0	68.0	61.0	50.6		
TP25-05	100.0	100.0	100.0	100.0	99.0	97.0	96.0	94.0	91.0	88.0	84.0	80.0	71.0	62.0	49.8		
TP25-06	100.0	100.0	96.0	95.0	90.0	88.0	86.0	84.0	79.0	75.0	71.0	66.0	58.0	48.0	37.4		
TP25-07	100.0	100.0	100.0	100.0	100.0	100.0	99.0	99.0	98.0	97.0	96.0	93.0	88.0	81.0	73.6

Material Gradation: Table 1 shows the gradation as a percentage by weight of the fines (silts and clays), sand and gravel components as well as the Unified Soil Classification (USC [included after test pit summary]) for the samples tested from Area A.

Test Pit	Depth (m)	Fines (%)* <0.075mm	Sand (%)* 0.075-4.75mm	Gravel (%)* 4.75-75mm	USC
Area A					
TP25-01	4.8	59	35	6	SM5
TP25-02	4.3	79	16	5	SM7
TP25-03	4.6	79	18	3	SM7
TP25-04	4.2	51	30	19	SM5
TP25-05	4.4	50	41	9	SM5
TP25-06	4.2	37	42	21	SM3
TP25-07	4.3	74	24	2	SM7
Average – Area A		61	29	9	-

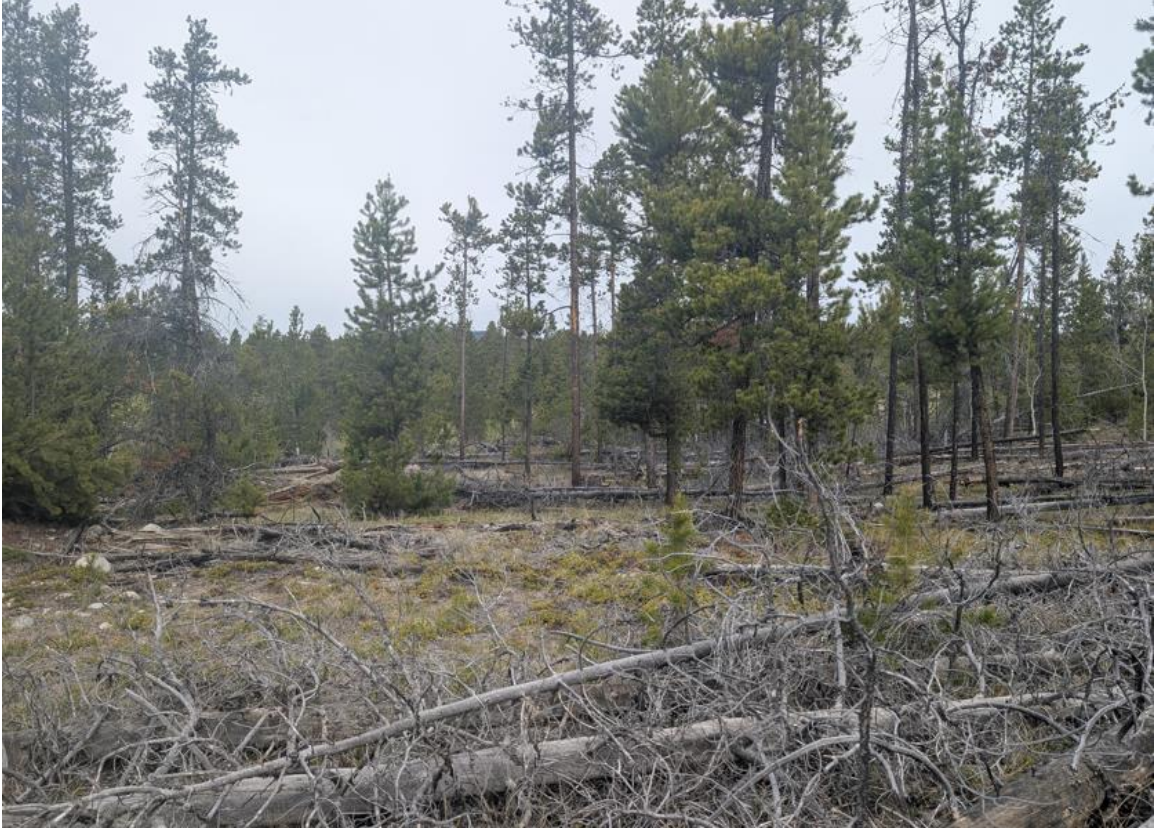
Photo of undeveloped portion of Area A

- Area A has been partially logged above the face but may require additional clearing, grubbing and stripping of overburden prior to extraction of granular materials.

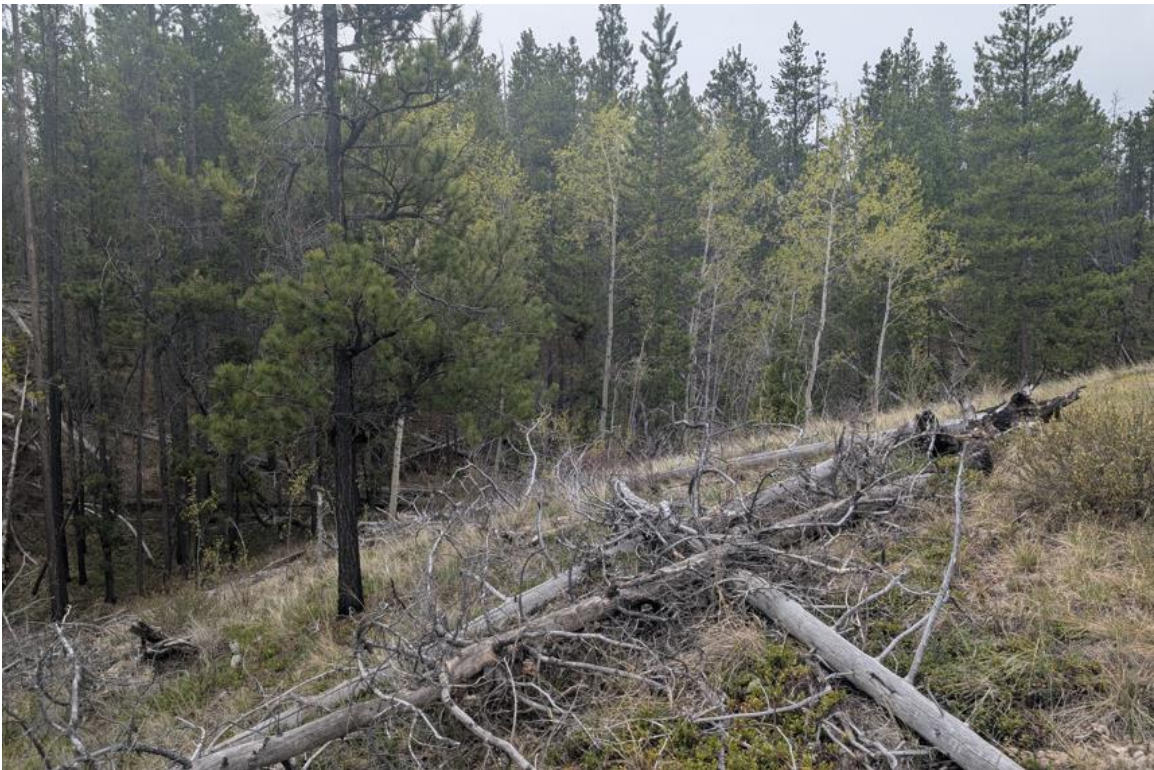
An area of lower elevation separates TP25-05 and TP25-06/07

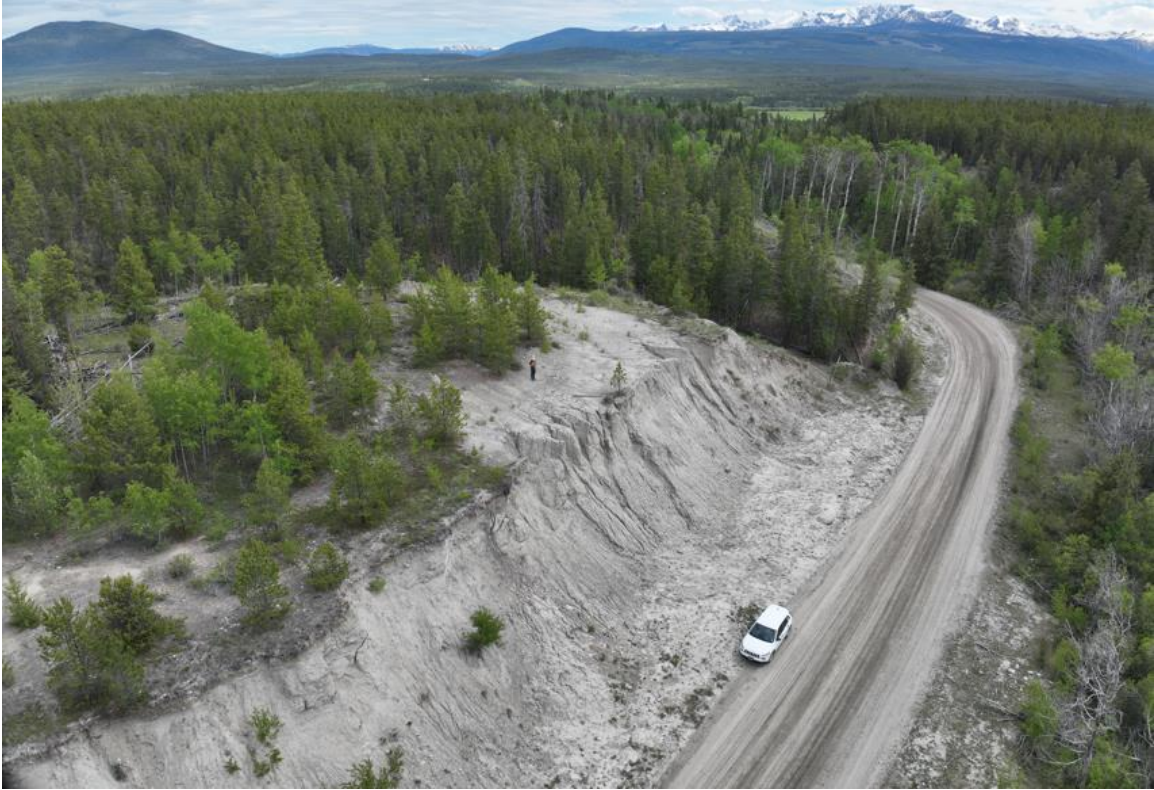
Drone photo facing south toward Tatla Lake. Some trees at the top of the face have been removed since this photo was taken.

- All trees, vegetation, and overburden are to be removed within 2m of the top of the pit faces. Topsoil, overburden, and aggregate cannot be removed within five meters of the reserve boundary.

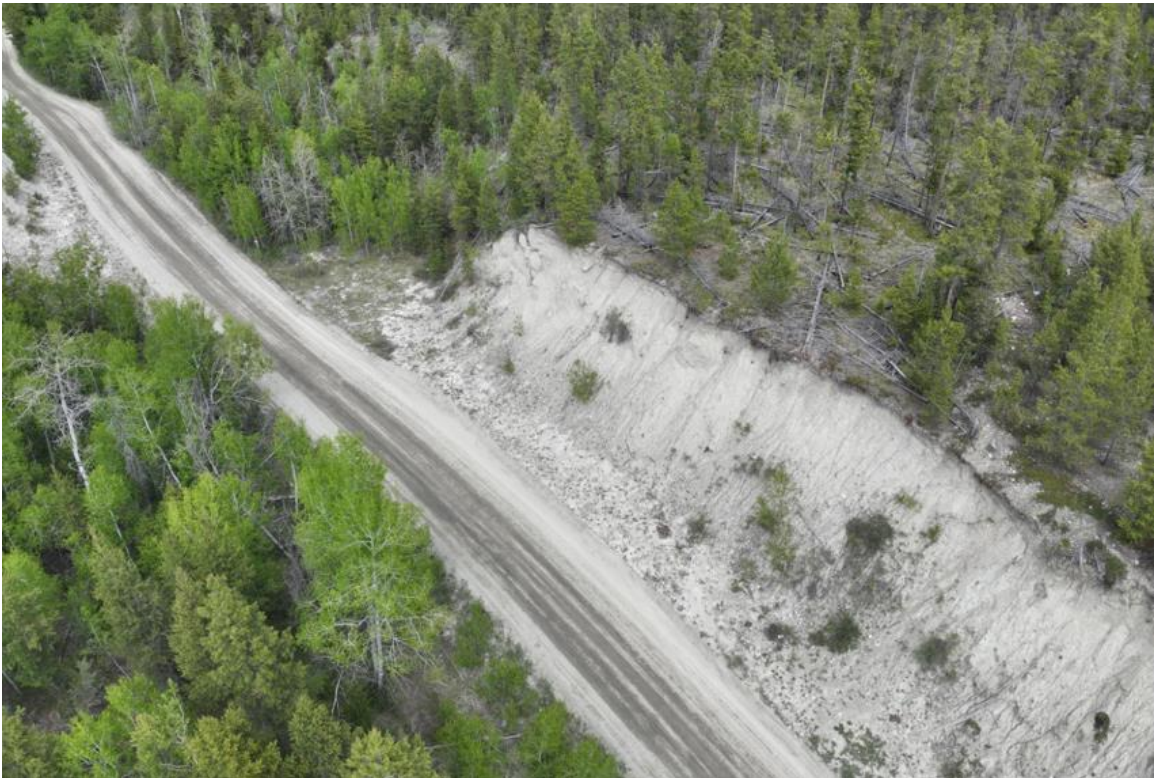
Drone photo taken from same location as previous photo, facing northeast.
